Inspection Photos

Location Name: CAERUS PICEANCE LLC GMR 27-2B1 (B27) Pad

Location #: 335376

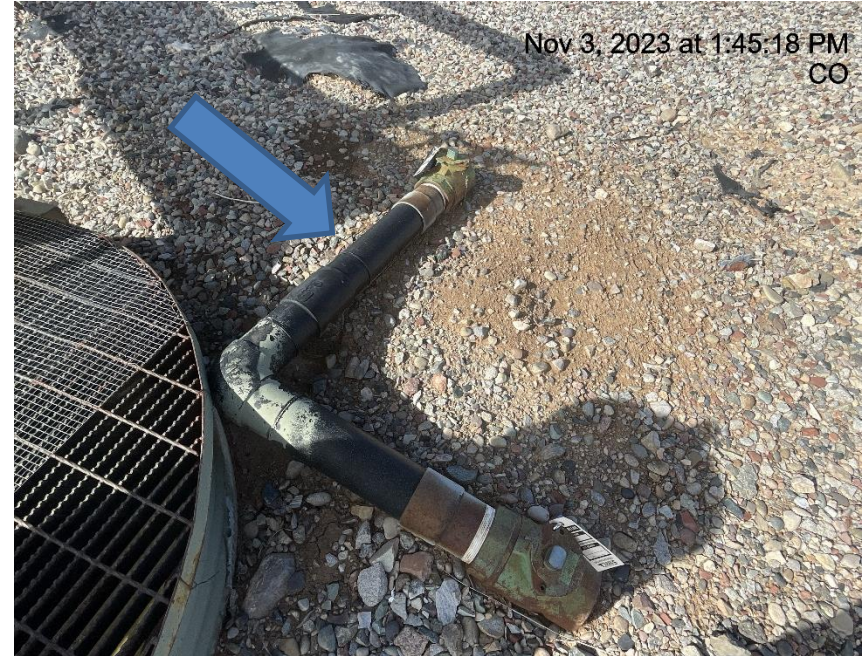
Photo # 5401 Debris

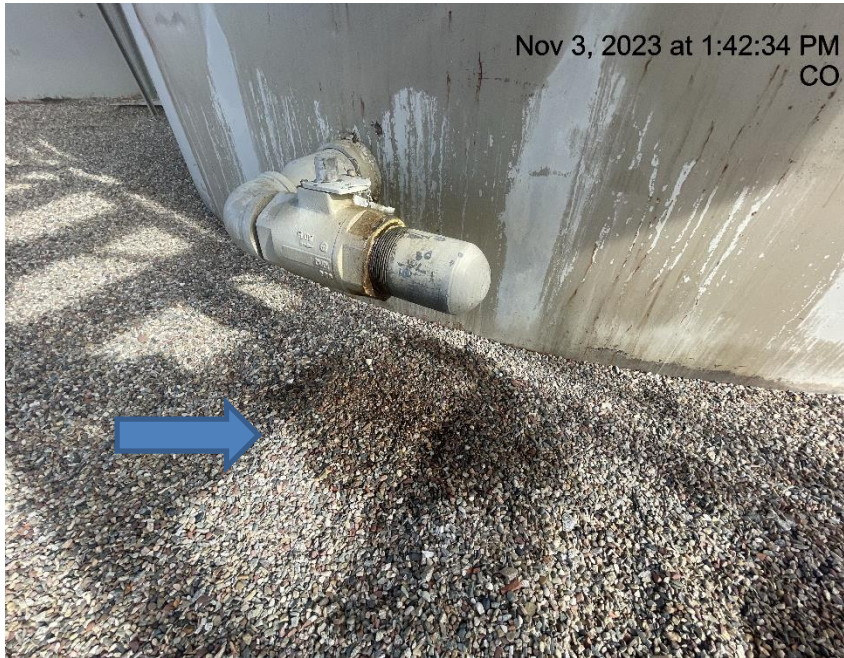
Photo # 5402 Stained gravel

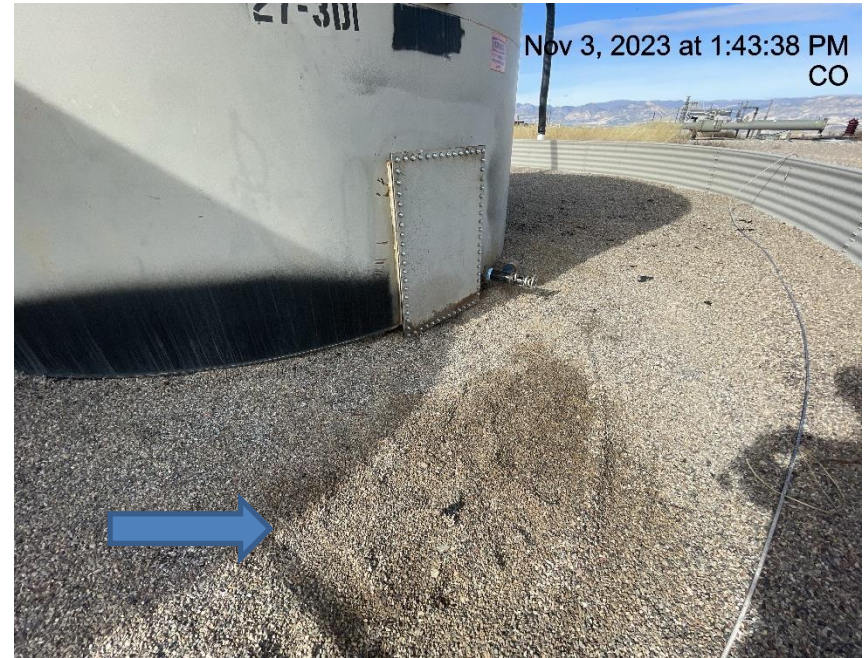
Photo # 5403 Stained gravel

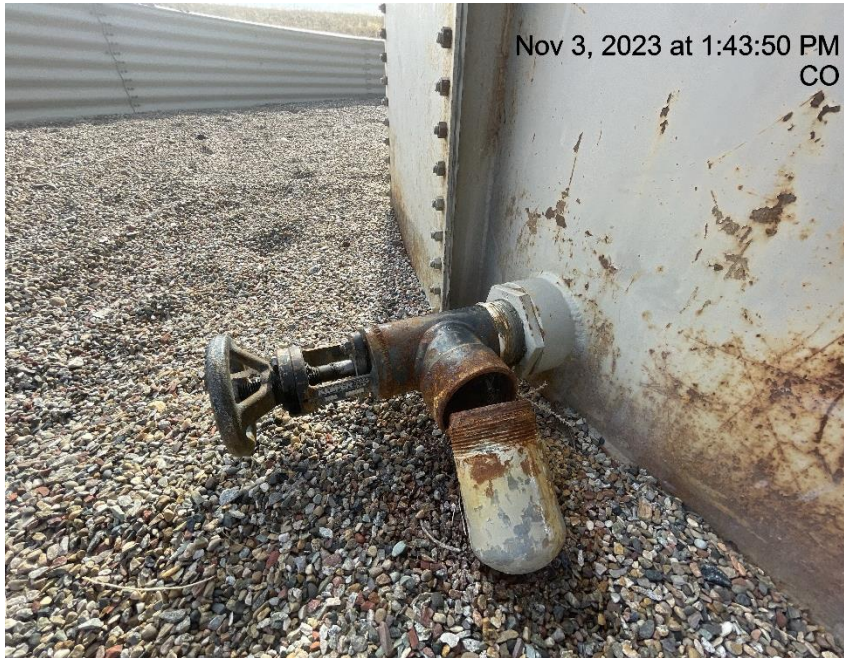
Photo # 5404 Open ended load line

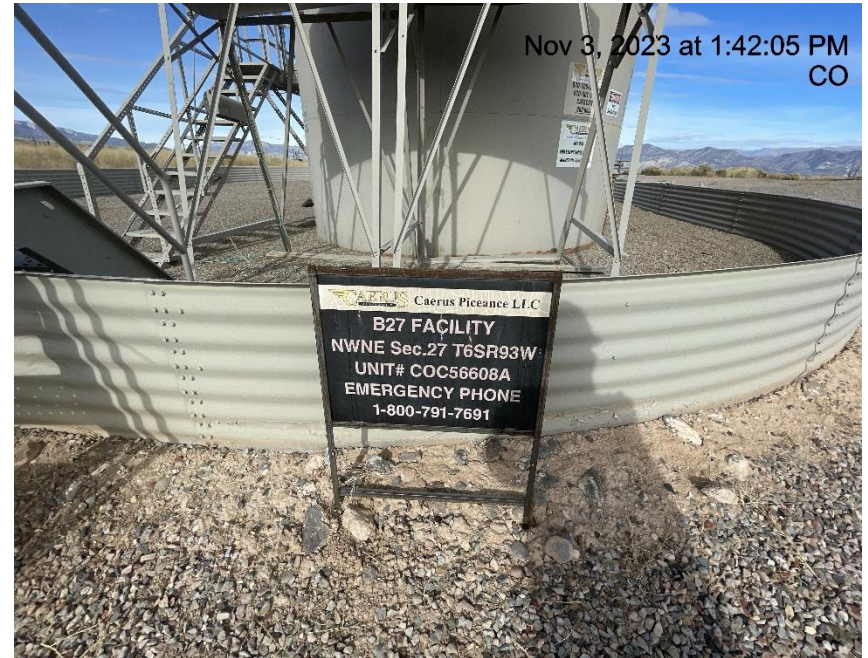
Photo # 5405 Battery sign lacks required info
