Inspection Photos

Operator: TEP ROCKY MOUNTAIN LLC #96850

Location ID: 322539

Inspection Doc: 696205405

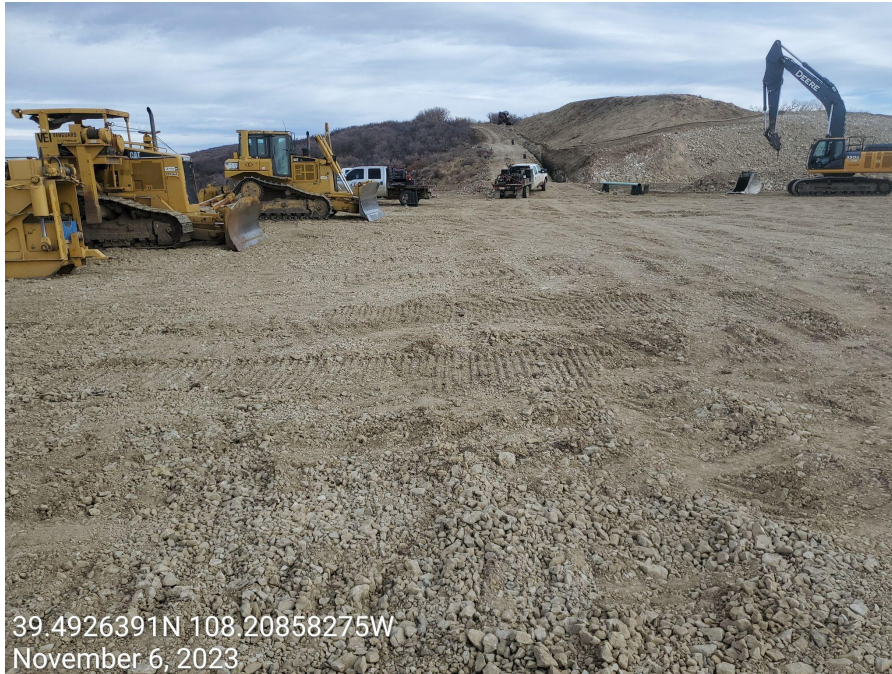
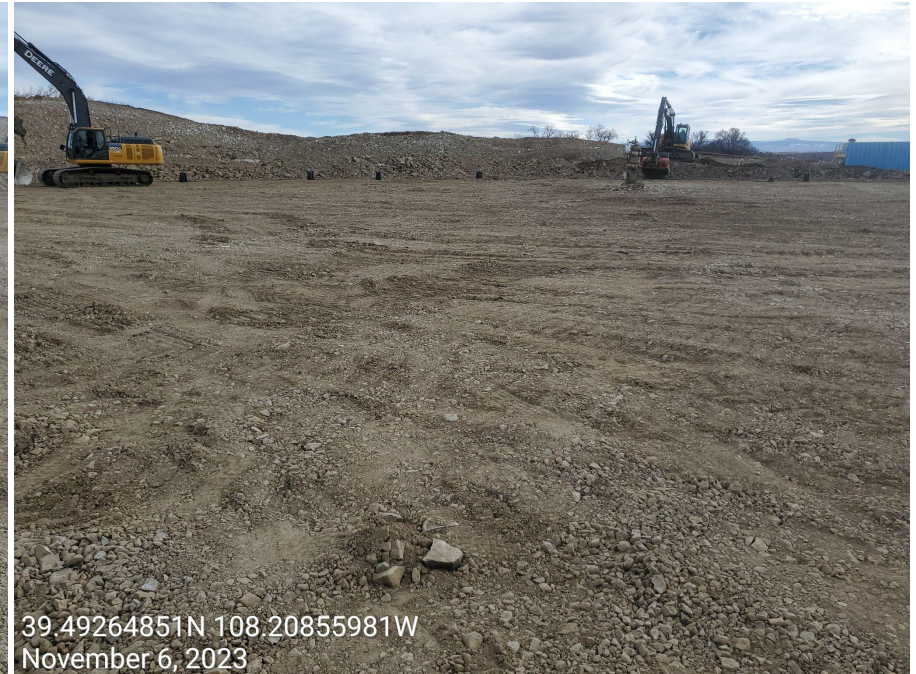
Photo 1: Photos 1-2 taken from the west end of the working pad surface. Photos provide an overview of the Location from north, northeast, southeast to south.

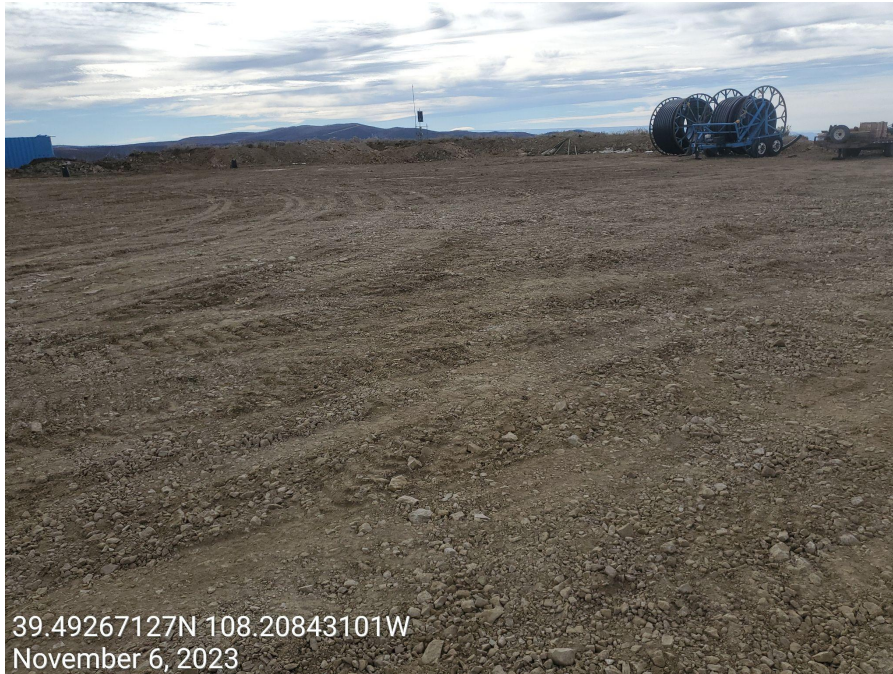
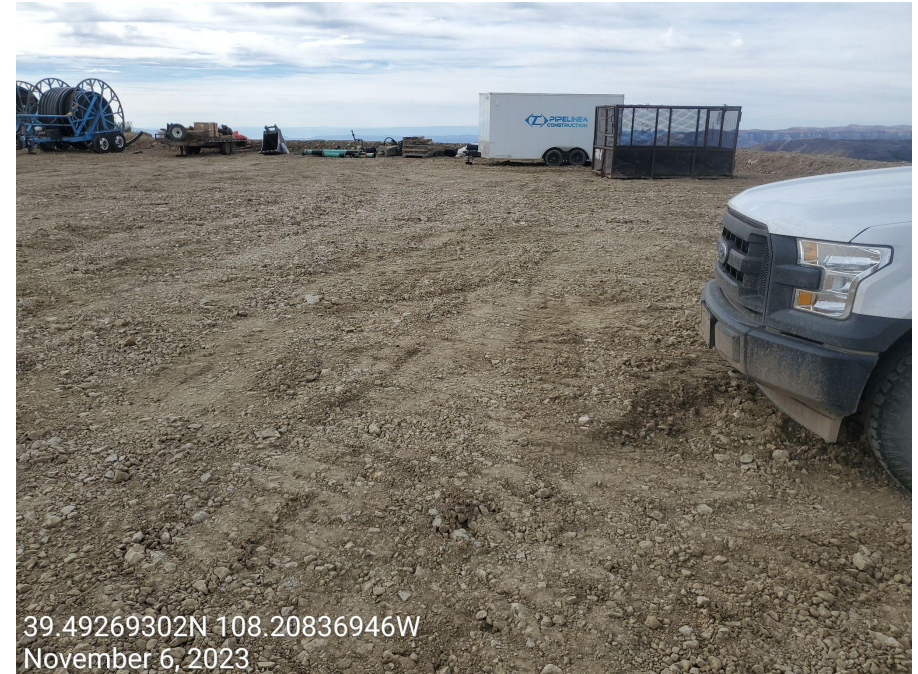
Photo 2: See comments under photo 1.

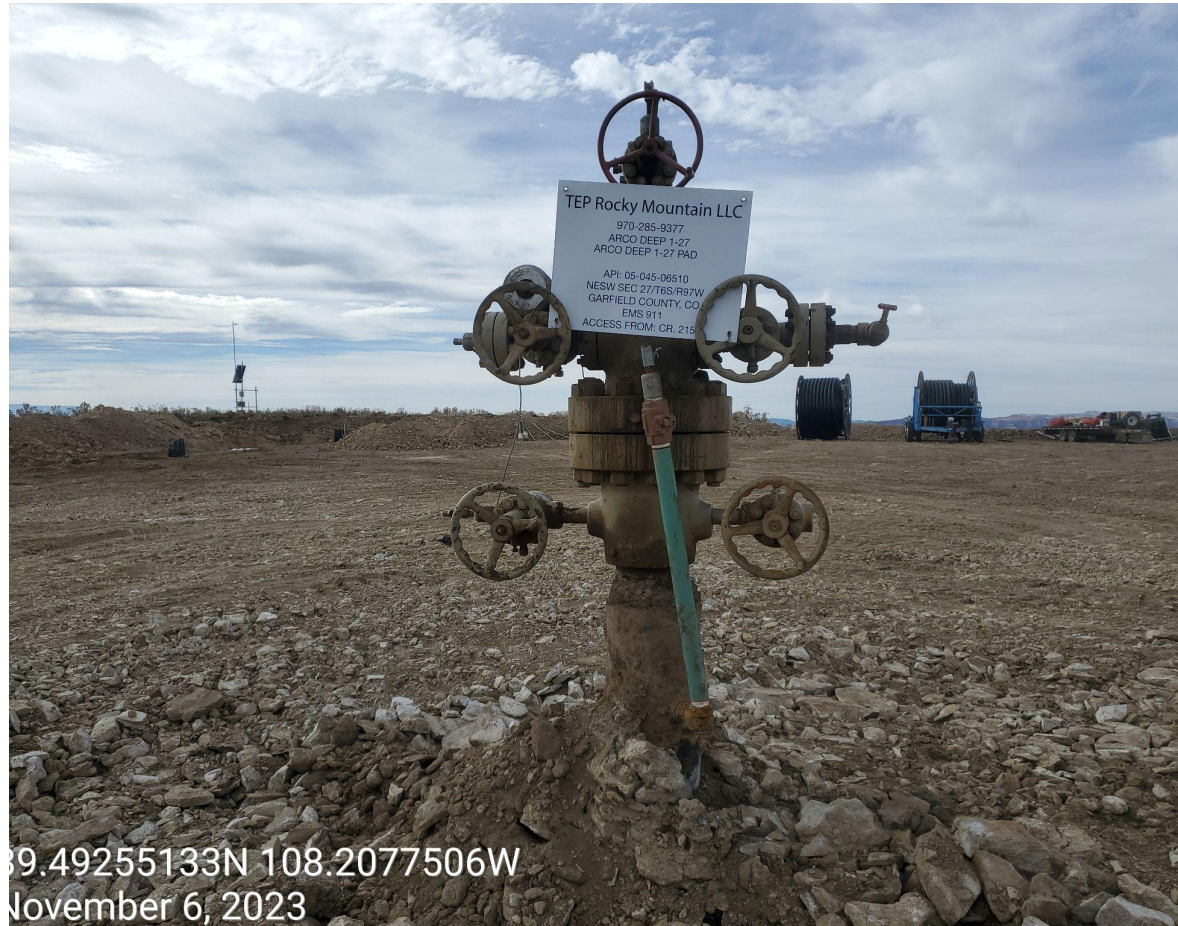
Photo 3: Wellhead

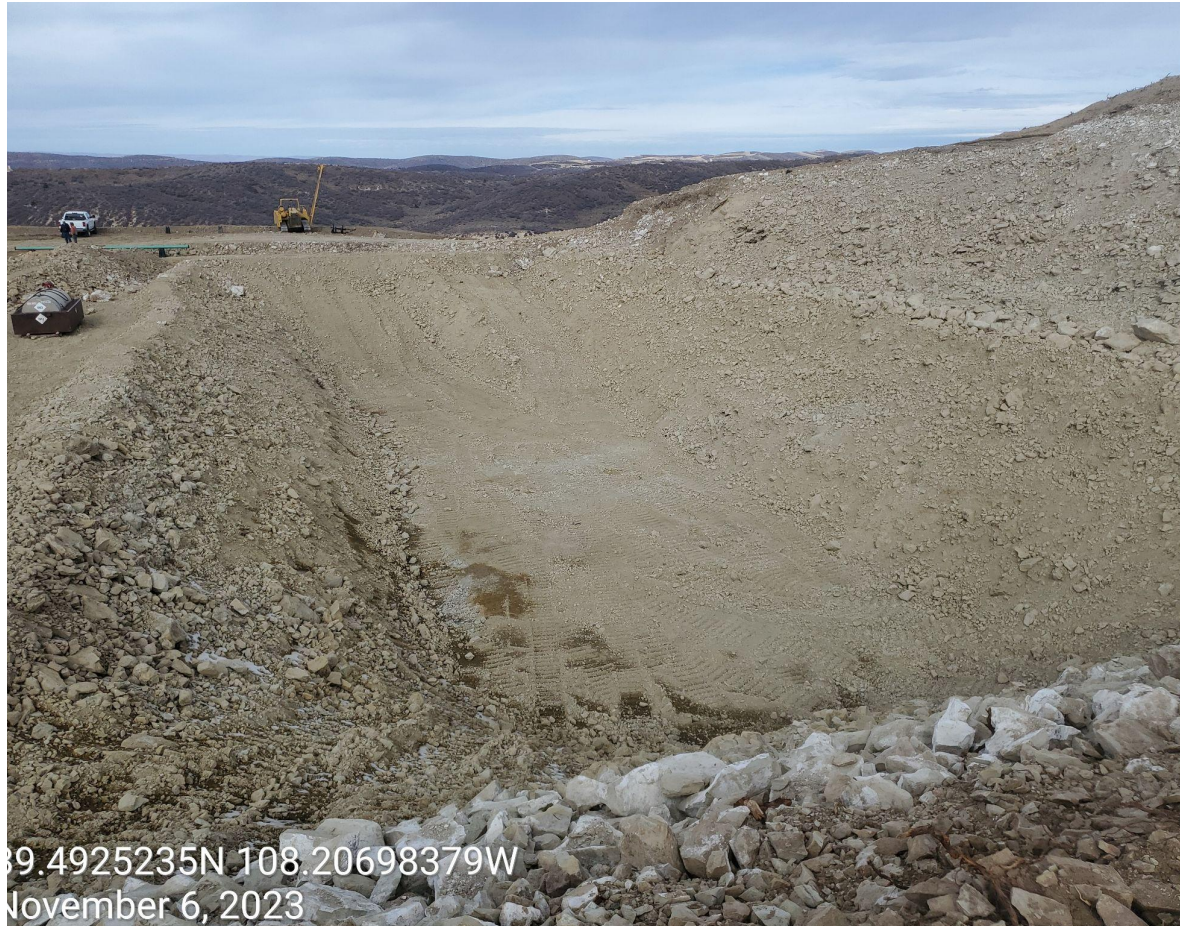
Photo 4: Photo shows cuttings trench on the north end of the Location; trench required Form 15 permitting.

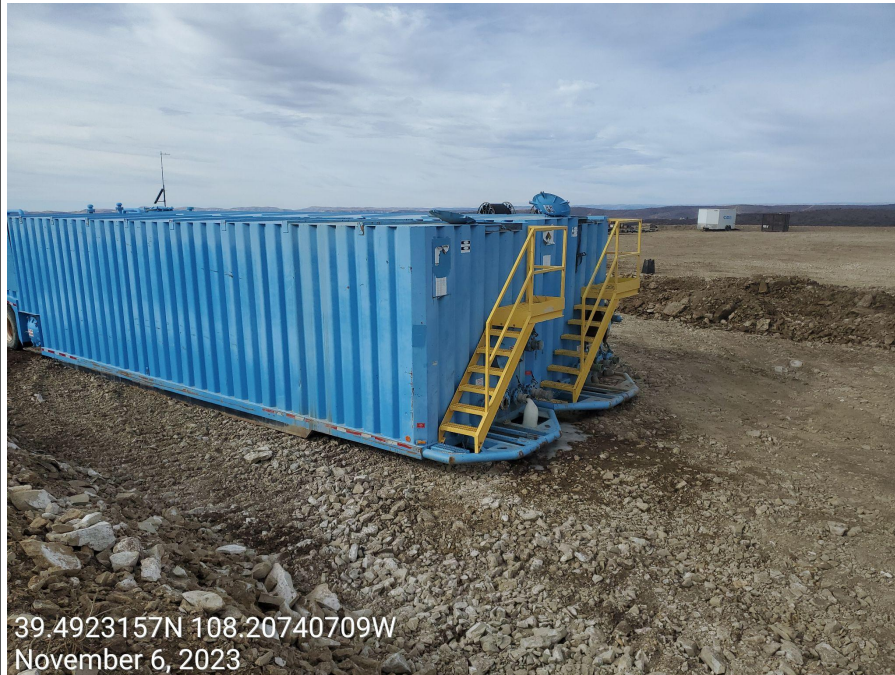
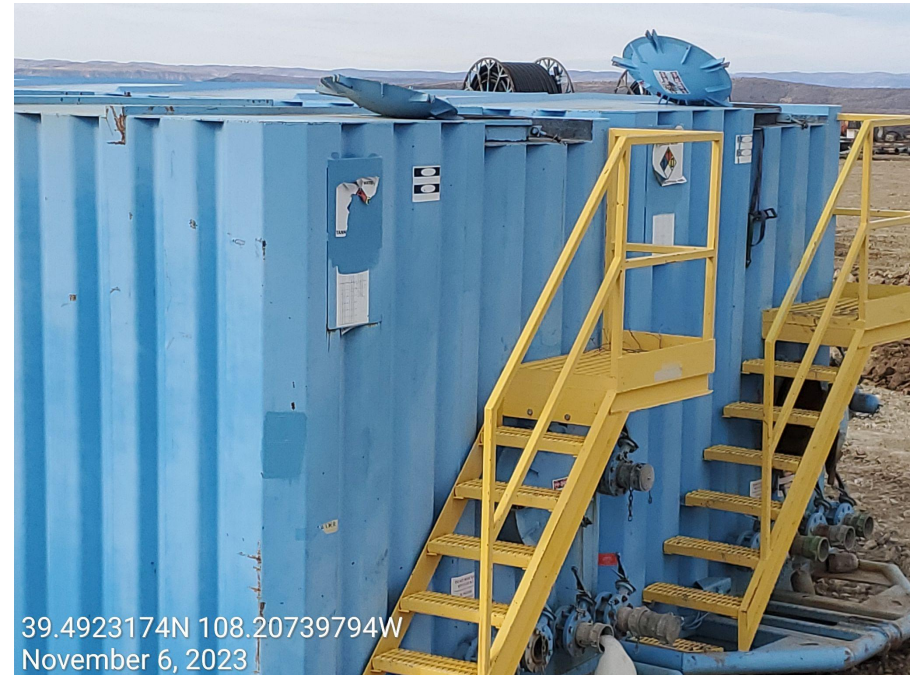
Photo 5: Tanks on east end of the Location lacks required labeling/signage.

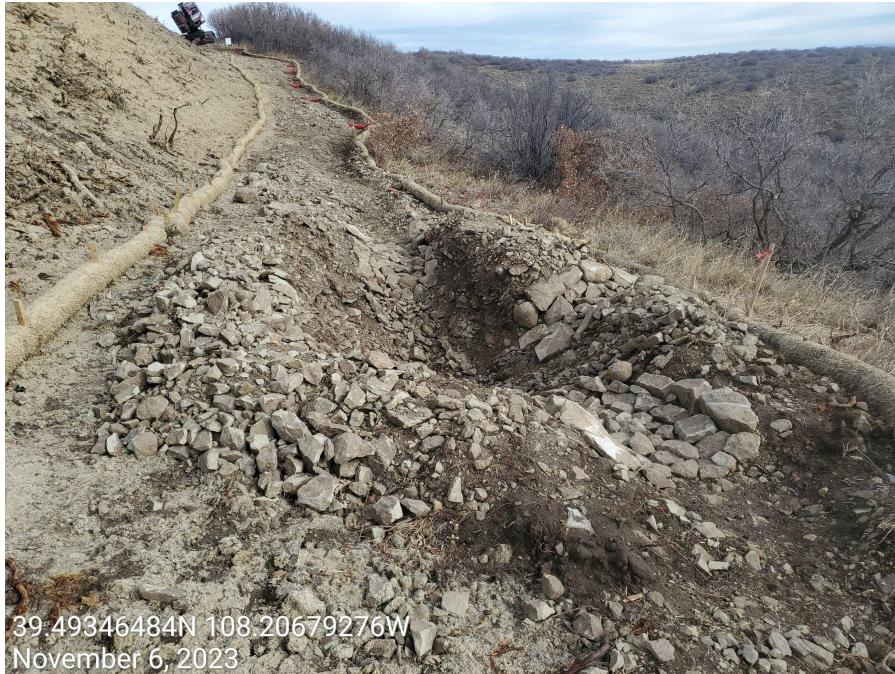
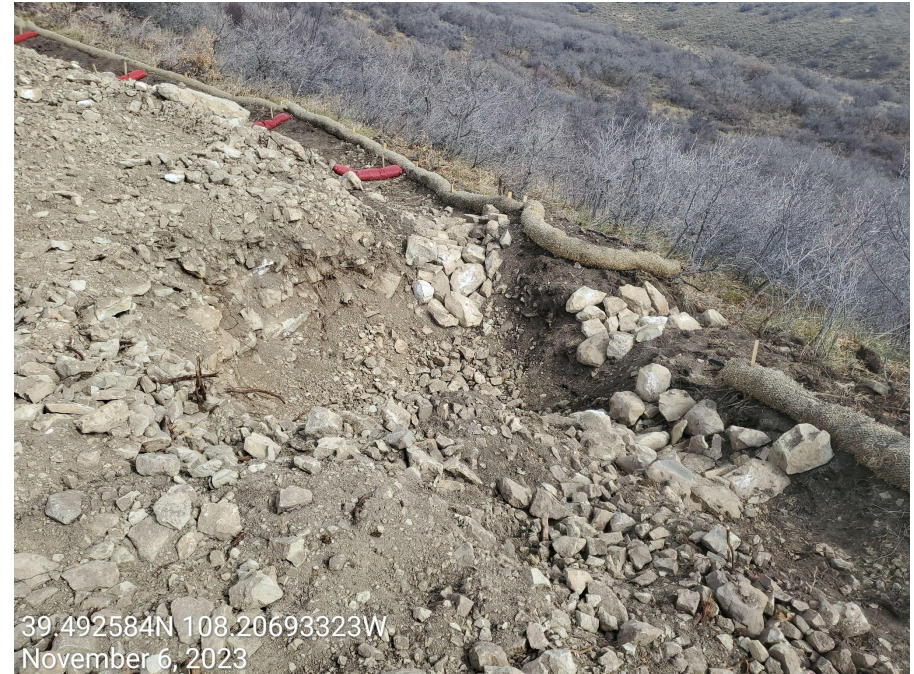
Photo 6: Photos 6-8 show sediment traps constructed on the east, south and west ends of the Location.

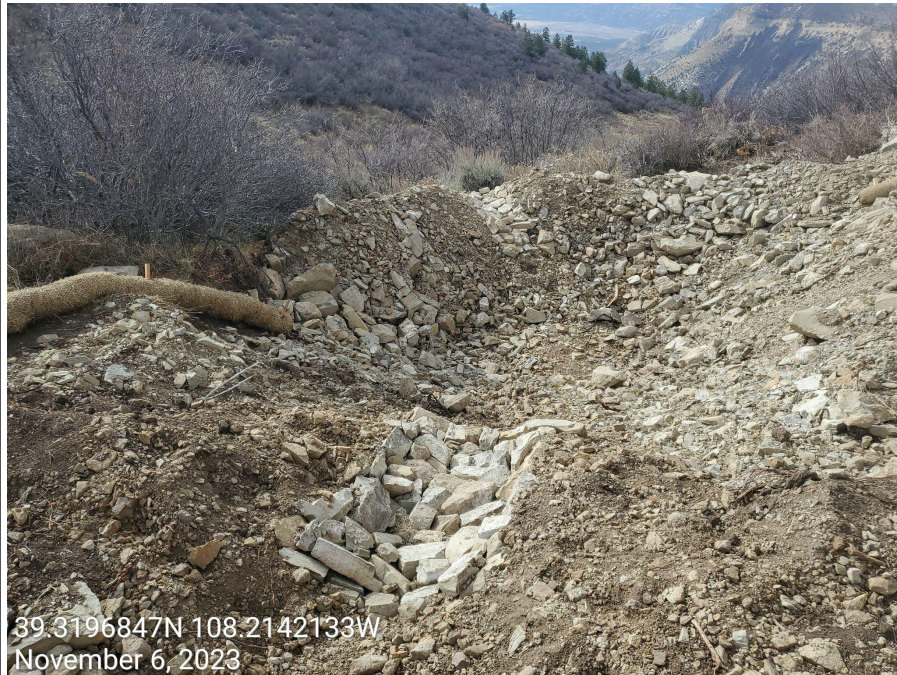
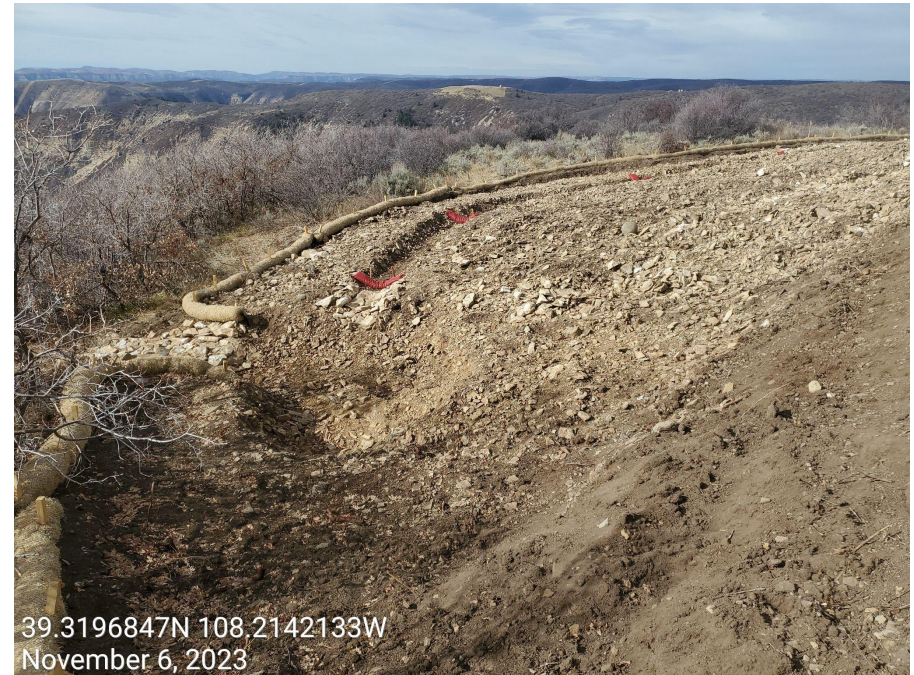
Photo 7: See comments under photo 6.

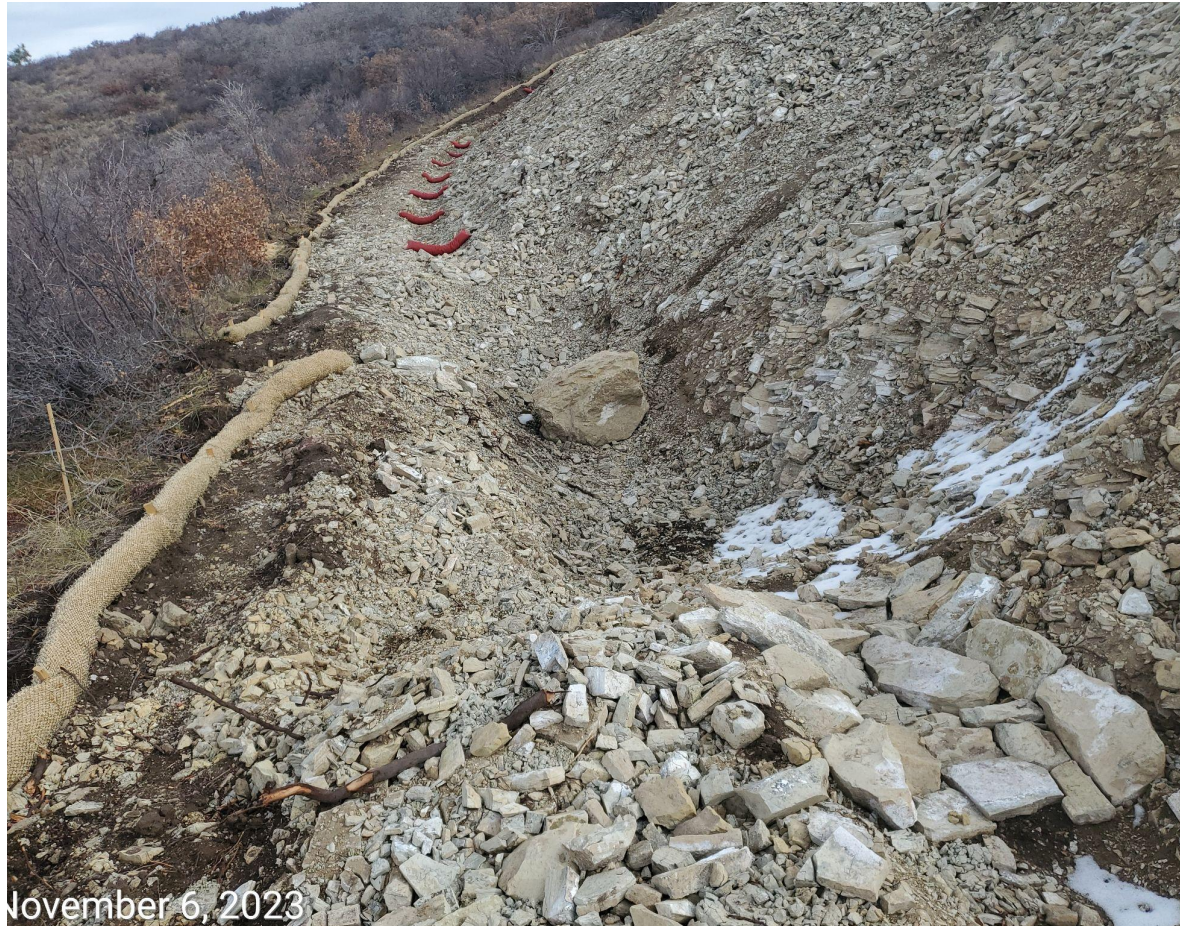
Photo 8: See comments under photo 6.

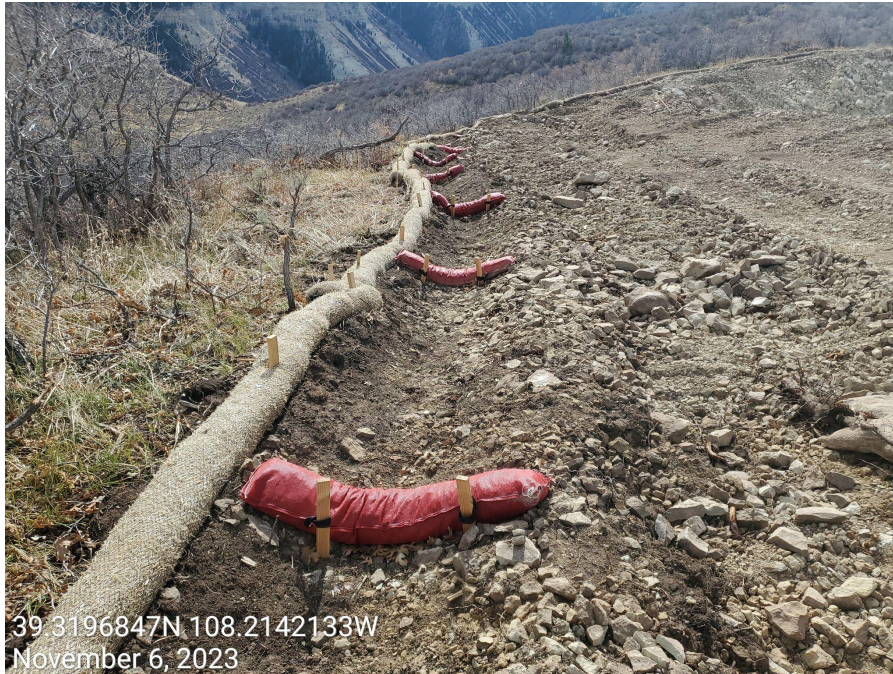
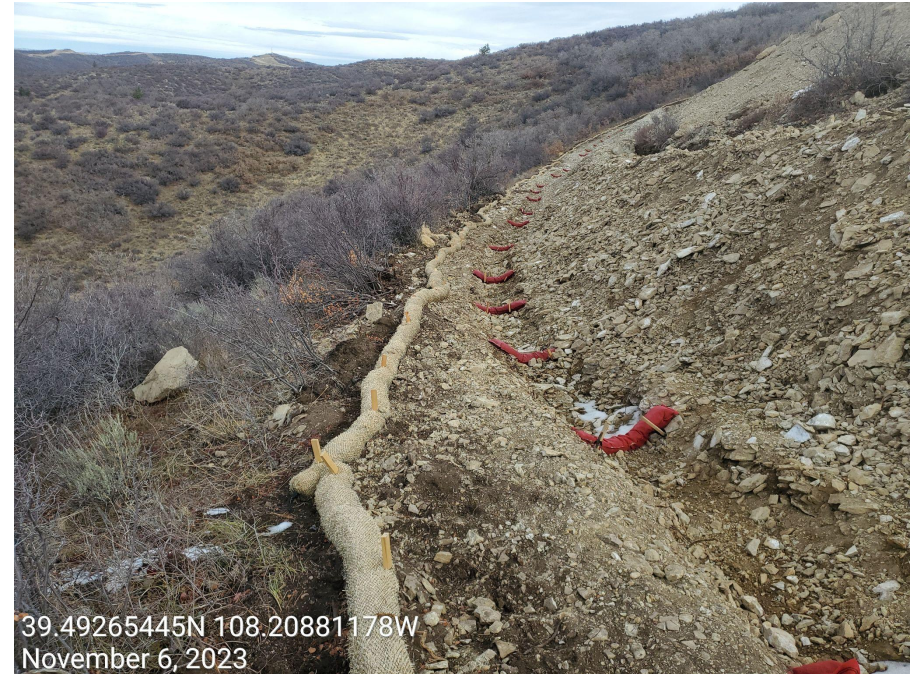
Photo 5: Photos examples showing the stormwater diversion ditch constructed along the Location's perimeter.

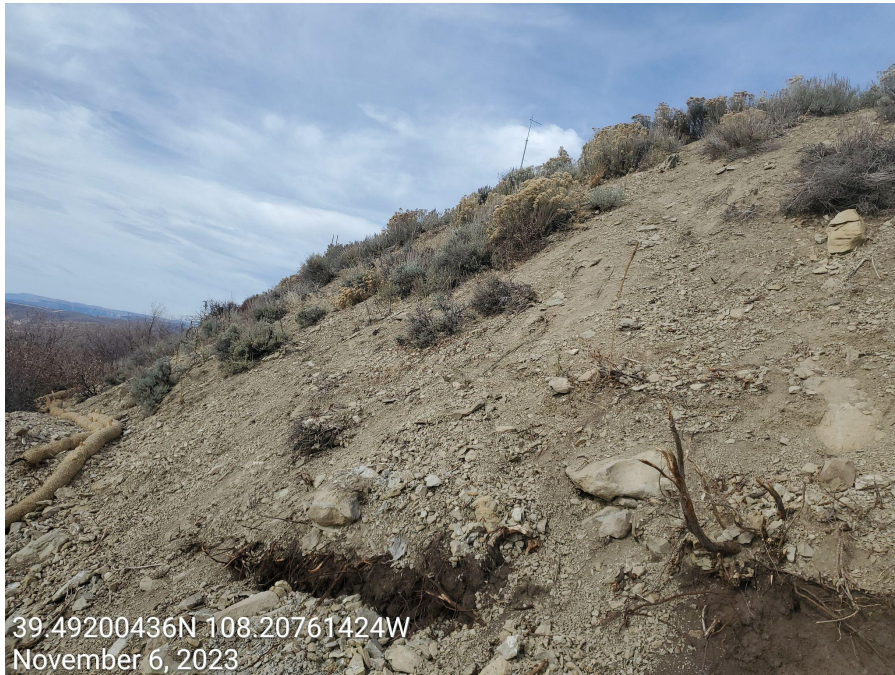
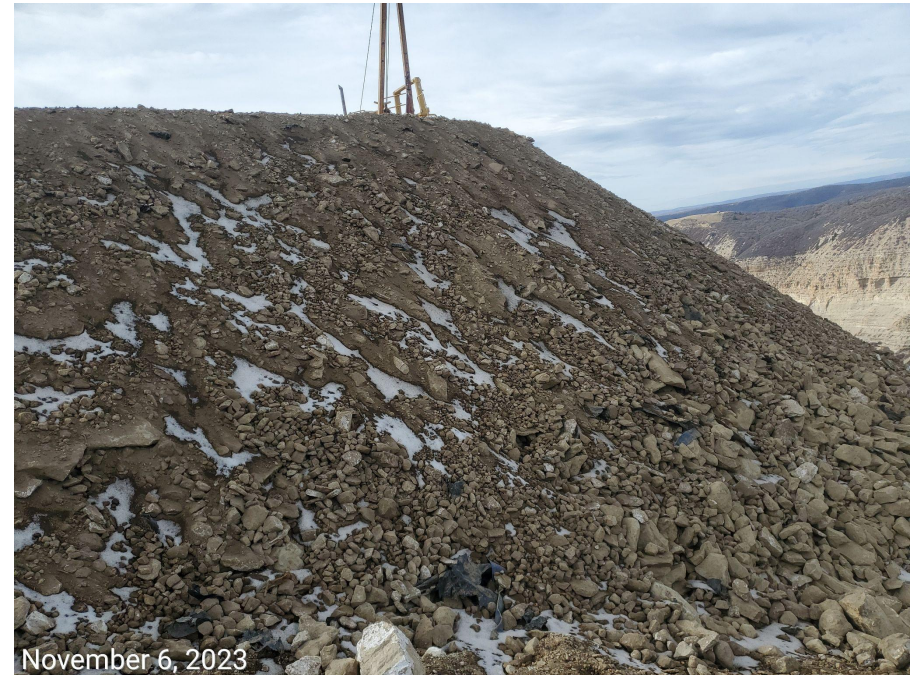
Photo 10: Photos 10-12 example showing control measures to stabilize, as well as to minimize erosion and degradation are missing or insufficient along the fill slopes.

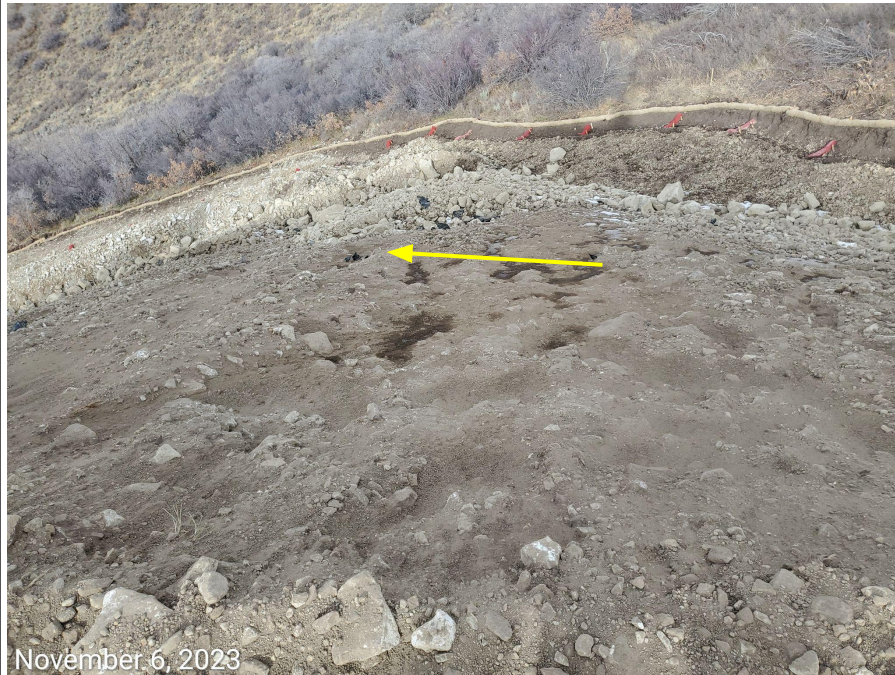
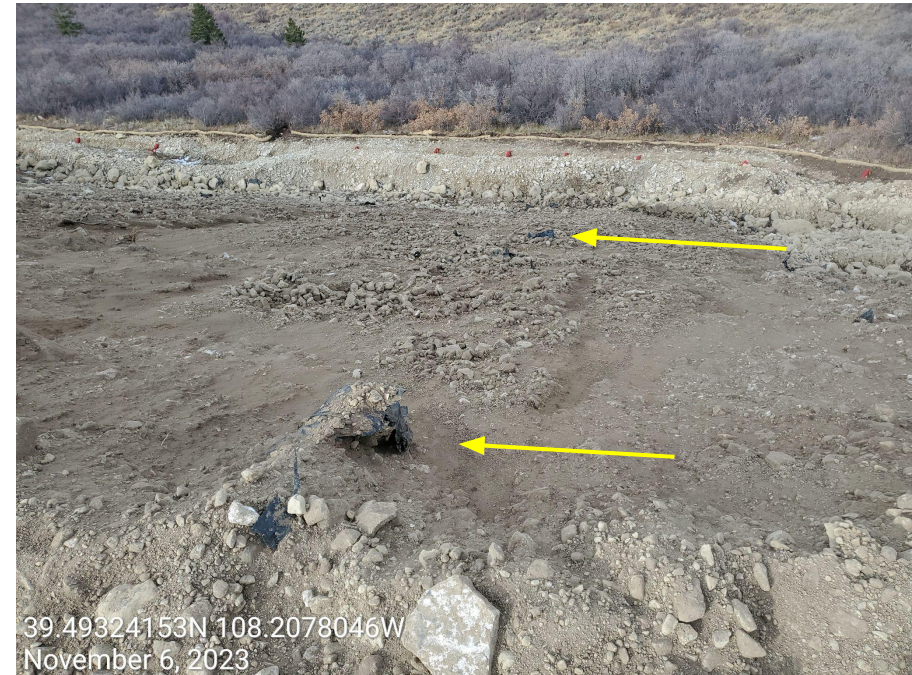
Photo 11: See comments under photo 10. Photo also example showing various tarp/liner material observed along the fill slopes.

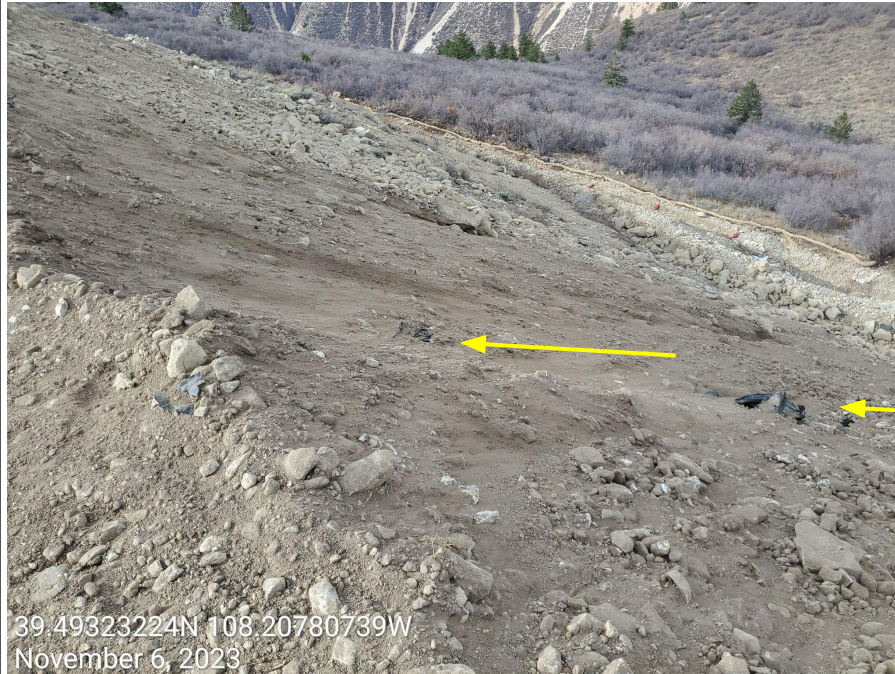
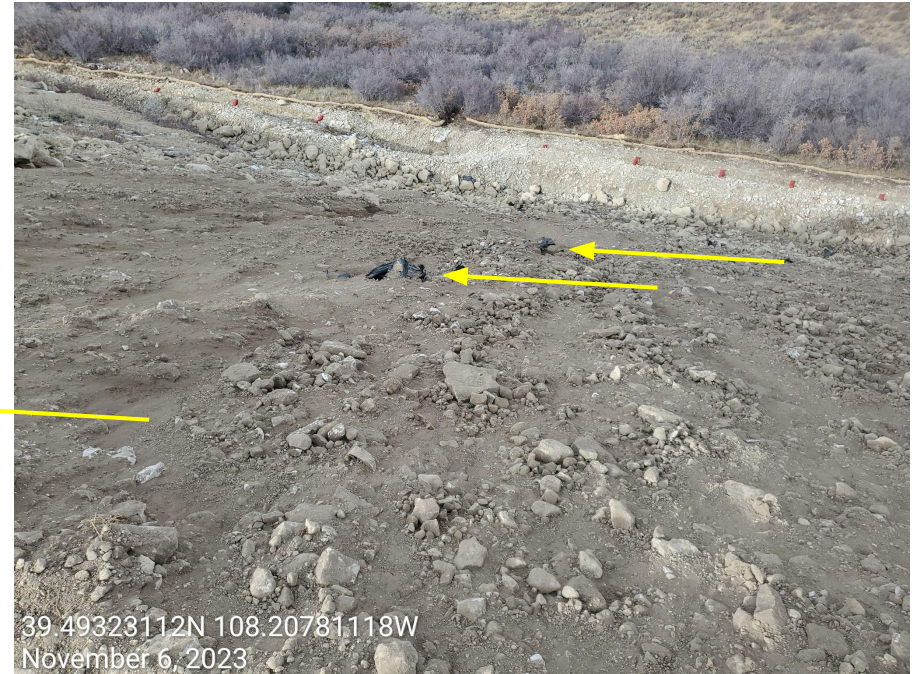
Photo 12: See comments under photo 11.

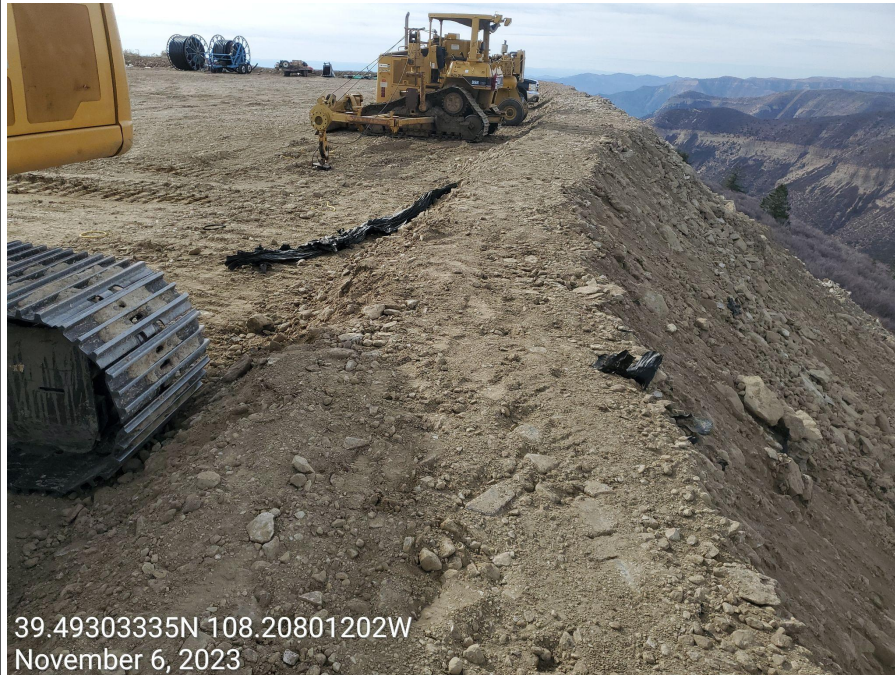
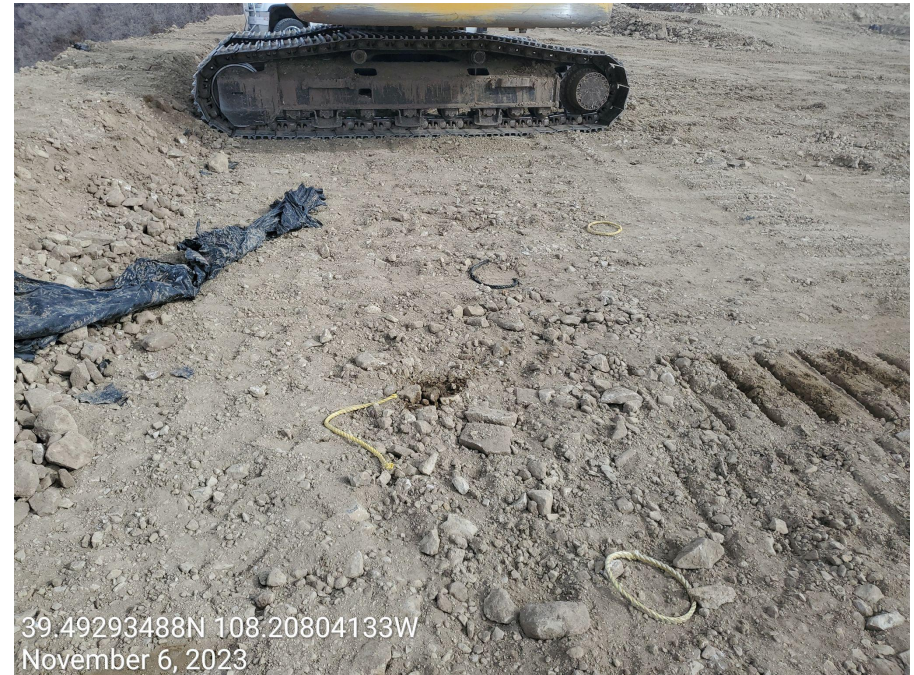
Photo 13: Trash/debris on Location

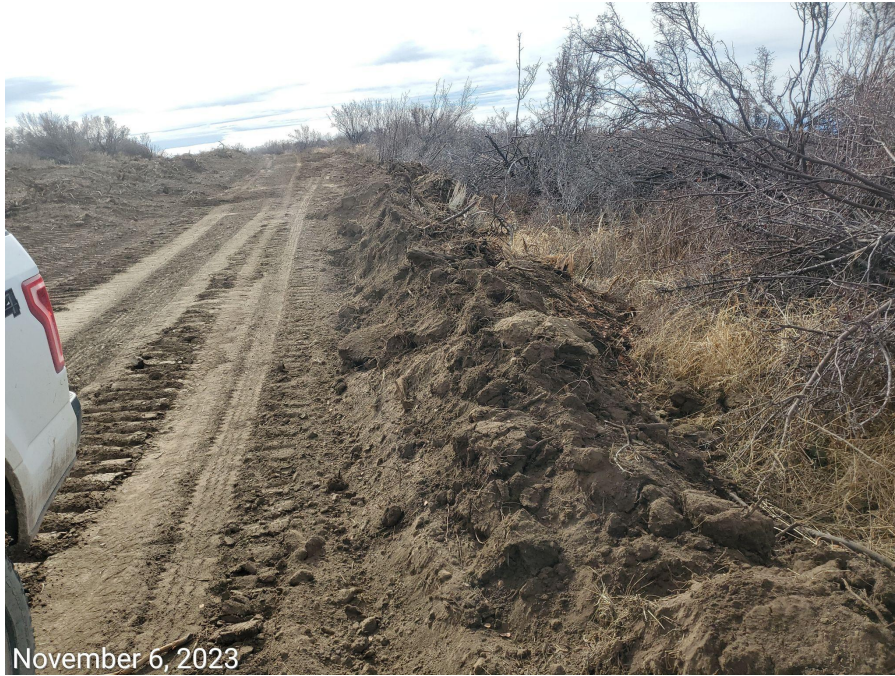
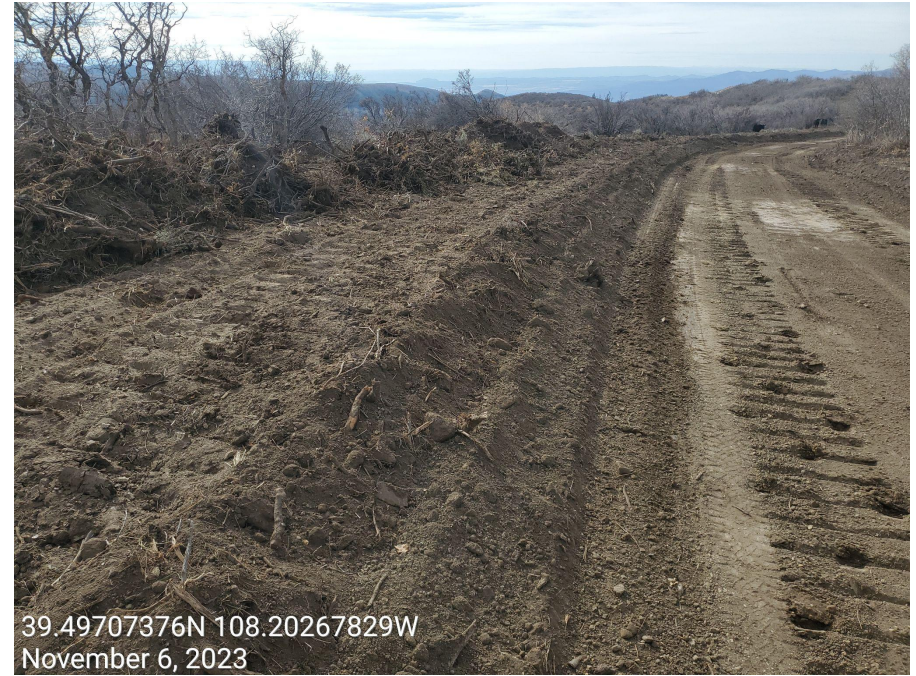
Photo 14: Photos 14-16 taken from the access road / pipeline right away. Photos show stormwater and erosion control measures to manage runoff to minimize erosion, degradation and sediment transport are missing or insufficient along the access road/ROW.

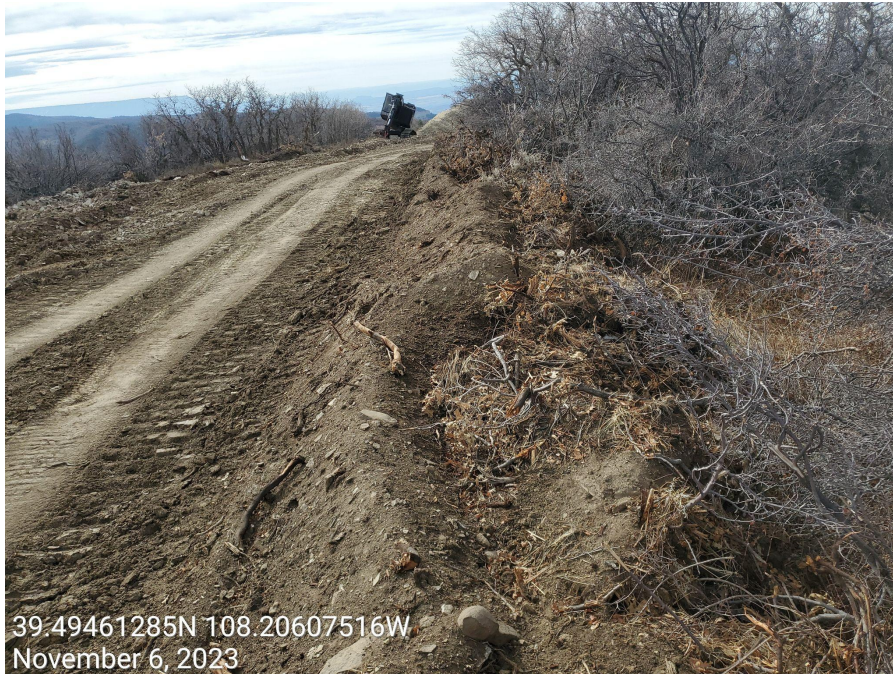
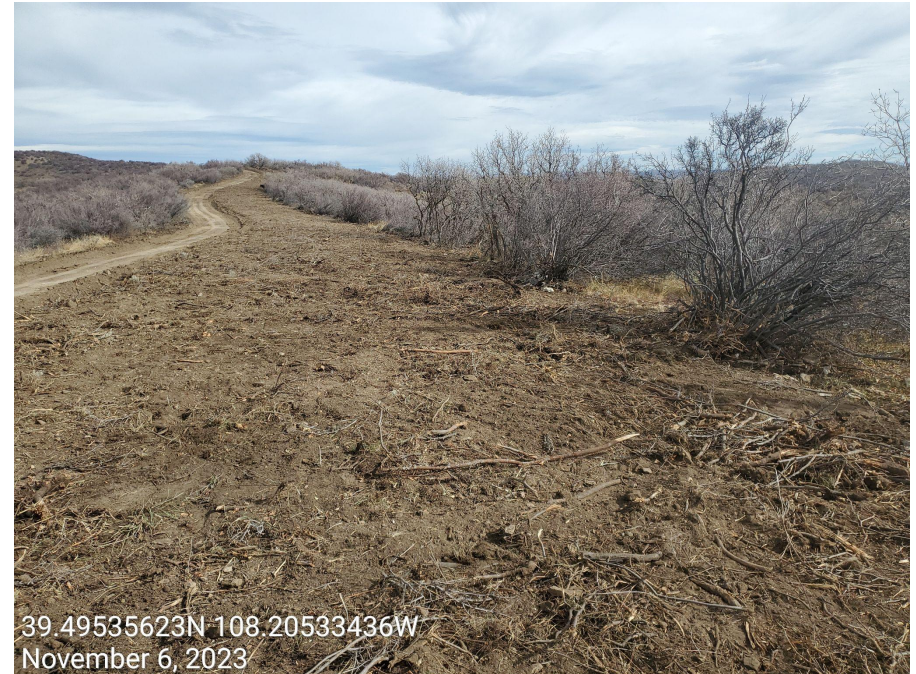
Photo 15: See comments under photo 14.

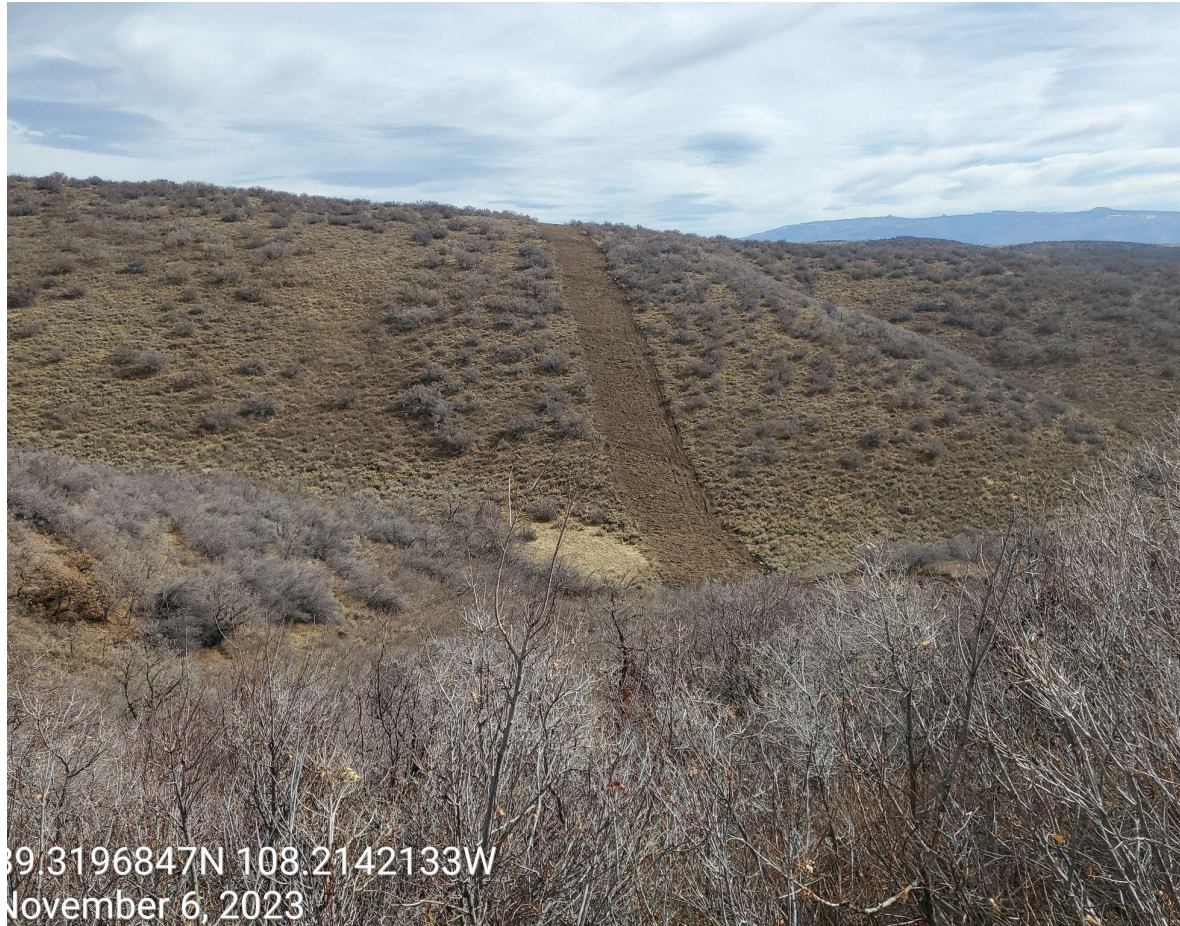
Photo 16: Photo shows pipeline ROW recently constructed. Stormwater and erosion control measures not apparent.

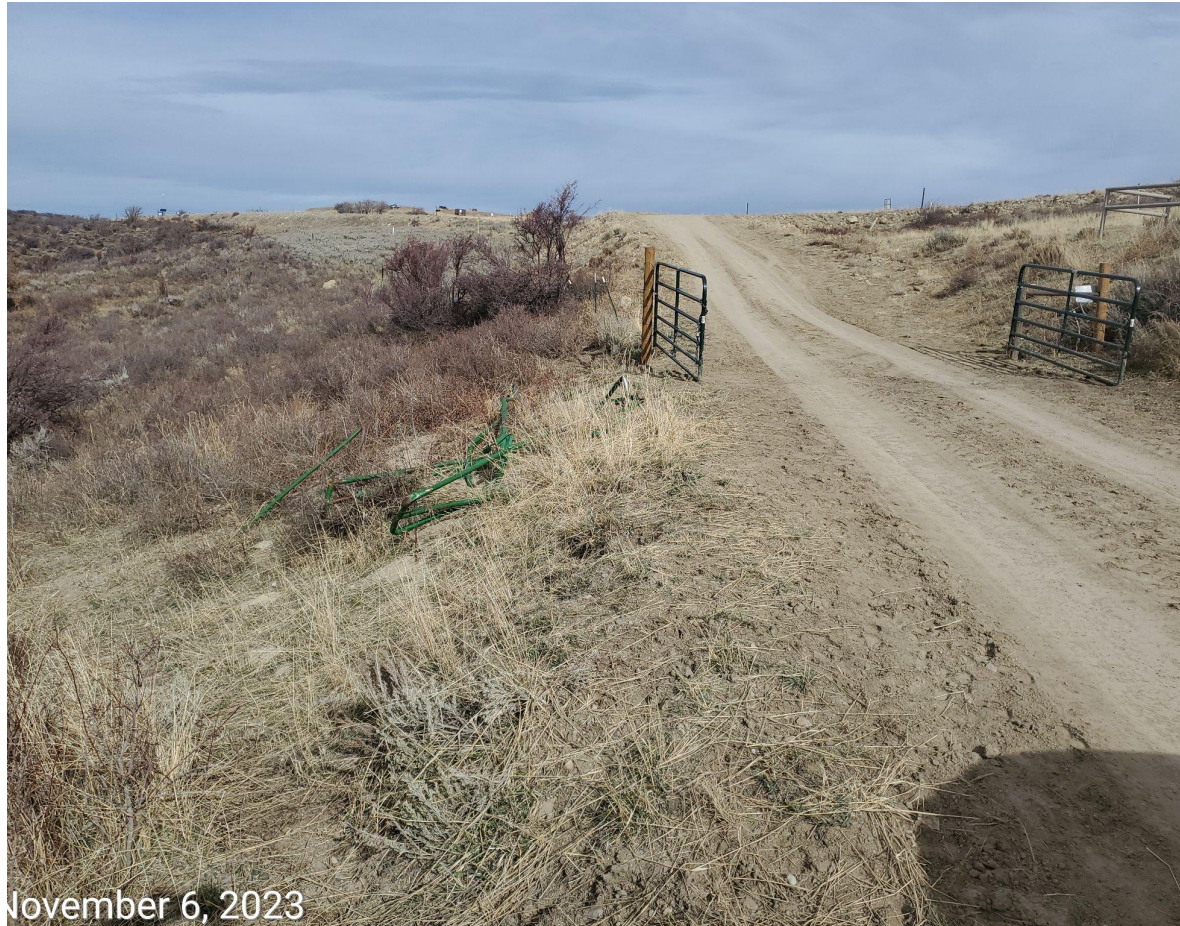
Photo 17: Photo shows broken gate remains improperly stored along the O&G access road.
