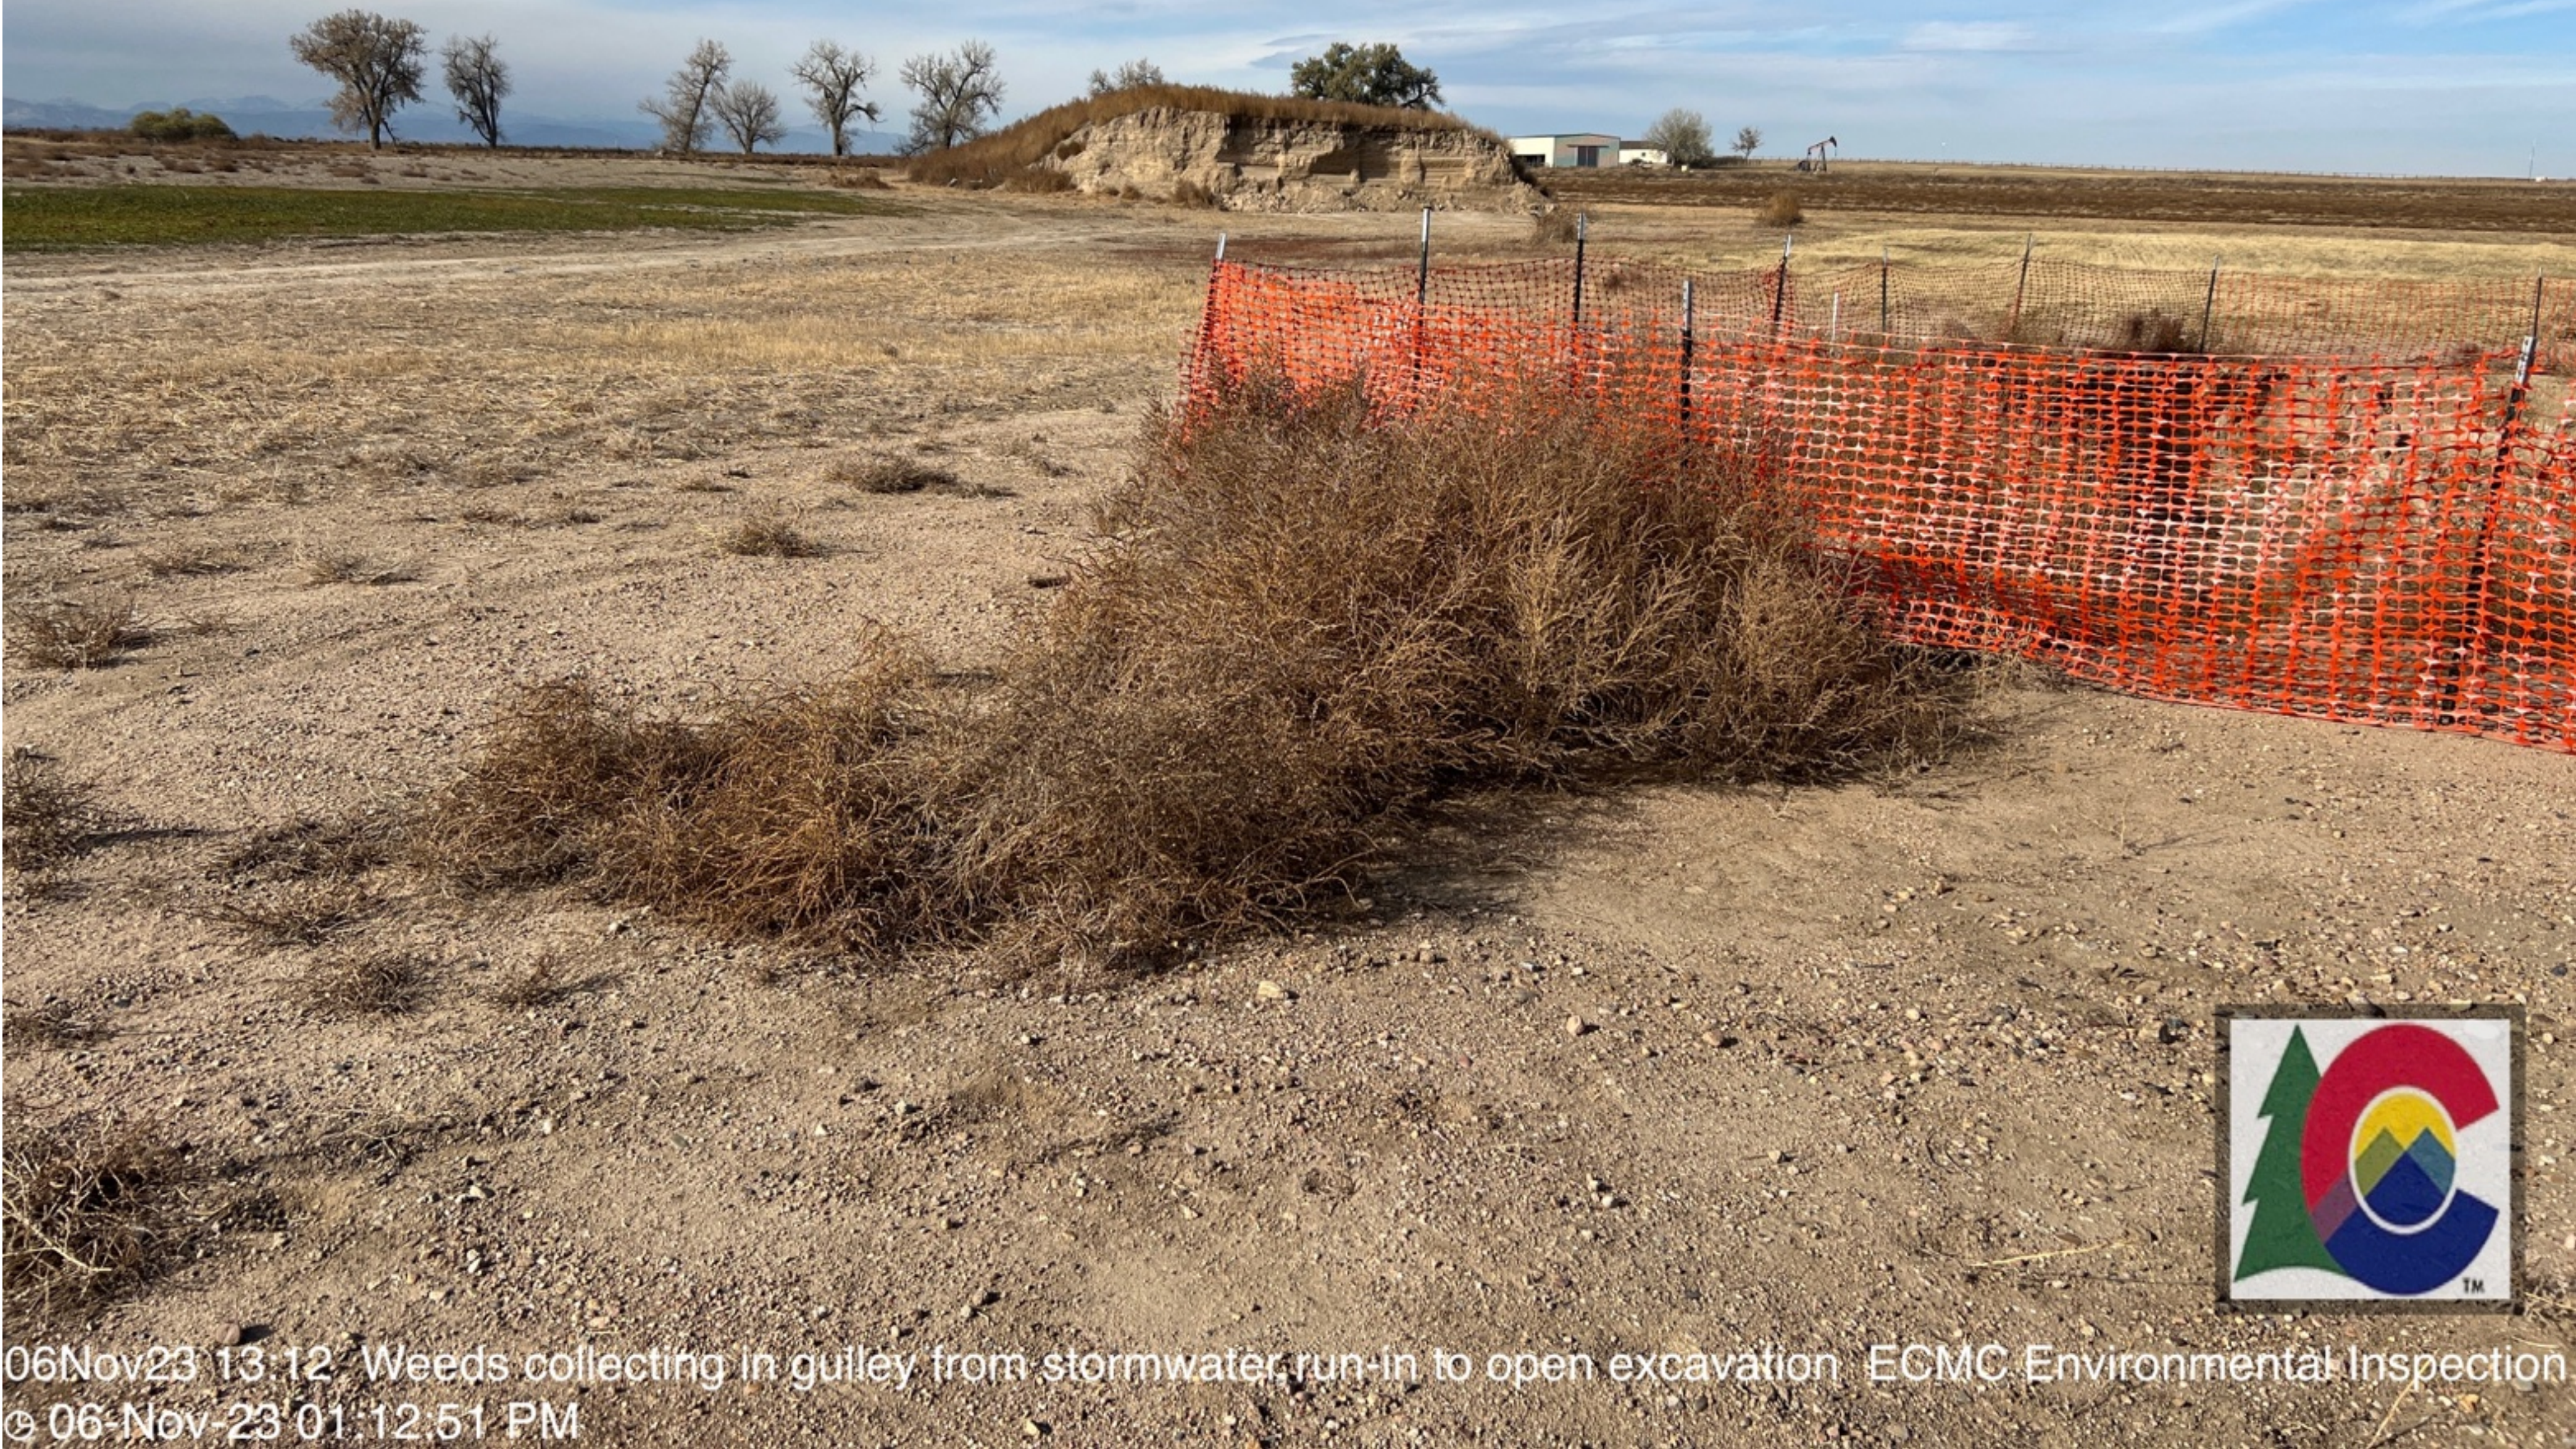
06Nov23 13:12 Weeds collecting in gulley from stormwater run-in to open excavation ECMC Environmental Inspection
© 06-Nov-23 01:12:51 PM

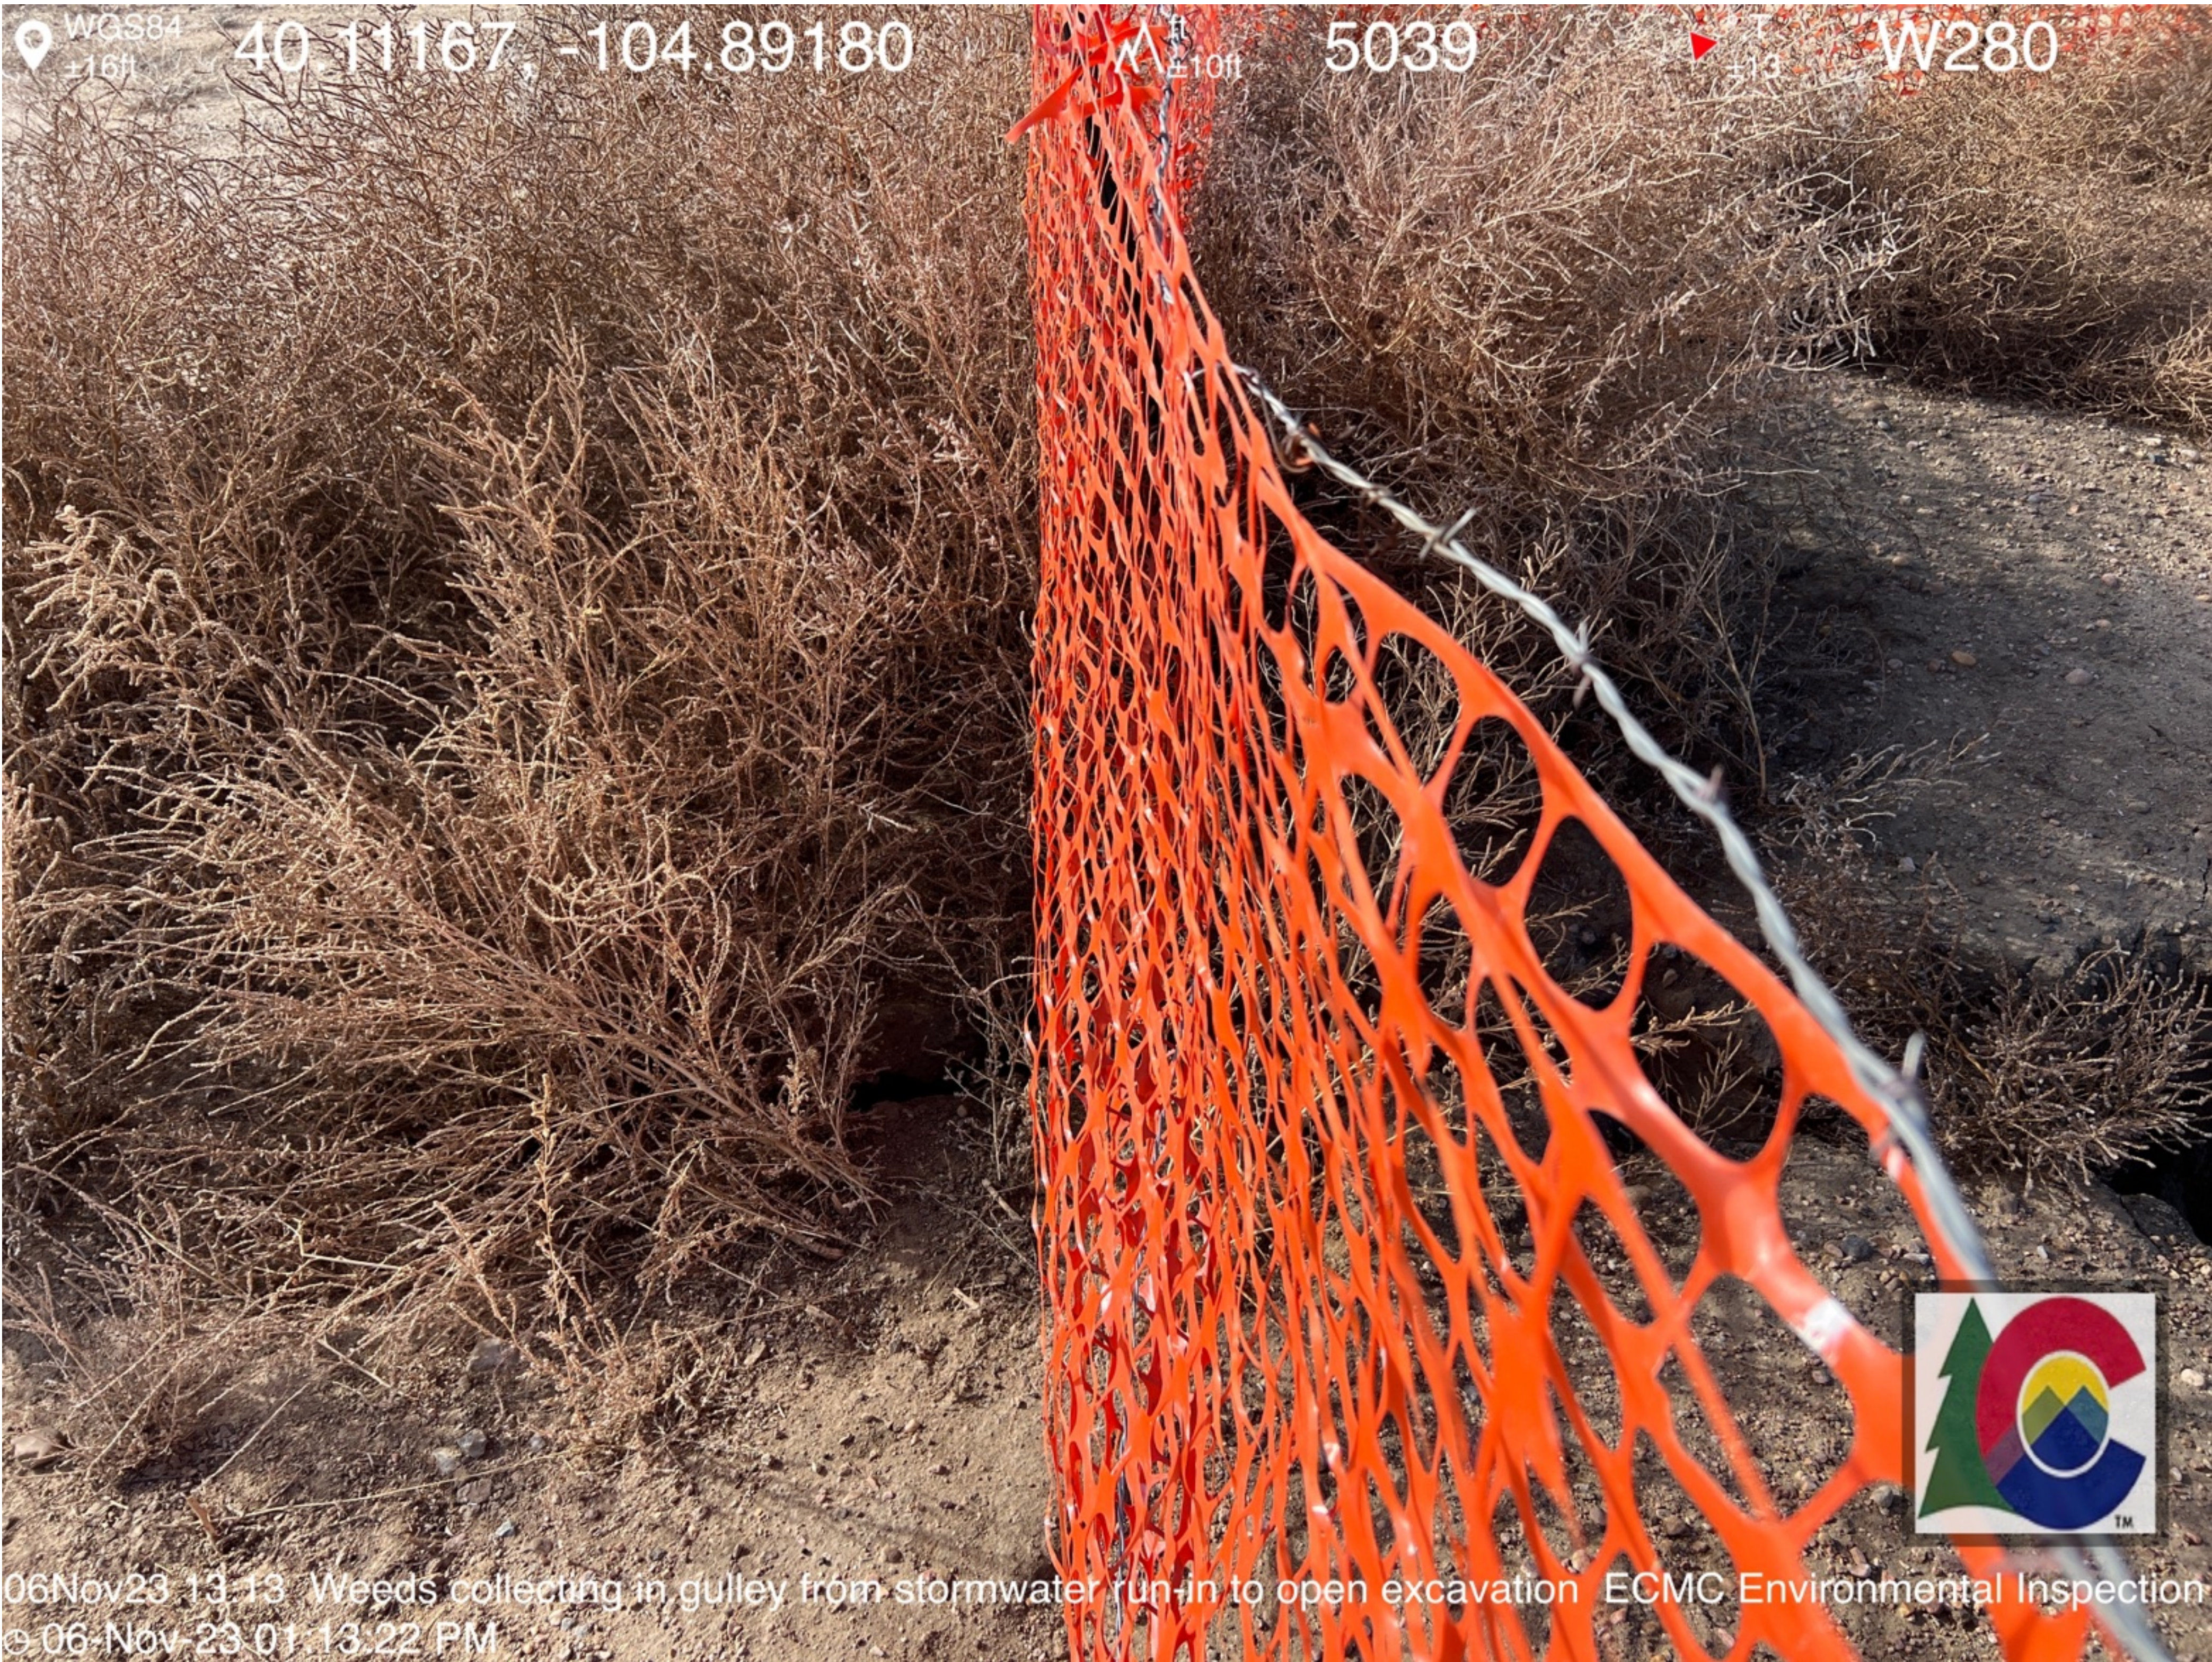
06Nov23 13:13 Weeds collecting in gulley from stormwater run-in to open excavation ECMC Environmental Inspection
© 06-Nov-23 01:13:22 PM

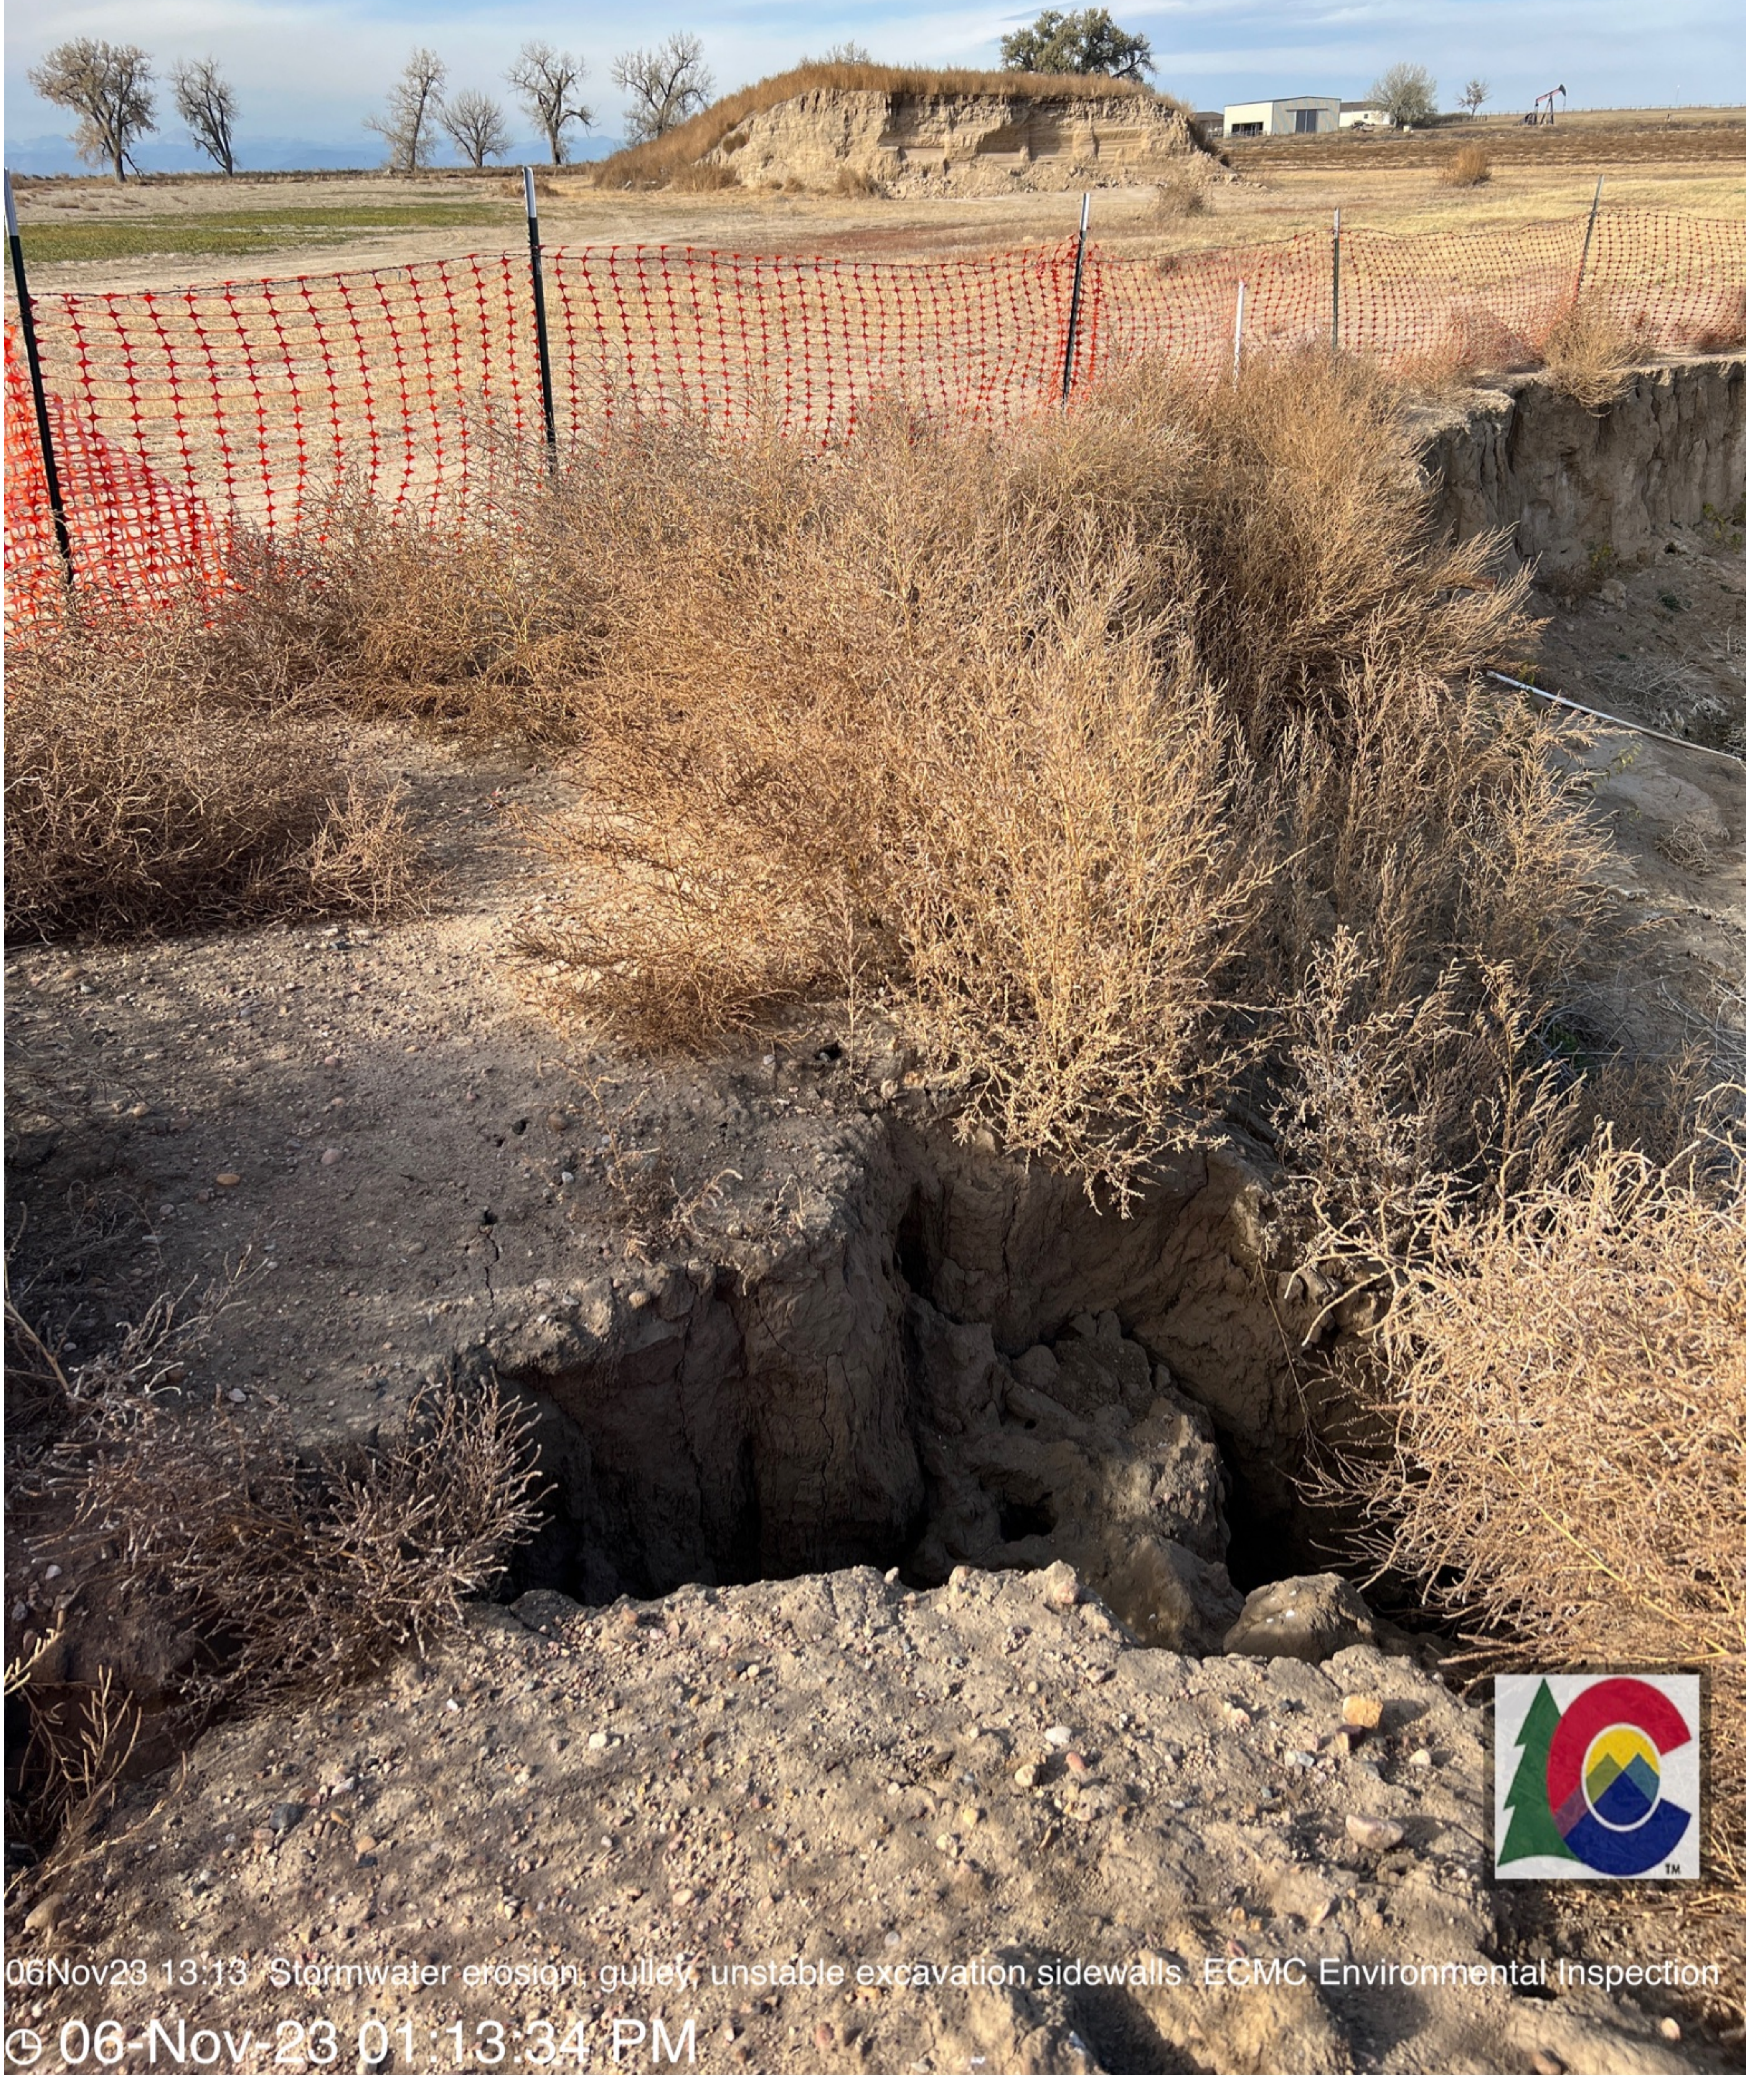
06Nov23 13:13 Stormwater erosion gully, unstable excavation sidewalls ECMC Environmental Inspection

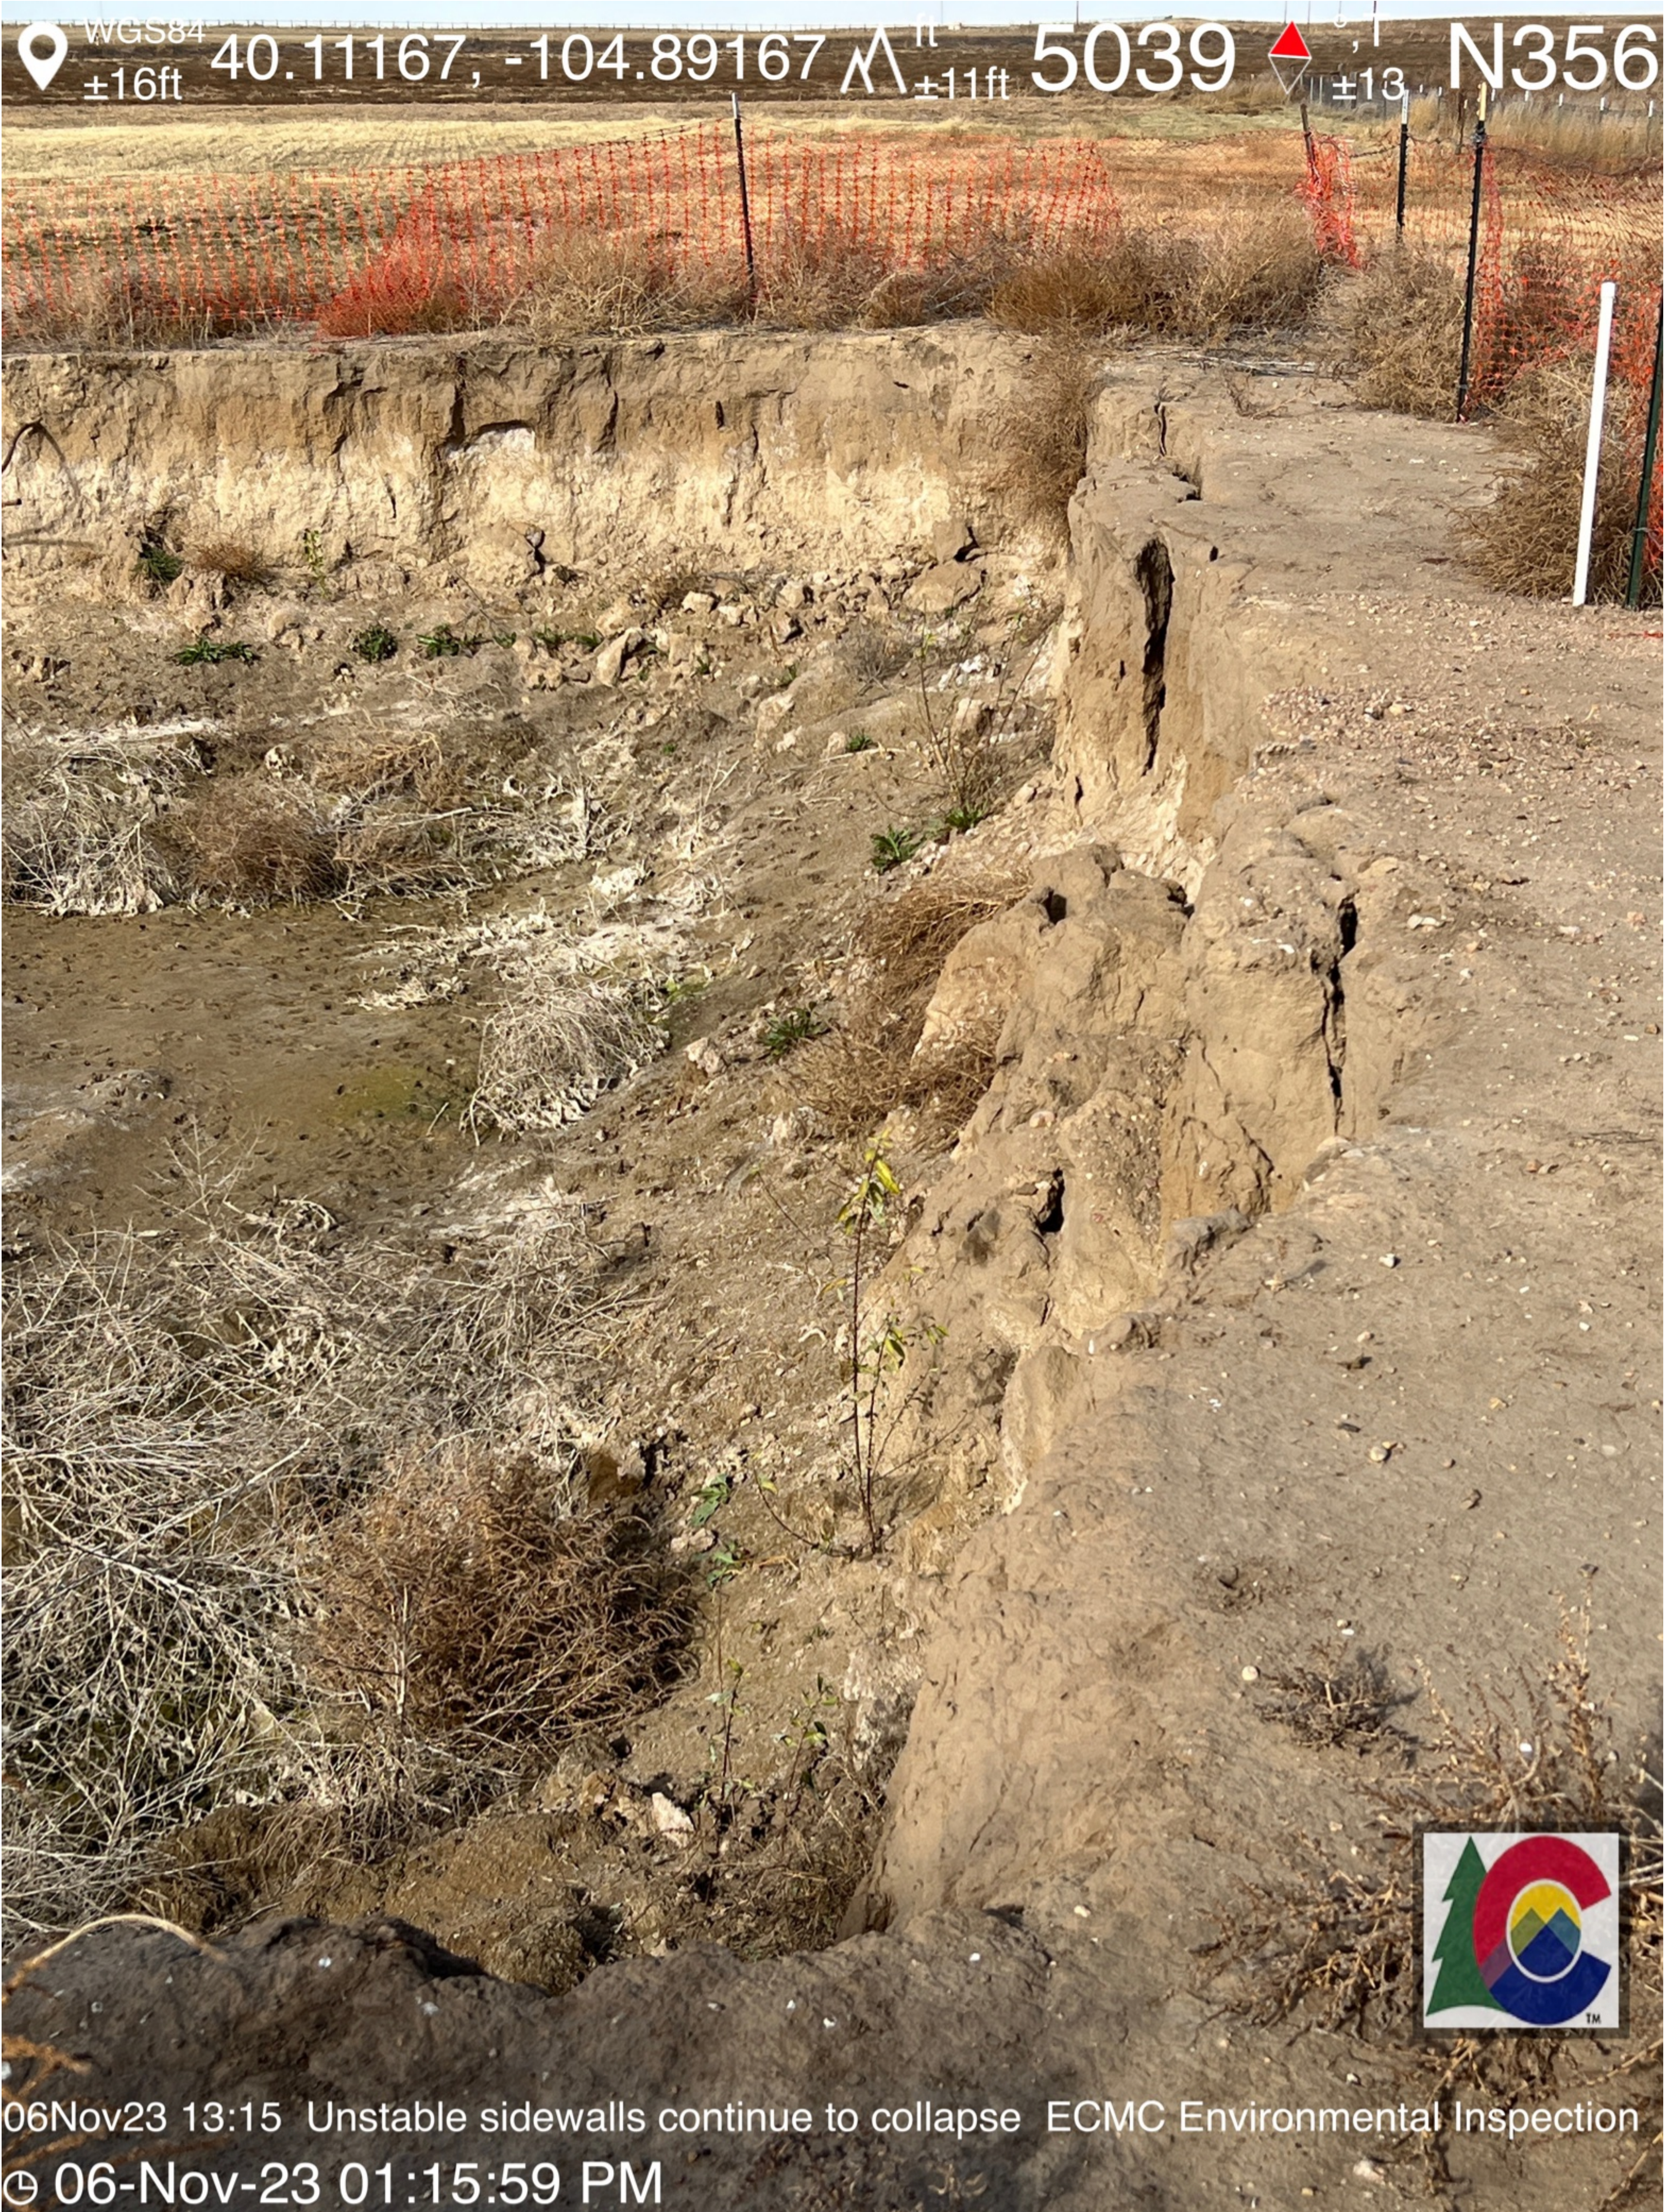
06Nov23 13:15 Unstable sidewalls continue to collapse ECMC Environmental Inspection
© 06-Nov-23 01:15:59 PM

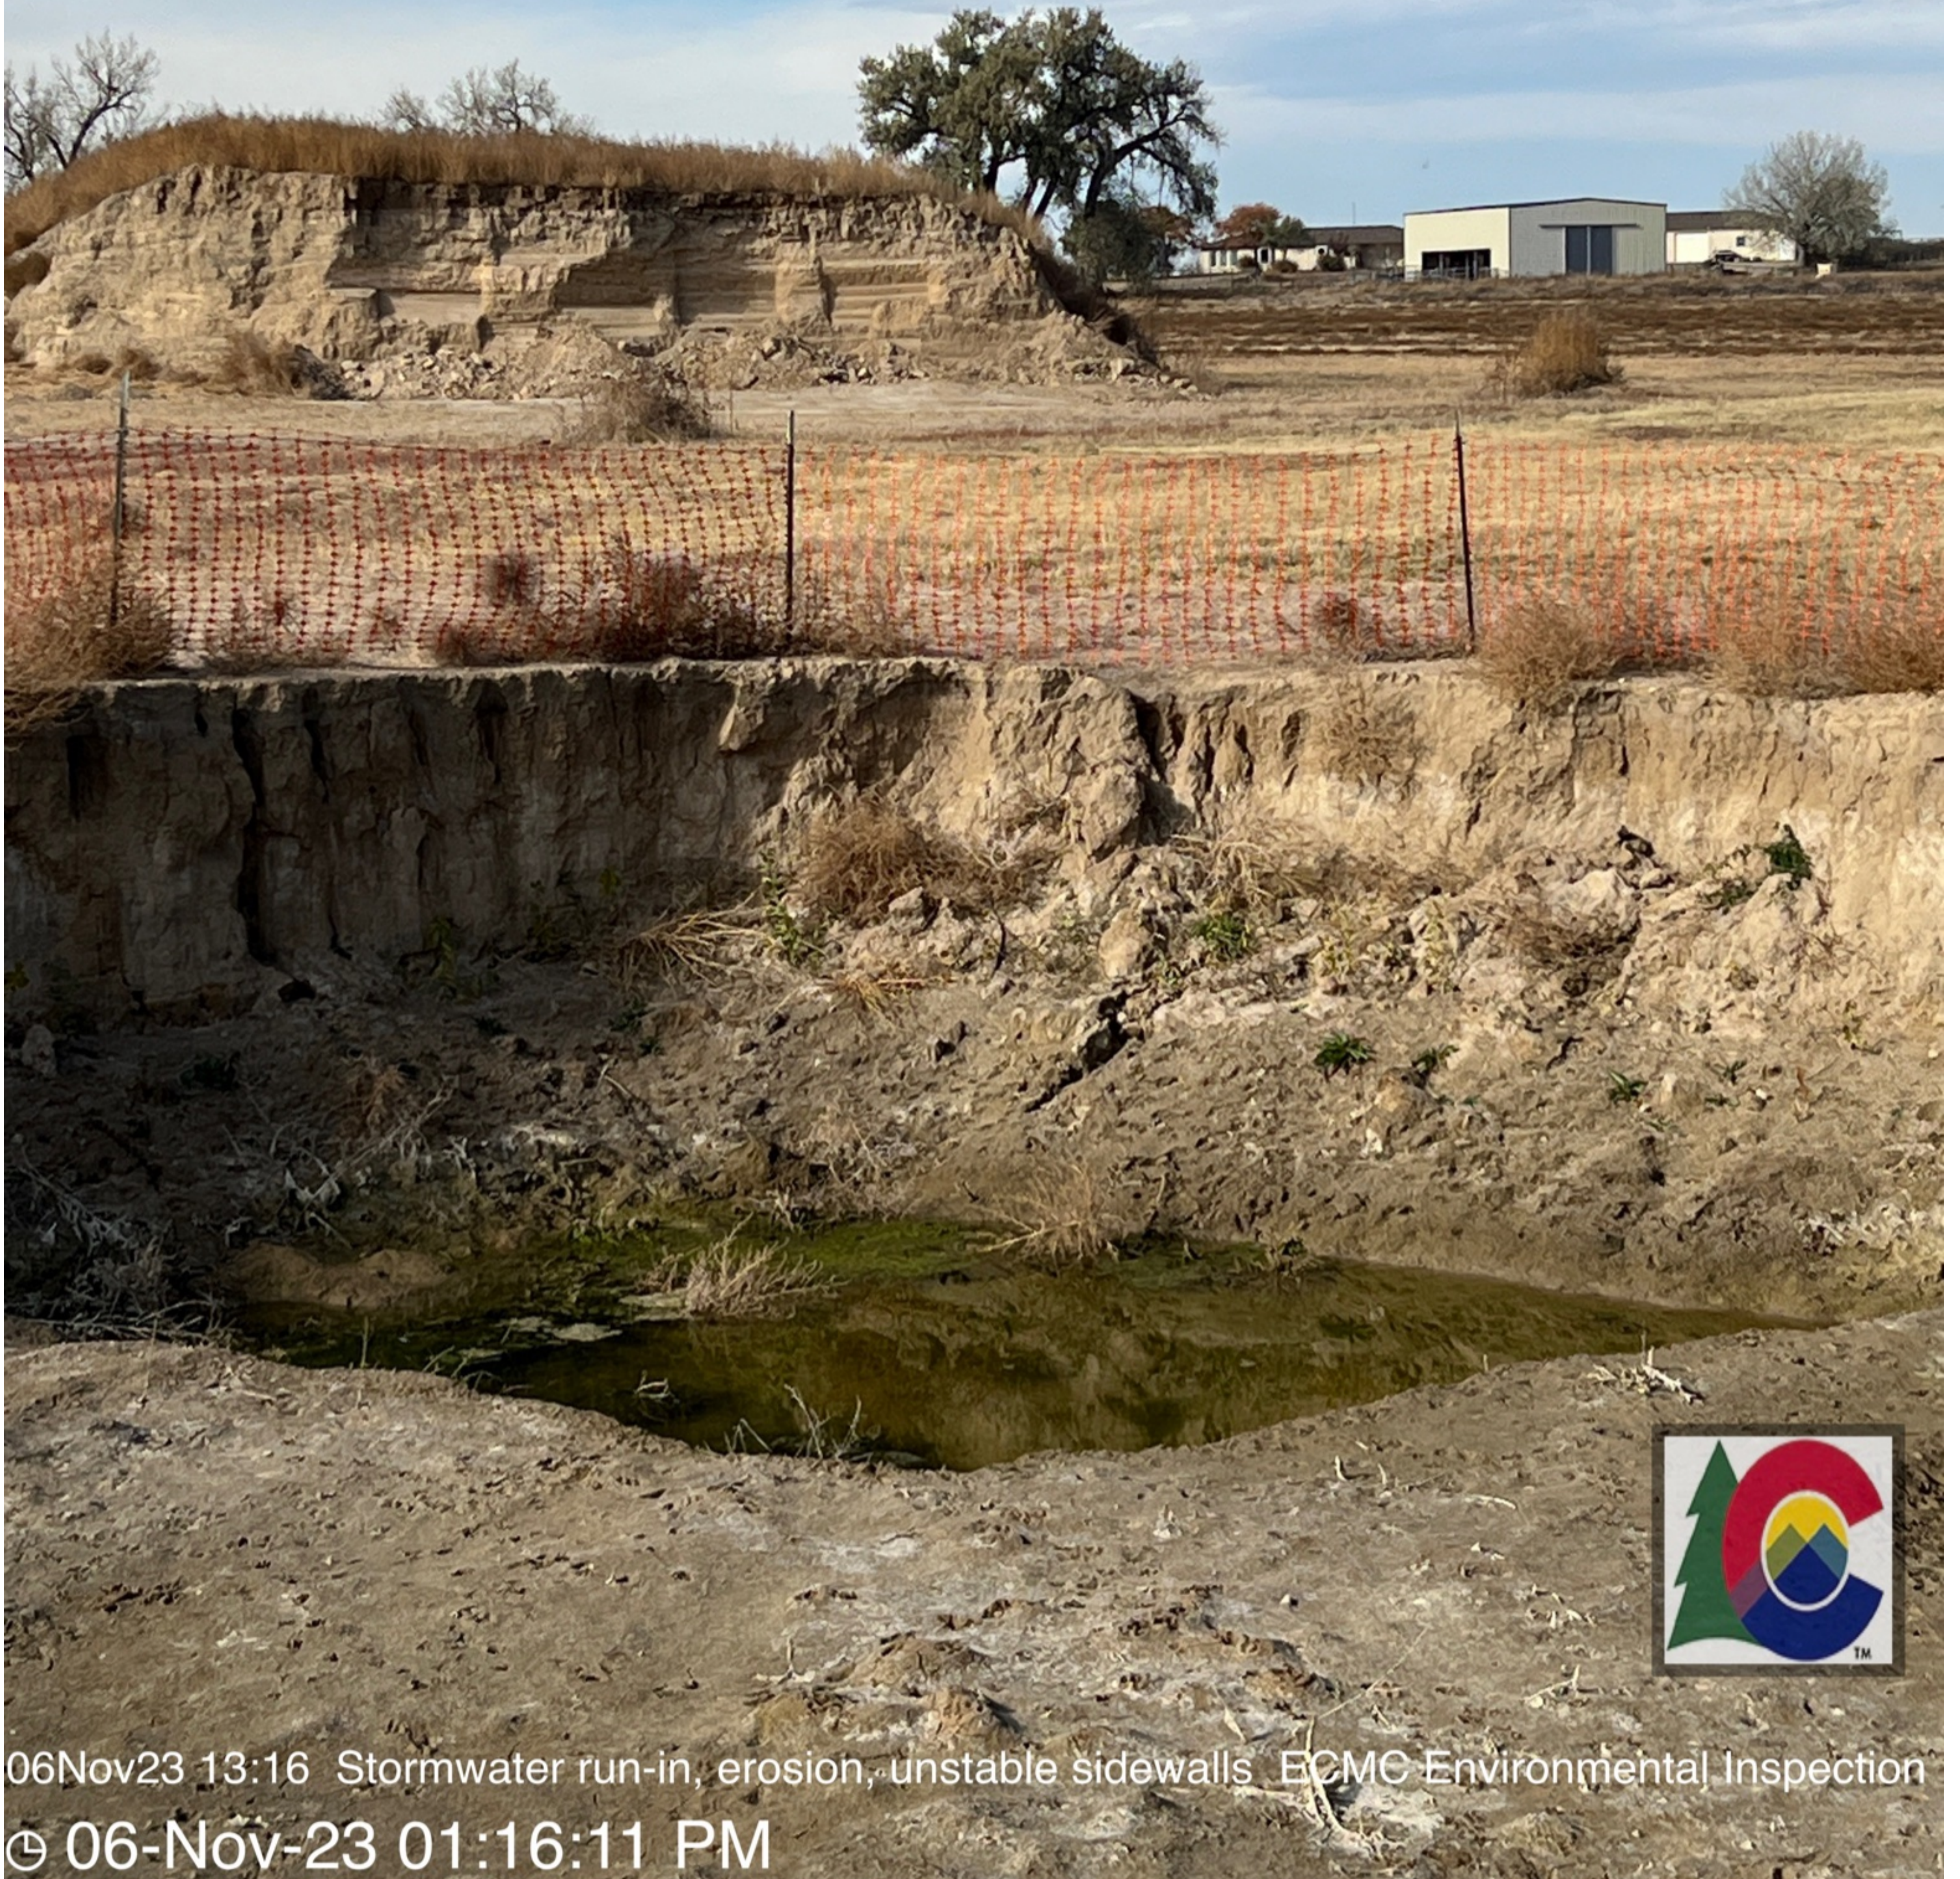
06Nov23 13:16 Stormwater run-in, erosion, unstable sidewalls ECMC Environmental Inspection

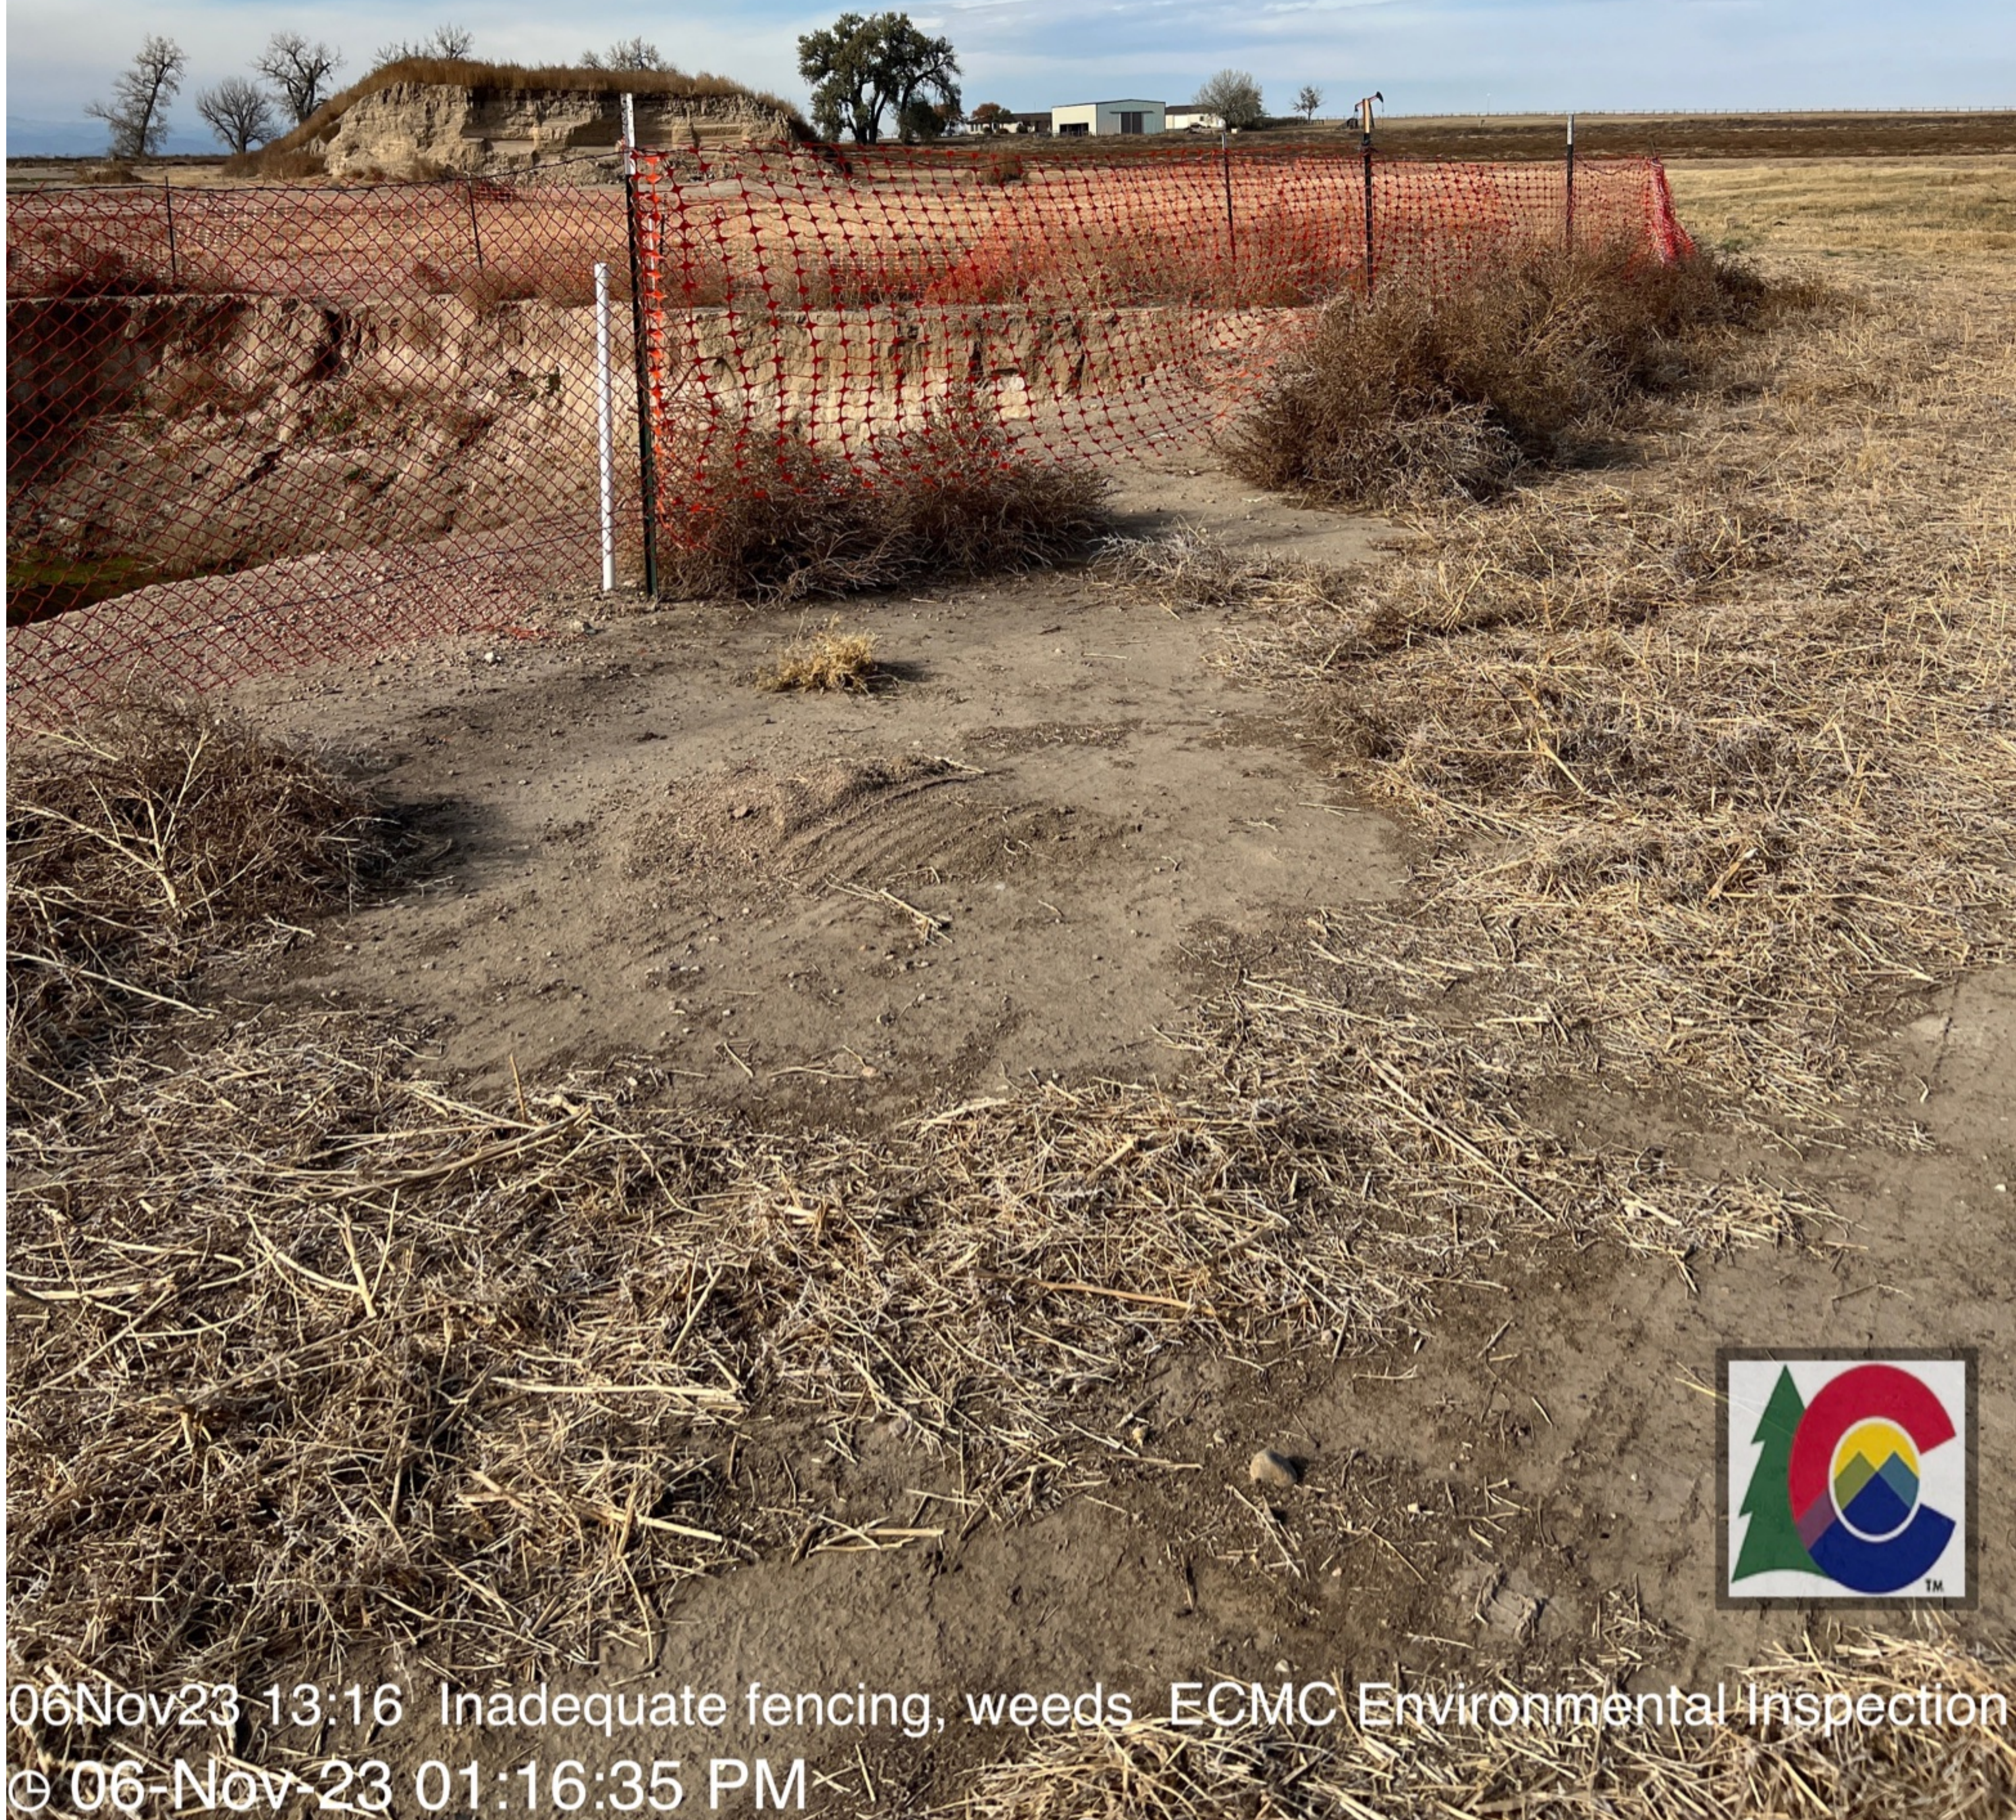
06Nov23 13:16 Inadequate fencing, weeds ECMC Environmental Inspection
© 06-Nov-23 01:16:35 PM
