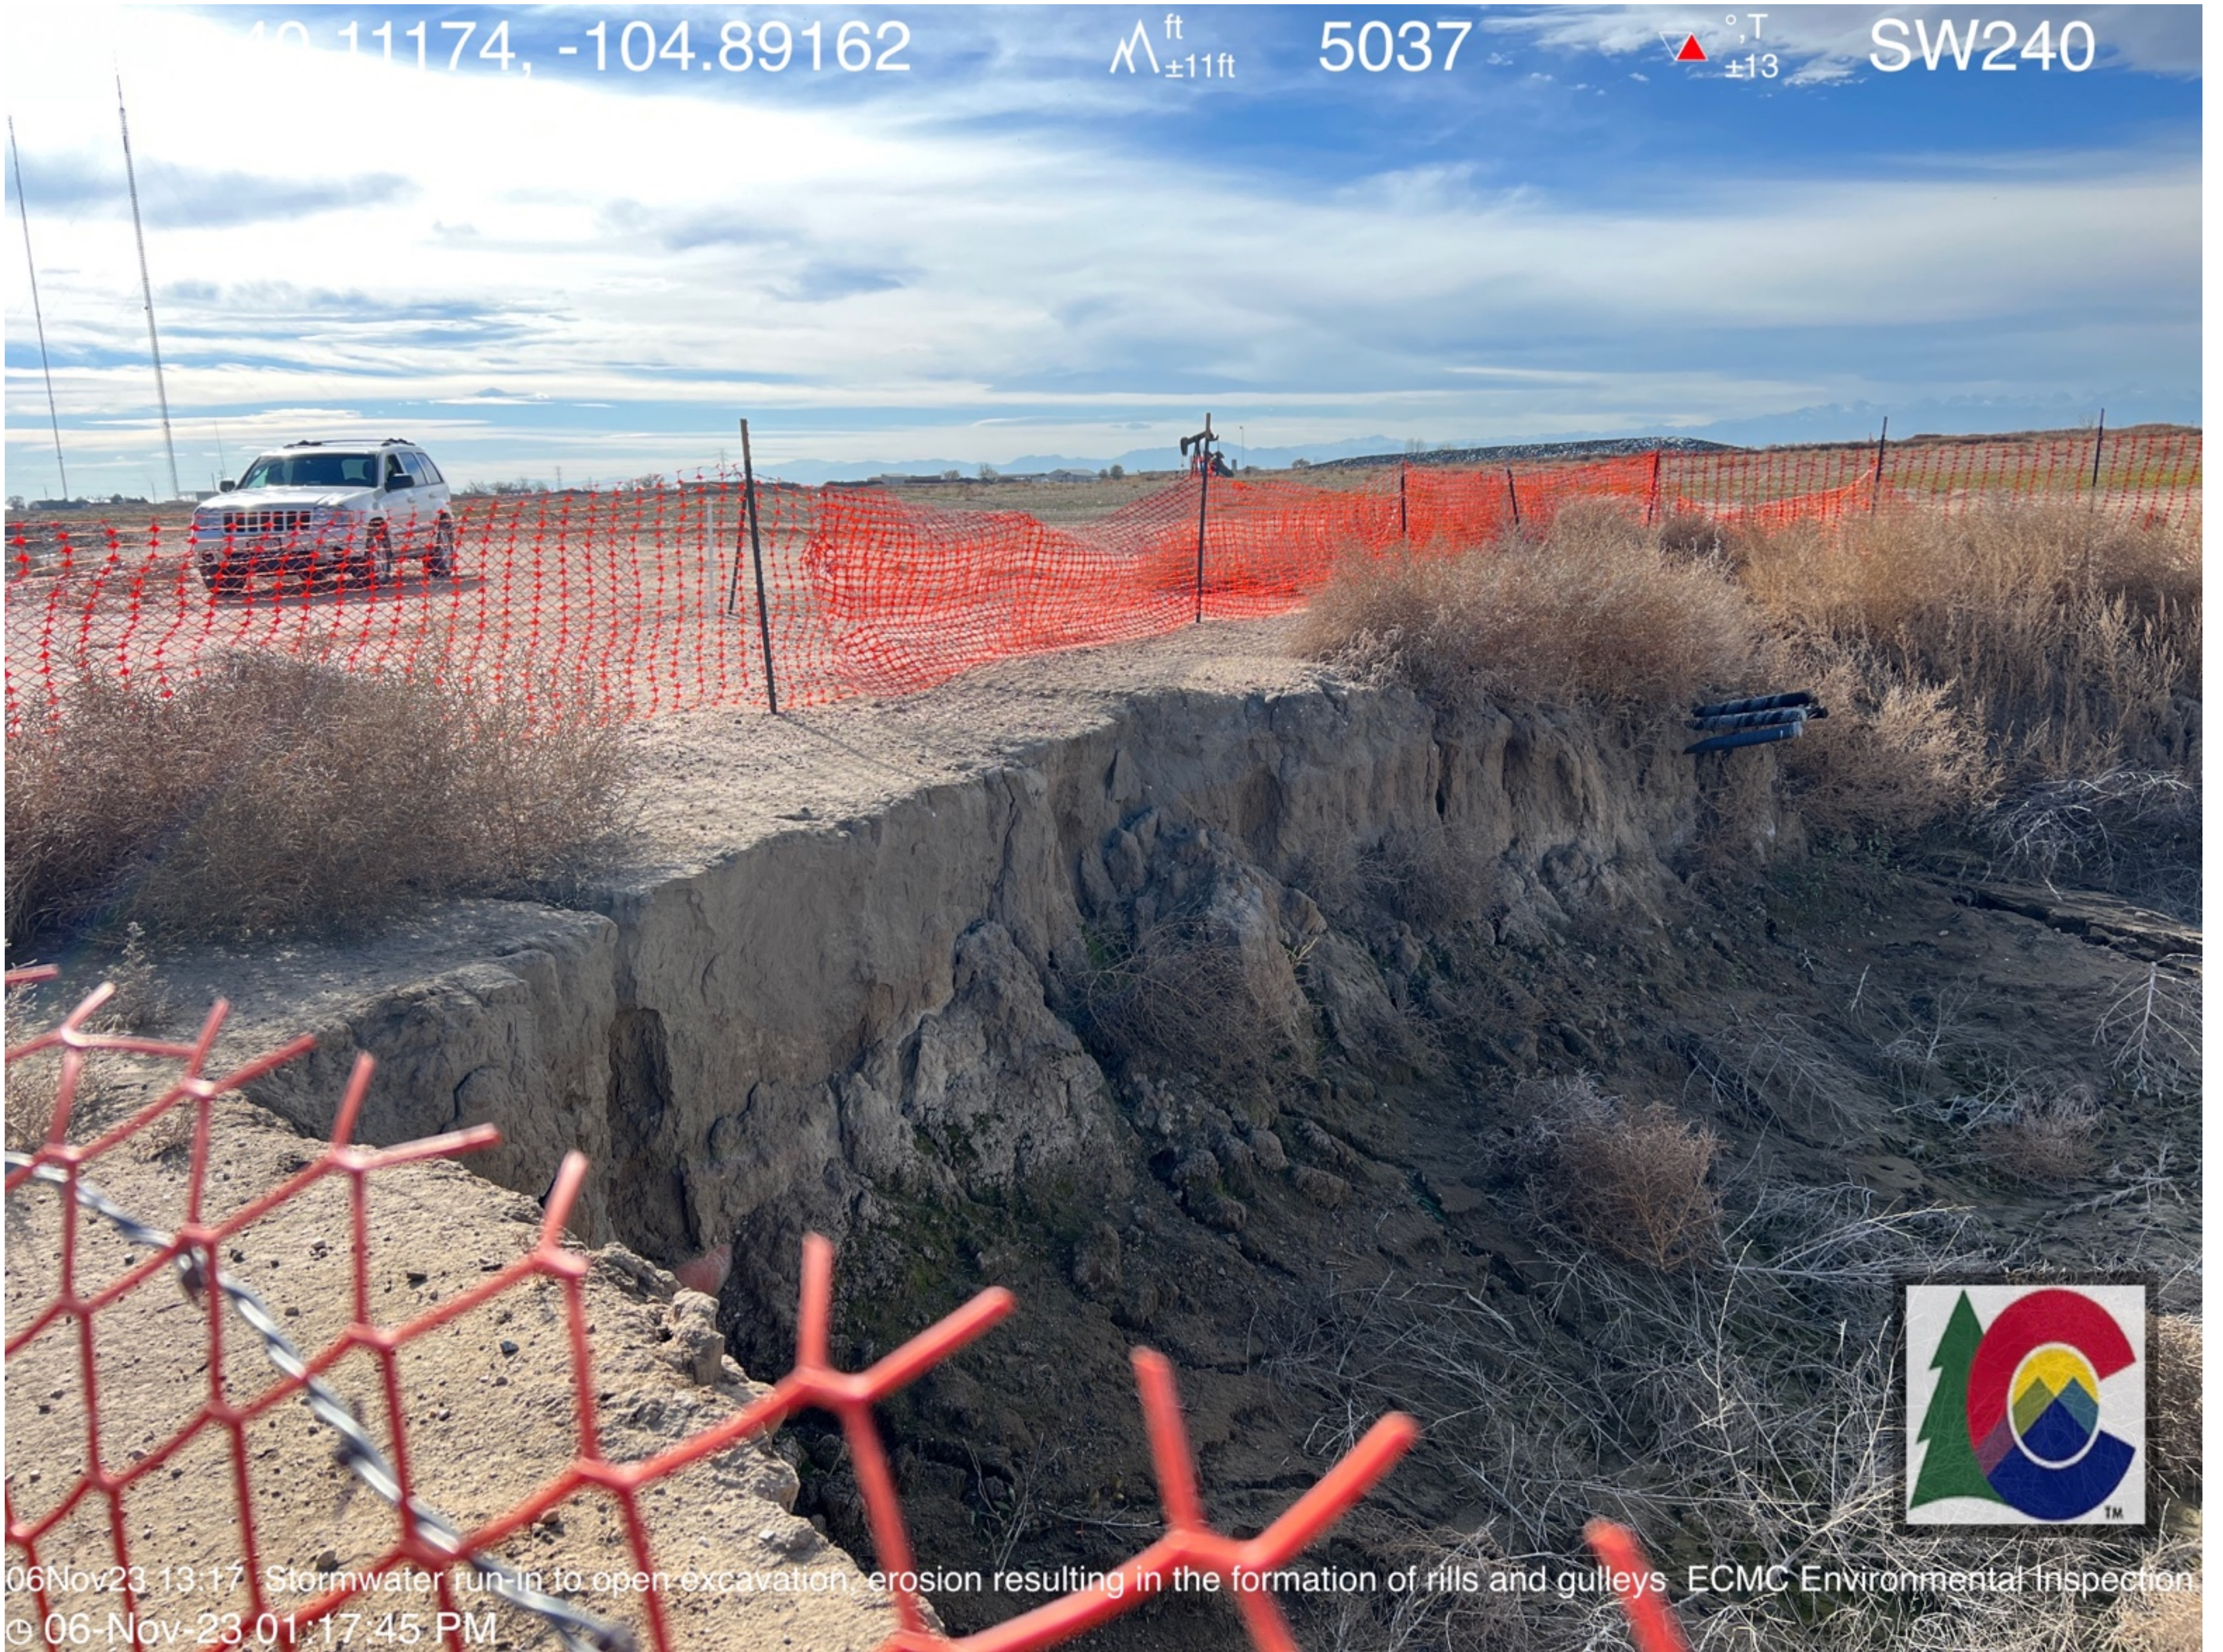
06Nov23 13:17 Stormwater run-in to open excavation, erosion resulting in the formation of rills and gulleys ECMC Environmental Inspection
© 06-Nov-23 01:17:45 PM

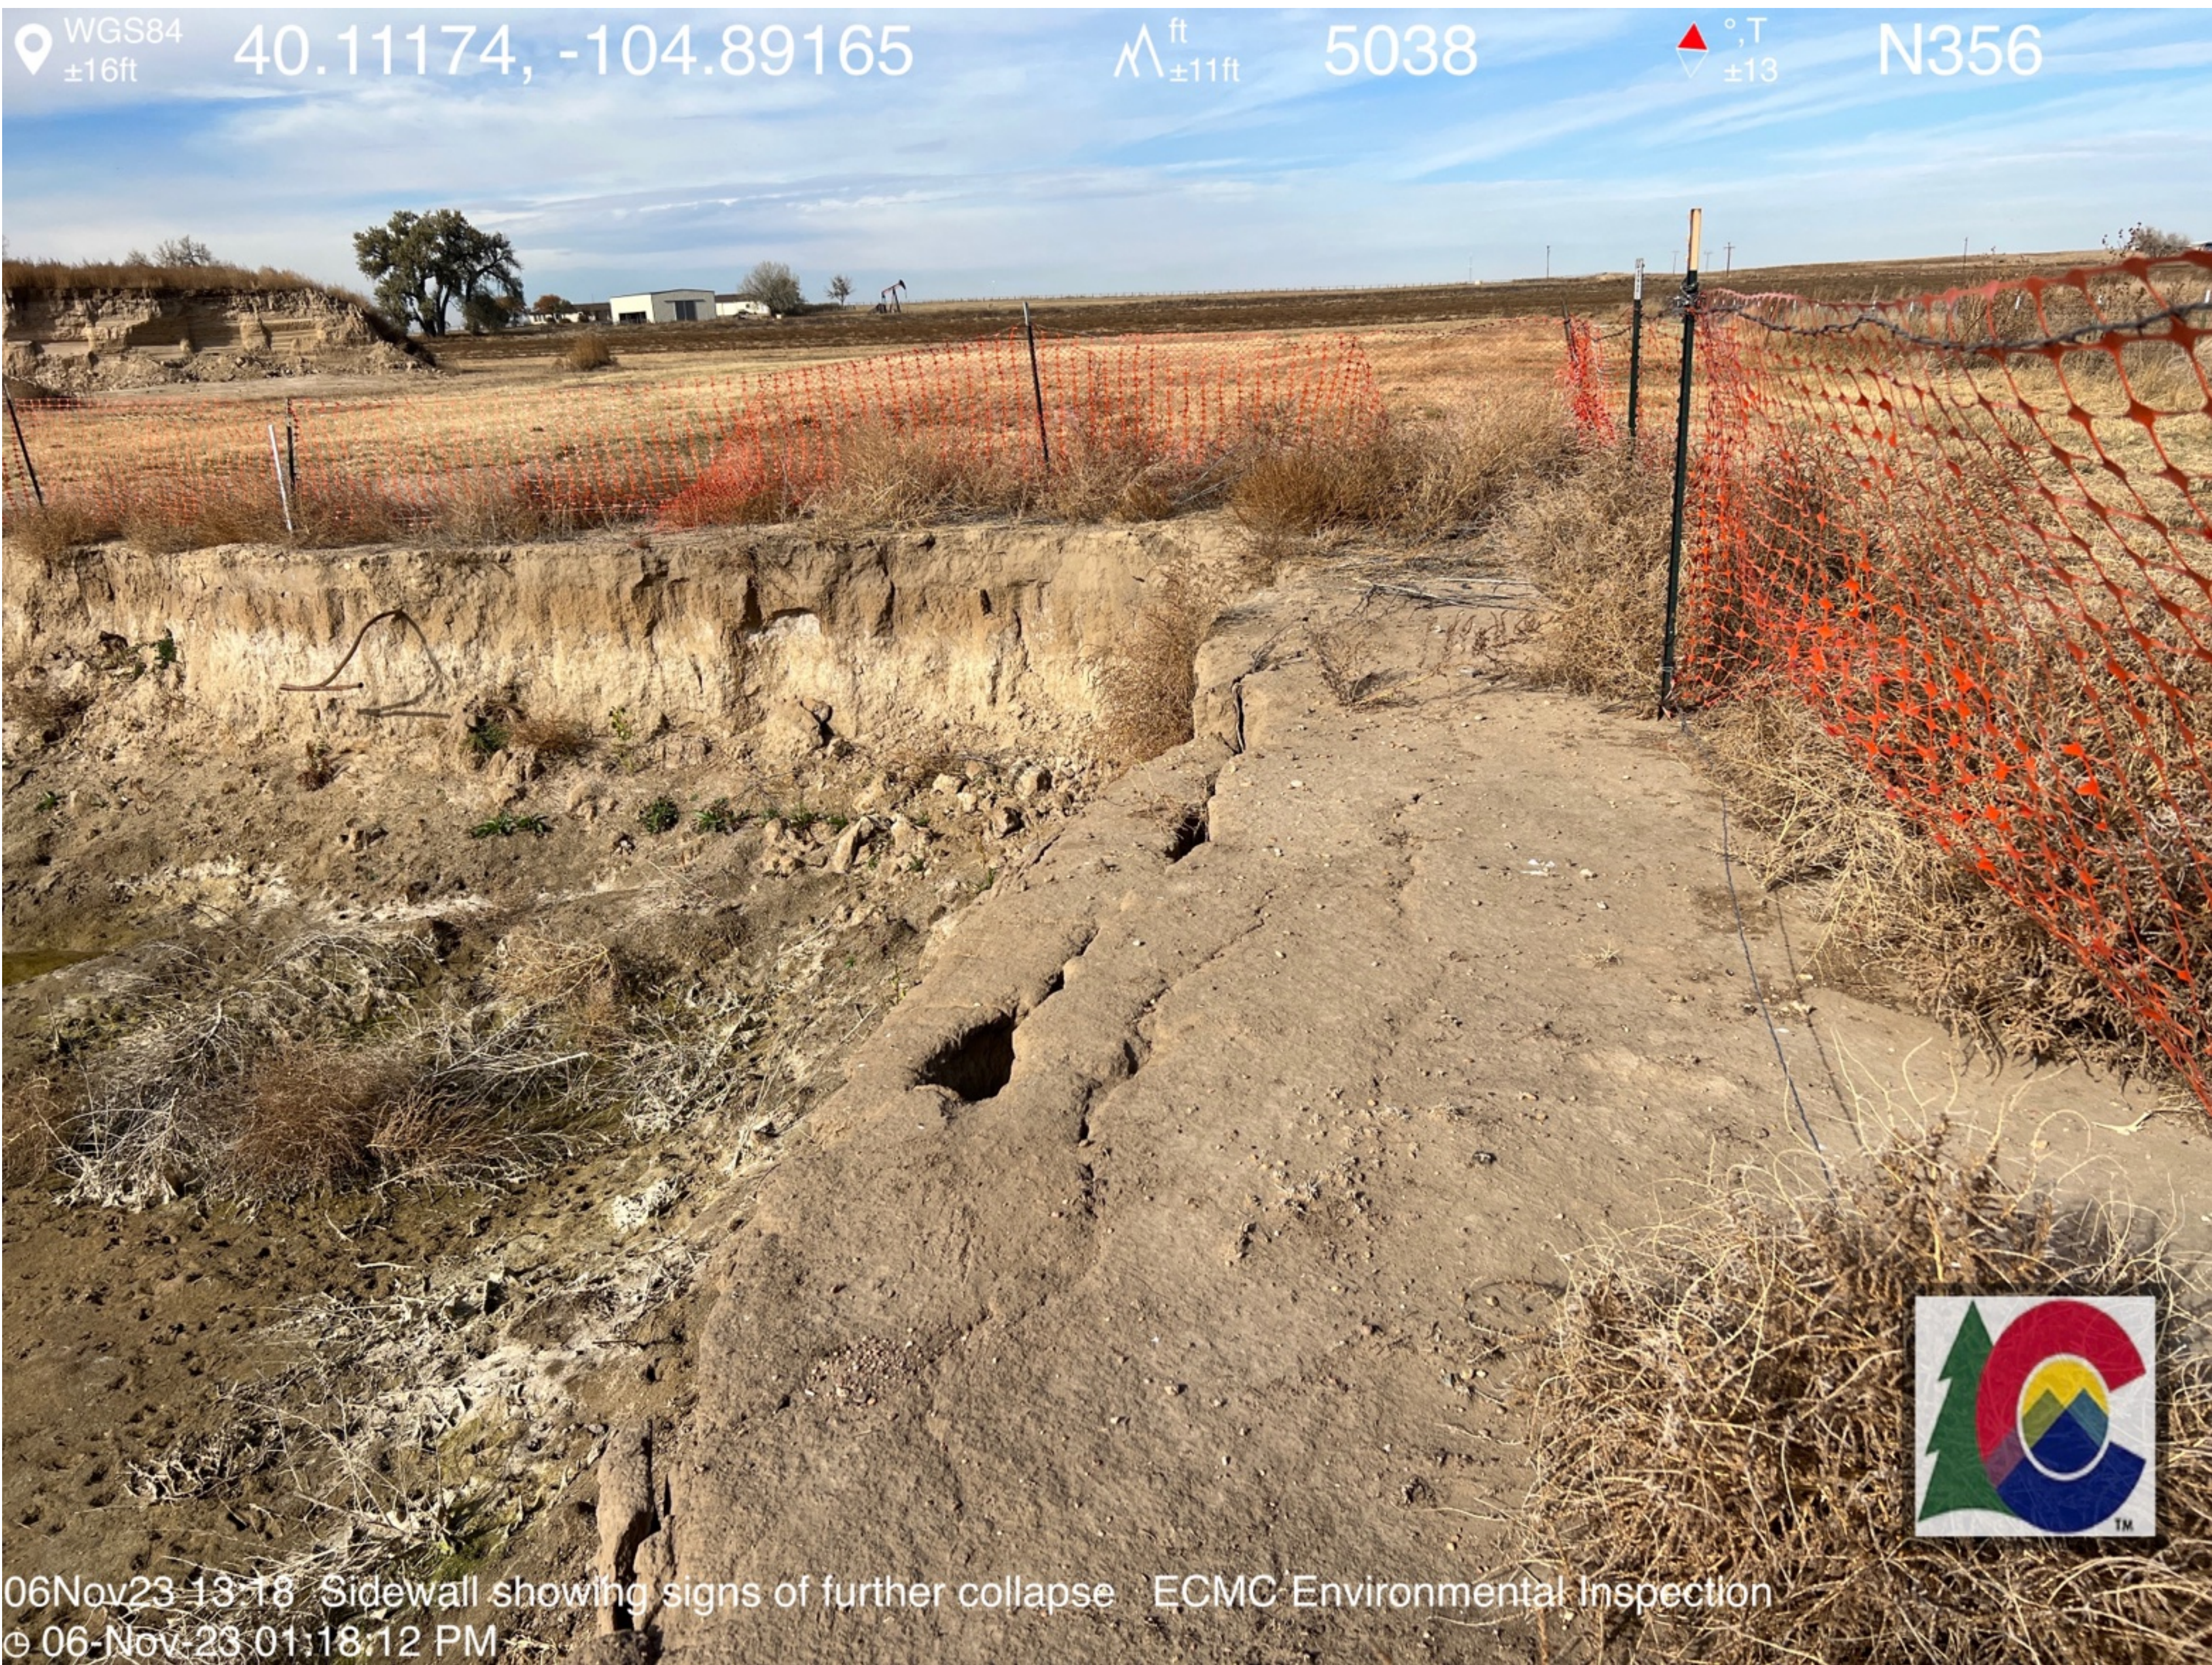
06Nov23 13:18 Sidewall showing signs of further collapse ECMC Environmental Inspection
© 06-Nov-23 01:18:12 PM

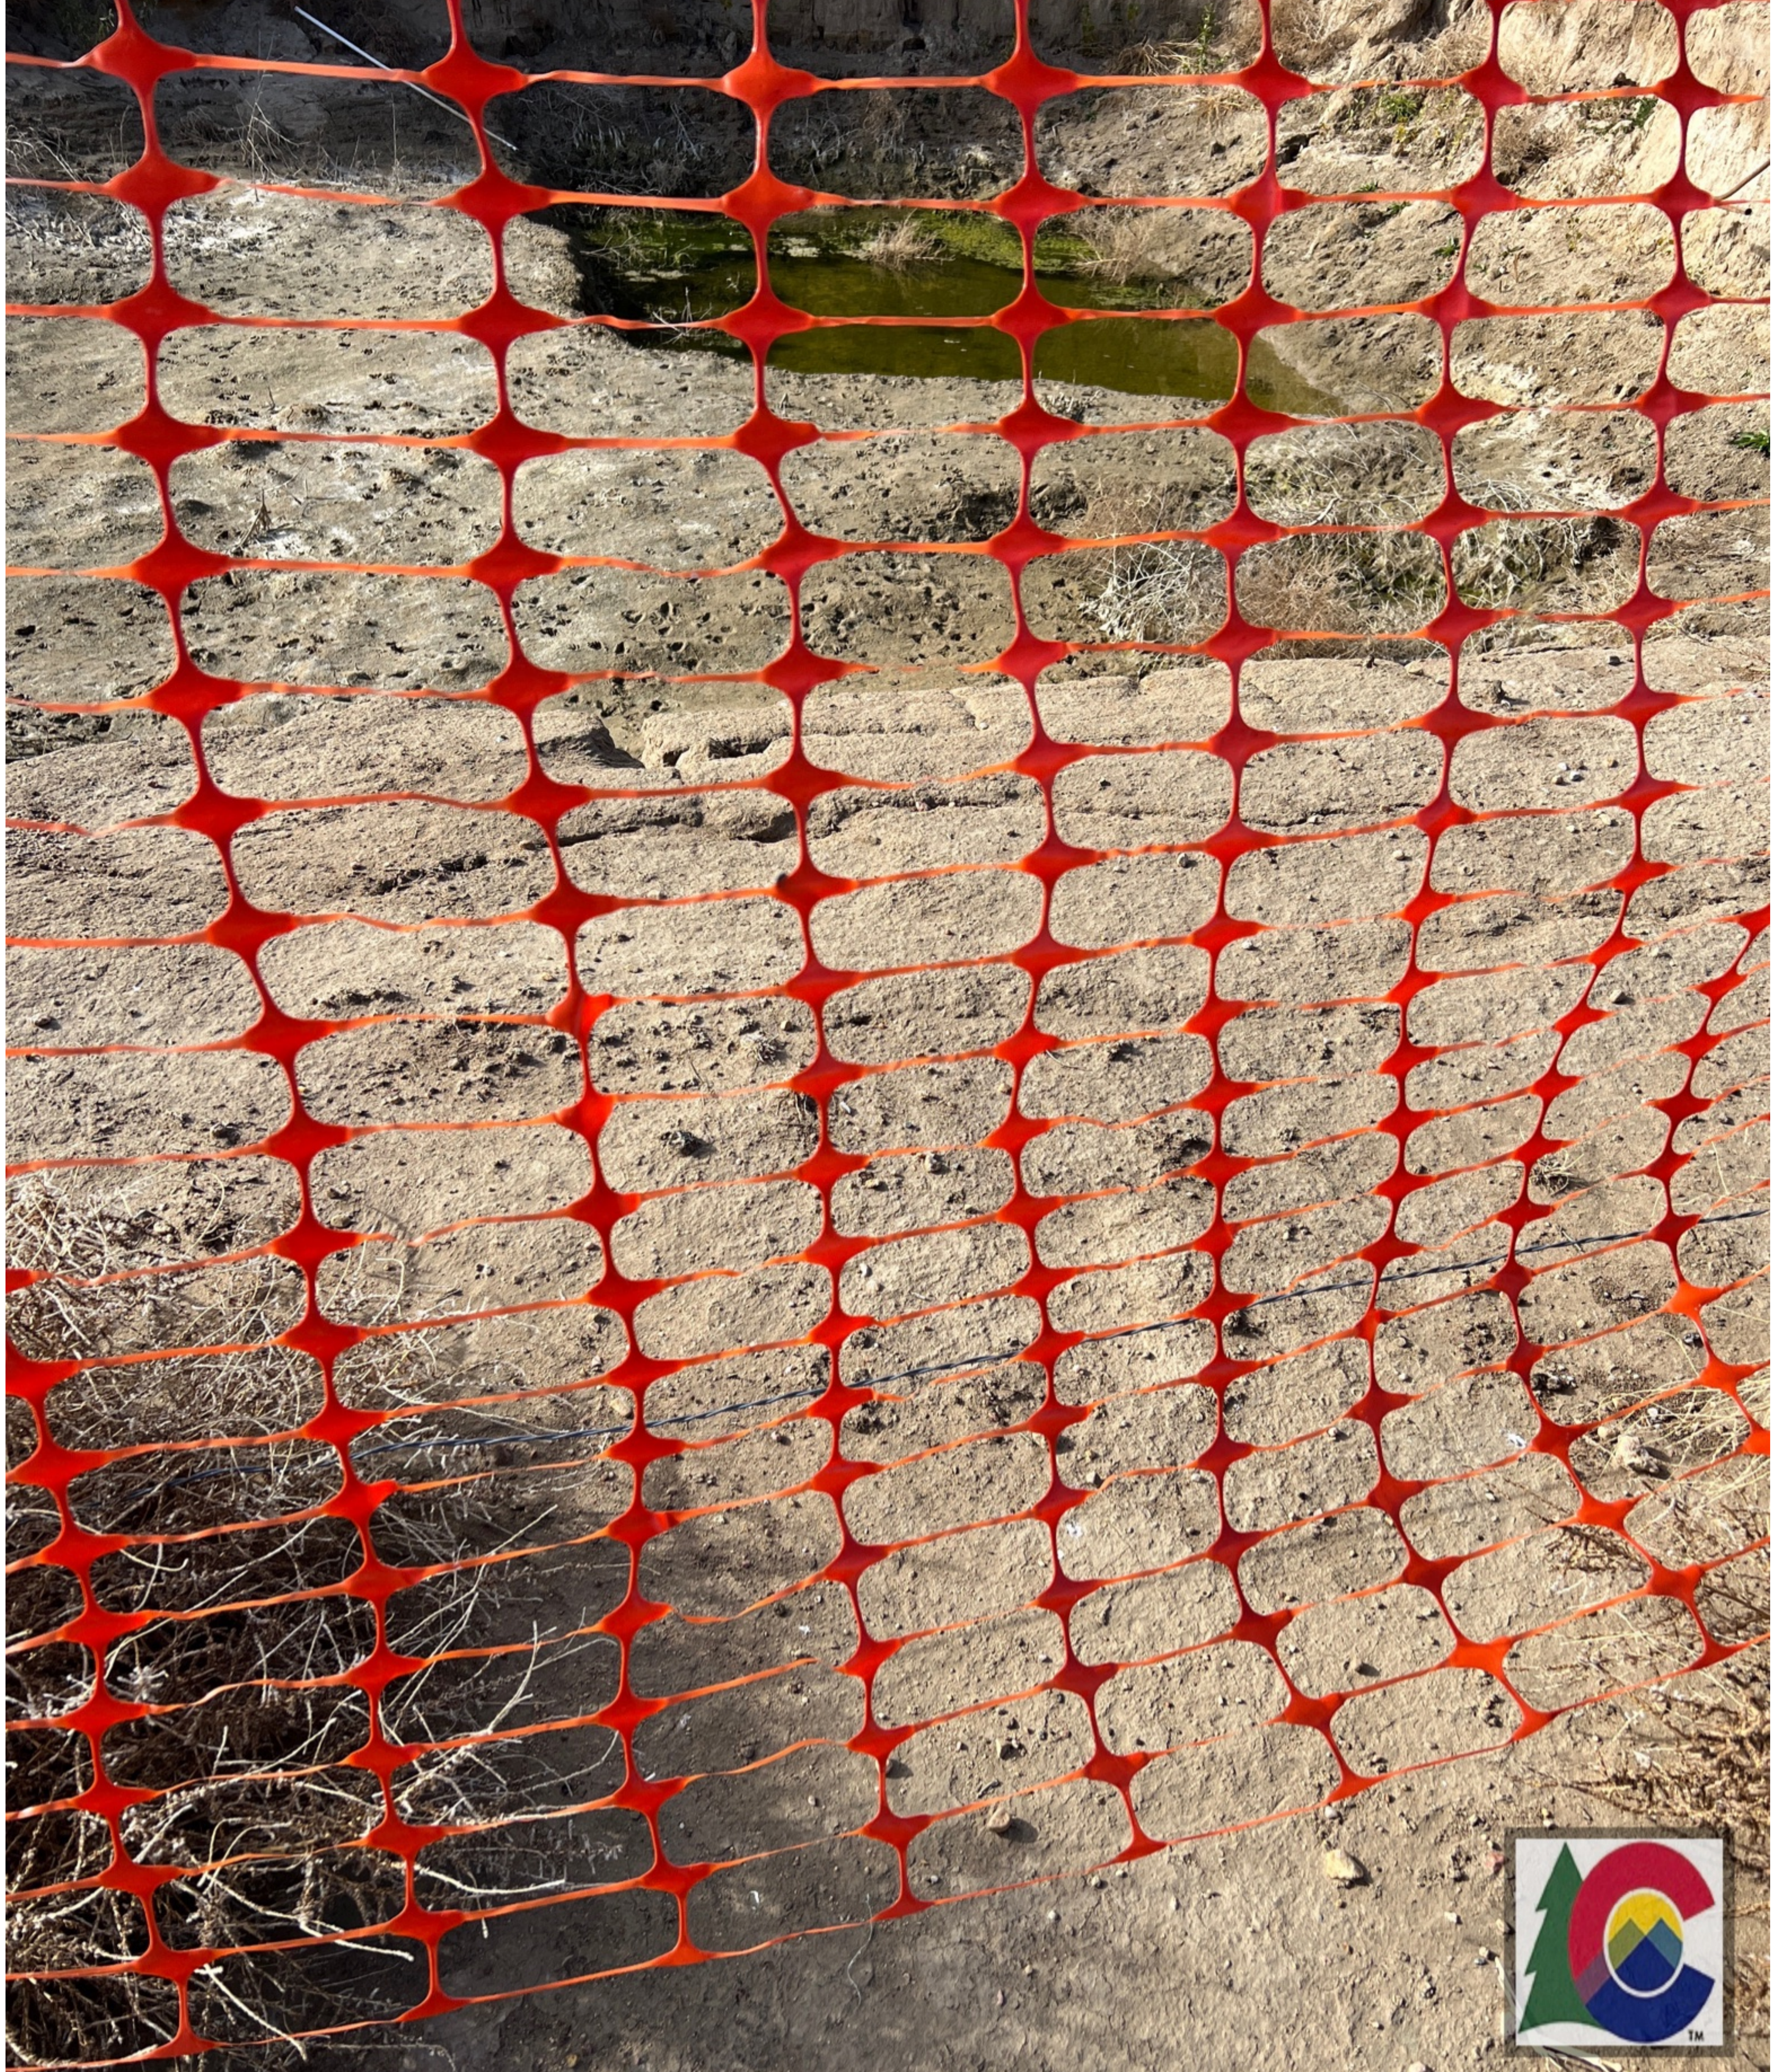
06Nov23 13:19 Gap between fencing and ground ECMC Environmental Inspection
© 06-Nov-23 01:19:00 PM

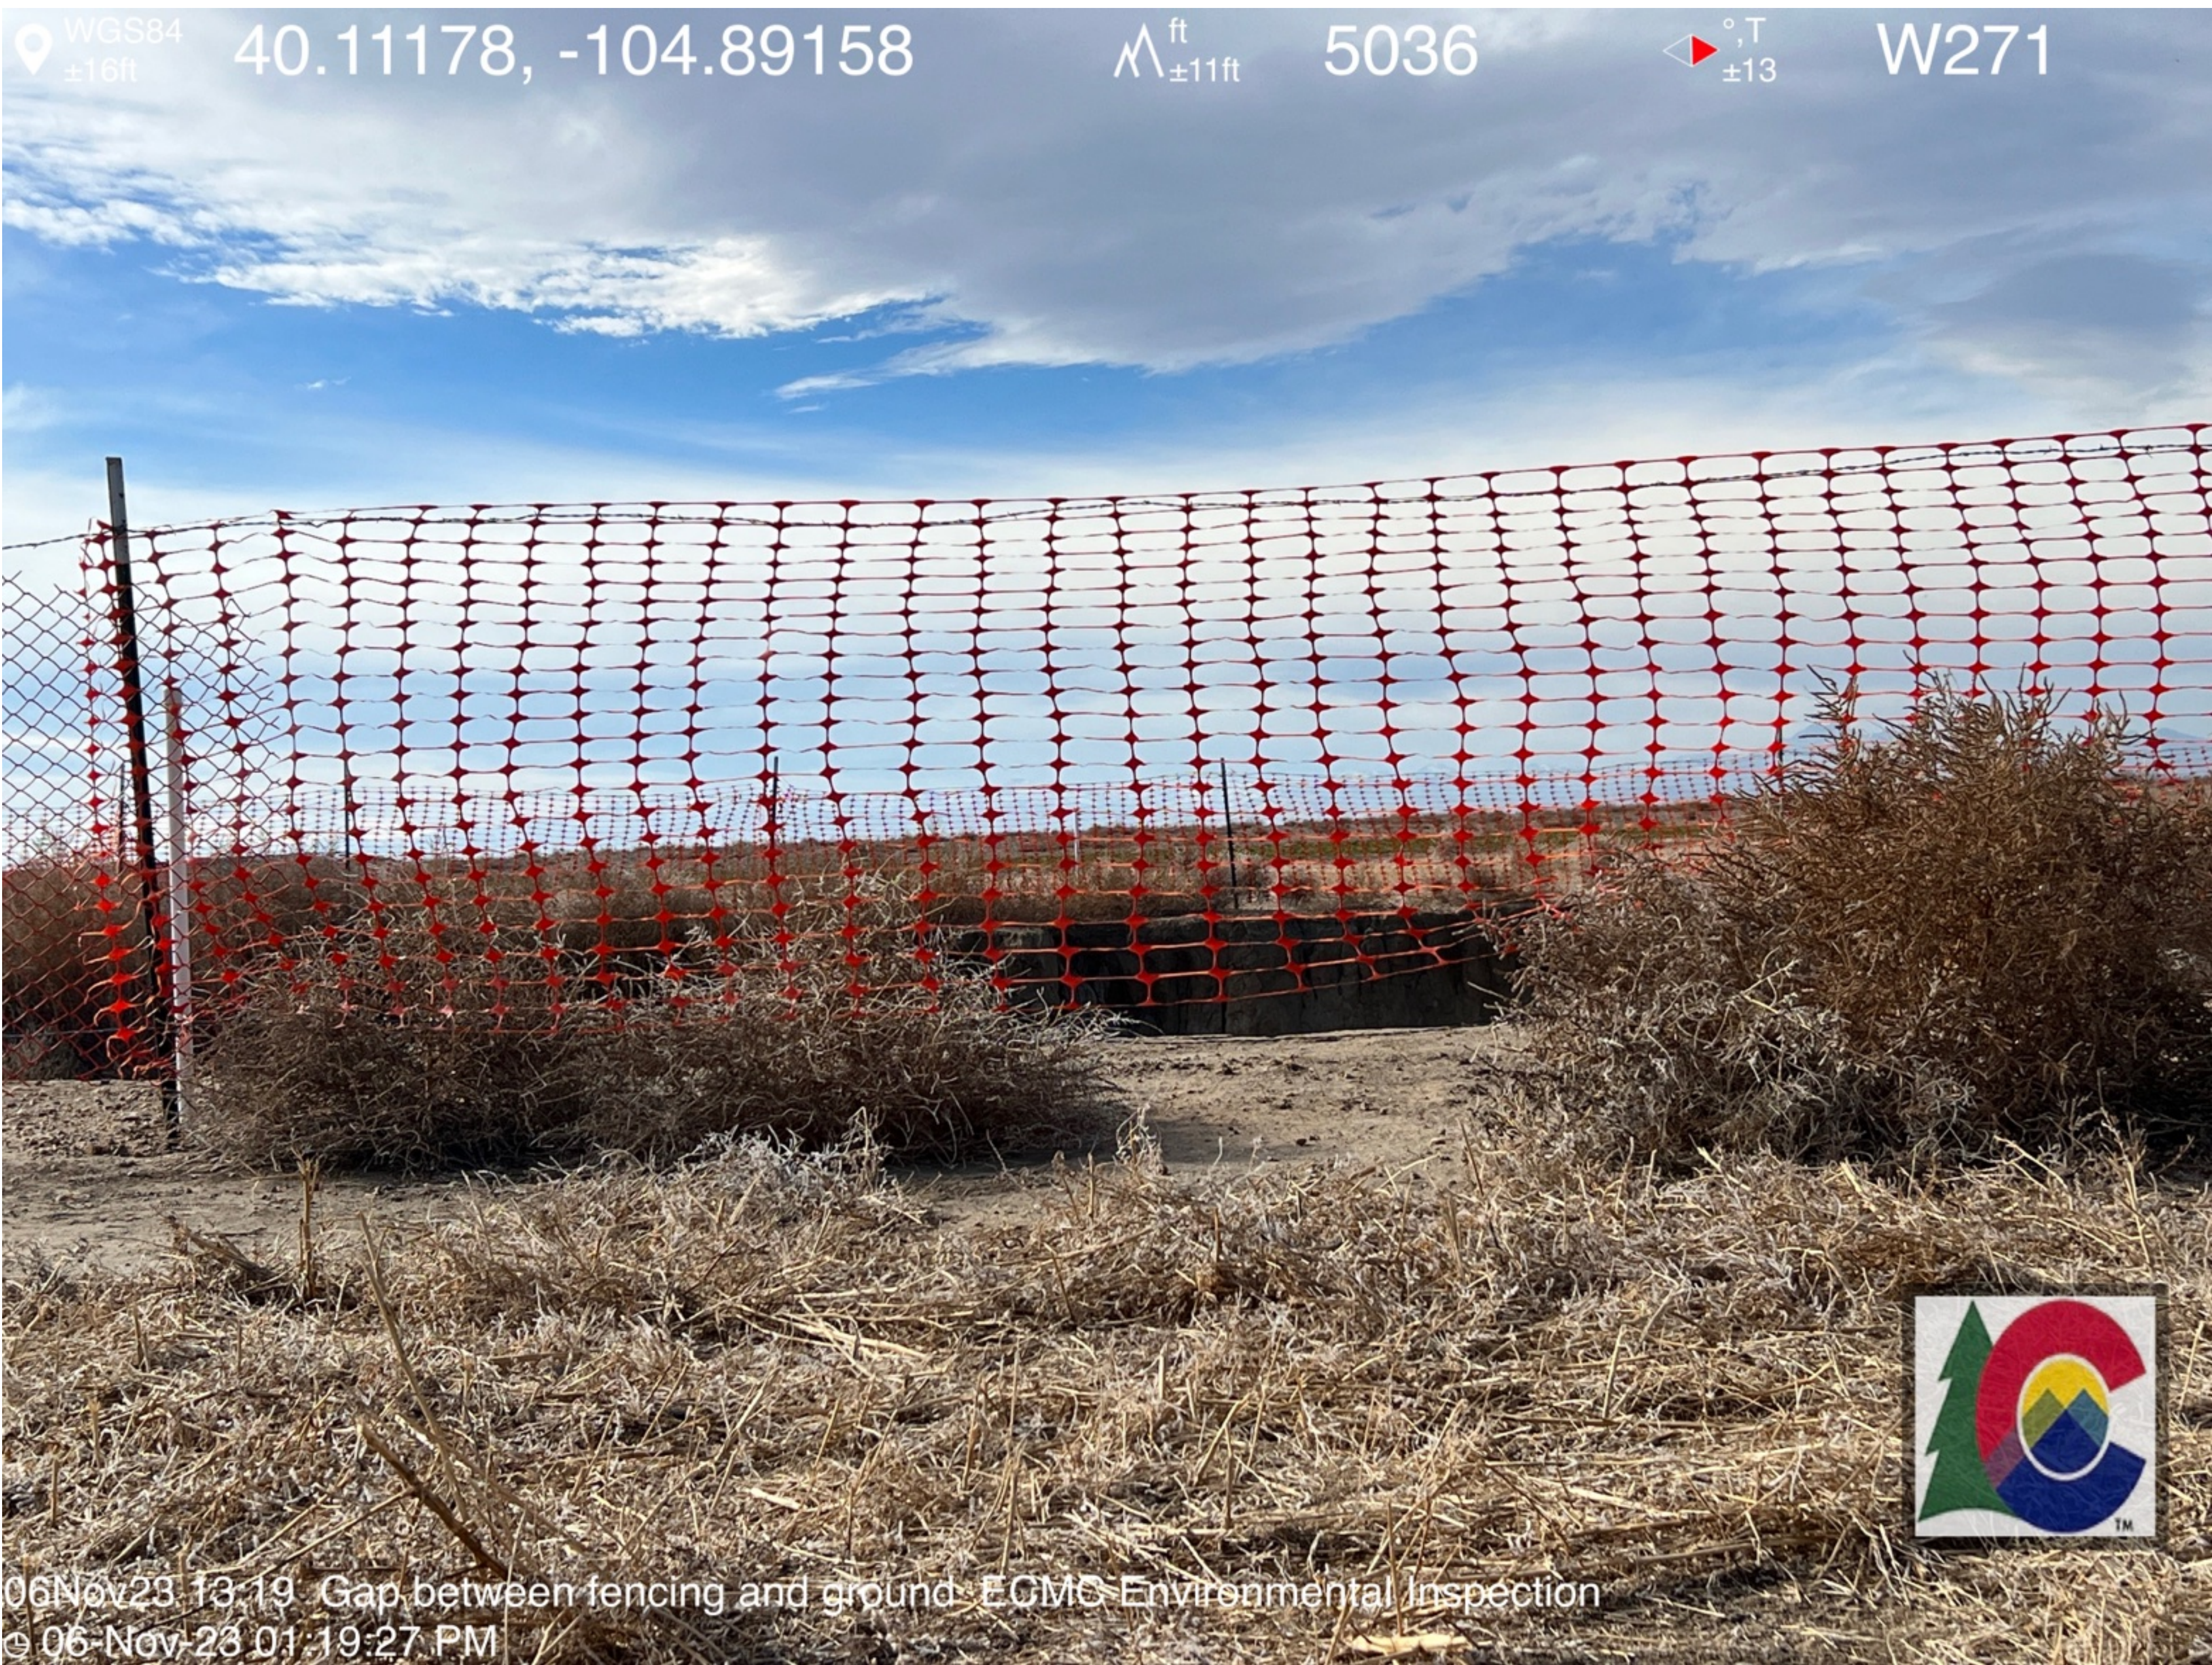
06Nov23 13:19 Gap in excavation fencing, weeds - ECMC Environmental Inspection
© 06-Nov-23 01:19:43 PM

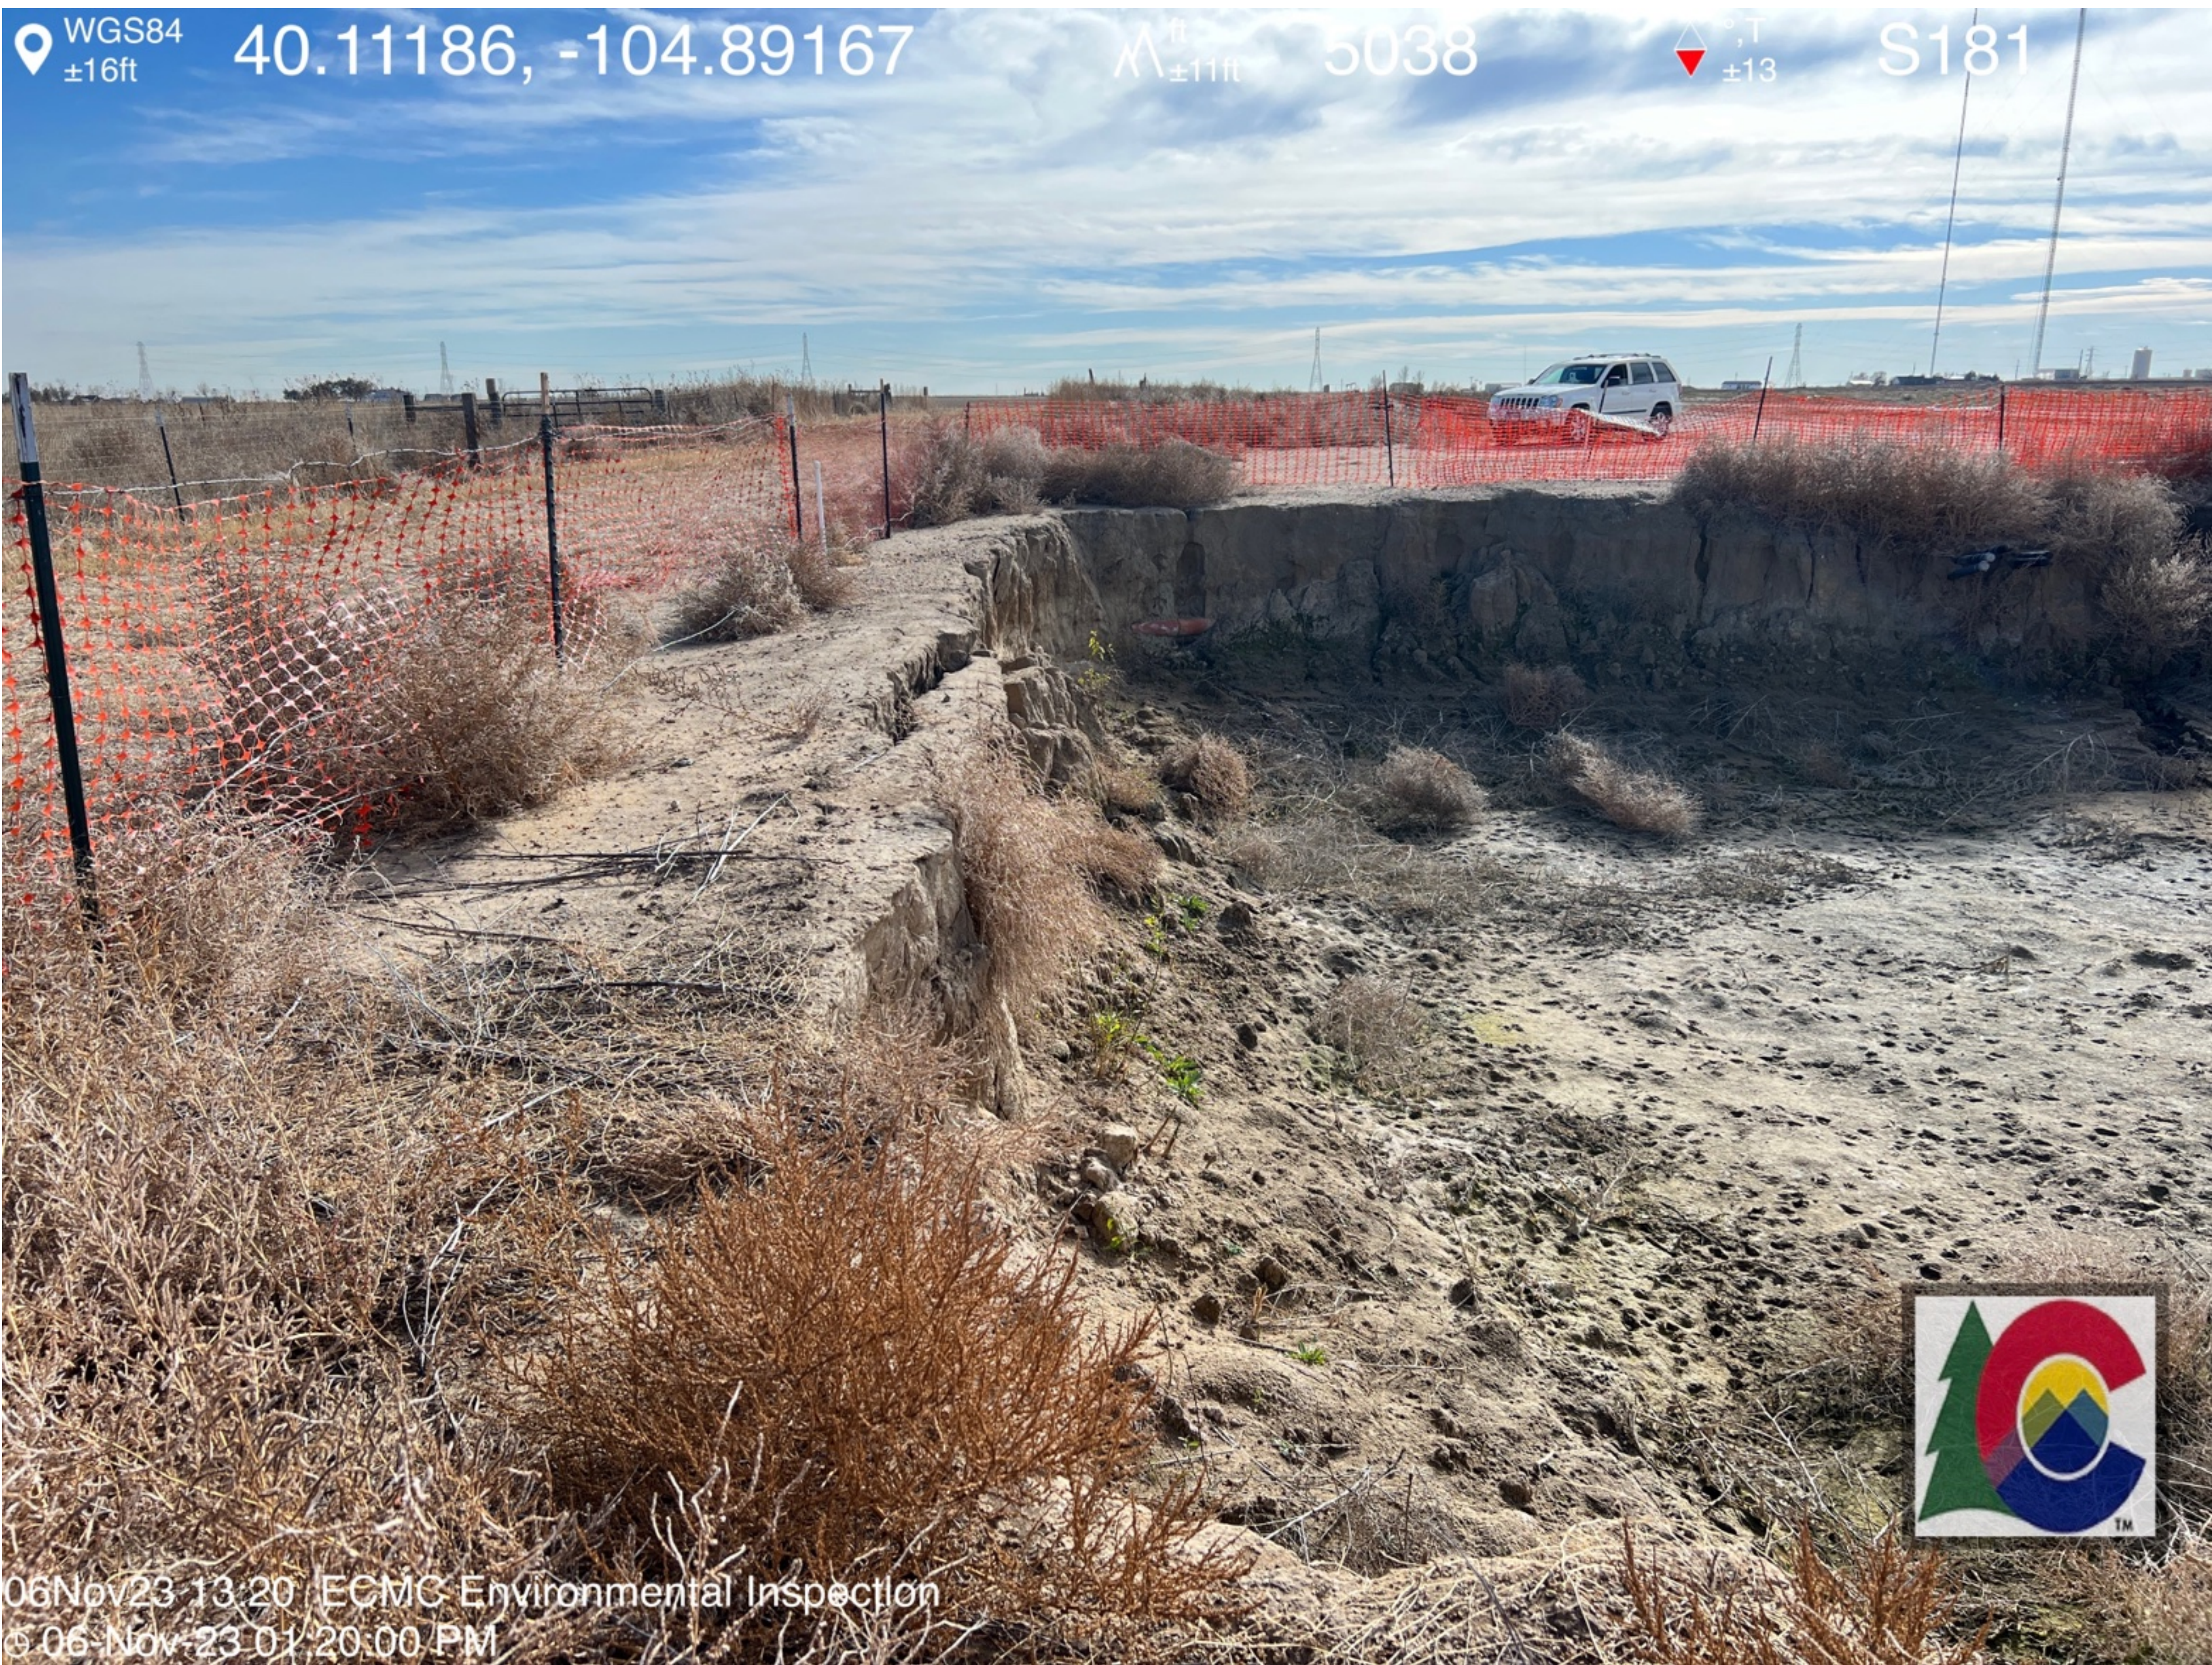
06Nov23 13:20 Animal tracks in excavation ECMC Environmental Inspection
© 06-Nov-23 01:20:05 PM

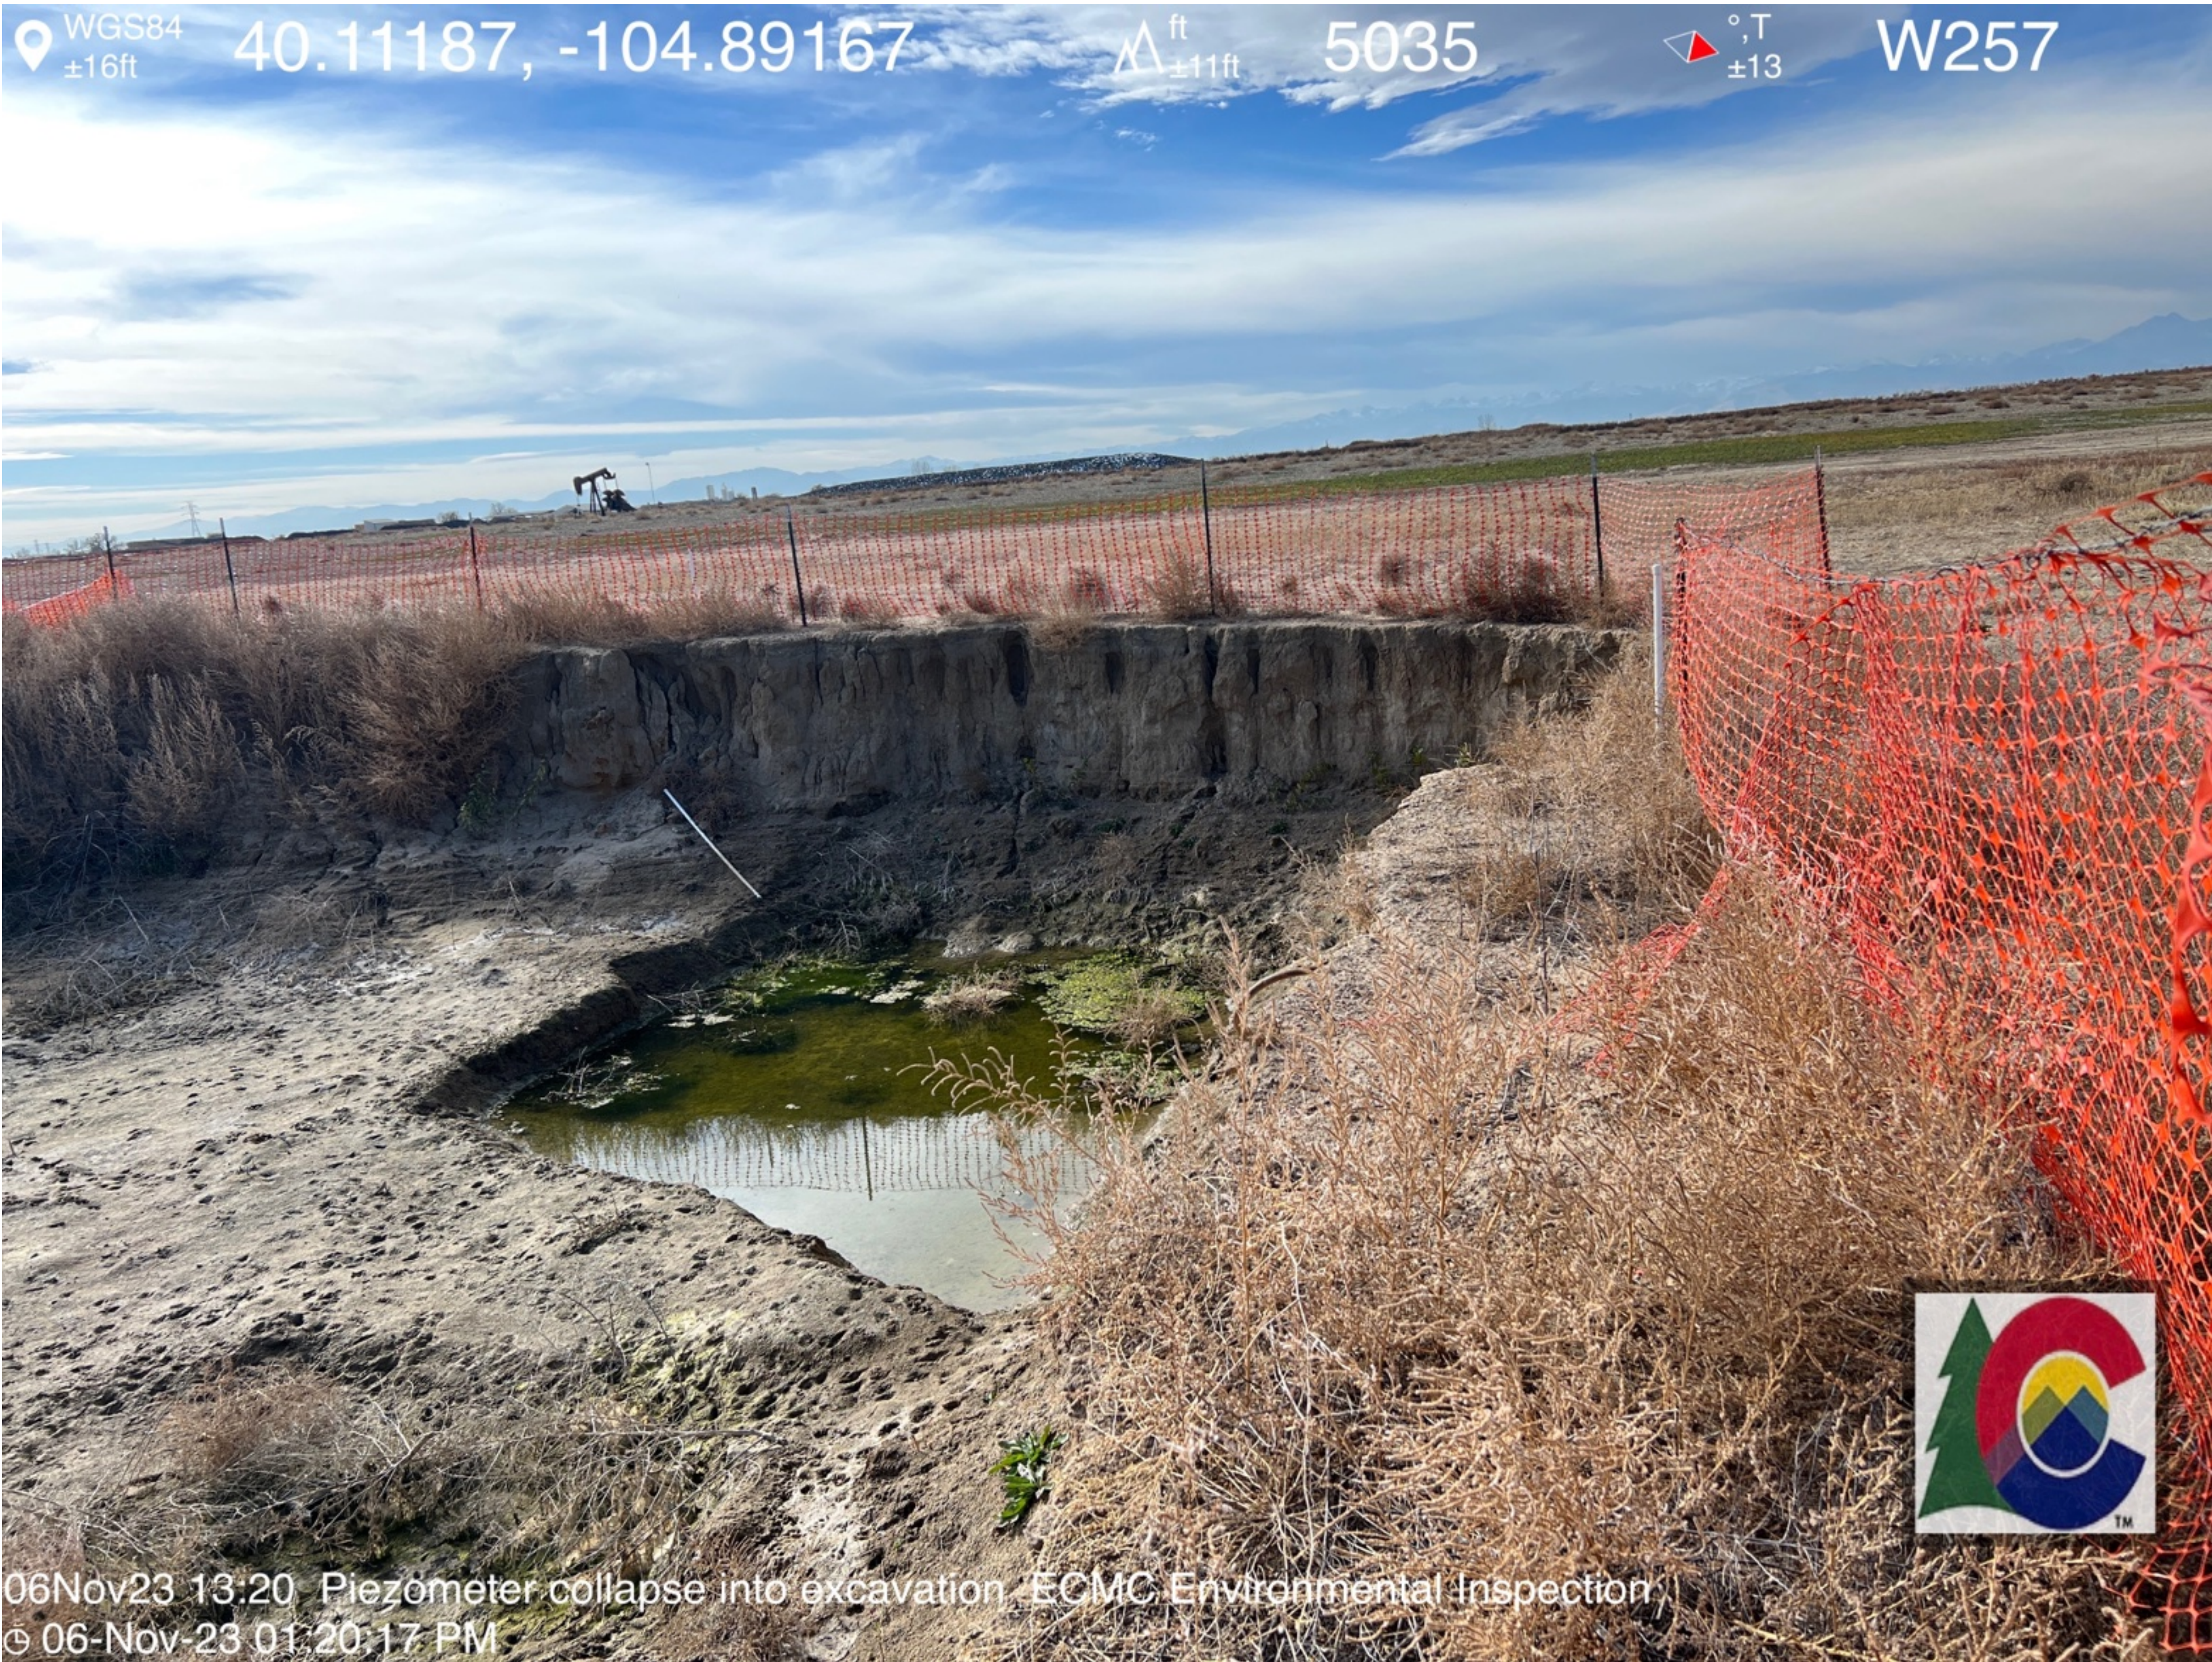
06Nov23 13:20 Sidewall collapsing ECMC Environmental Inspection
© 06-Nov-23 01:20:35 PM
