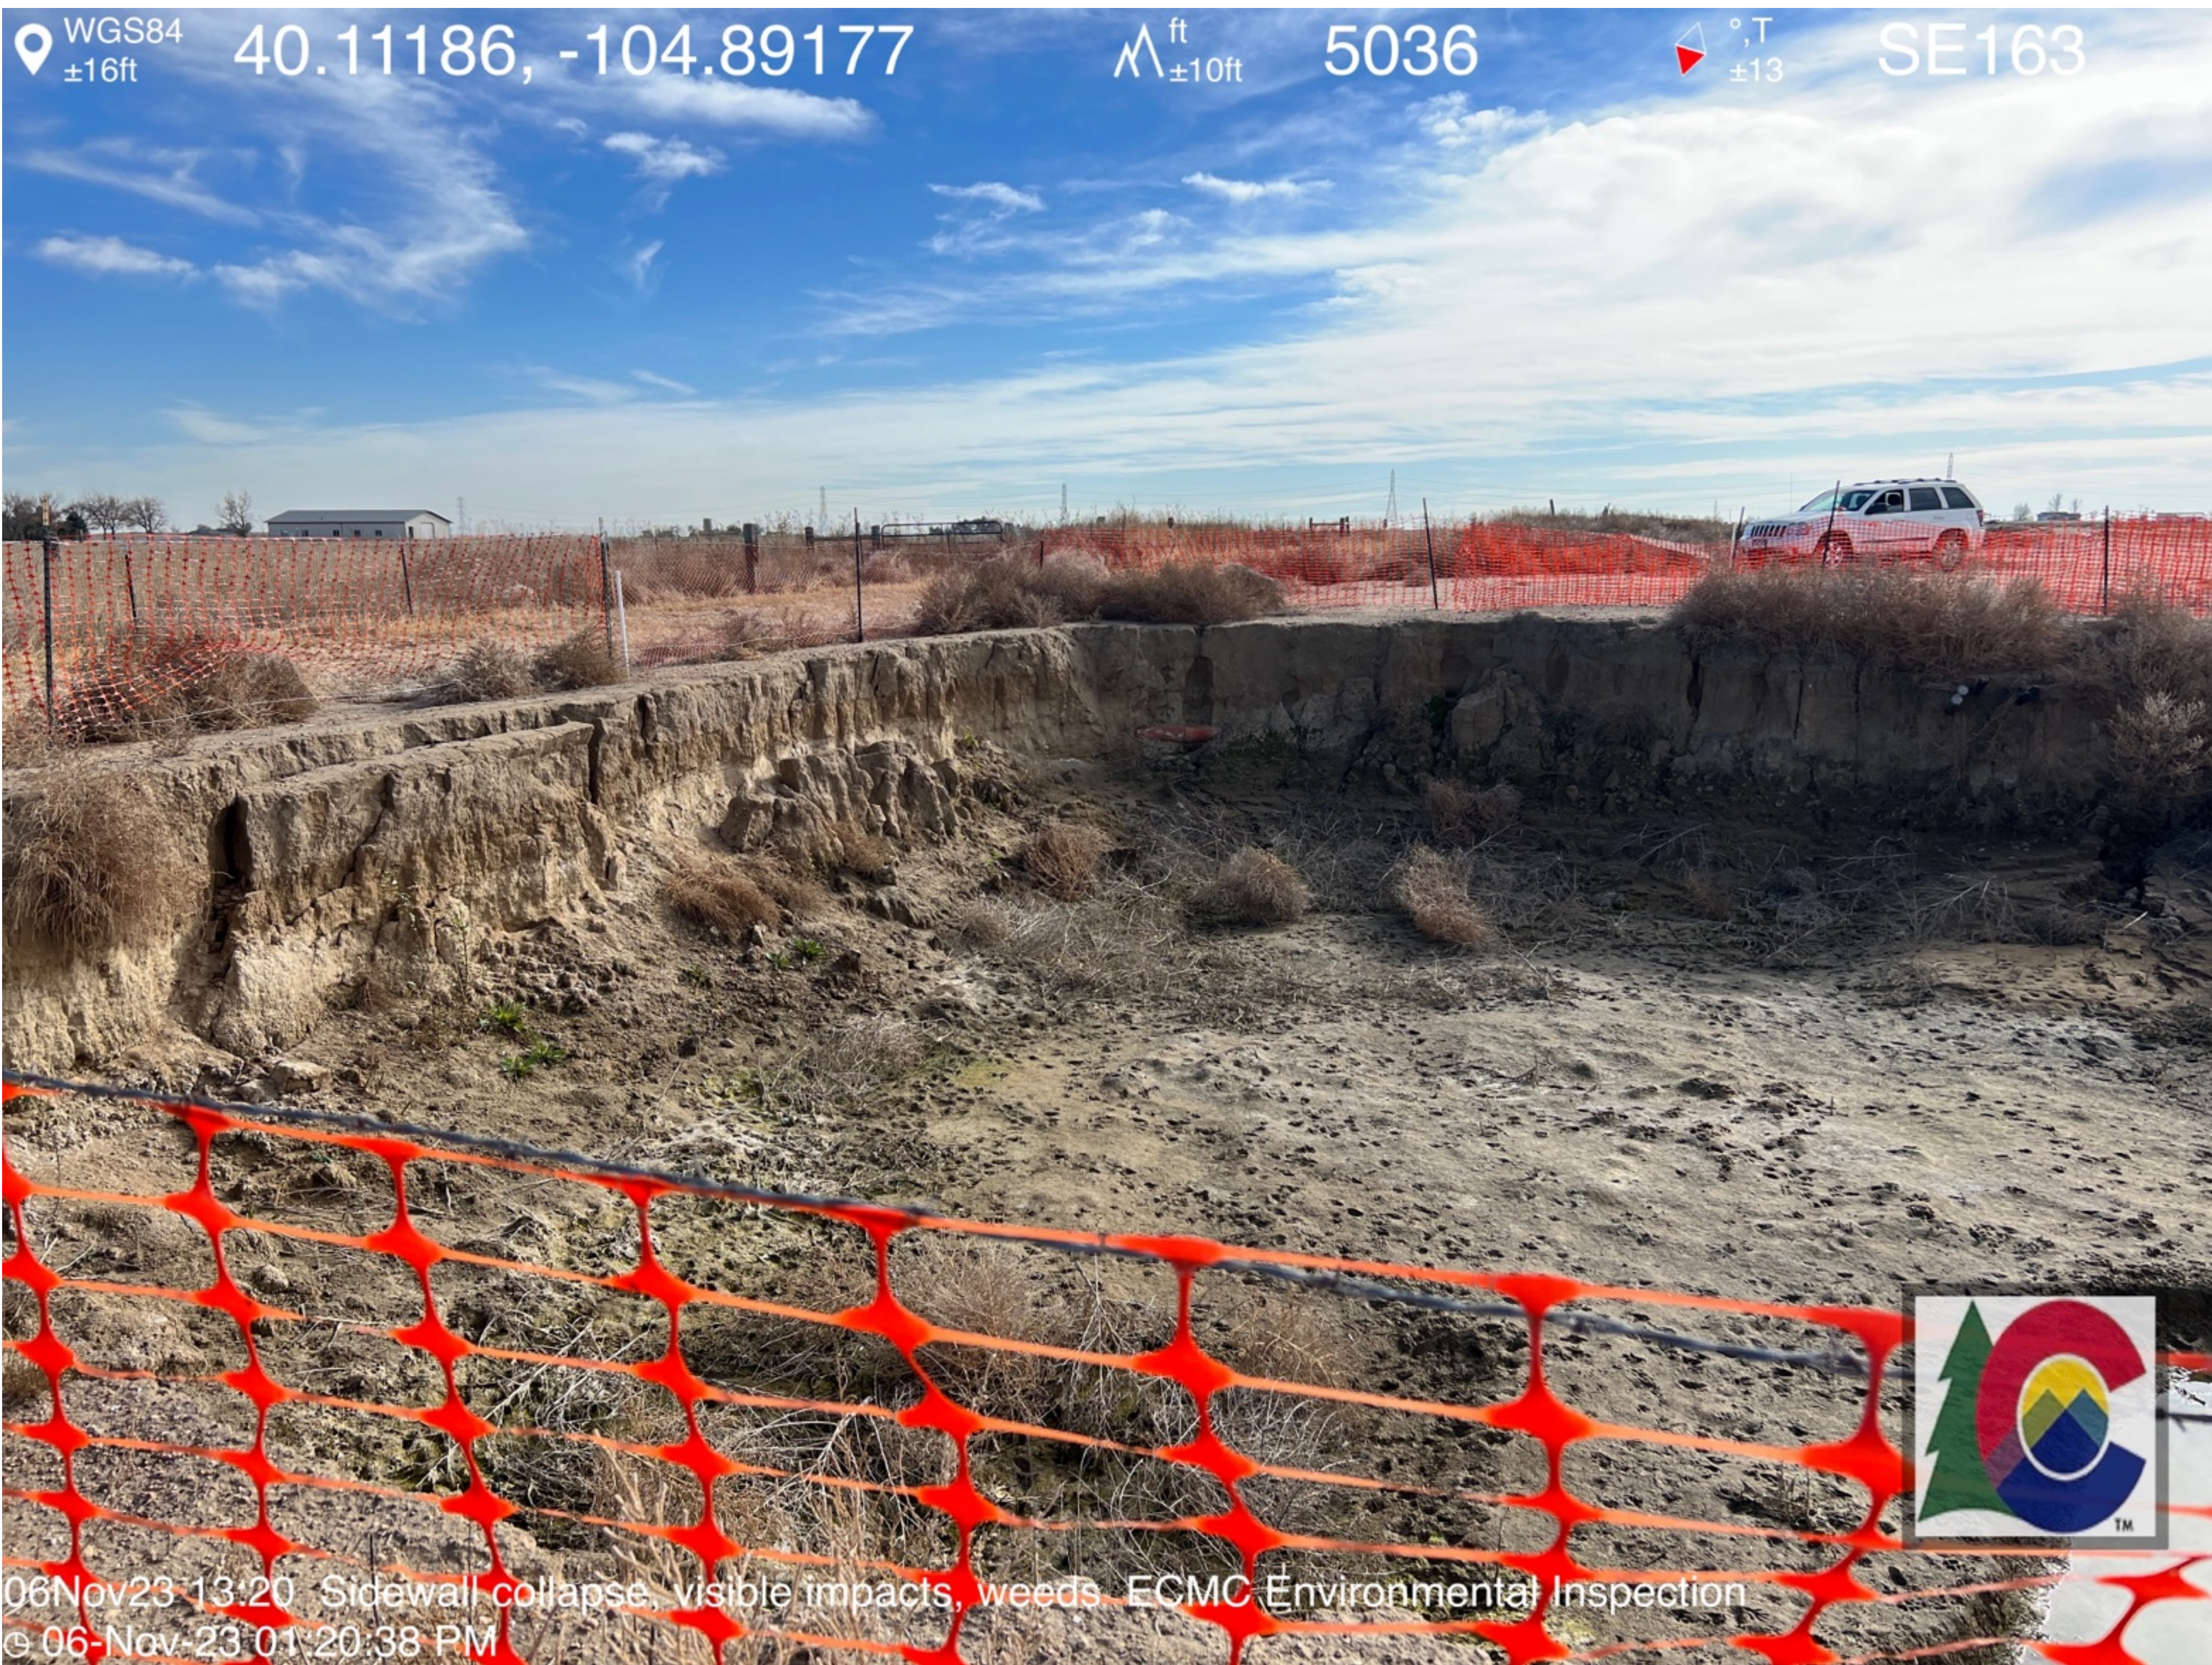
06Nov23 13:20 Sidewall collapse, visible impacts, weeds. ECMC Environmental Inspection
© 06-Nov-23 01:20:38 PM

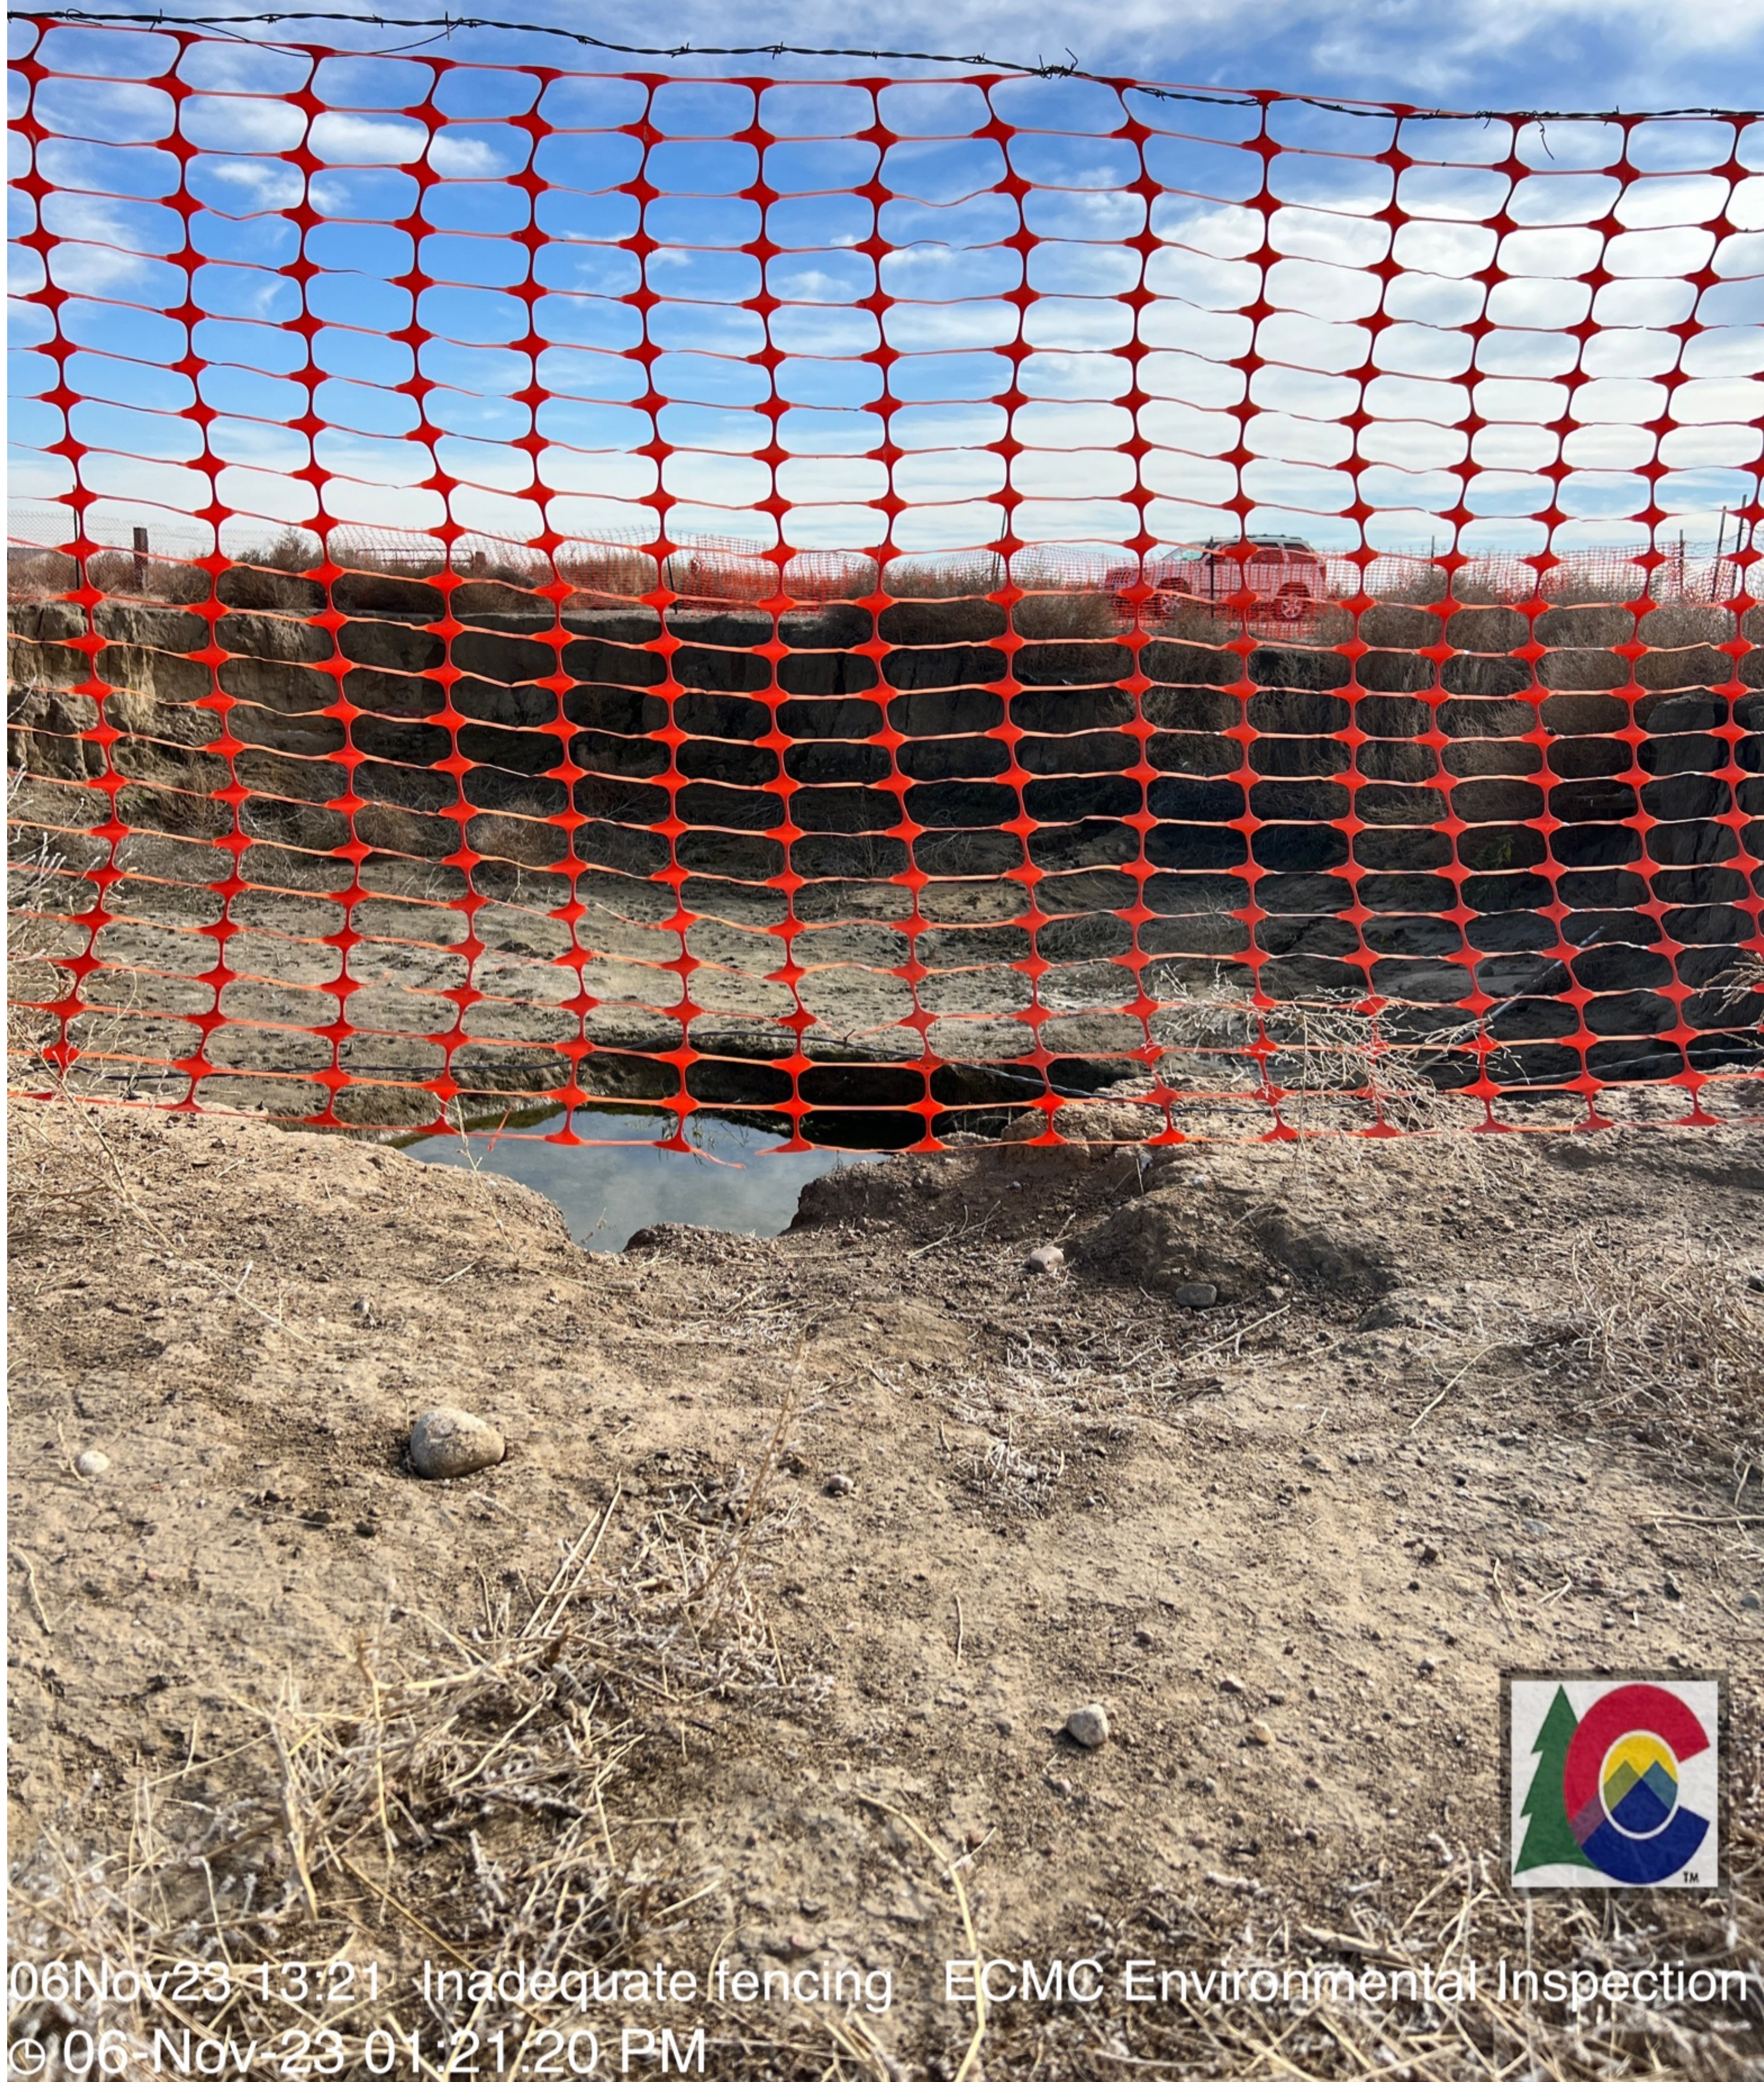
06Nov23 13:21 Inadequate fencing ECMC Environmental Inspection
© 06-Nov-23 01:21:20 PM

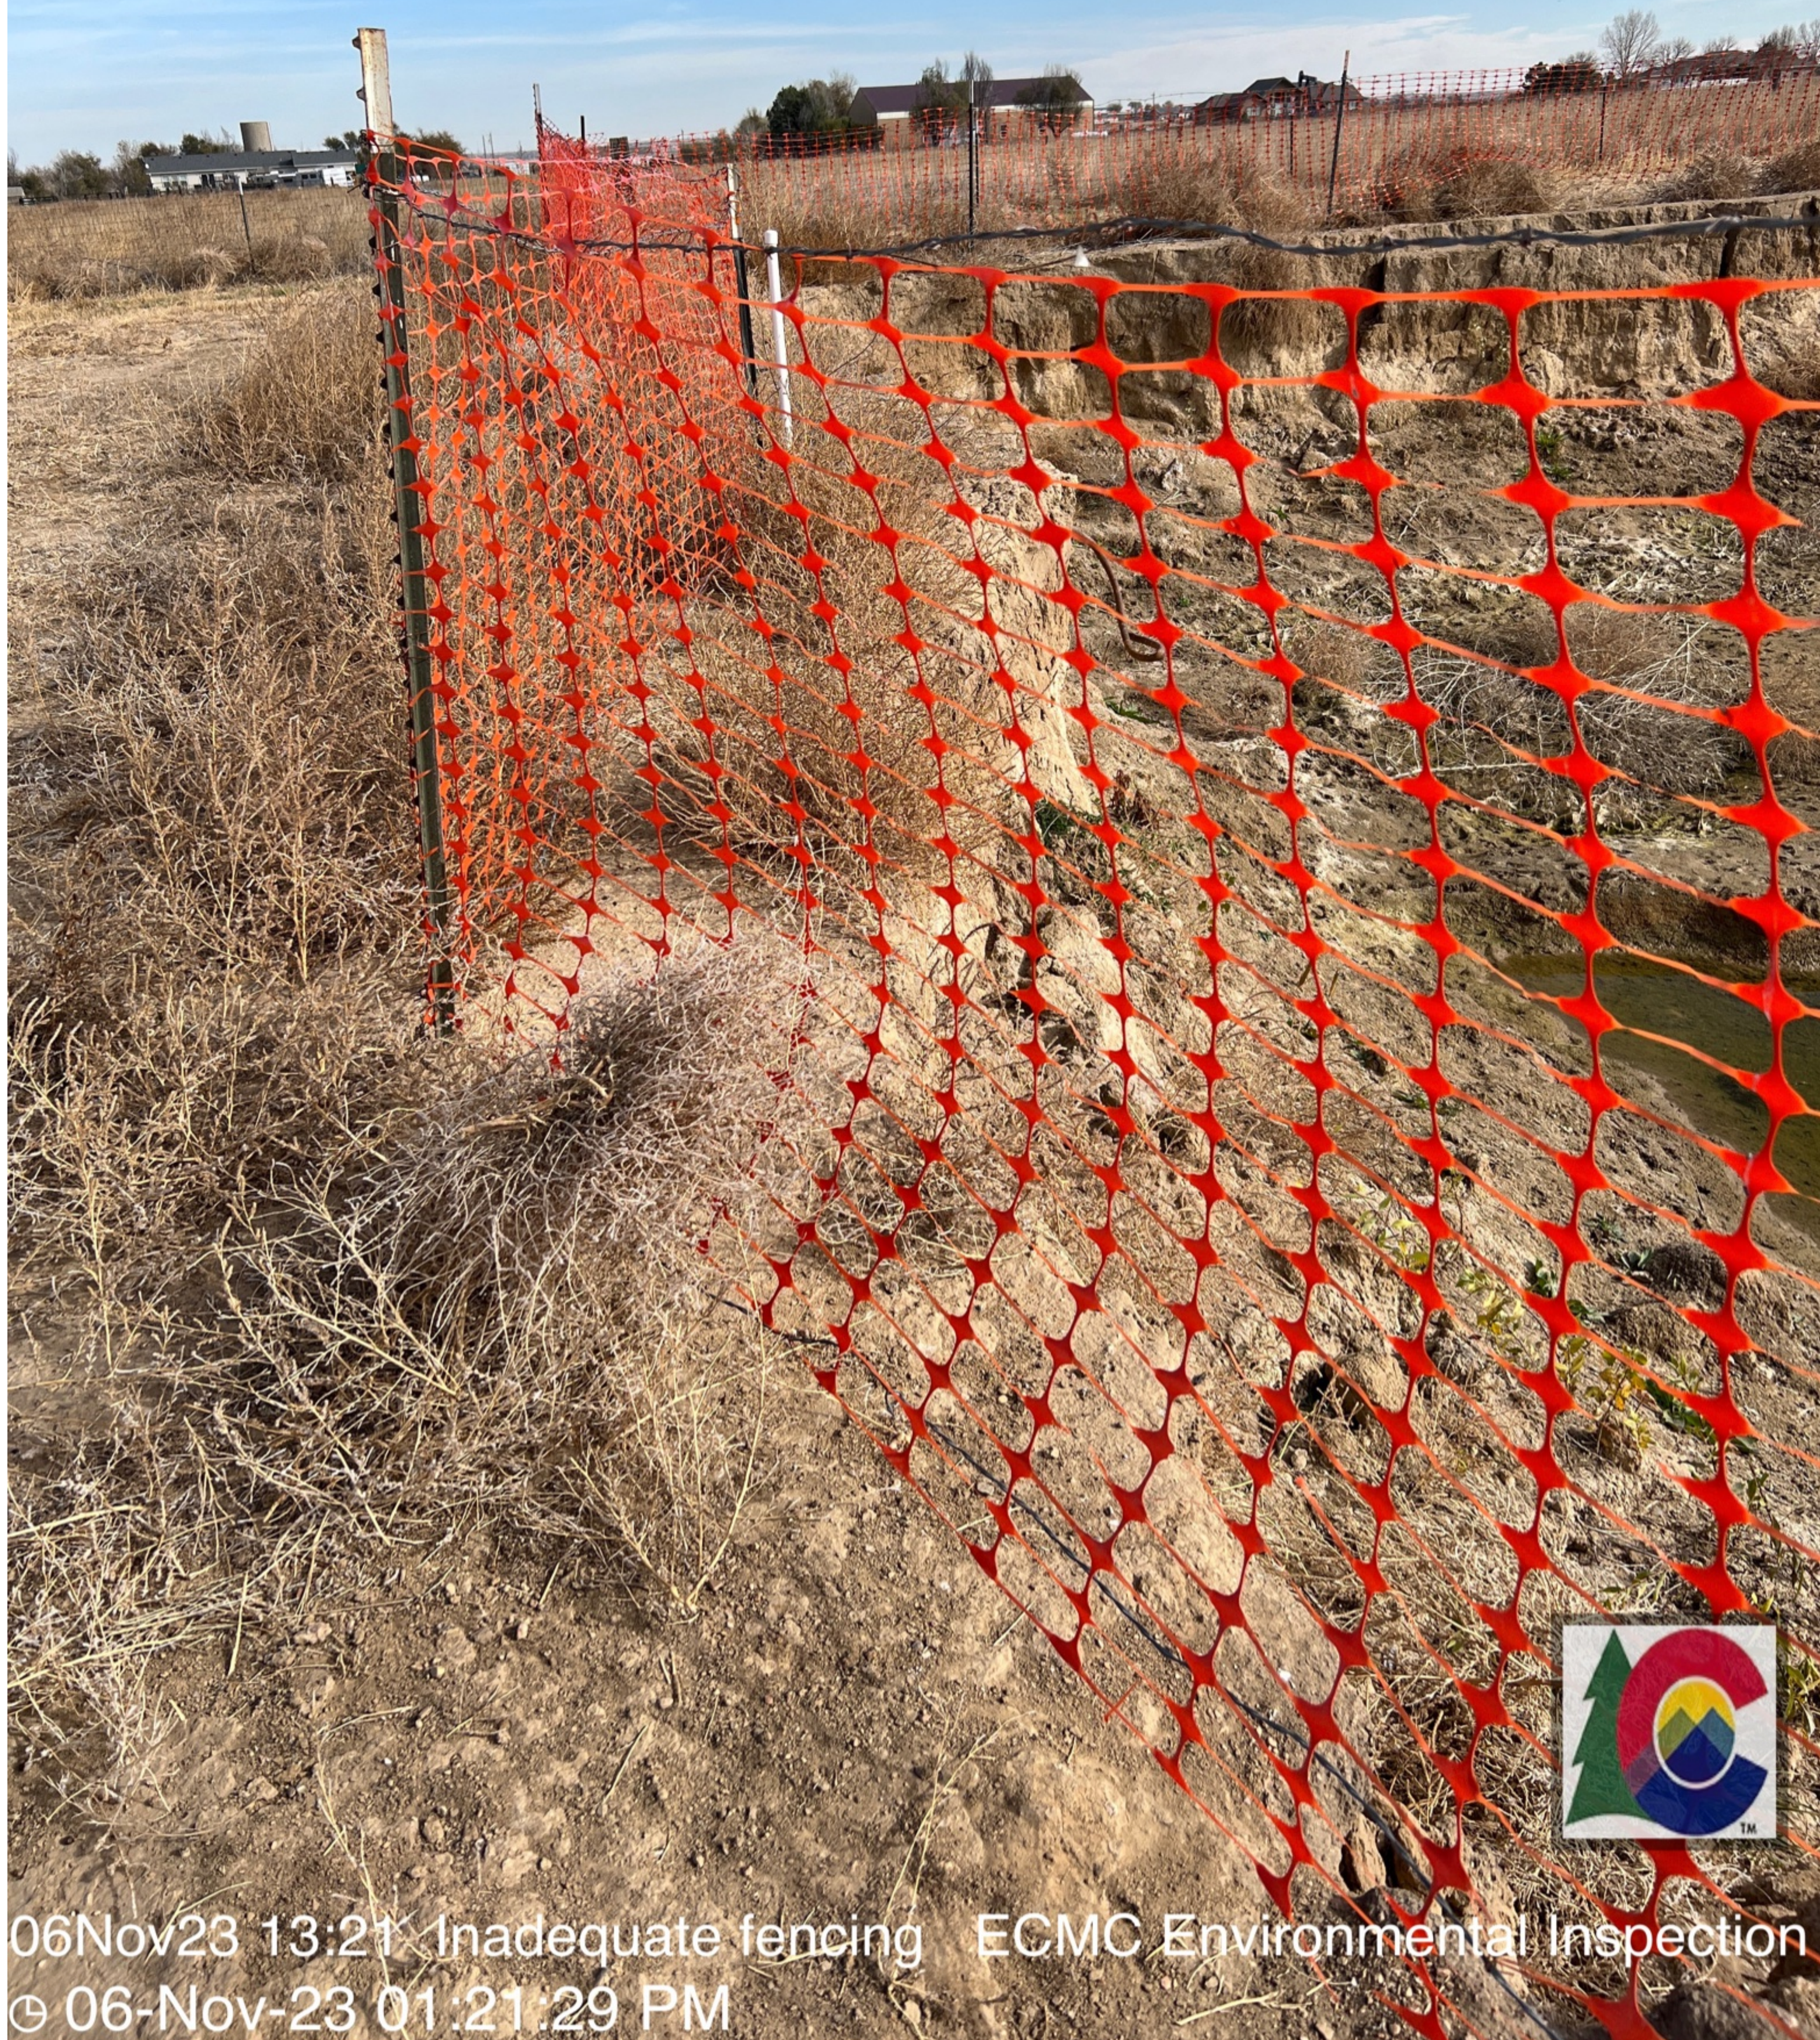
06Nov23 13:21 Inadequate fencing ECMC Environmental Inspection
© 06-Nov-23 01:21:29 PM

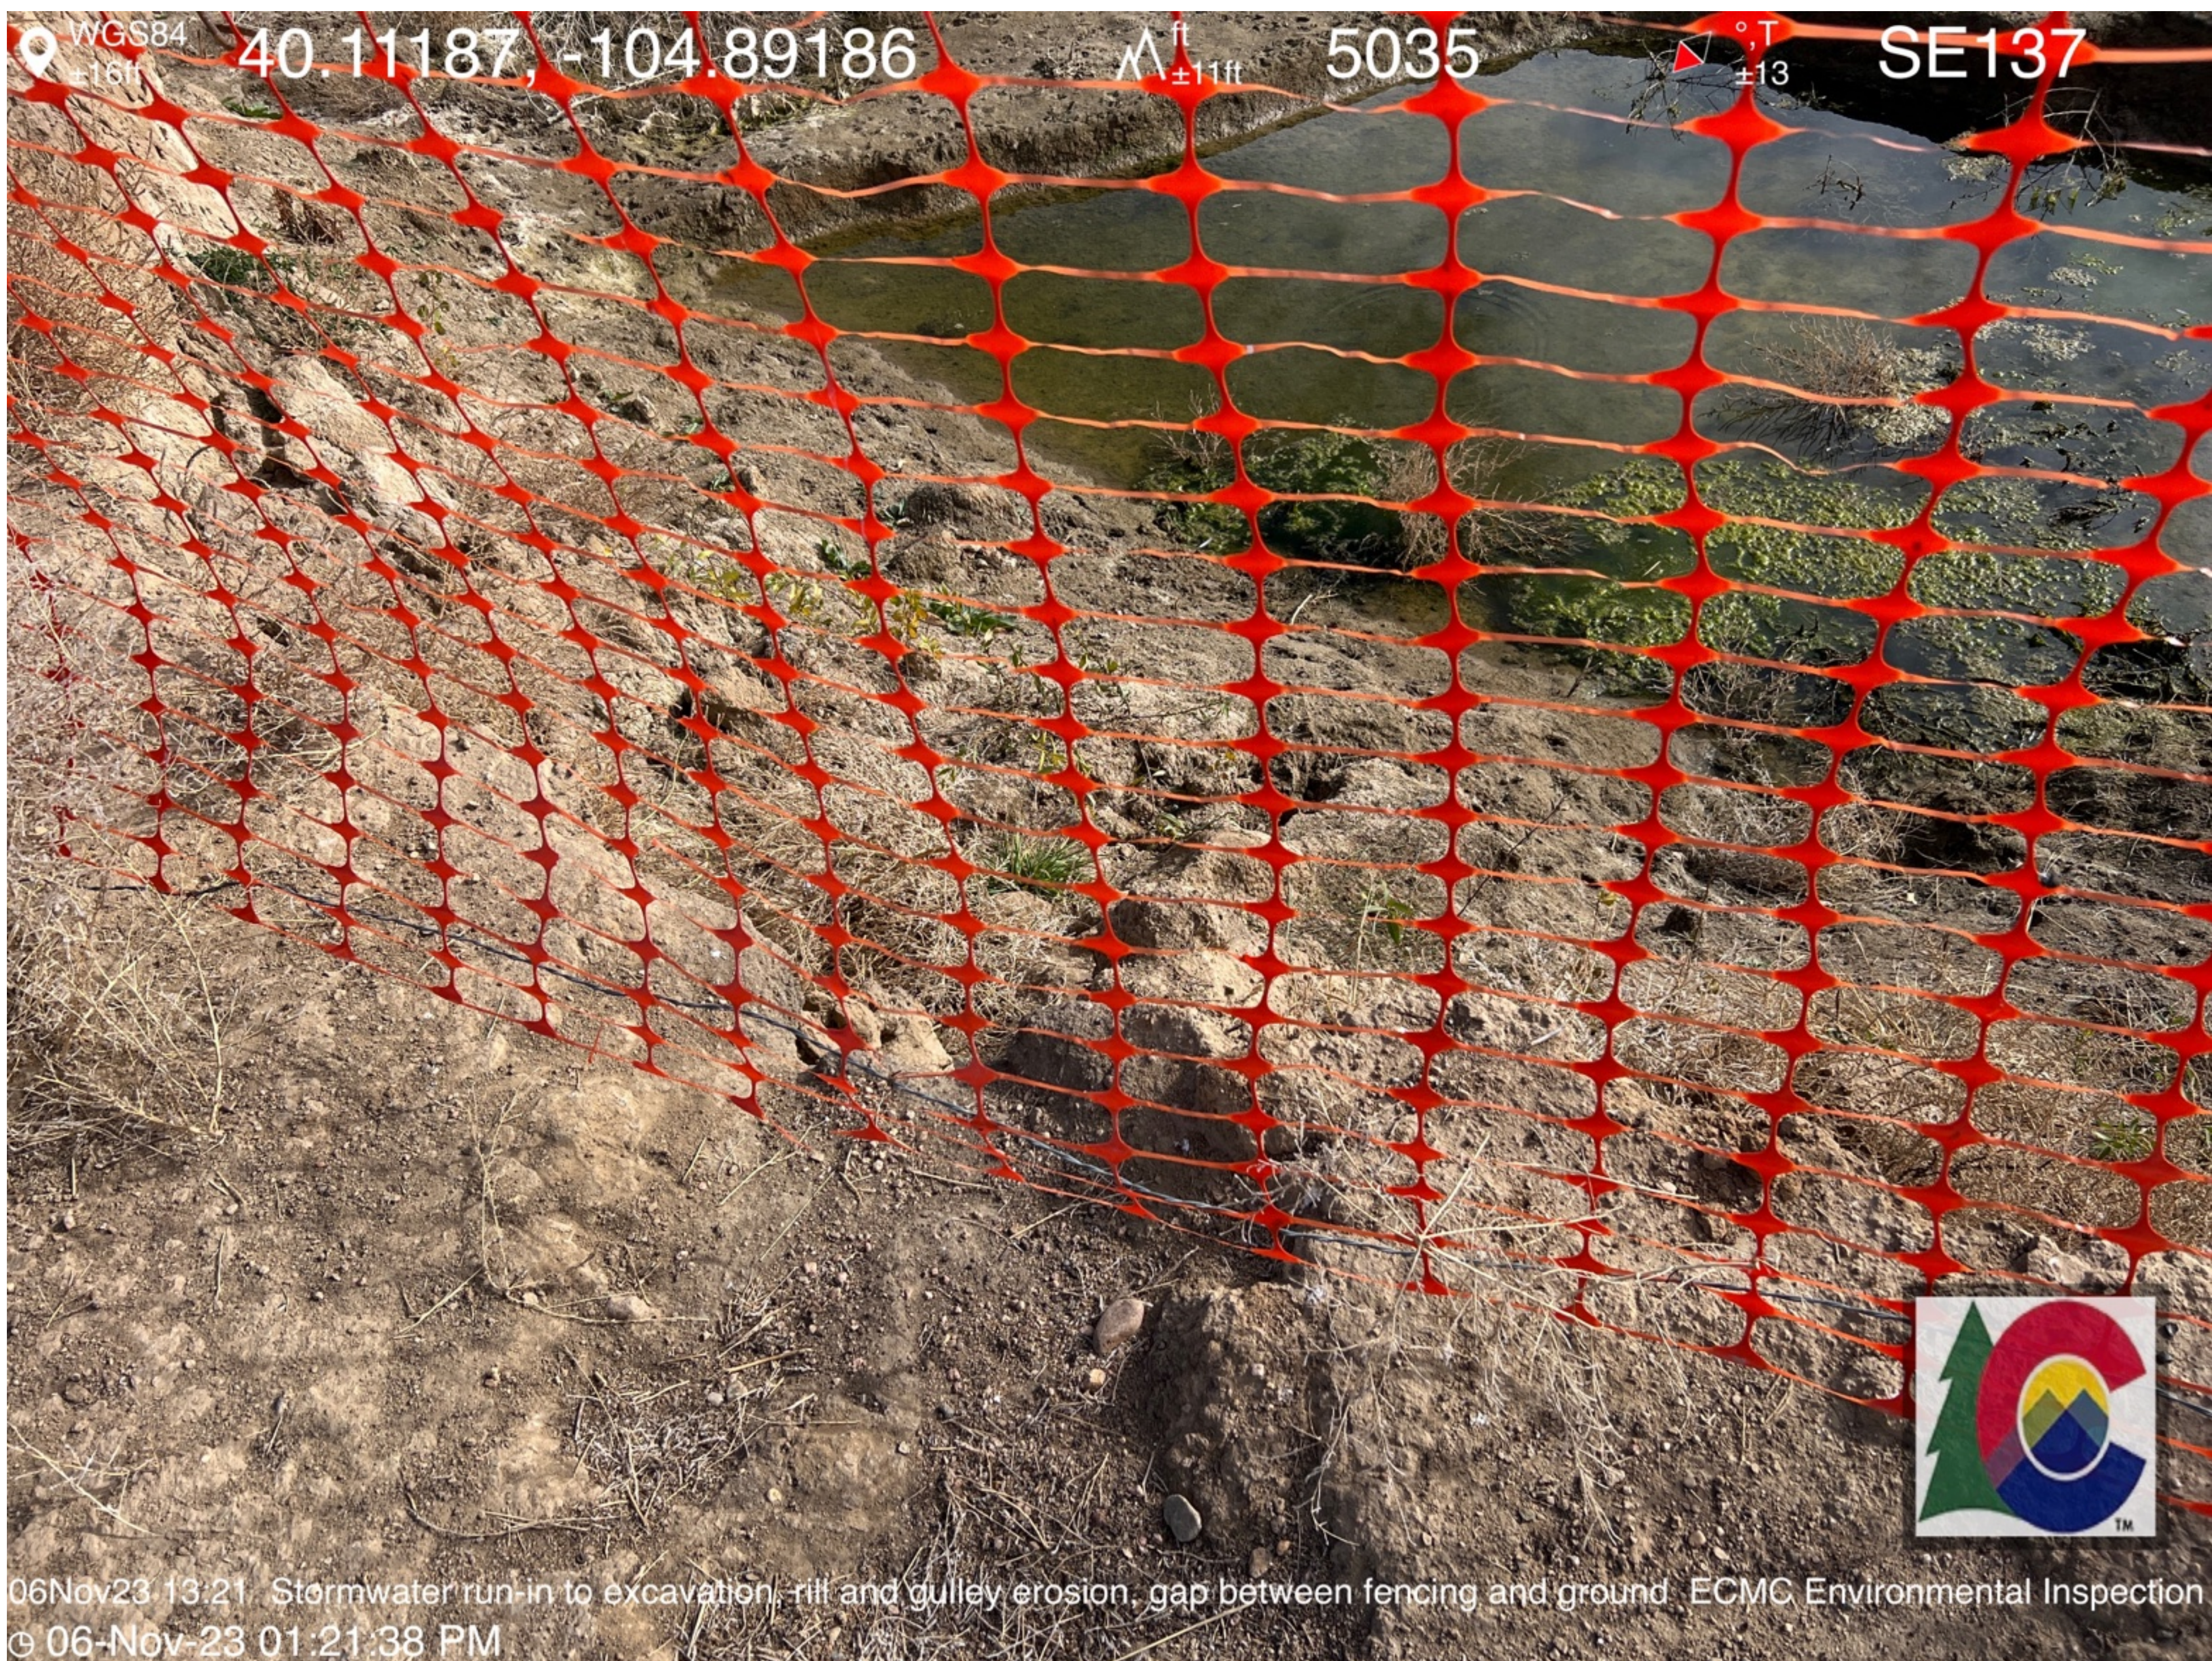
06Nov23 13:21 Stormwater run-in to excavation, rill and gulley erosion, gap between fencing and ground ECMC Environmental Inspection
© 06-Nov-23 01:21:38 PM

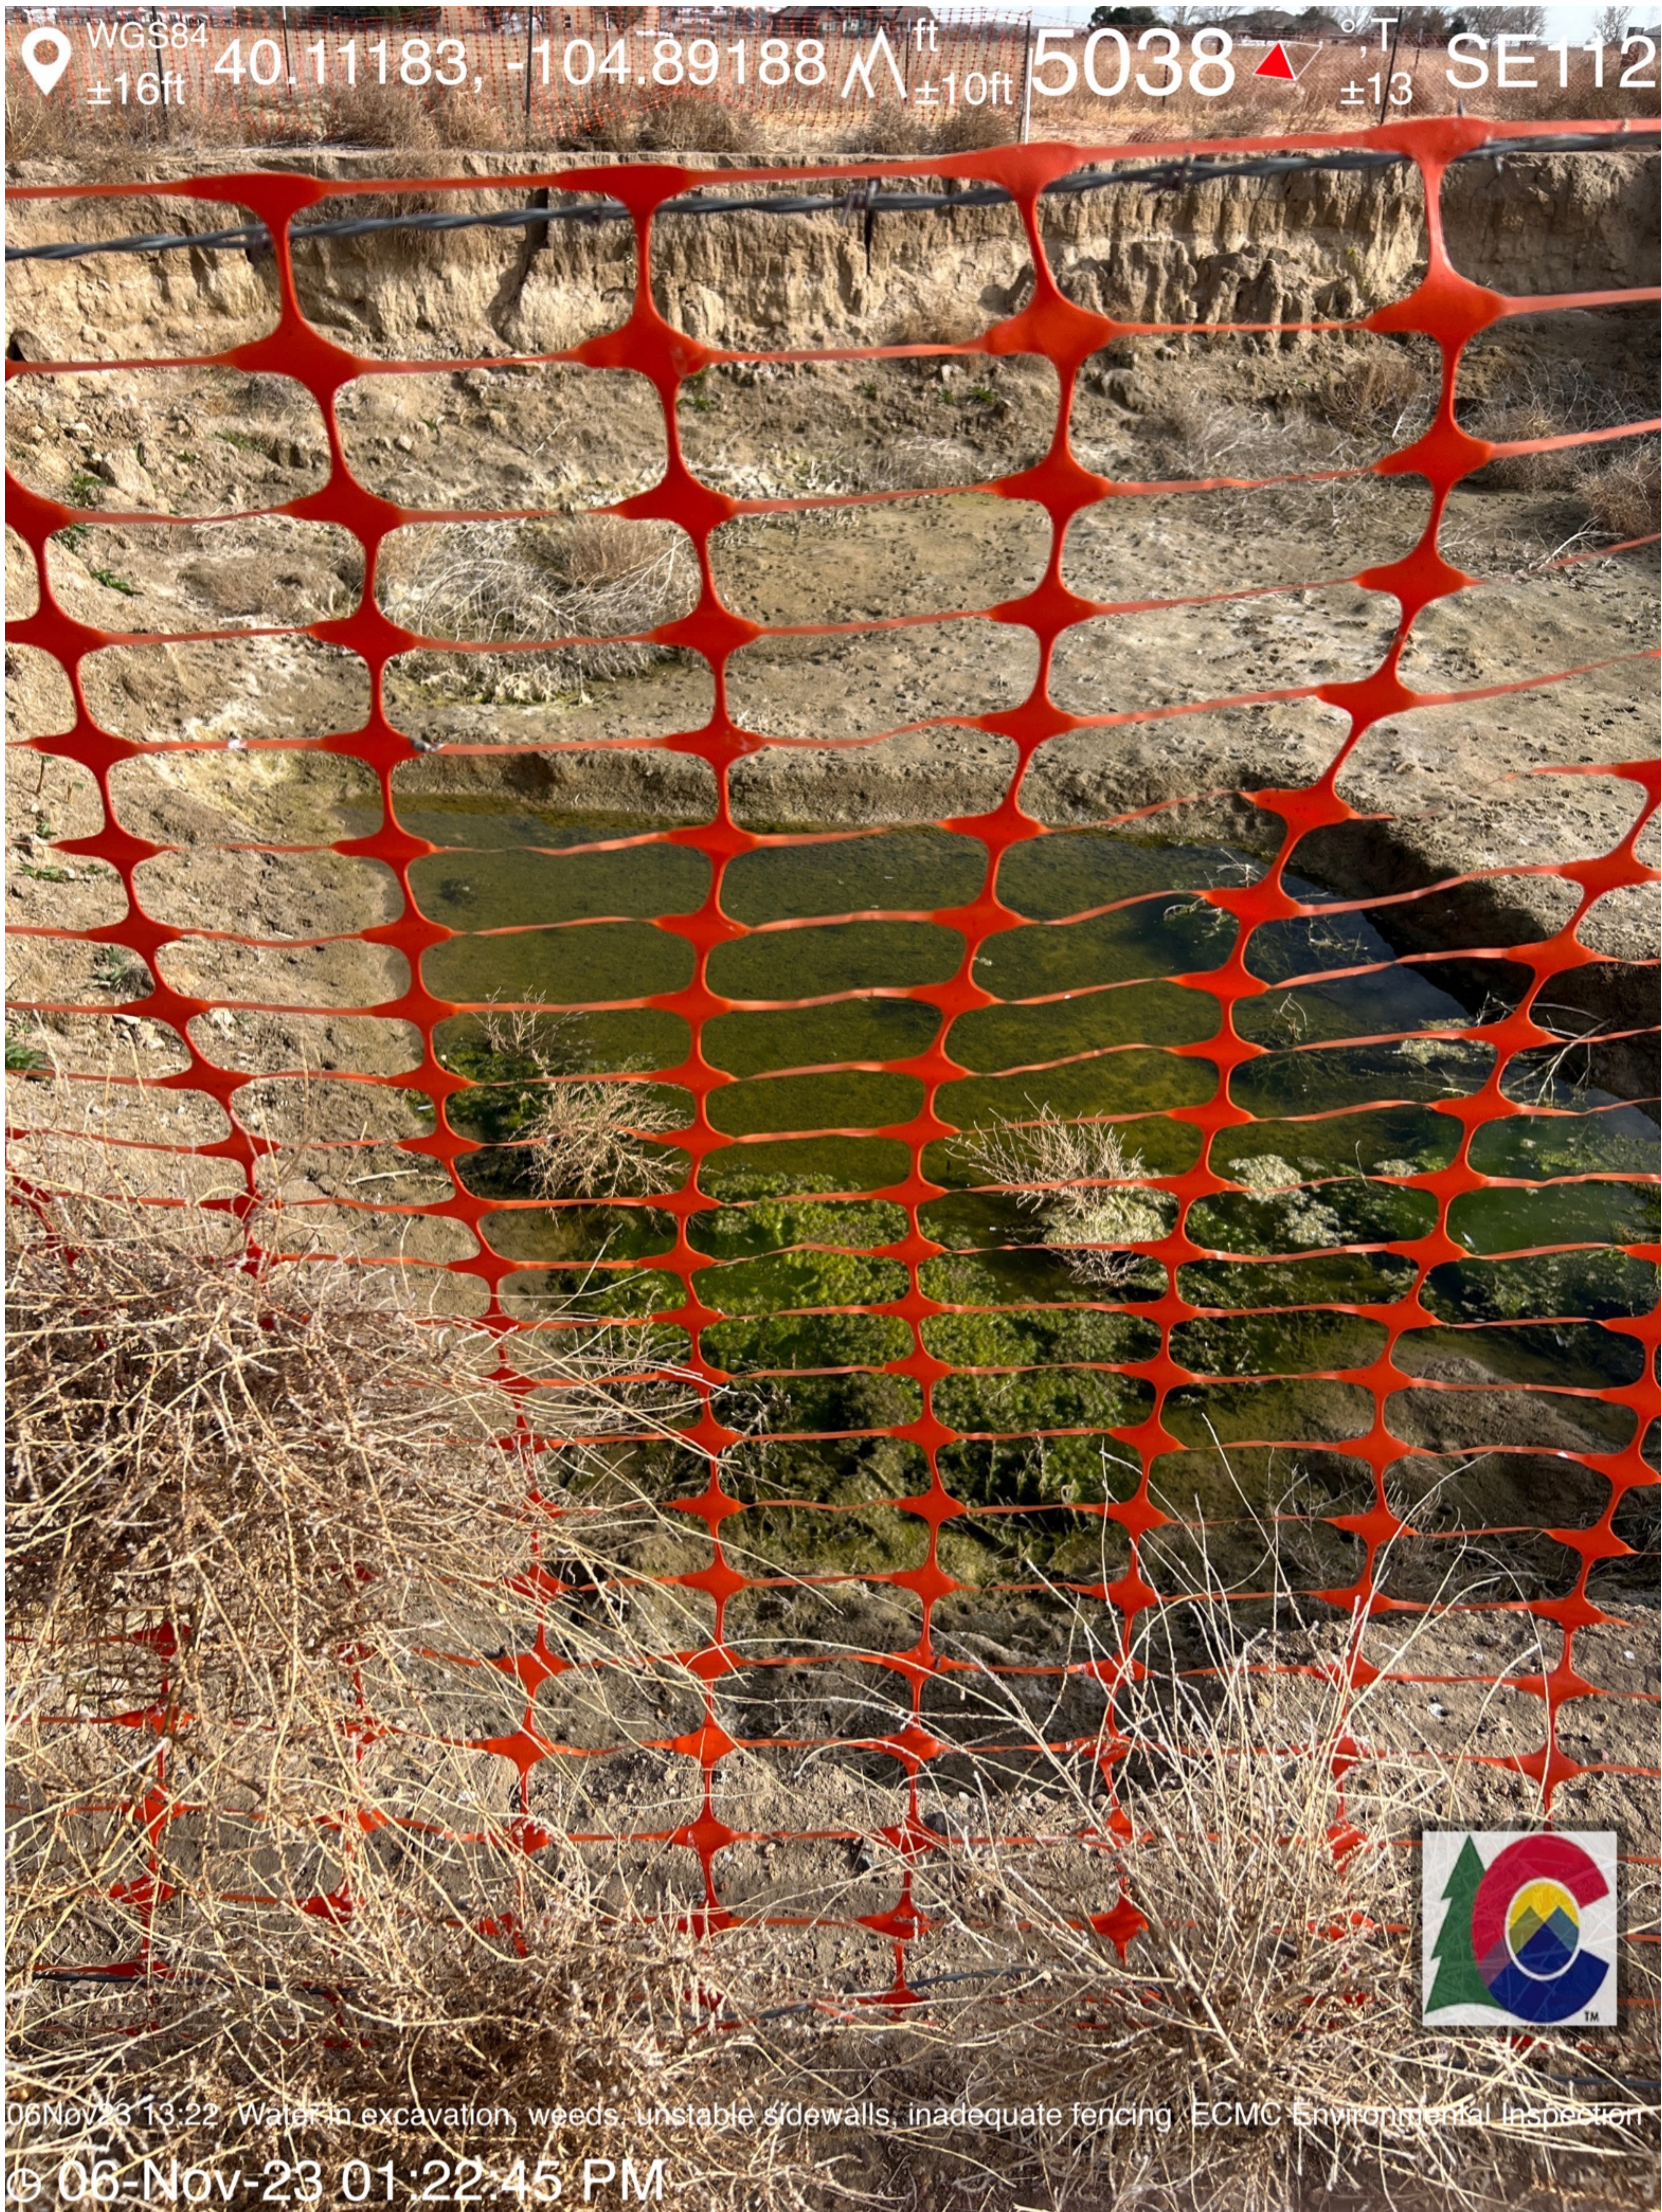
06Nov23 13:22 Water in excavation, weeds, unstable sidewalls, inadequate fencing, ECMC Environmental Inspection

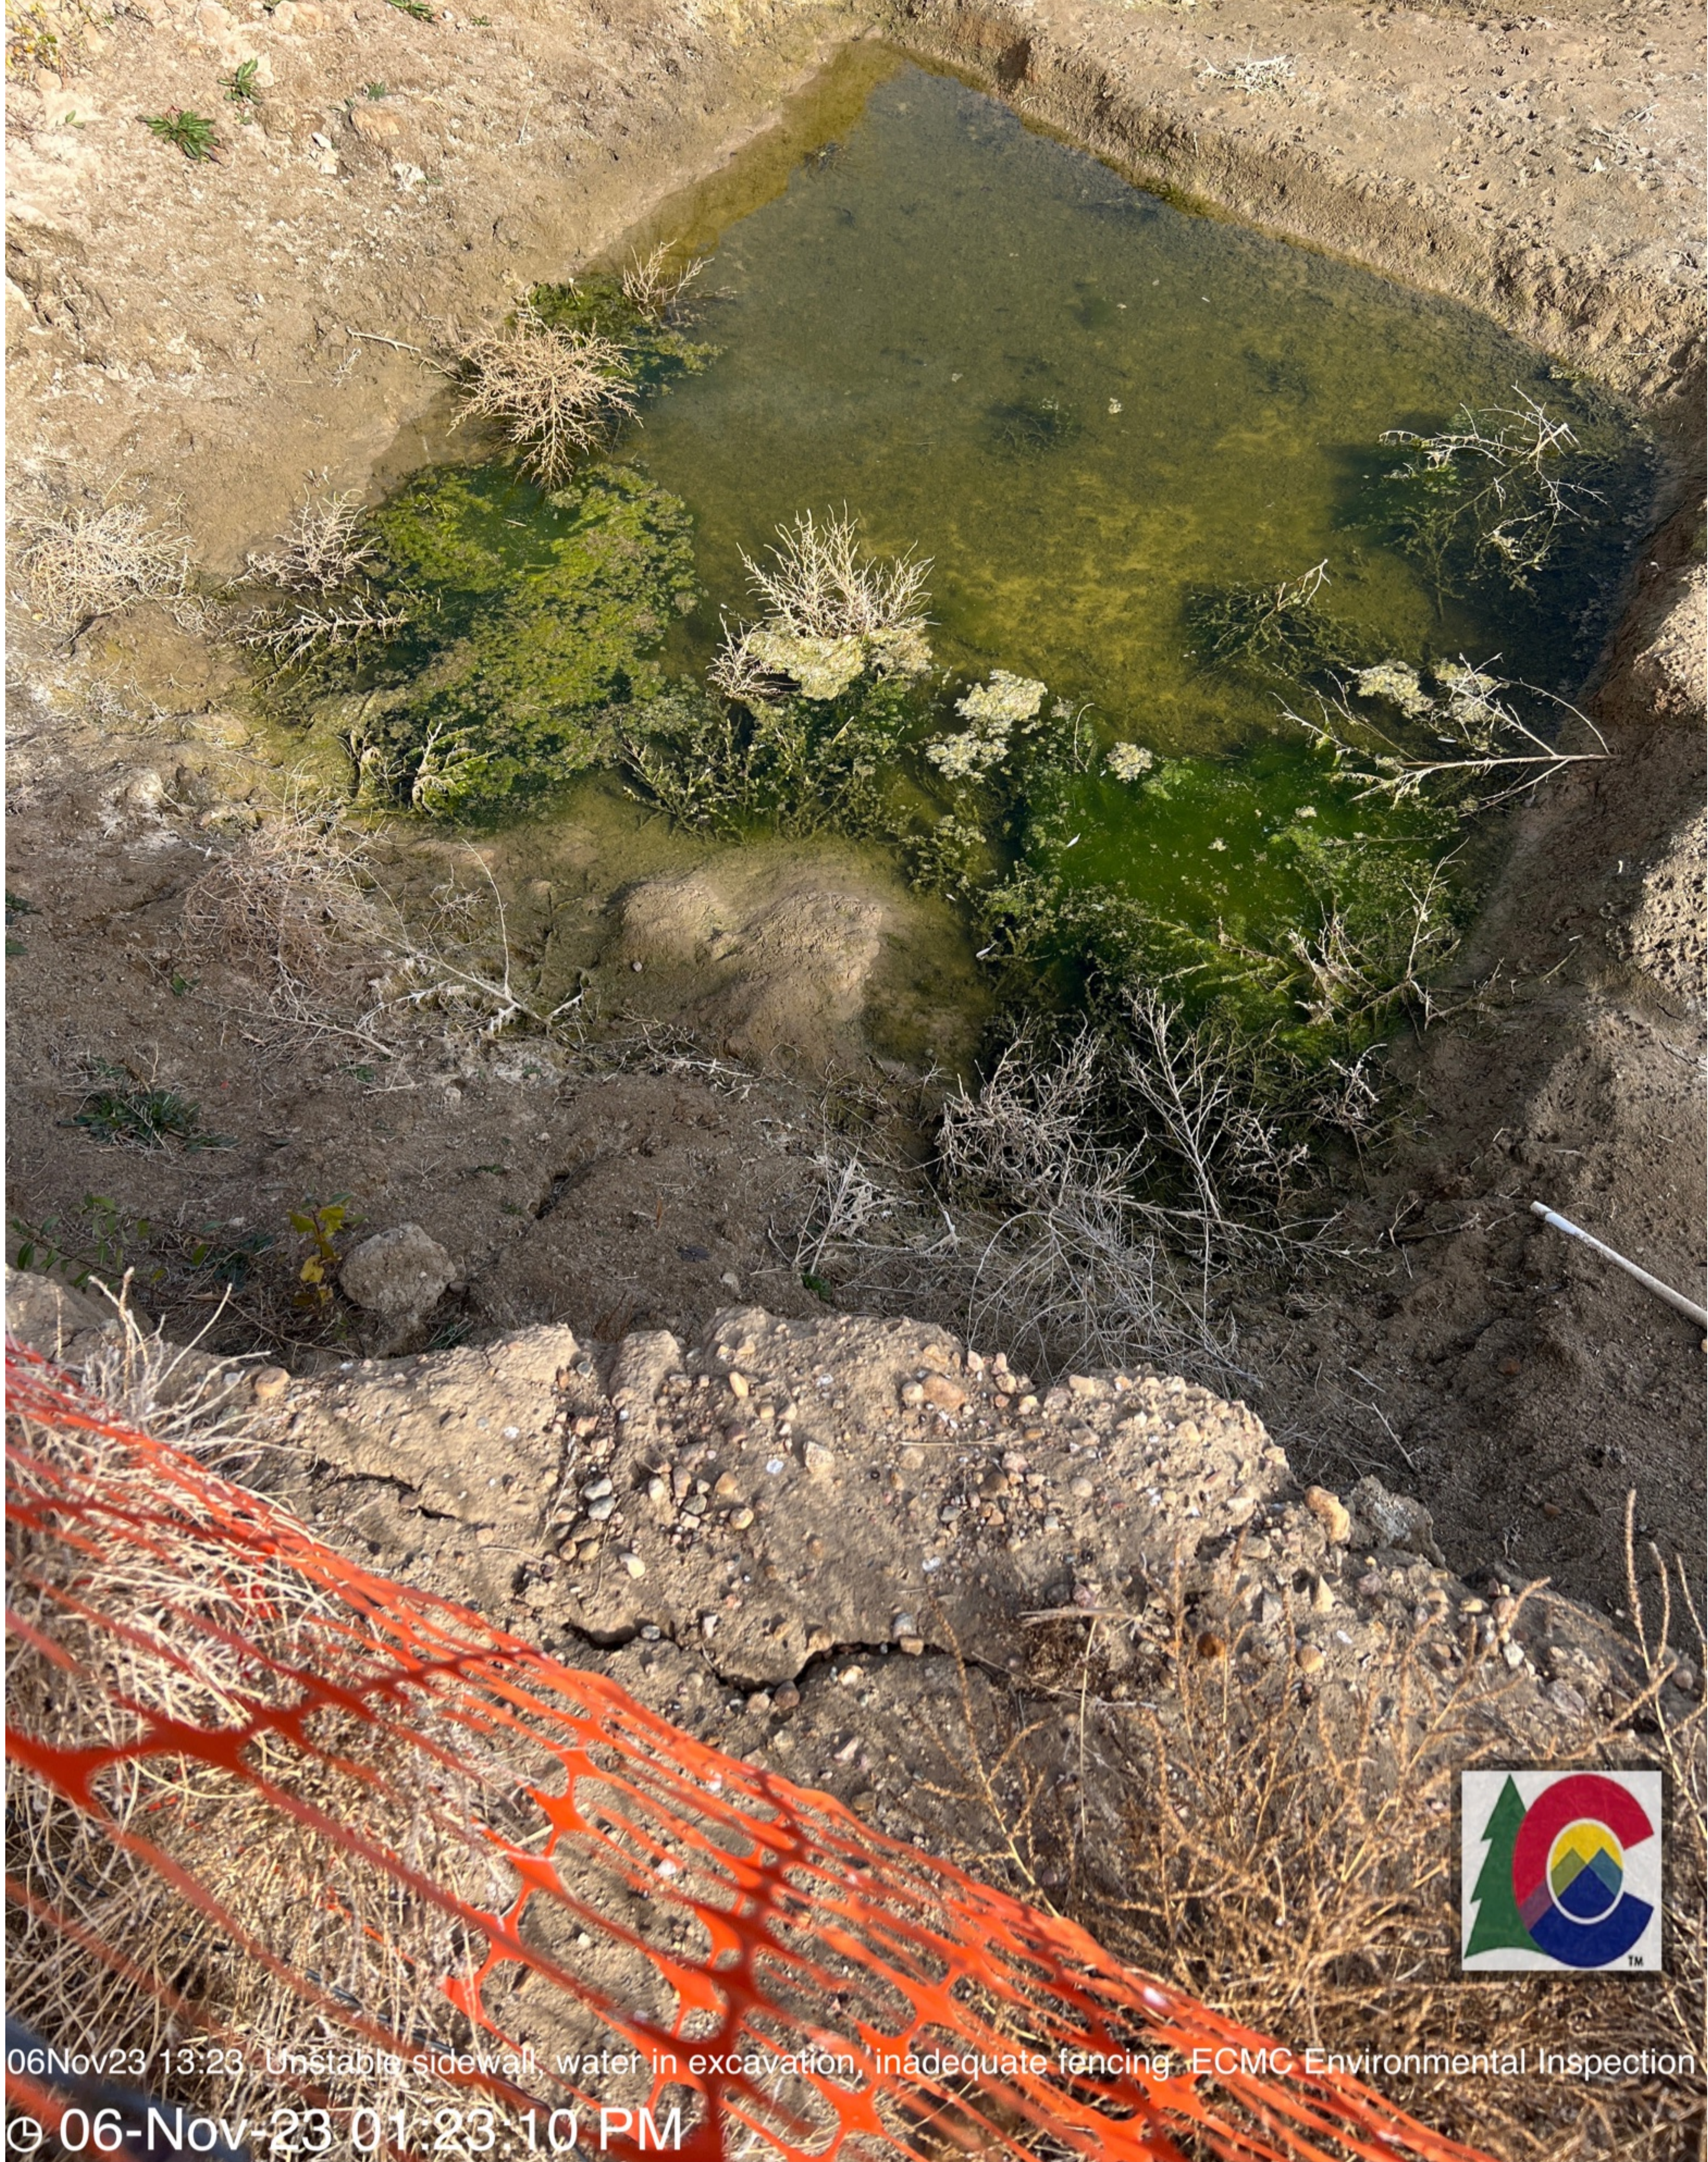
06Nov23 13:23 Unstable sidewall, water in excavation, inadequate fencing ECMC Environmental Inspection
© 06-Nov-23 01:23 10 PM
