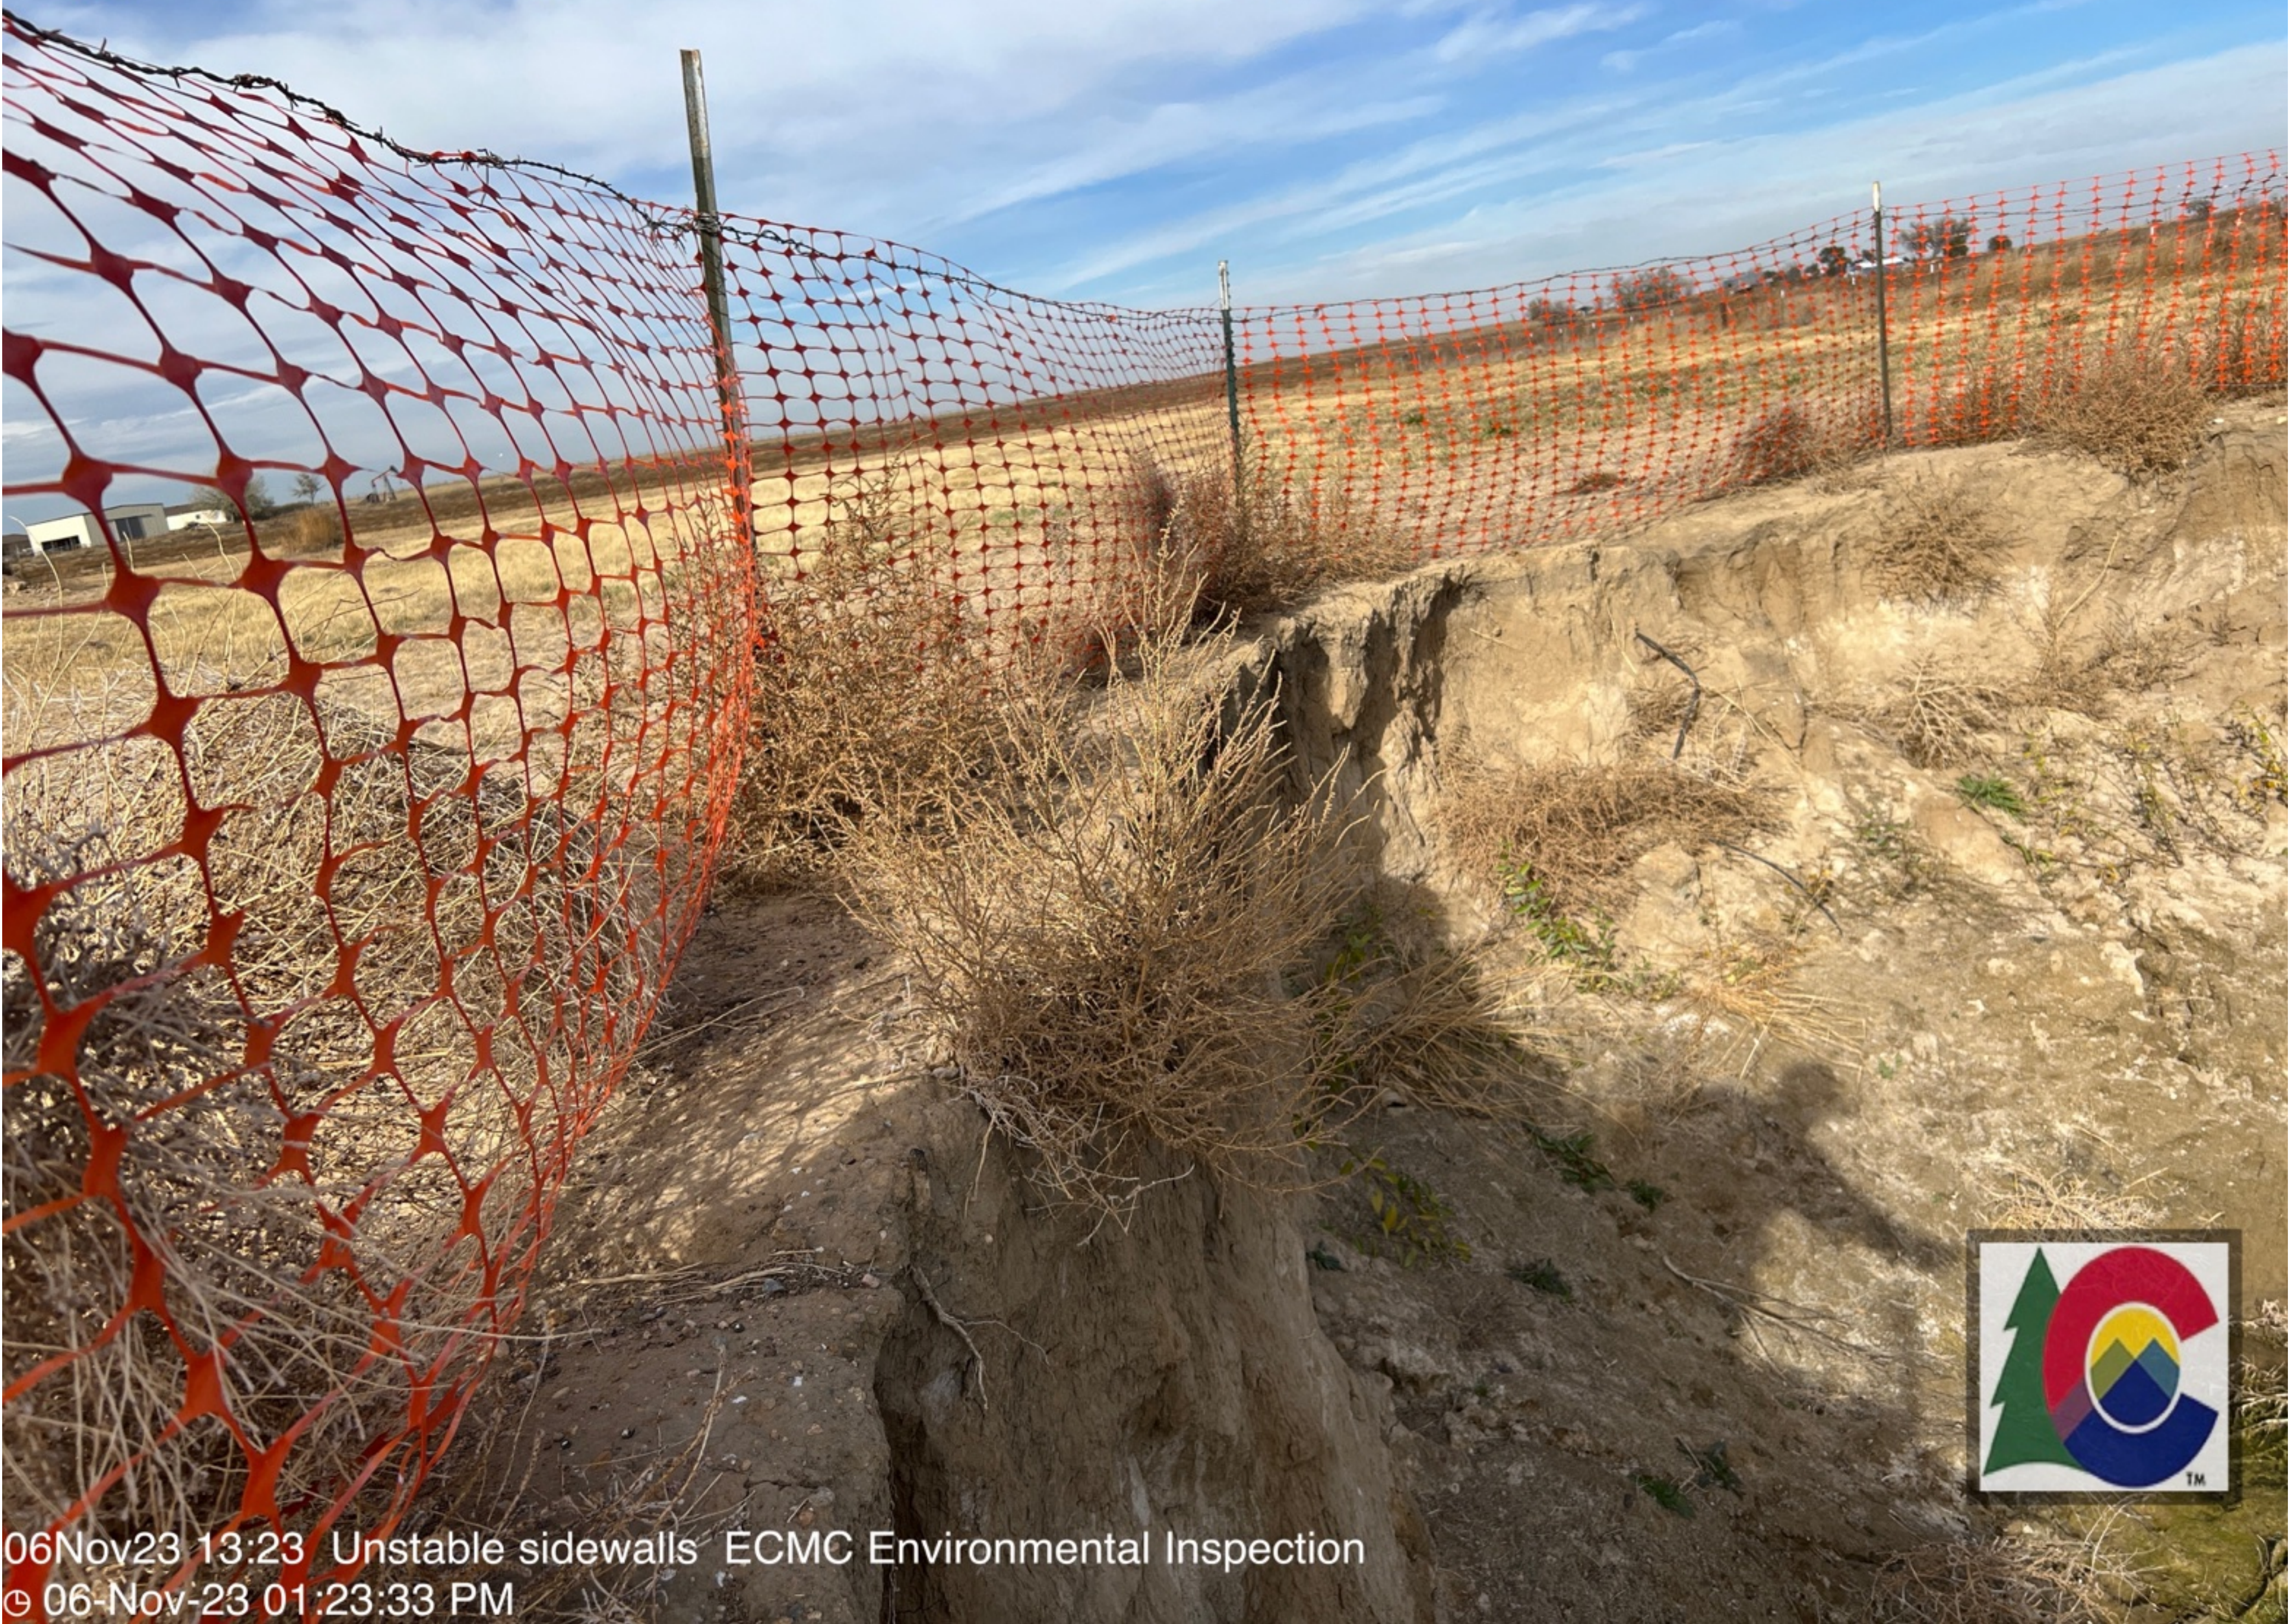
06Nov23 13:23 Unstable sidewalls ECMC Environmental Inspection
© 06-Nov-23 01:23:33 PM

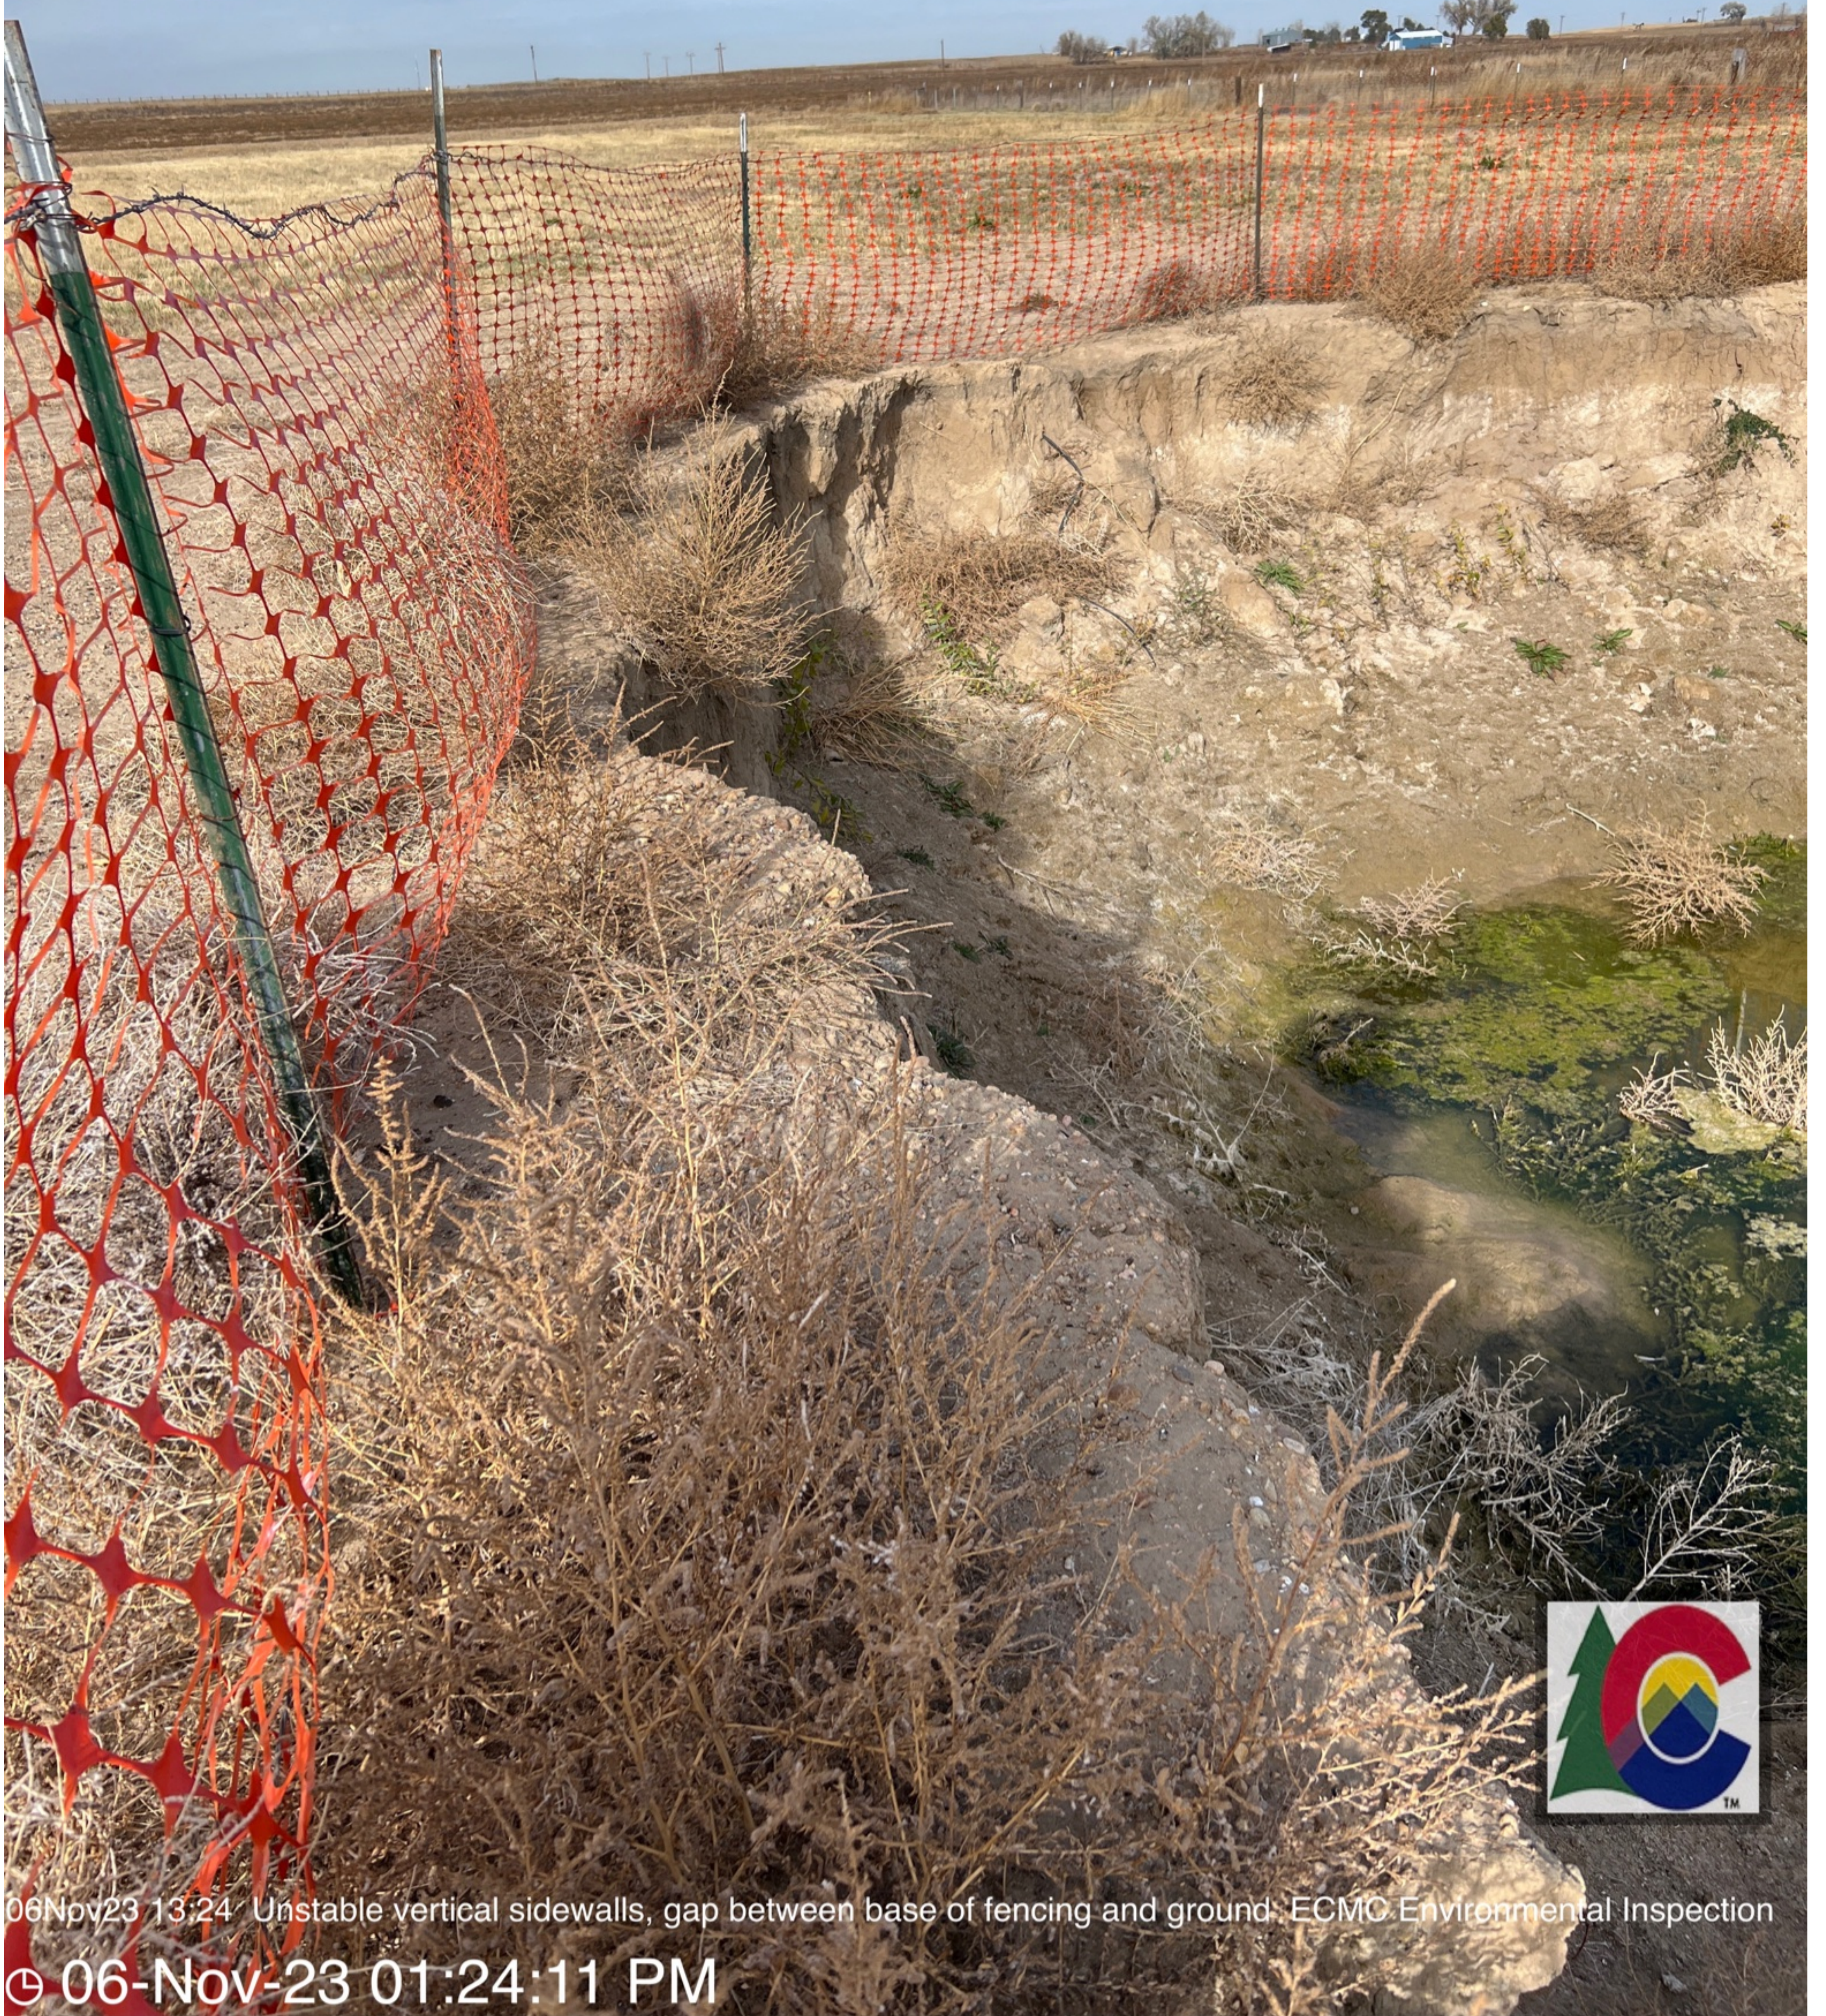
06Nov23 13:24 Unstable vertical sidewalls, gap between base of fencing and ground. ECMC Environmental Inspection

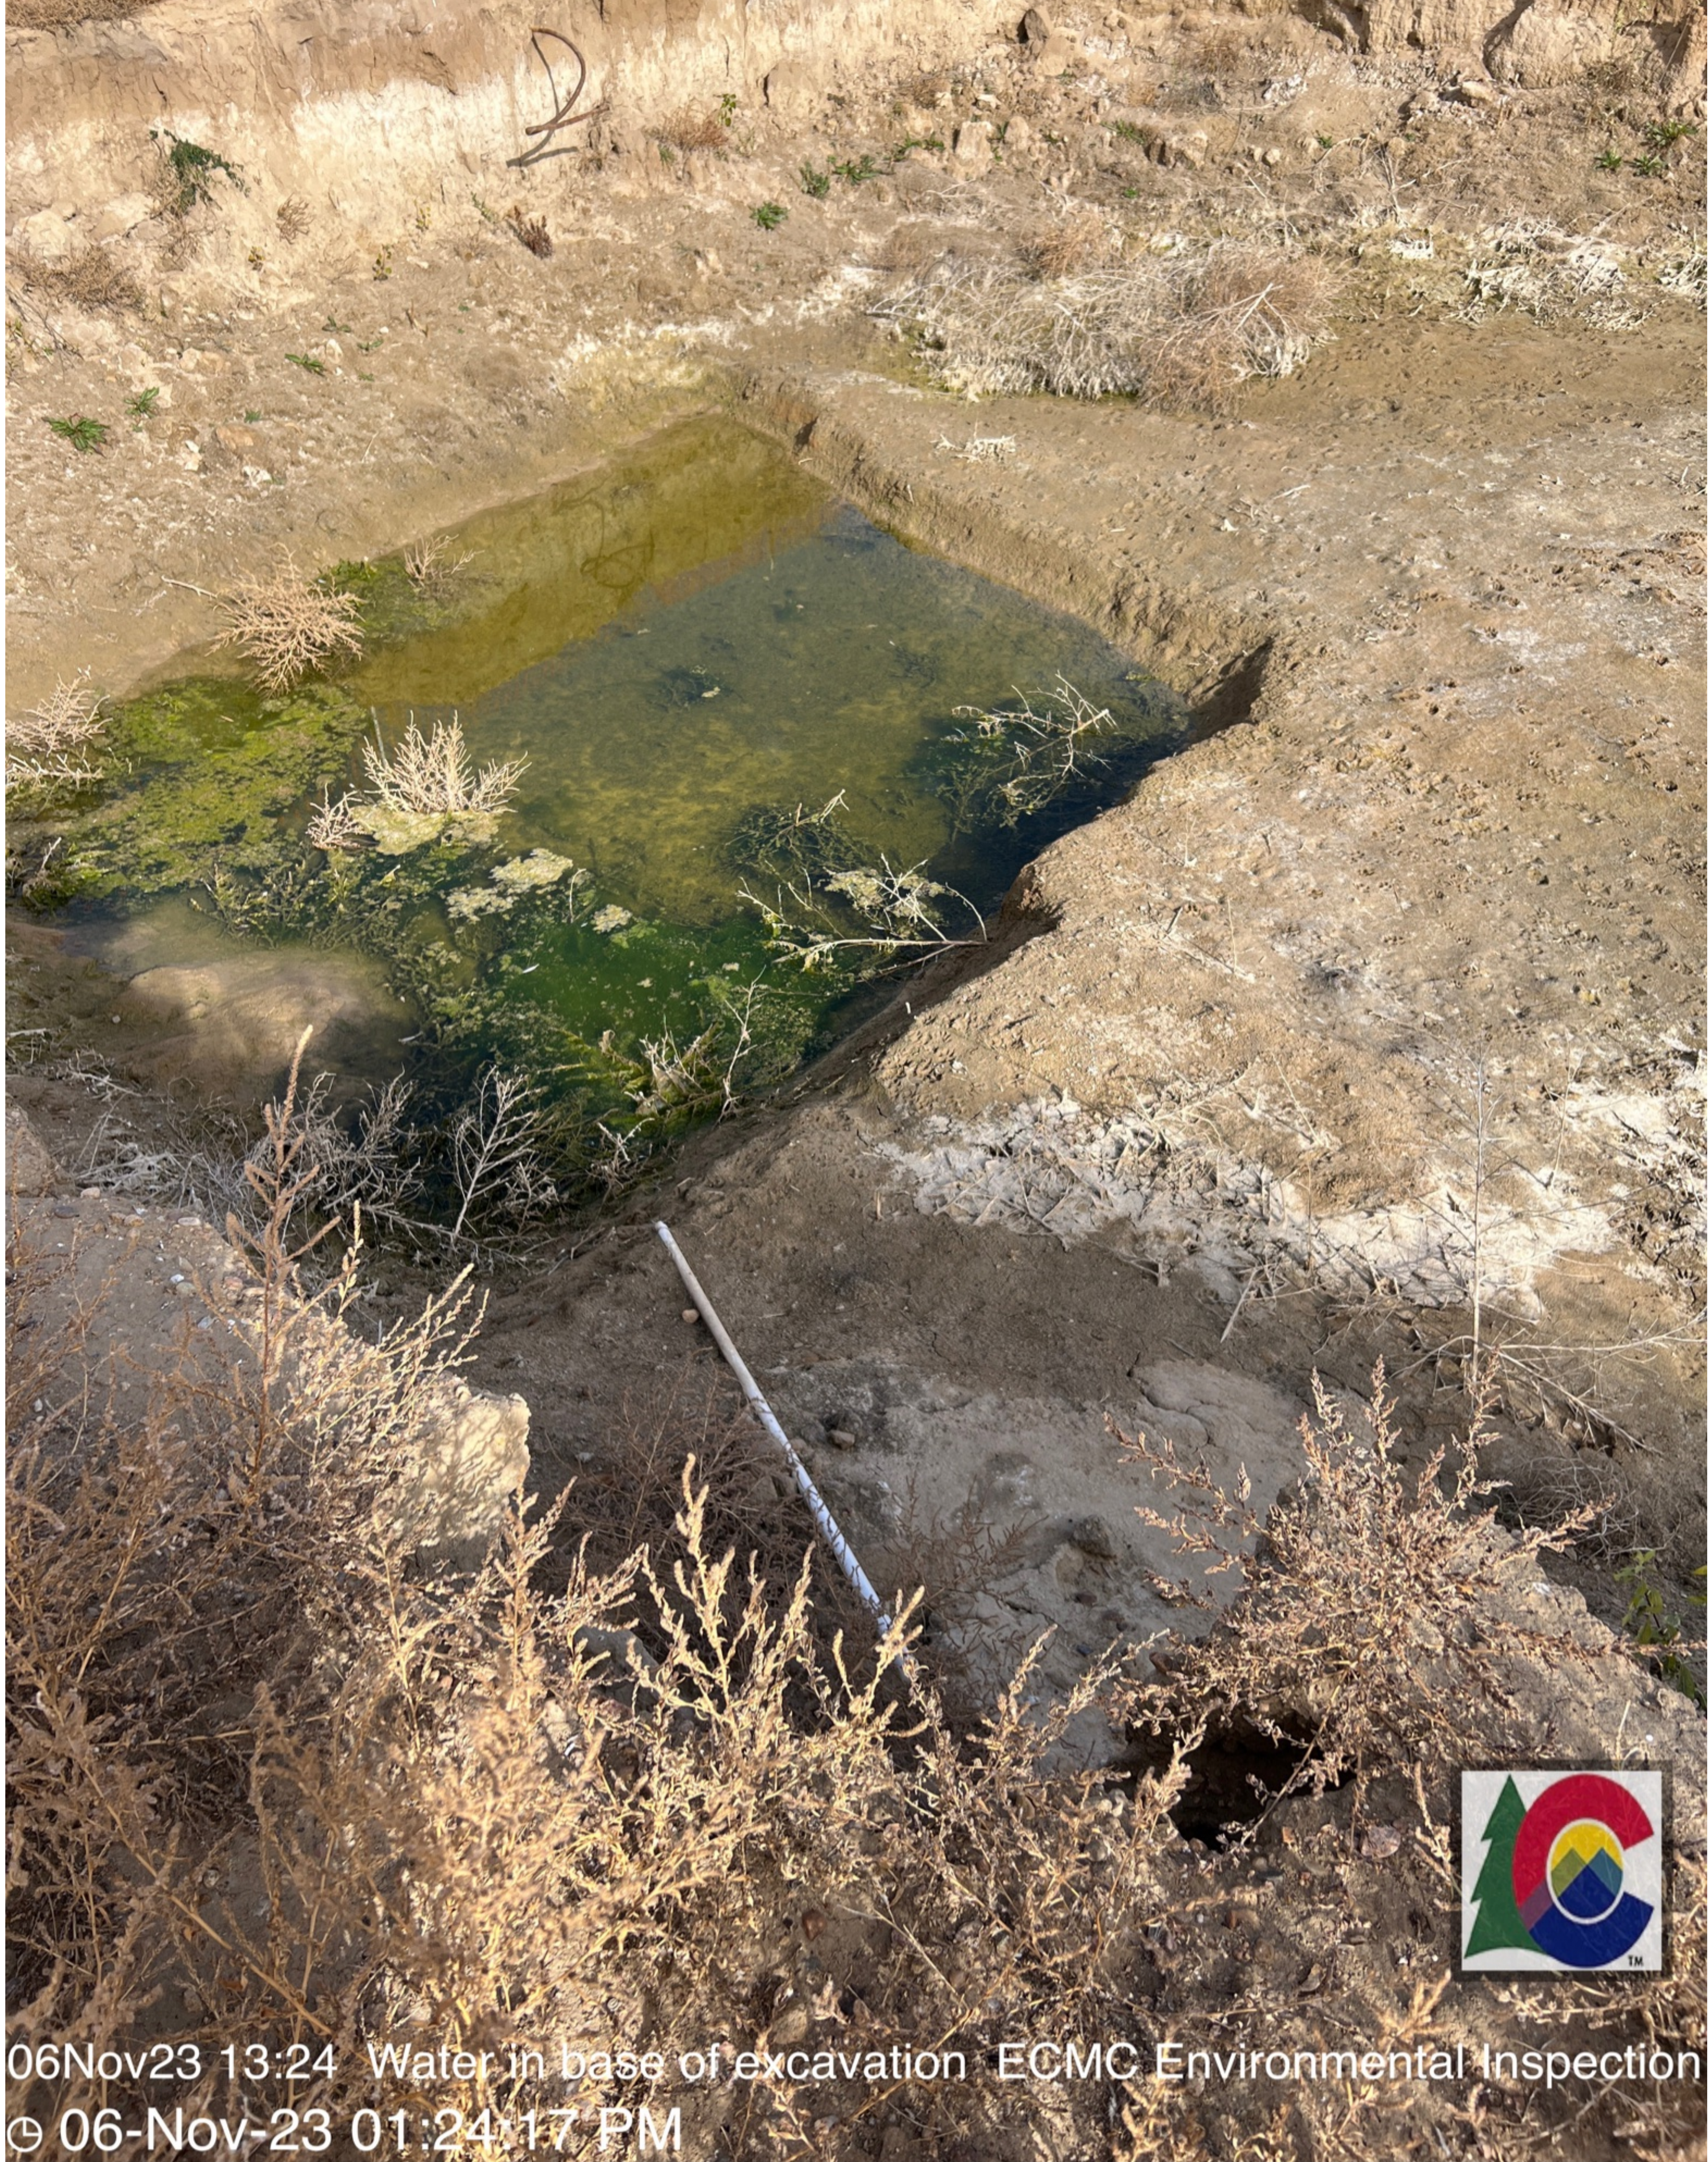
06Nov23 13:24 Water in base of excavation ECMC Environmental Inspection
© 06-Nov-23 01:24:17 PM

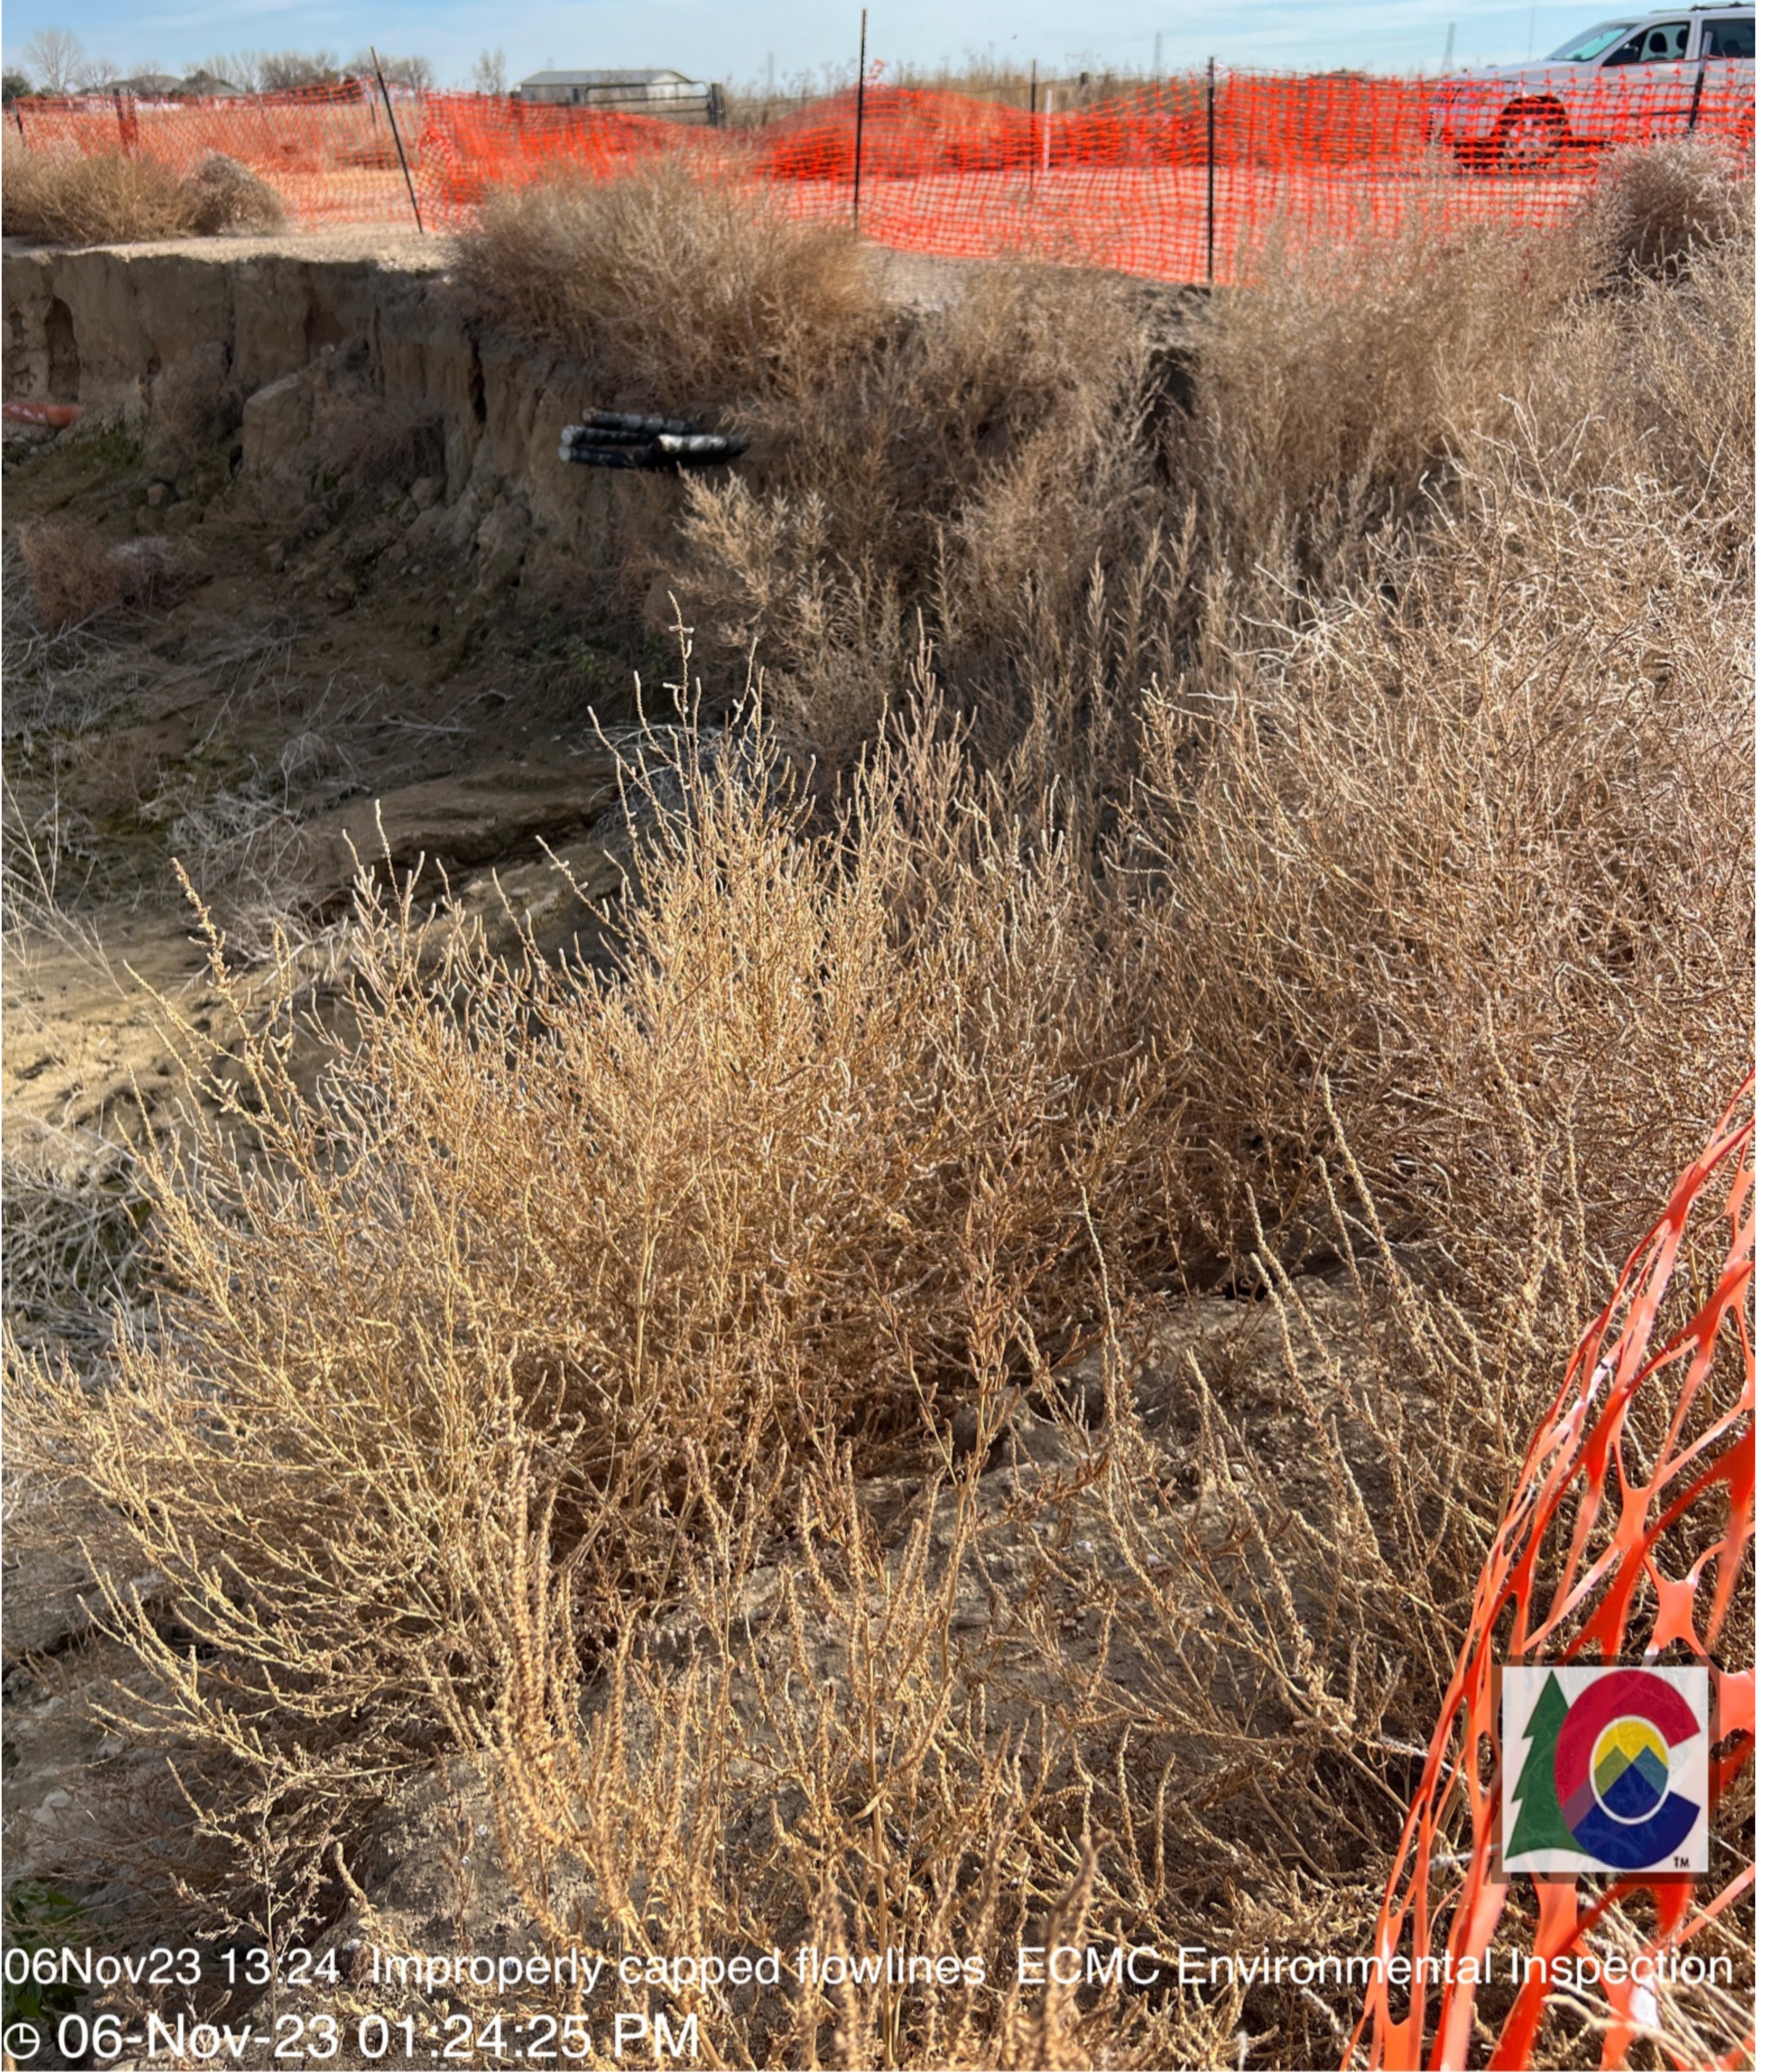
06Nov23 13:24 Improperly capped flowlines ECMC Environmental Inspection
© 06-Nov-23 01:24:25 PM

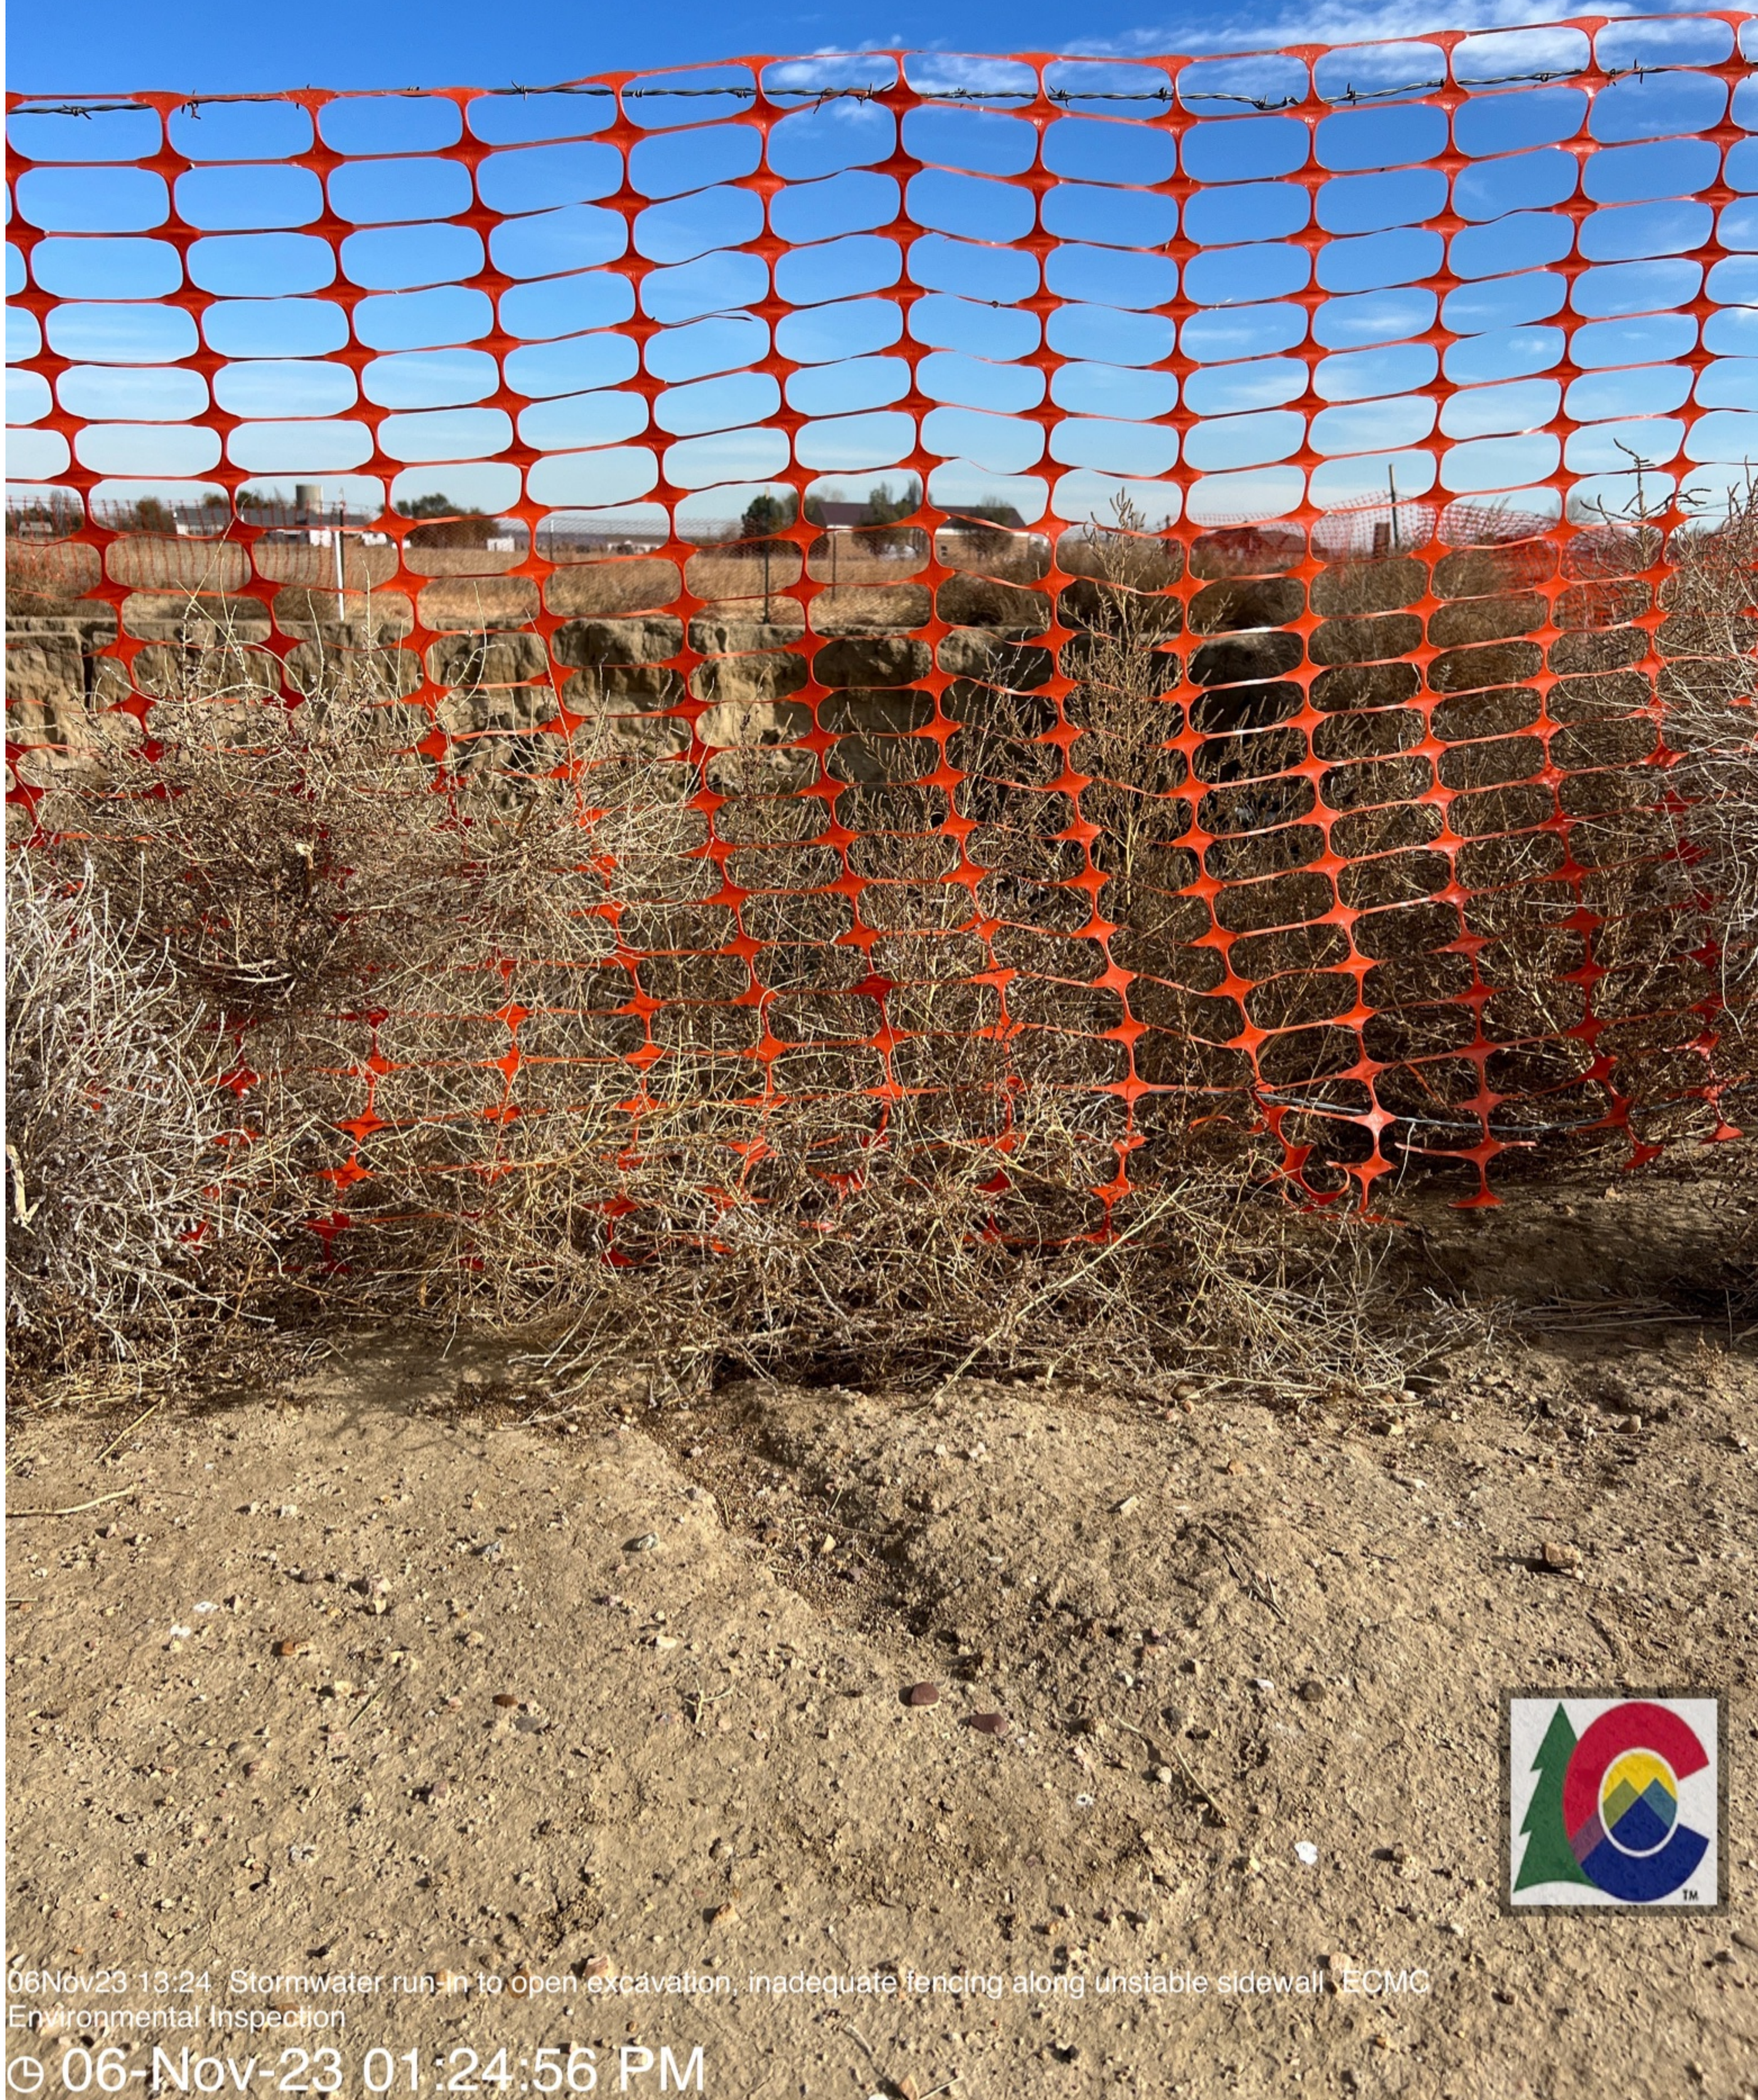
06Nov23 13:24 Stormwater run-in to open excavation, inadequate fencing along unstable sidewall ECMC Environmental Inspection

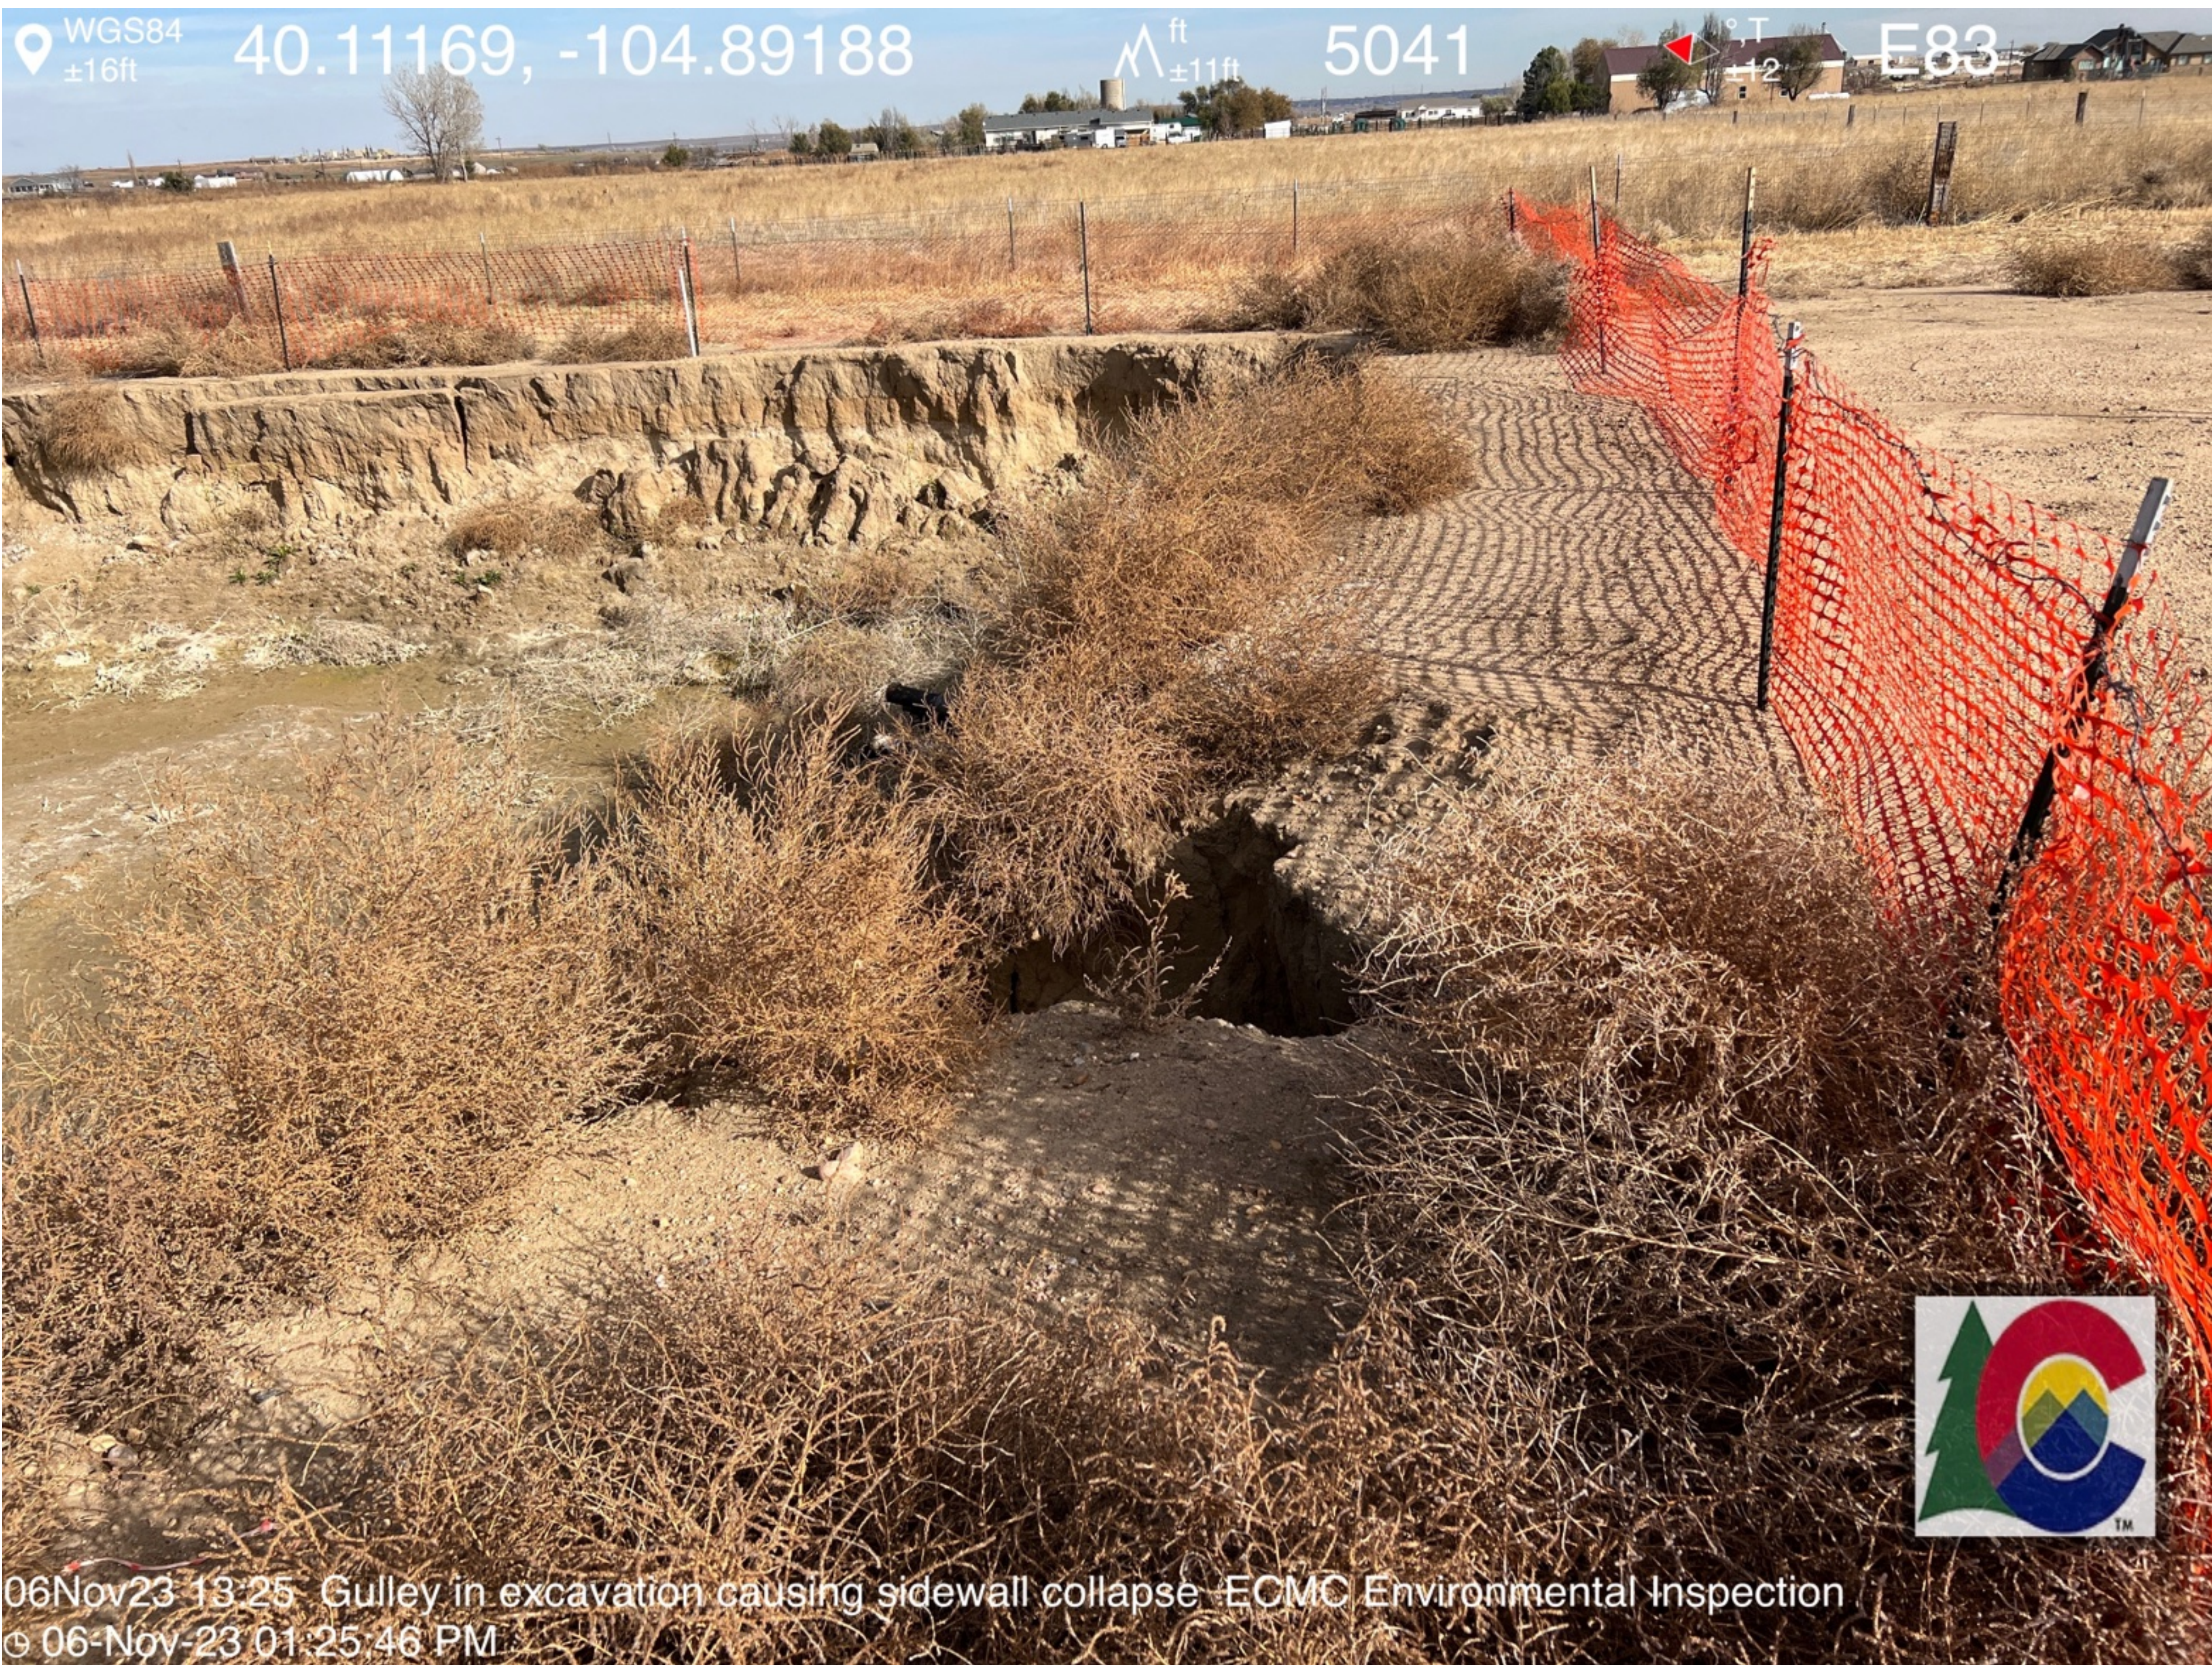
06Nov23 13:25 Gulley in excavation causing sidewall collapse -ECMC Environmental Inspection
© 06-Nov-23 01:25:46 PM
