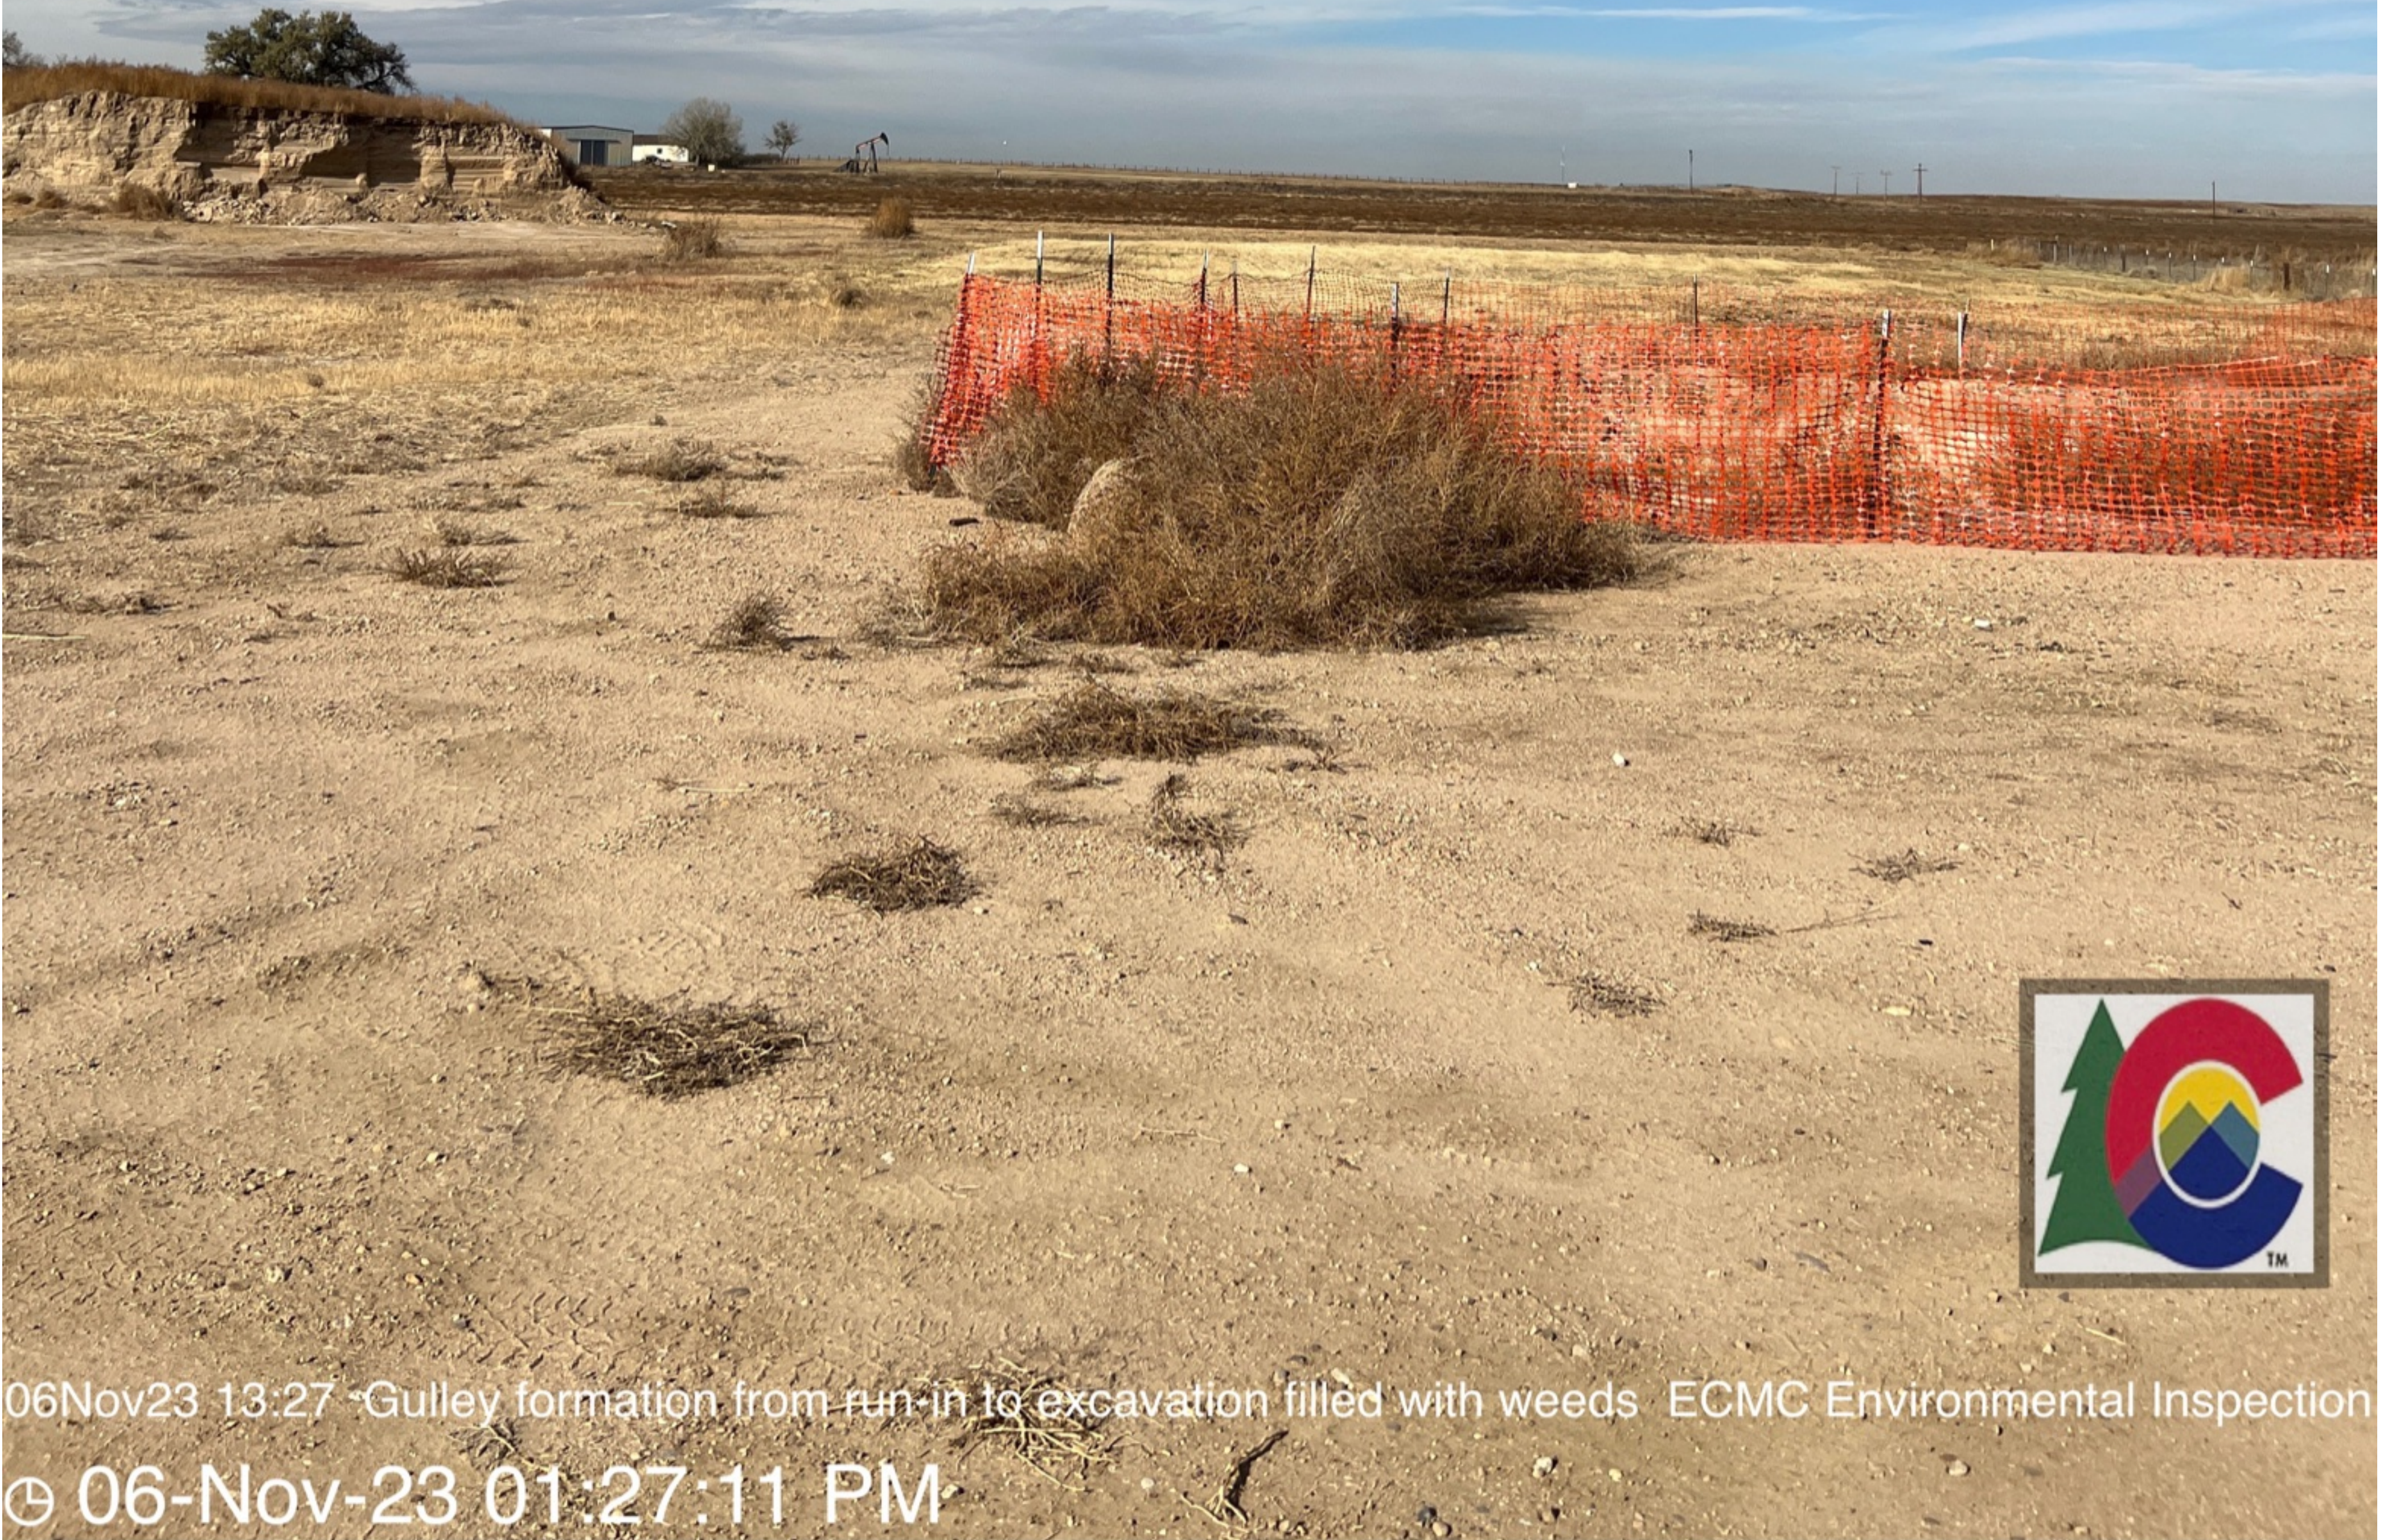
06Nov23 13:27 Gulley formation from run-in to excavation filled with weeds ECMC Environmental Inspection
