**Diversified Energy LLC  
Bingman 1-14  
Location ID: 313094**

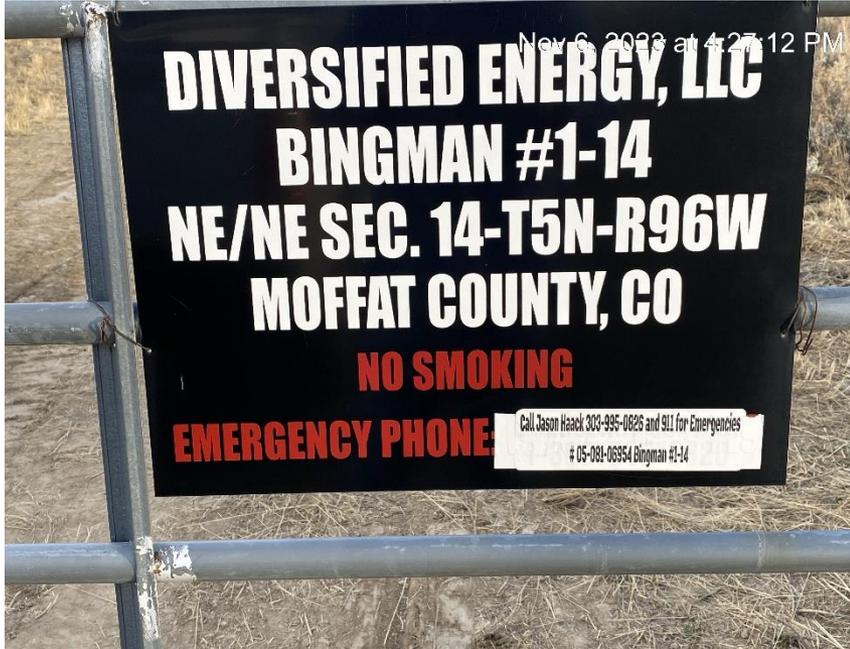
As signs are replaced additional information will be required

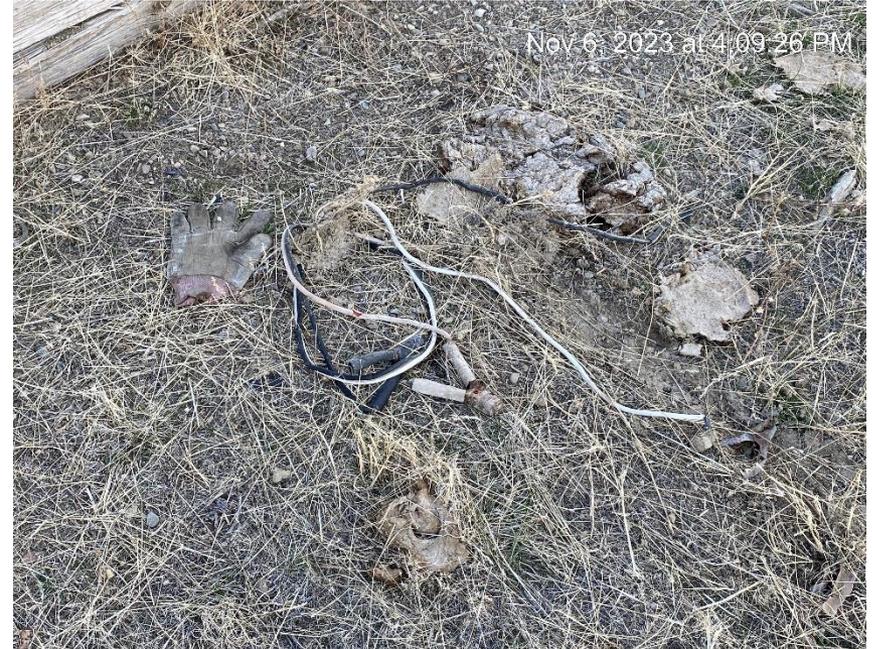
Debris

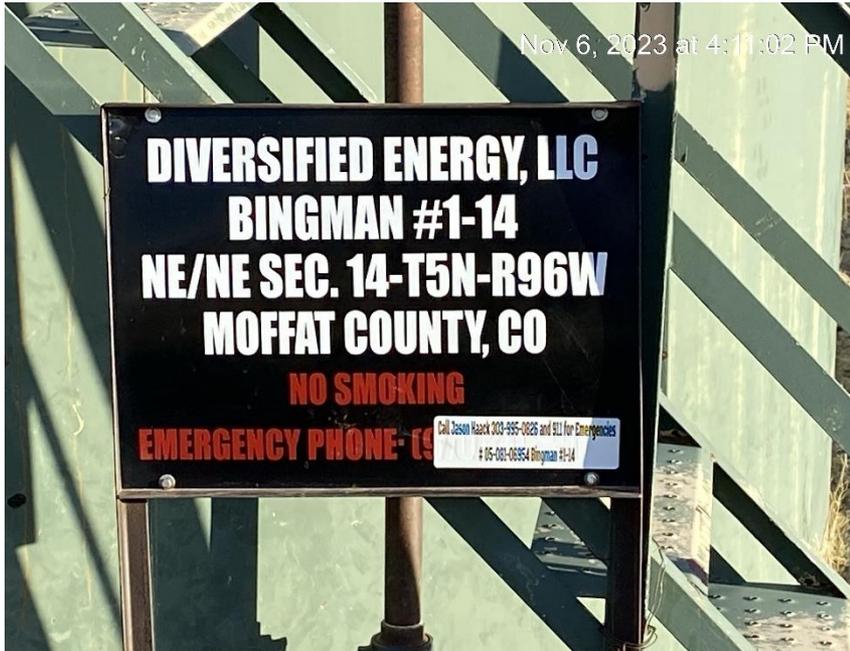
Sign at tank battery missing require information

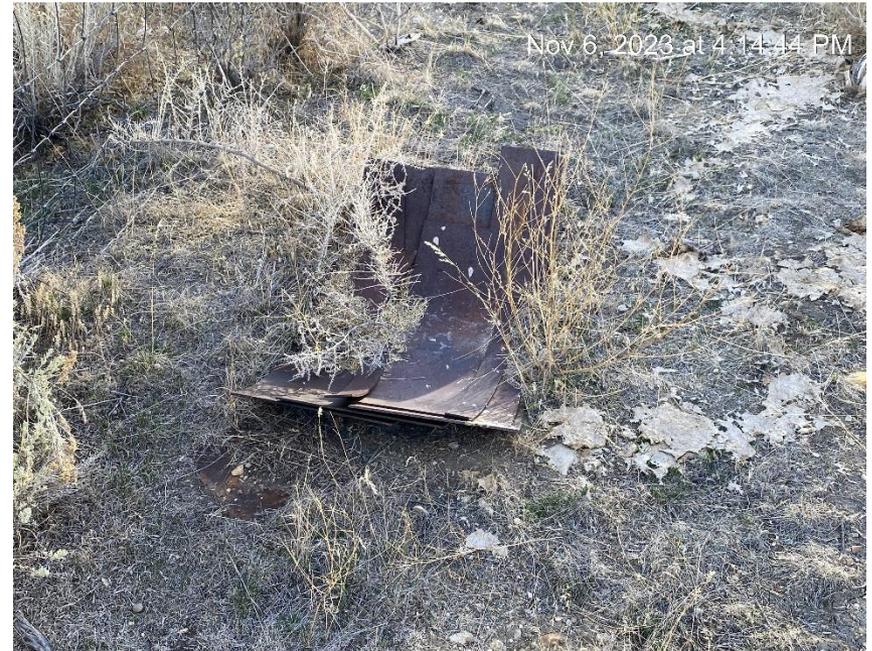
Debris from 6/1/23

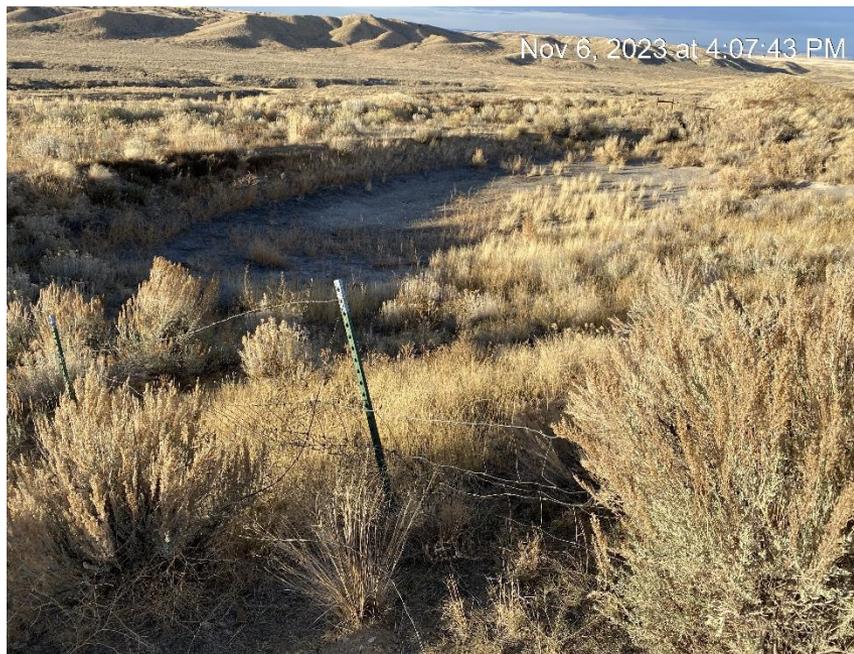
**Fence not maintained**

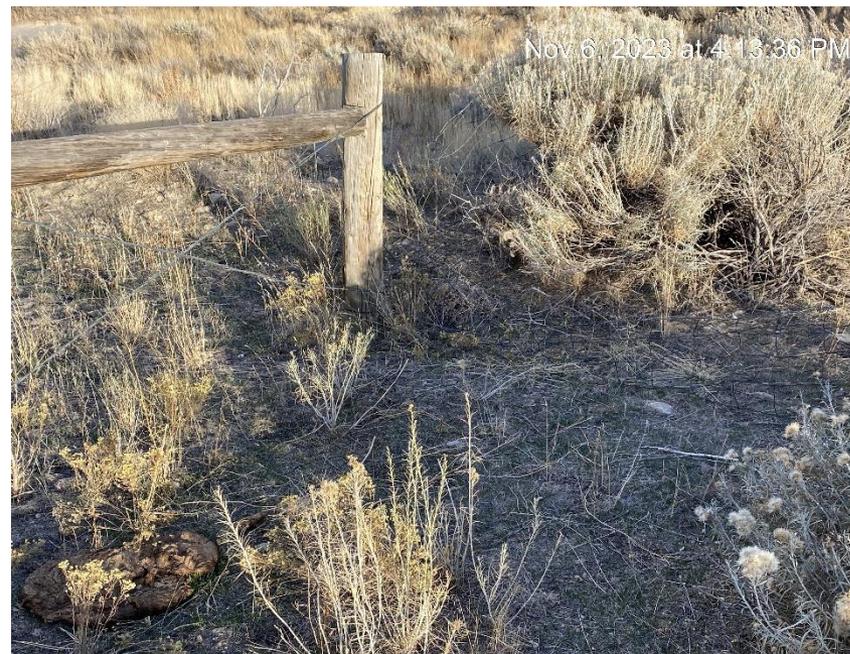
**Fence not maintained**

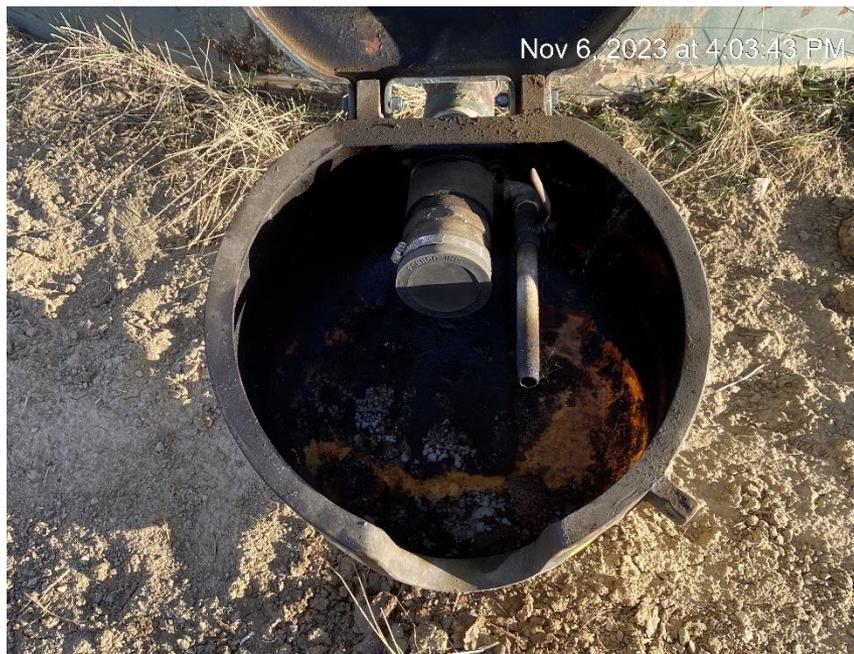
Insufficient cap on loadline

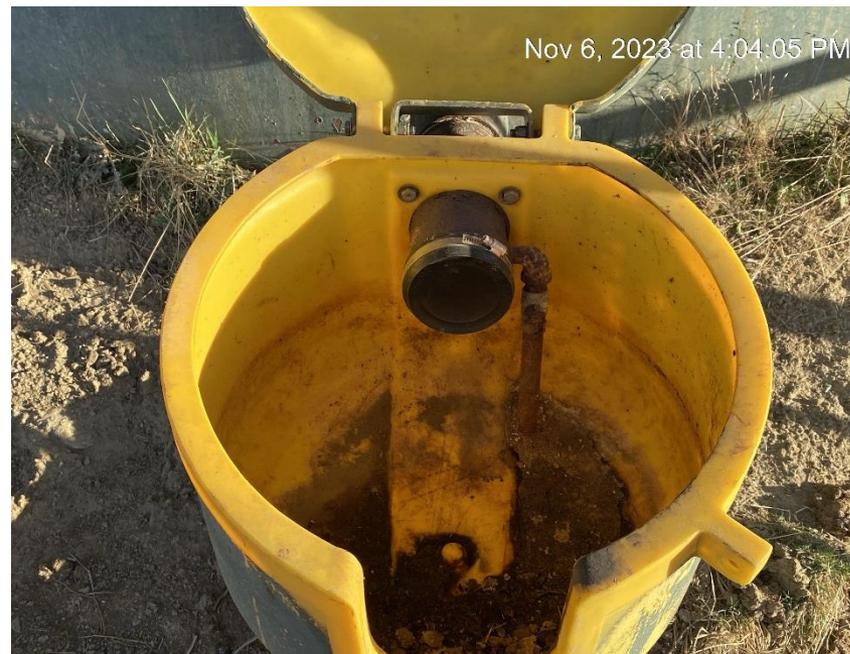
Insufficient cap on loadline
