Inspection Photos
Location: Becks 41-16 and Becks 41-16 TR
Facility ID: 334237

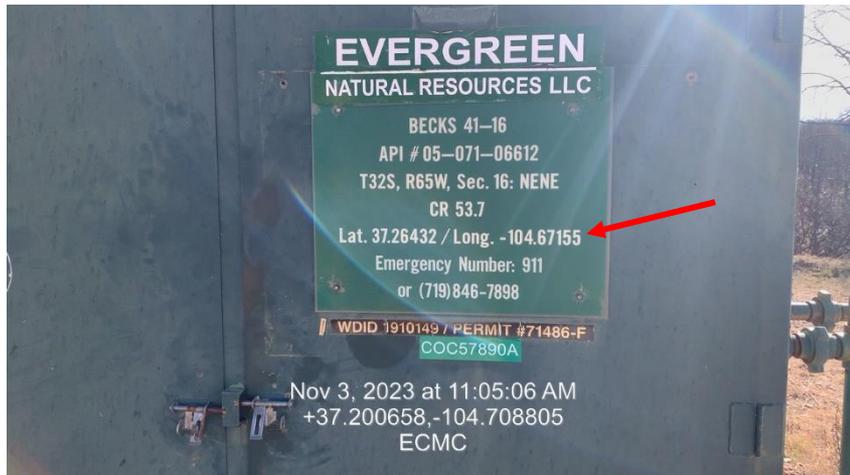
Photo 1 – Well Site Placard, Incorrect Latitude and Longitude

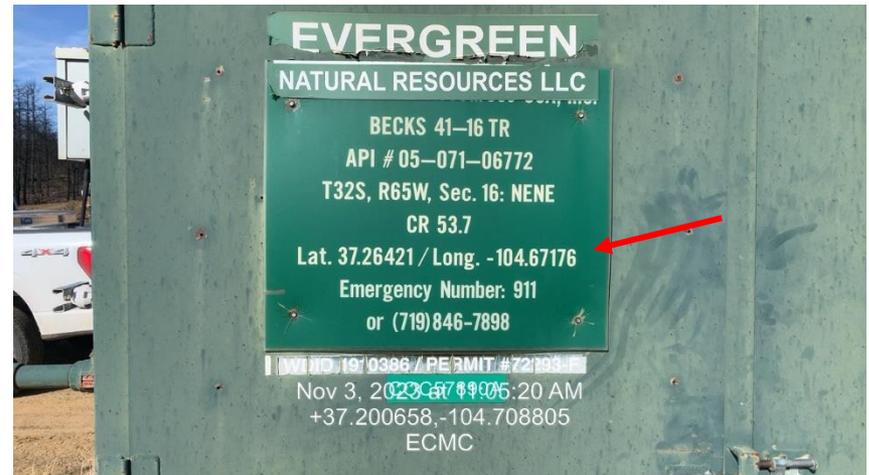
Photo 2 – Well Site Placard, Incorrect Longitude

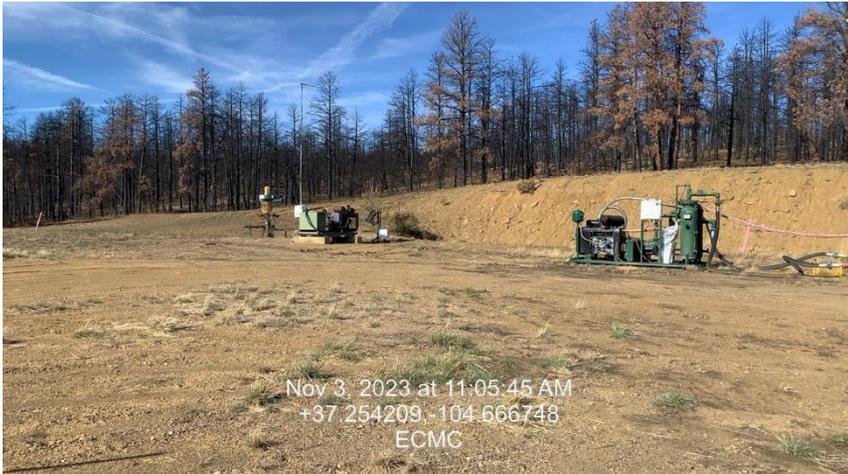
Photo 3 – TR wellhead

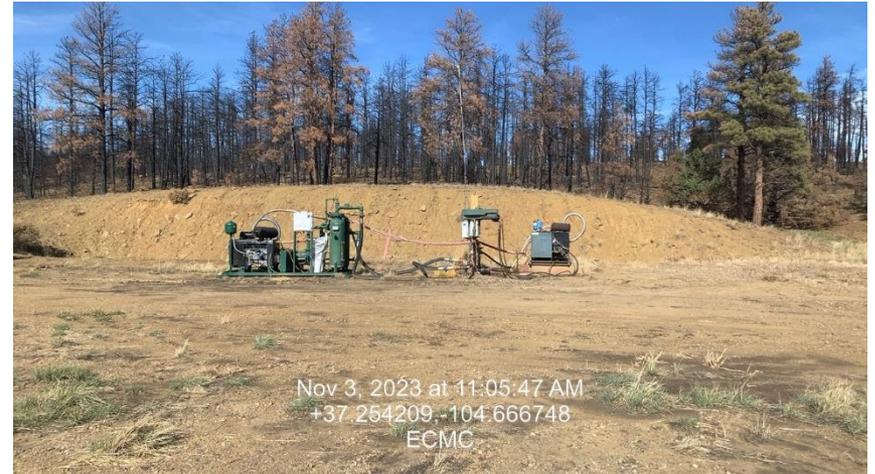
Photo 4 – Wellhead

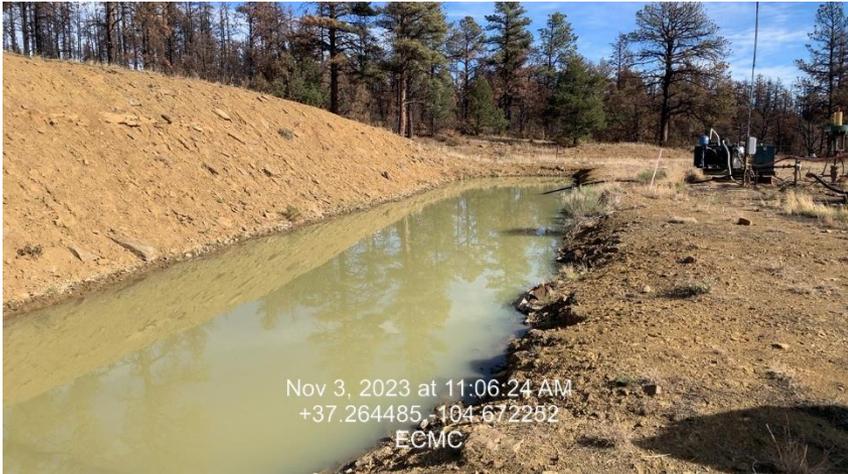
Photo 5 – Pit looking east

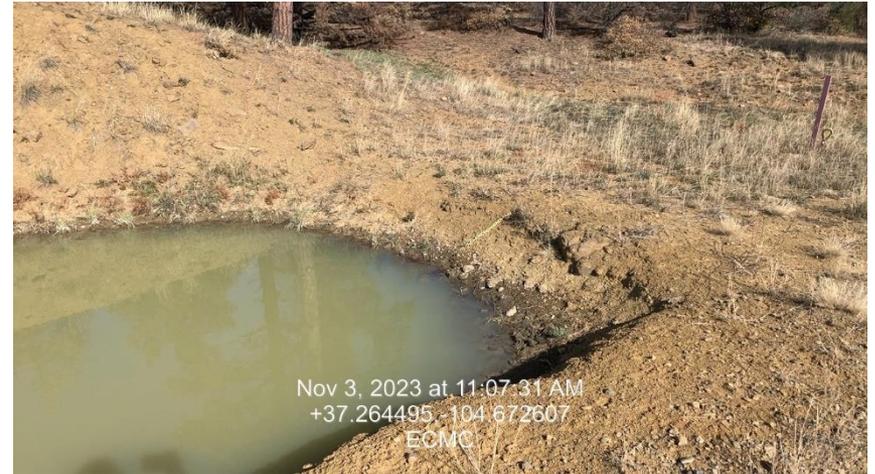
Photo 6 – Pit Freeboard

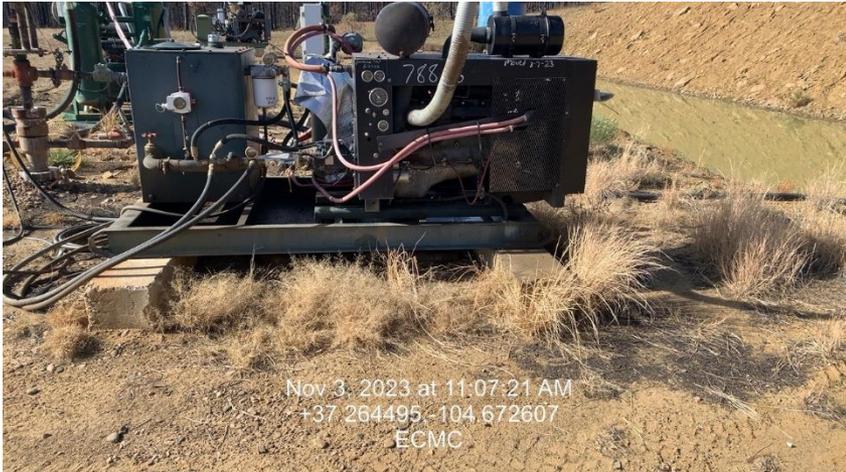
Photo 7 – Vegetation Around equipment

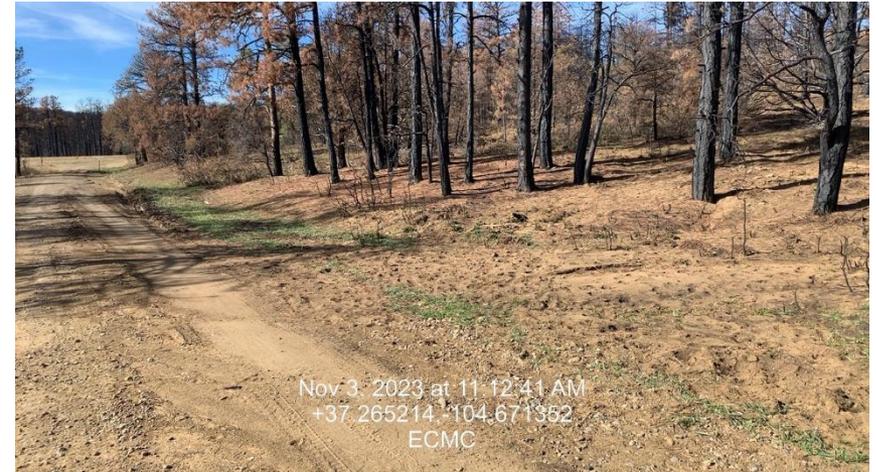
Photo 8 – Plugged culvert in cross drainage, erosion on downstream side of roadway at this location

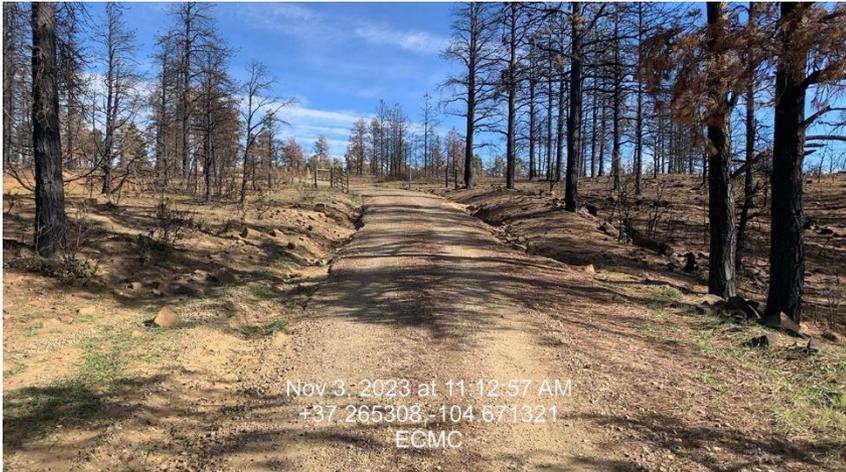
Photo 9 – Riling along access road
