06Nov23 08:37 ECMC Environmental Inspection
© 06-Nov-23 08:37:11 AM

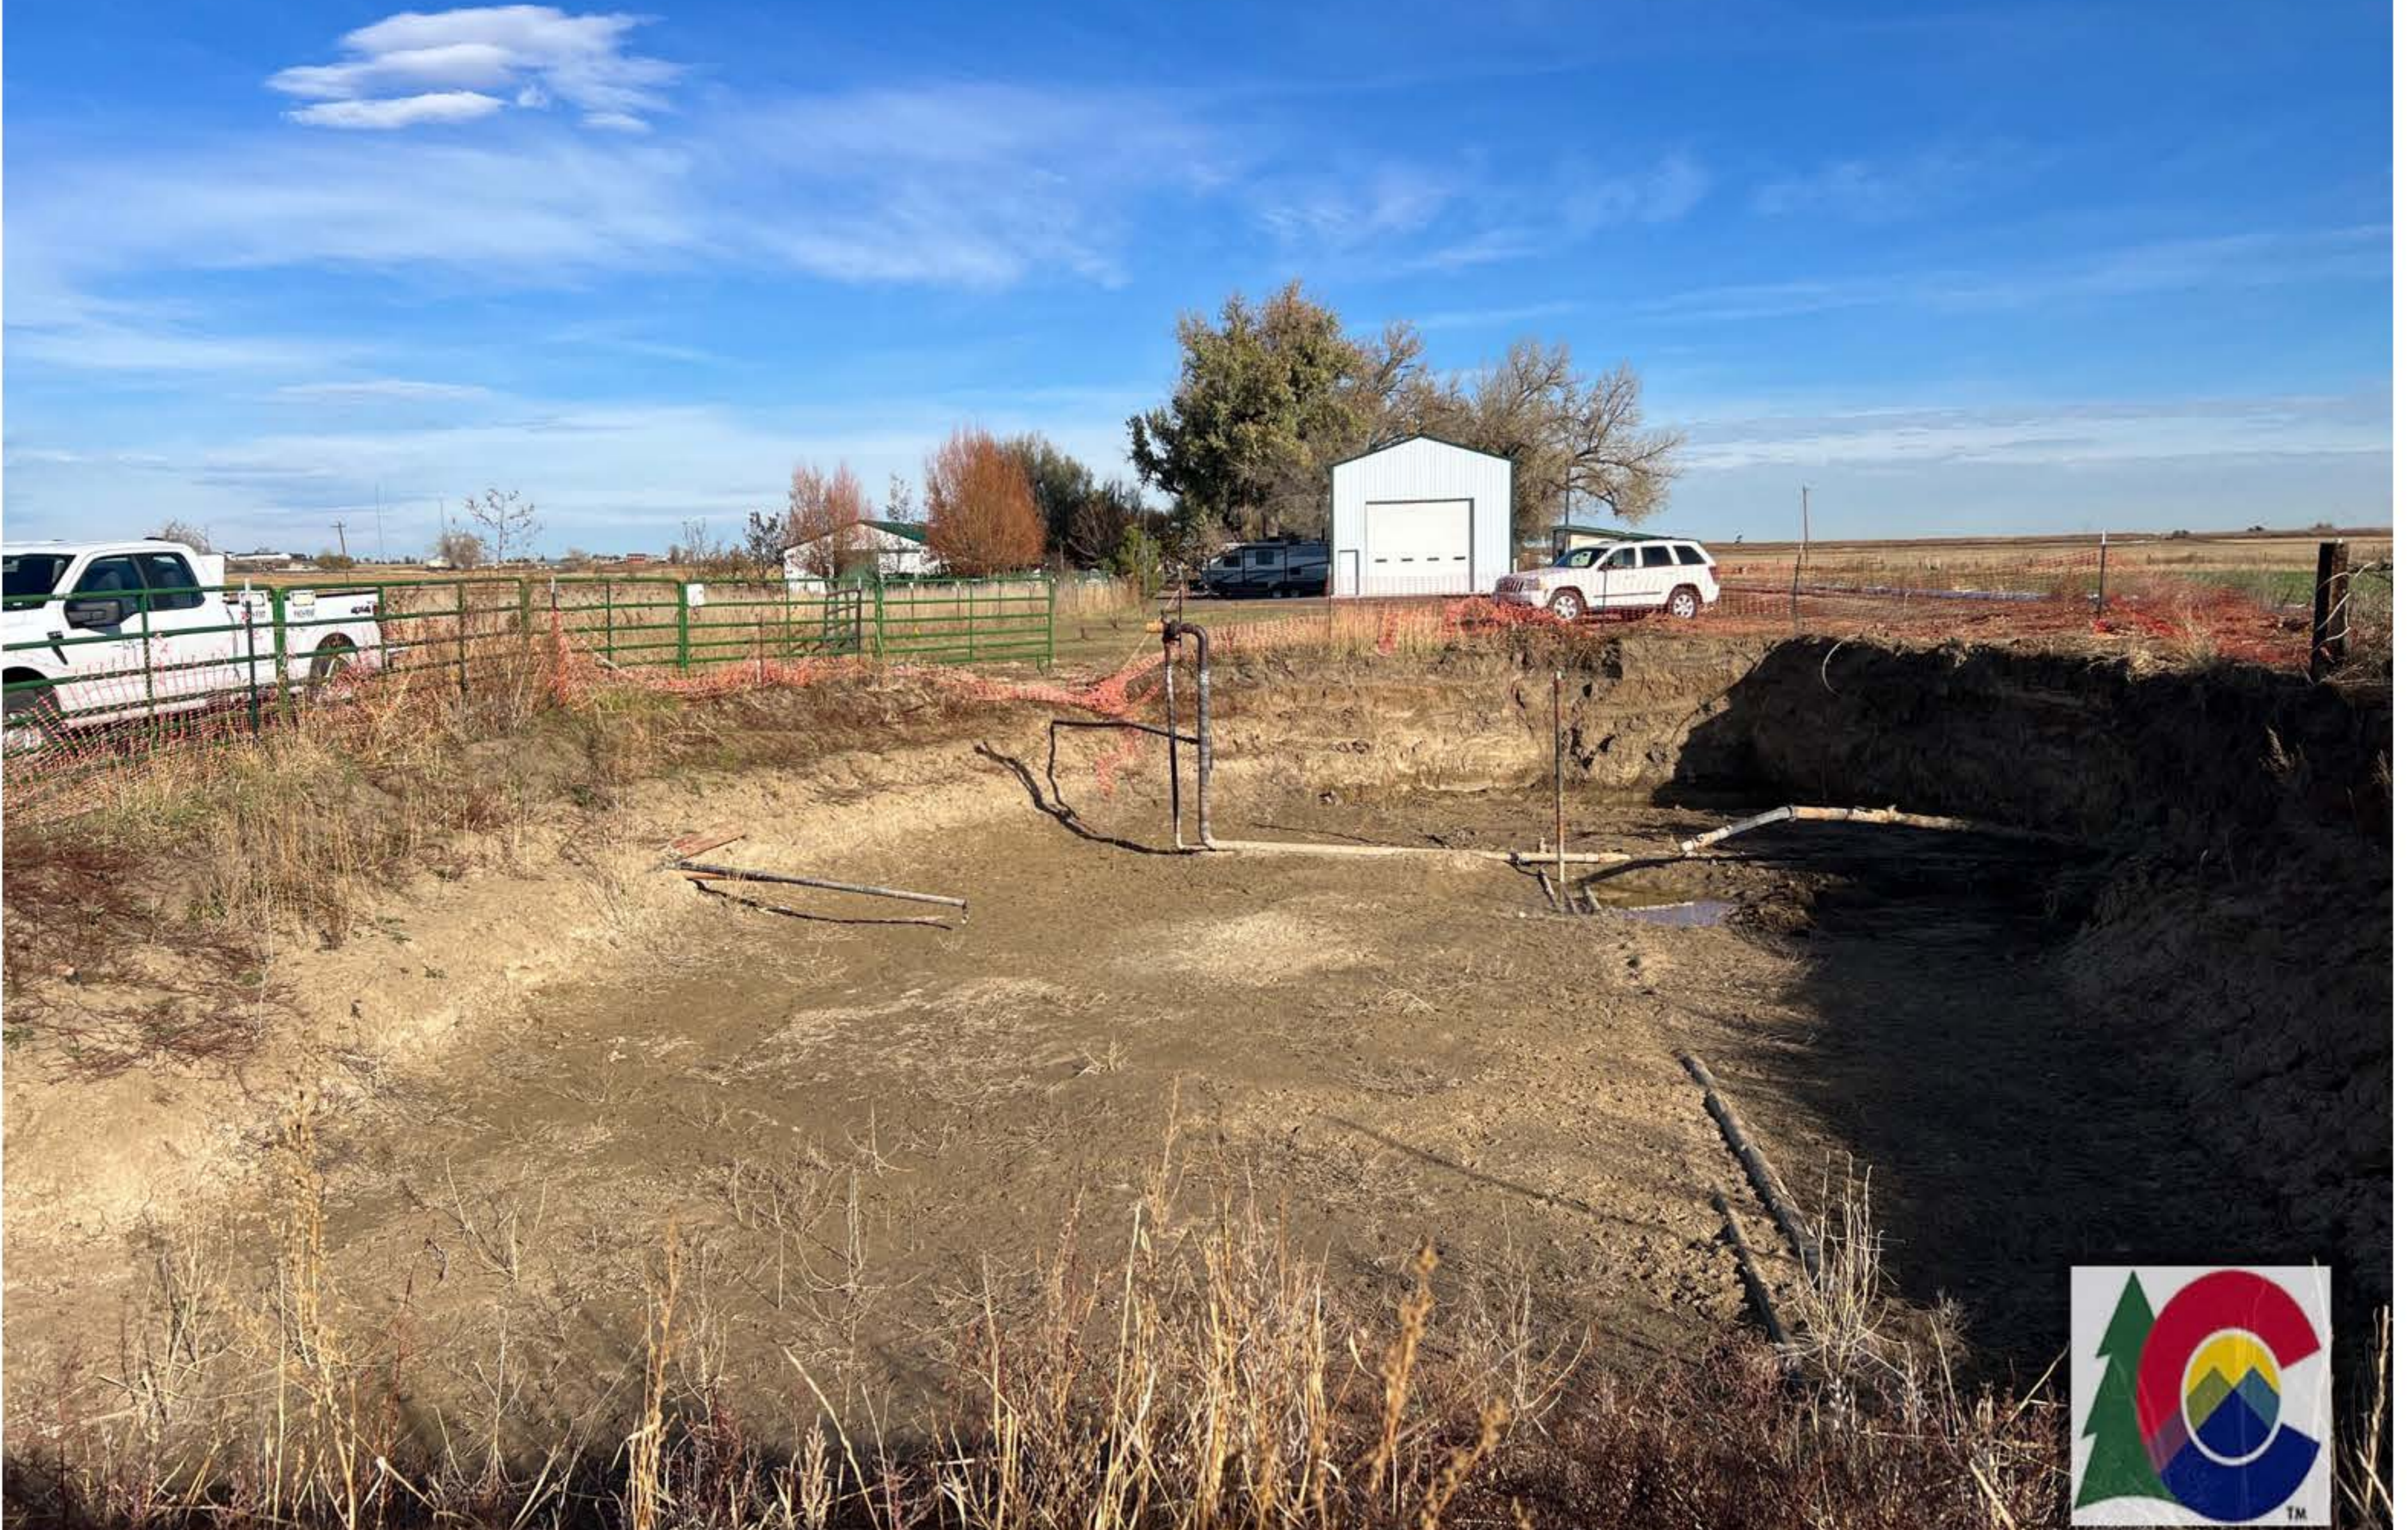
06Nov23 08:56 - Uncapped/improperly capped flowlines in excavation, inadequate fencing ECMG Environmental Inspection
© 06-Nov-23 08:56:53 AM

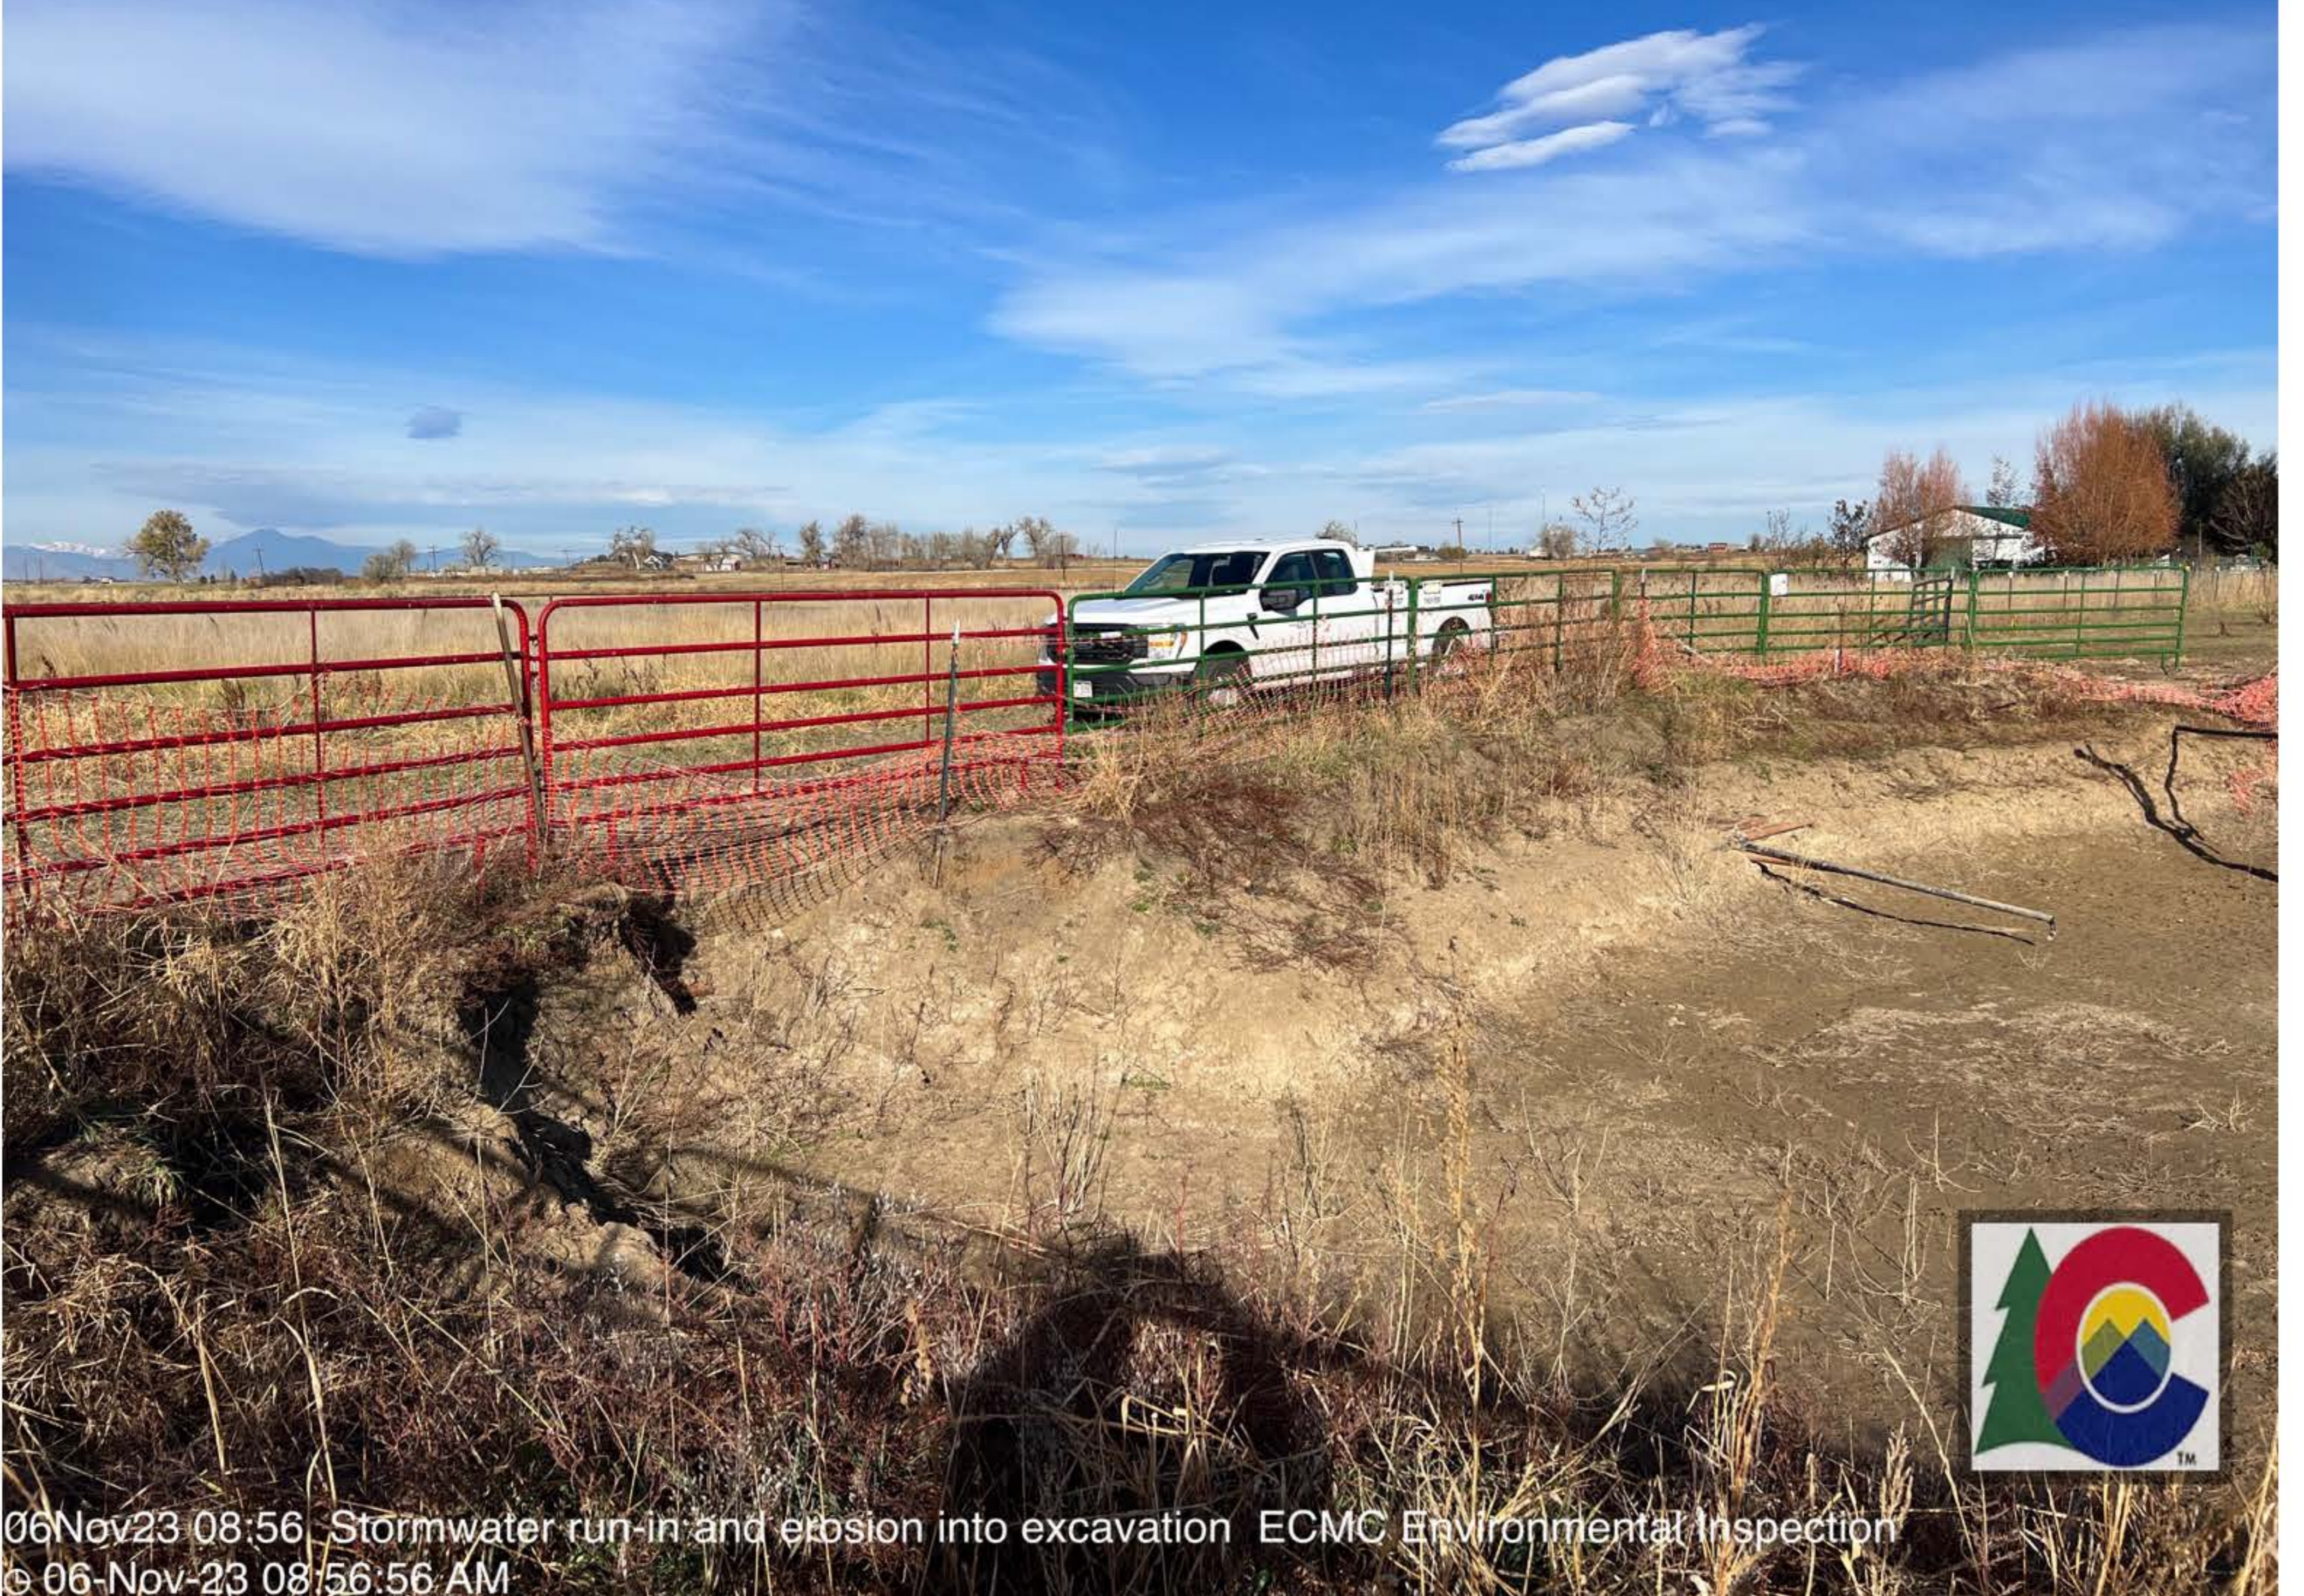
06Nov23 08:56 Stormwater run-in and erosion into excavation ECMC Environmental Inspection
© 06-Nov-23 08:56:56 AM

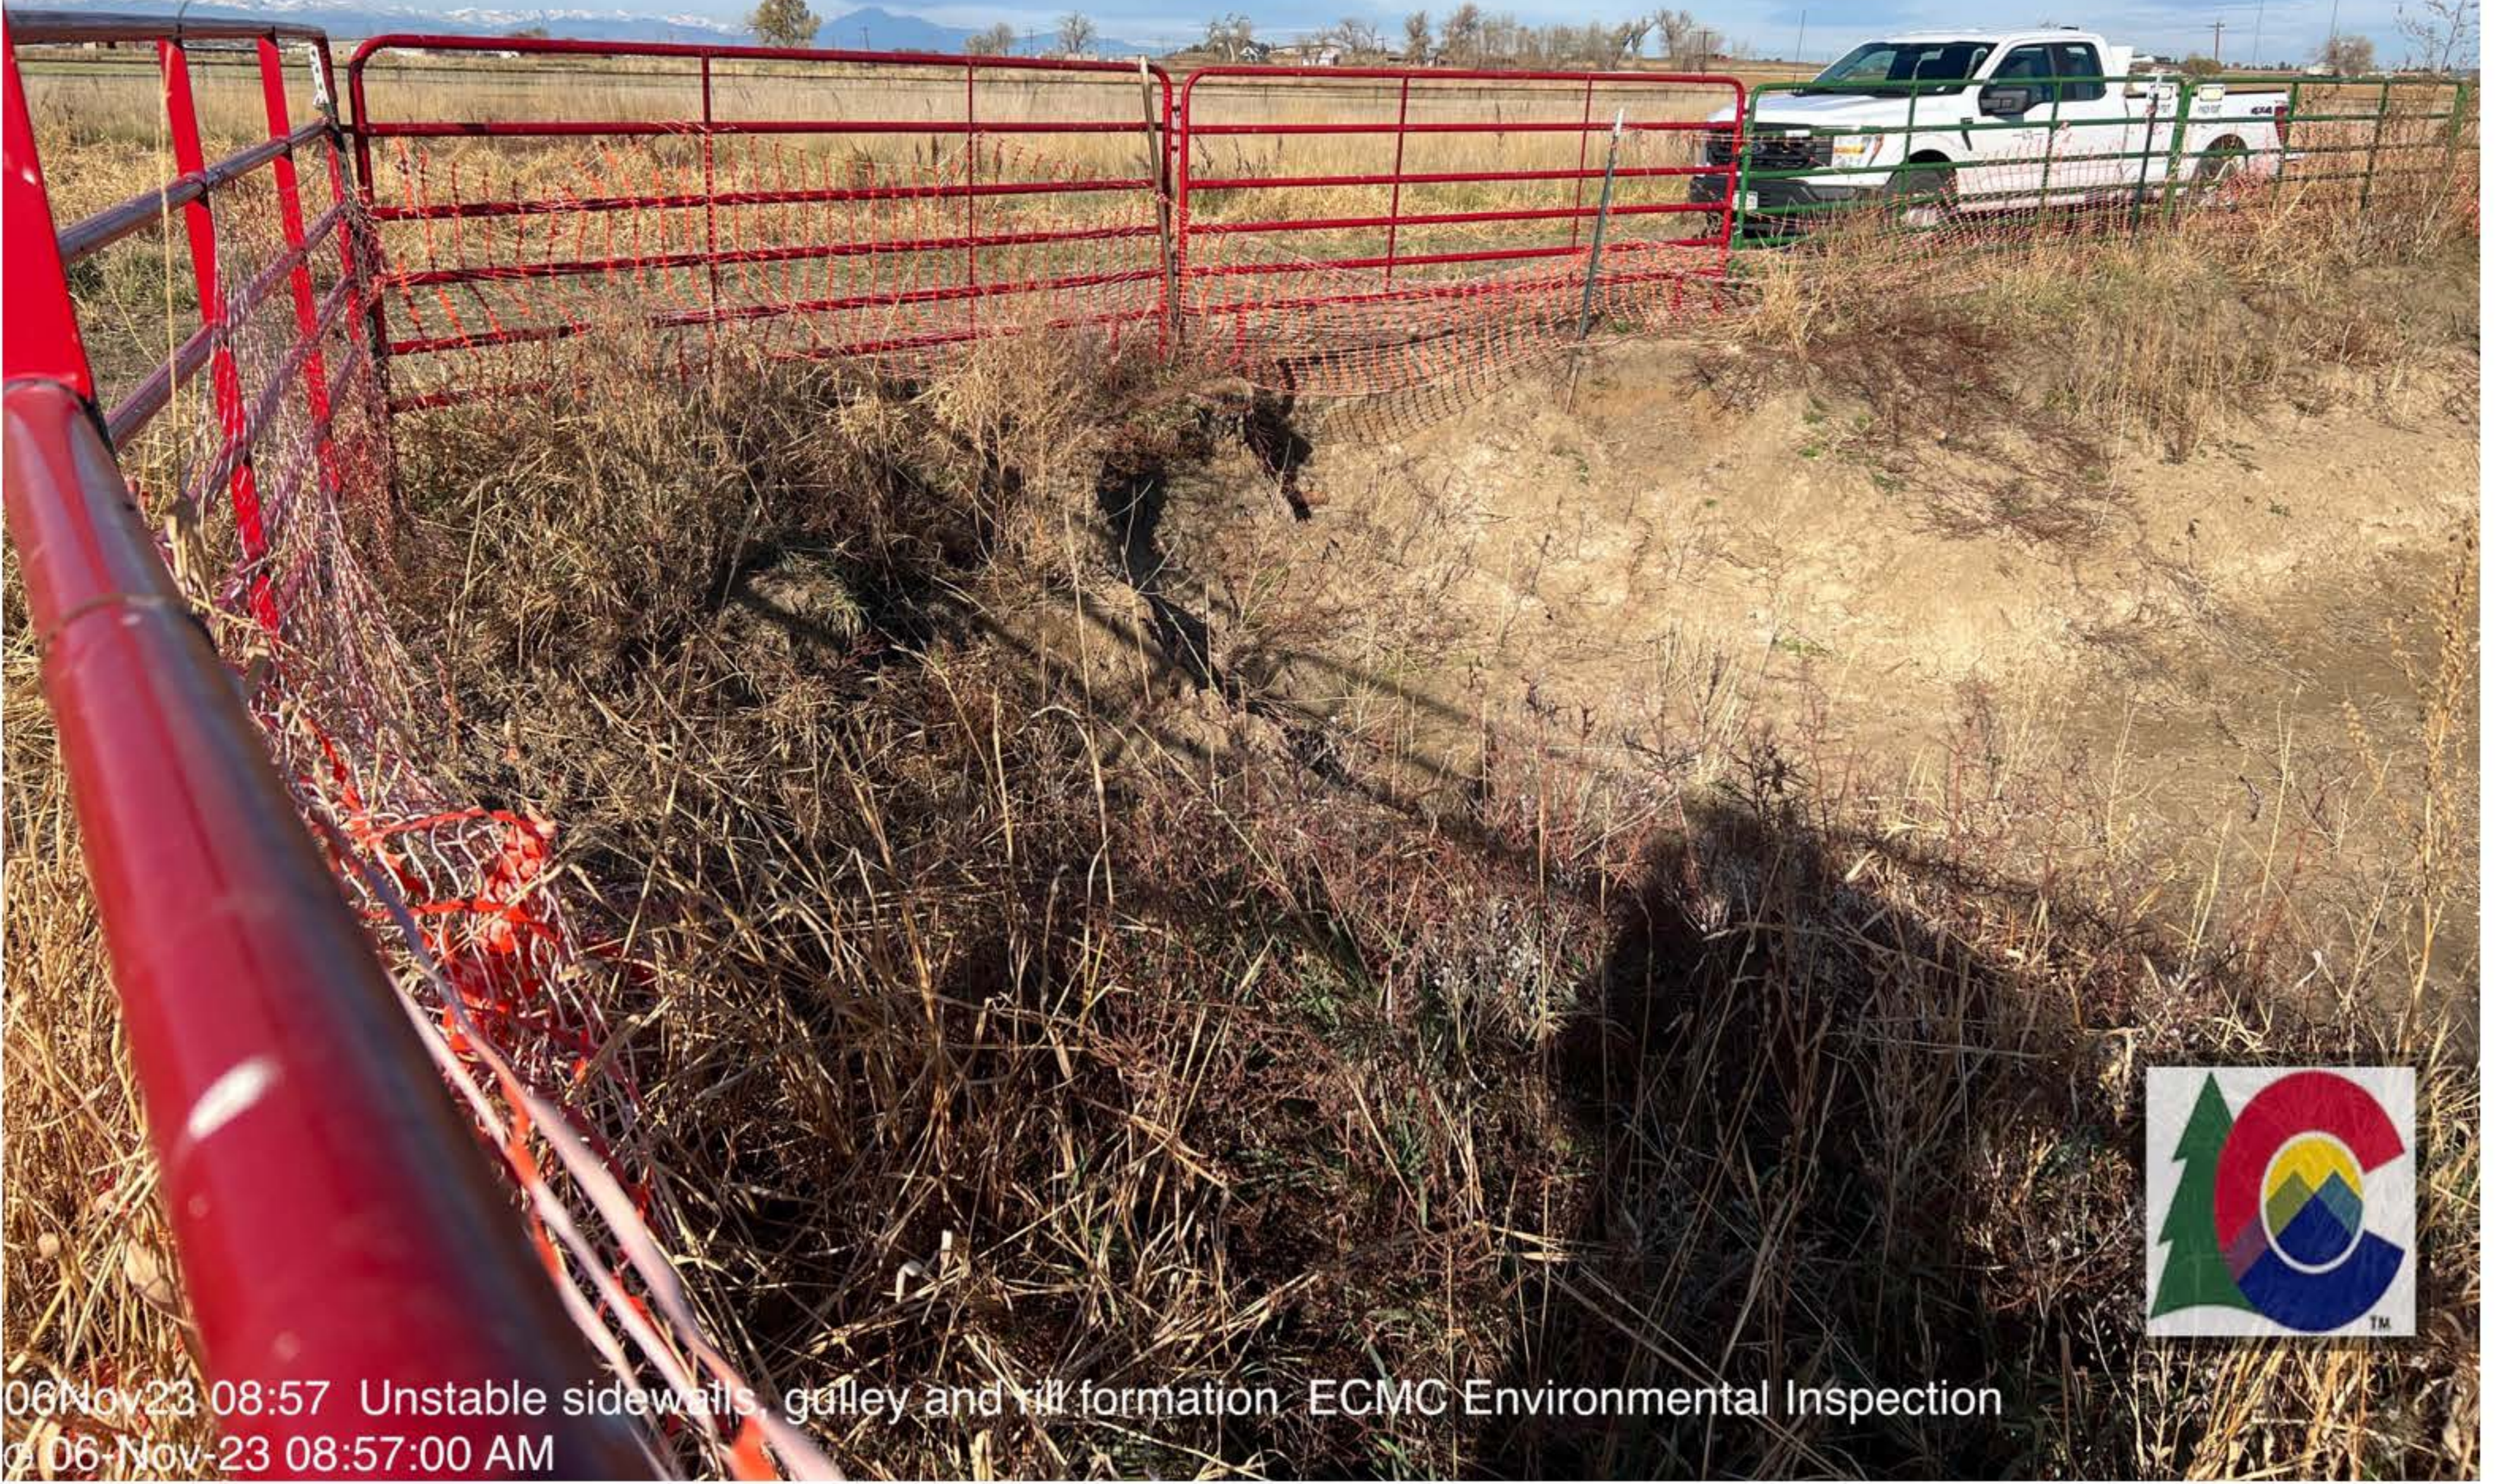
06 Nov 23 08:57 Unstable sidewalls, gulley and rill formation ECMC Environmental Inspection
06 Nov 23 08:57:00 AM

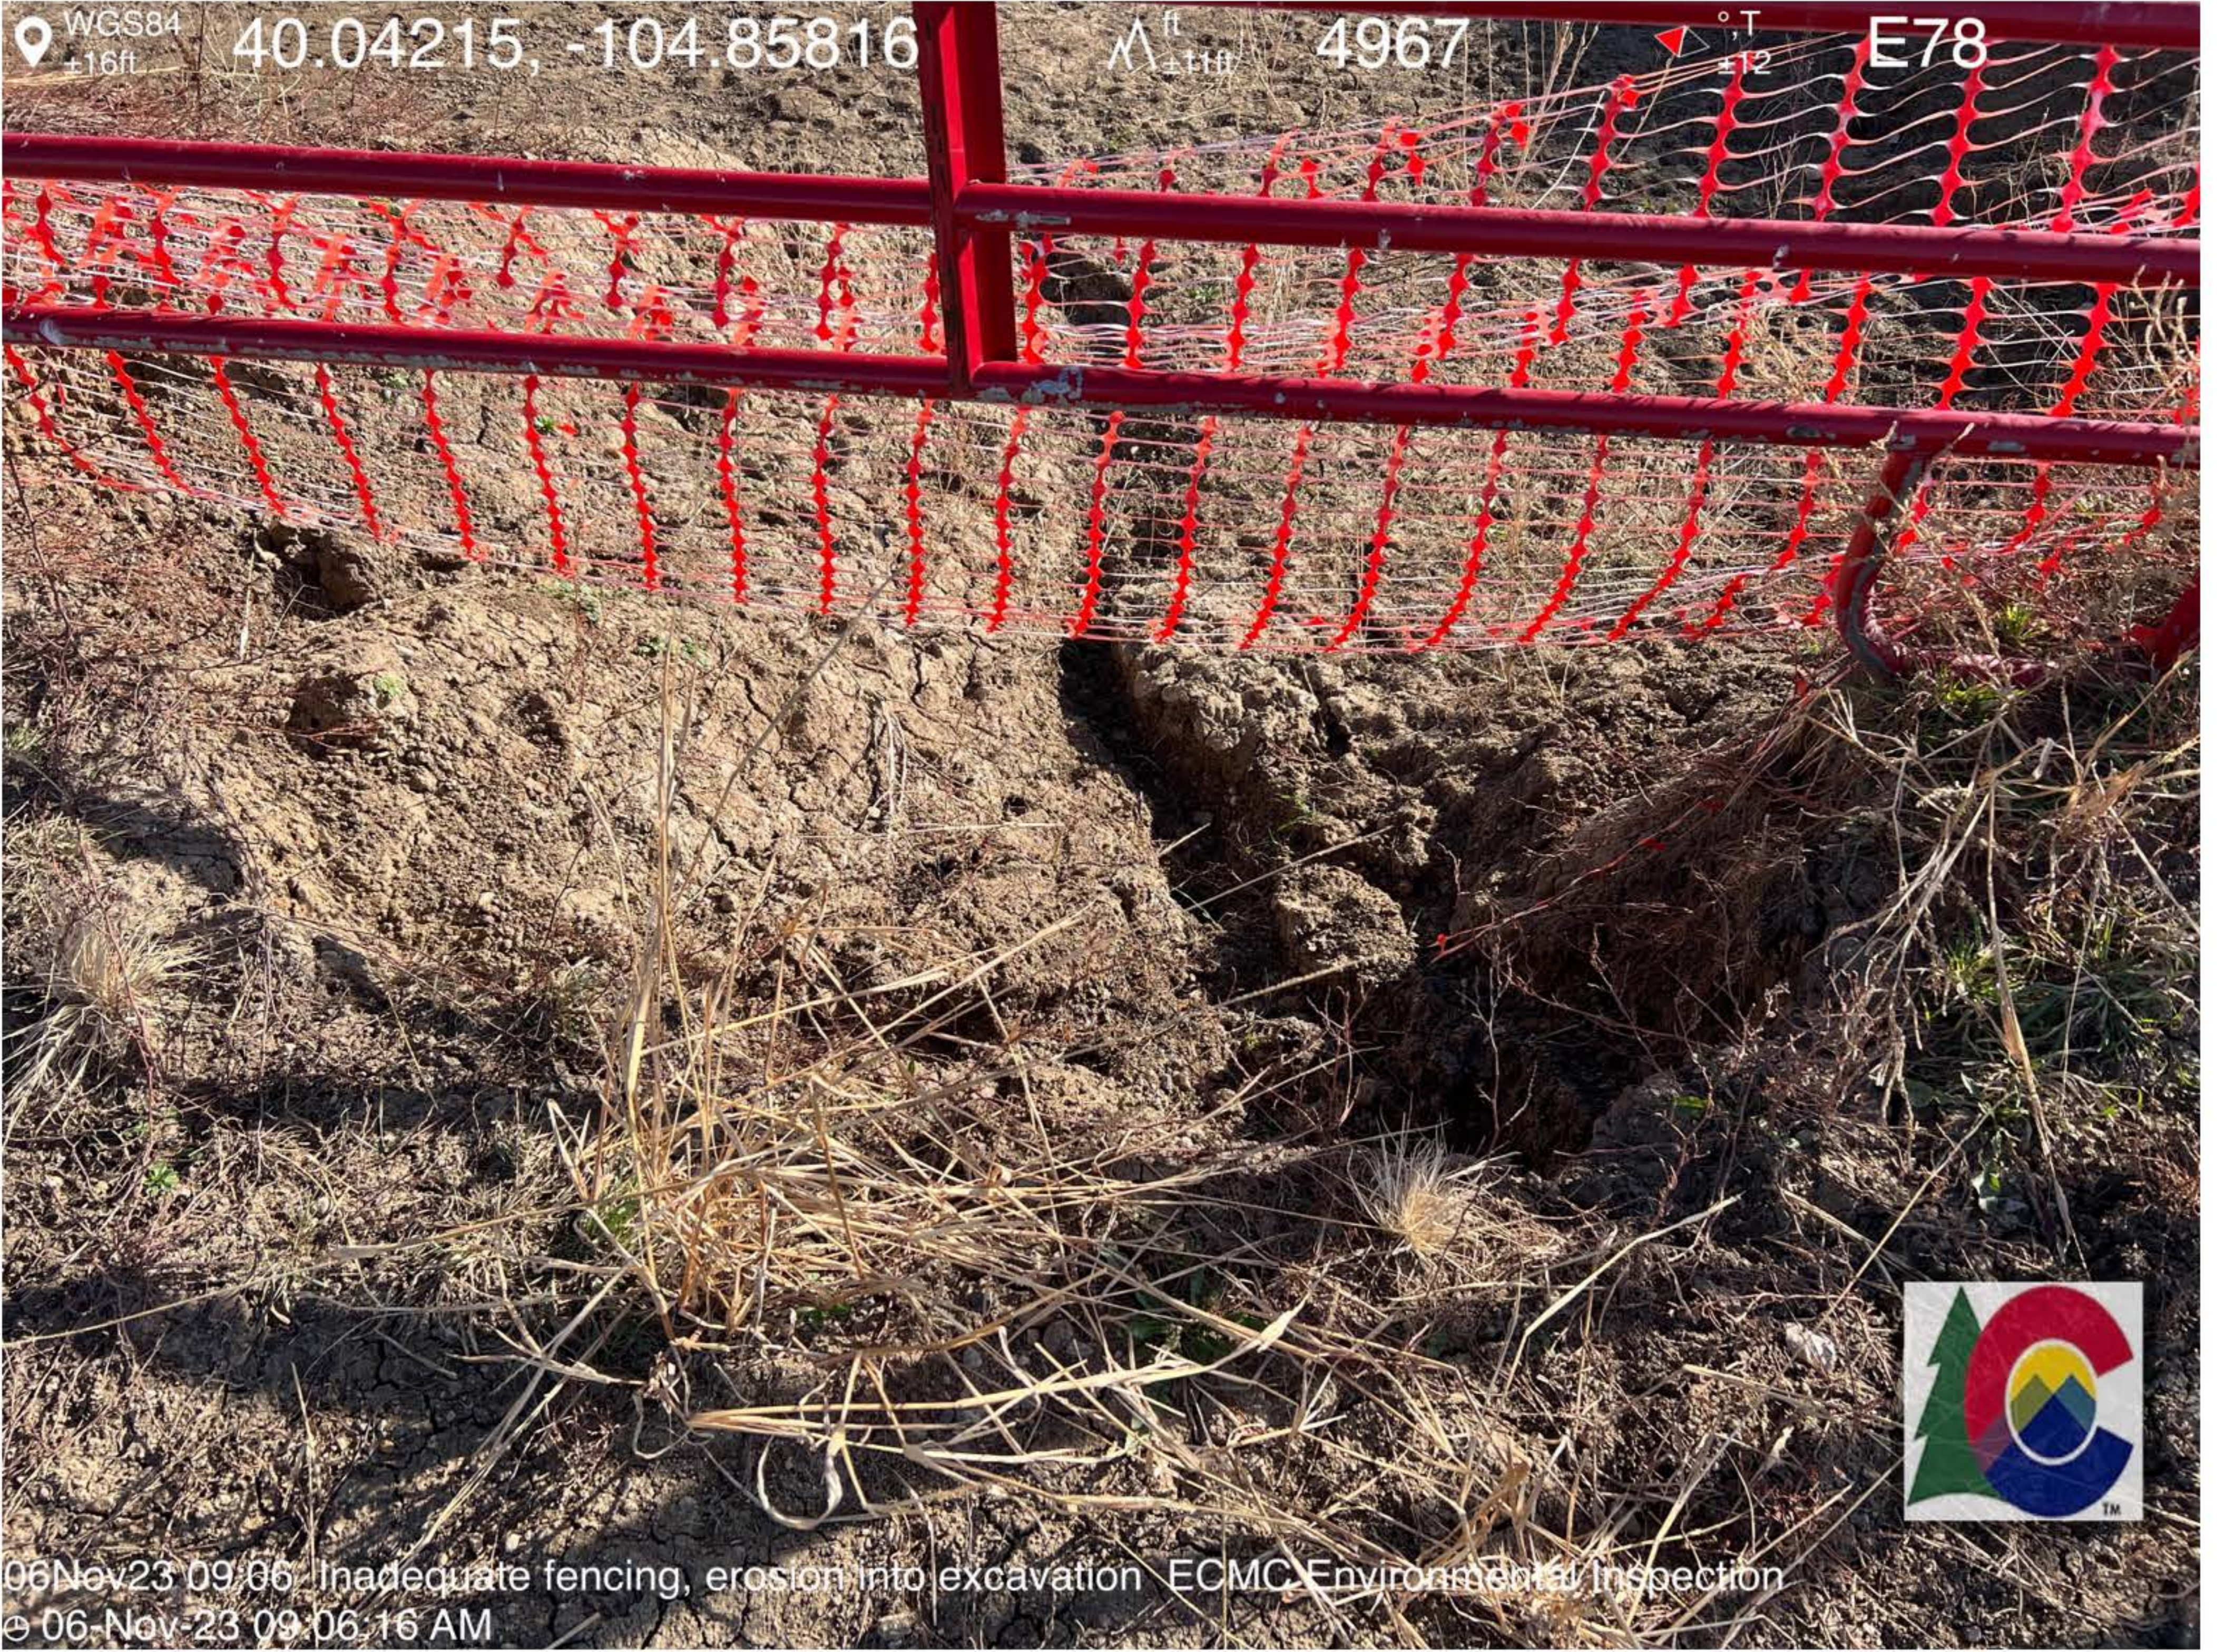
06Nov23 09:06 Inadequate fencing, erosion into excavation ECMC Environmental Inspection
© 06-Nov-23 09:06:16 AM

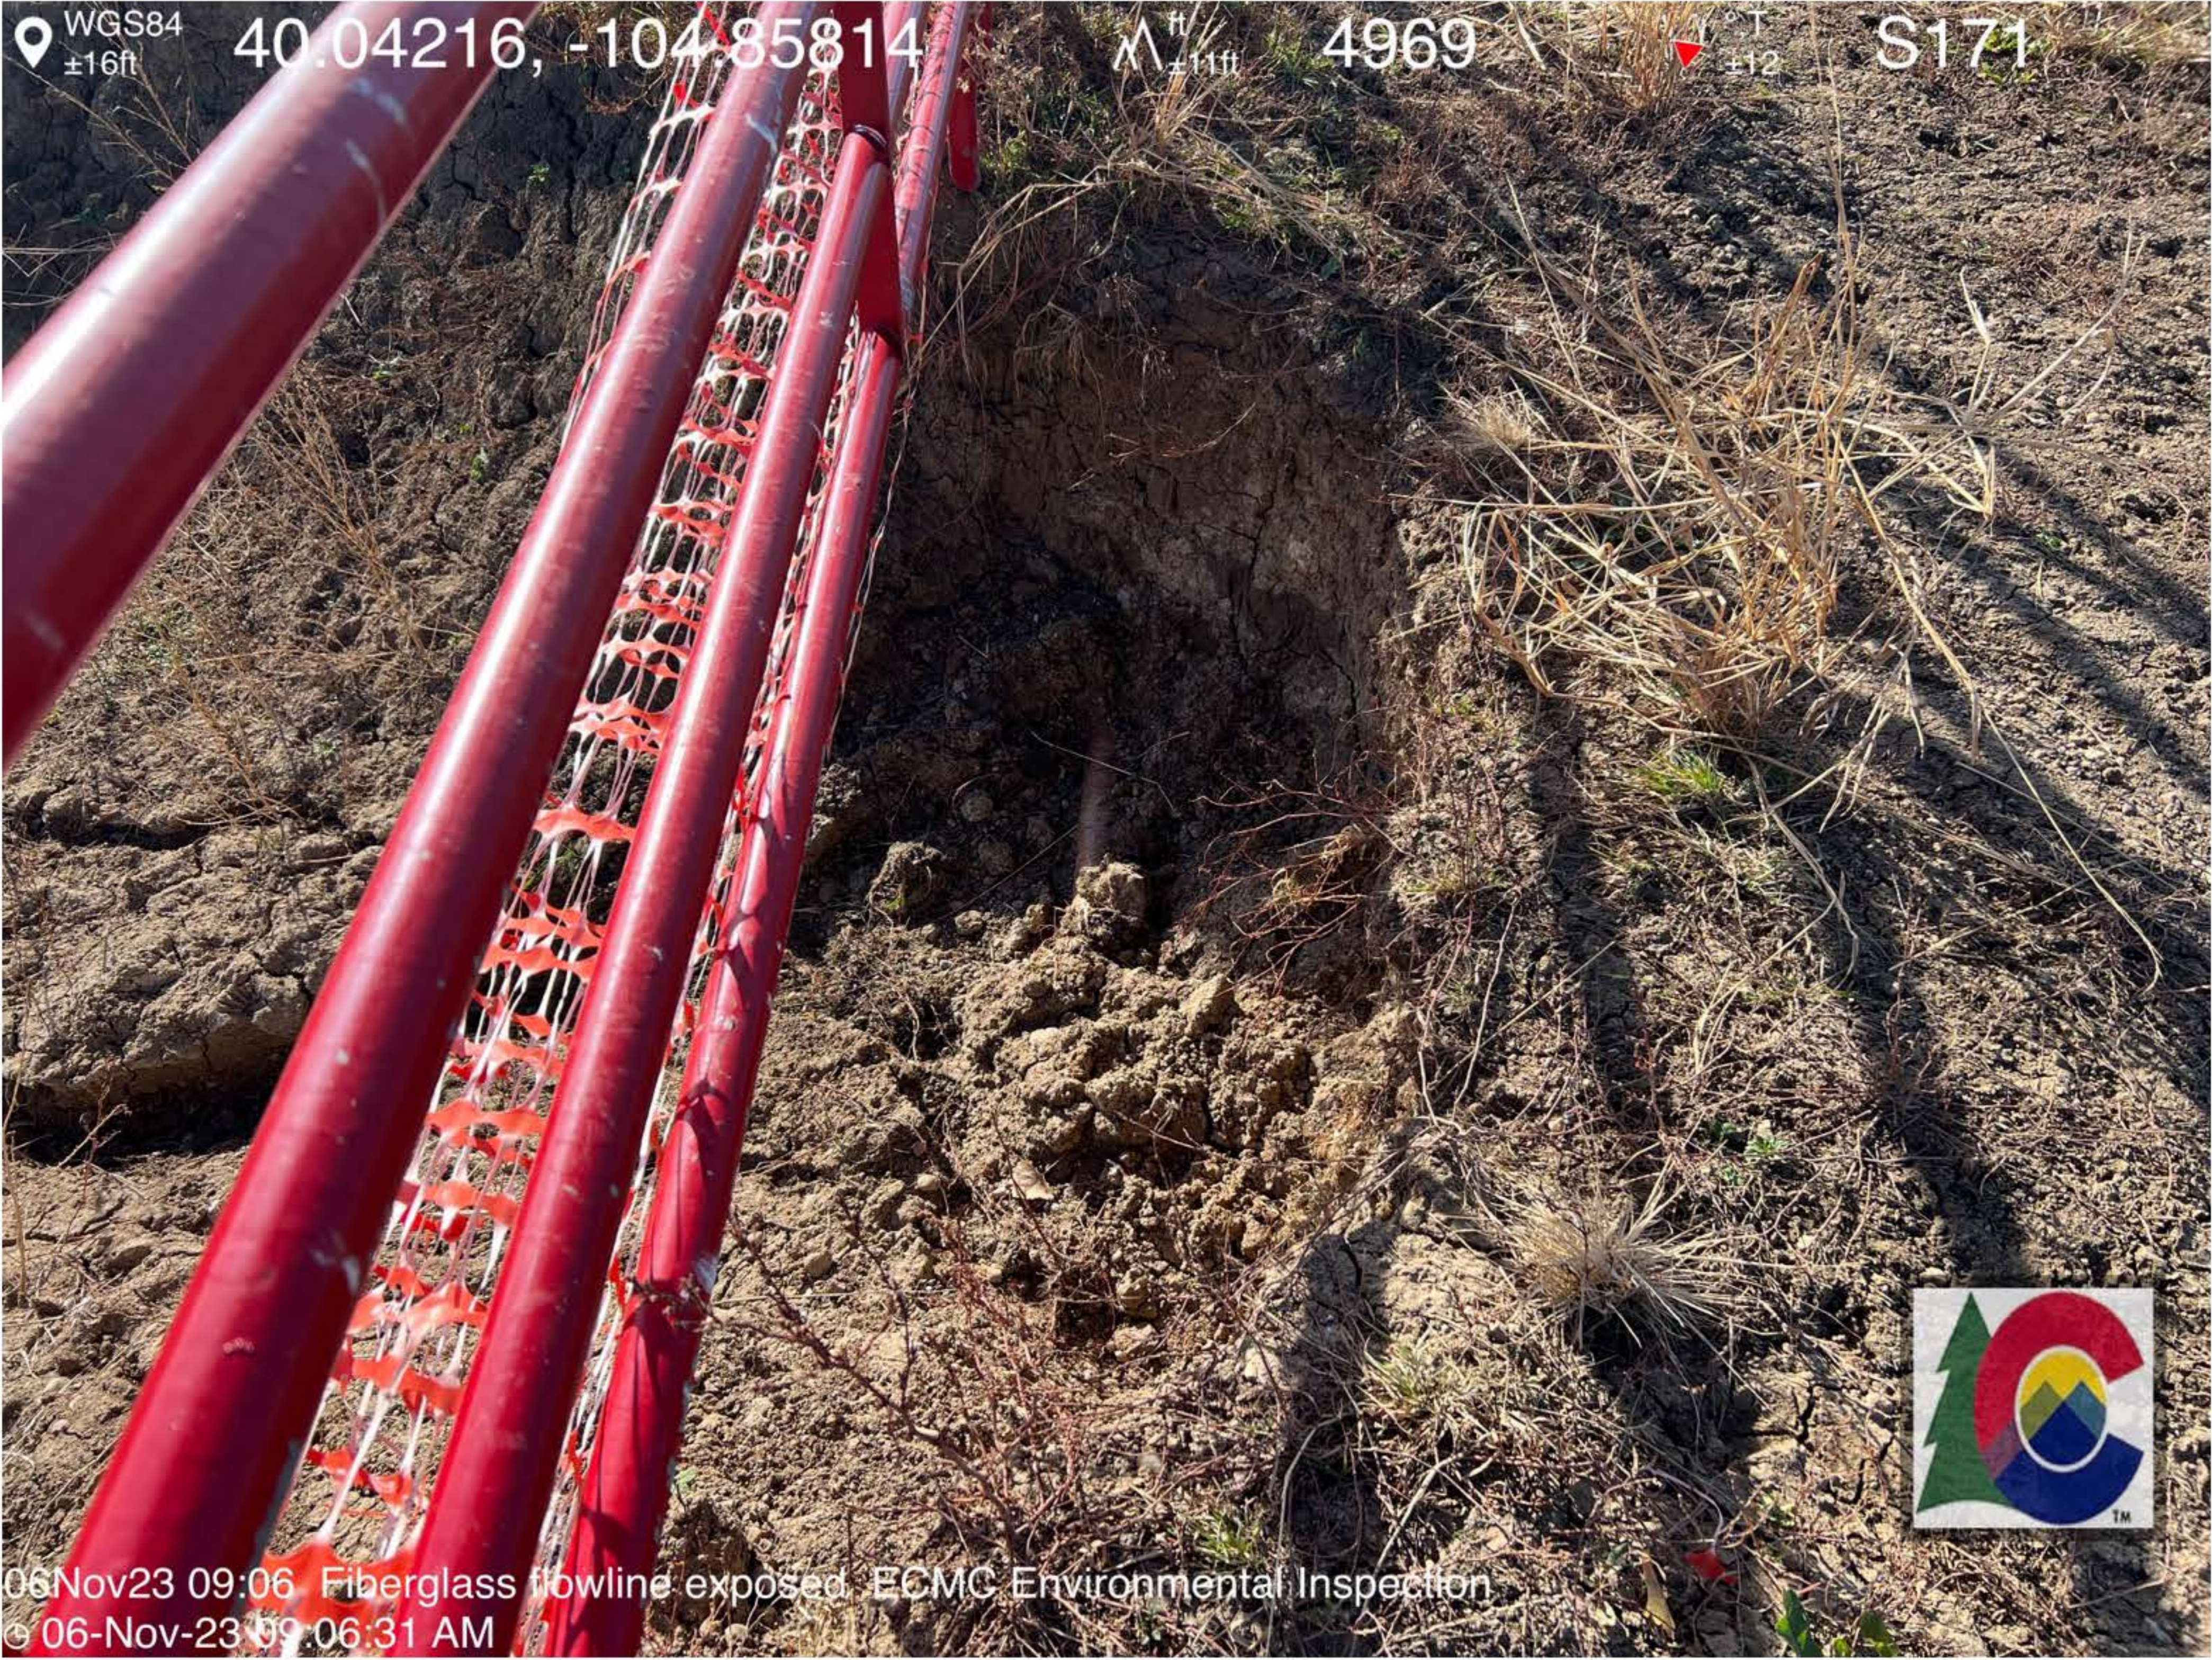
06Nov23 09:06 Fiberglass flowline exposed ECMC Environmental Inspection
© 06-Nov-23 09:06:31 AM

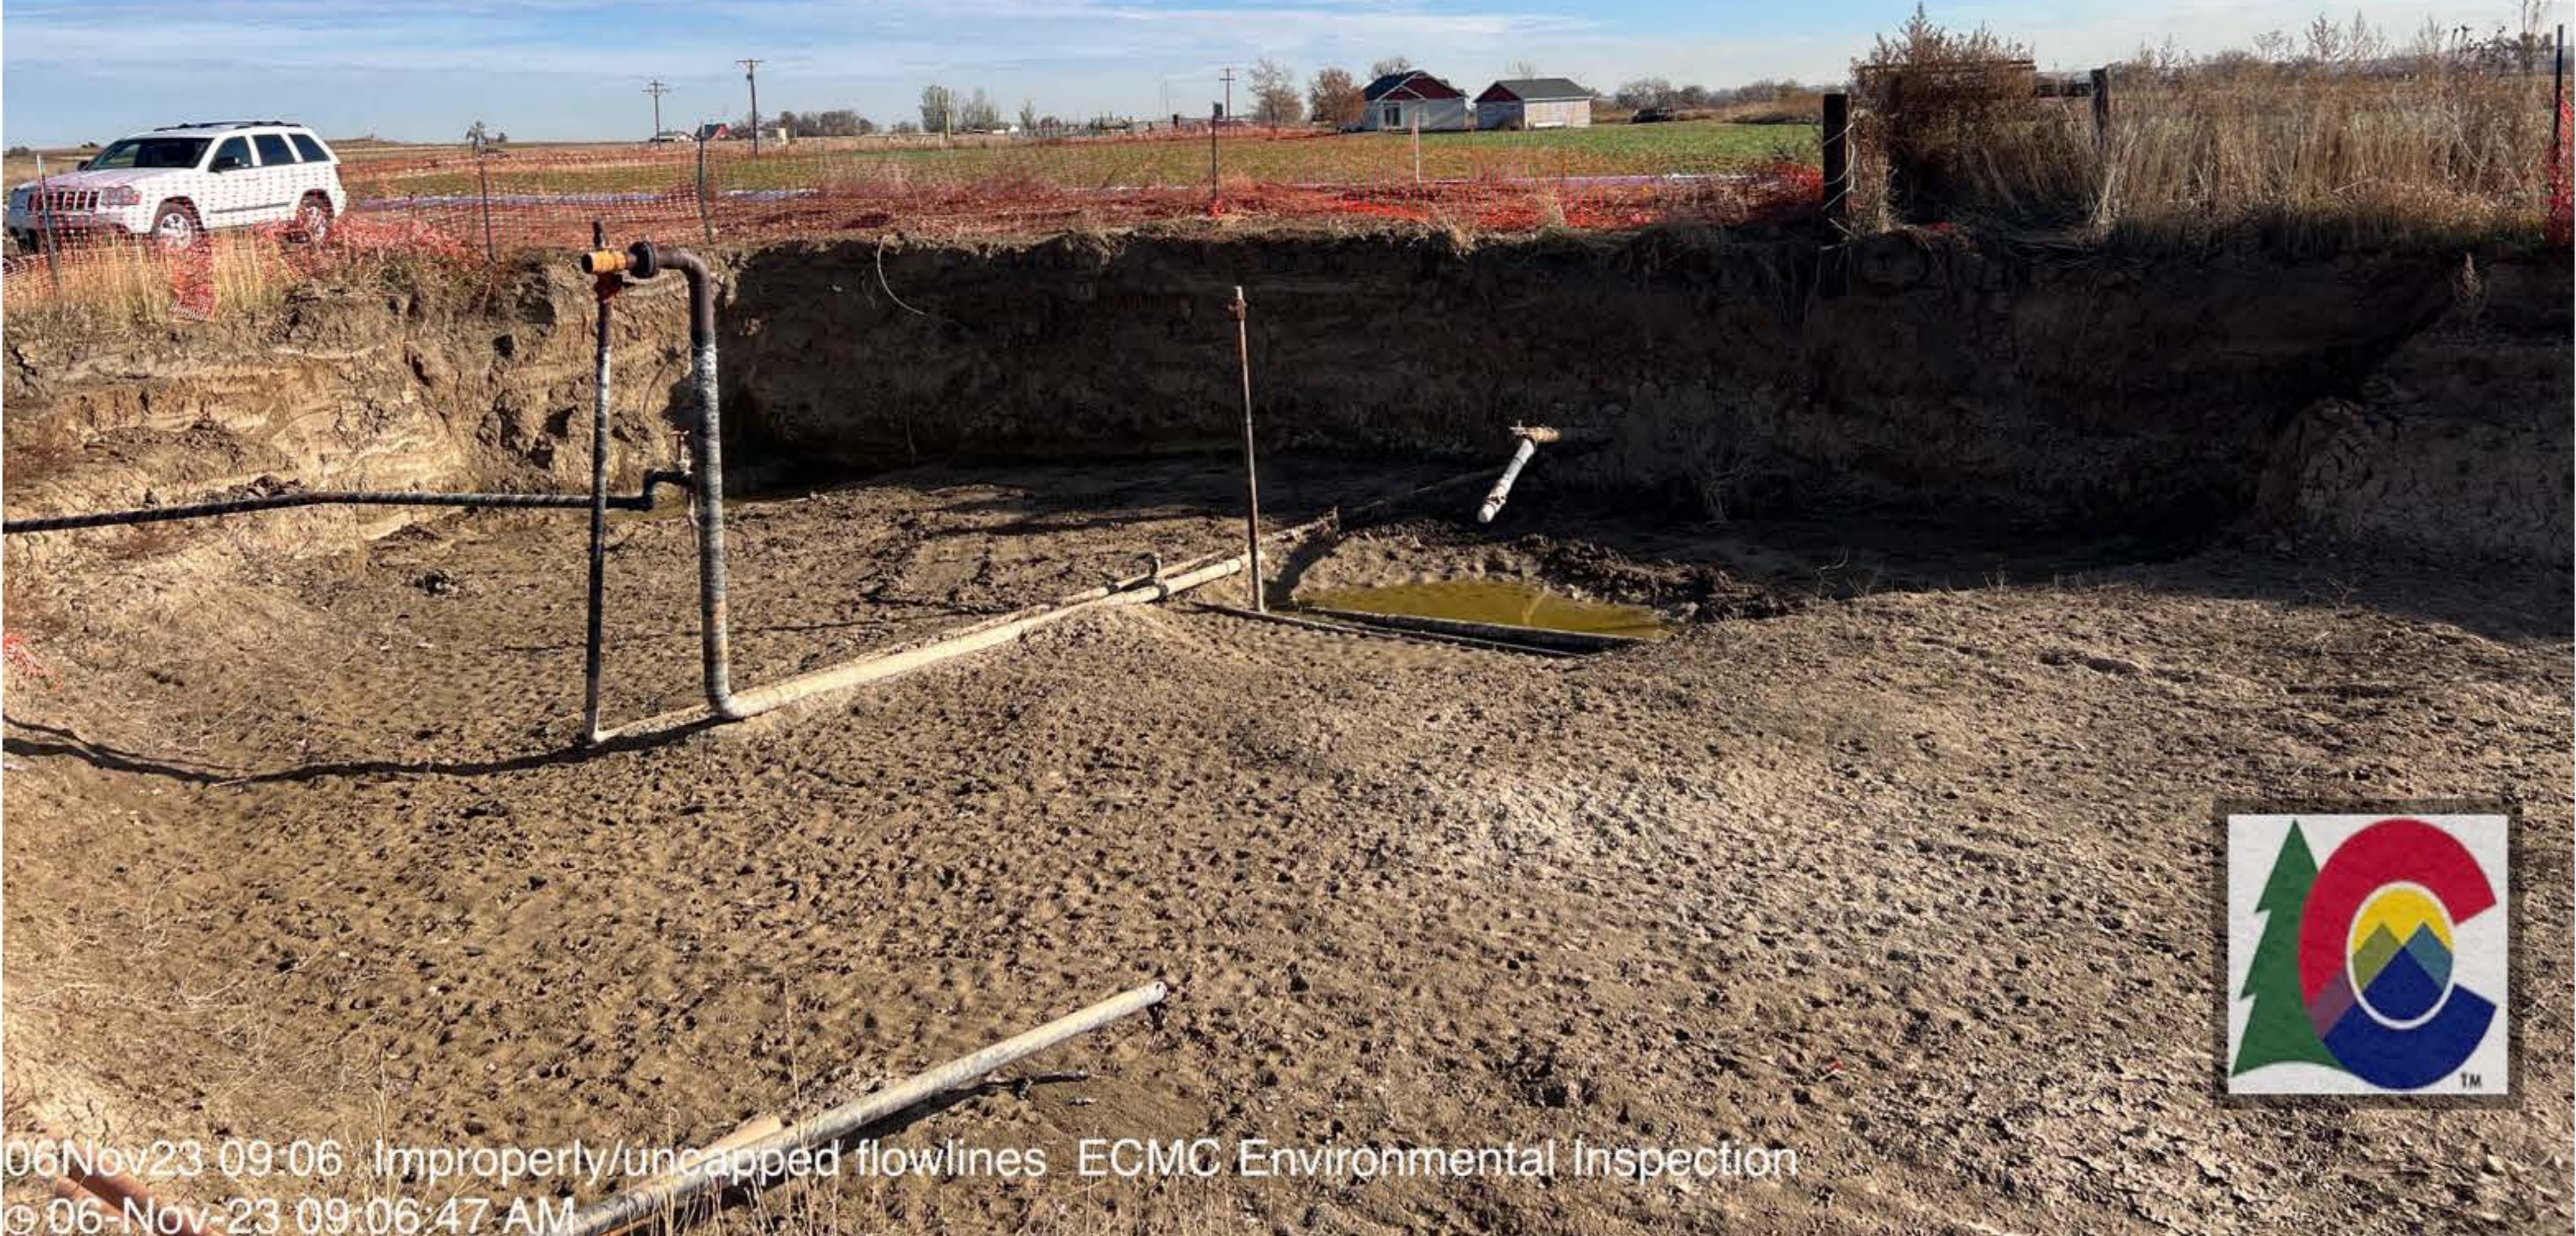
06Nov23 09:06 Improperly/uncapped flowlines ECMC Environmental Inspection
© 06-Nov-23 09:06:47 AM
