06Nov23 08:37 ECMC Environmental Inspection
© 06-Nov-23 08:37:11 AM

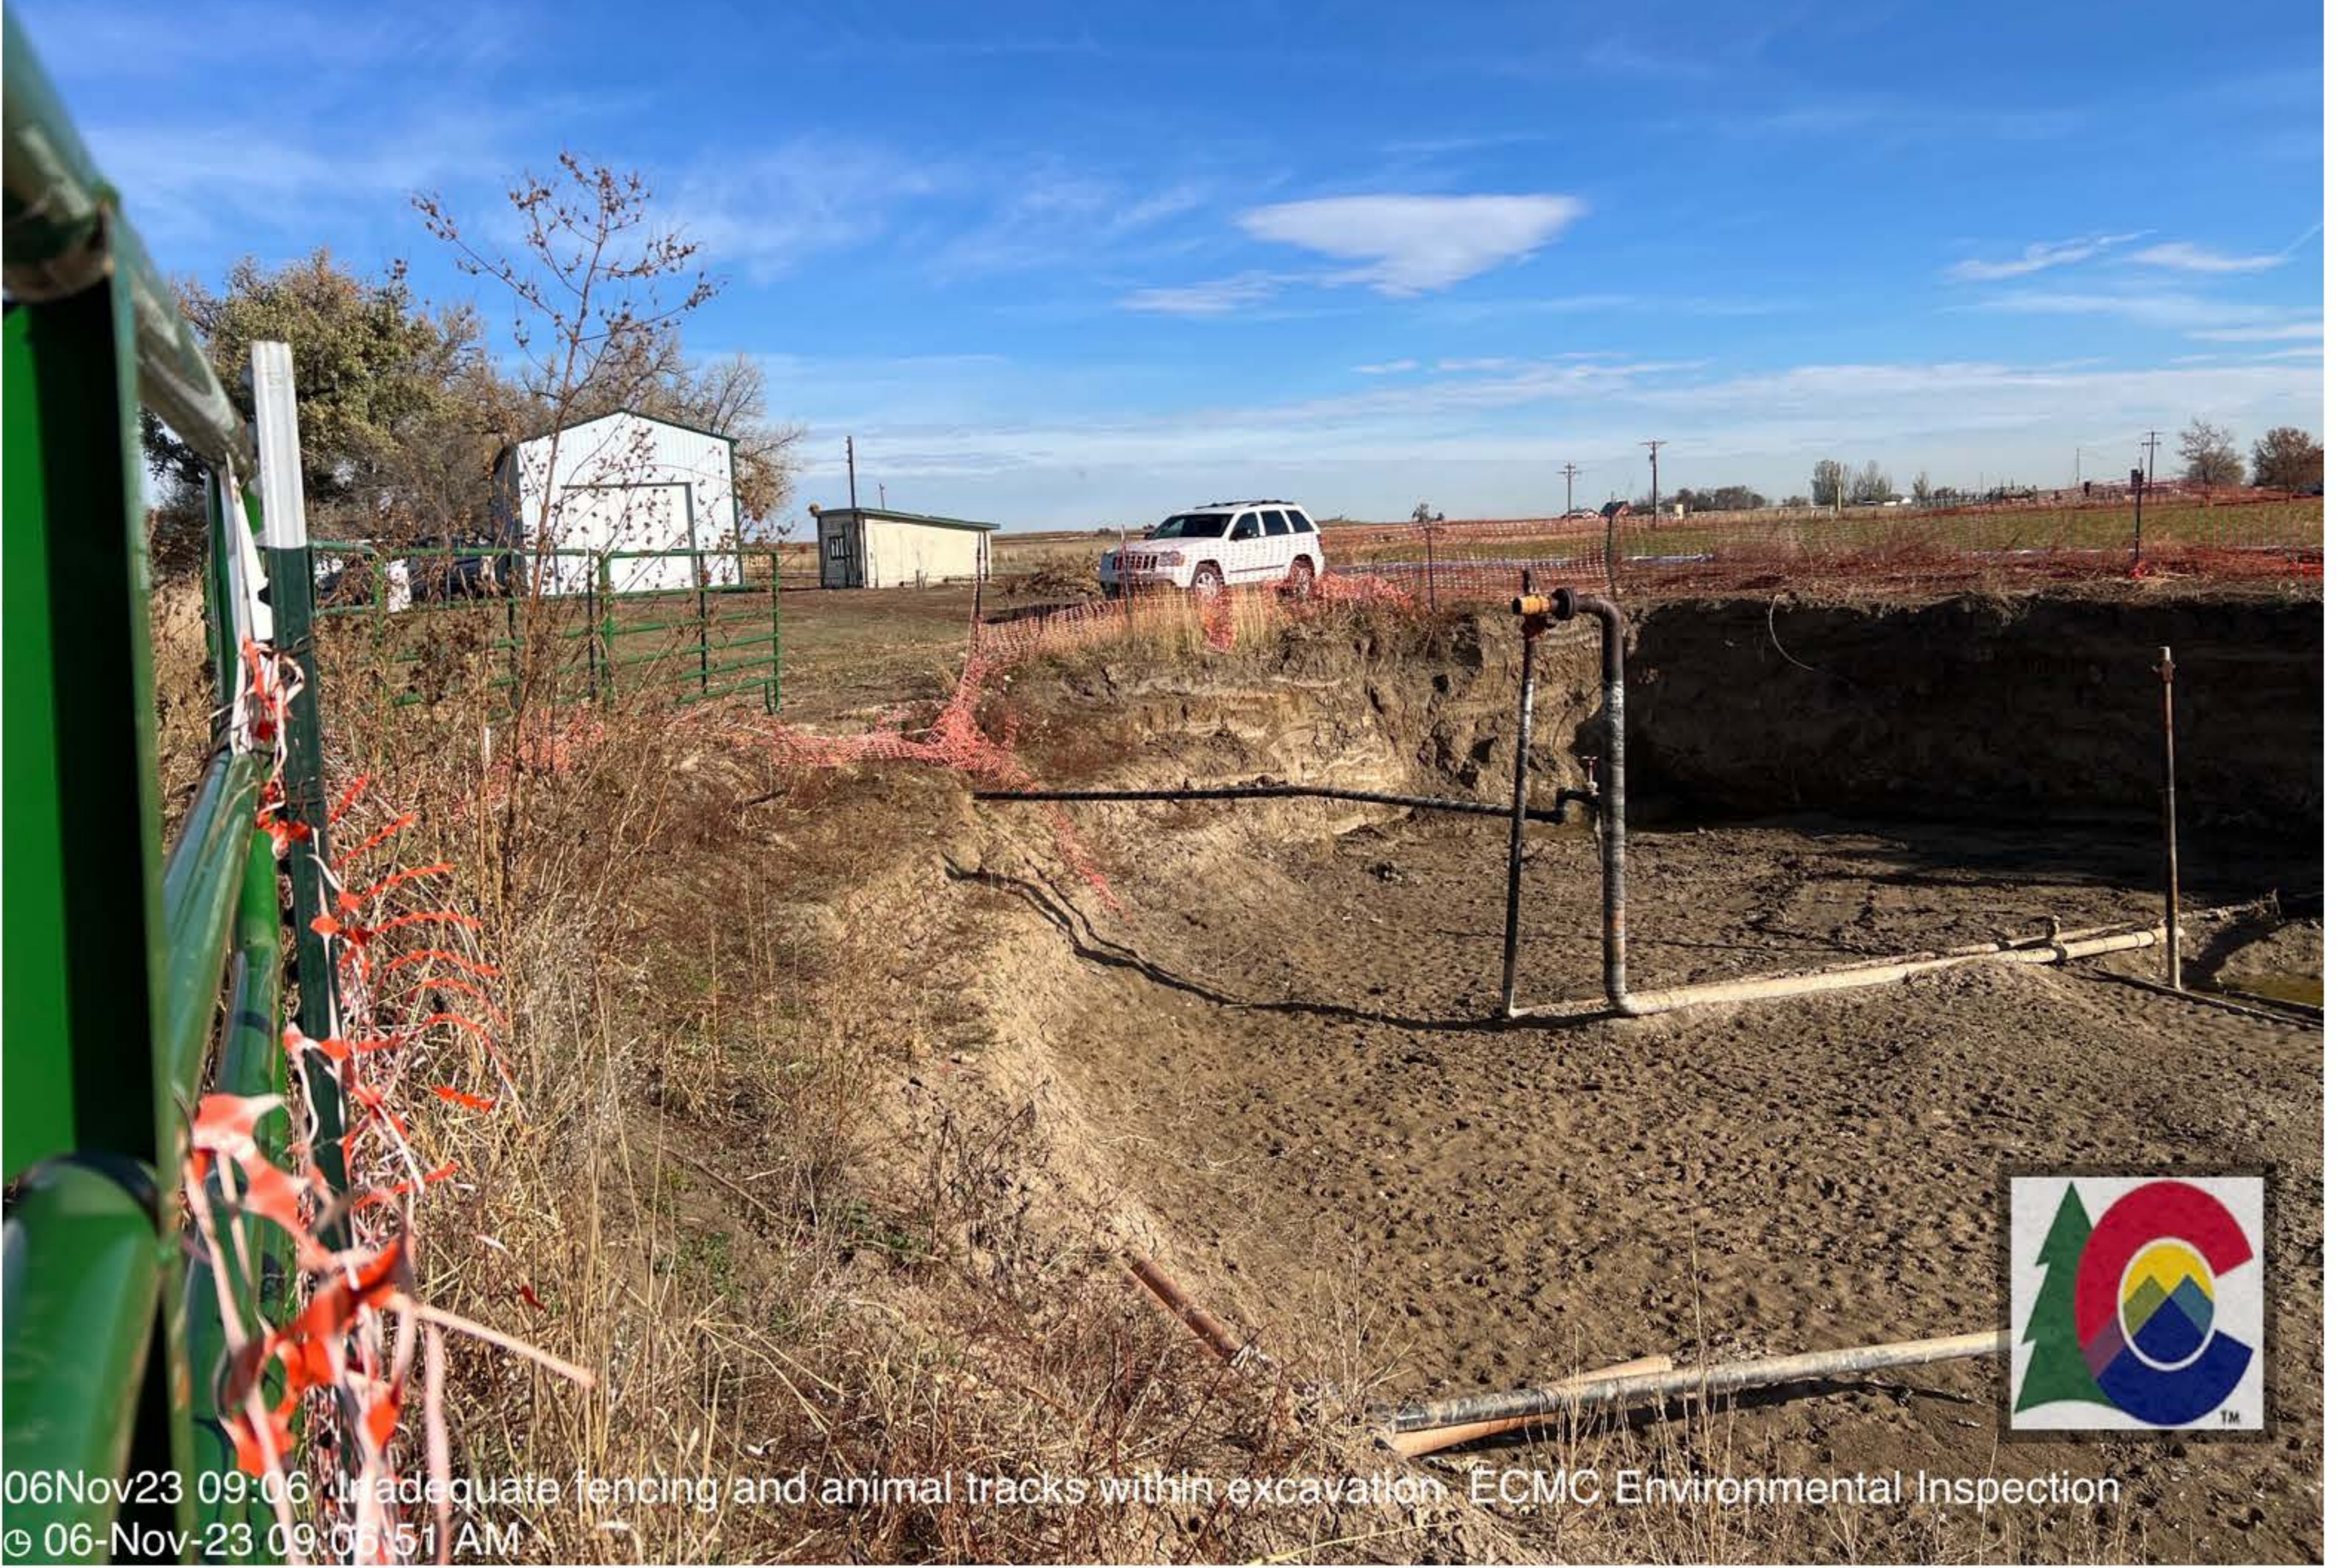
06Nov23 09:06 Inadequate fencing and animal tracks within excavation ECMC Environmental Inspection
© 06-Nov-23 09:06:51 AM

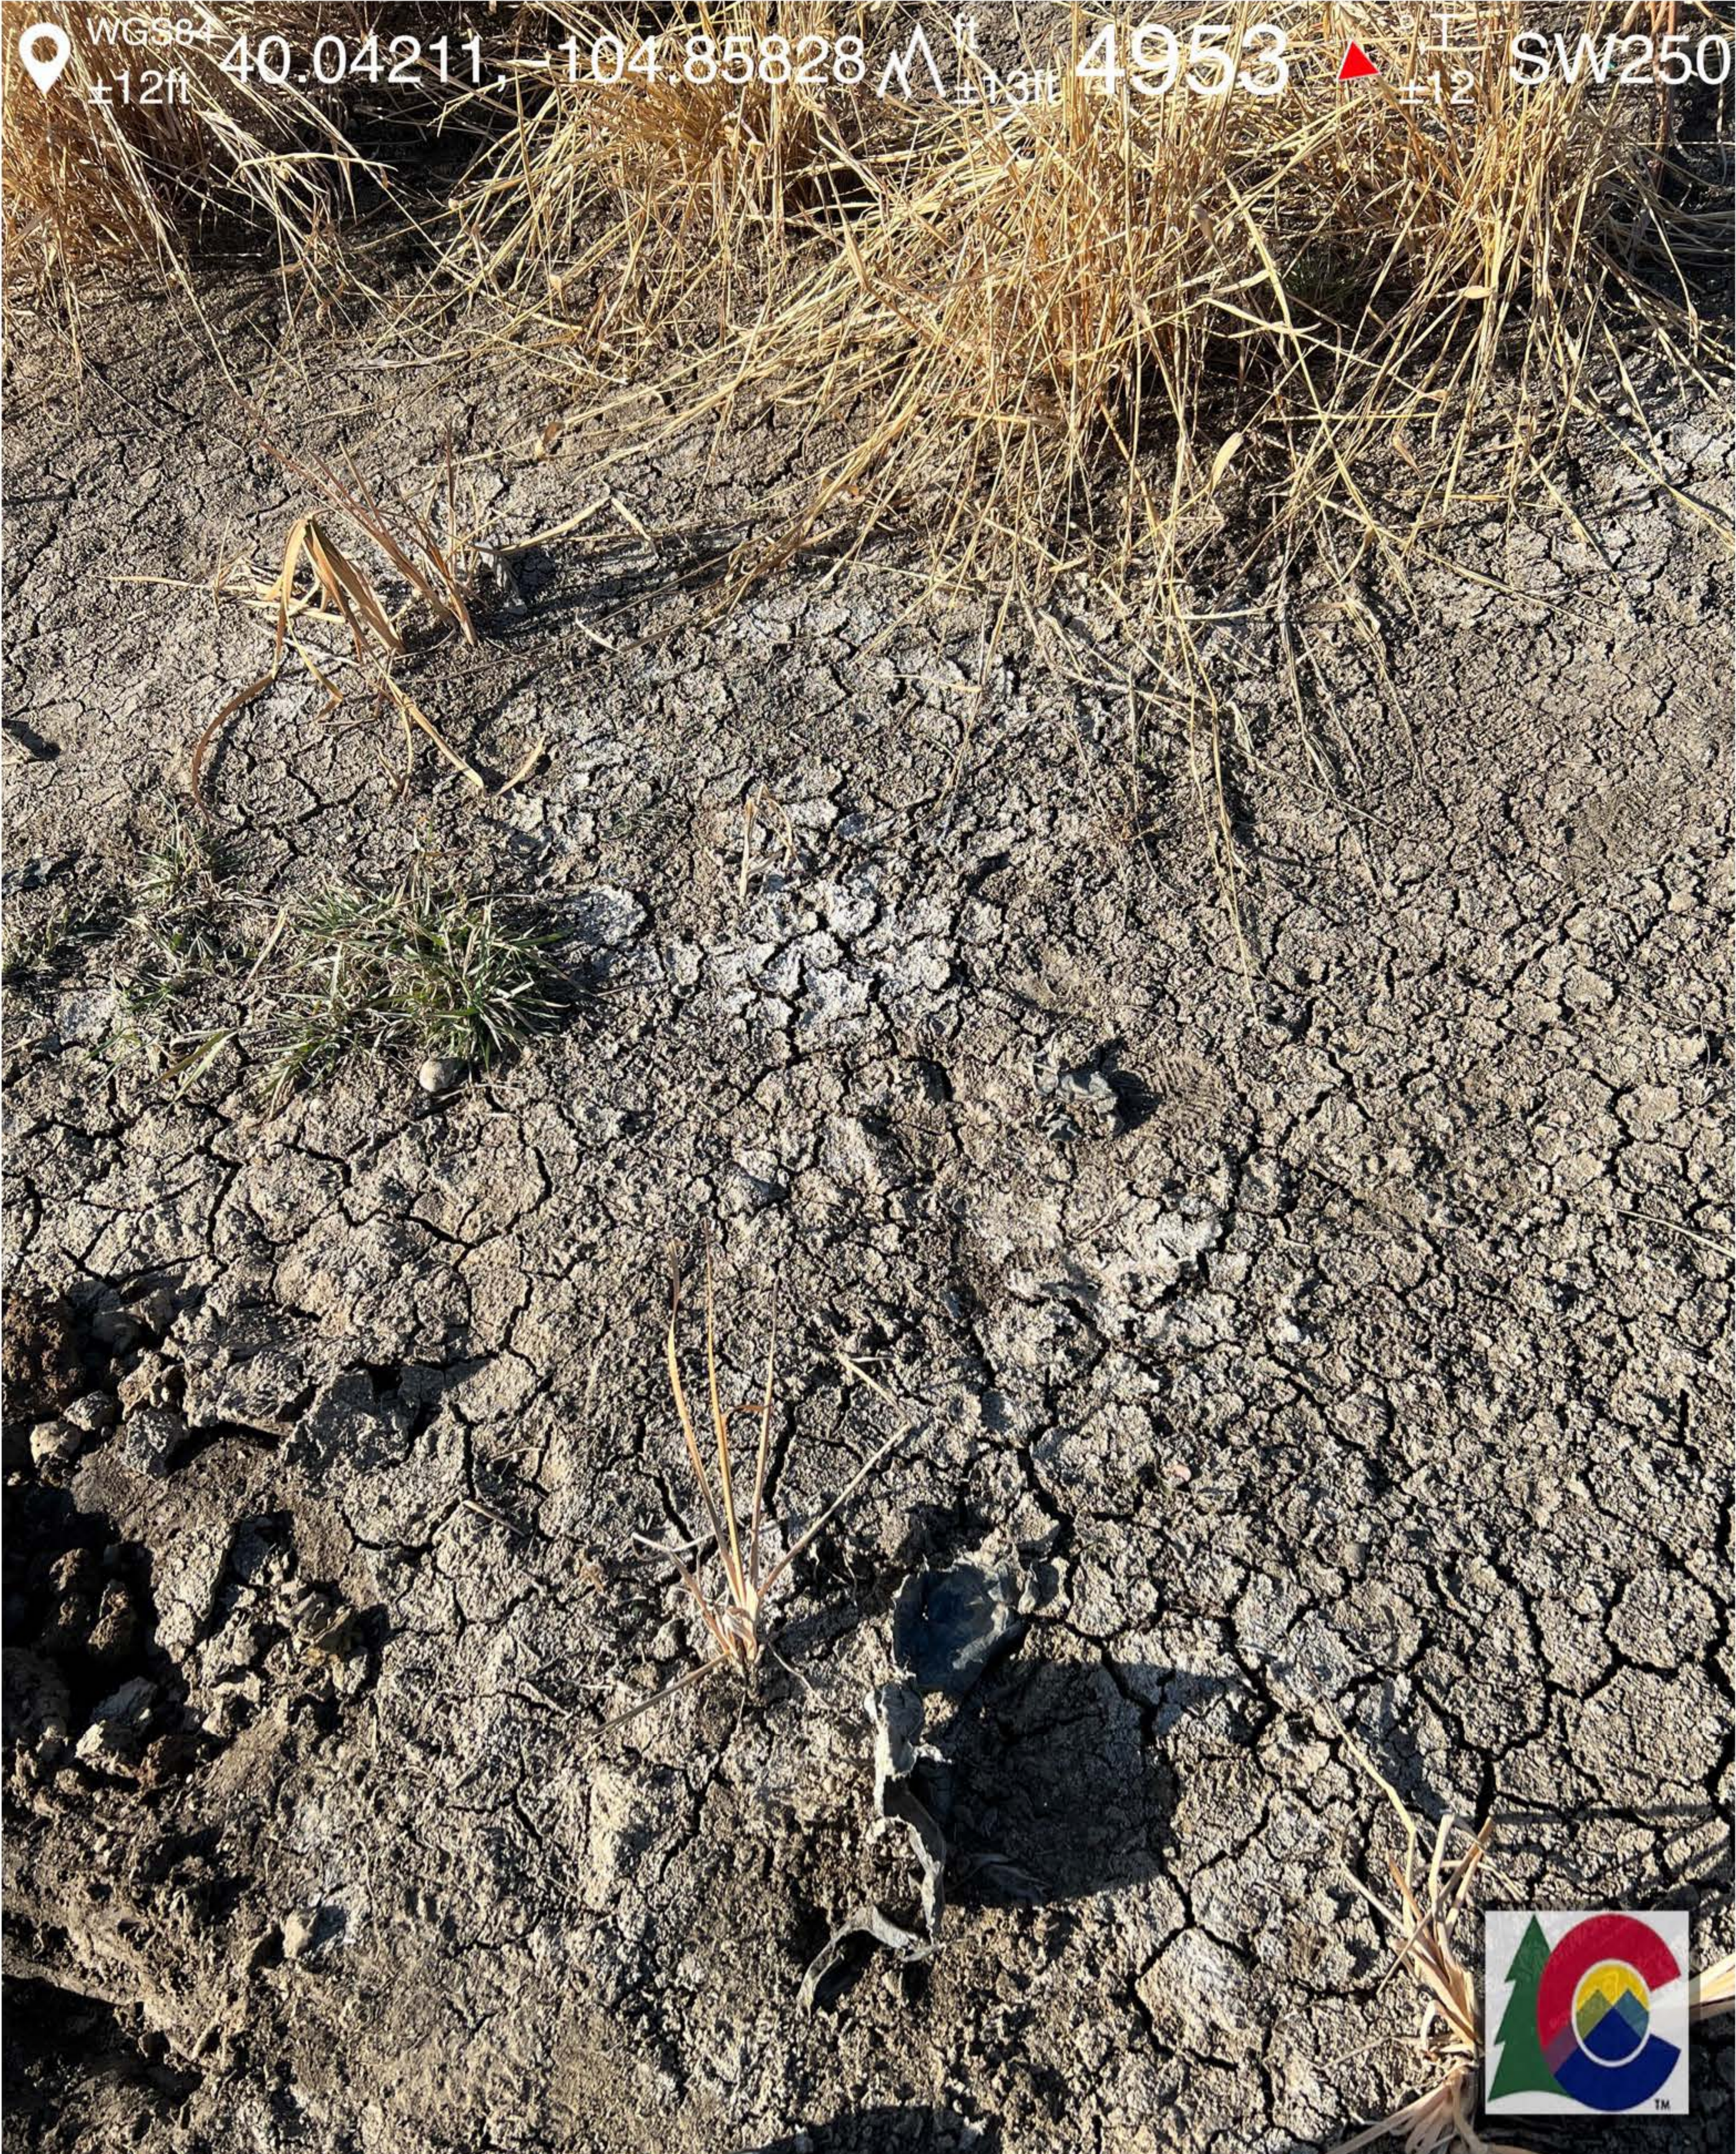
06Nov23 09:08 Torn liner ECMC Environmental Inspection
© 06-Nov-23 09:08:52 AM

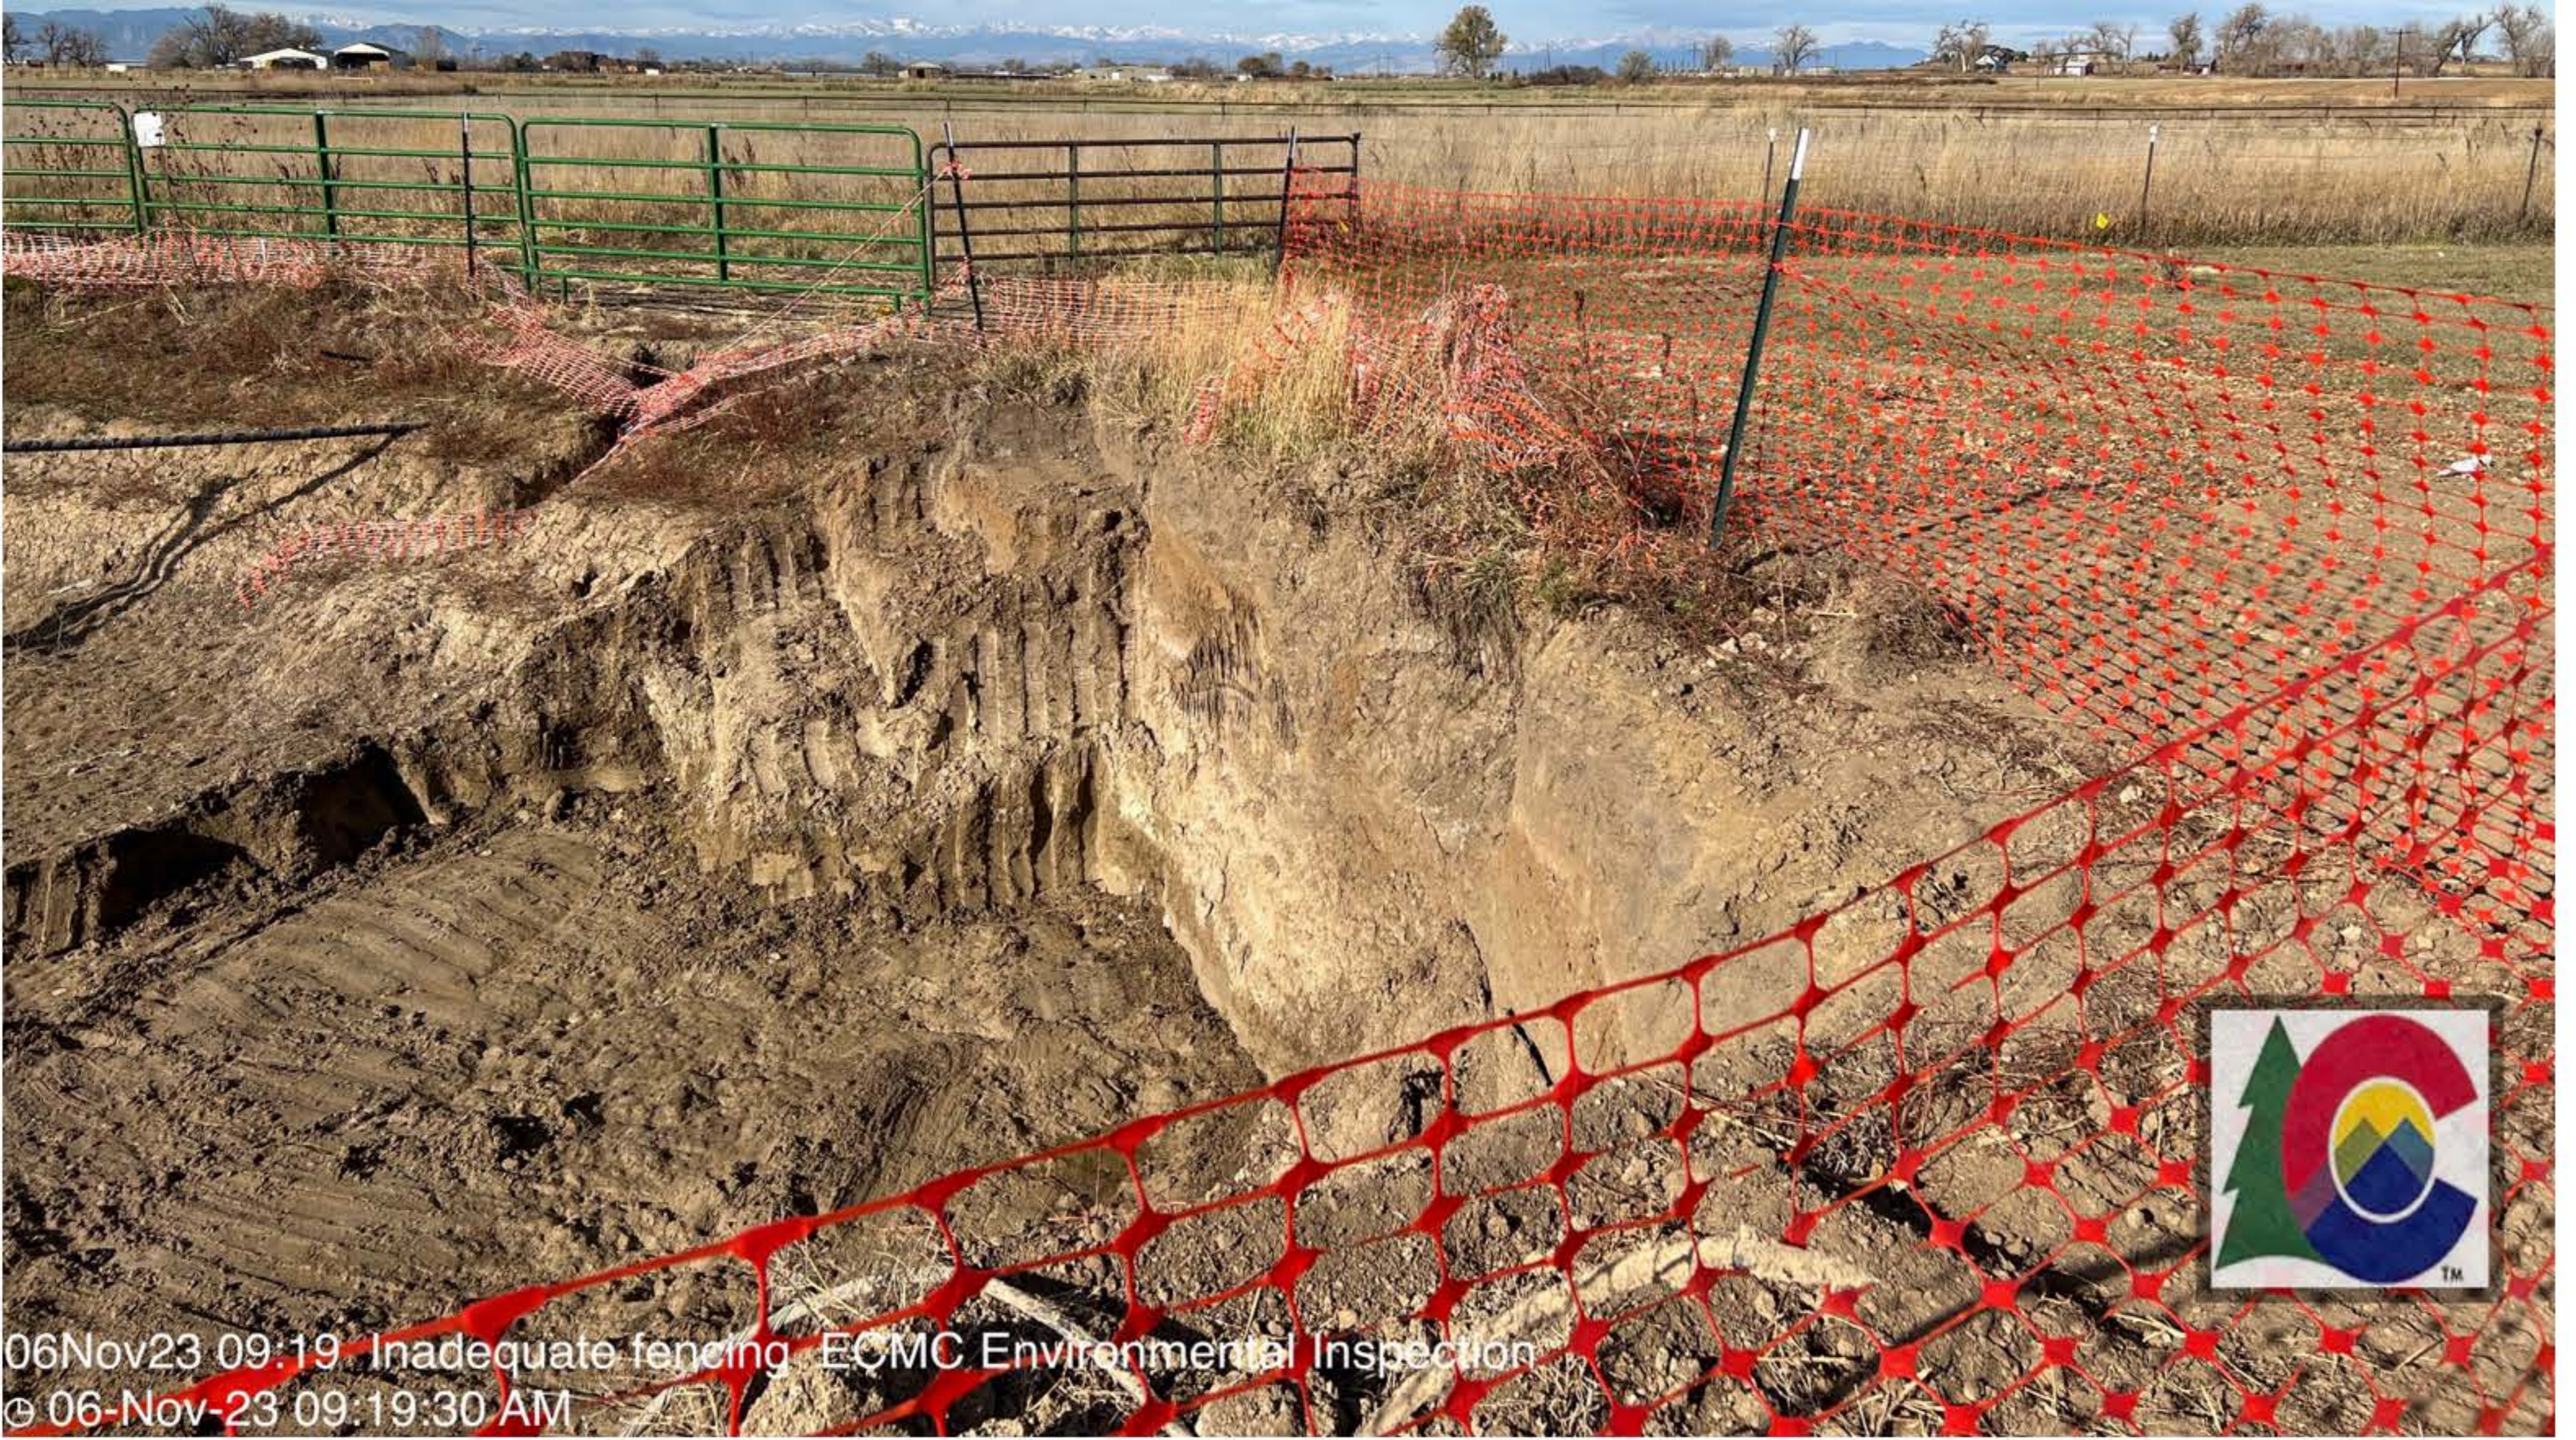
06Nov23 09:19 Inadequate fencing - EMC Environmental Inspection
© 06-Nov-23 09:19:30 AM

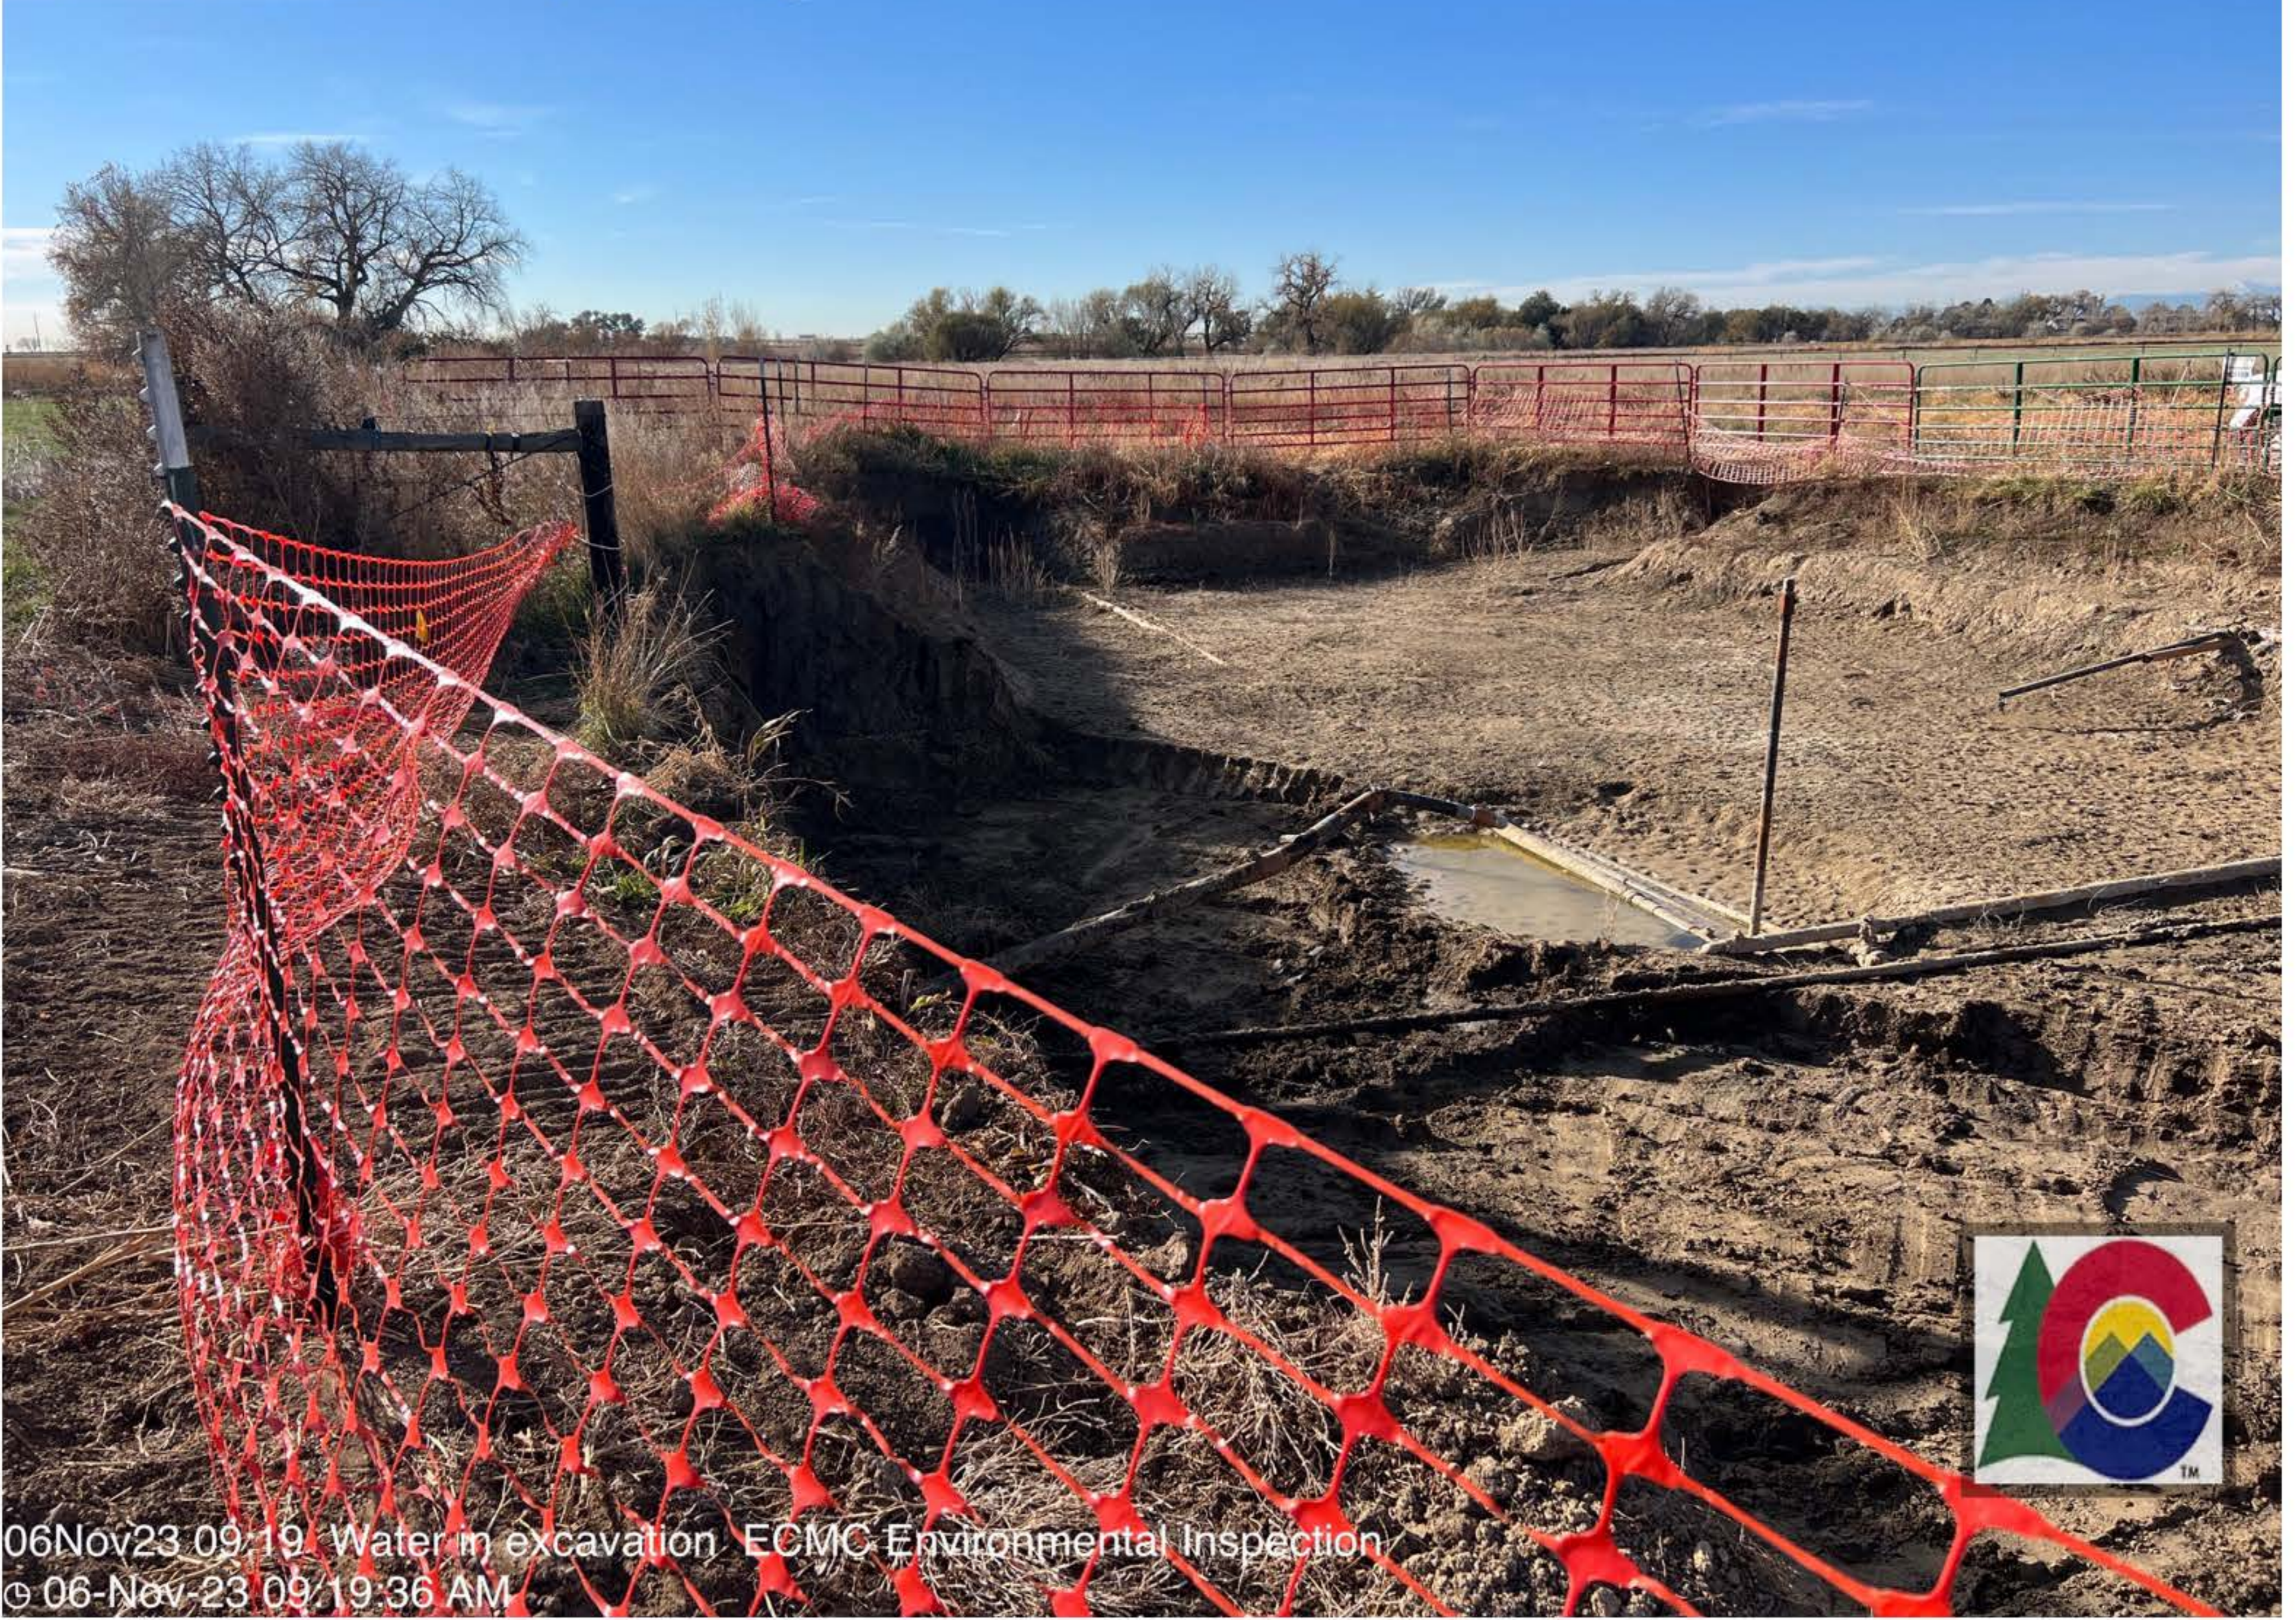
06Nov23 09:19 Water in excavation ECMC Environmental Inspection
© 06-Nov-23 09:19:36 AM

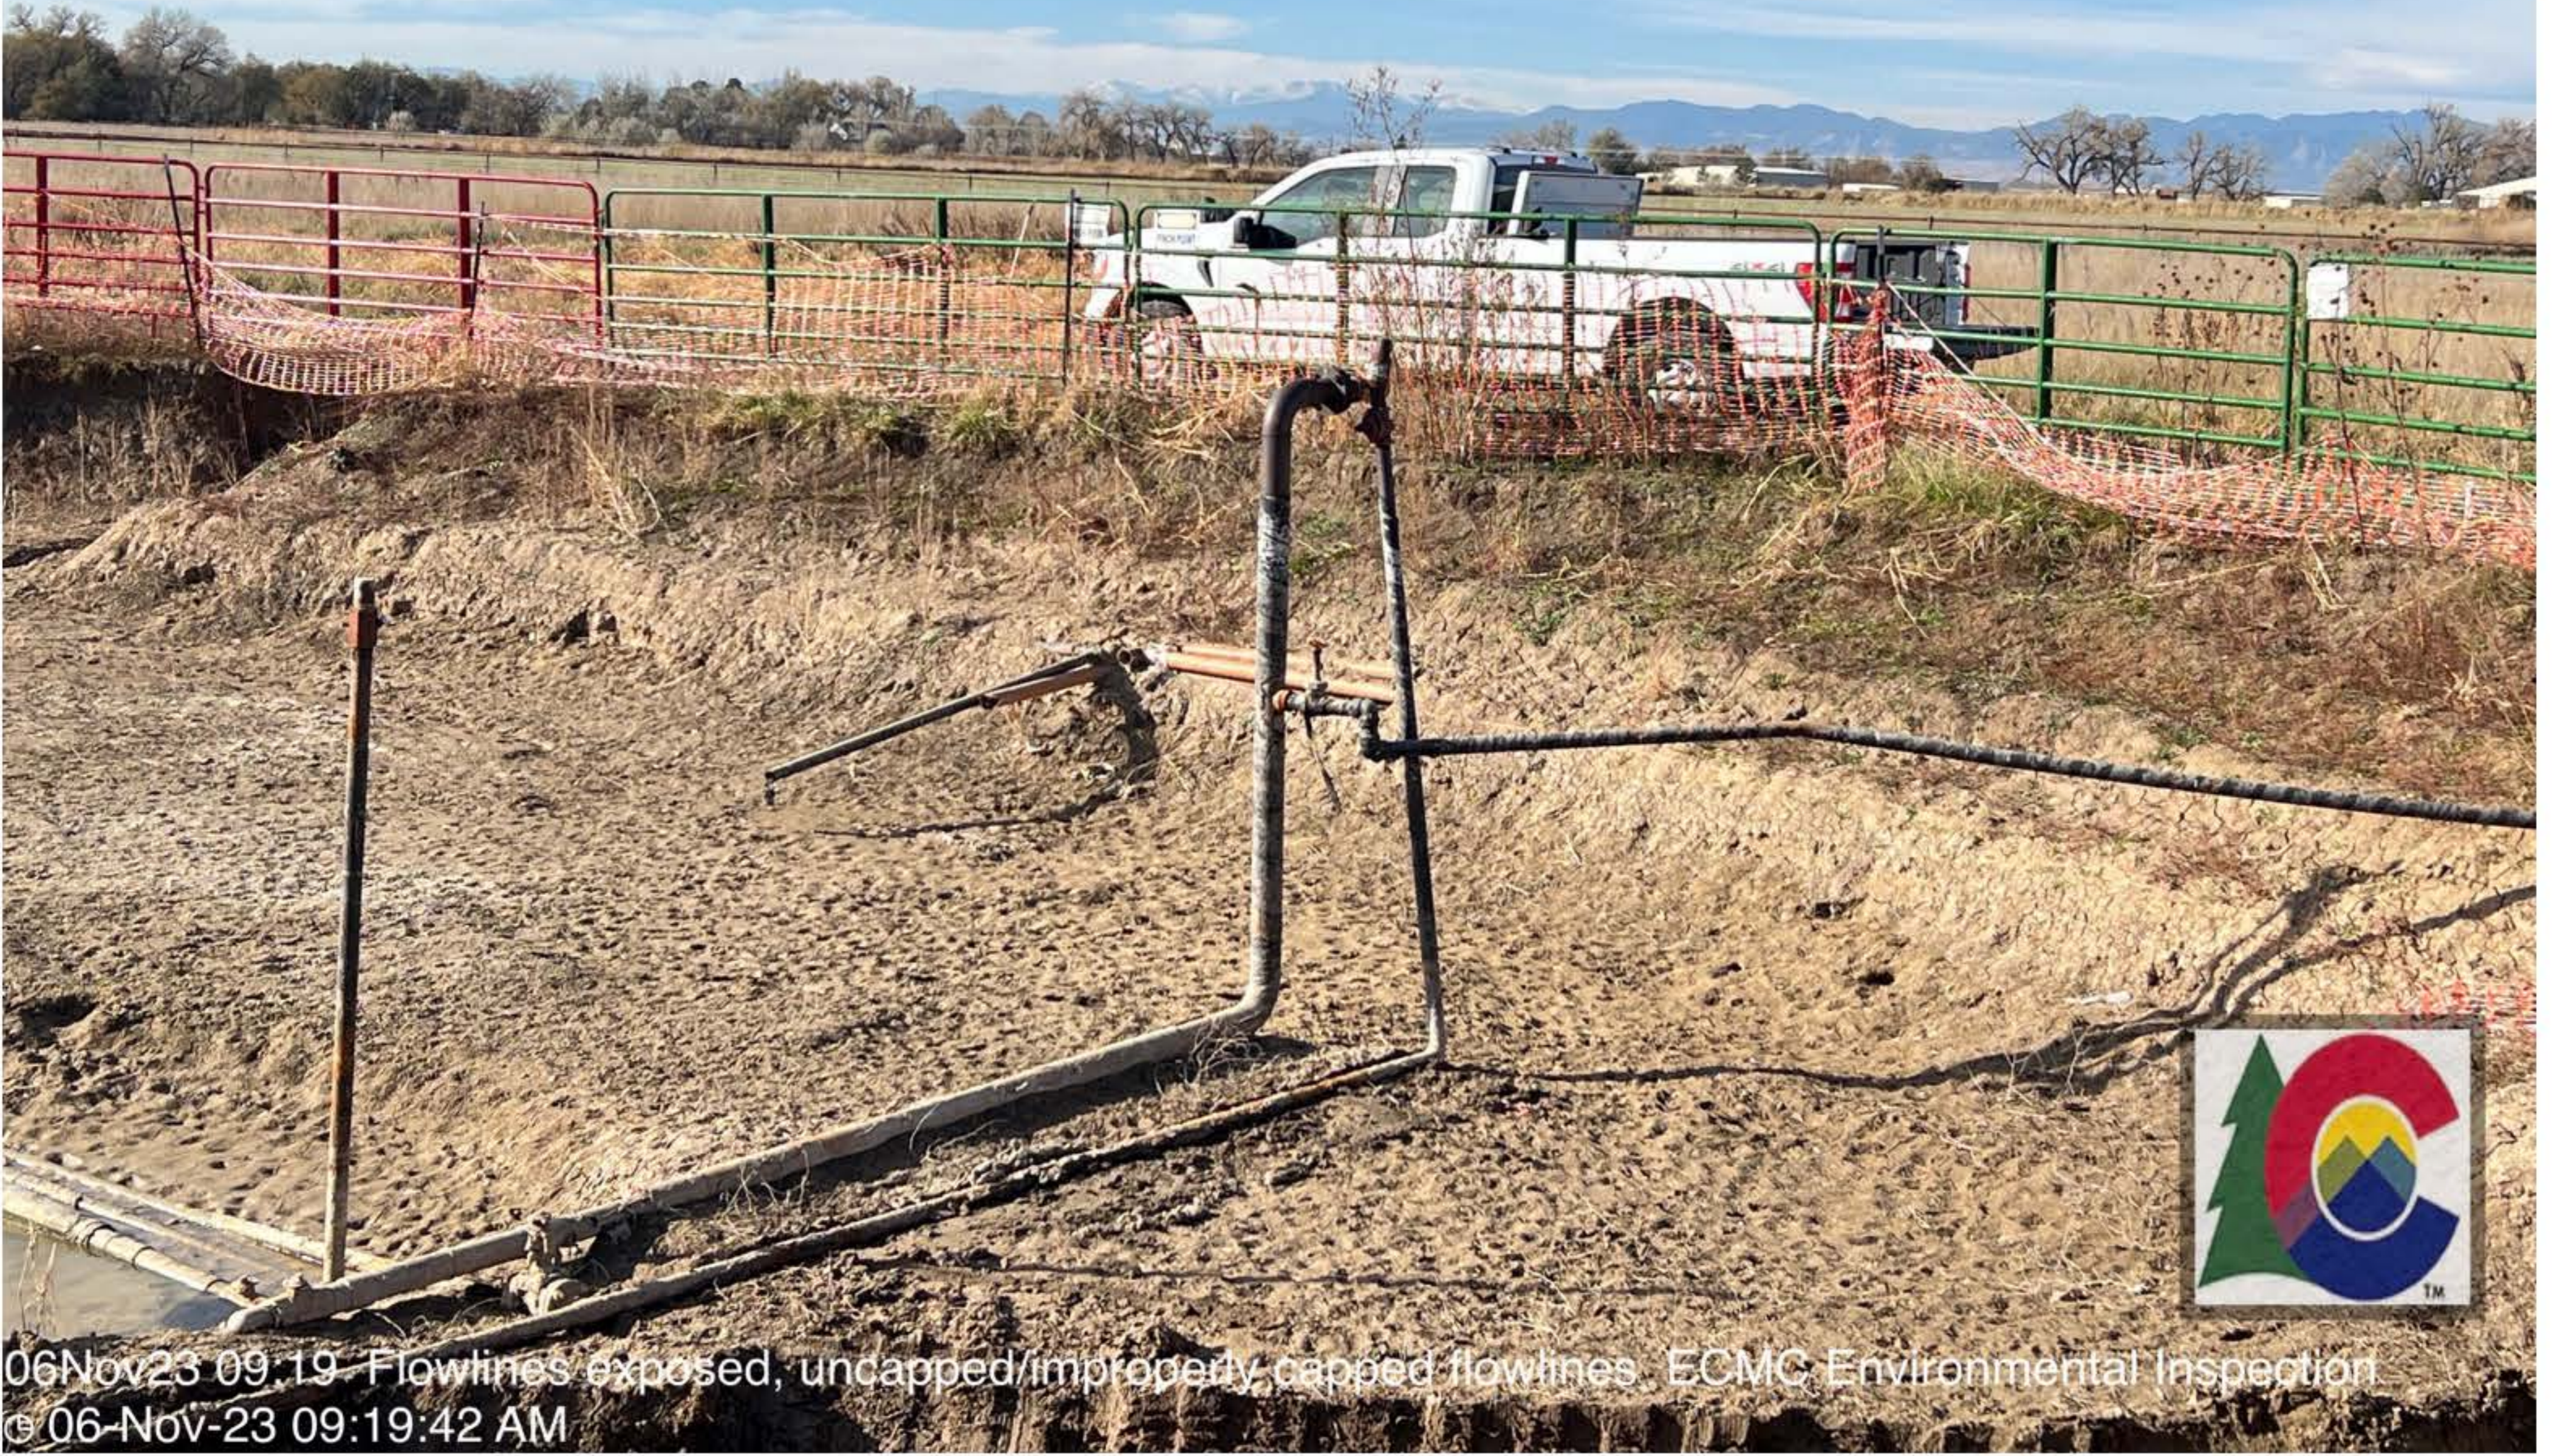
06Nov23 09:19 - Flowlines exposed, uncapped/improperly capped flowlines. ECMC Environmental Inspection
© 06-Nov-23 09:19:42 AM

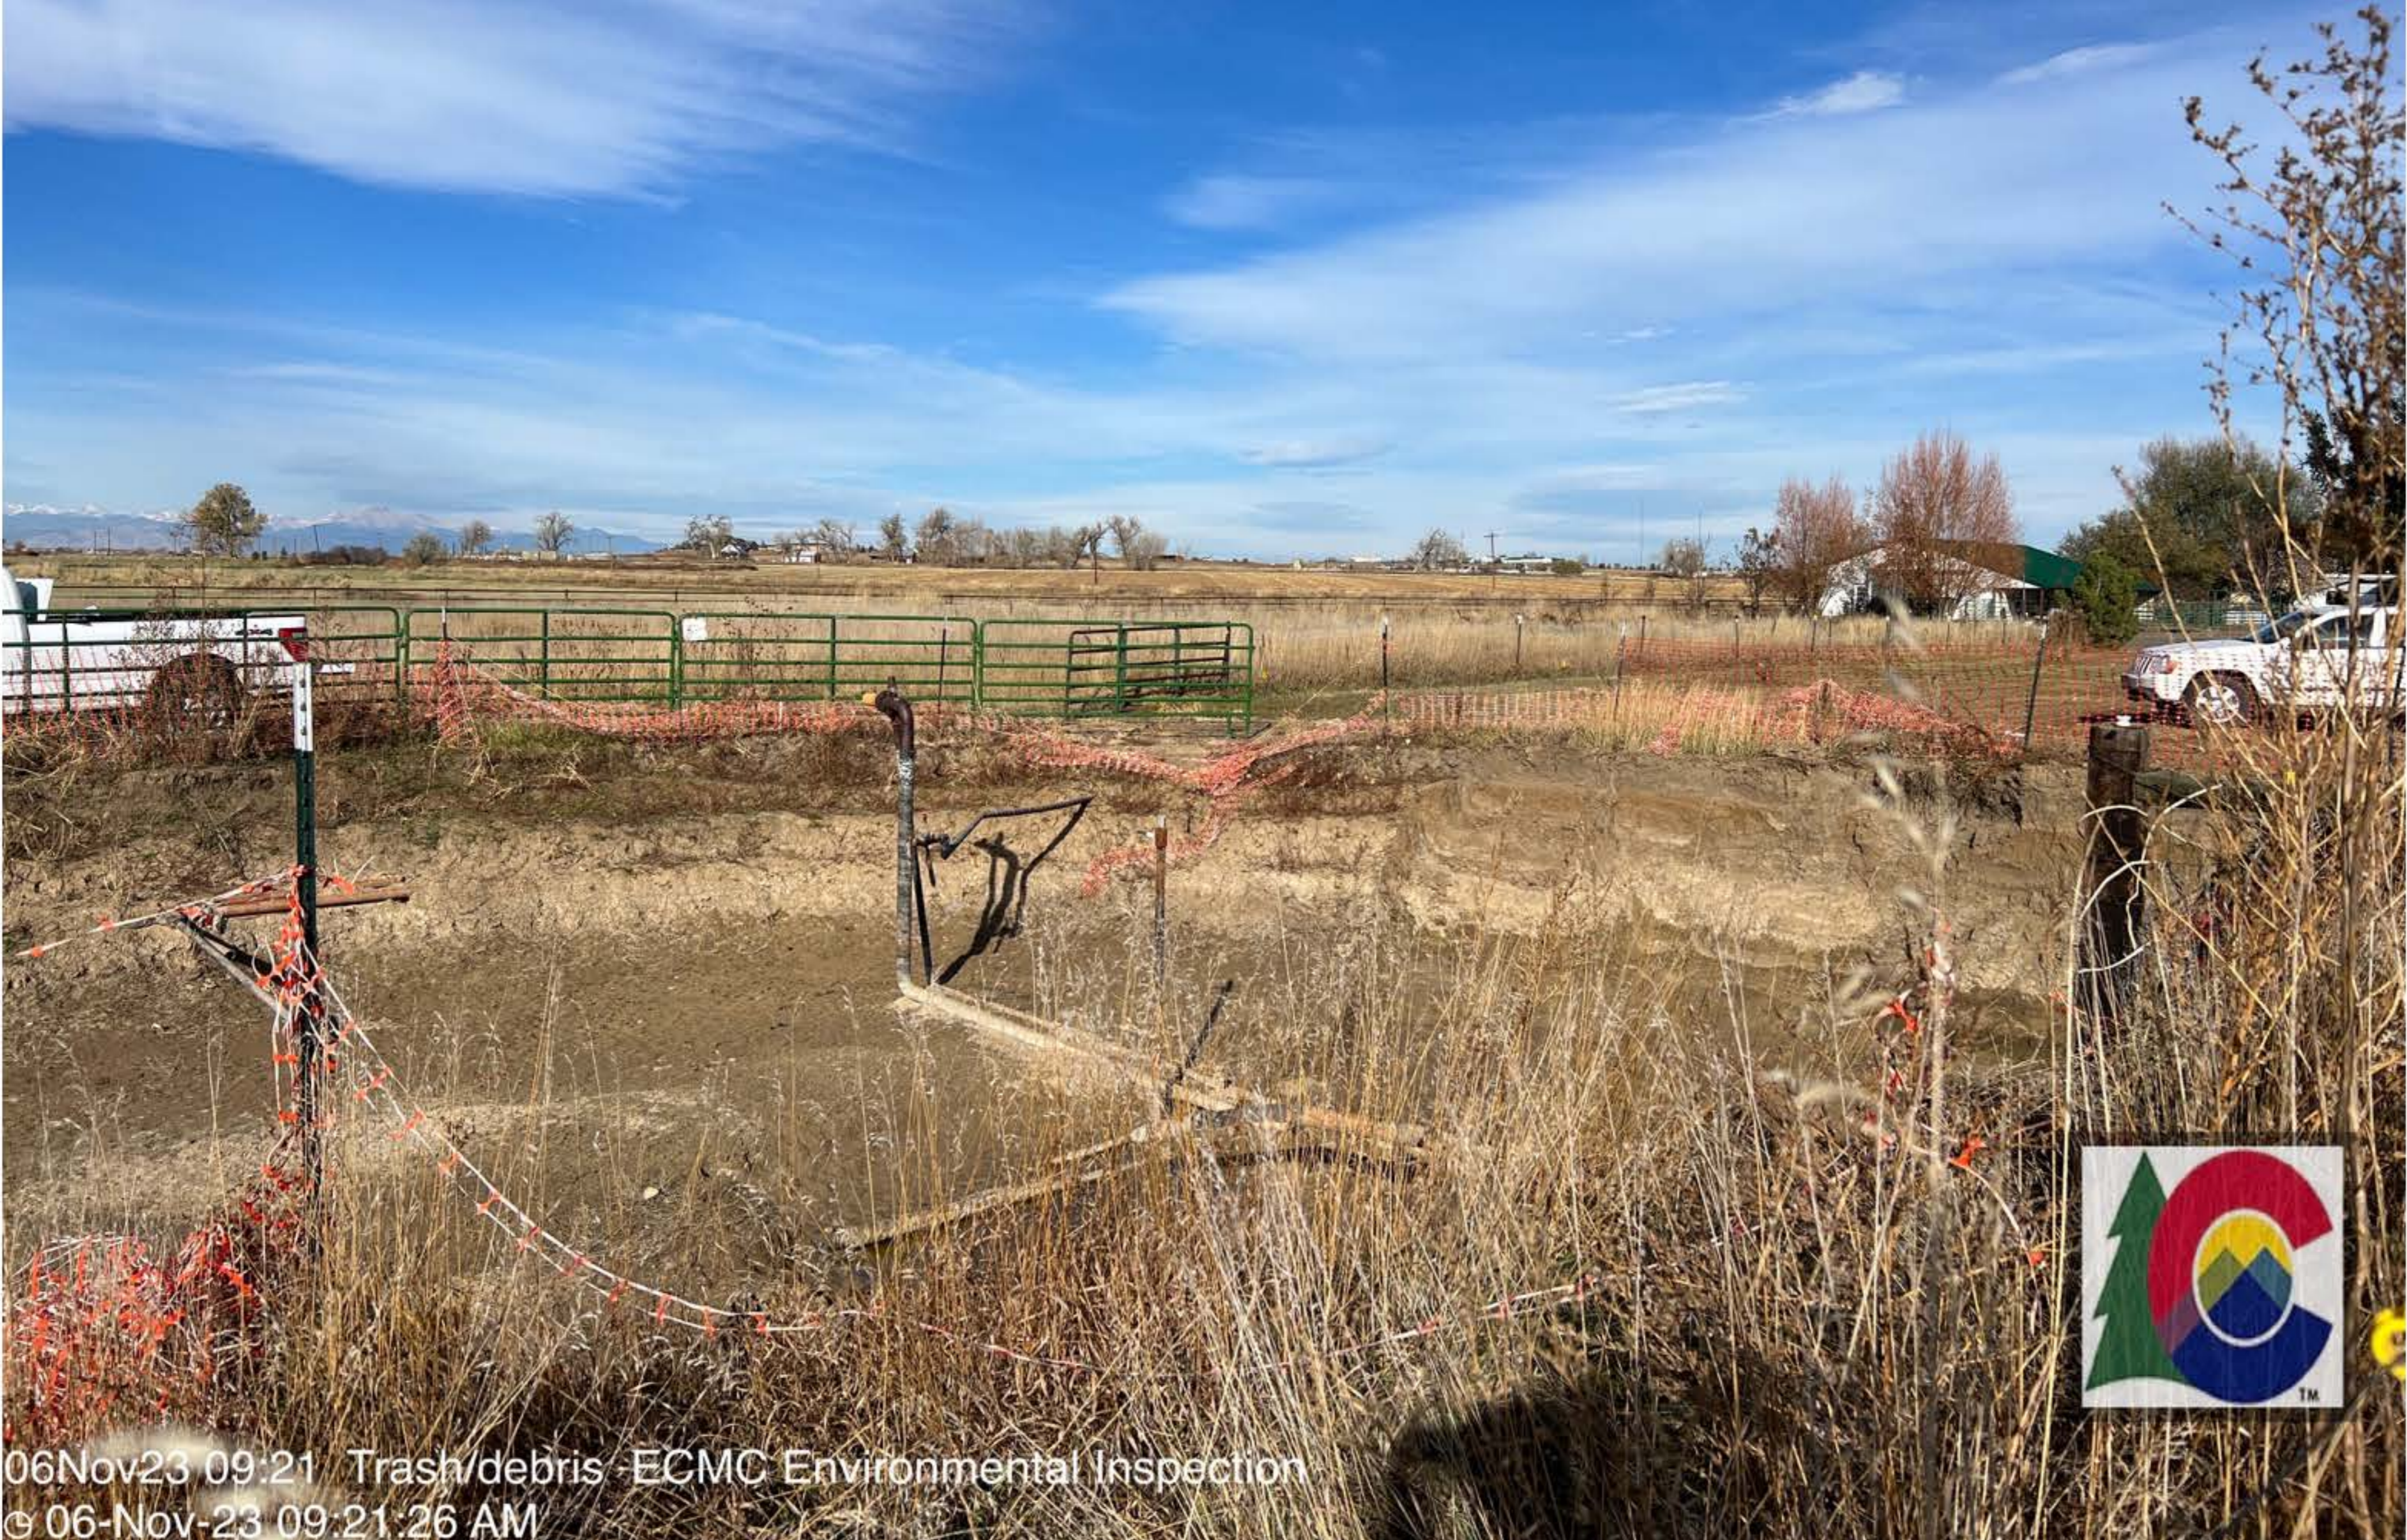
06Nov23 09:21 Trash/debris -ECMC Environmental Inspection
© 06-Nov-23 09:21:26 AM
