06Nov23 08:37 ECMC Environmental Inspection
© 06-Nov-23 08:37:11 AM

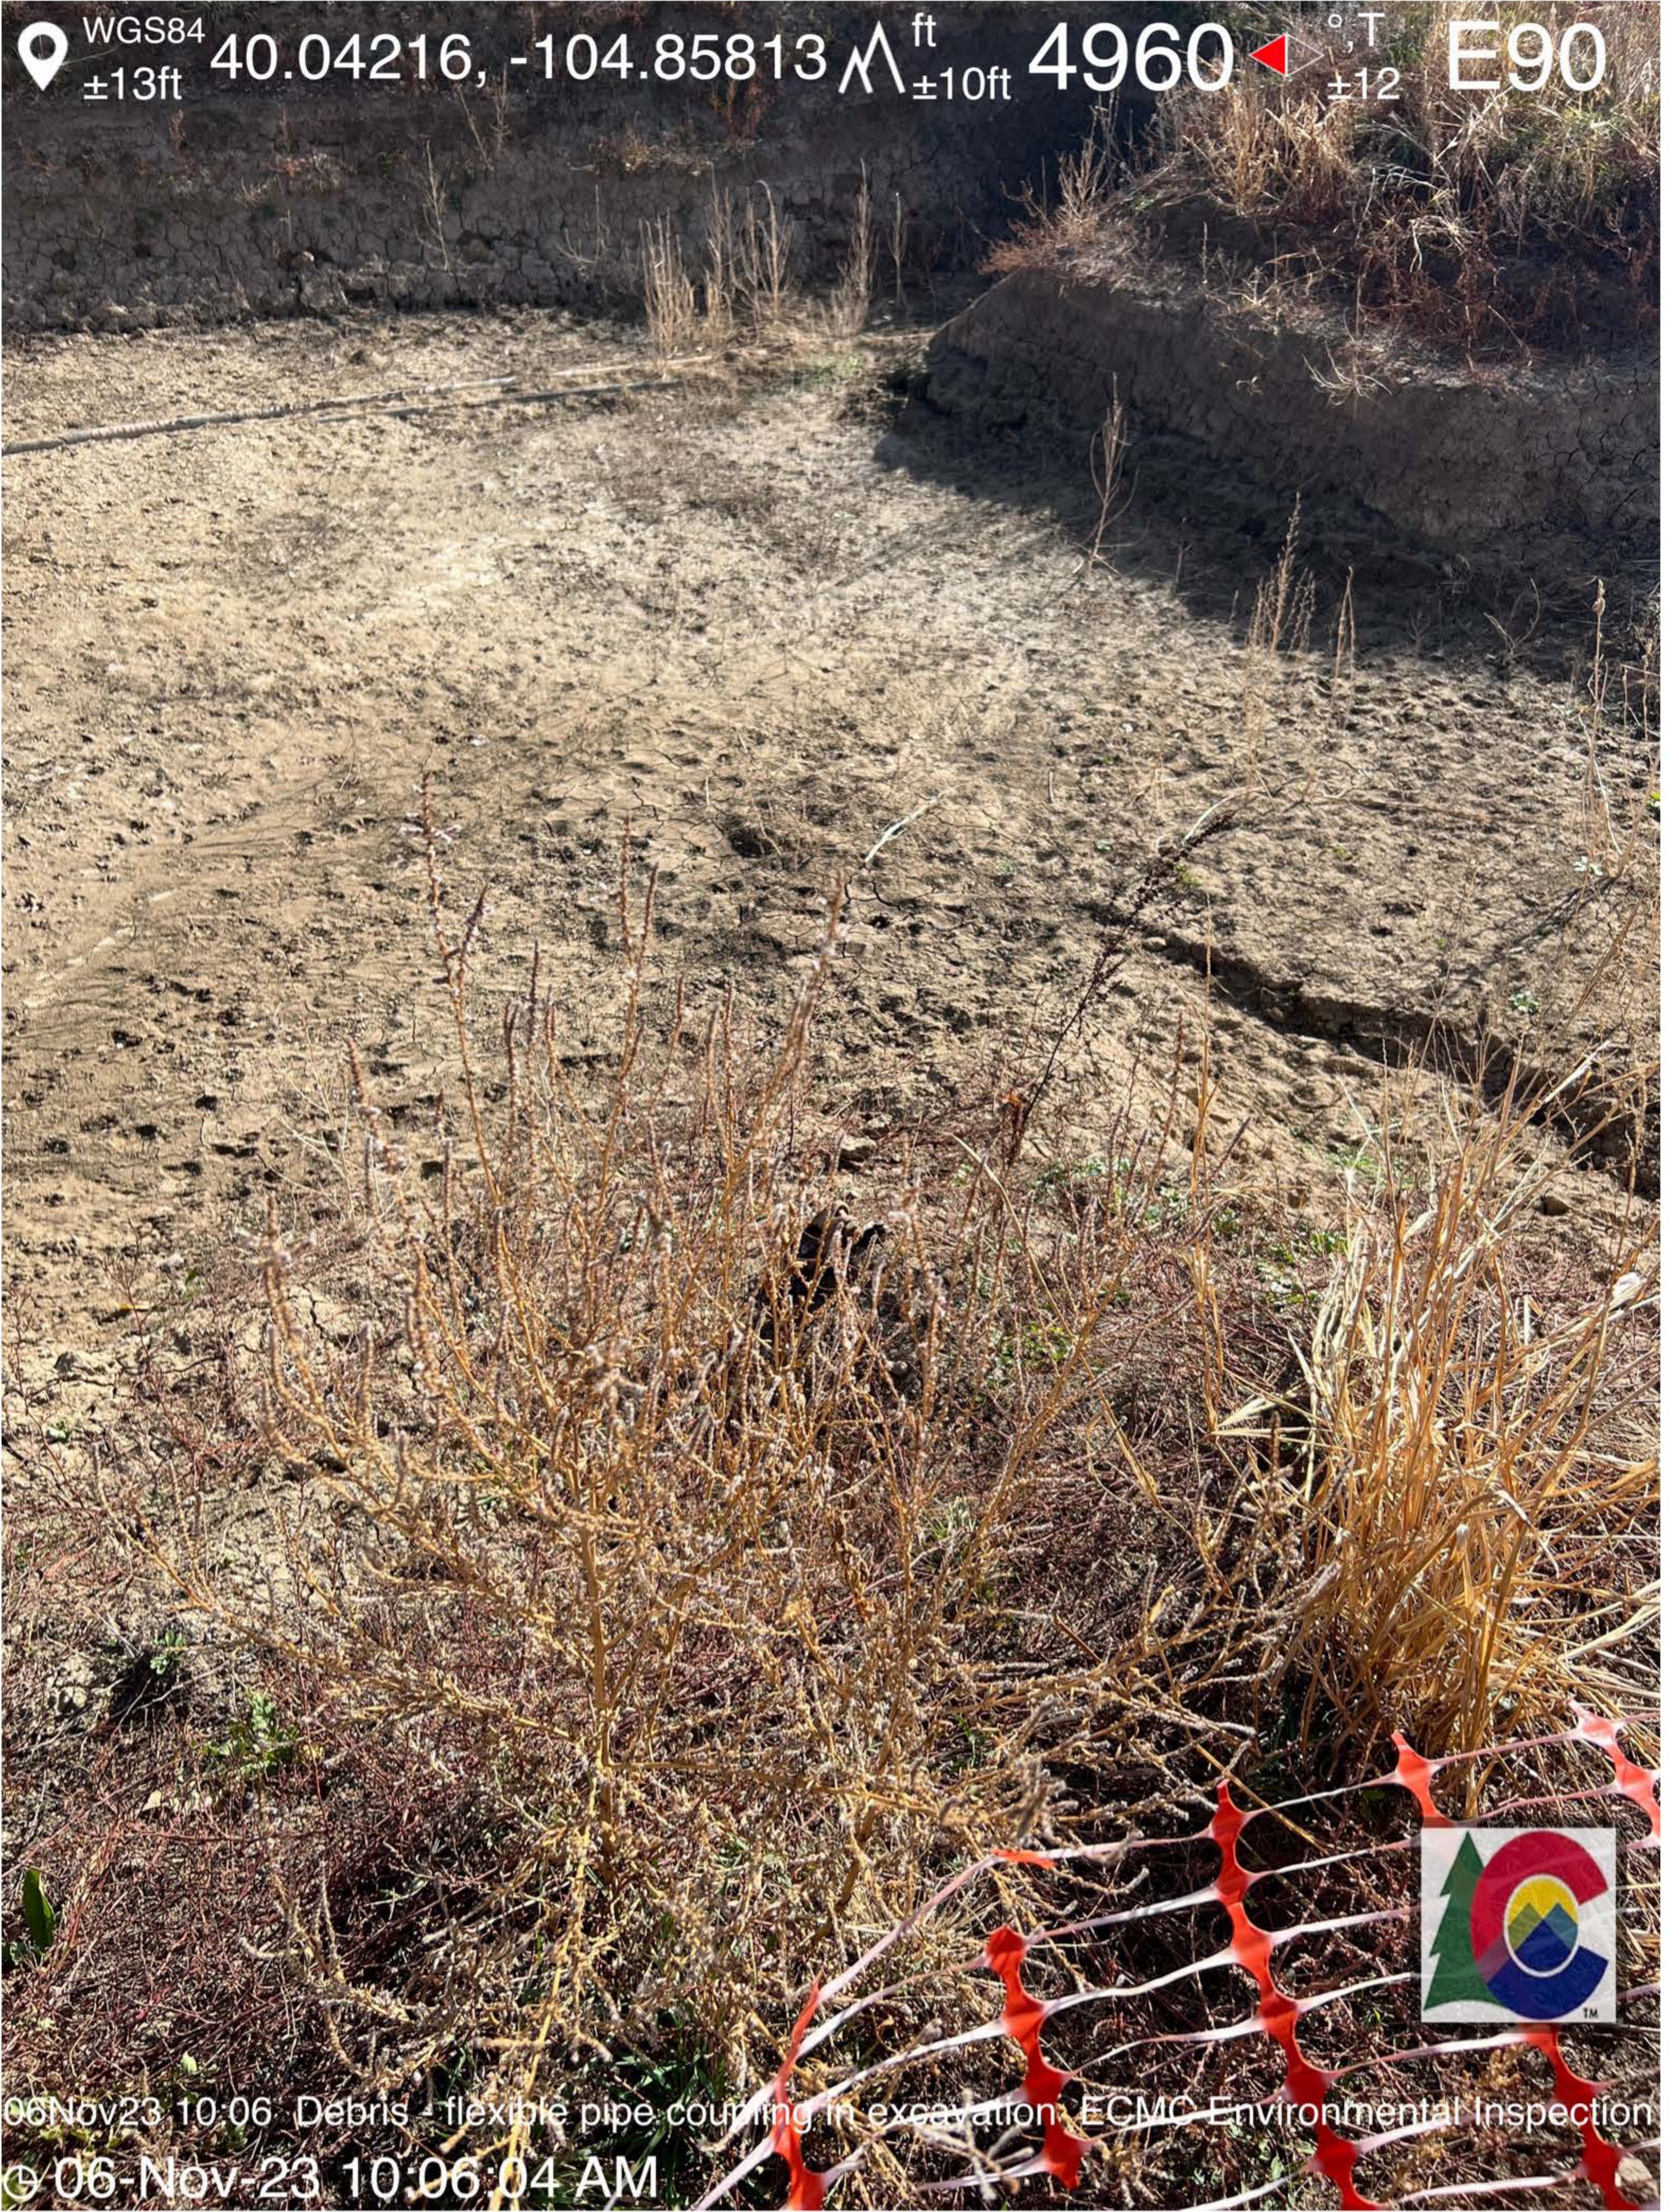
06Nov23 10:06 Debris - flexible pipe courting in excavation. ECMC Environmental Inspection

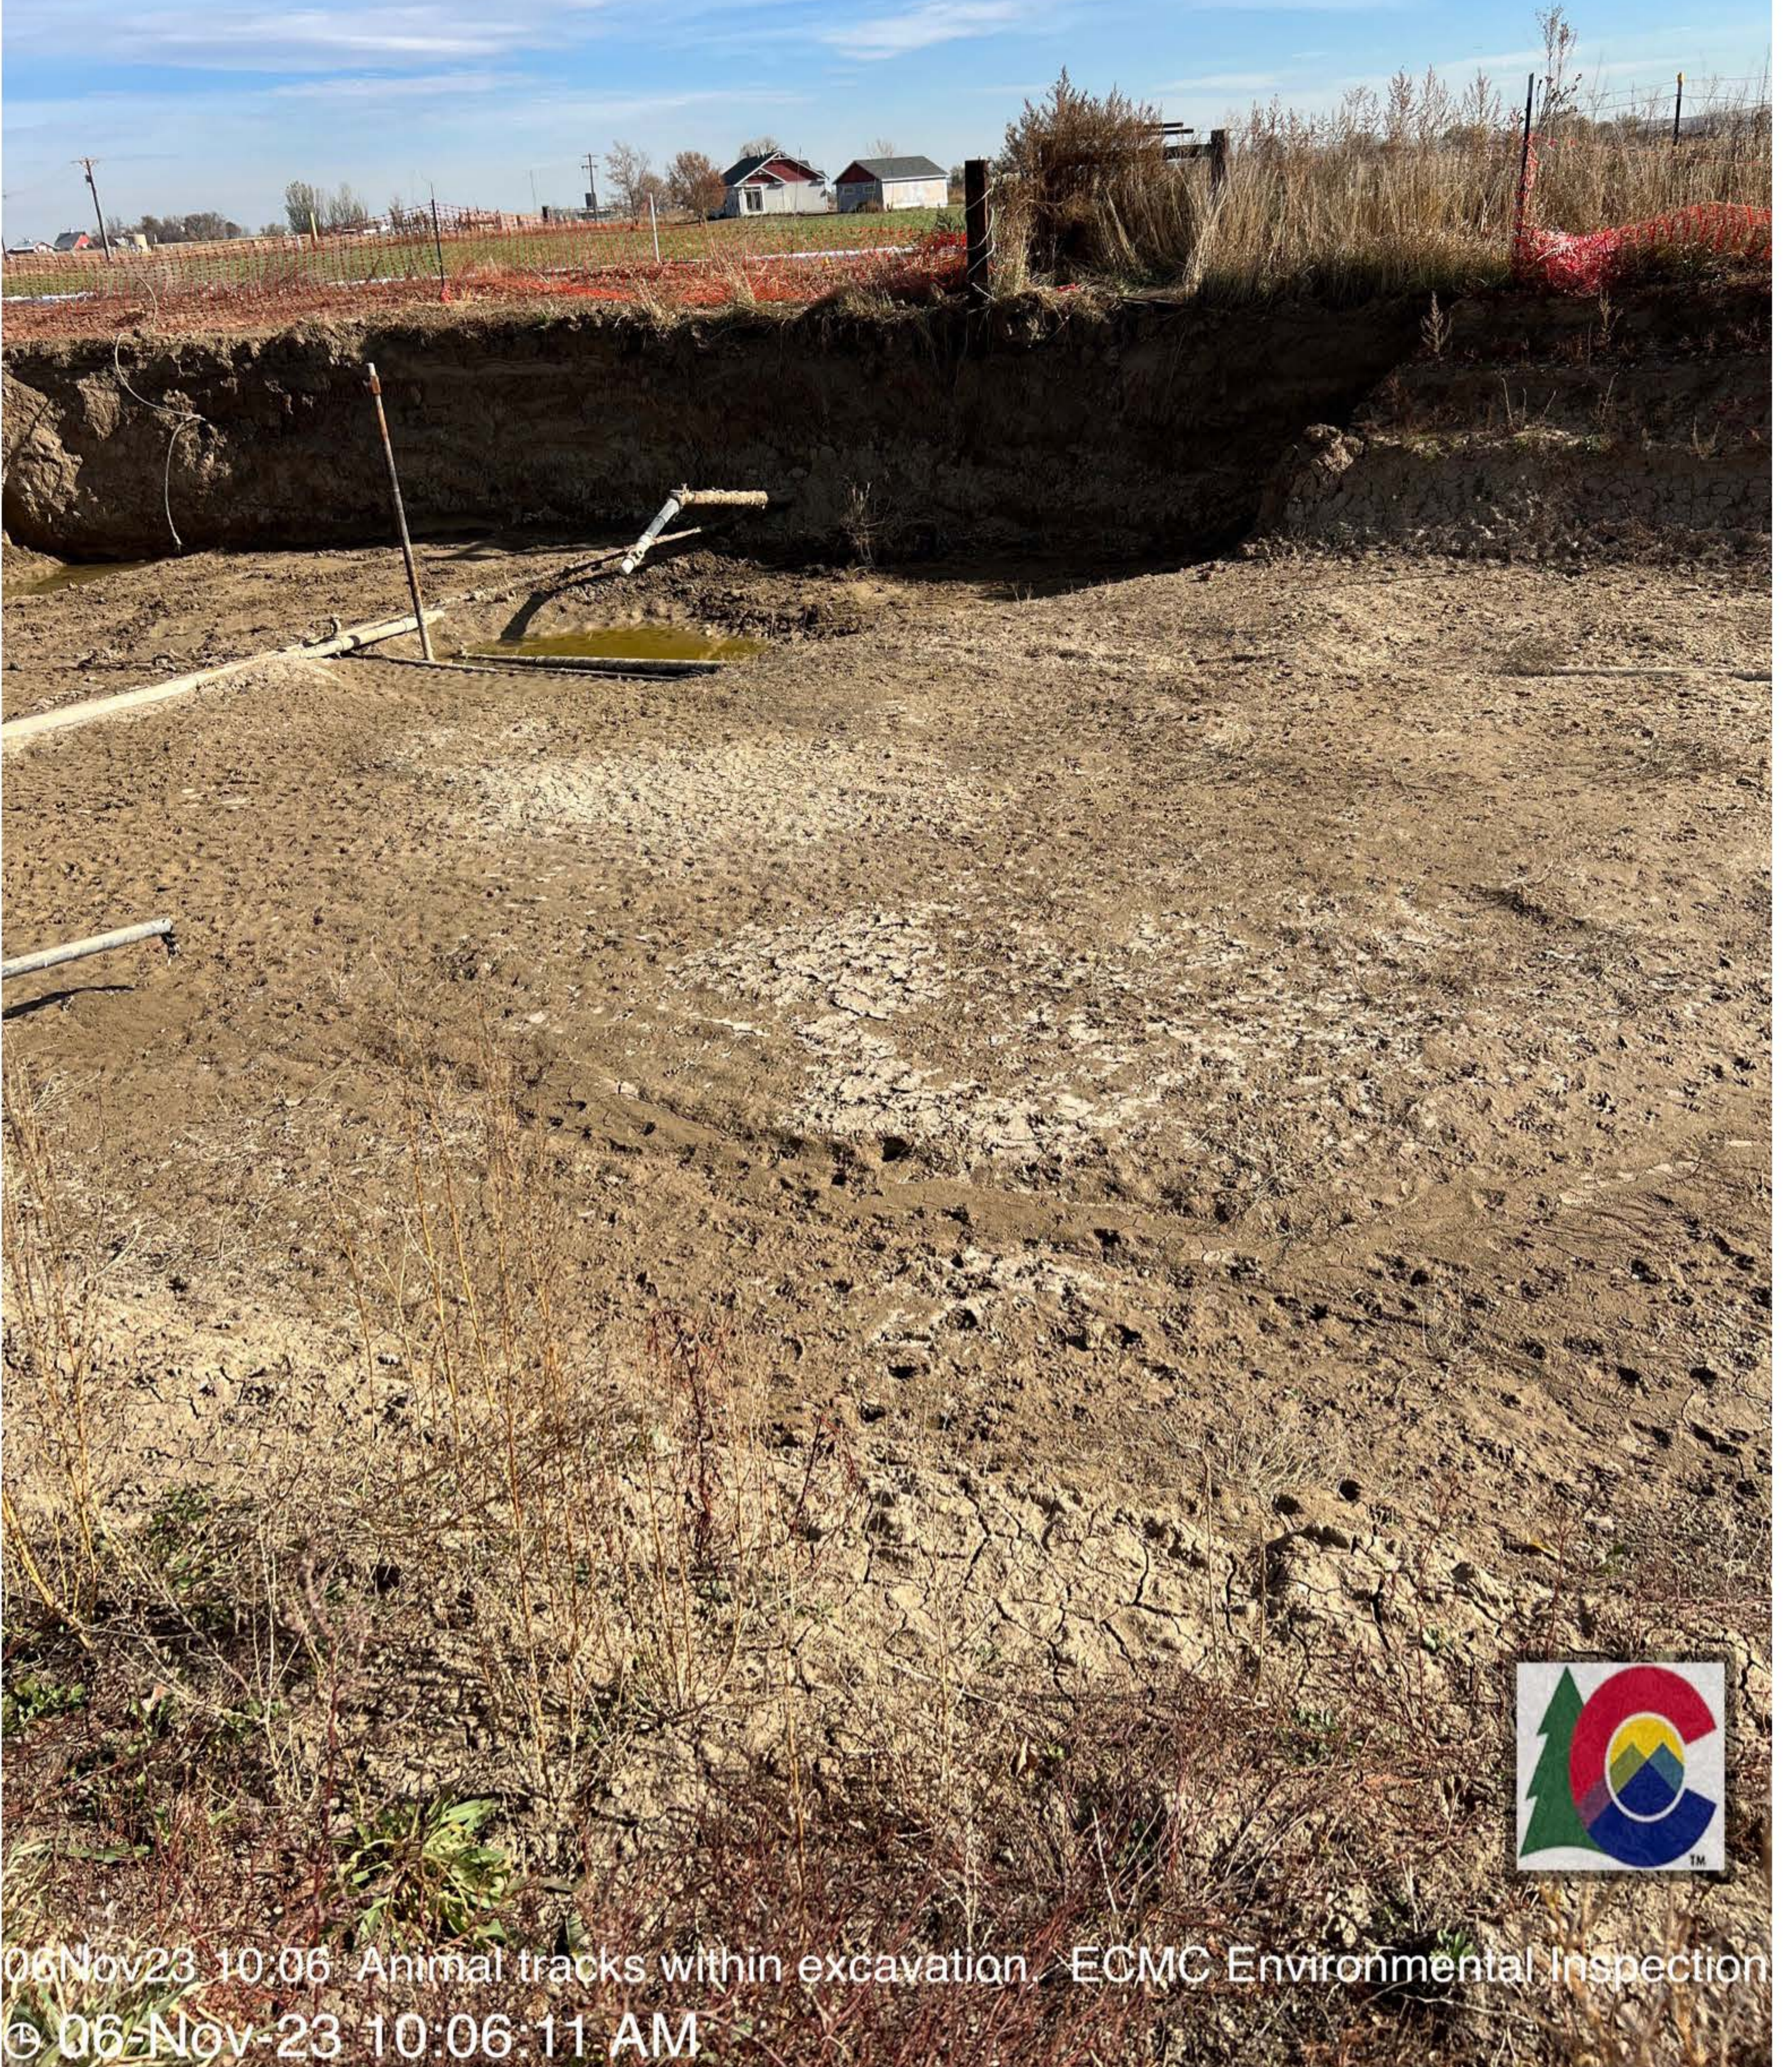
06 Nov 23 10:06 Animal tracks within excavation. ECMC Environmental Inspection
© 06 Nov 23 10:06:11 AM

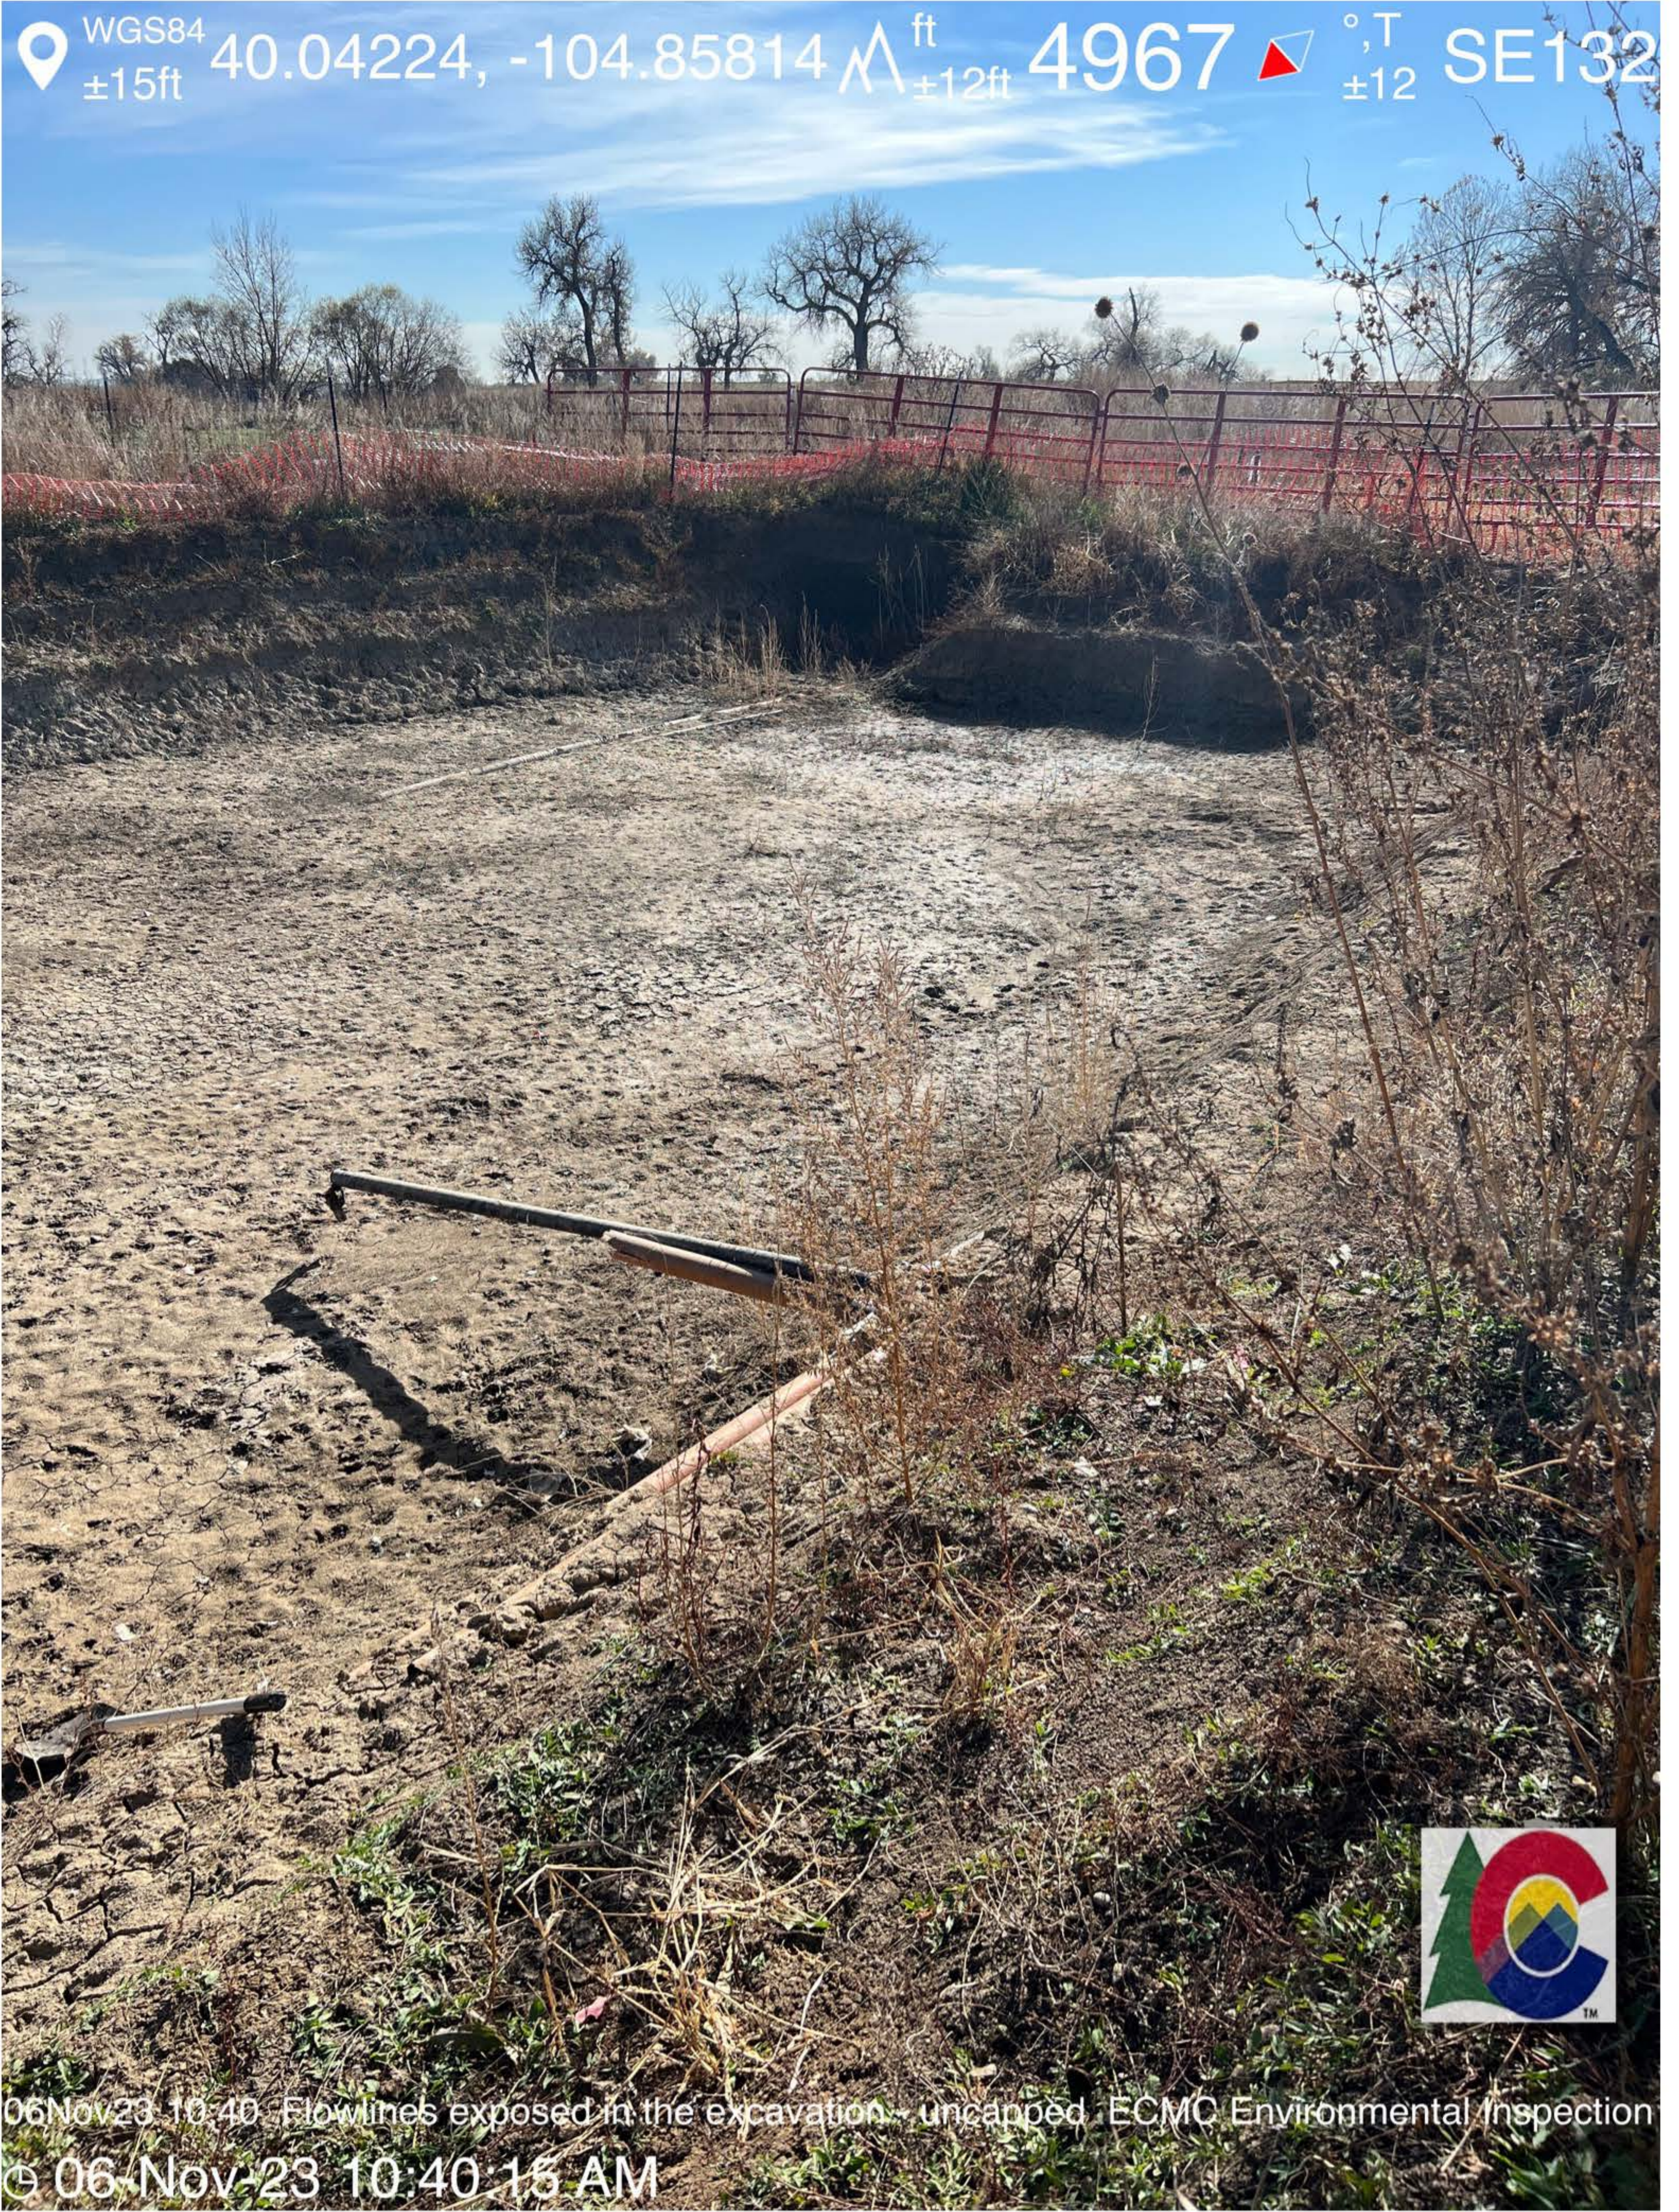
06Nov23 10:40 Flowlines exposed in the excavation - uncapped ECMC Environmental Inspection

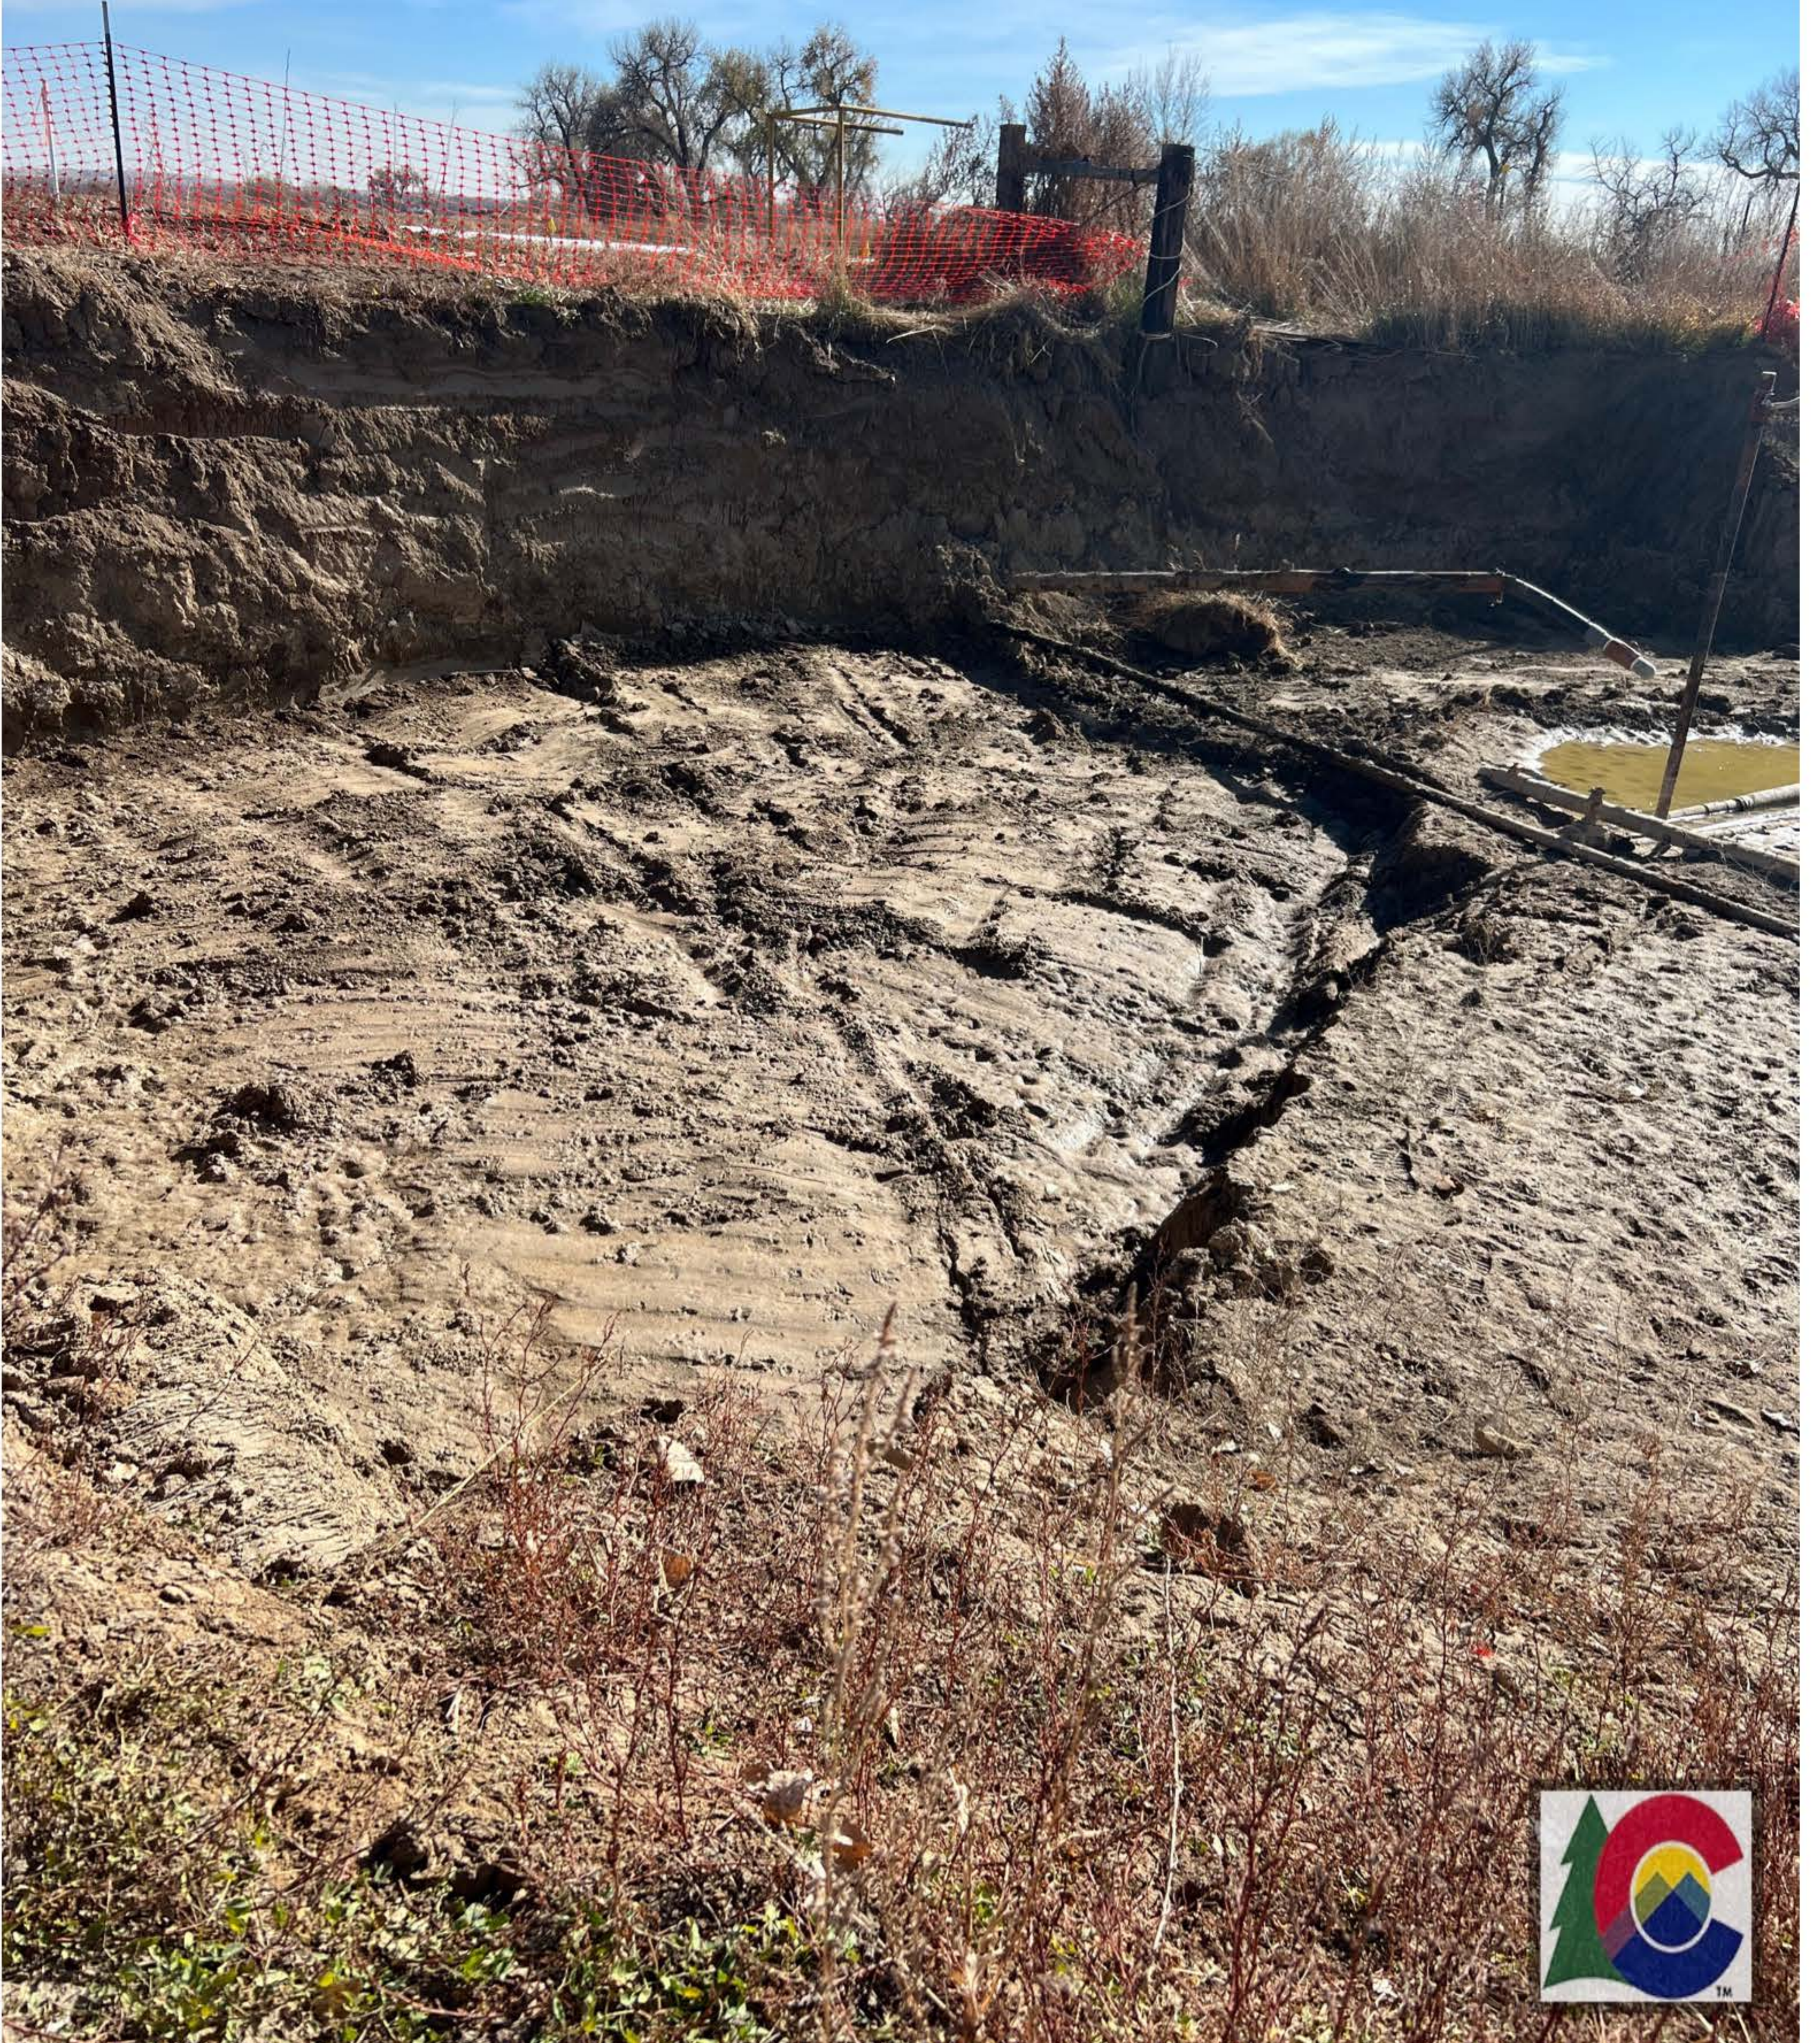
06Nov23 10:55 Area of excavation recently overexcavated ECMC Environmental Inspection
© 06-Nov-23 10:55:11 AM

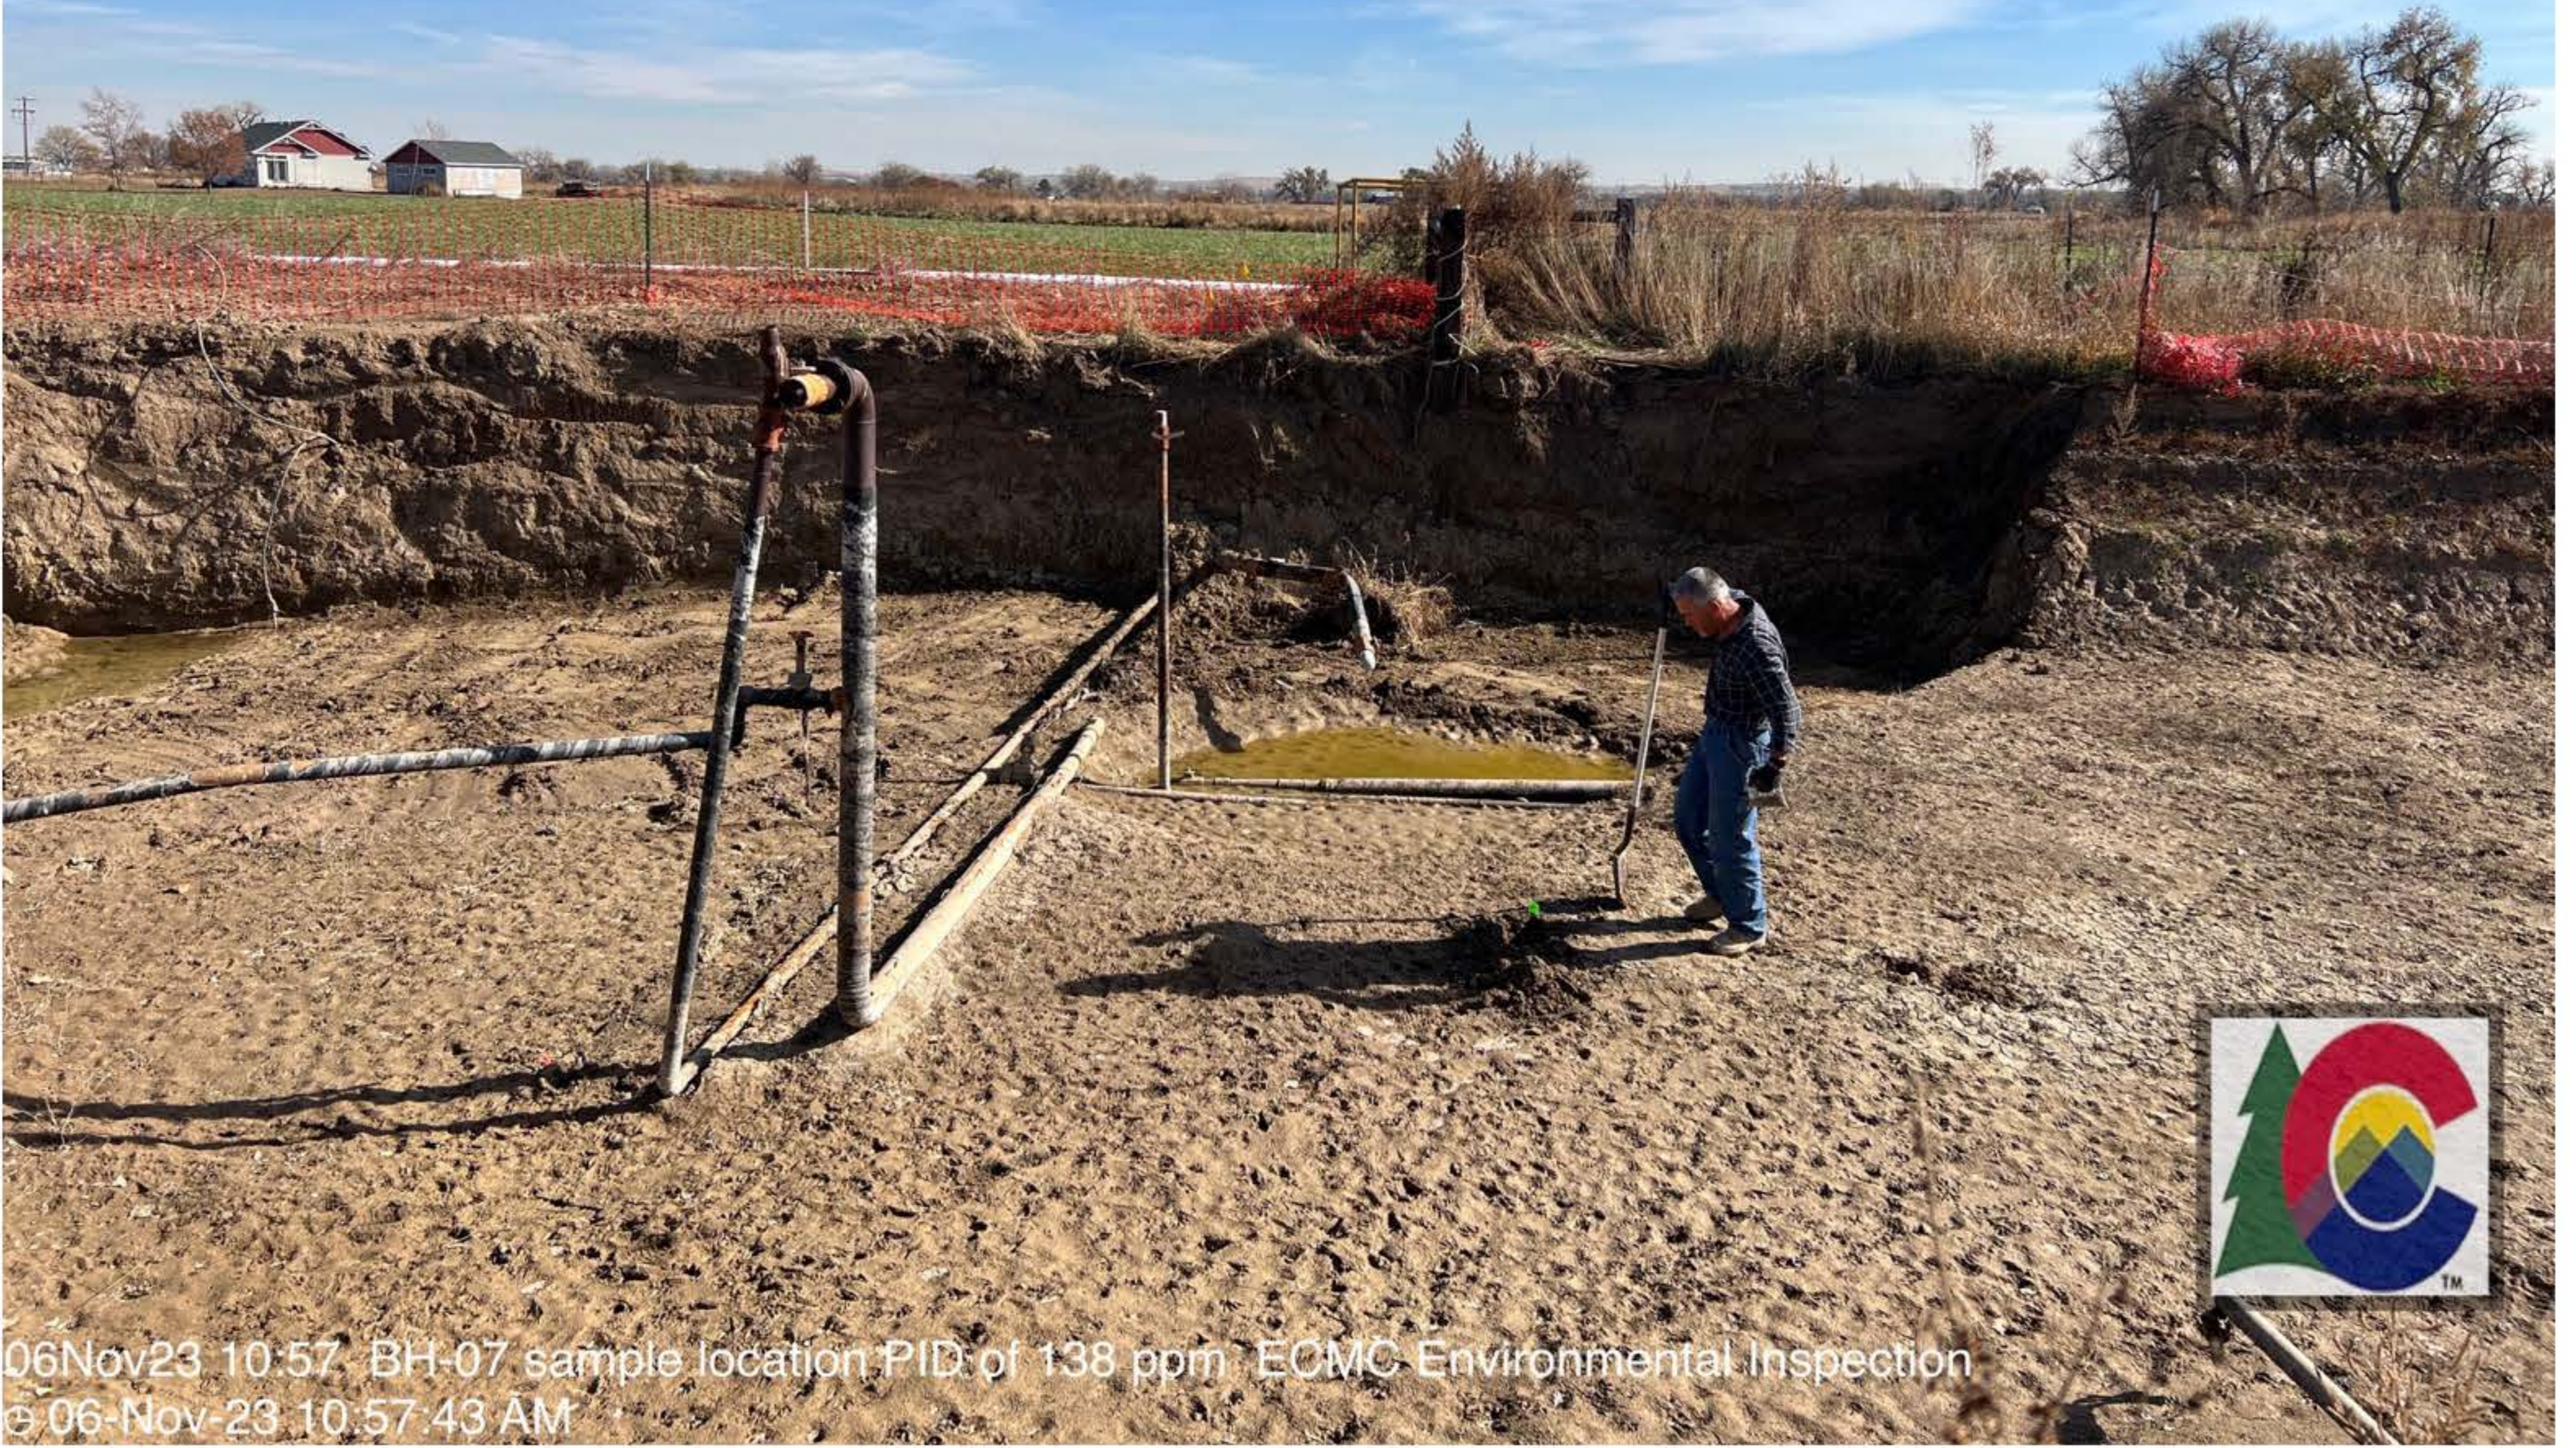
06Nov23 10:57 BH-07 sample location PID of 138 ppm ECMC Environmental Inspection
© 06-Nov-23 10:57:43 AM
