Inspection Photos

Loc: 322234

Operator: **INCREMENTAL OIL & GAS (FLORENCE) LLC**

Inspection Date: 11/08/2023

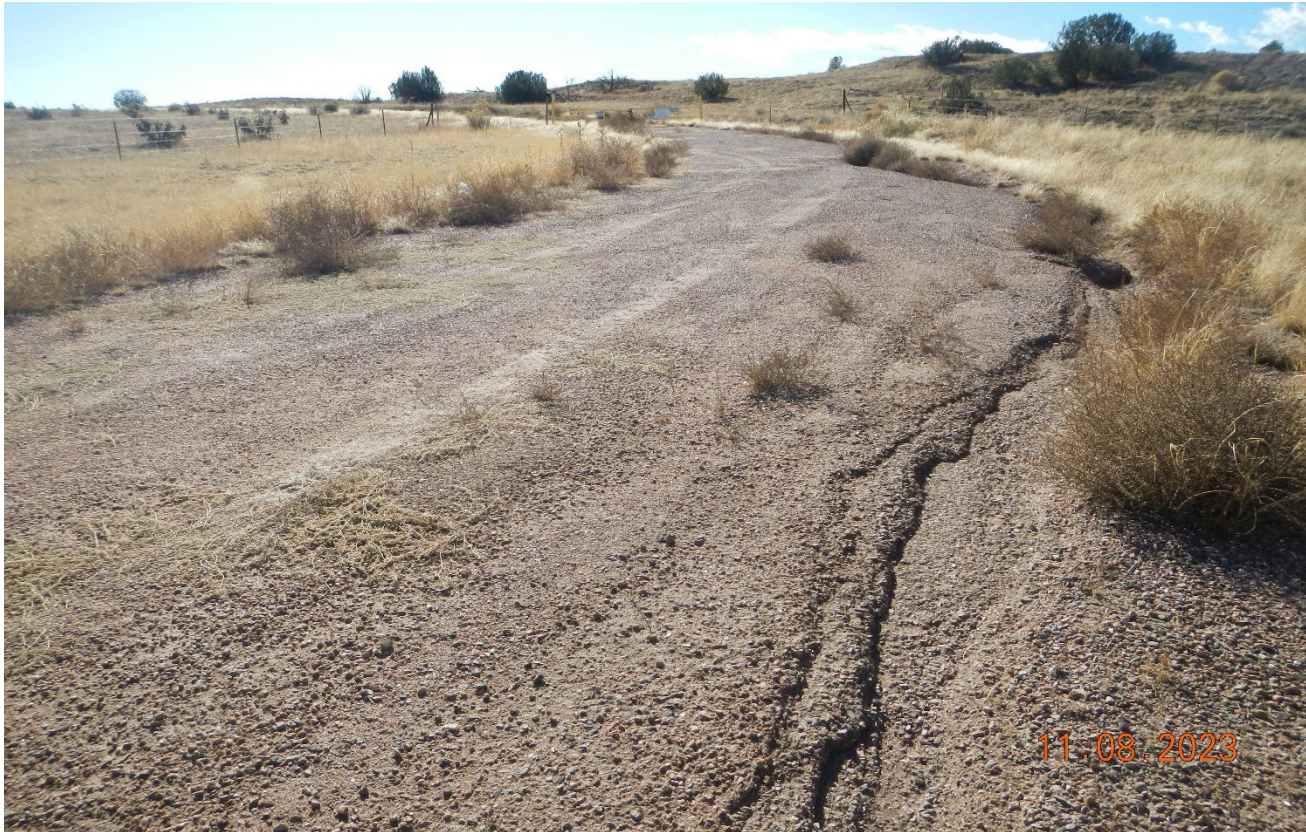
Photo 1. Facing southeast at the beginning of the access road. There is erosion occurring along the road.

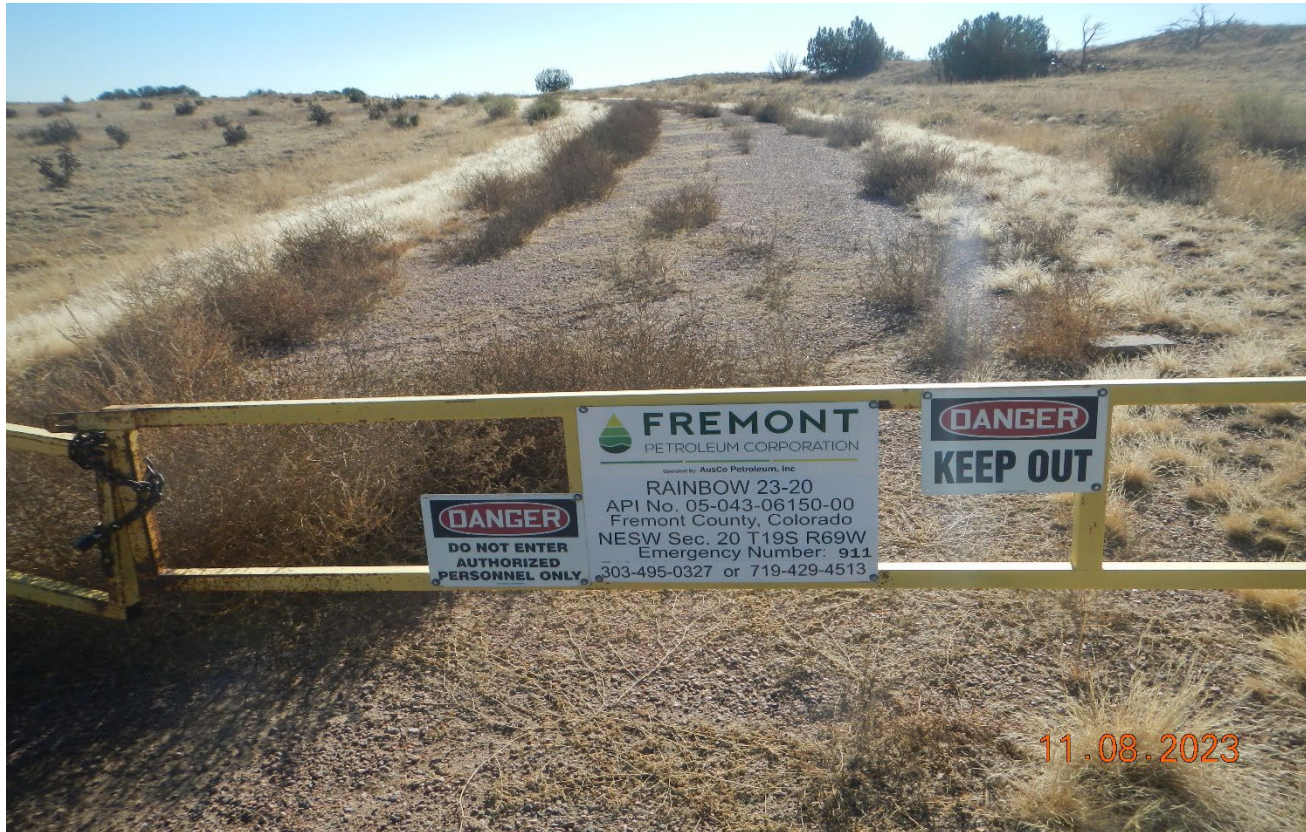
Photo 2. Facing southeast along the road. There are undesirable weeds growing along the road side that need to be removed/controlled..

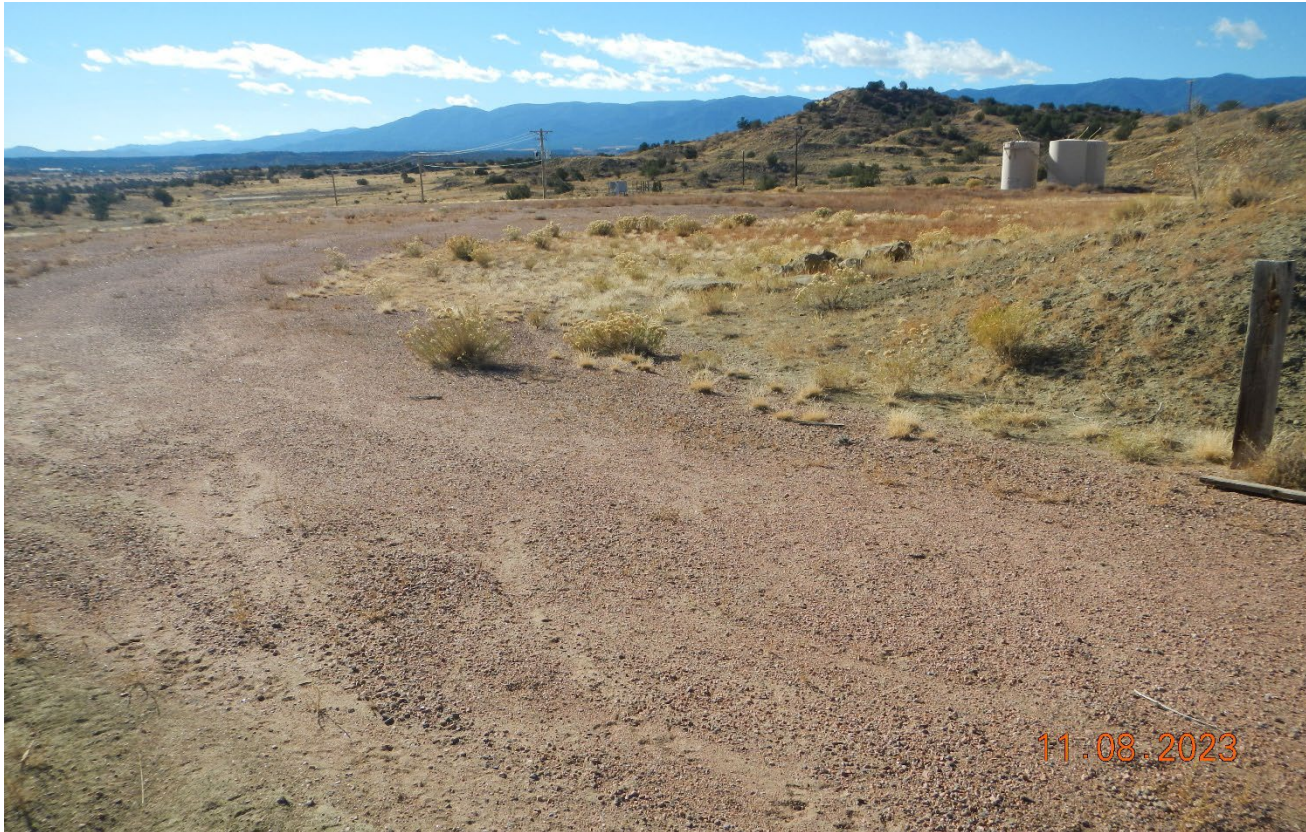
Photo 3. Facing south toward the location. The well has been plugged and abandoned however final reclamation has not yet been completed.

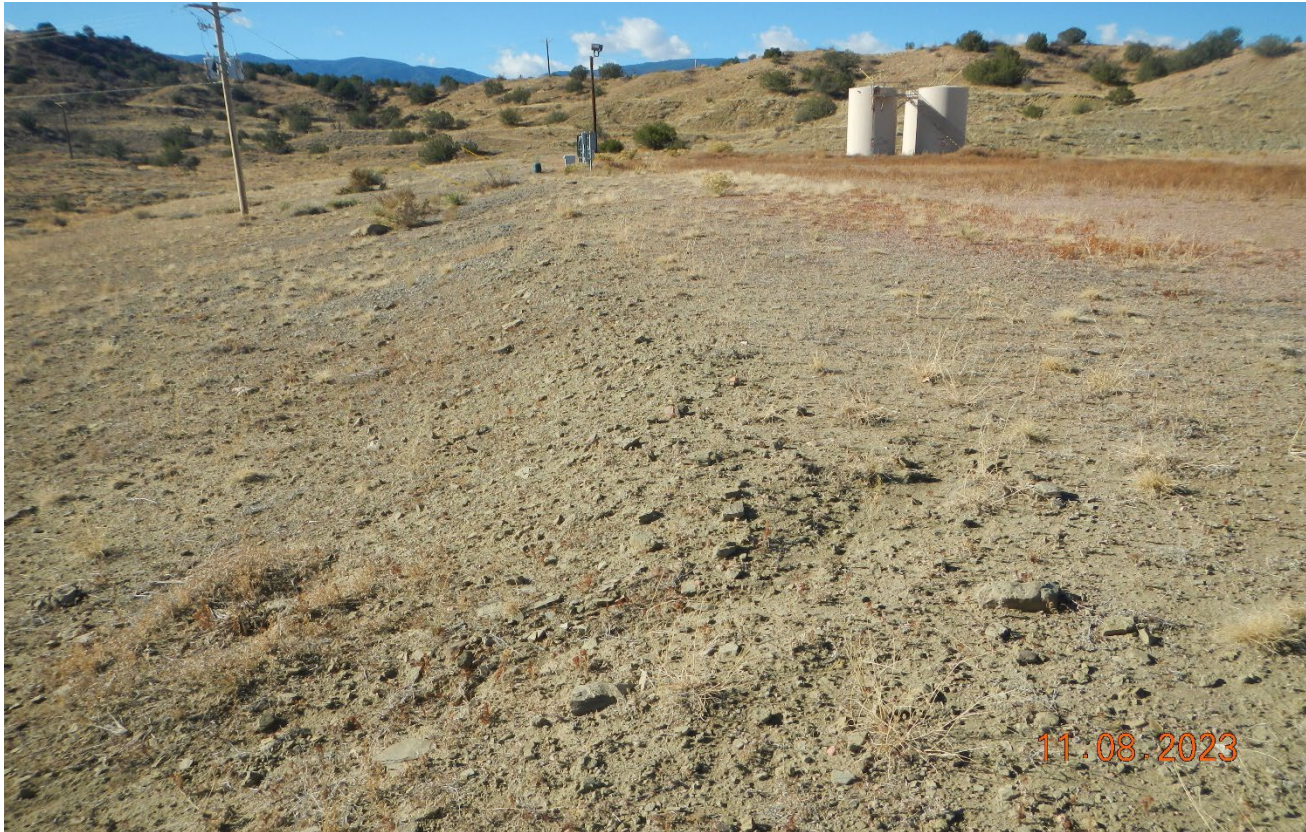
Photo 4. Facing southwest along the fill slope. The location will need to be recontoured back to the original slopes

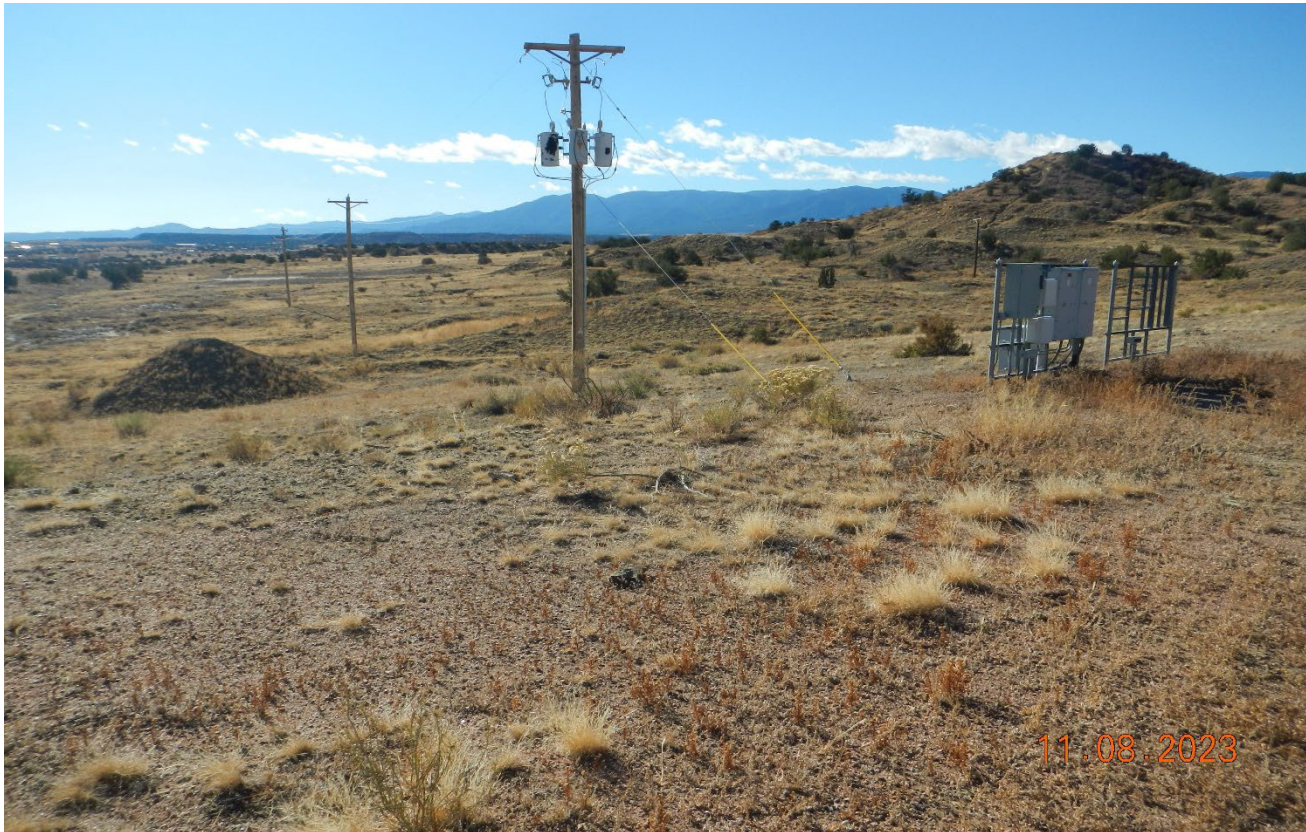
Photo 5. The electric utilities remain at the location and should have been removed with 3 months of abandonment. The entire powerline and poles servicing this location must be removed..

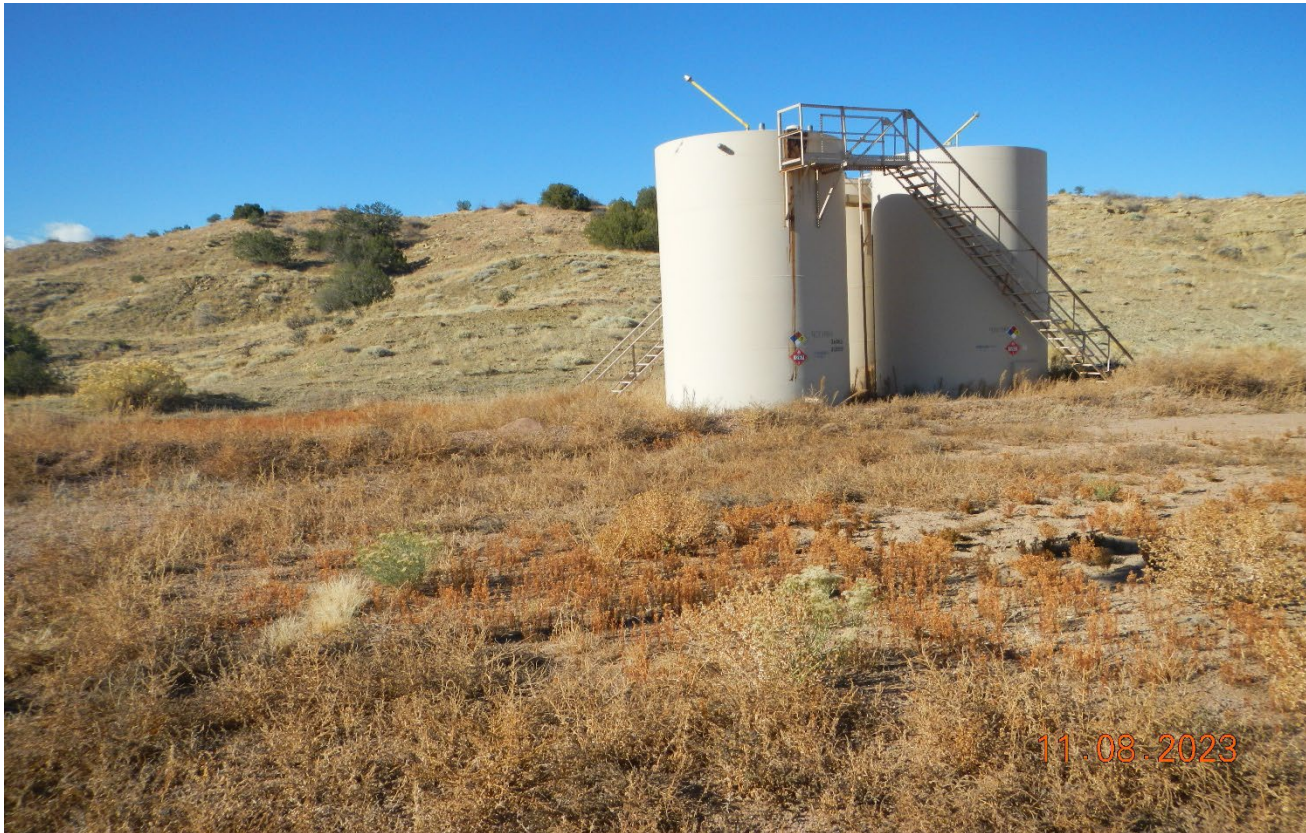
Photo 6. Facing toward the south side of the location. There are tanks that have not been removed. All equipment should have been removed within 3 months of abandonment..

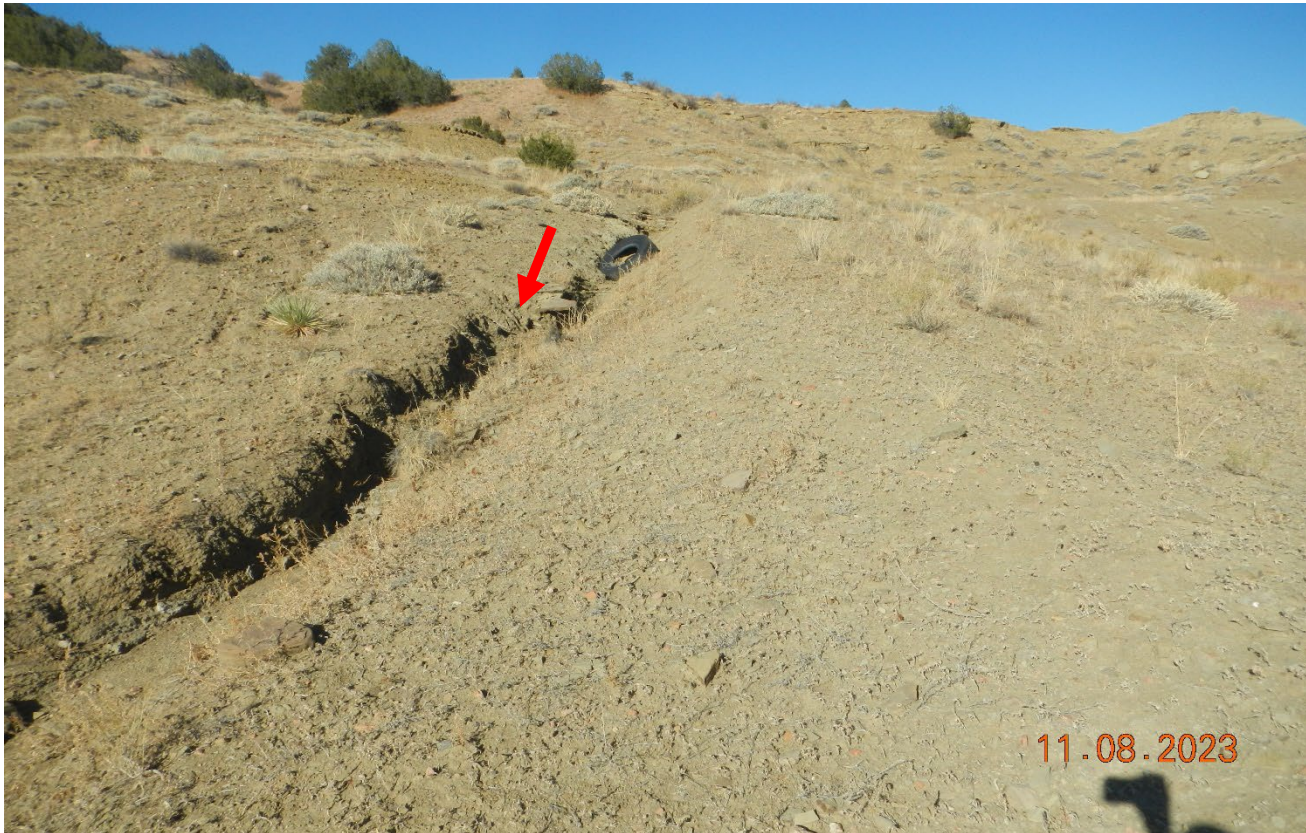
Photo 7. Facing west at the south side of the location. There is an erosion channel shown at red arrow which will need to be repaired and stabilized.

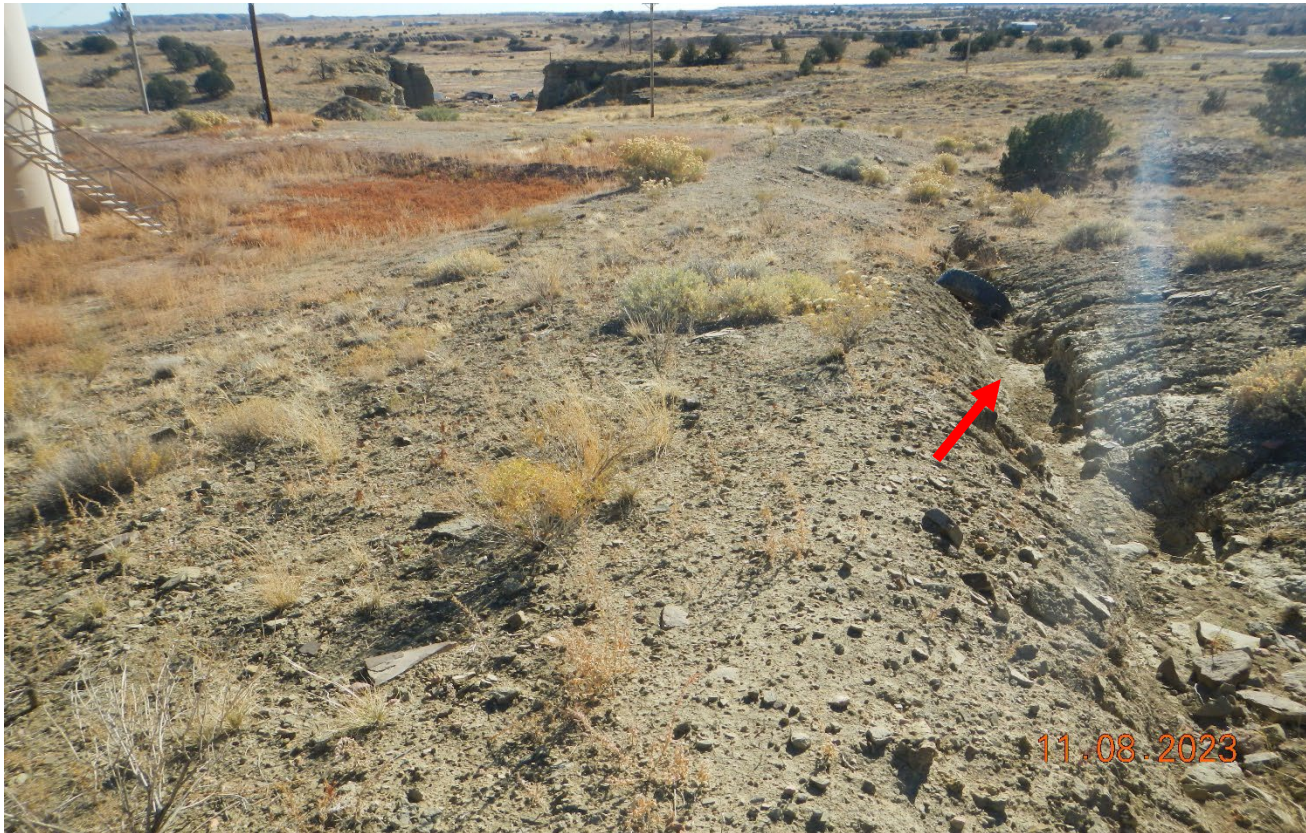
Photo 8. Facing southeast at the south side of the location. There is an erosion channel shown at red arrow which will need to be repaired and stabilized.

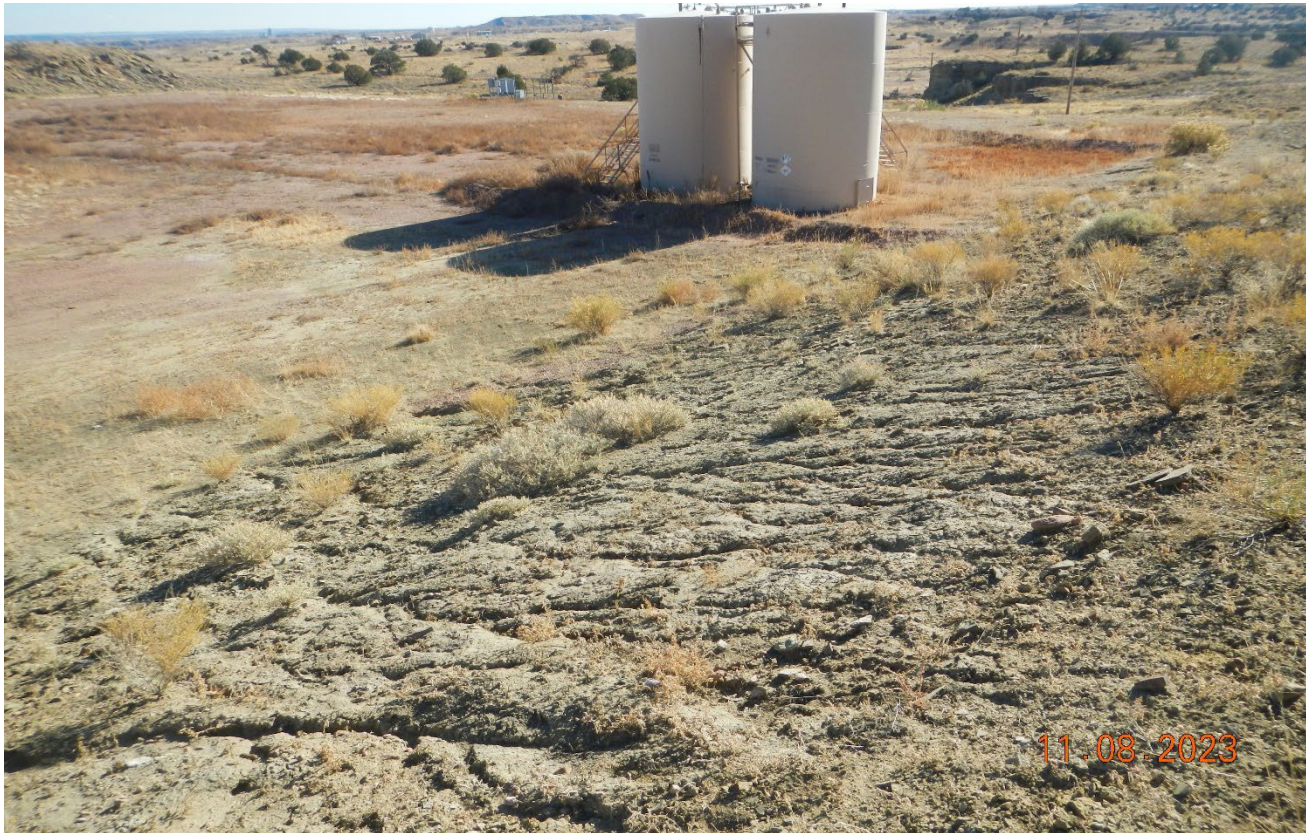
Photo 9. Facing east along the cut slope. There is rilling erosion along the cut slope.

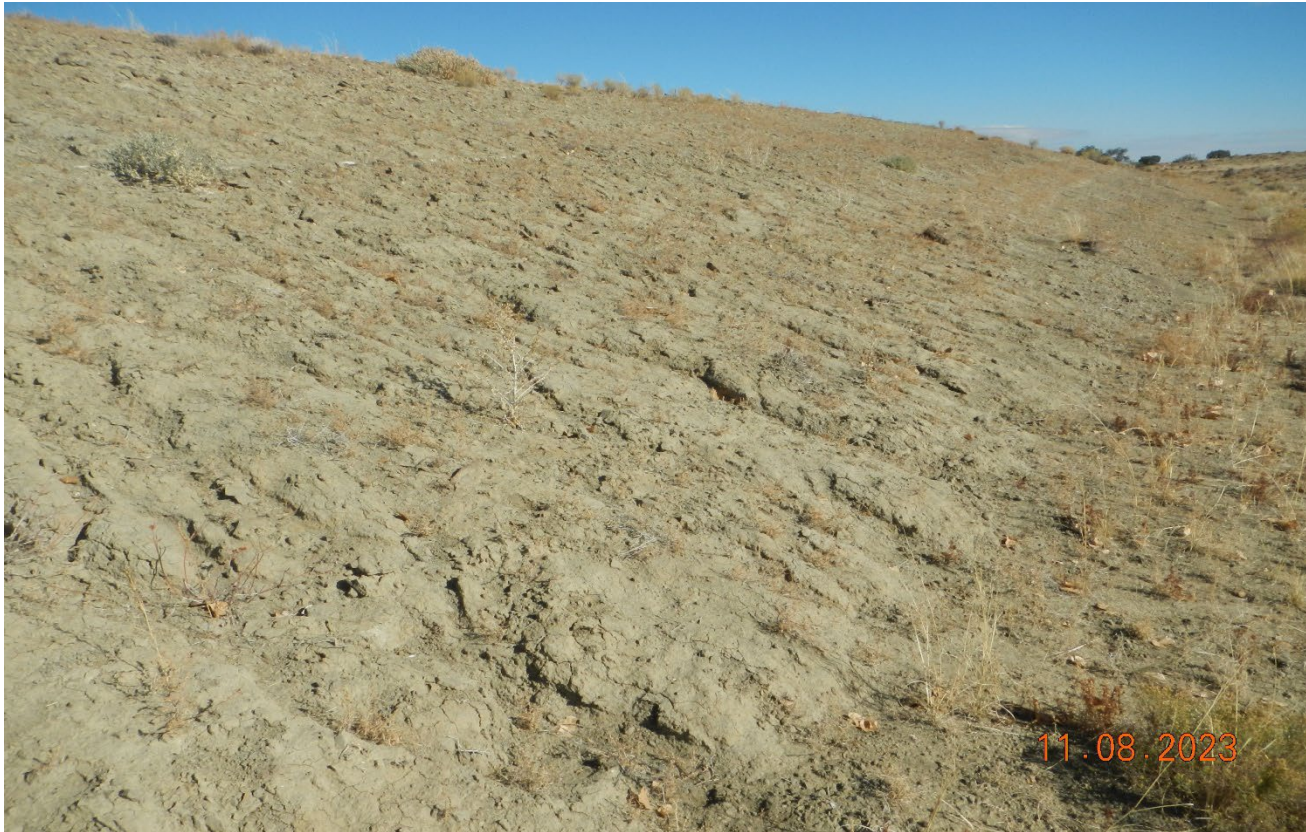
Photo 10. Facing east along the cut slope. There is rilling erosion along the cut slope.

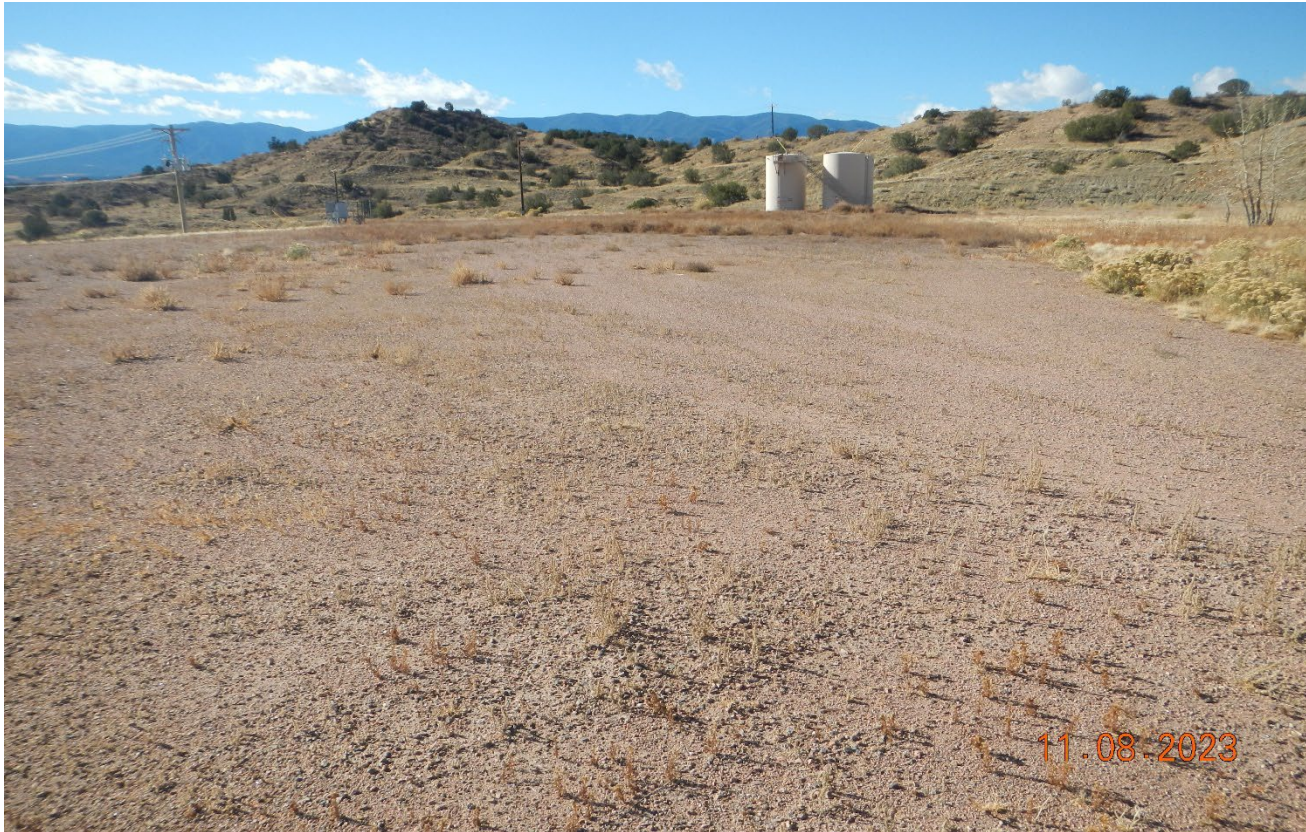
Photo 11. Facing south at the location. All gravel must be removed and the location will must be reclaimed per 1004 Rules.
