# SITE-SPECIFIC QUALITY ASSURANCE & QUALITY CONTROL AUDIT

Permit Closure Type – Final

## PERMIT CLOSURE REPORT – DESIGNATION LAND USE CHANGE

Location Name – HAAS-66N67W 15NESE

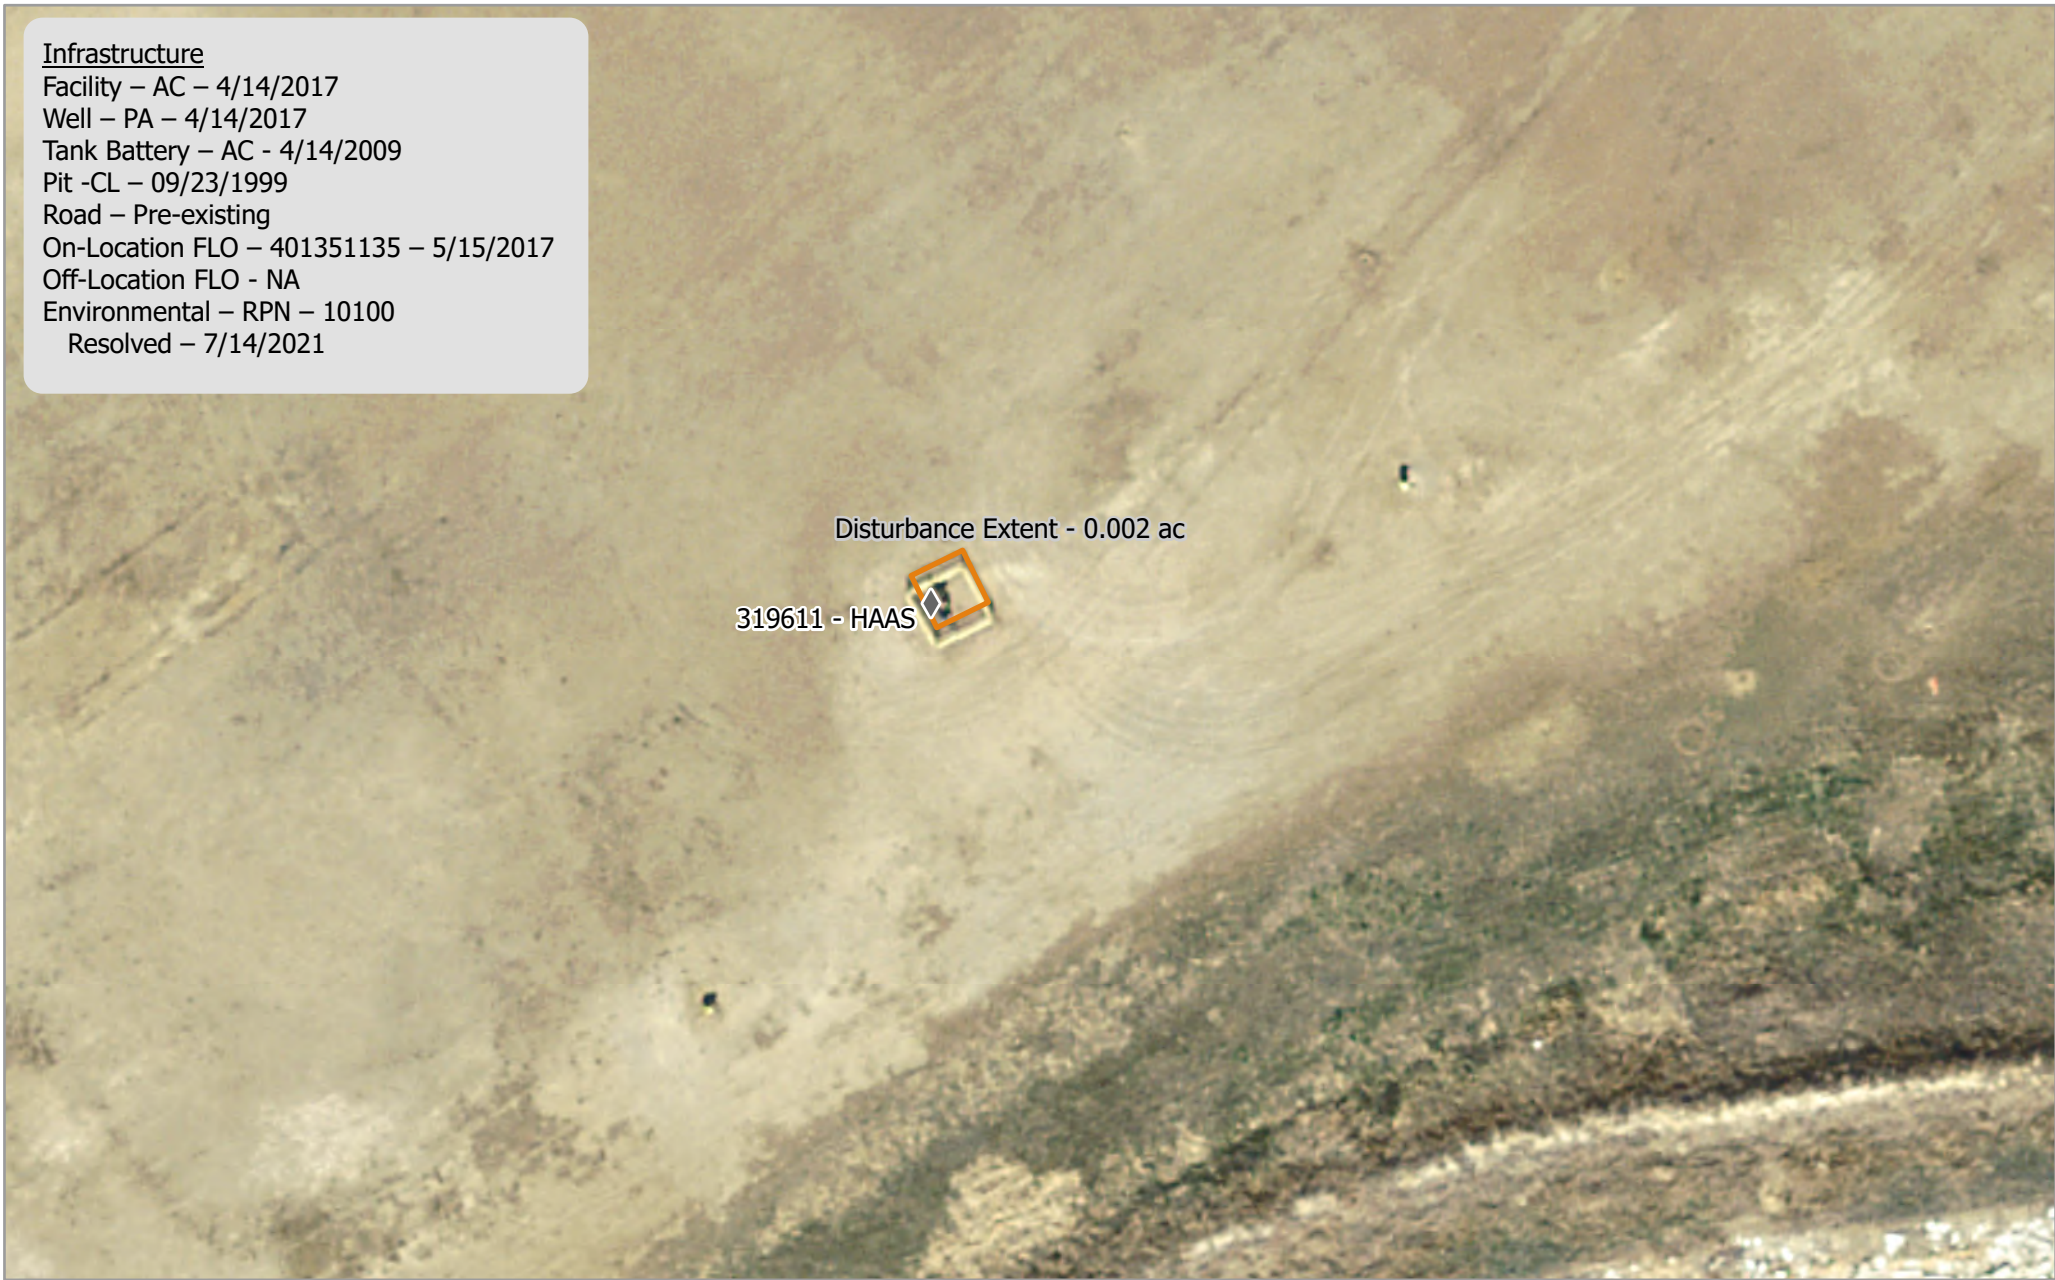
**CIV - 319611- HAAS  
Map Extent - DRCOG 2012**

Disturbance Extent - 0.002 ac
