Inspection Photos

Loc: 321069

Operator: **SCHREIDER & COMPANY INC**

Inspection Date: 10/31/2023

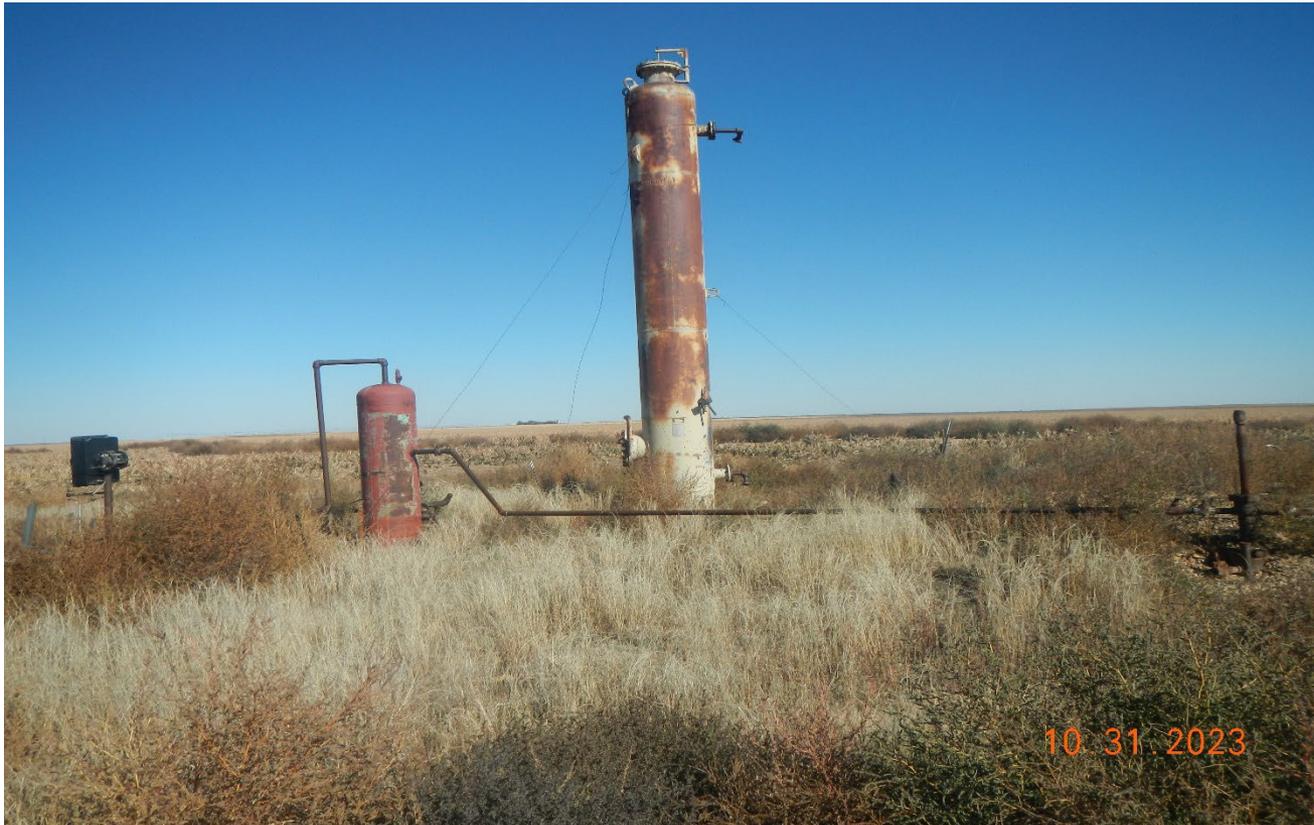
Photo 1. Facing east toward the wellsite. There is dry weeds and vegetation around the equipment which is a fire hazard..

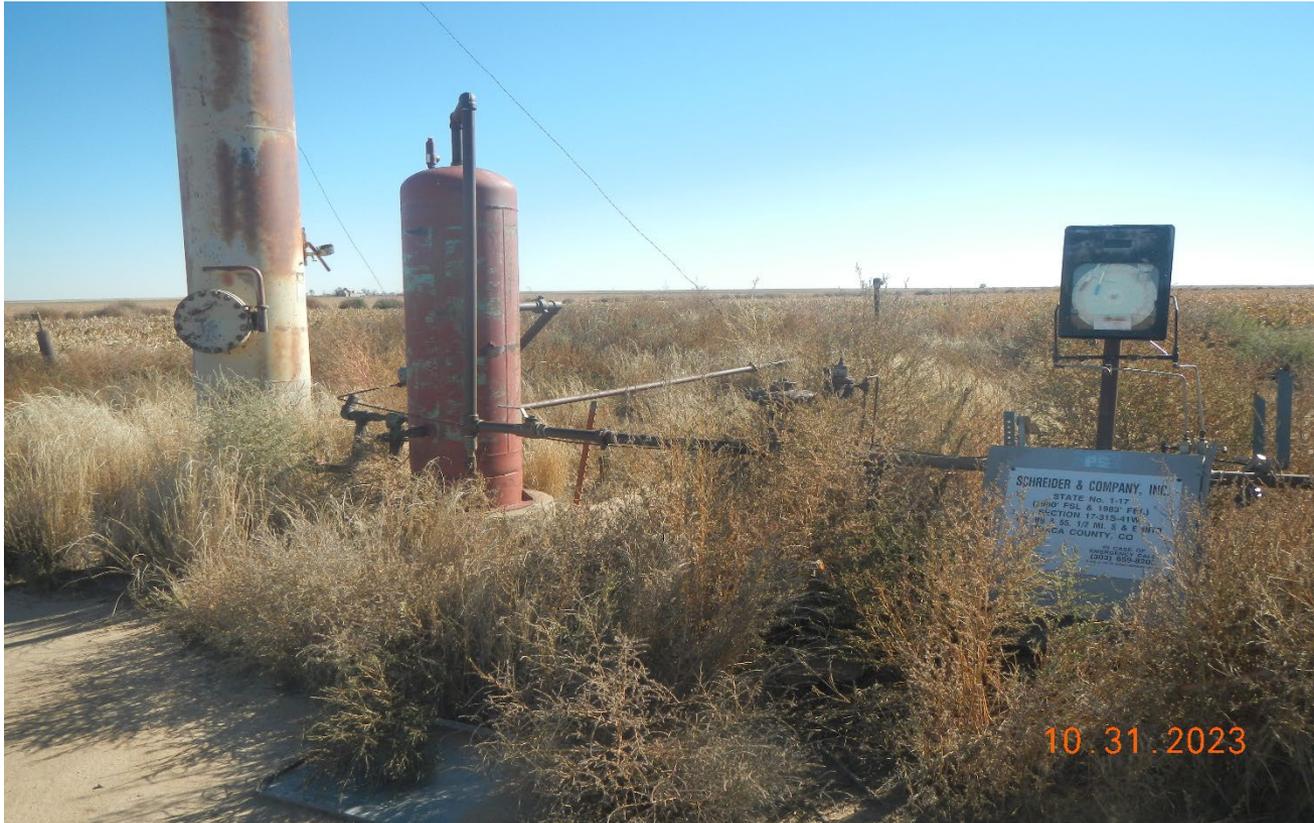
Photo 2. Well sign is posted at the location. There is dry weeds and vegetation around the equipment which is a fire hazard.

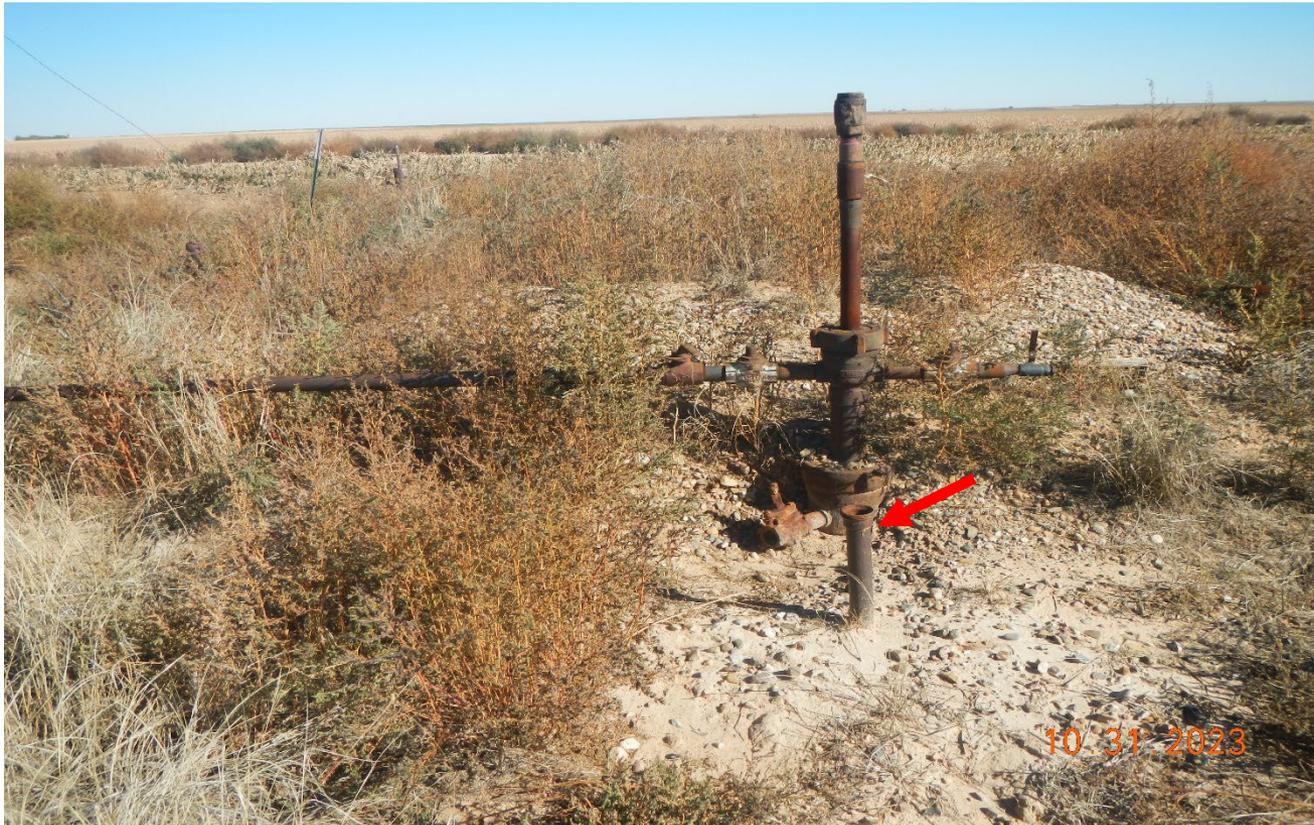
Photo 3. Facing toward the well head. There is a pipe riser at red arrow with no OOSLAT.

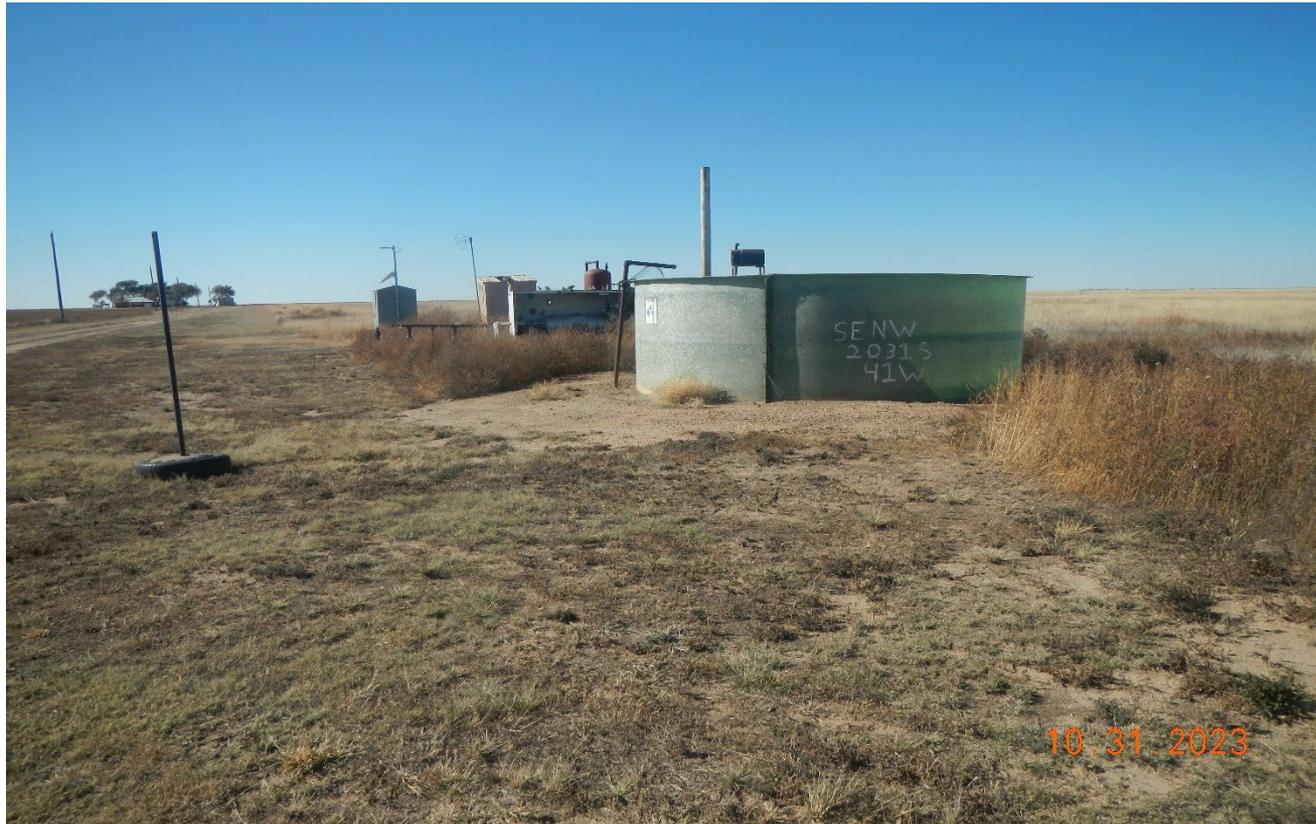
Photo 4. Facing toward offsite facility at Lat/Long:37.33139, -102.06825.

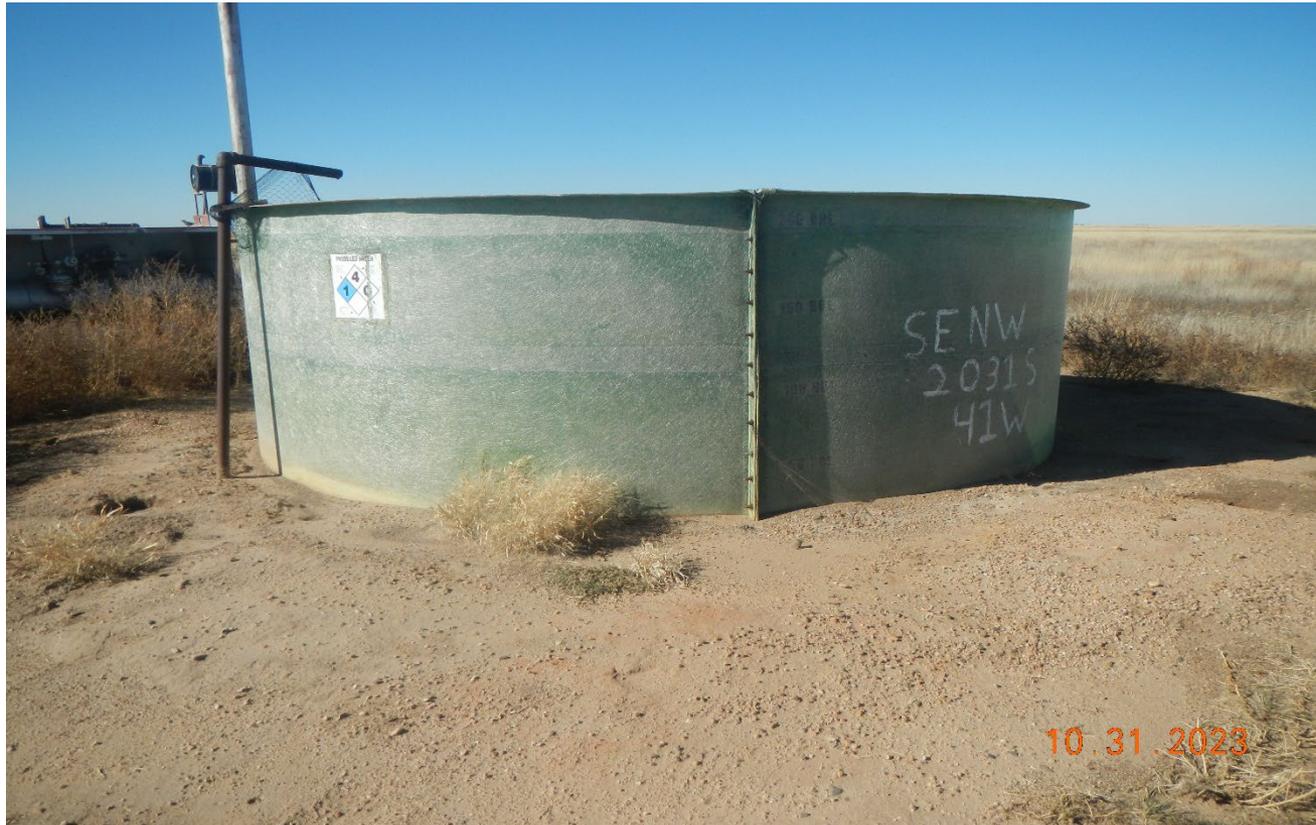
Photo 5. The open top tank does not have secondary containment or proper labeling..

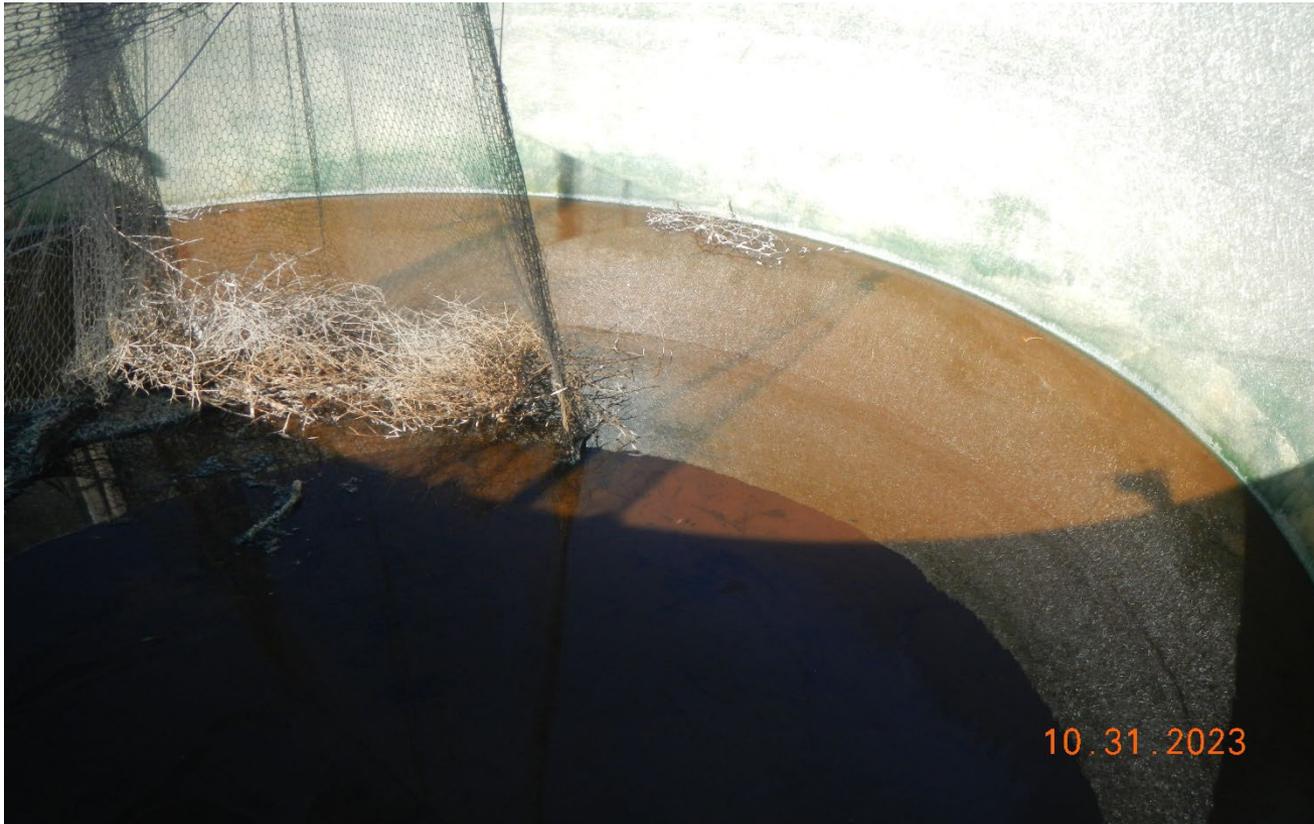
Photo 6. The netting on the open top tank is in disrepair.

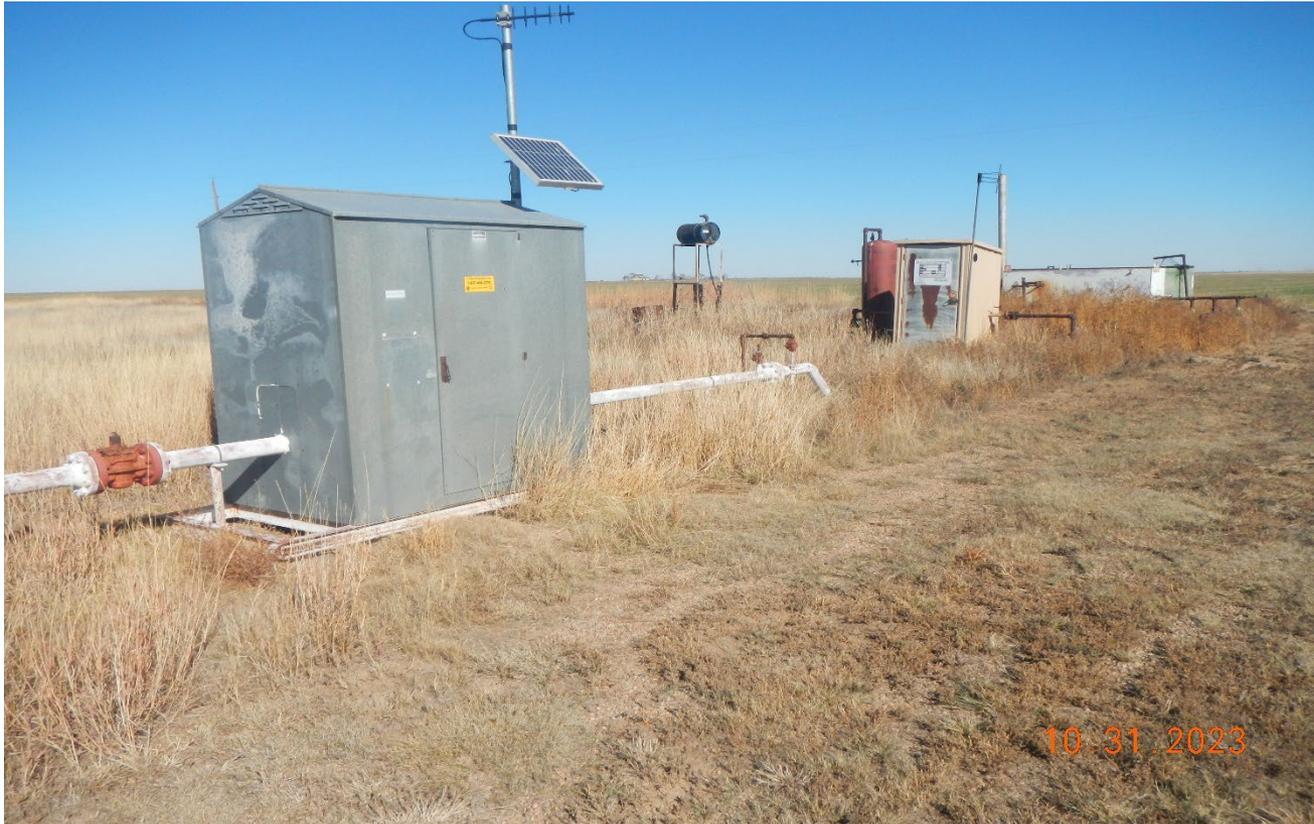
Photo 7. Facing northeast at the offsite meter facility Lat/Long: 37.33139, -102.06825.
