Inspection Photos

Operator: LARAMIE ENERGY LLC #10433

Location ID: 481743

Inspection Doc: 696205412

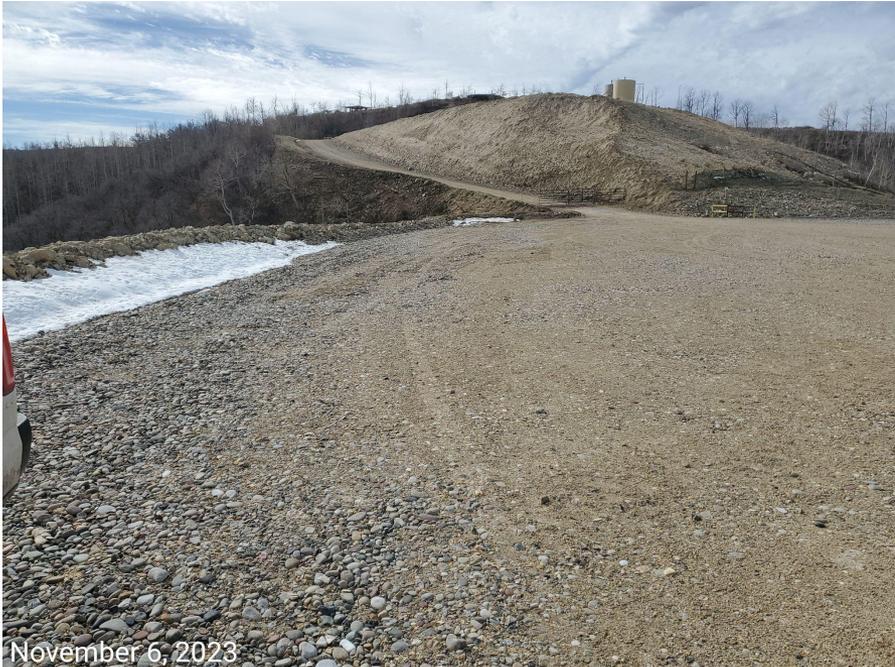
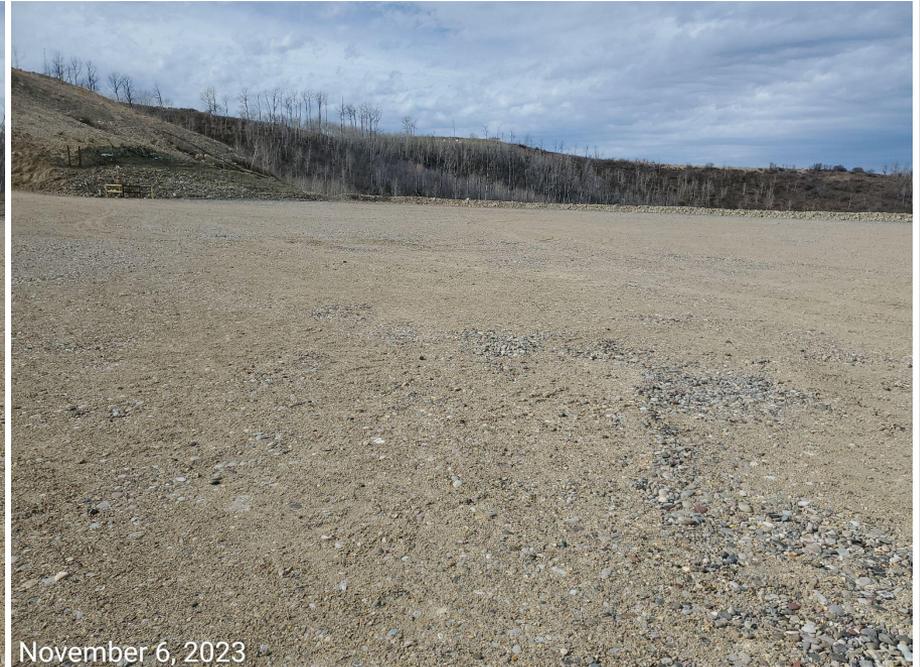
Photo 1: Photos 1-2 taken from the southeast end of the working pad surface. Photos provide an overview of the Location from southwest, west north to northeast

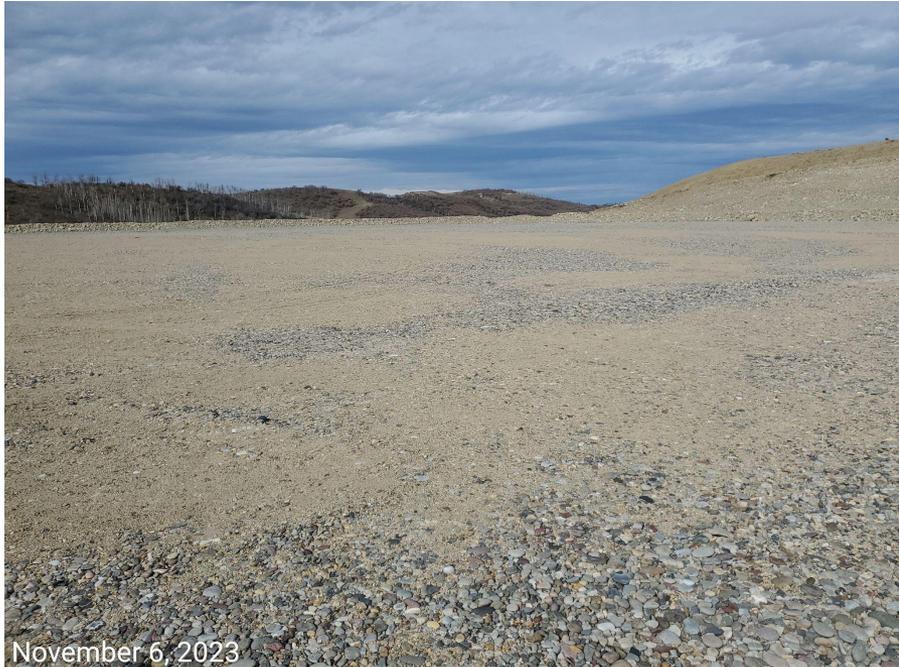
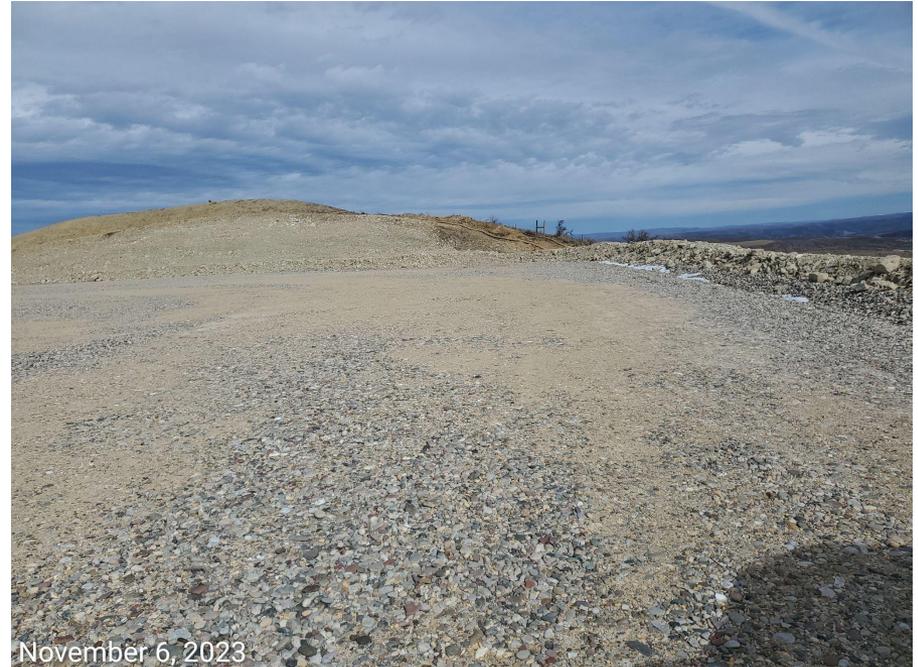
Photo 2: See comments under photo 1.

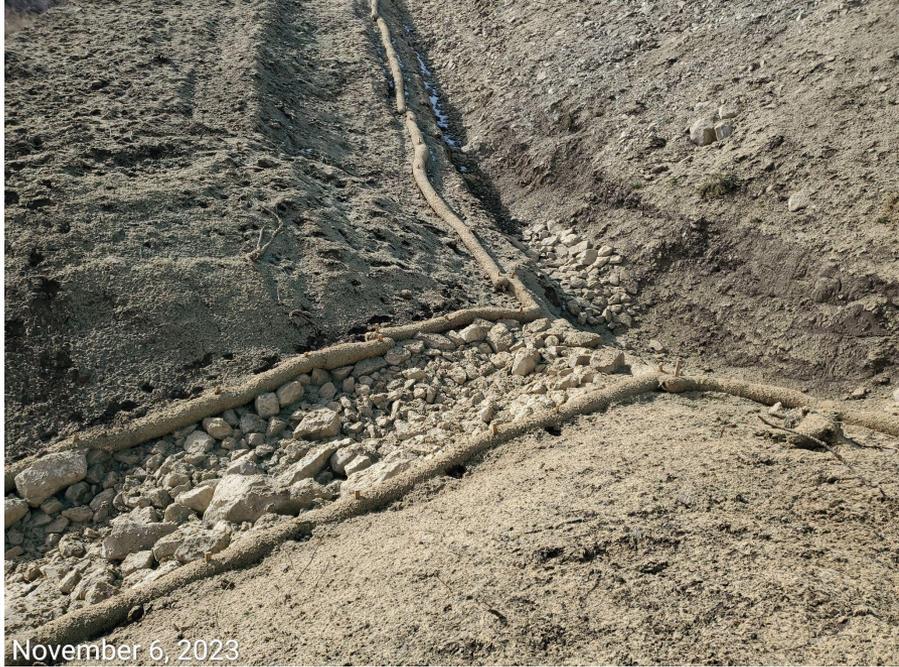
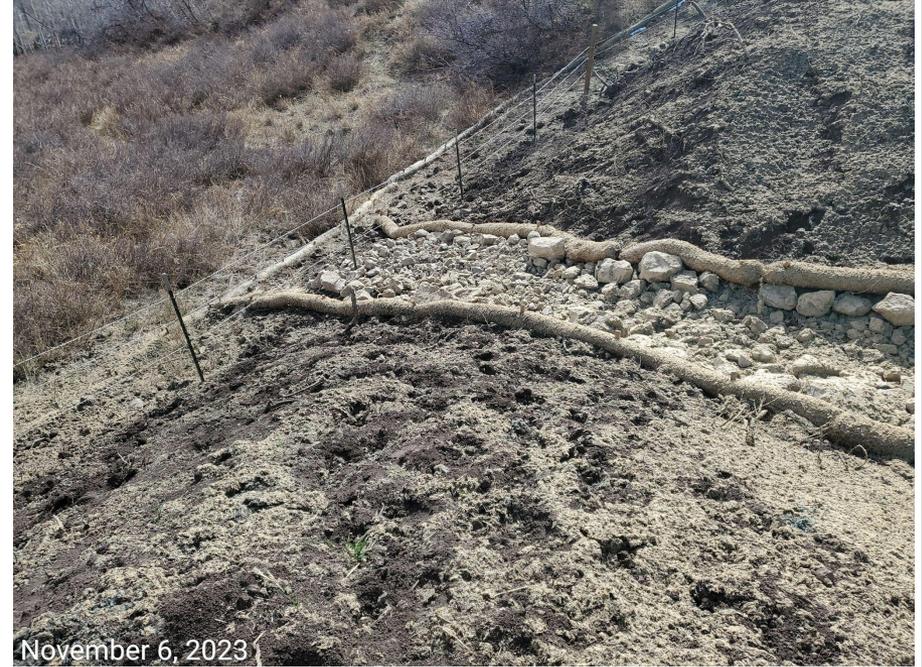
Photo 3: Photos taken from the southeastern perimeter of the Location. The two sediment traps per the 2A have been constructed.

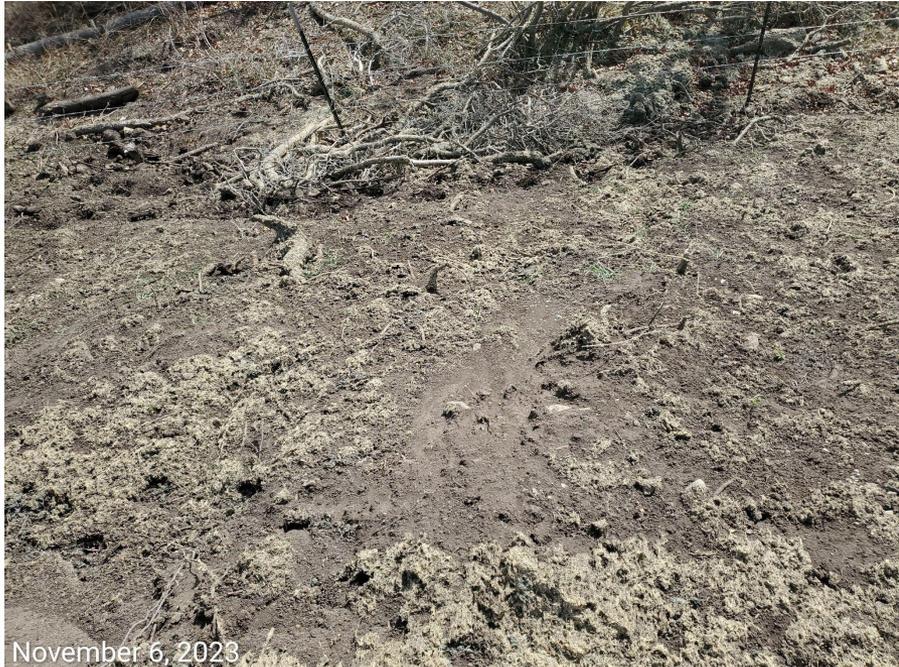
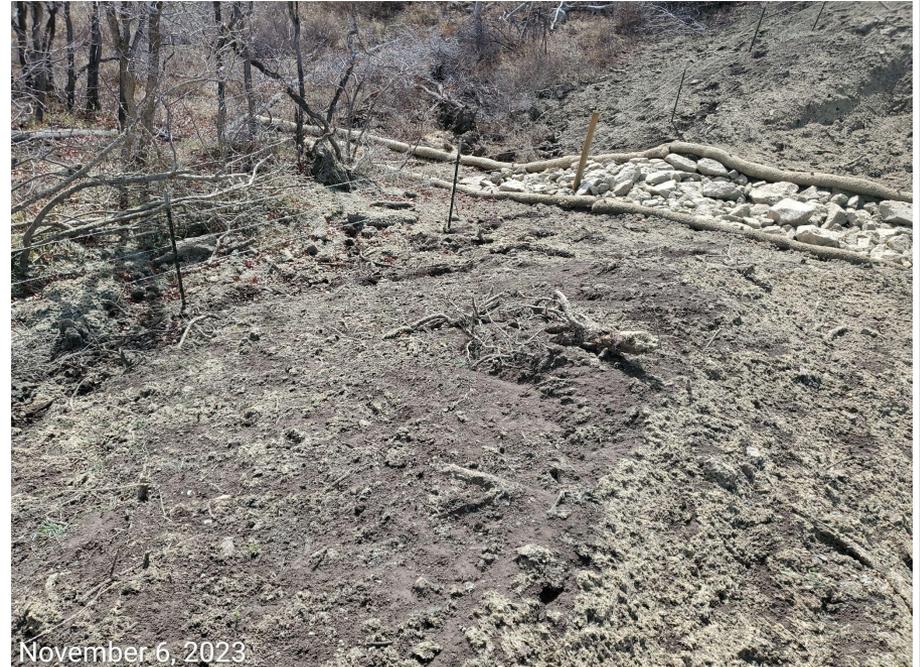
Photo 4: Photos taken from the topsoil stockpiles on the eastern perimeter of the Location. Photo shows hydromulch applied to areas of the stockpiles (adjacent to the sediment traps recently implemented) is no longer in proper functioning condition

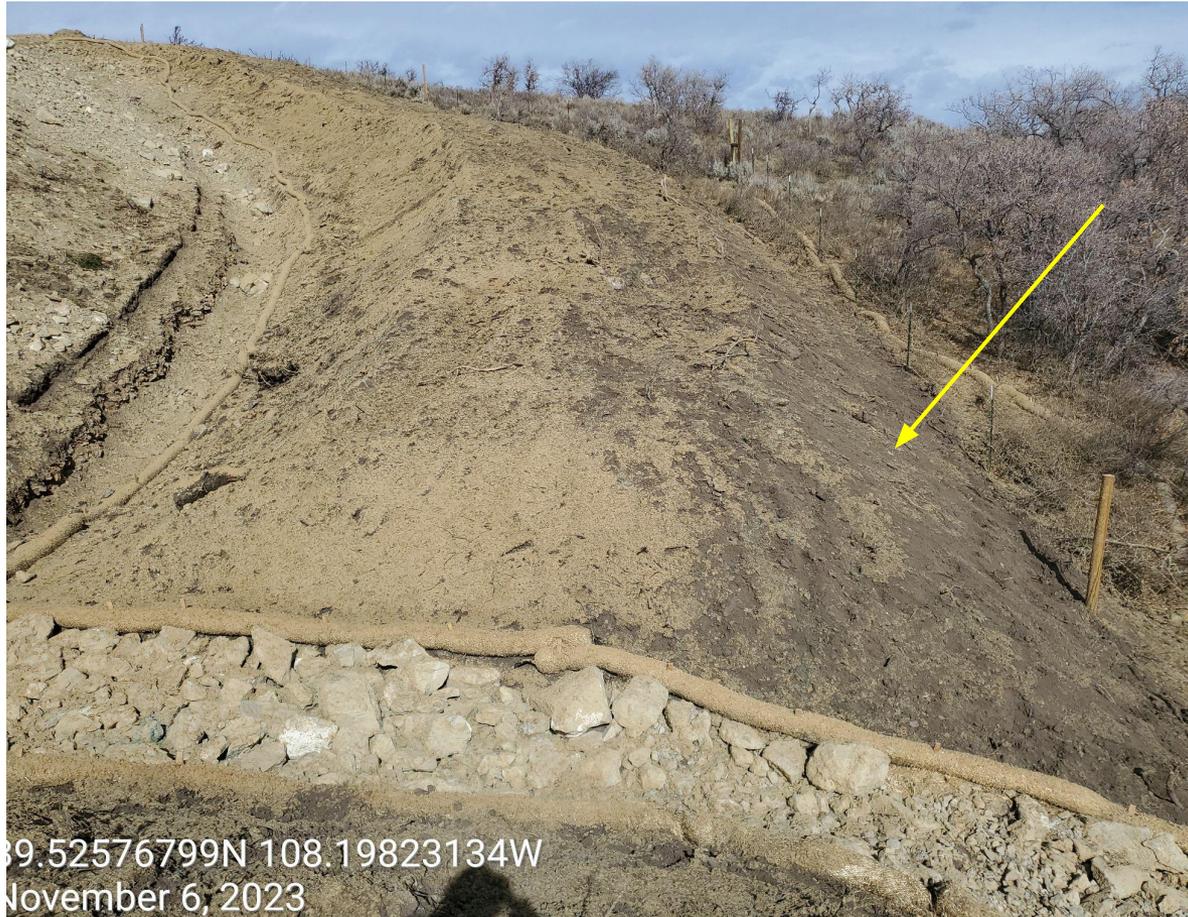
Photo 5: See comments under photo 4.

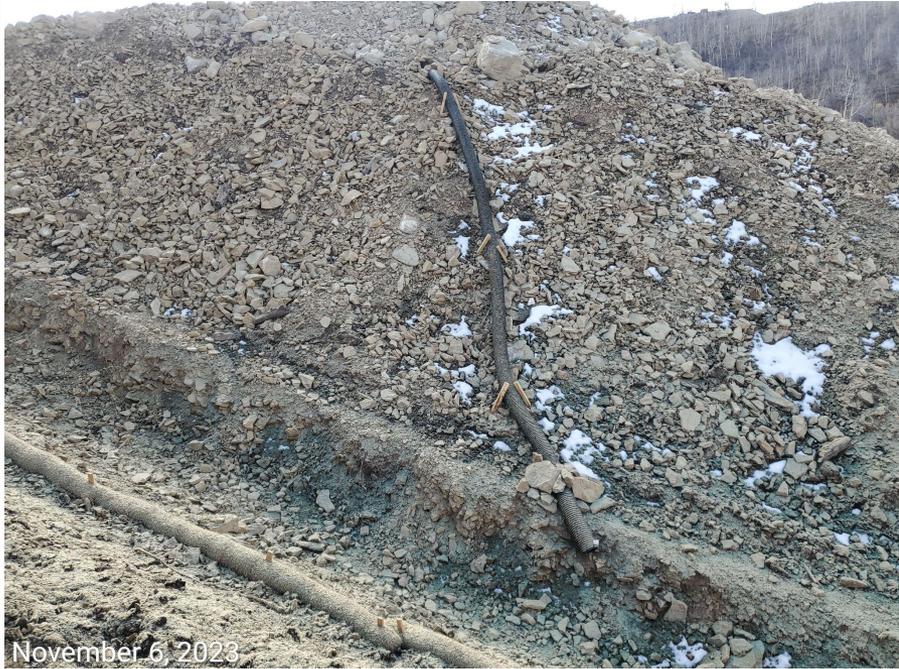
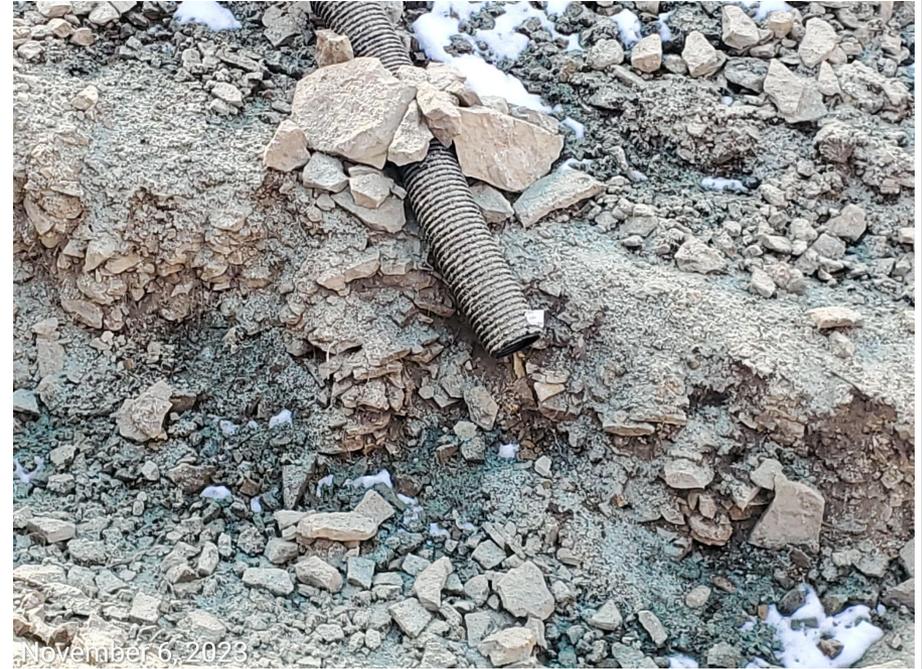
Photo 6: Photos taken from the slope drain on the northwest end of the Location; outlet protection remains missing per good engineering practices.

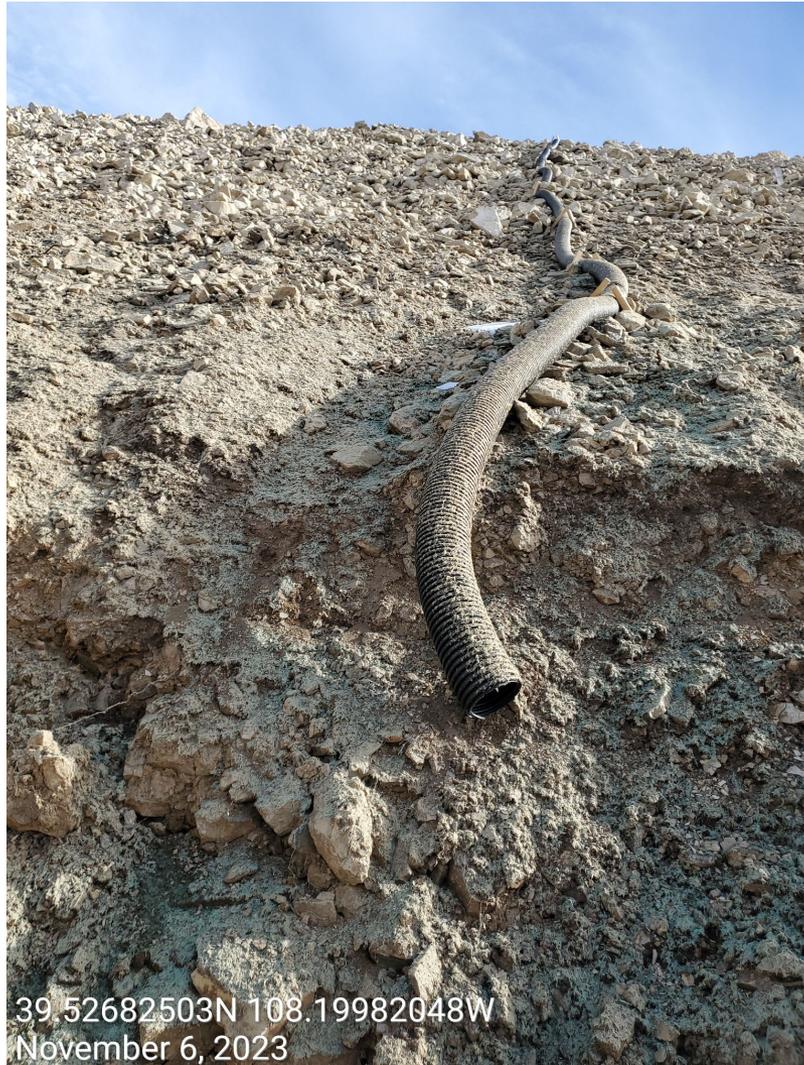
Photo 7: Photo taken from the slope drain on the west end of the Location; outlet protection remains missing per good engineering practices.

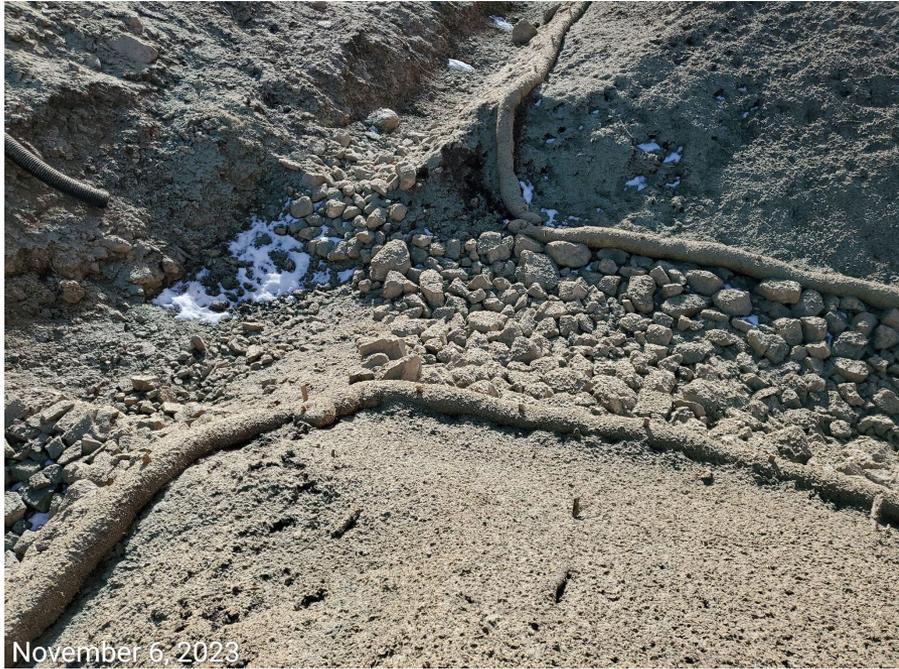
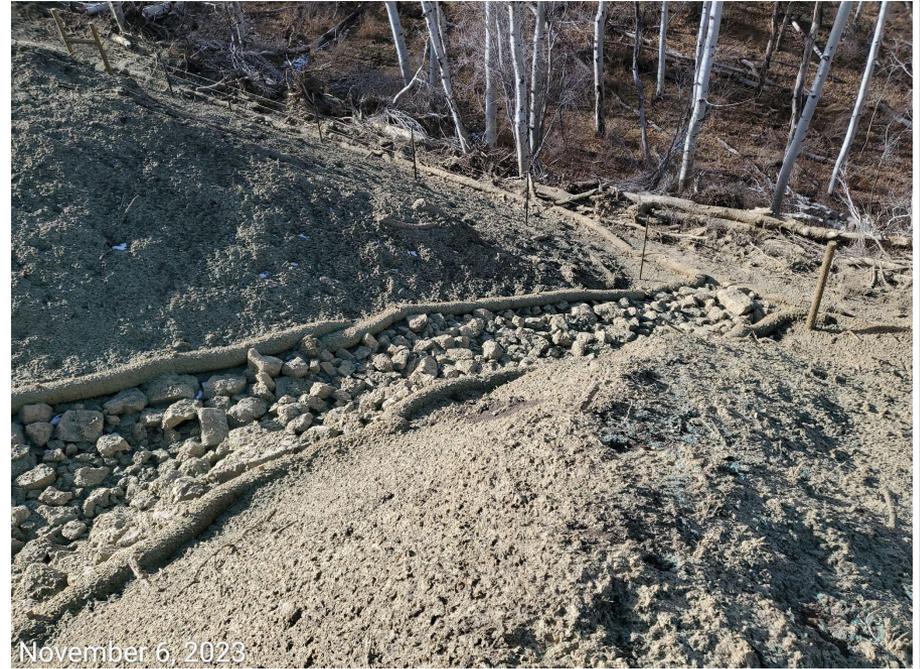
Photo 8: Photos taken from the western perimeter of the Location. Sediment trap per the 2A has been constructed.

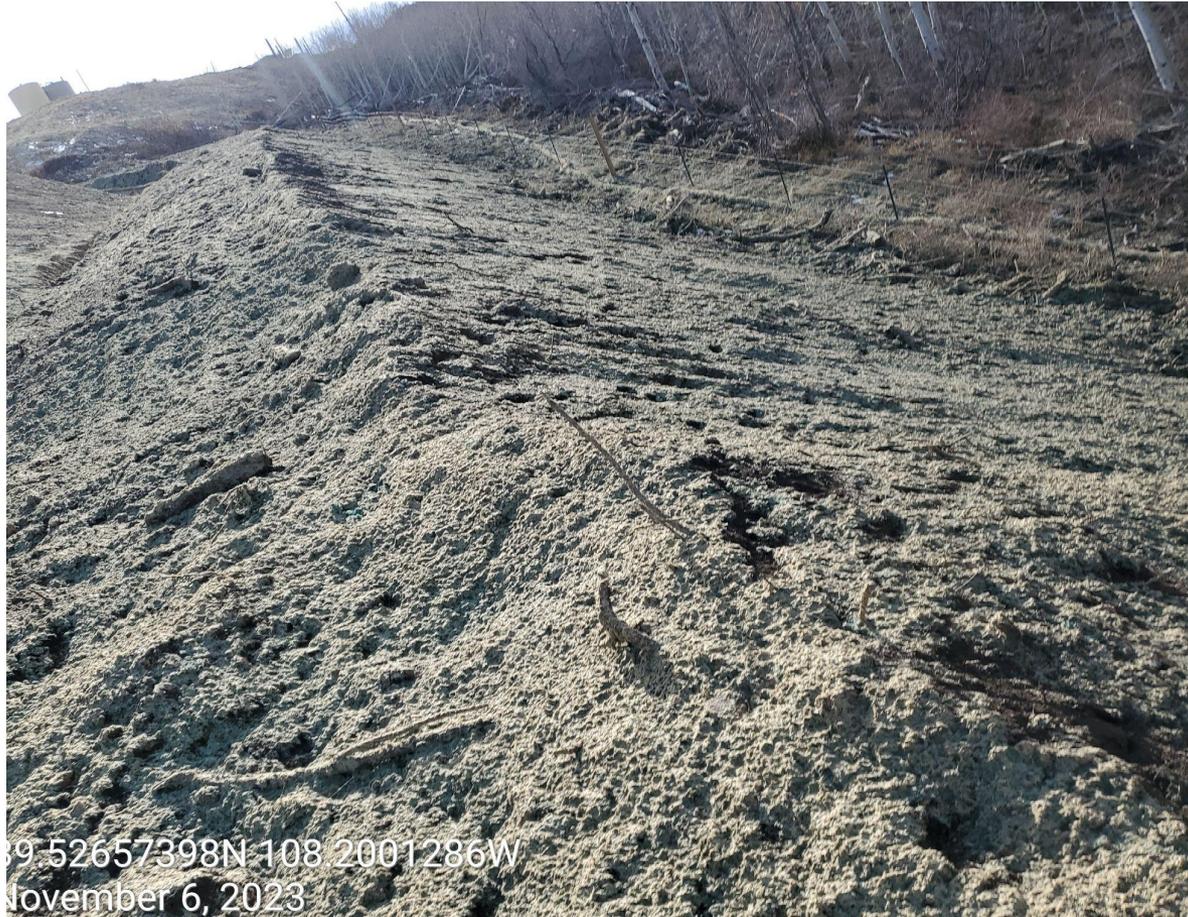
Photo 9: Hydromulch along the western topsoil stockpiles have been maintained; control appeared to be in proper functioning condition at time of inspection.

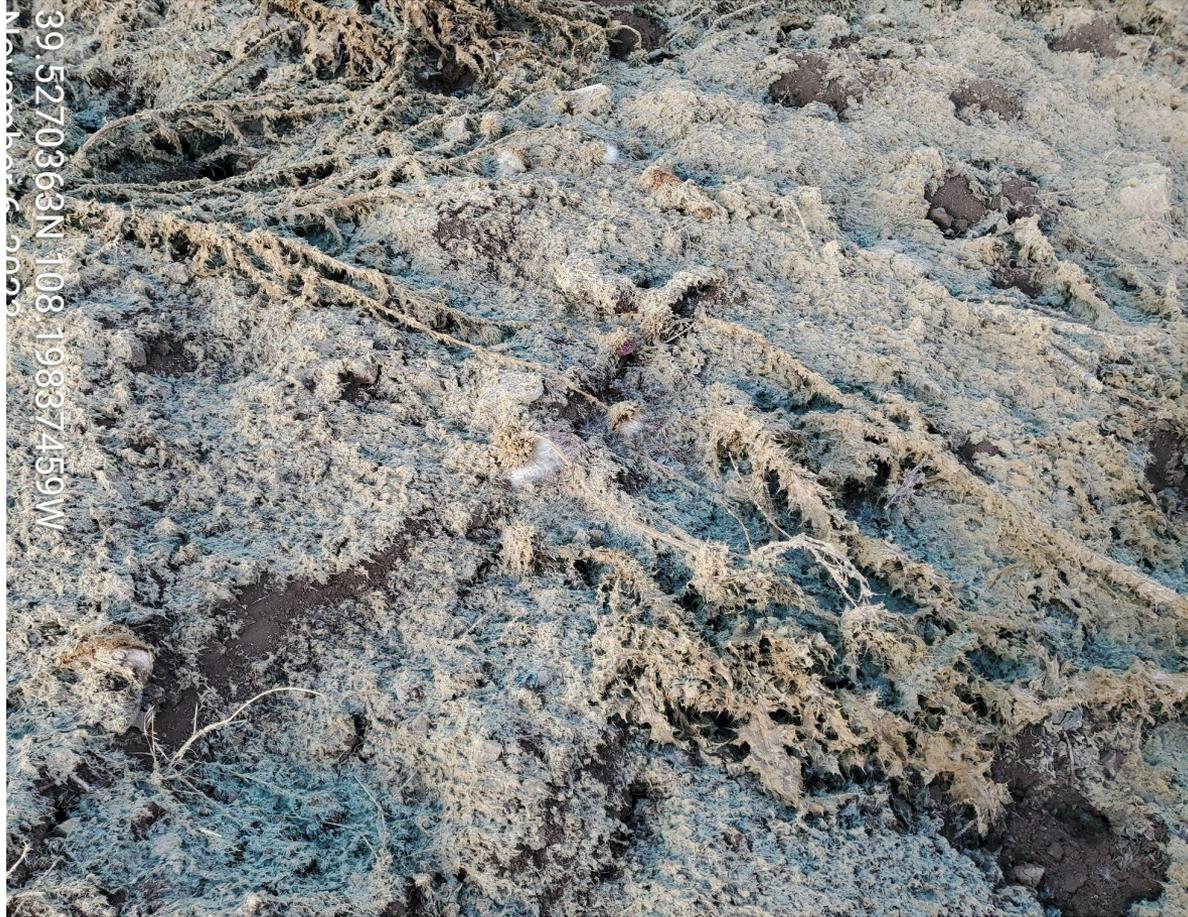
Photo 10: Photo shows weeds observed along the topsoil stockpiles. Weed management activities appear to have been performed, and the majority of Noxious weeds previously observed on the topsoil stockpiles have been removed. It is unclear if plants had been managed prior to maturity, and some weeds with seed were observed along areas of the topsoil stockpile on the north side of the Location. Weed management at this time is considered “in-process”; additional weed management efforts will likely be necessary during the 2024 growing season to comport with 606.c and 1003.f requirements.
