**Crowheart Energy LLC
Peppler Fee Com 12-18
Location ID: 313060**

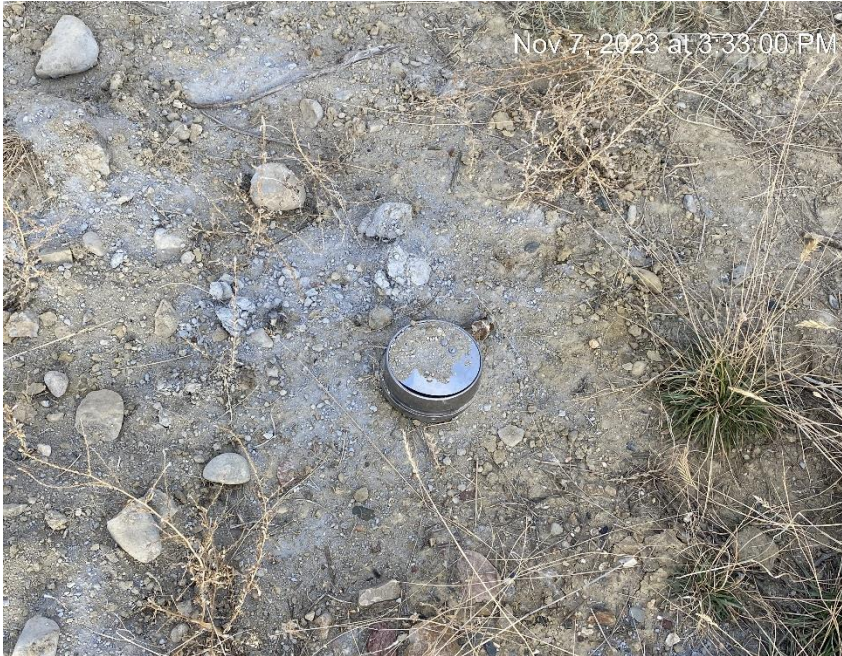
Debris around wellhead

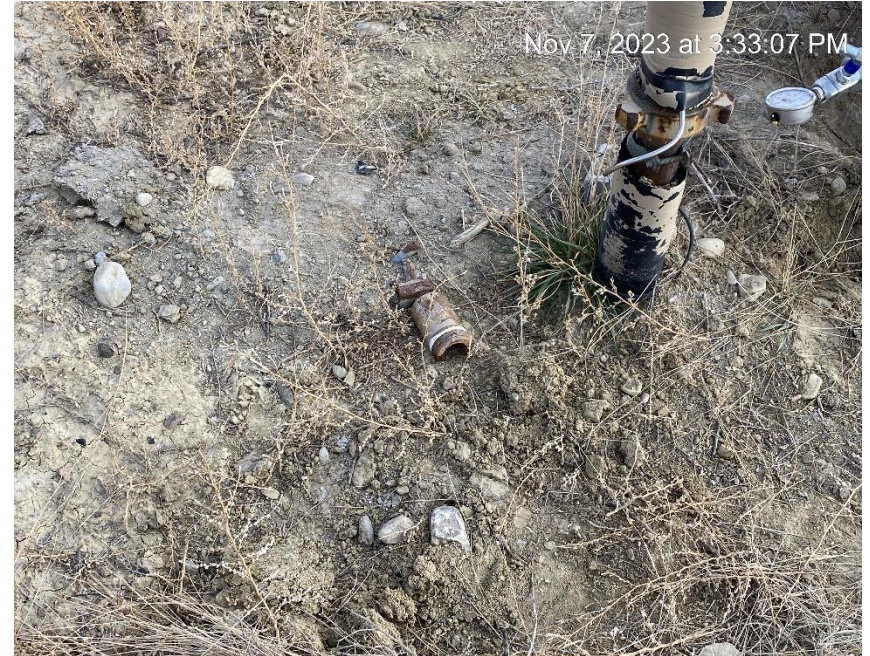
Debris around wellhead

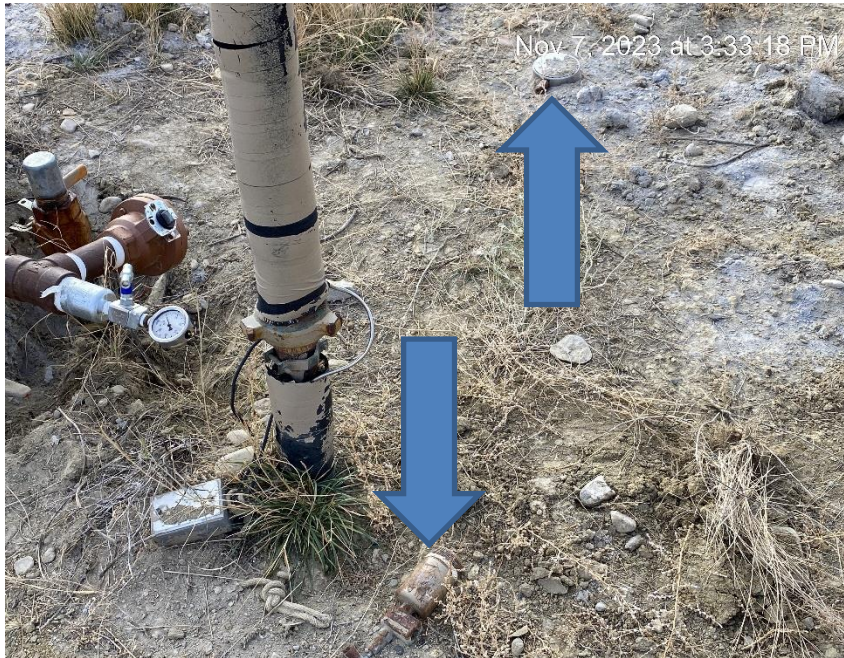
Debris around wellhead

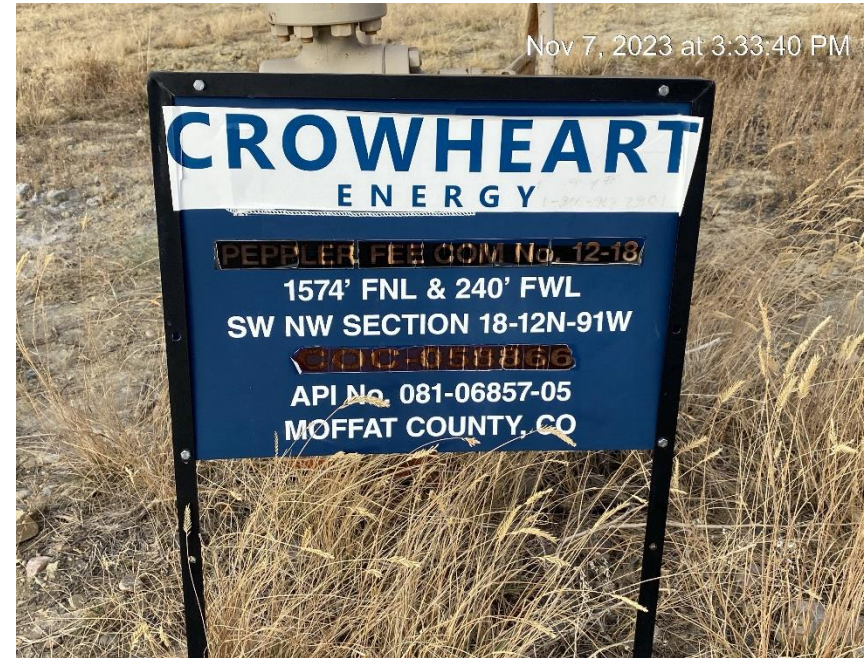
Illegible and missing required information

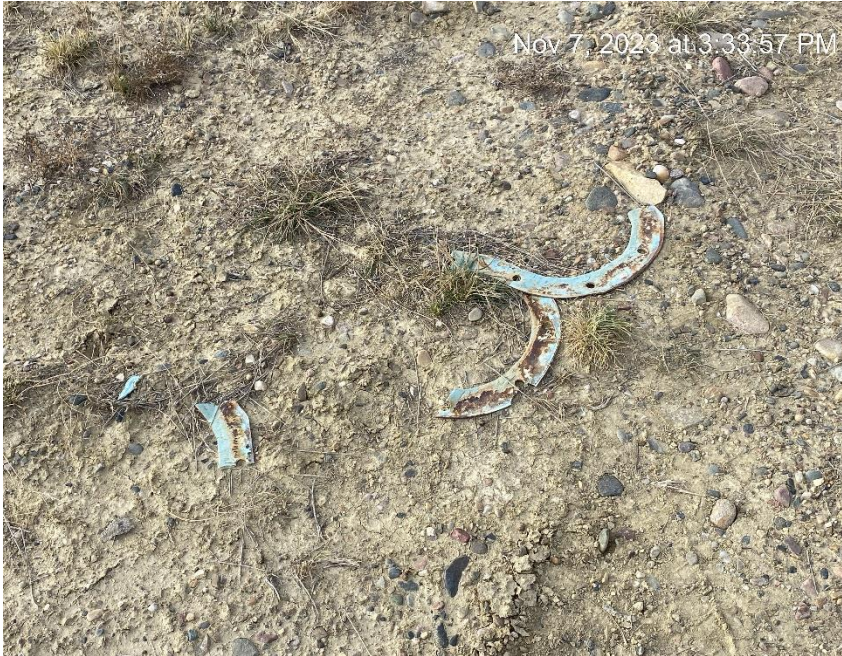
Debris where production equipment was removed

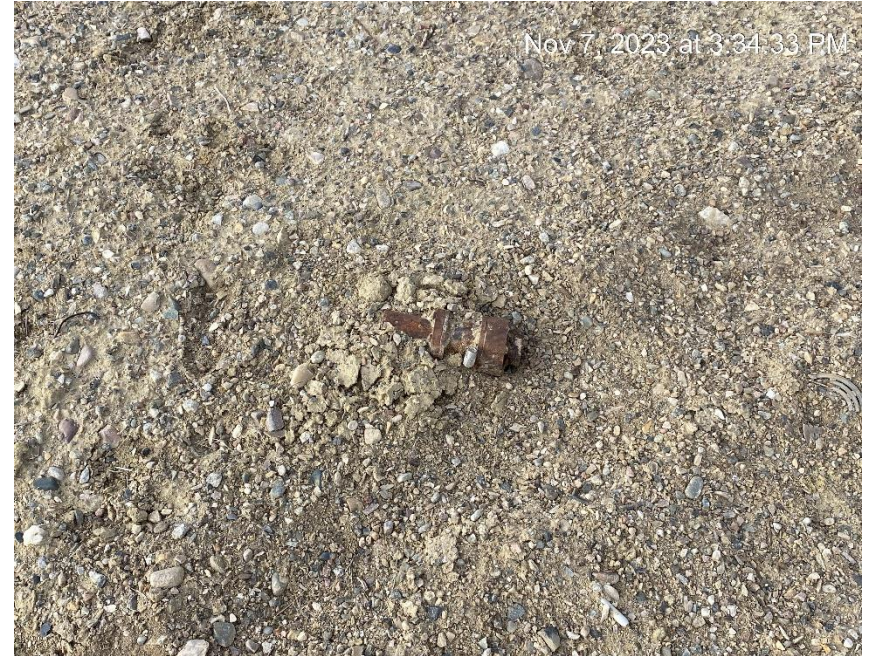
Debris where production equipment was removed

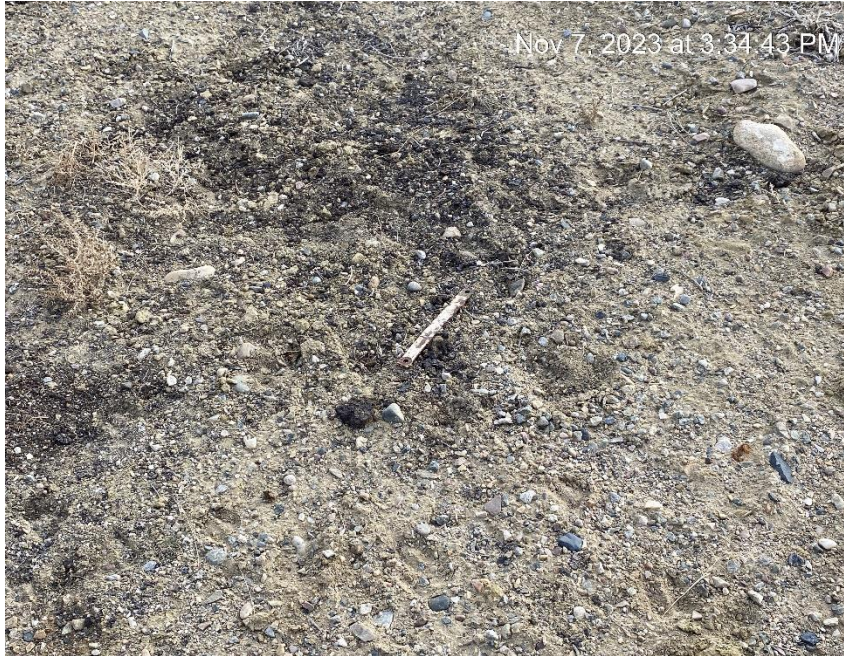
Debris where production equipment was removed

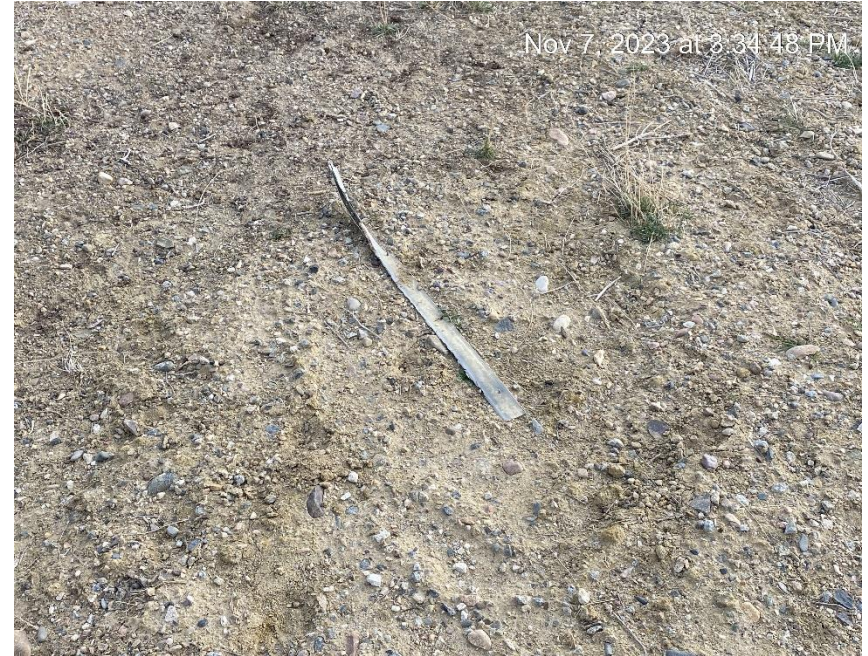
Debris where production equipment was removed

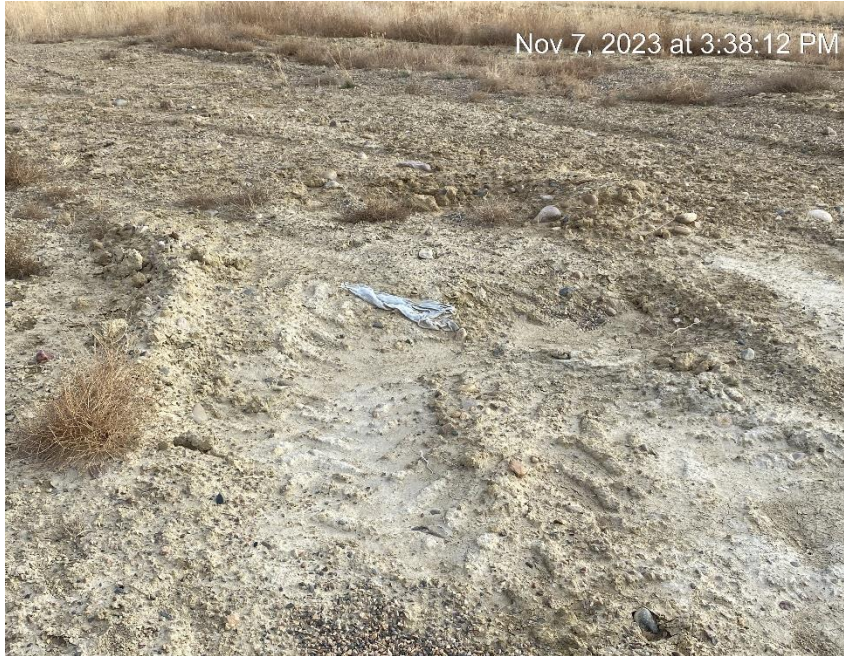
Debris where tank battery was removed

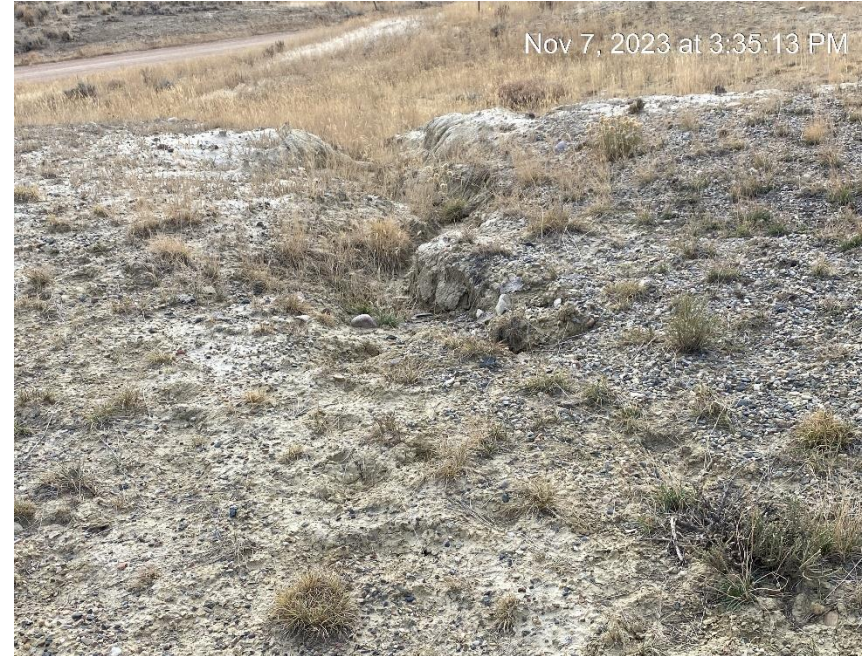
Erosion along edge of location
