Construction and Stormwater Inspection

Date: 11/02/2023

Operator: CIVITAS NORTH LLC - 10661

Inspection Photos
Location Name: Canvasback Pad
Location ID: 461821

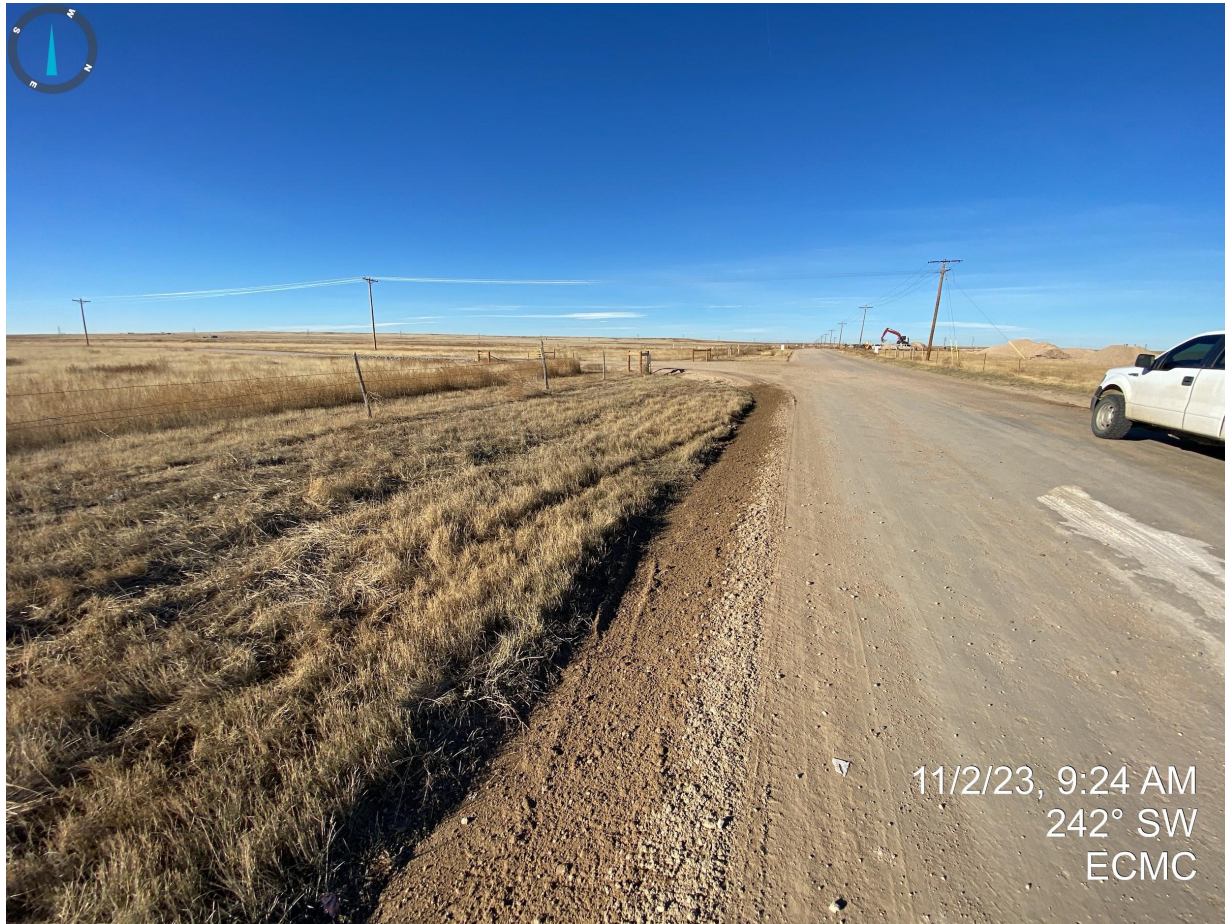
Photo 1. Taken near the location entrance. Culvert debris previously documented has been removed.

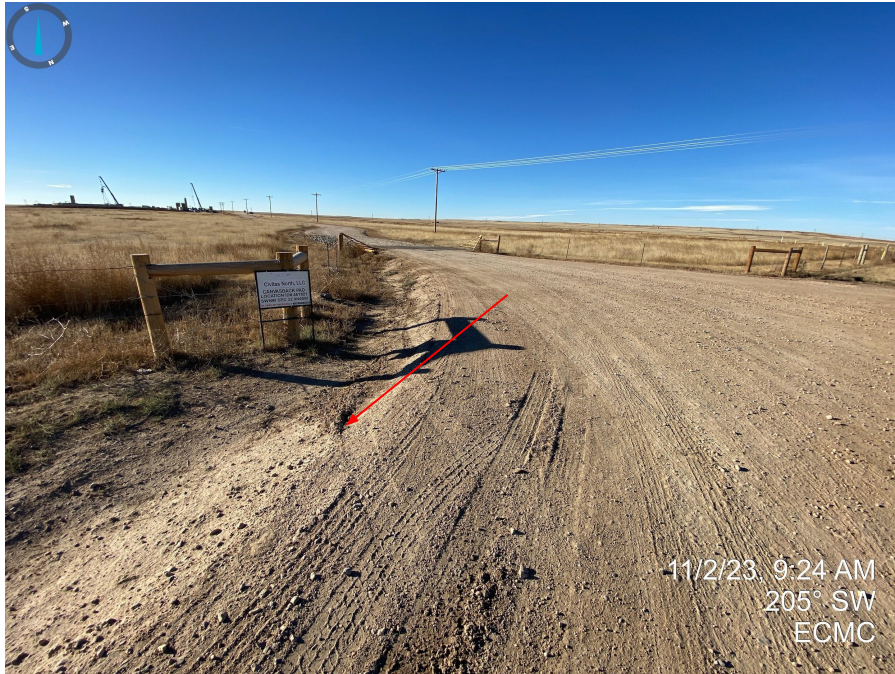
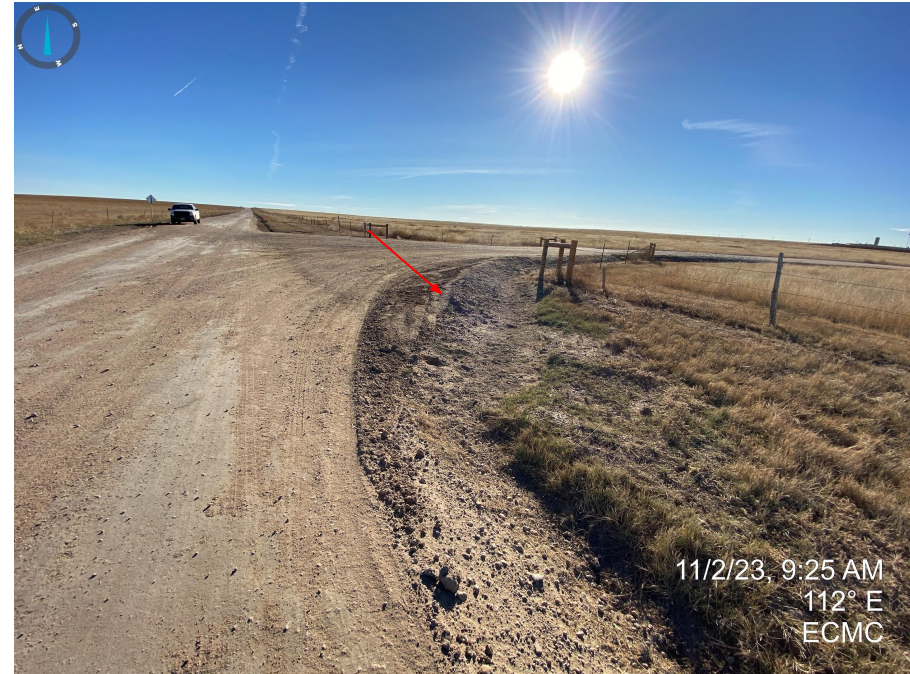
Photos 2 & 3. Taken from the location entrance. Photo illustrates that the culvert previously installed appears to have been removed or buried with soil. Additional stormwater control measures/BMPs or maintenance is required.

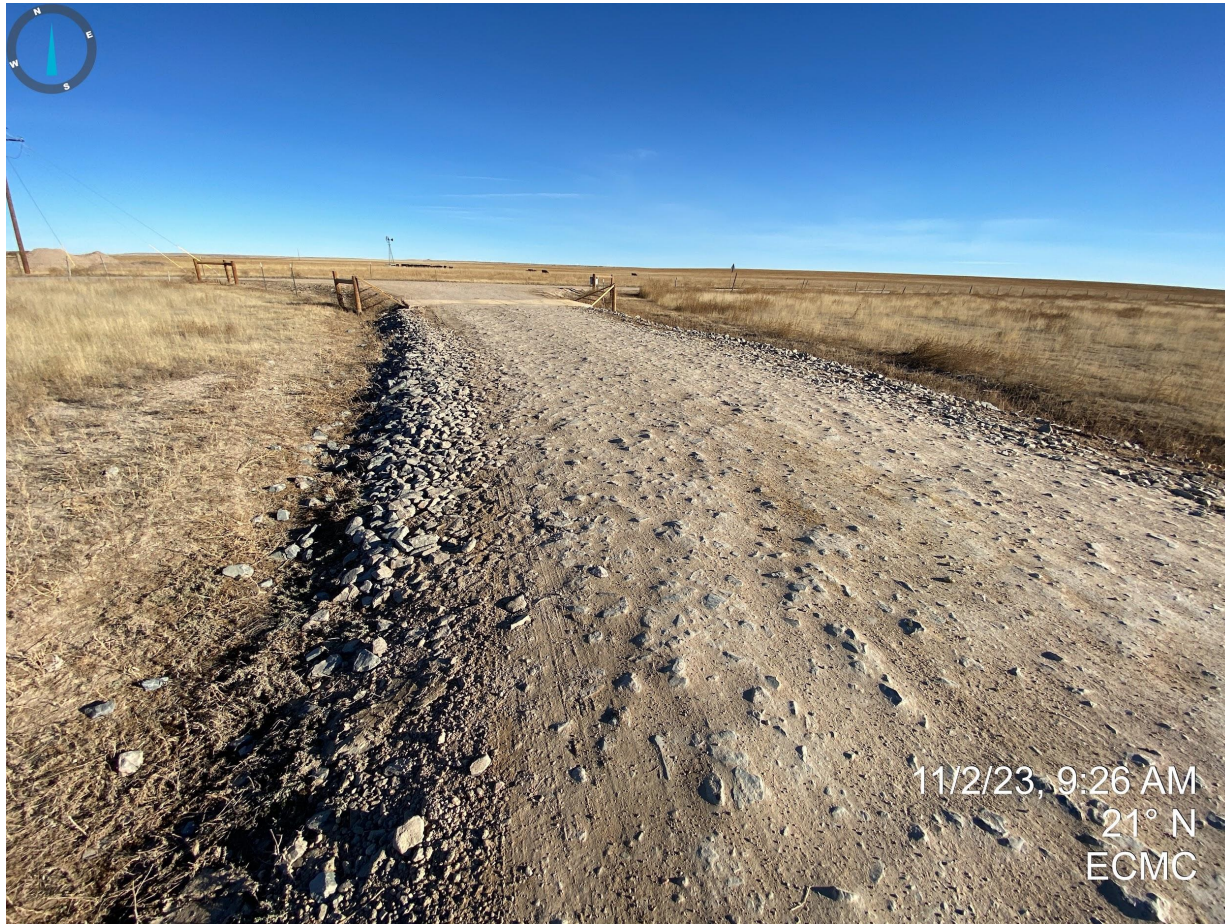
Photo 4. Vehicle track out pad requires maintenance as it is beginning to fill with sediment.

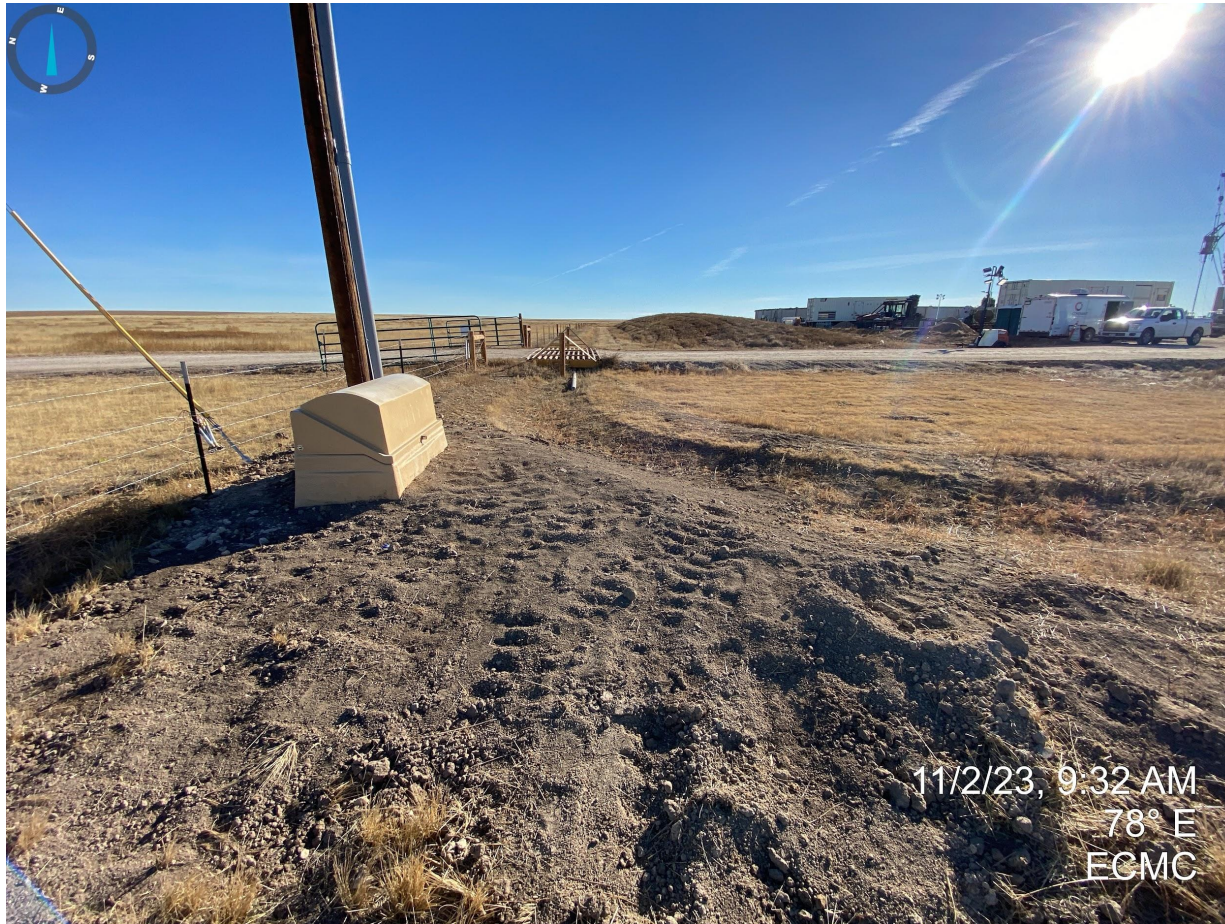
Photo 5. Taken from the northwest corner of the location. Photo illustrates unstabilized soils within the perimeter stormwater control and disturbance area limits. Additional stabilization BMPs are required to prevent erosion degradation from occurring.

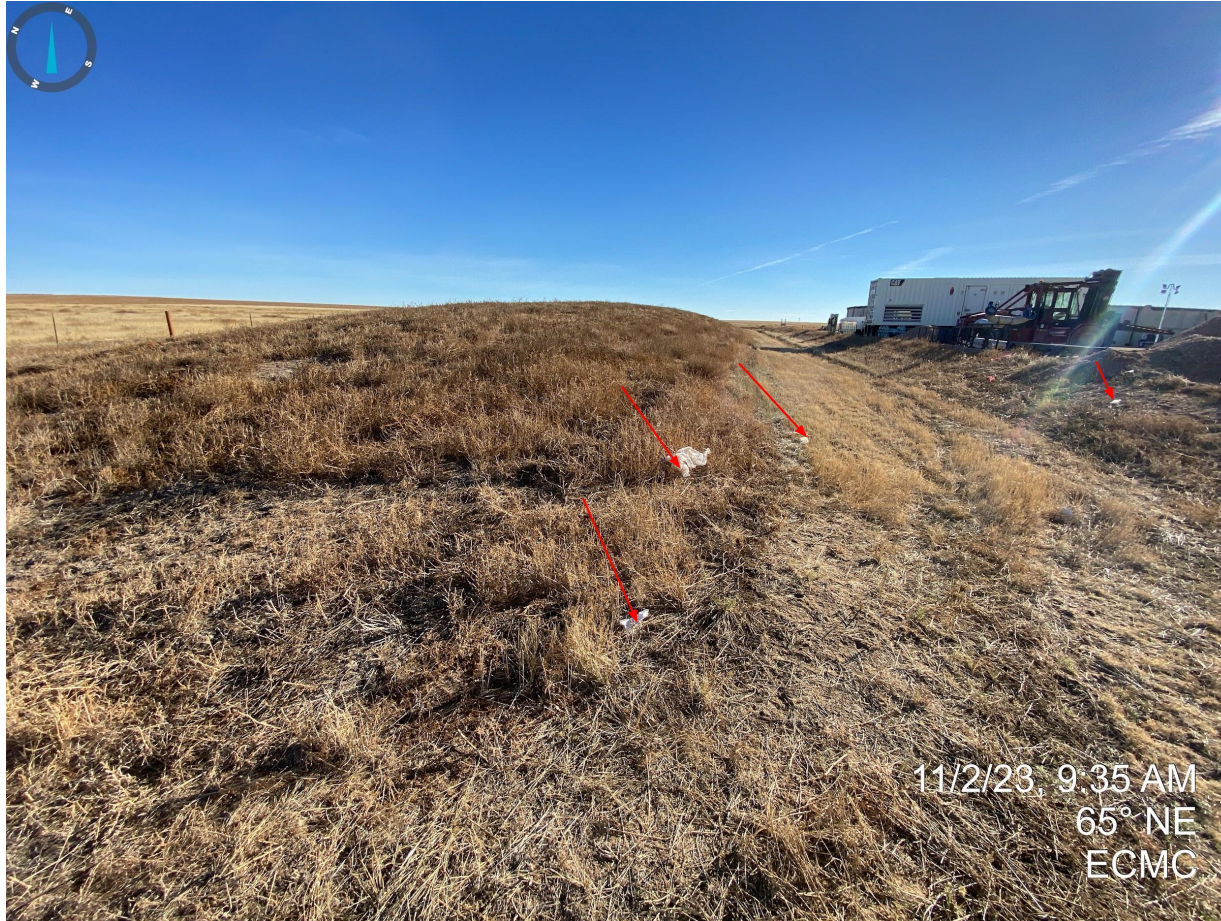
Photo 6. Trash observed on within the topsoil stockpile area.

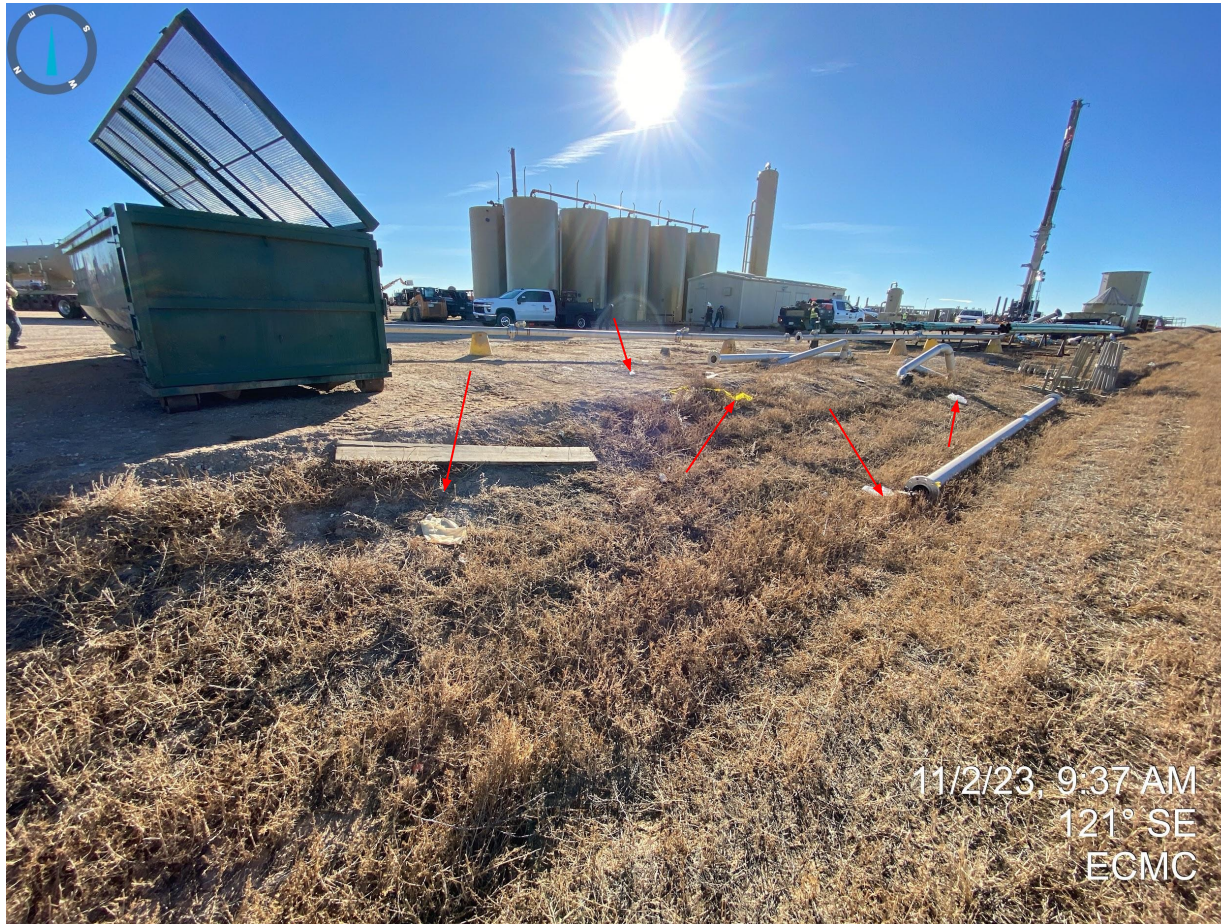
Photo 7. Taken from the western side of the location. Photo illustrates trash observed on location. The Operator shall self inspect the entire location, including off of location, and remove all debris. All personnel should be reminded of good housekeeping standards and regulations. Also pictured, undesirable vegetation (russian thistle and kochia) observed throughout the perimeter of the construction area.

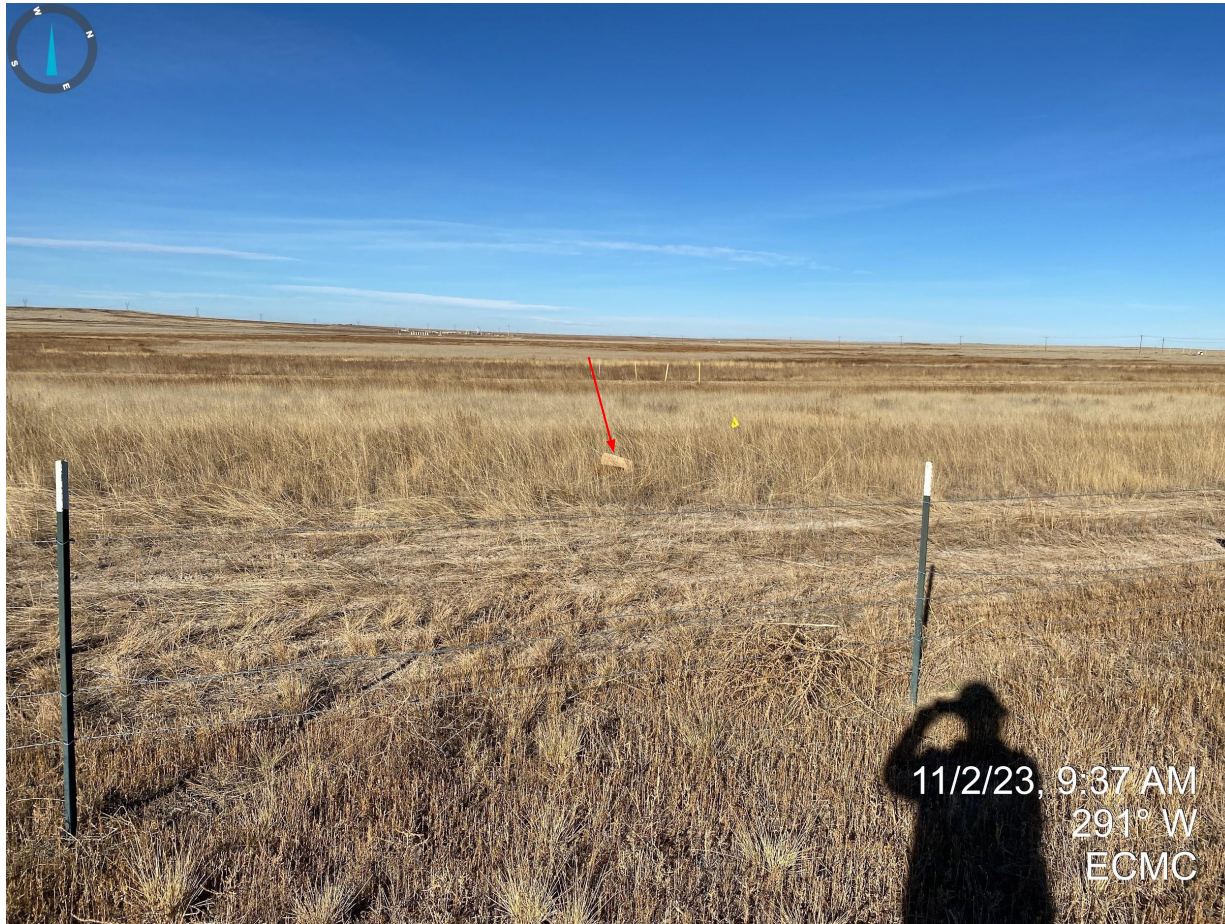
Photo 8. Taken from the western side of the location. Trash that has blown off location pictured.

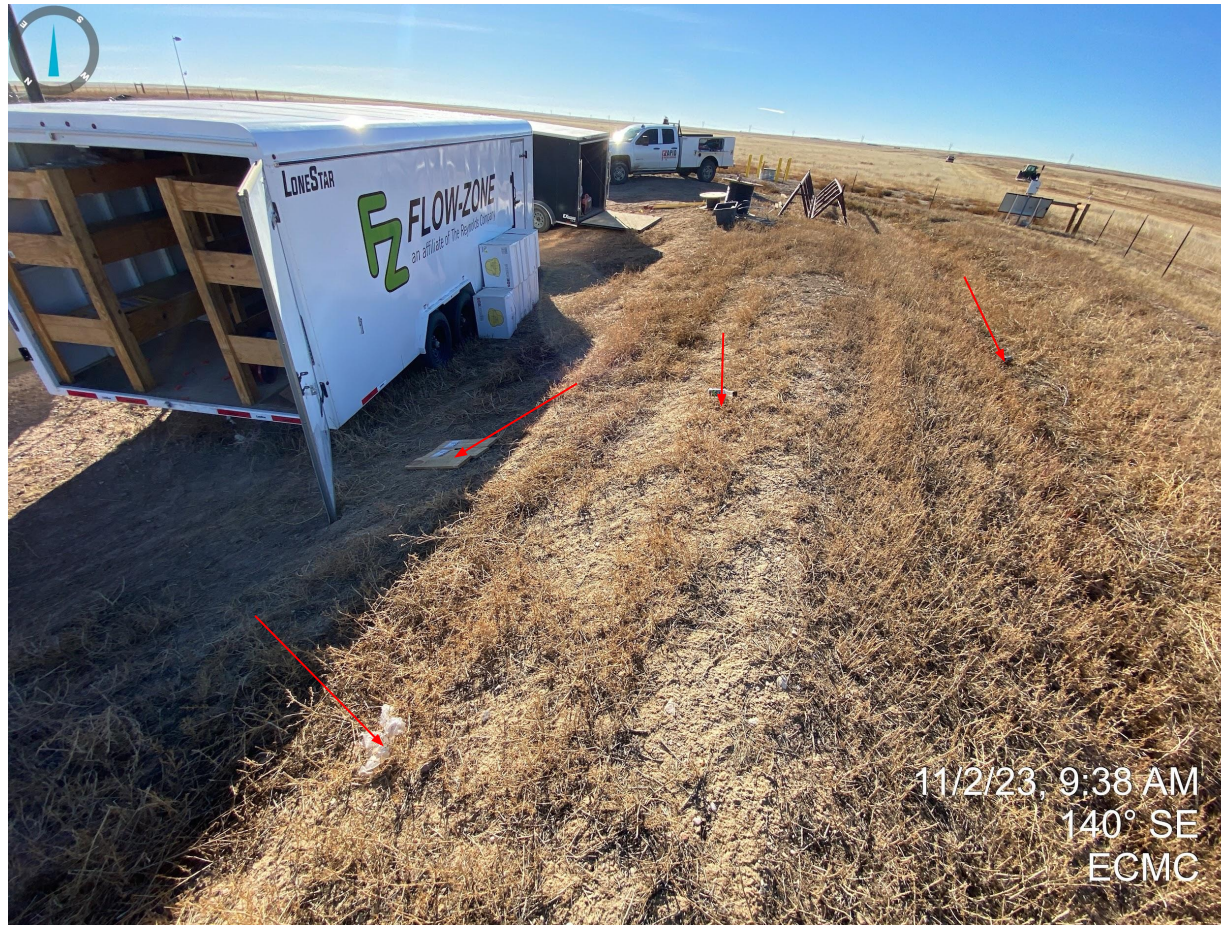
Photo 9. Taken from the southwestern corner of the location. See comments in Photo 7.

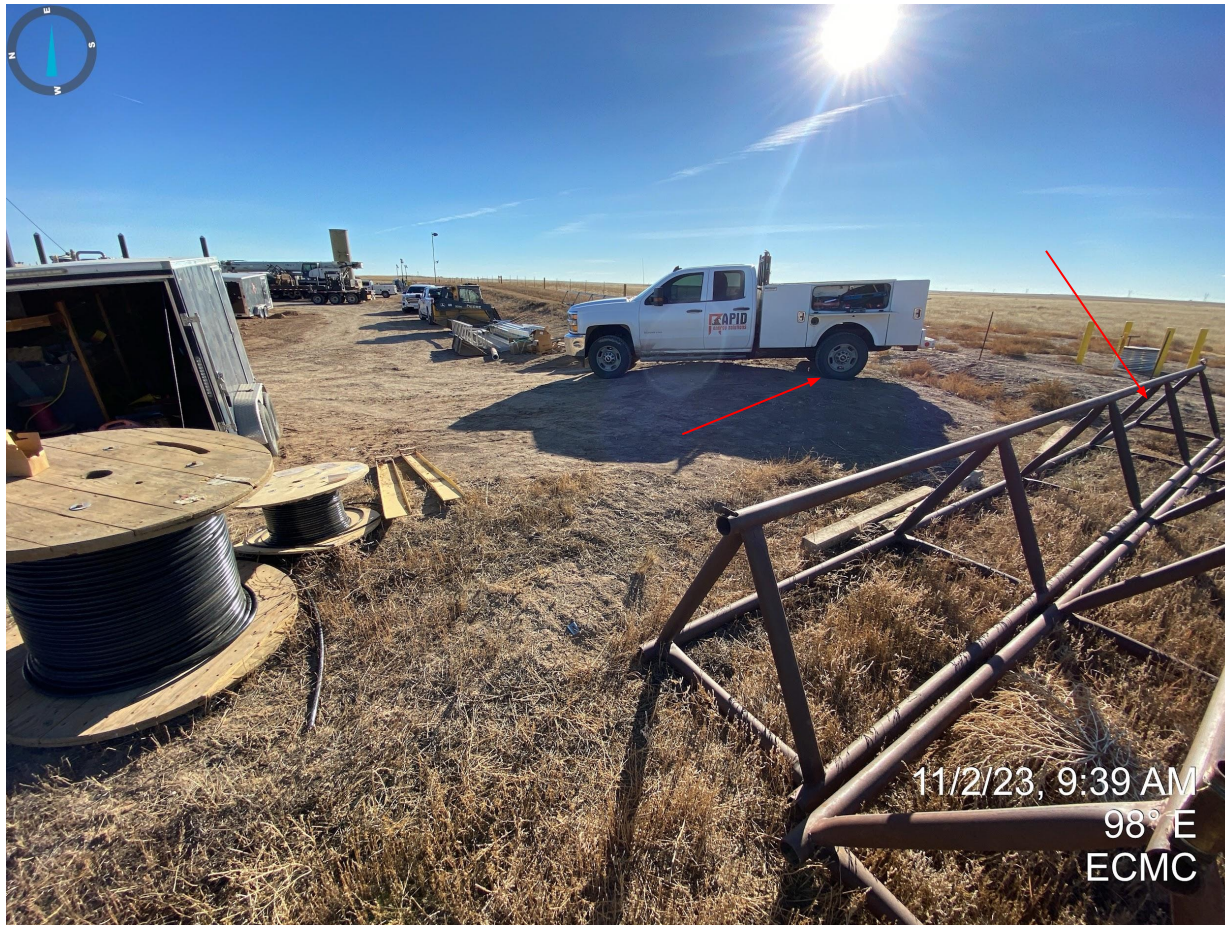
Photo 10. Taken from the southwestern corner of the location. Photo illustrates equipment/supplies placed on the perimeter stormwater ditch and berm.

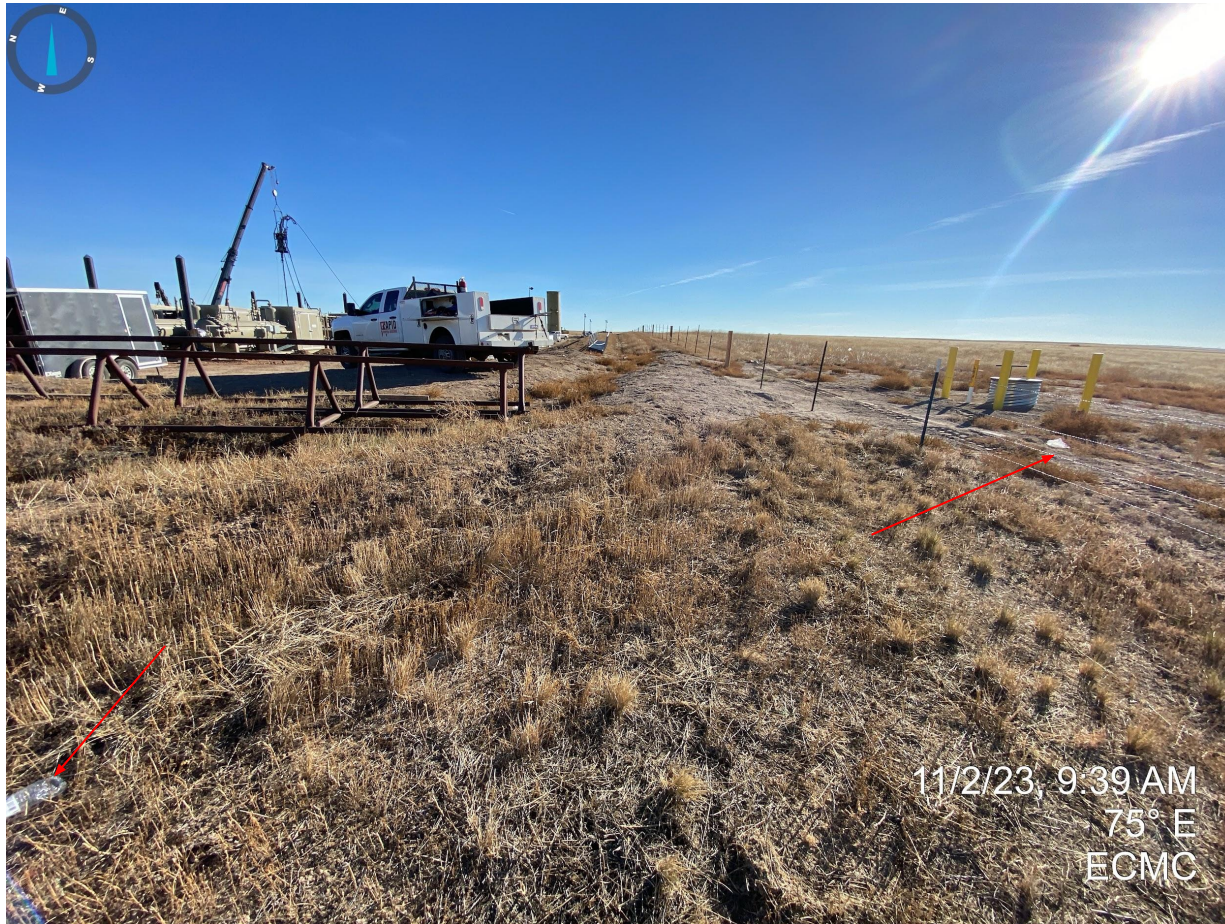
Photo 11. Taken from the southwestern corner of the location. See comments in Photo 7.

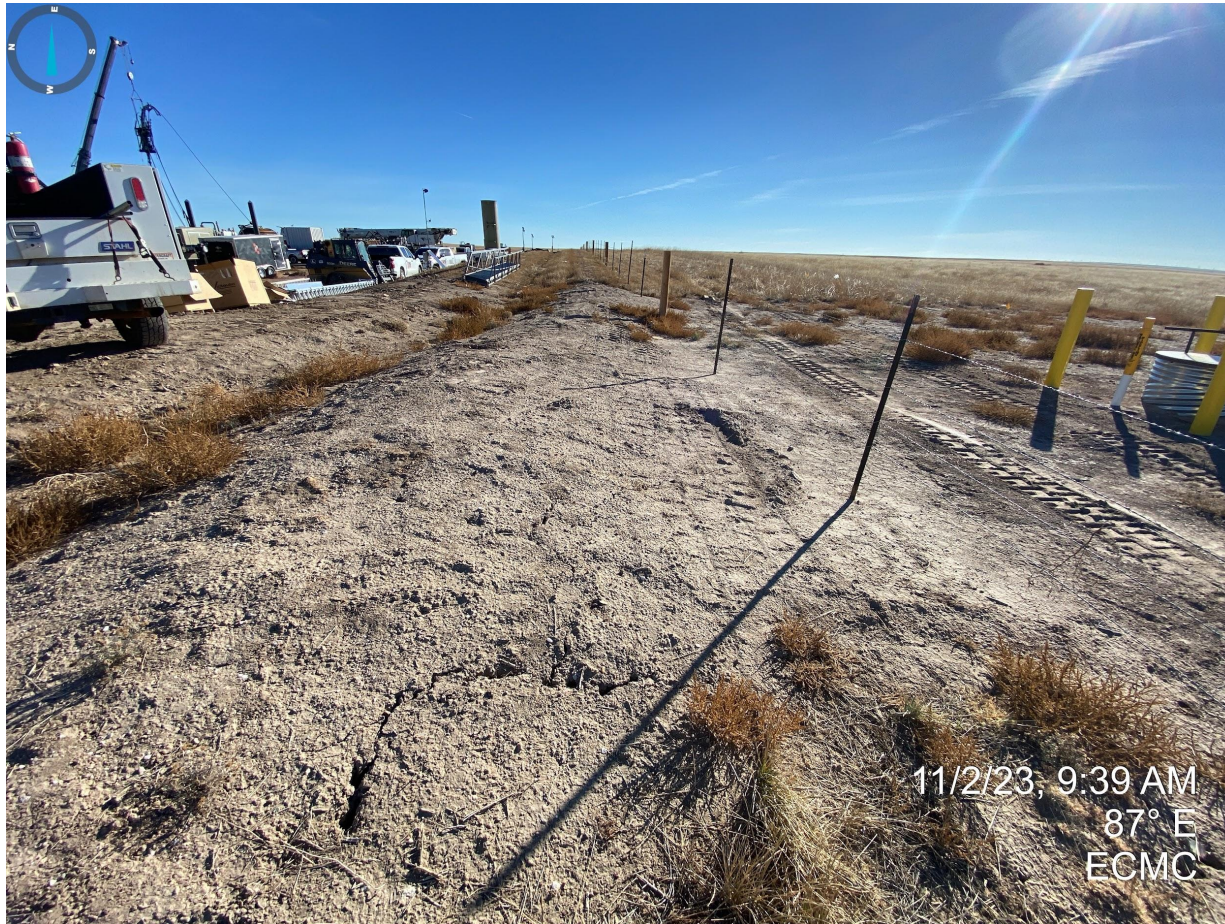
Photo 12. Taken from the southwestern corner of the location. Photo illustrates unstabilized soils within the perimeter stormwater control and disturbance area limits. Additional stabilization BMPs are required to prevent erosion degradation from occurring.

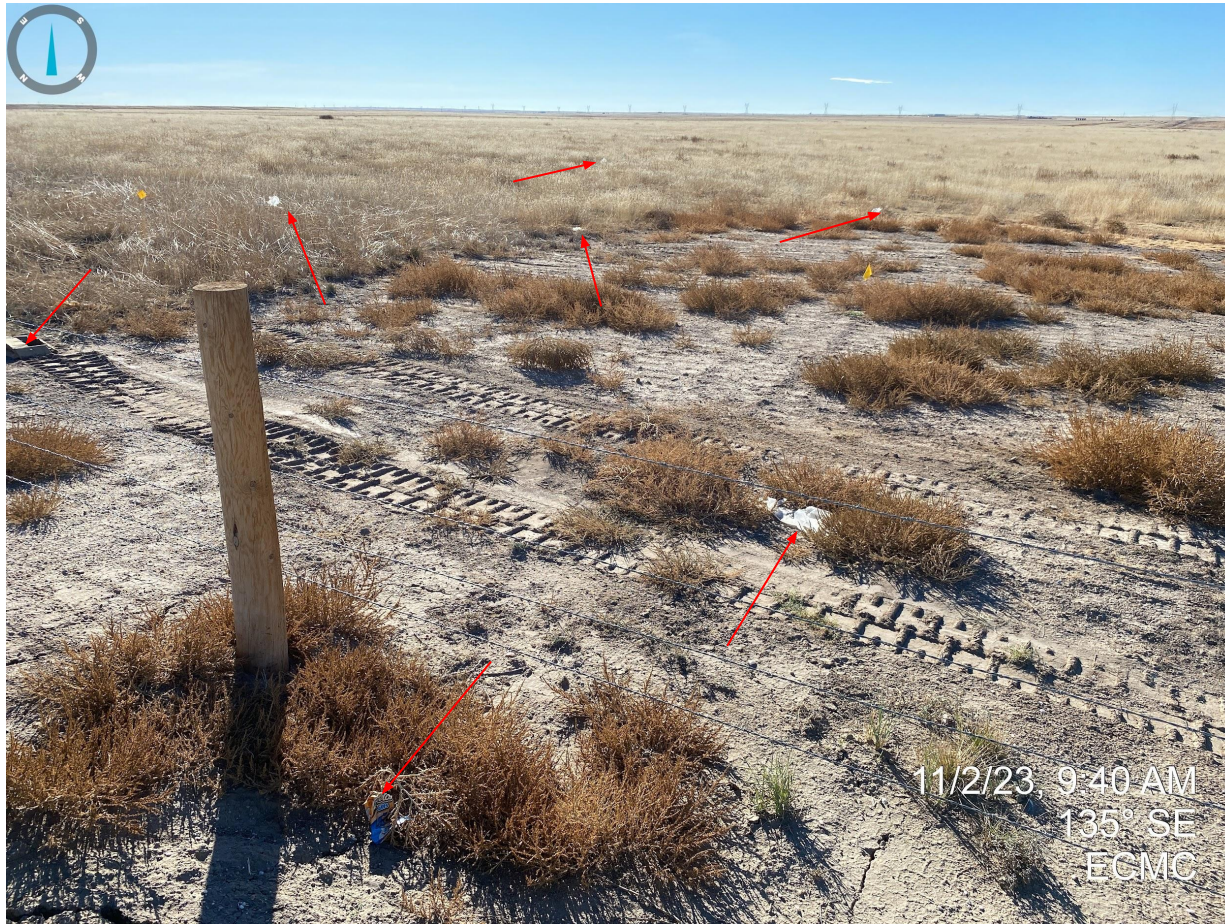
Photo 13. Taken near the southwest corner of the location. Photo illustrates trash that has blown off location.

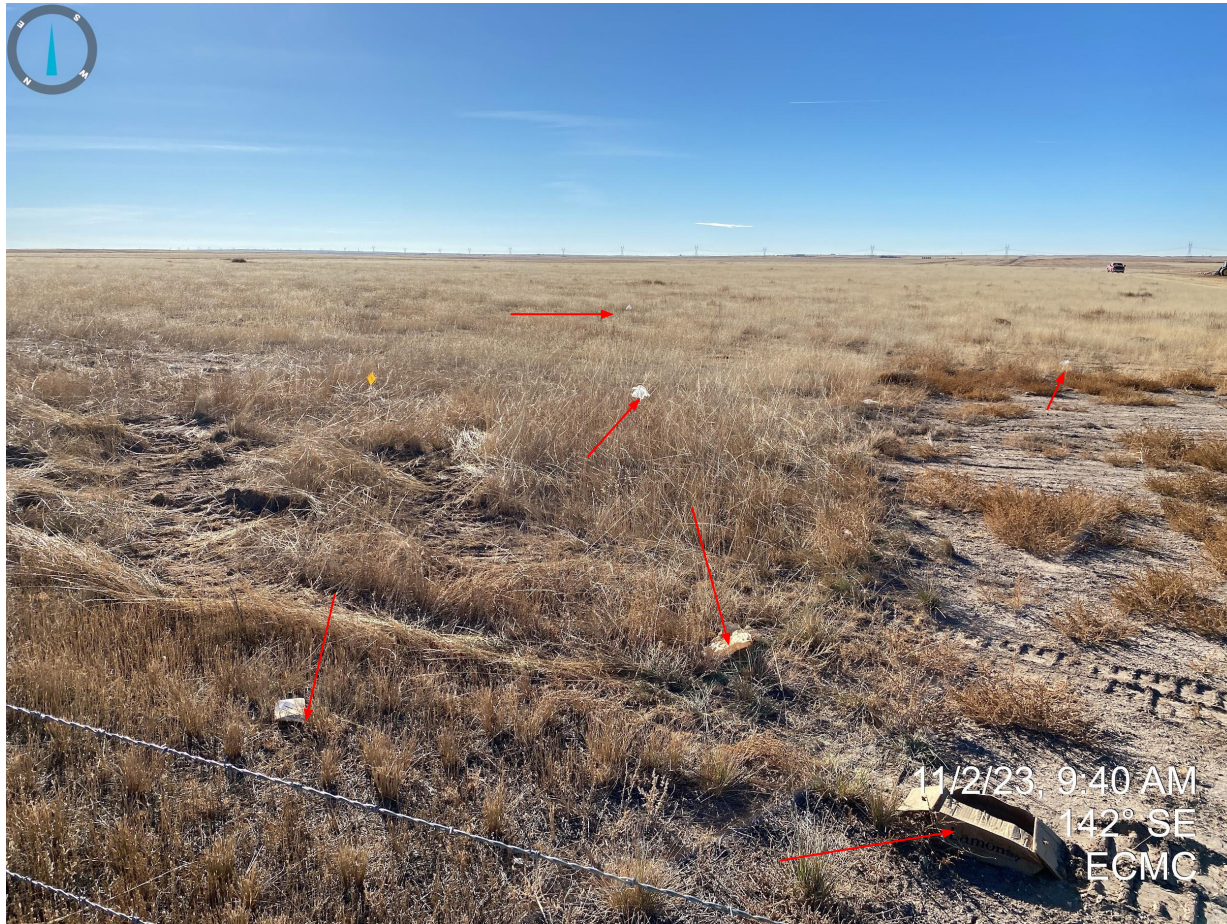
Photo 14. See comments in Photo 13.

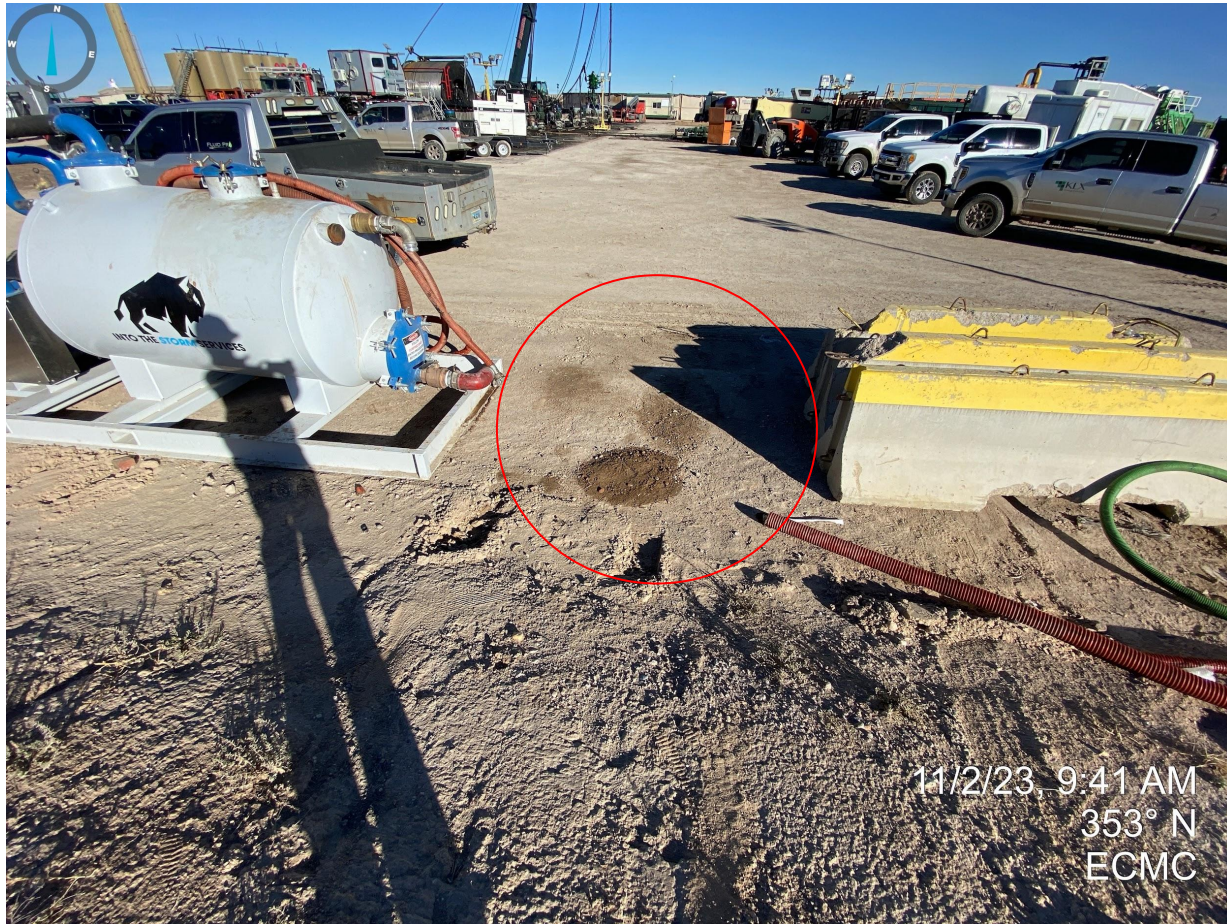
Photo 15. Stained soil observed on the southern portion of the location.

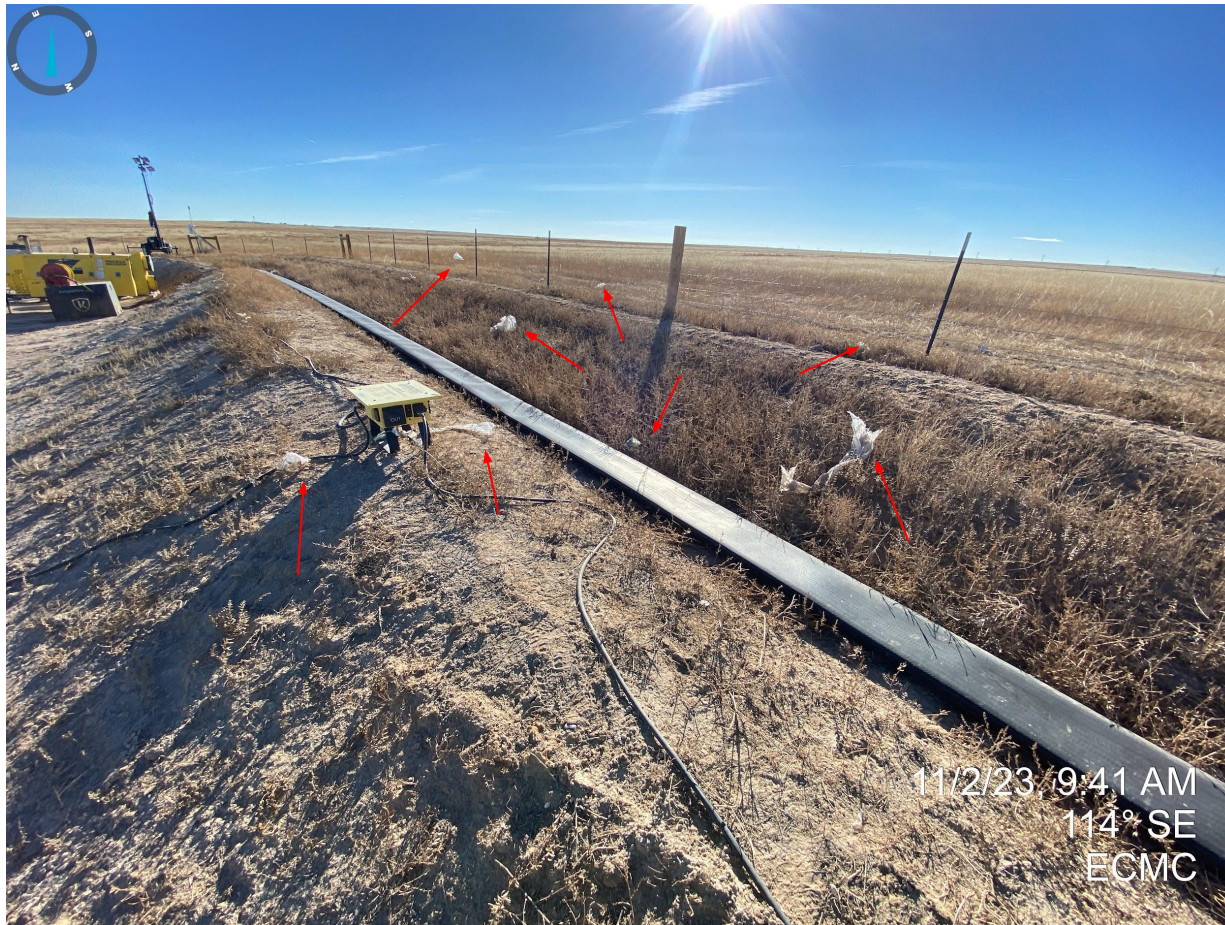
Photo 16. Taken from the southern portion of the location. Photo illustrates trash observed.

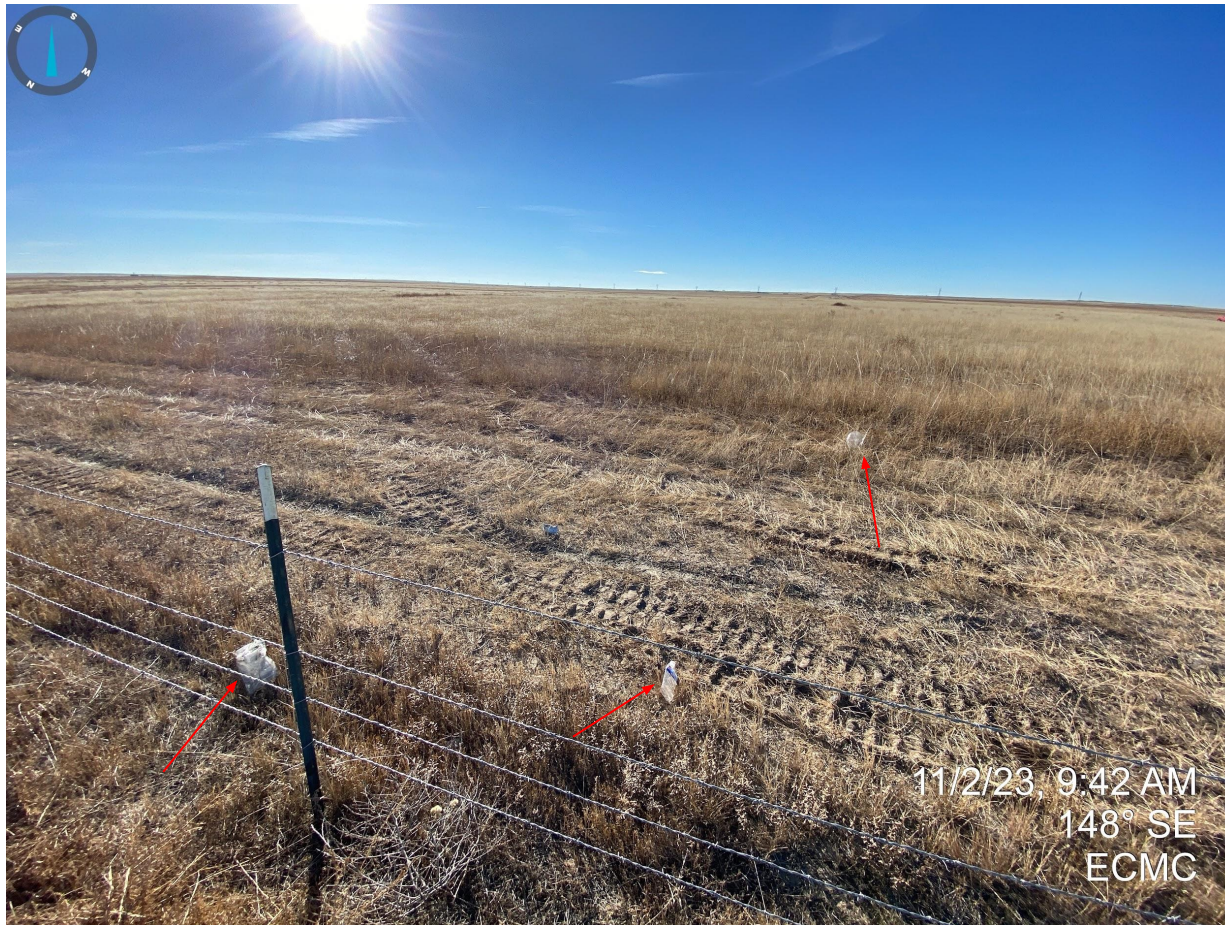
Photo 17. Continued from Photo 16. Trash observed to have blown off location.

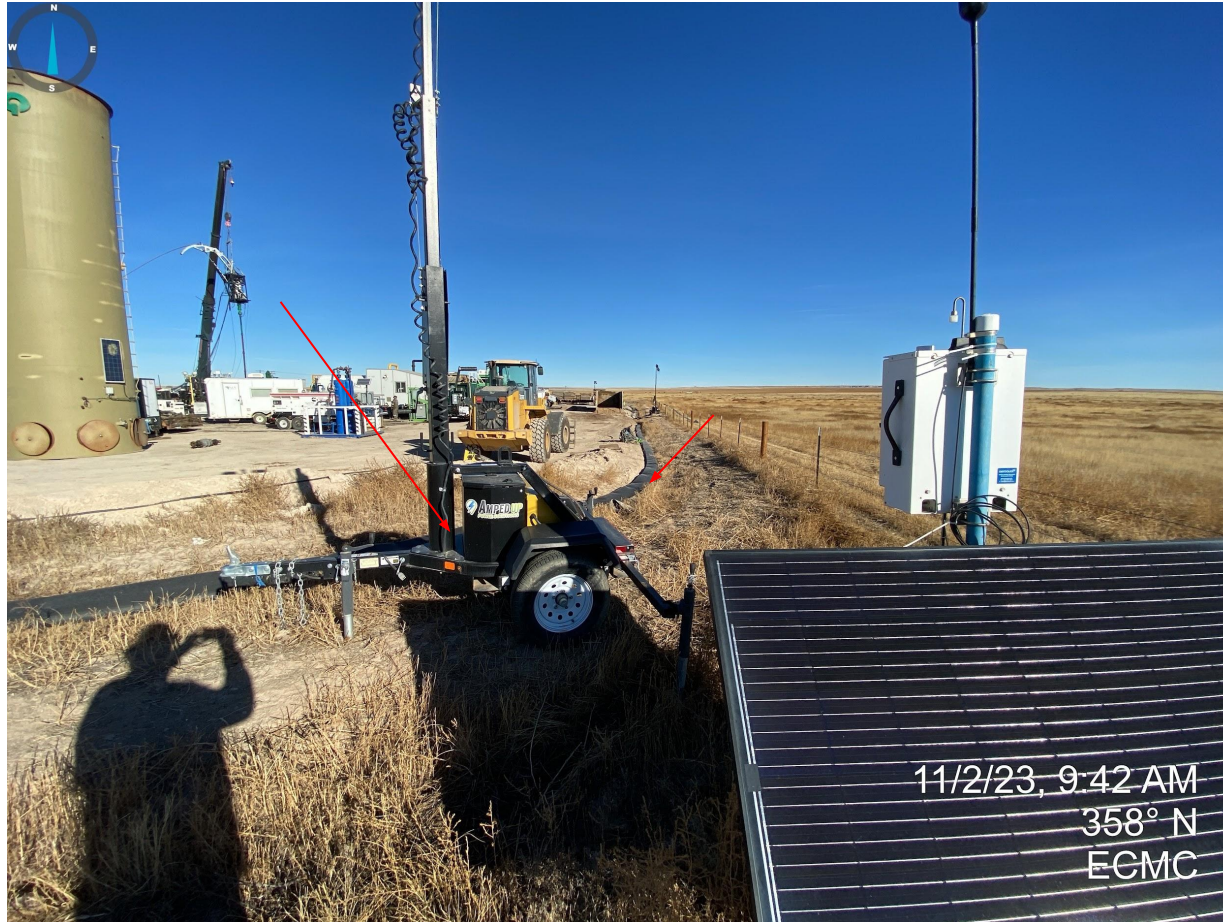
Photo 18. Taken from the southeastern corner of the location. Photo illustrates equipment within the perimeter stormwater controls (e.g. ditch and berms).

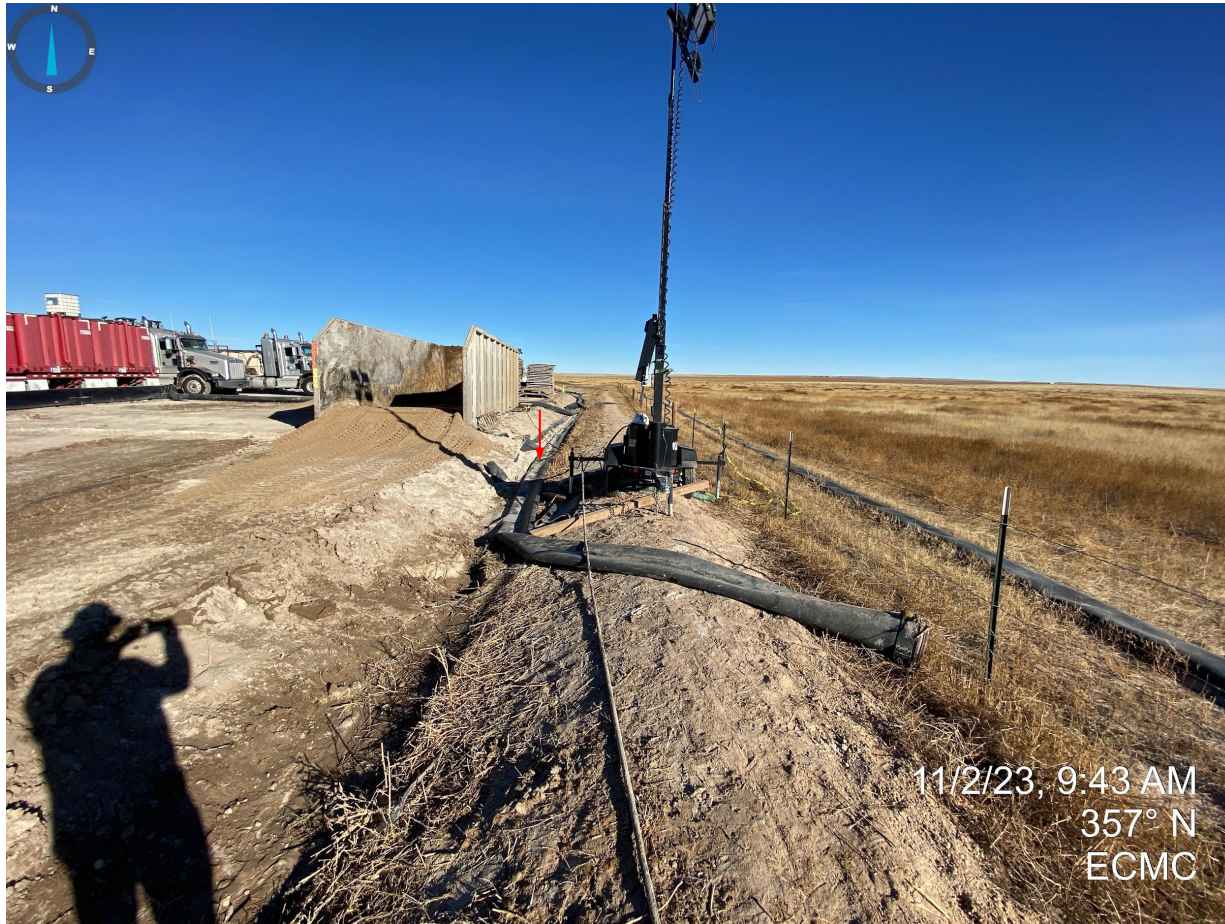
Photo 19. Eastern side of the location. See comments in Photo 18.

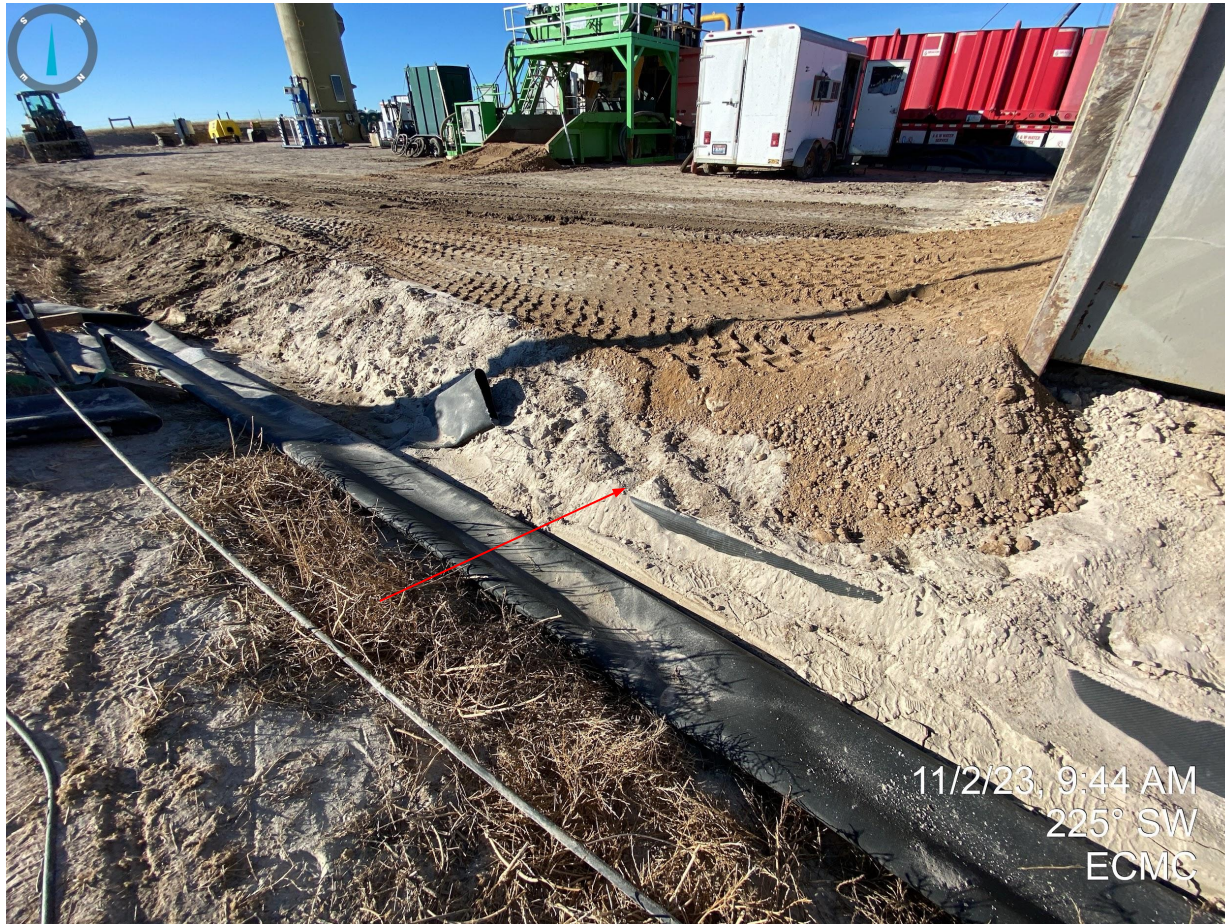
Photo 20. Taken from the eastern side of the location. Photo illustrates unknown and unconsolidated materials within the perimeter stormwater control.
