Construction and Stormwater Inspection

Date: 11/02/2023

Operator: CIVITAS NORTH LLC - 10661

Inspection Photos
Location Name: Canvasback Pad
Location ID: 461821

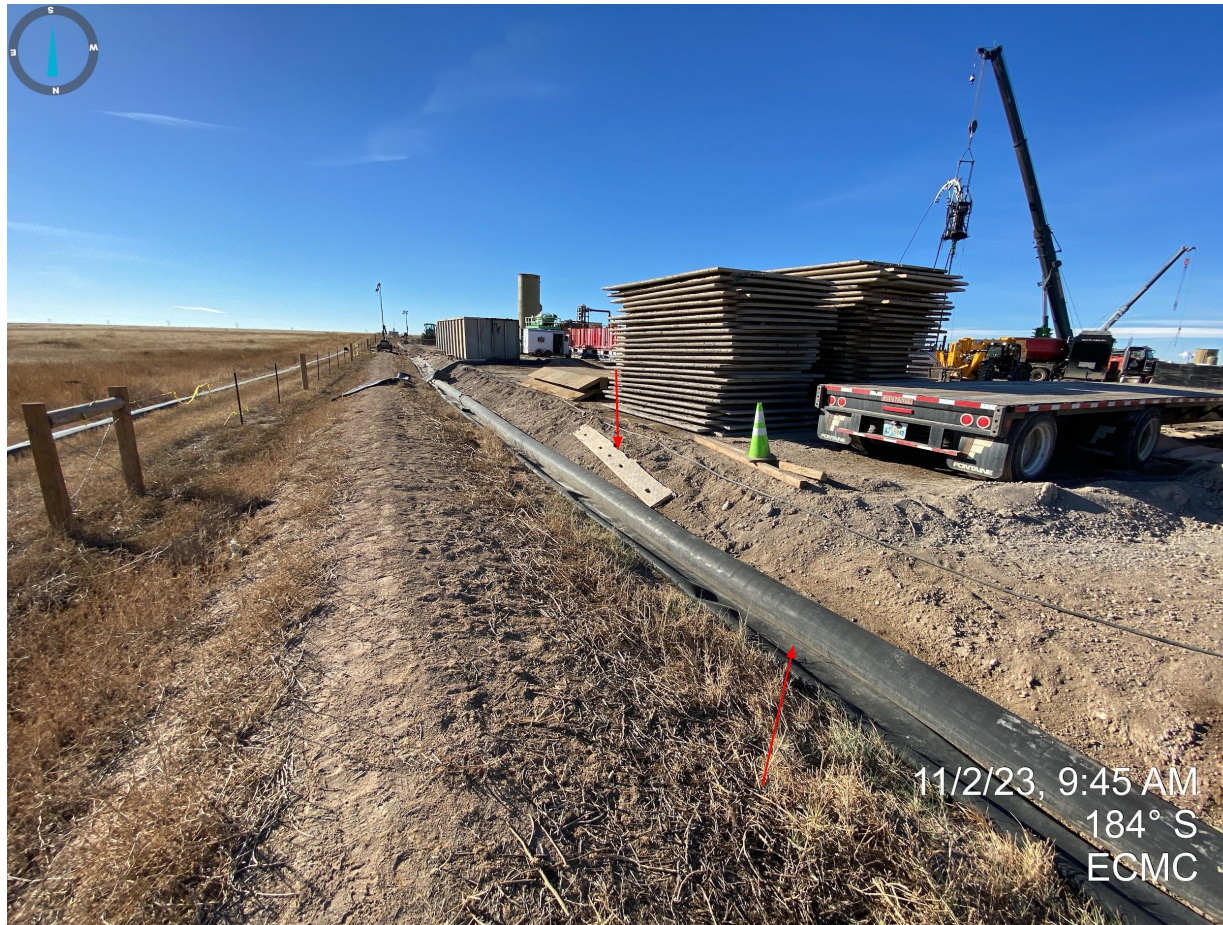
Photo 18. Taken from the southeastern corner of the location. Photo illustrates equipment within the perimeter stormwater controls (e.g. ditch and berms).

Photo 21. Eastern side of the location. See comments in Photo 18.

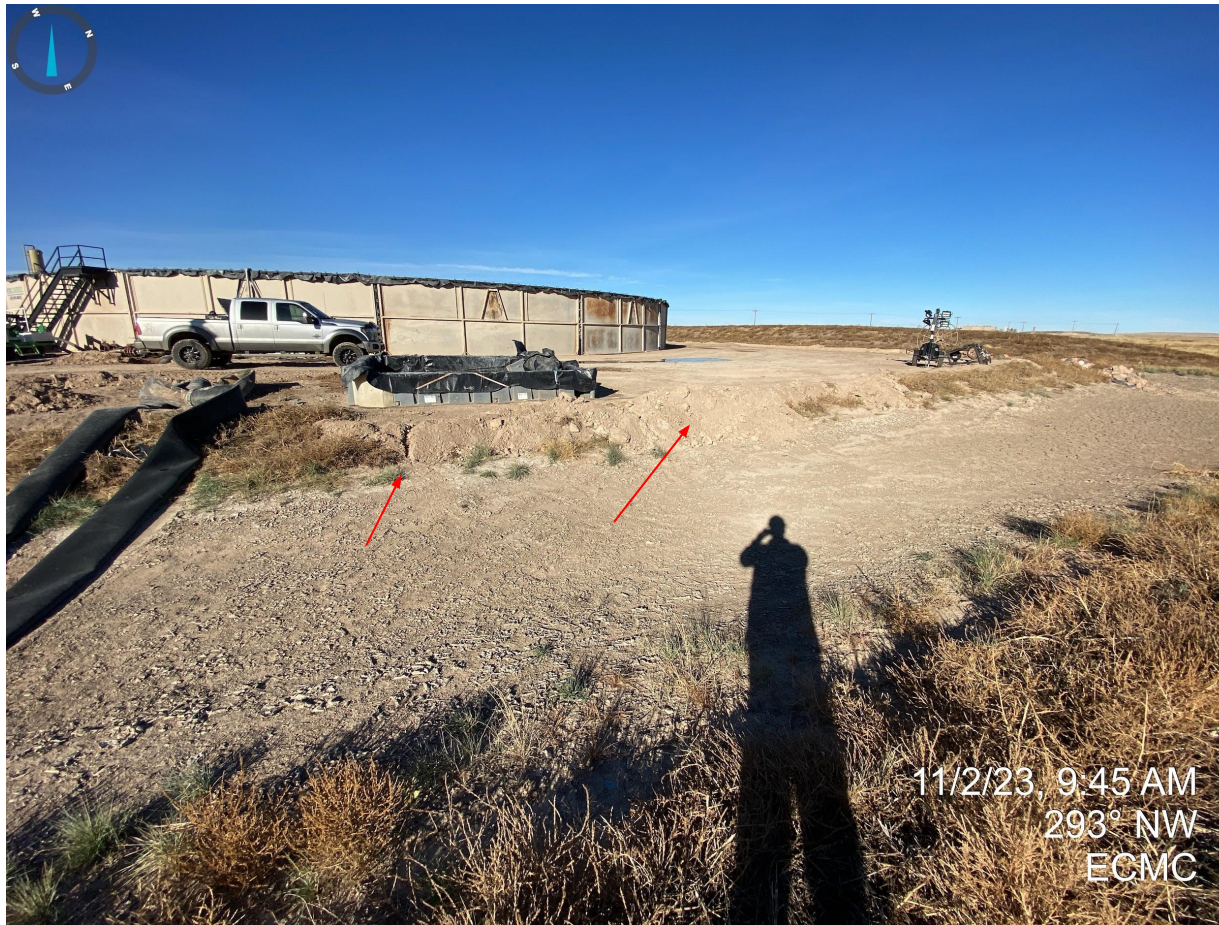
Photo22. Unstabilized soils and erosion degradation (e.g. rilling) occurring within the sediment basin on the northeast corner of the location.

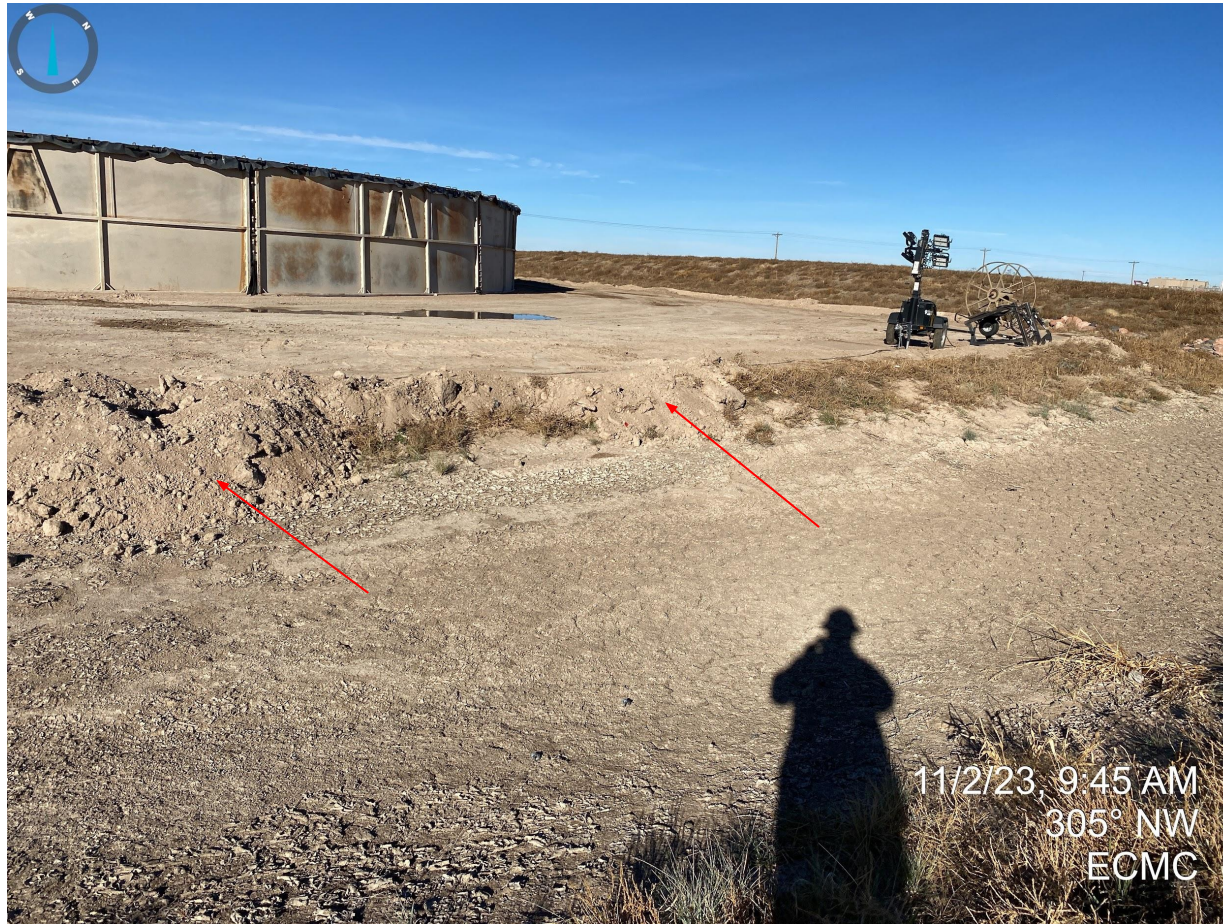
Photo 23. Continued from Photo 22.

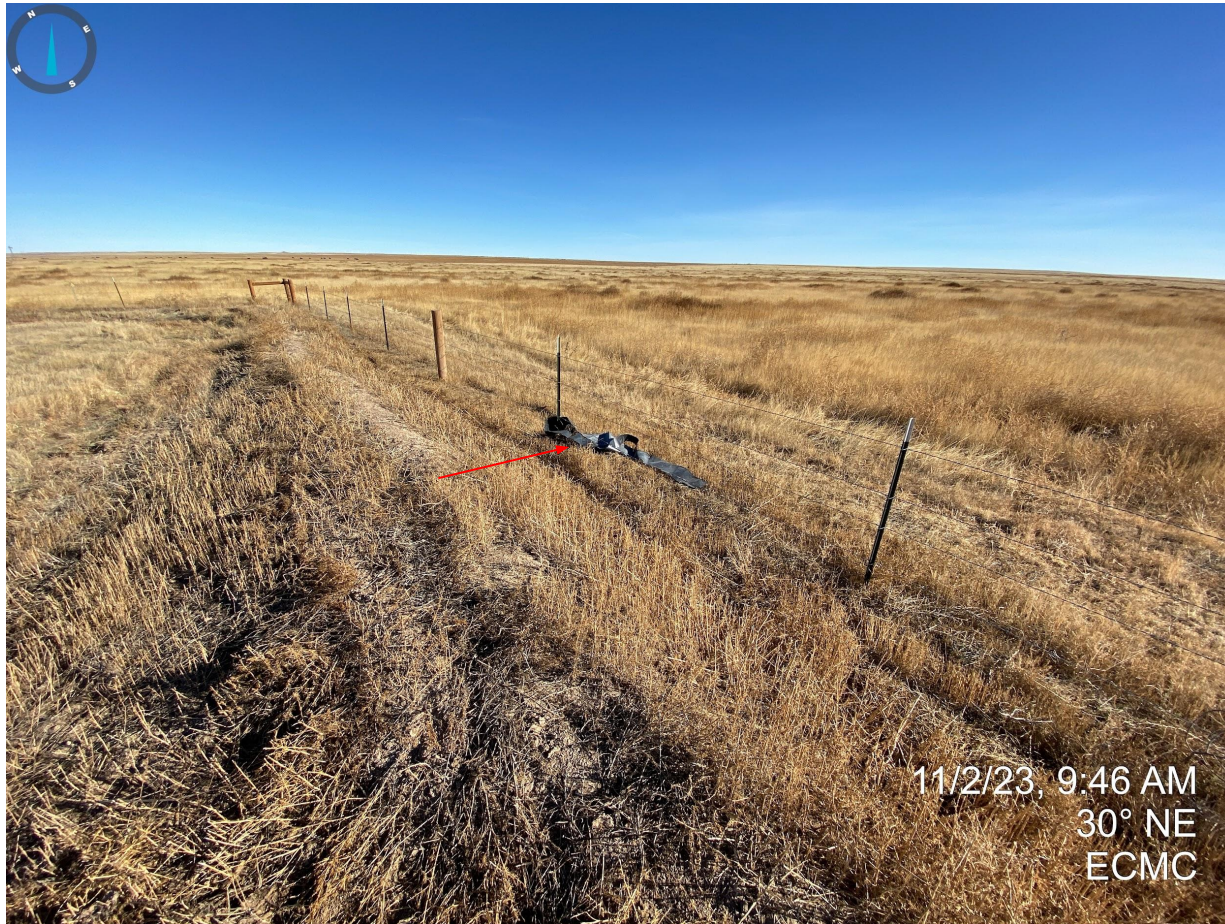
Photo 24. Trash observed within the northeast corner of the location.

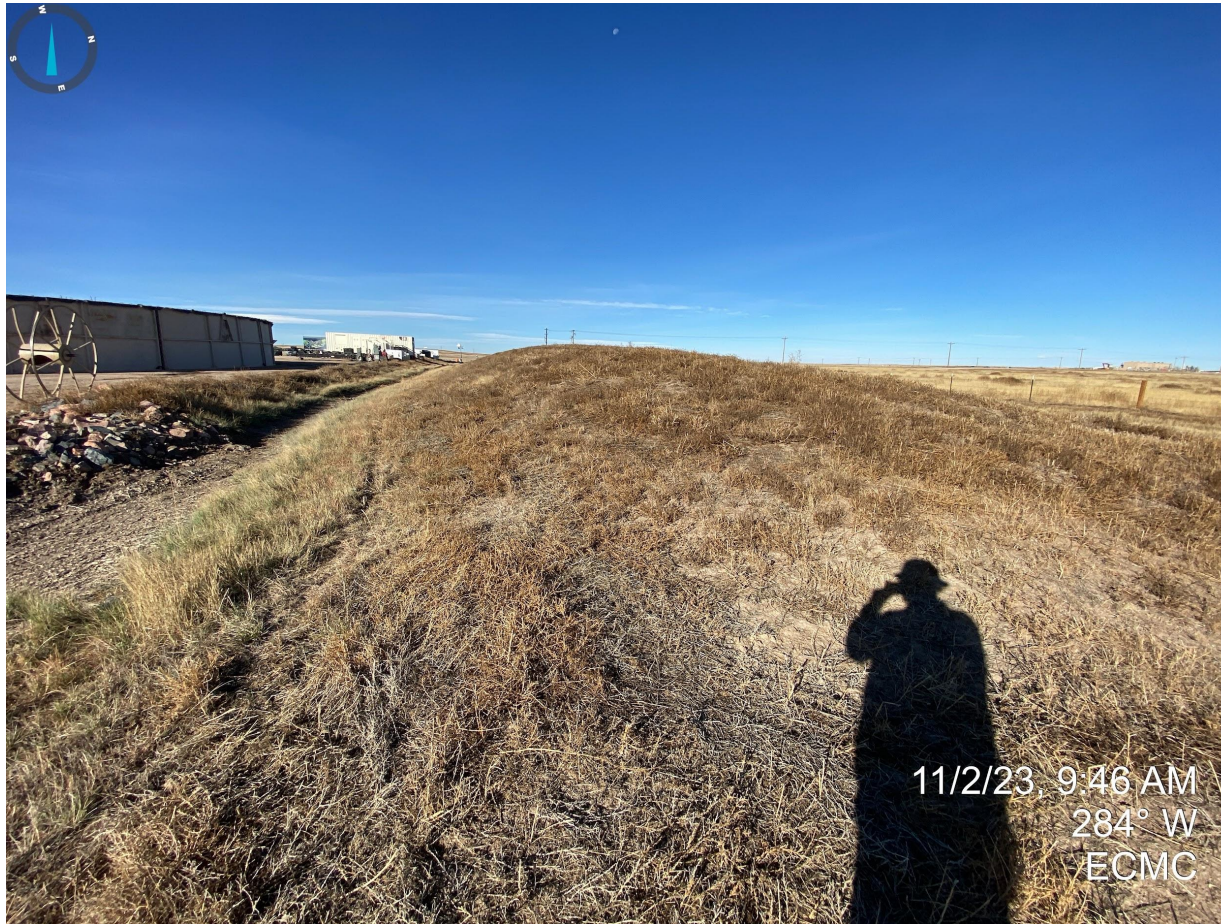
Photo 25. Undesirable vegetation (e.g. kochia and russian thistle) observed on the topsoil stockpile. It appears the weedy vegetation has been previously mowed, however, this is not a substitute for establishing desirable vegetation.

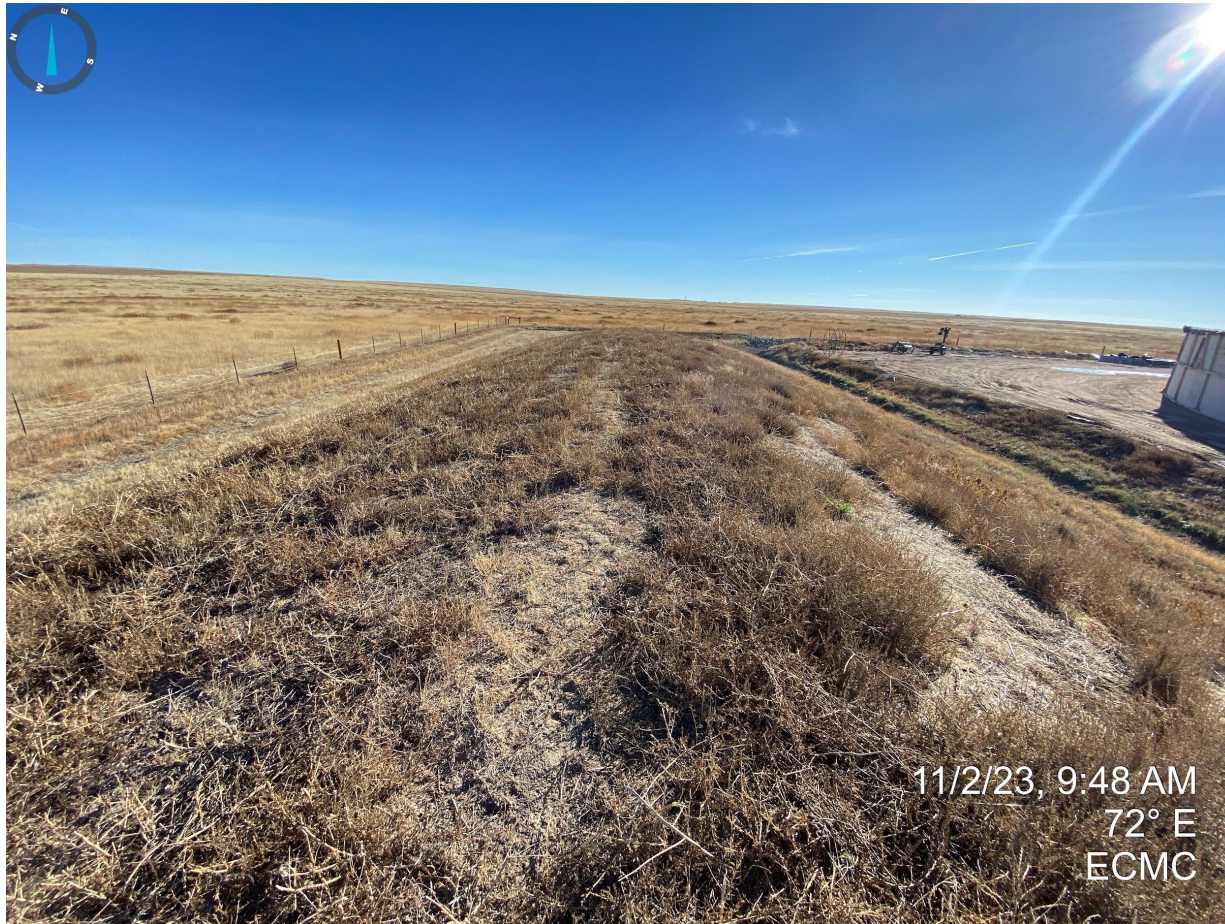
Photo 26. Taken from the center portion of the topsoil stockpile. See comments in Photo 25.
