Interim Reclamation and Stormwater Inspection

Operator: NOBLE ENERGY INC - 100322

Location ID: 431567

Location Name: Circle Ranch Federal

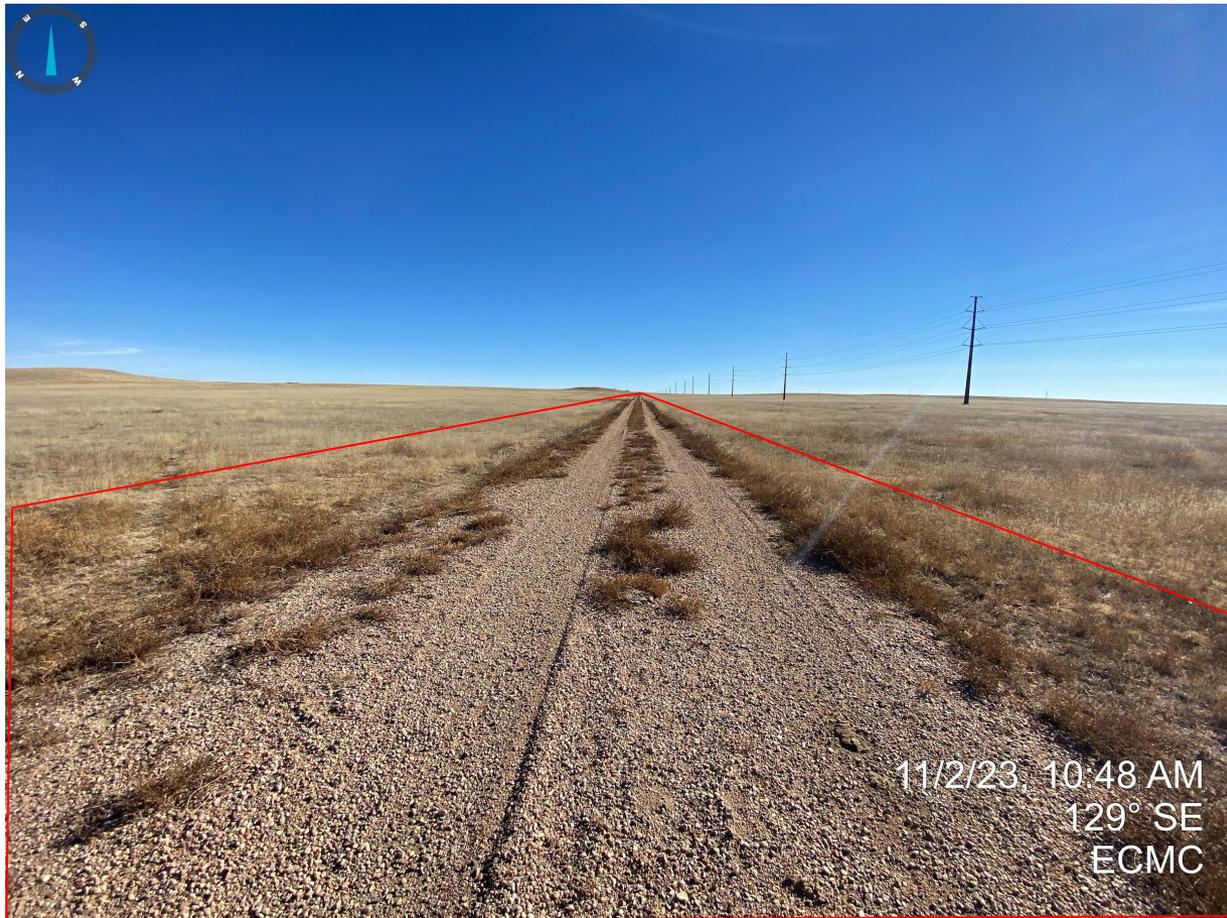
Photo 1. Undesirable vegetation (e.g. kochia and russian thistle) observed along the access road.

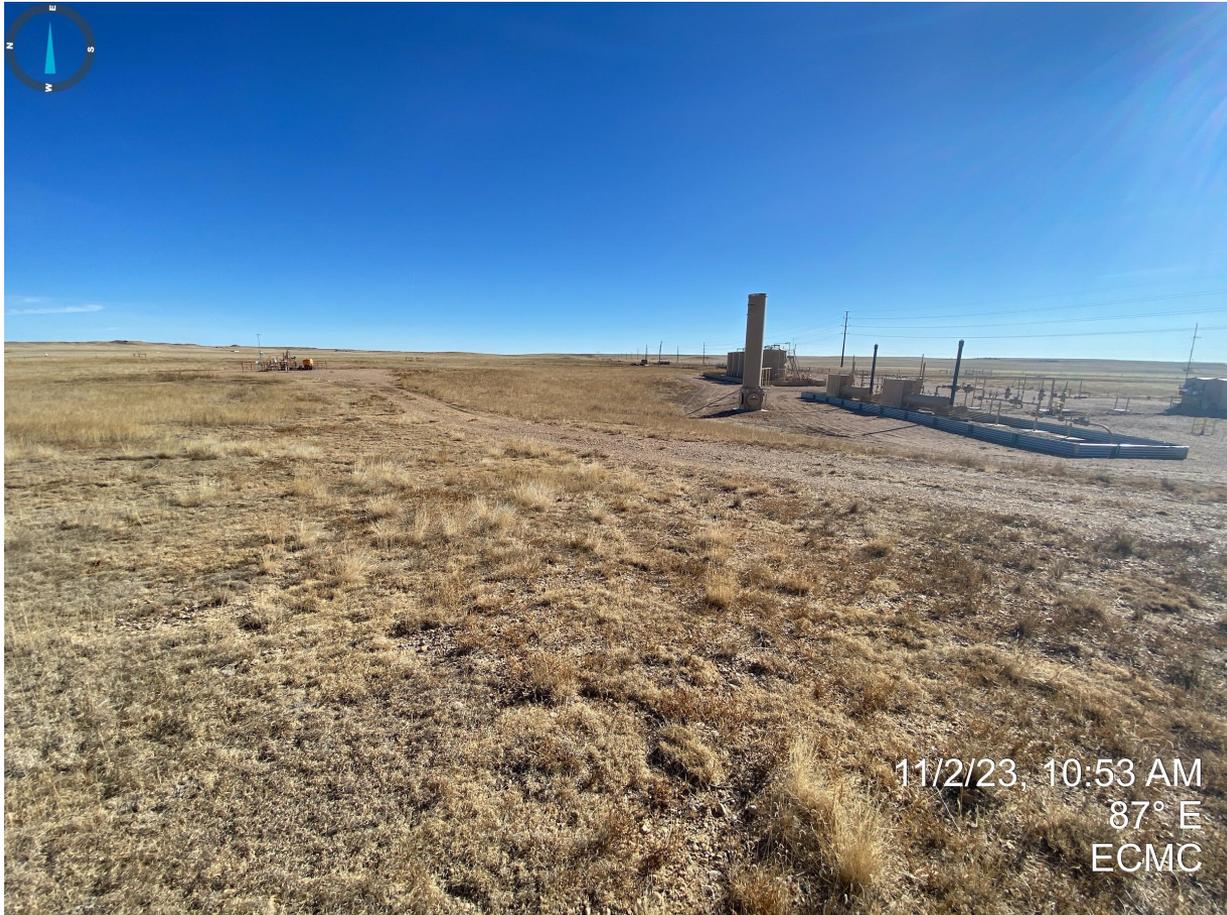
Photo 2. Interim areas appear to be progressing towards Rule 1003 standards with desirable vegetation observed throughout. A follow-up inspection will be performed during the next growing season to verify compliance with reclamation rules.

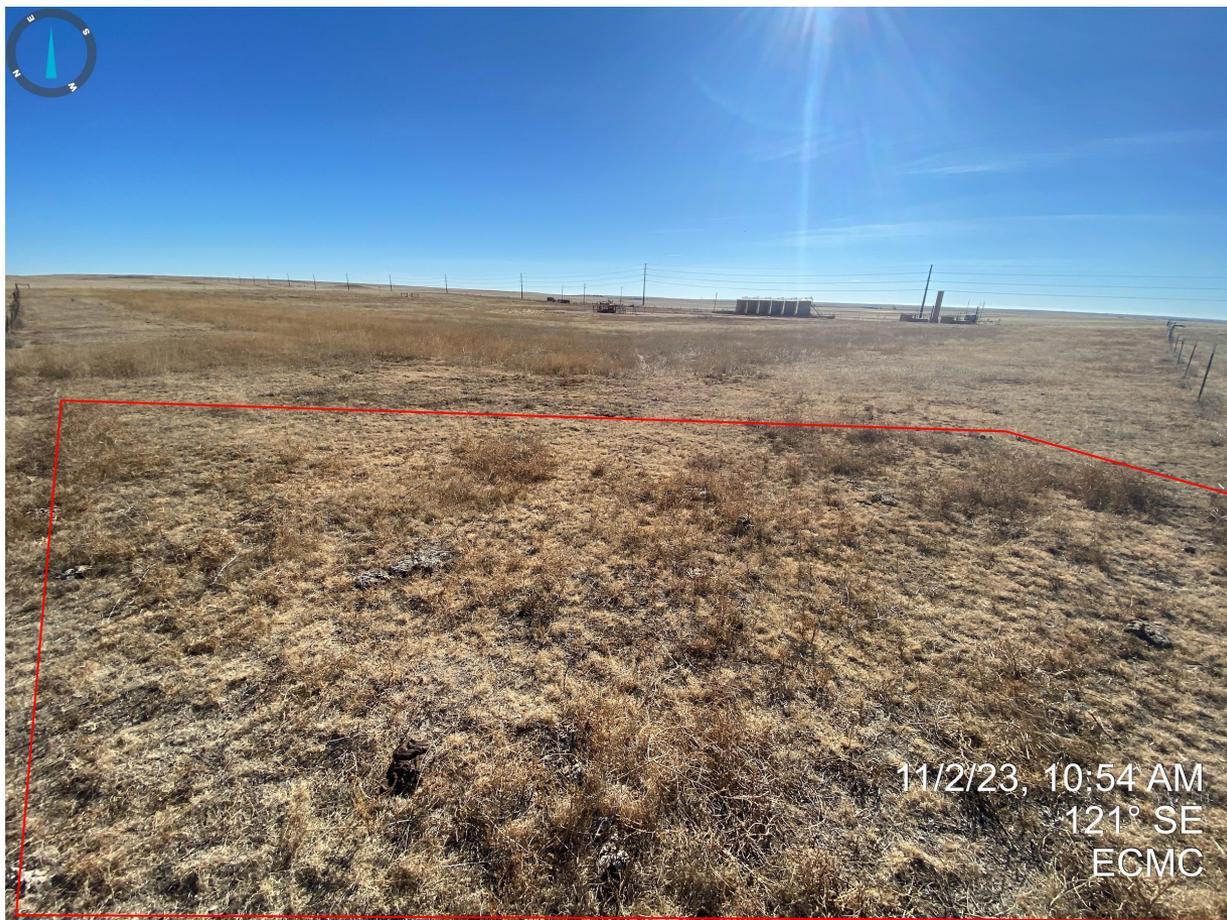
Photo 3. An isolated area of undesirable vegetation (e.g. russian thistle and kochia) observed in the northwest corner of the location. This is now considered debris as the tumbleweeds can easily break and distribute seeds off location

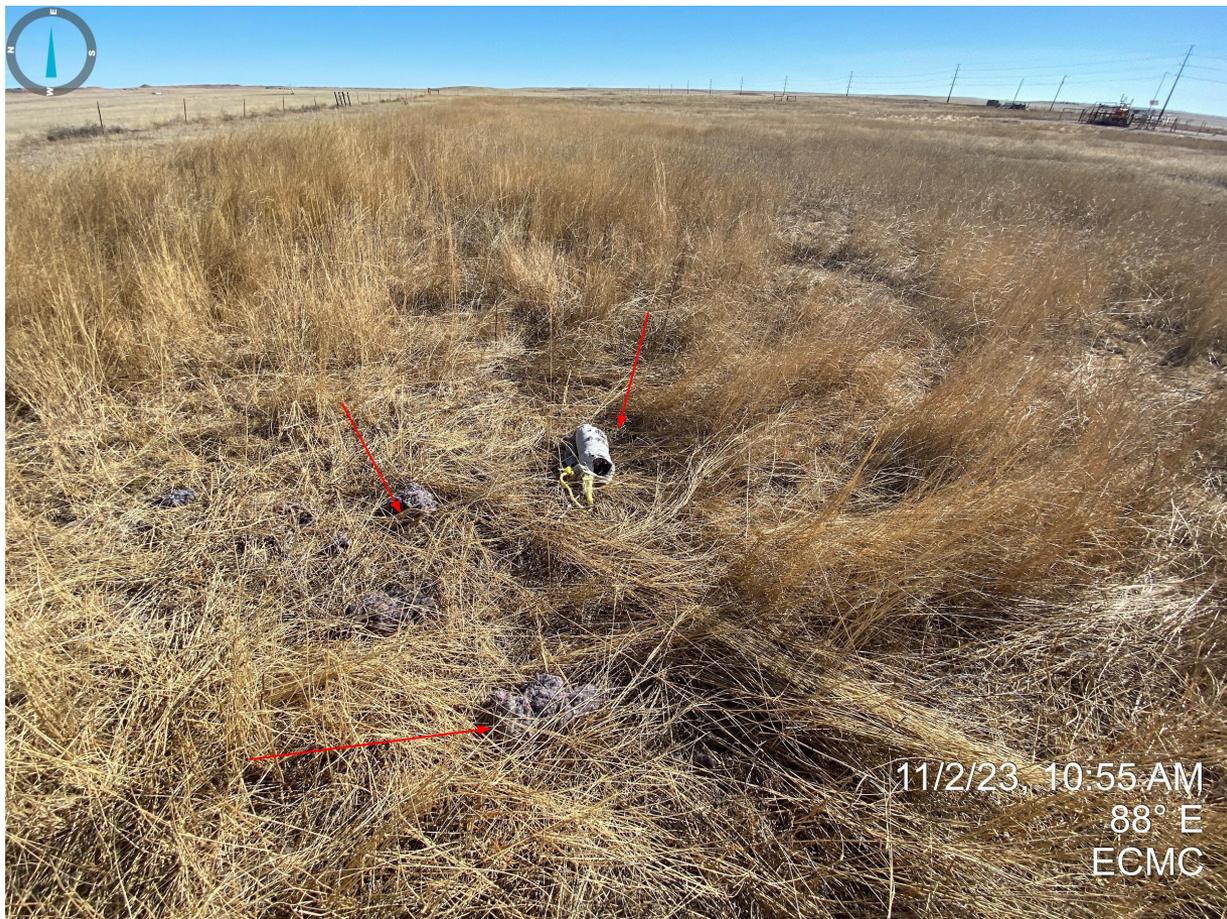
Photo 4. Trash observed in the northwest corner of the location.

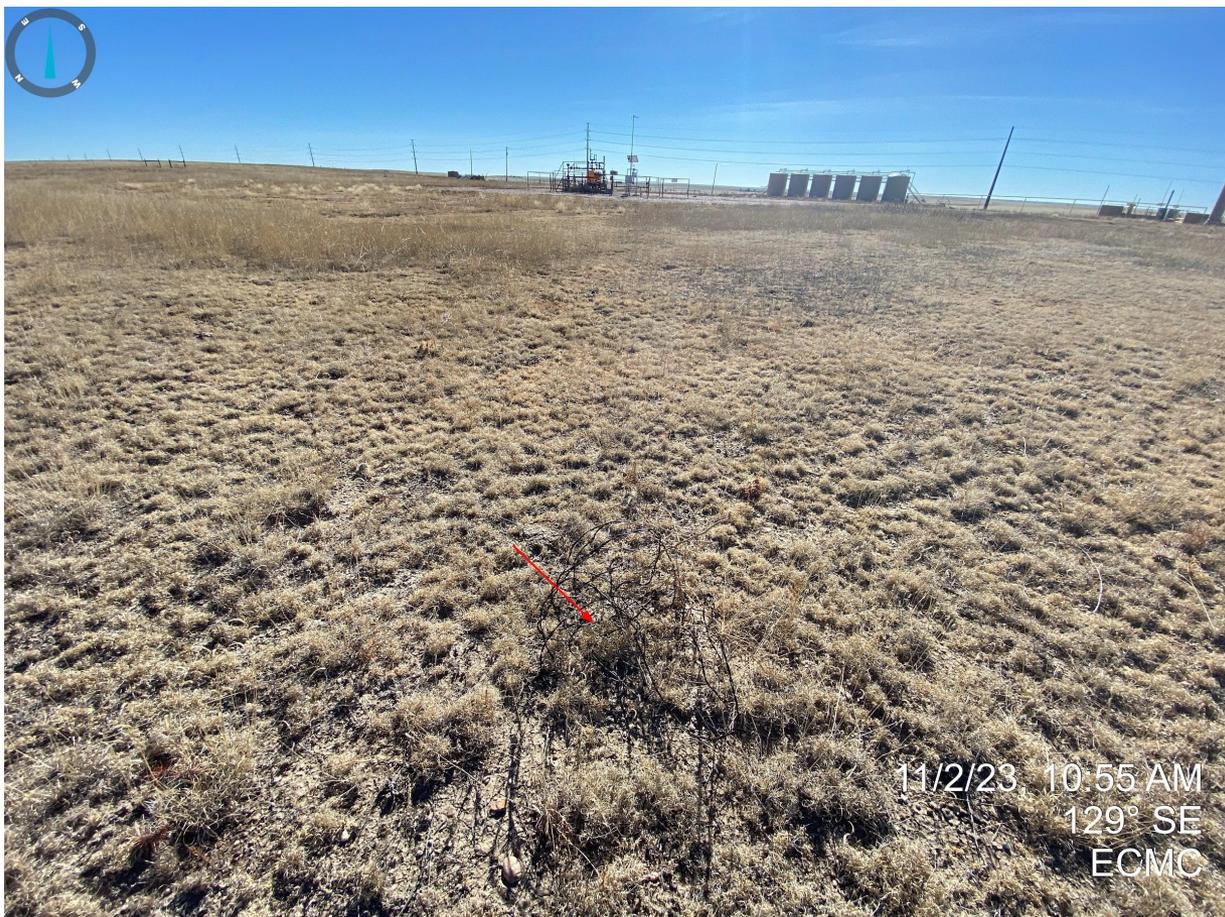
Photo 5. Trash (barb wire) observed northwest of the wellhead.

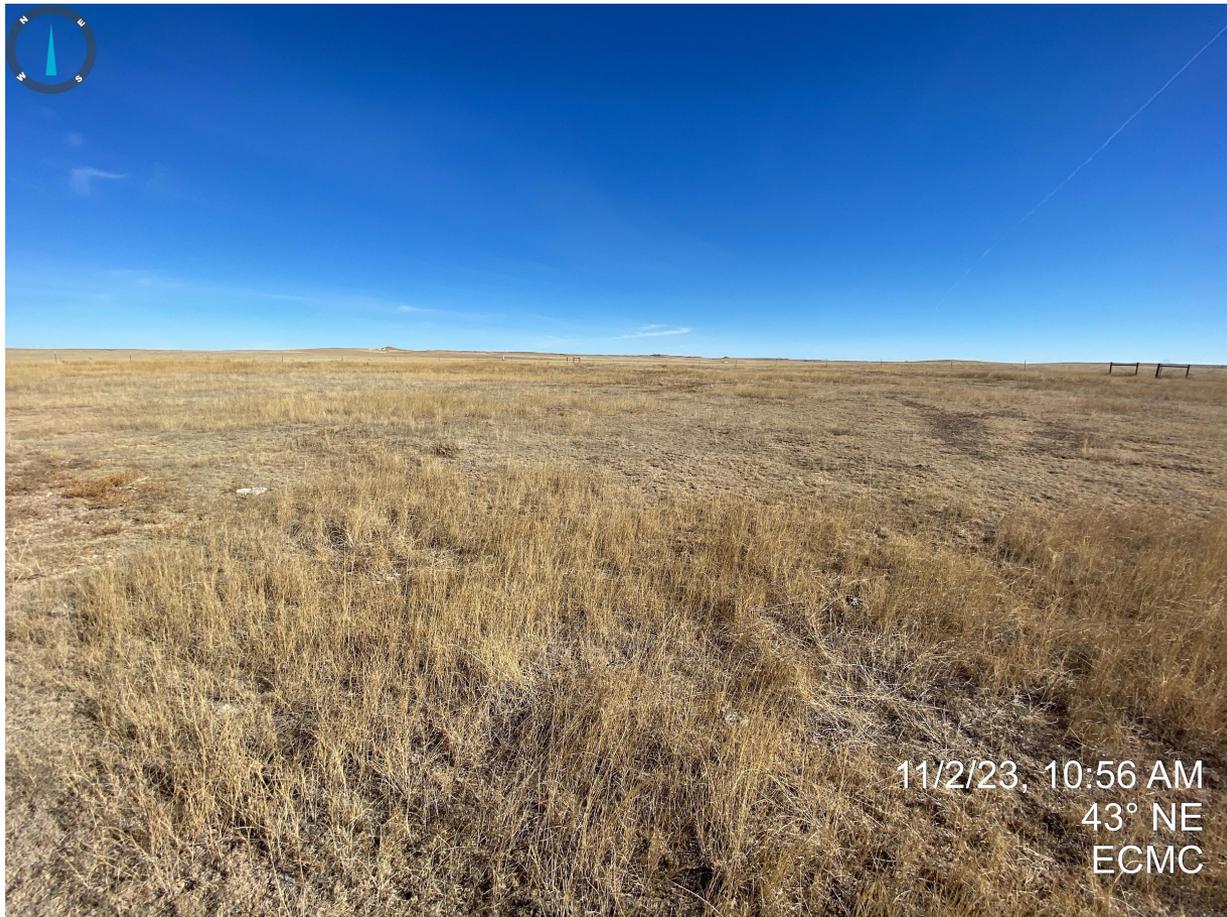
Photo 6. facing towards the northeast corner of the interim areas. Interim areas appear to be progressing towards Rule 1003 standards with desirable vegetation observed throughout. A follow-up inspection will be performed during the next growing season to verify compliance with reclamation rules.

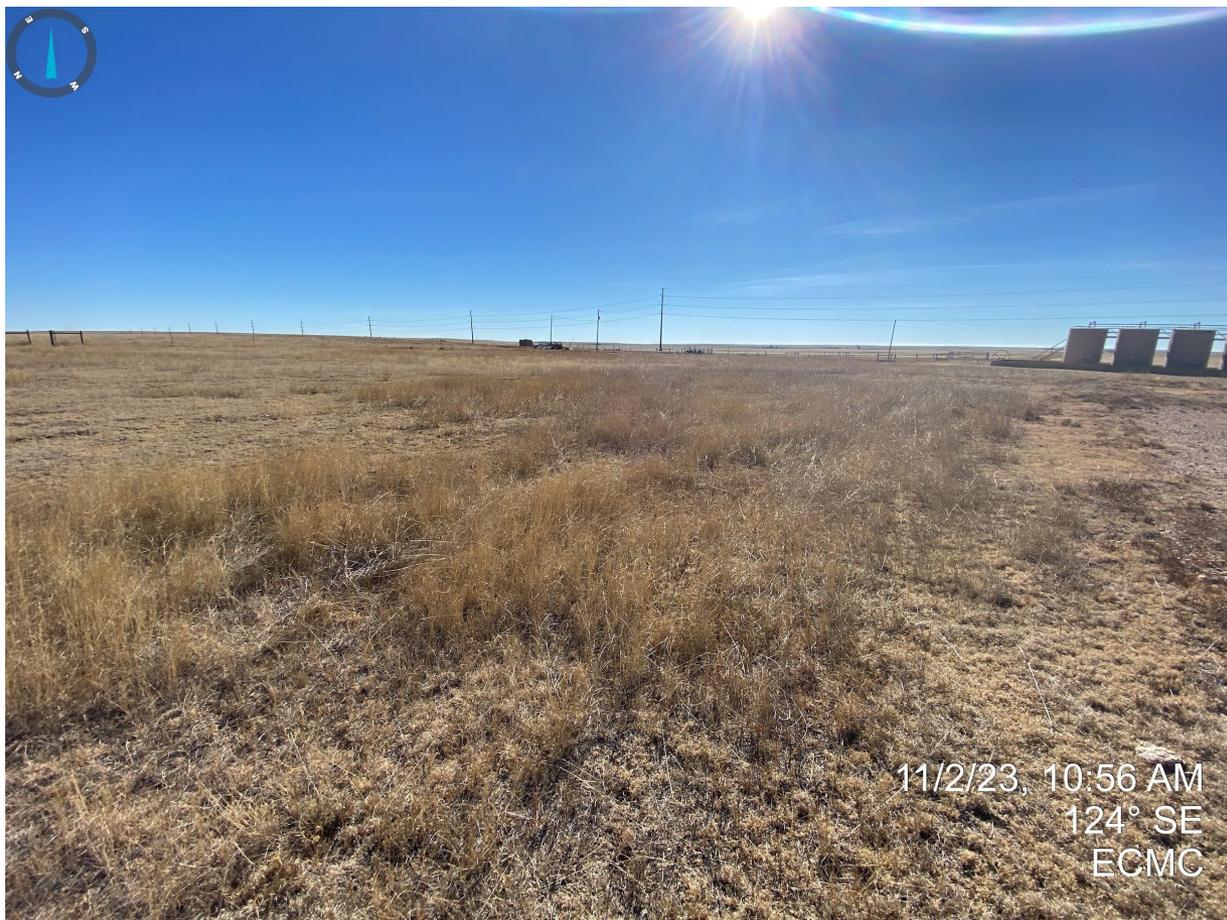
Photo 7. Facing towards the southeast corner of the interim areas. Interim areas appear to be progressing towards Rule 1003 standards with desirable vegetation observed throughout. A follow-up inspection will be performed during the next growing season to verify compliance with reclamation rules.

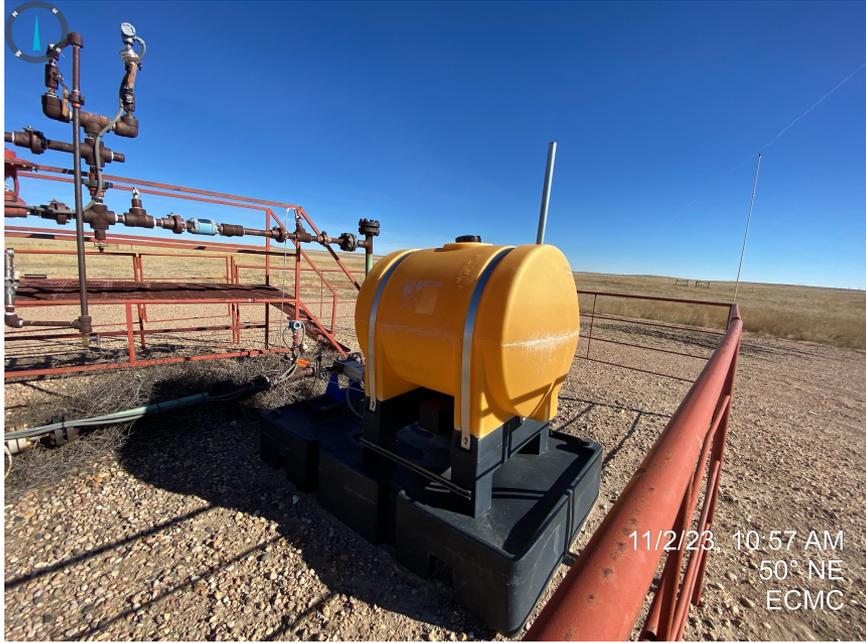
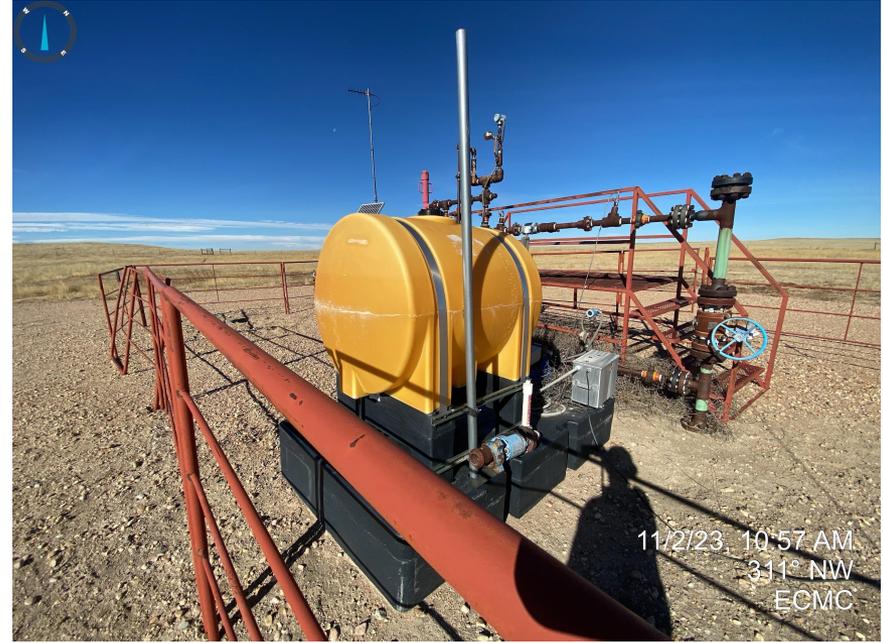
Photo 8. No labels at the day tank near the wellhead.

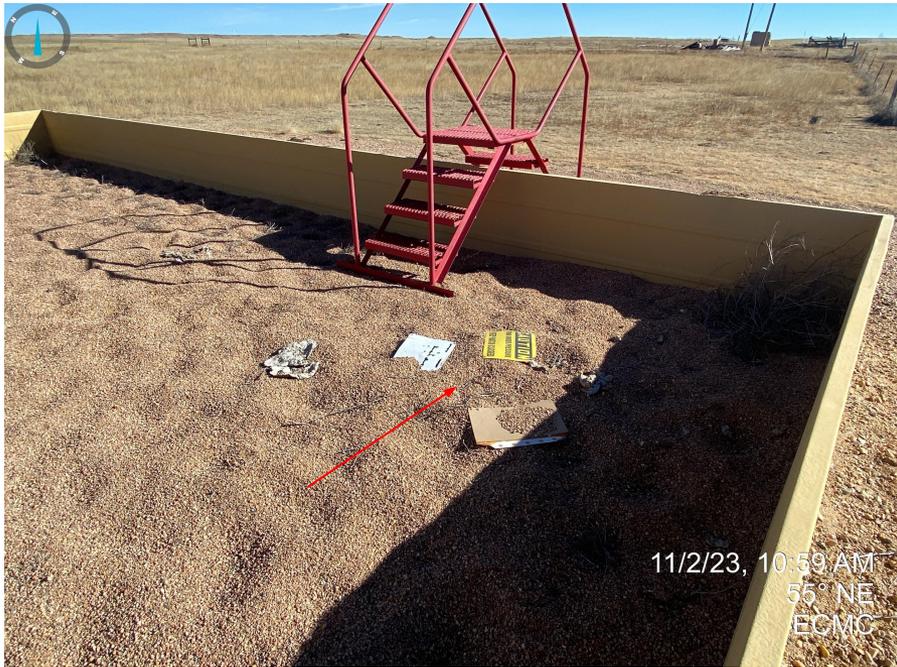
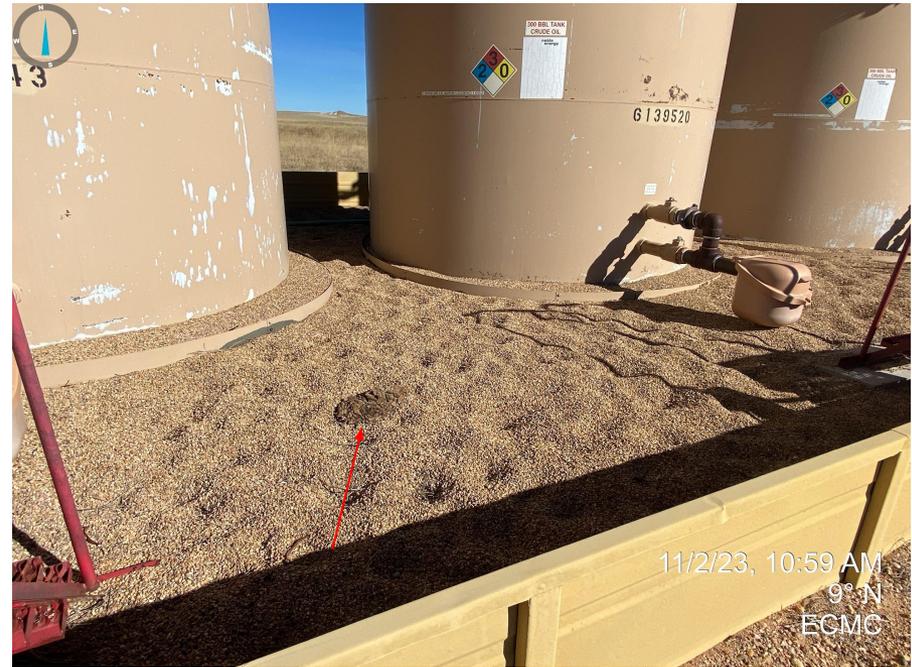
Photos 9 & 10. Debris within secondary containment (left) and evidence of livestock within containment at tank battery (right).

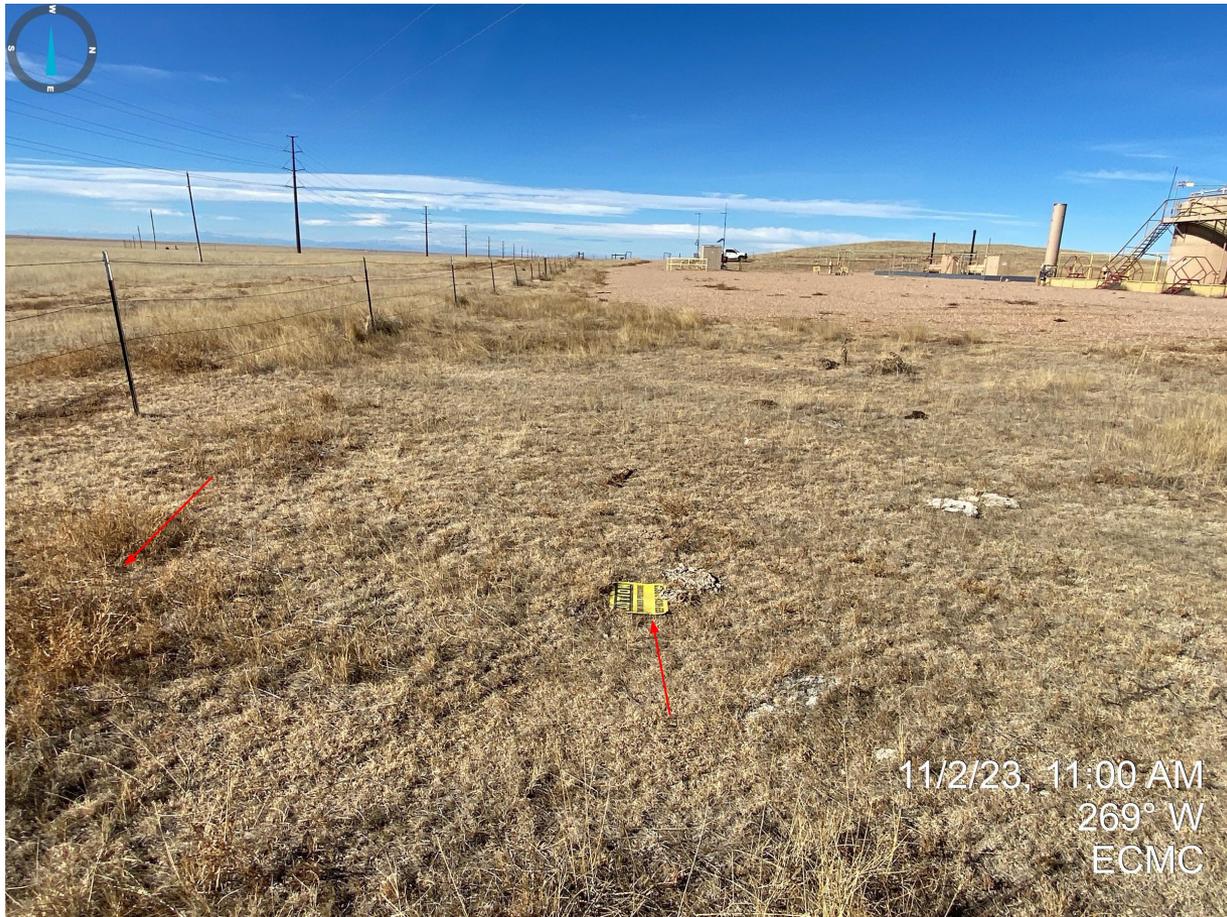
Photo 11. Debris and undesirable vegetation within the southeast corner of the location.

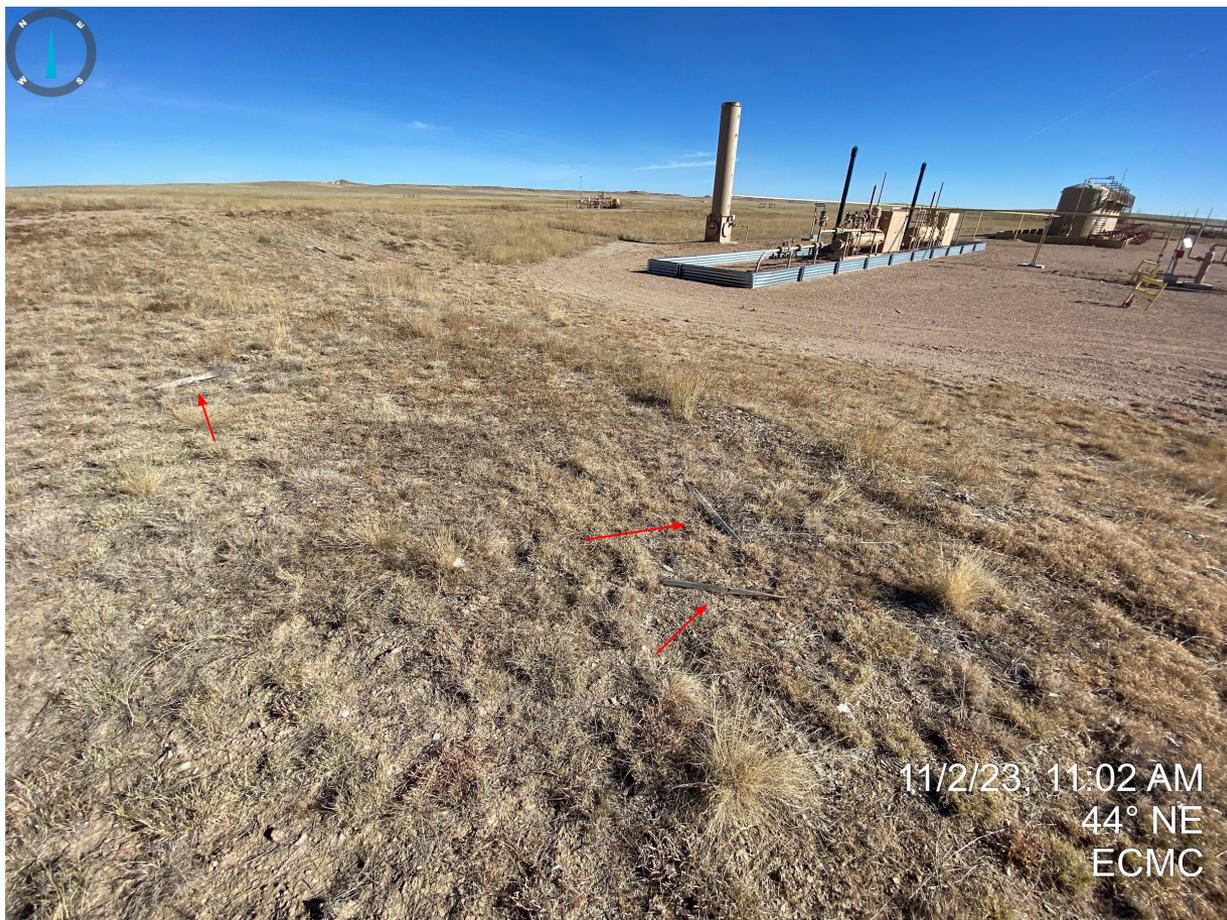
Photo 12. Wood debris observed on the west side of the production facilities.
