Interim Reclamation and Stormwater Inspection

Operator: VERDAD RESOURCES LLC - 10651

Location ID: 417324

Inspection Photos
Location Name: State 16-11-9-60H
Location ID: 417324

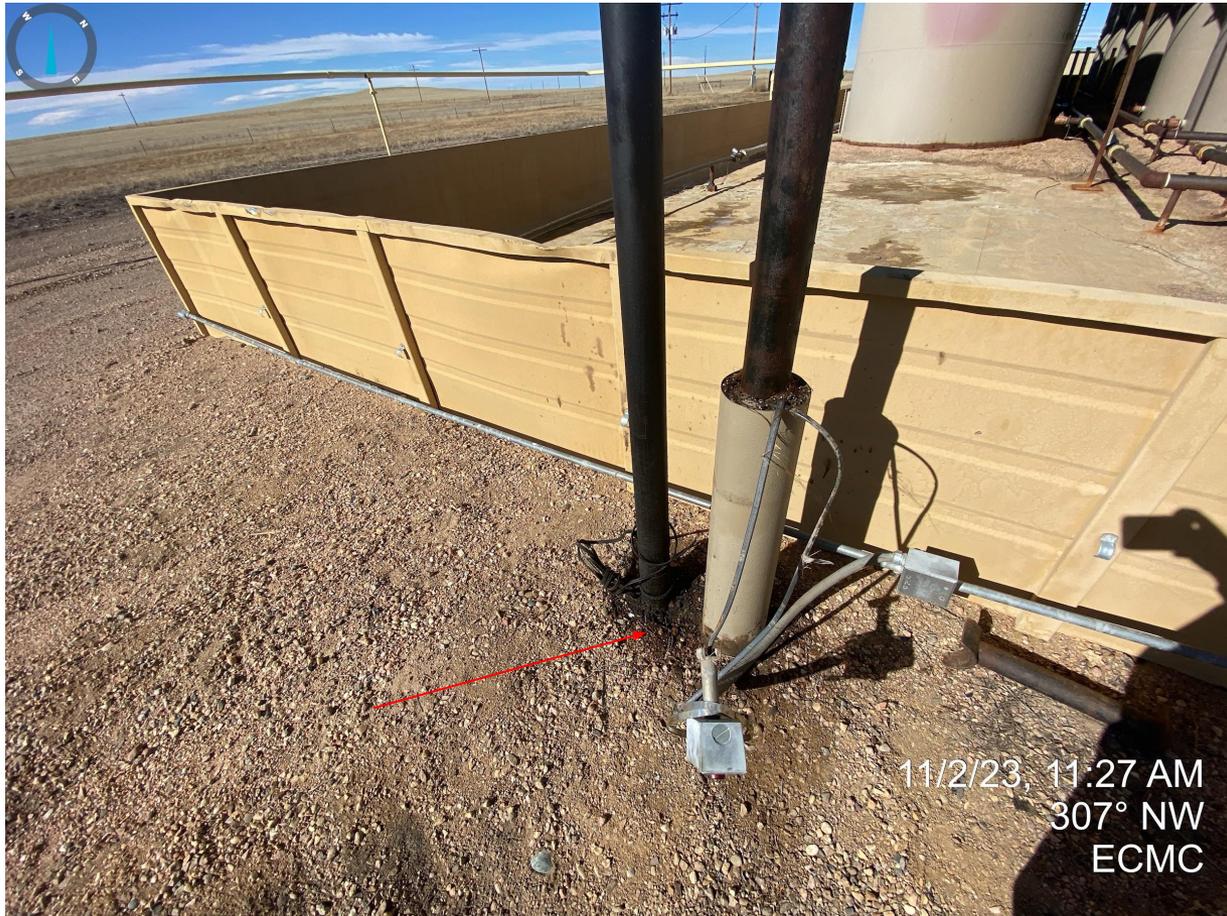
Photo 1. Stained soil observed on the south end of the tank battery facility.

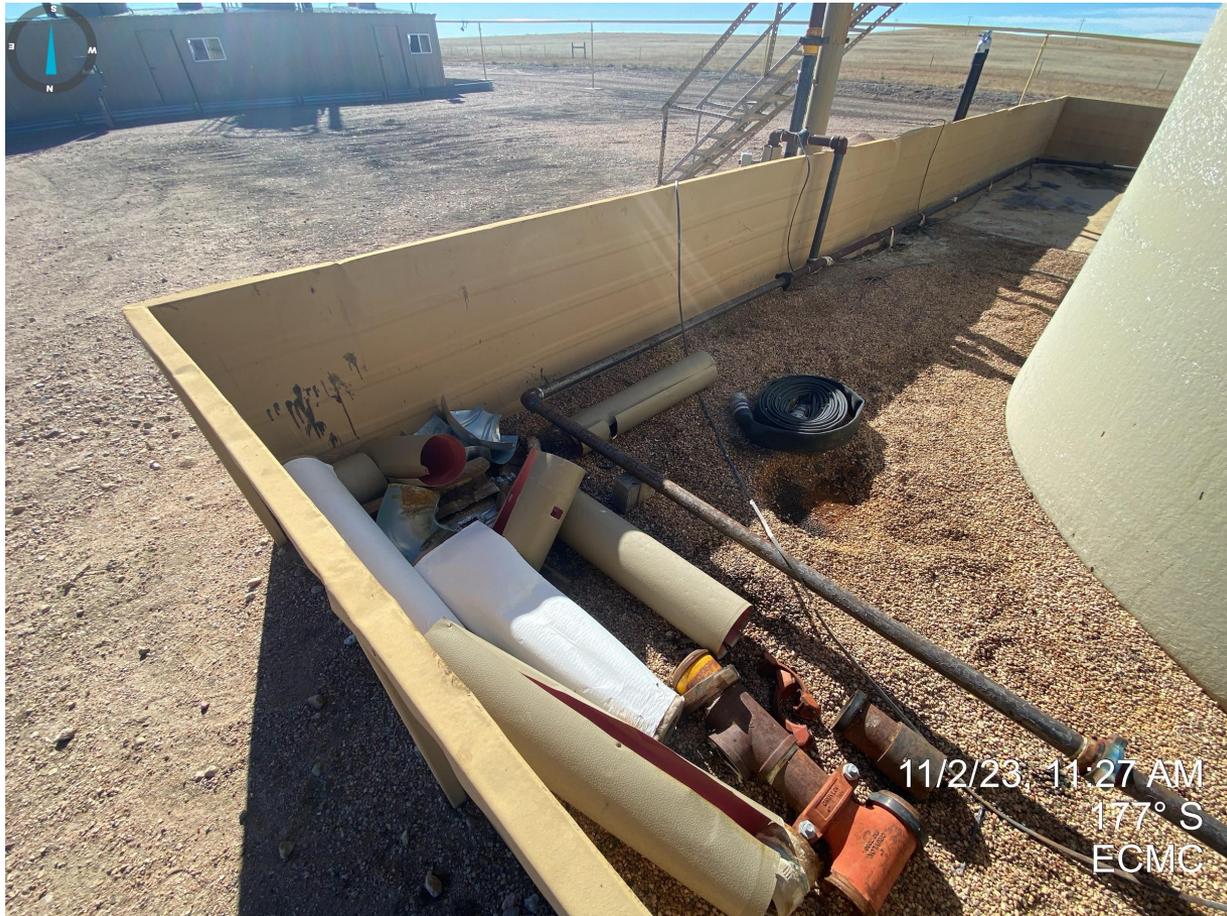
Photo 2. Unused equipment within the secondary containment of the tank battery.

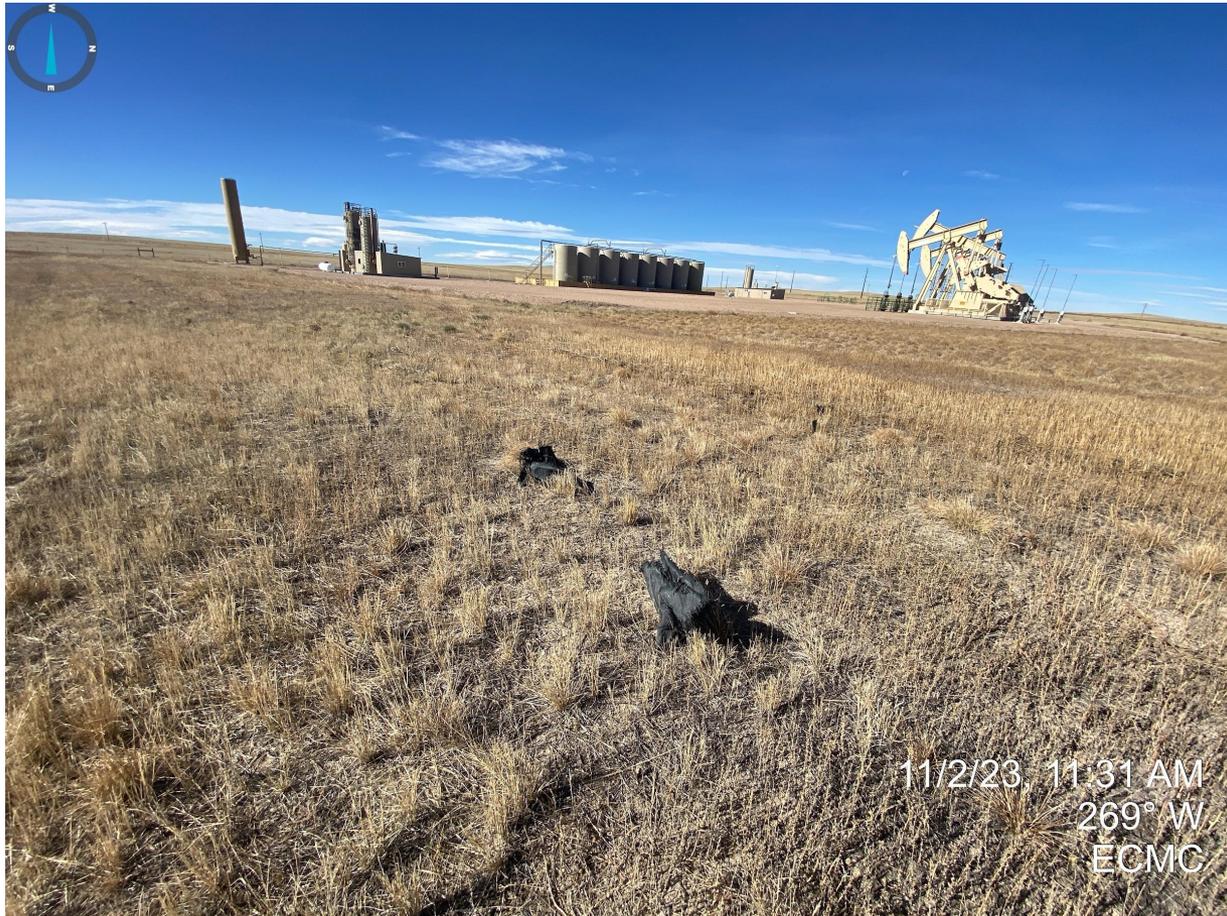
Photo 3. Trash observed in the eastern side of the interim areas.

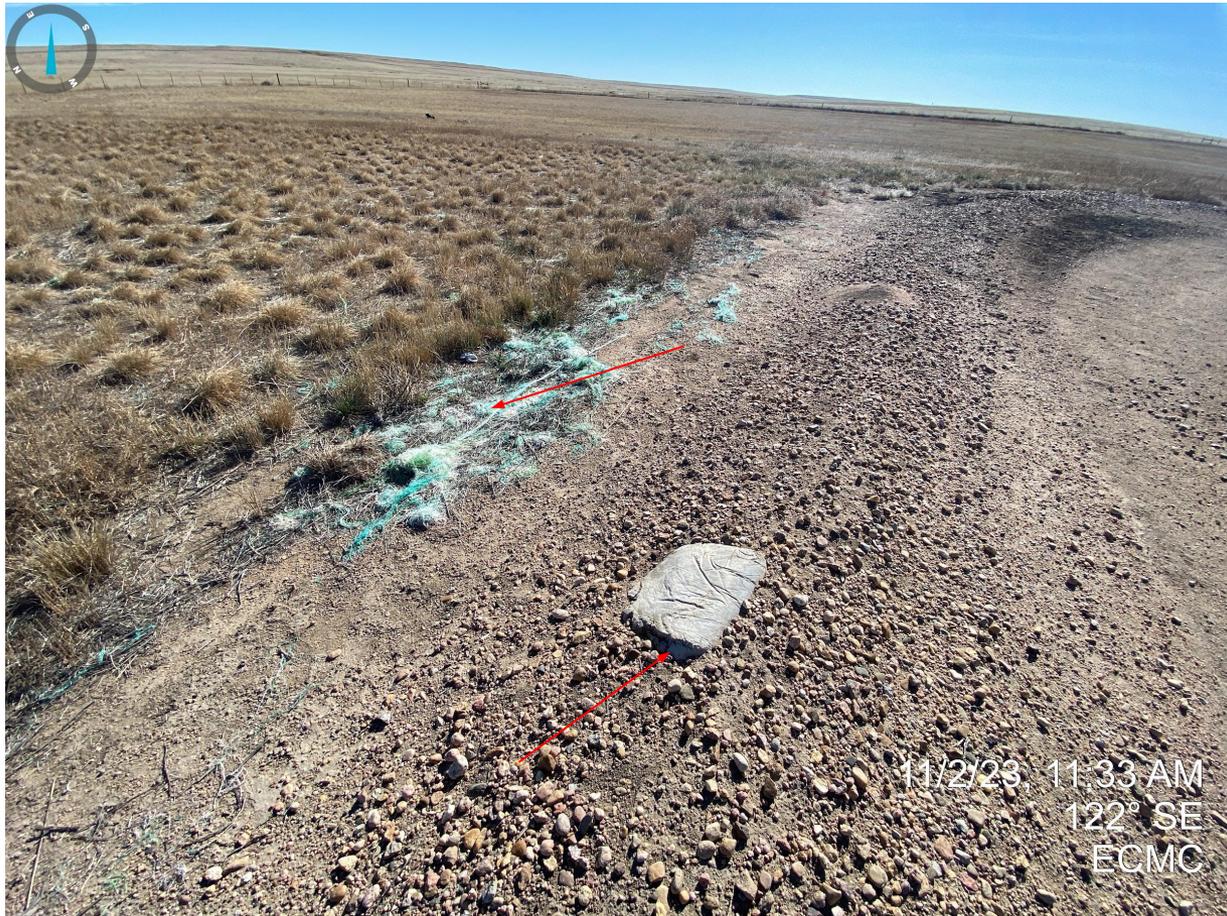
Photo 4. Previous inspection documented string/twine; this has not been removed since the previous corrective action inspection has been submitted.

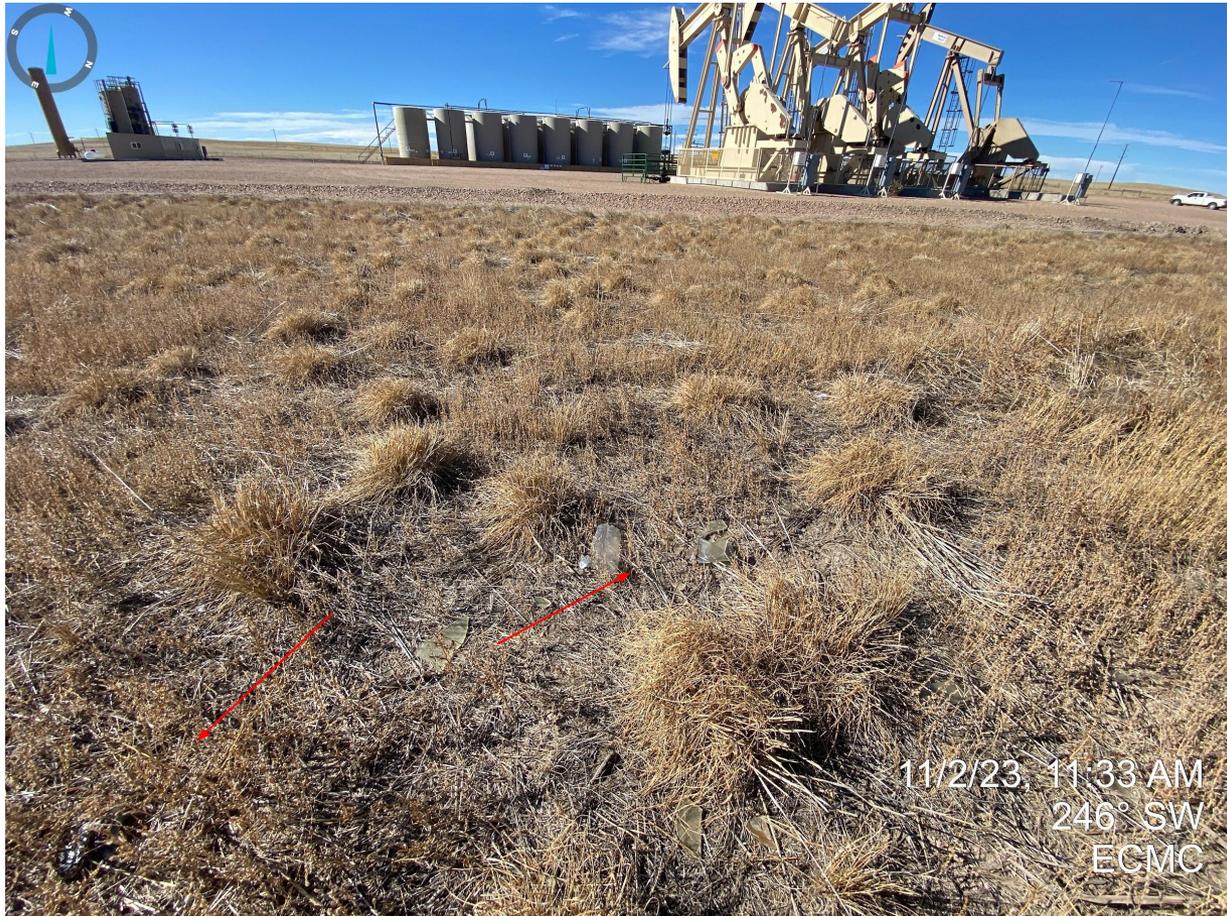
Photo 5. Trash and undesirable vegetation (e.g russian thistle, kochia, and crested wheatgrass) observed throughout the eastern interim areas.

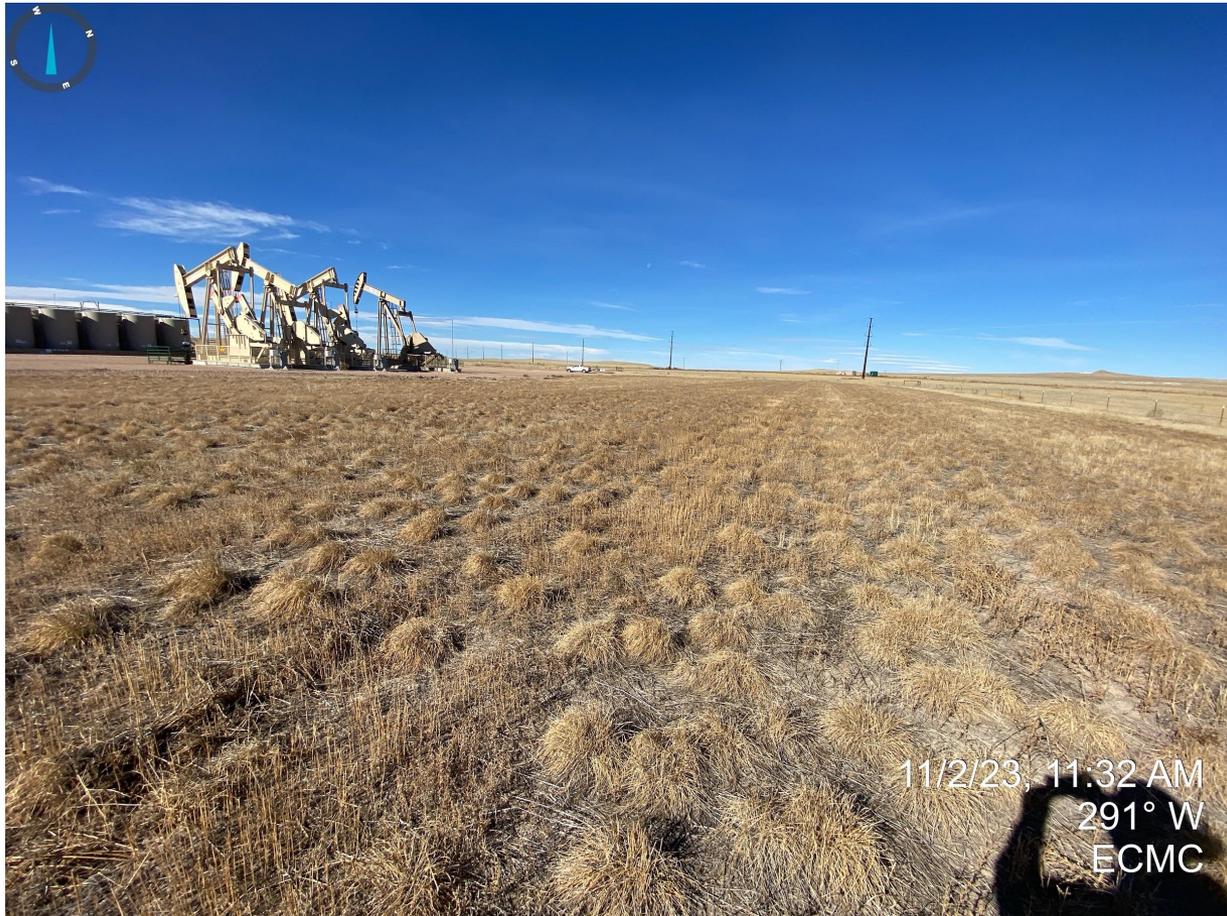
Photo 6. The eastern interim areas have been recently mowed, though there appears to be evidence of crested wheatgrass, an introduced species.

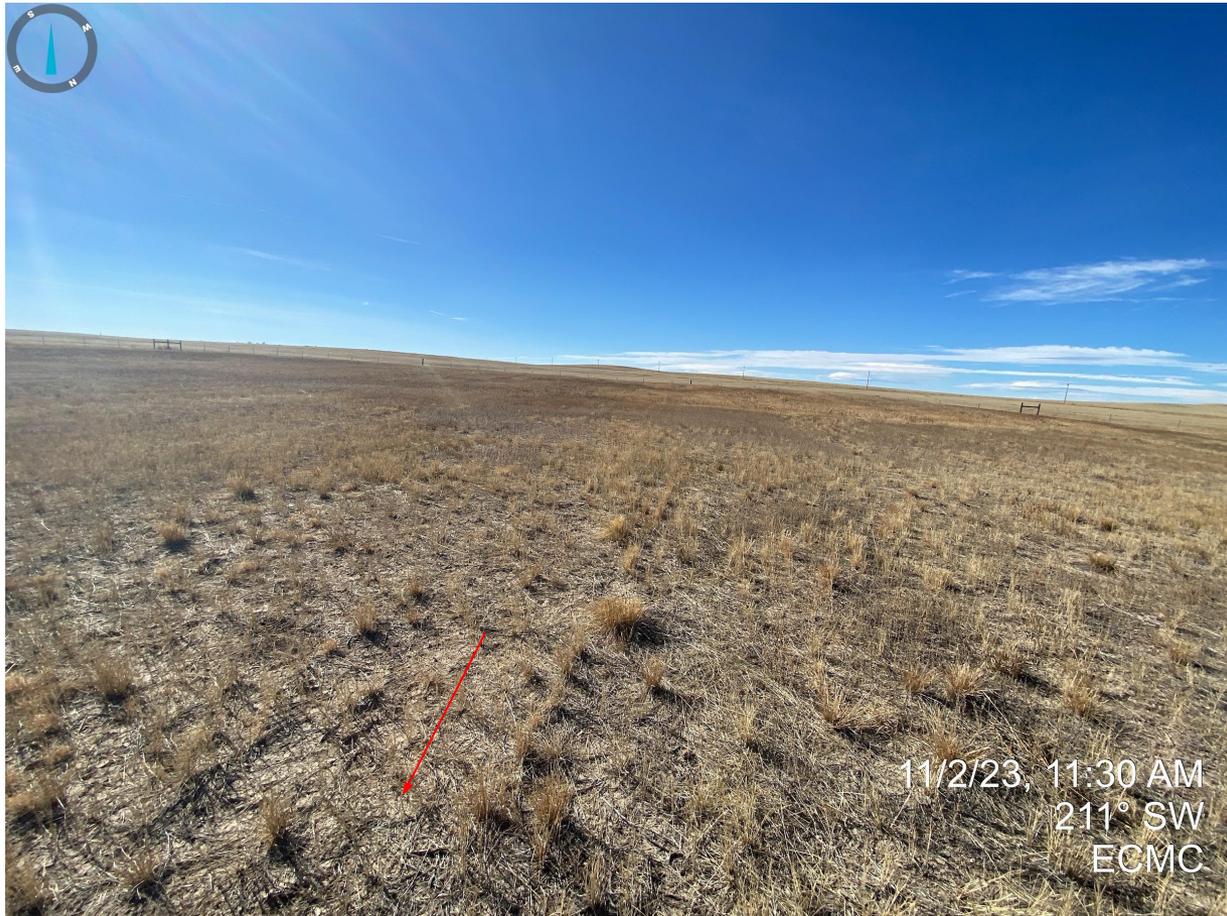
Photo 7. Non-uniform vegetative cover resulting in bare/exposed soils within the reclaimed pit. Undesirable vegetation (e.g. russian thistle, kochia and crested wheatgrass) observed throughout. Additional reclamation activities are required.

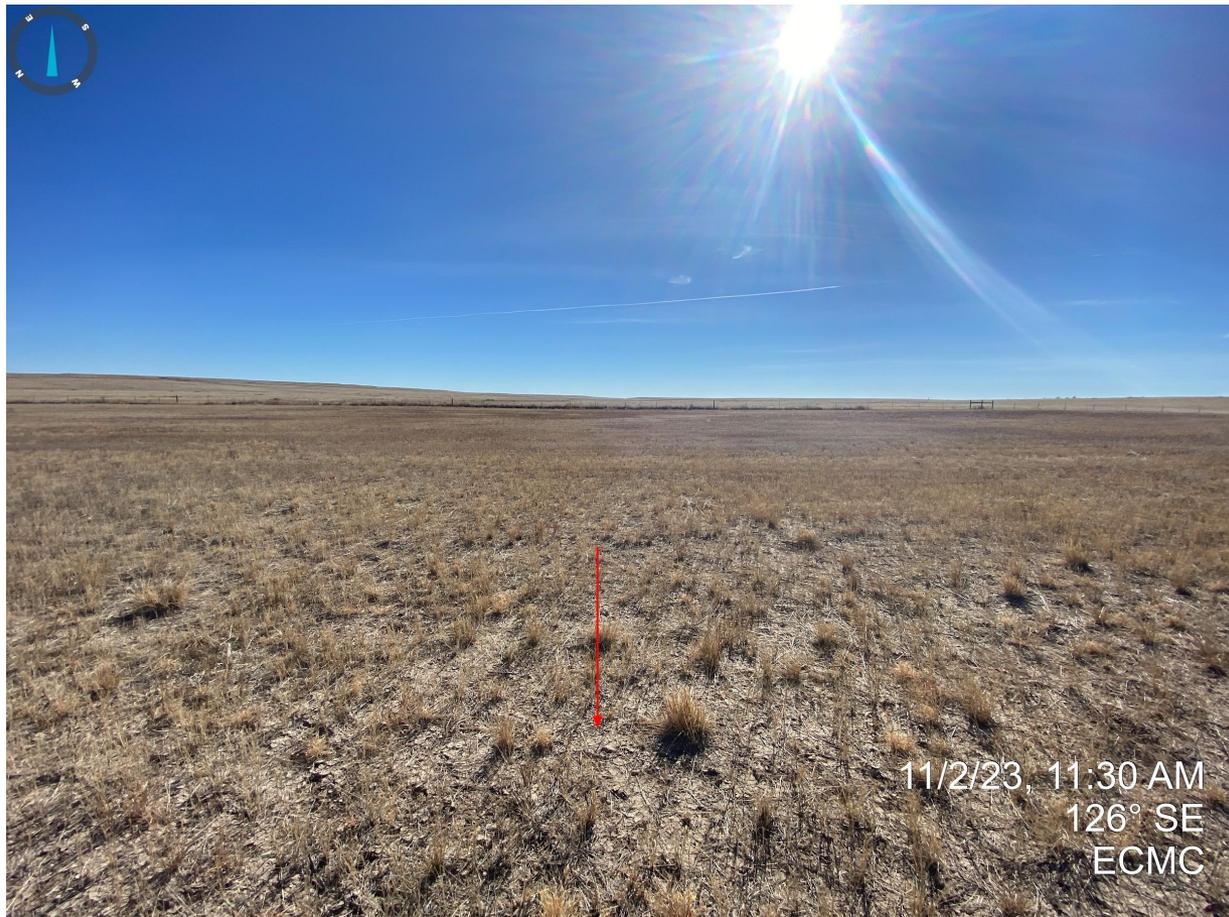
Photo 8. Continued from the previous photo, facing towards the southeast corner of the reclaimed pit.

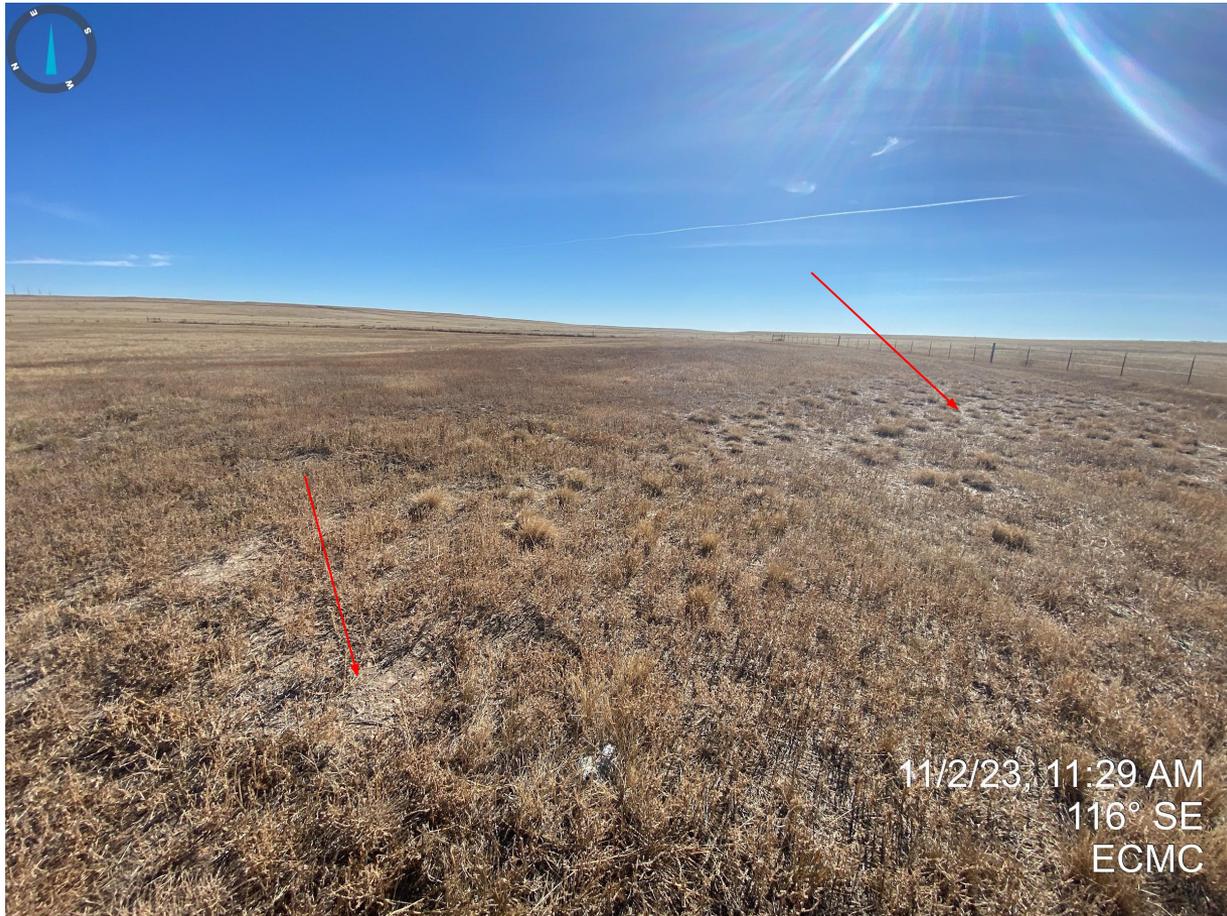
Photo 9. Continued from Photos 7 & 8. Southern portion of the former pit area.
