**Inspection Photos**  
**Location Name: HOWARD USX A/09-19**  
**Location #: 423200**

**Howard USX A 09-06D (123-33532) Wellsite**  
**Plugged & Abandoned | PA**  
**Plugging Ops; Workover: Tag cement; Cut tubing**

**Energy & Carbon Management  
Commission**

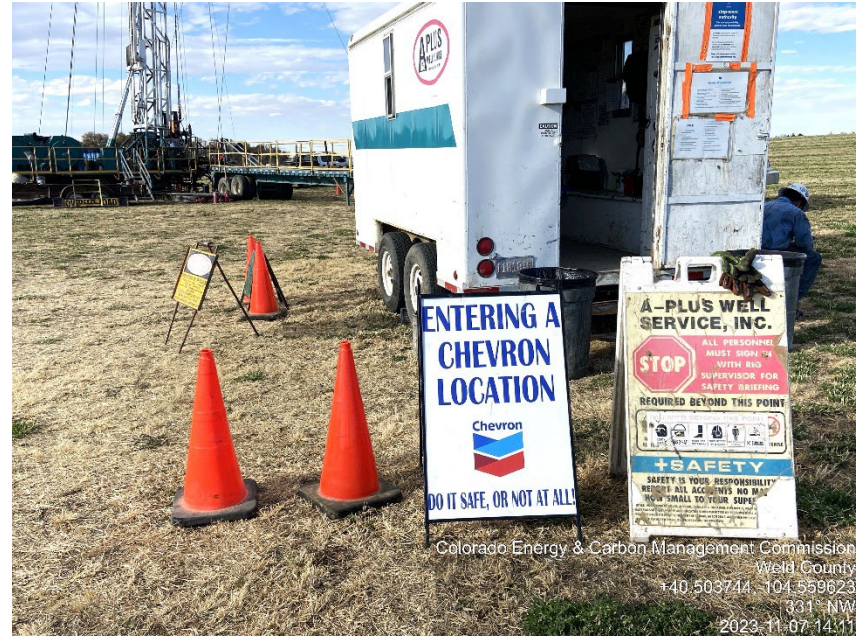
**Photo #2**

**Howard USX A 09-06D Wellsite**  
**Plugged & Abandoned | PA**  
**Plugging Ops; Workover: Tag cement; Cut tubing**  
*Site safety signage*

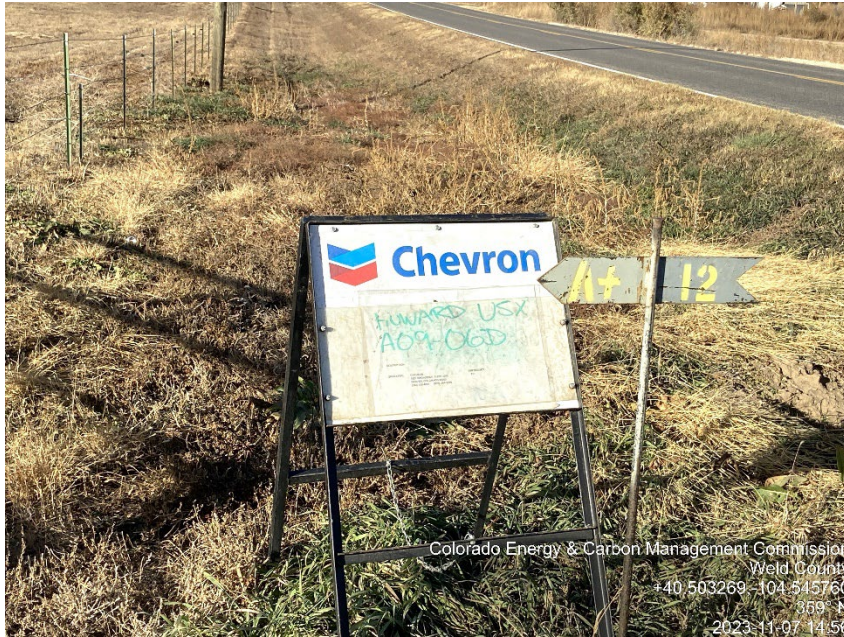
**Photo #3**

*Wellsite entrance*

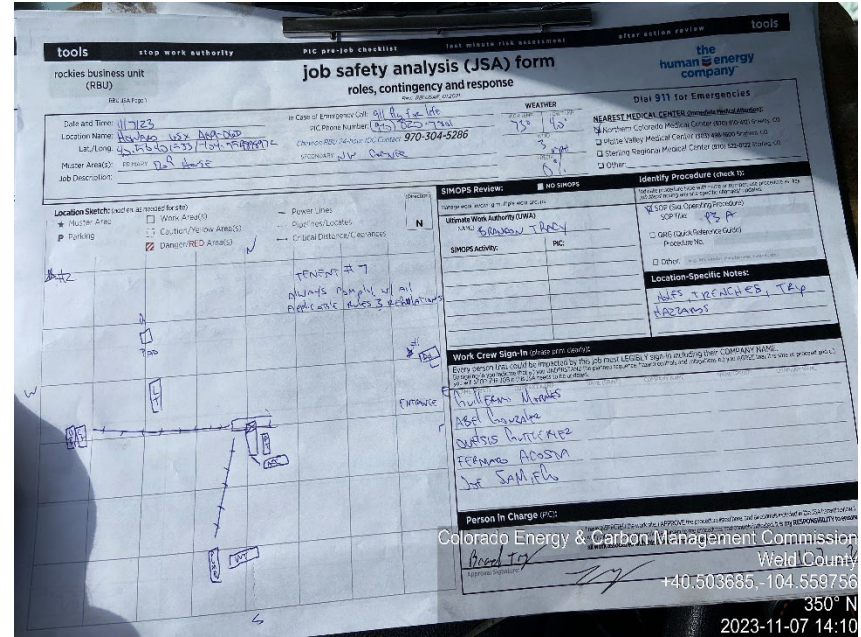
**Photo #4**

*JSA: 2023-11-07*

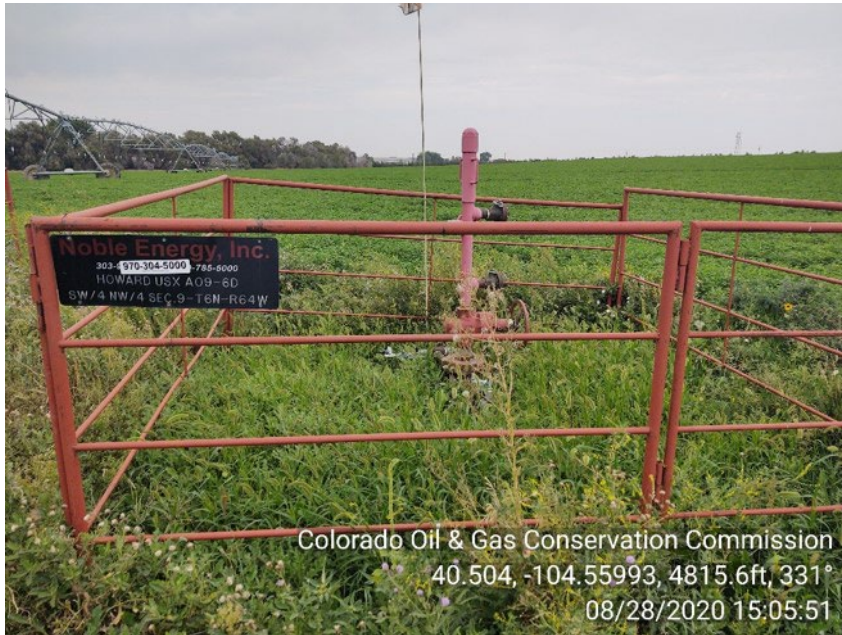
**Photo 5**

Wellsite sign
