Inspection Photos

Location Name: TEP ROCKY MOUNTAIN LLC MONUMENT RIDGE B Pad

Location ID: 442832

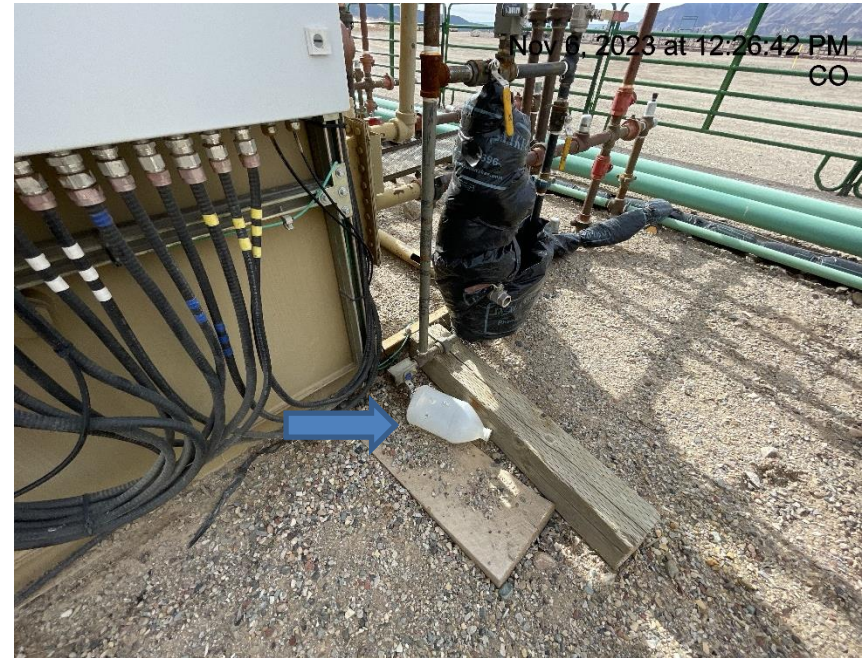
Photo # 5593 Debris

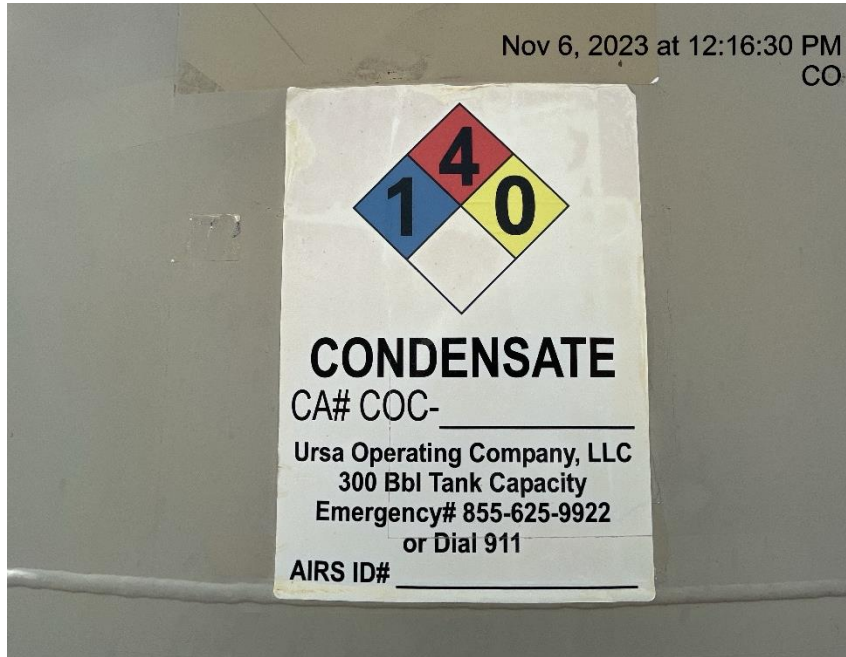
Photo # 5594 Tank label contains inaccurate information

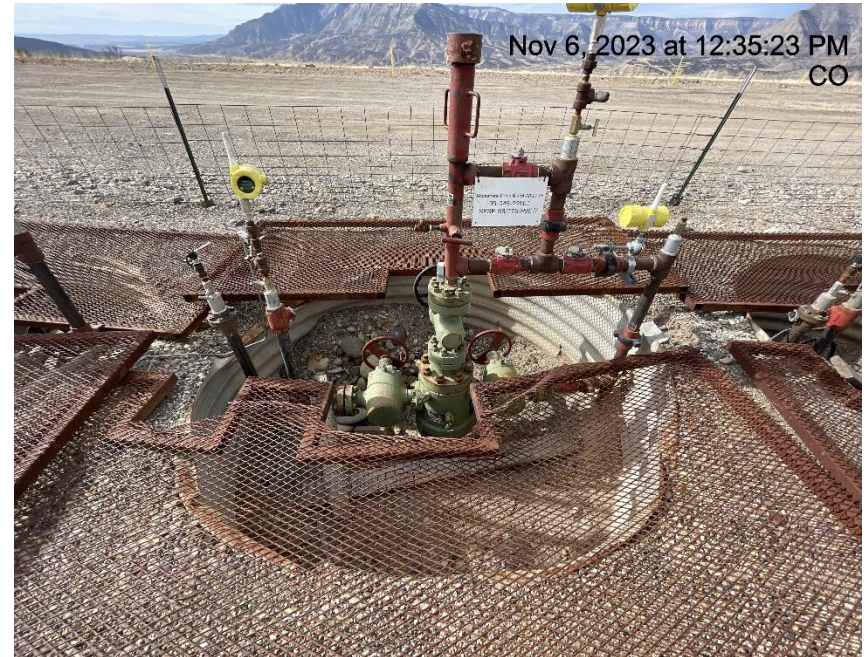
Photo # 5595 44A-08-07-95 Wellhead cellar lacks wildlife egress & cellar cover improperly placed & only partially covering cellar

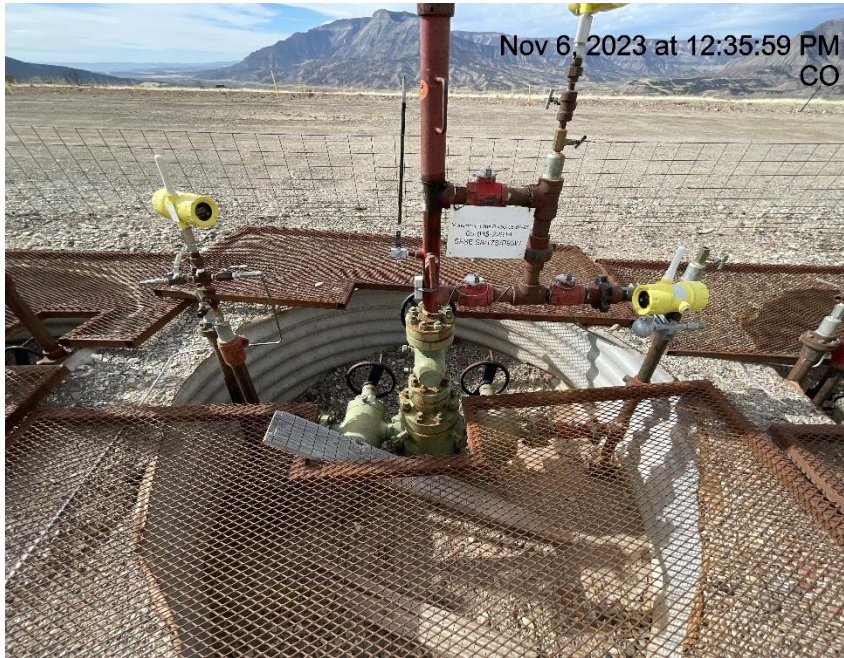
Photo # 5596 Multiple cellar covers improperly placed & only partially covering wellhead cellars

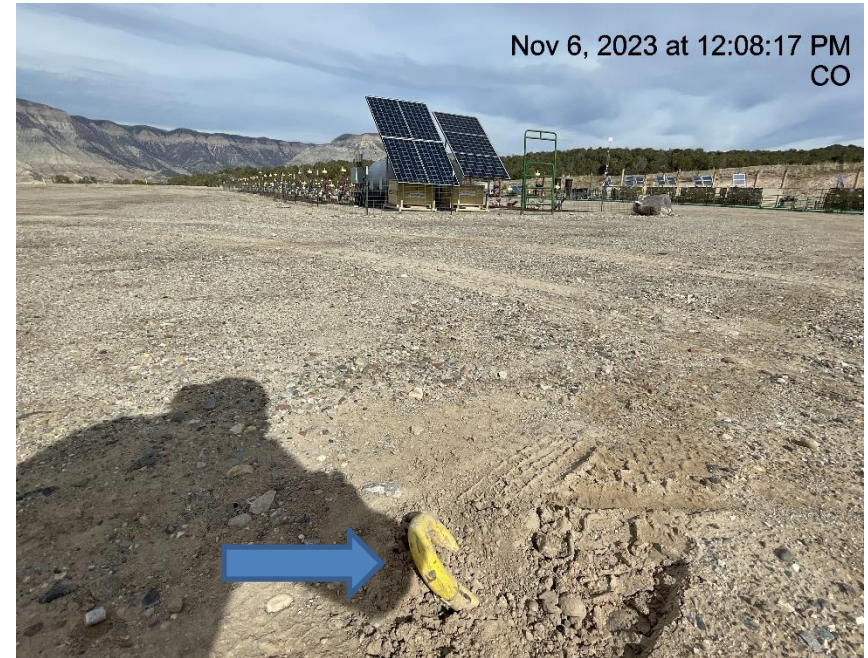
Photo # 5597 Unmarked deadman

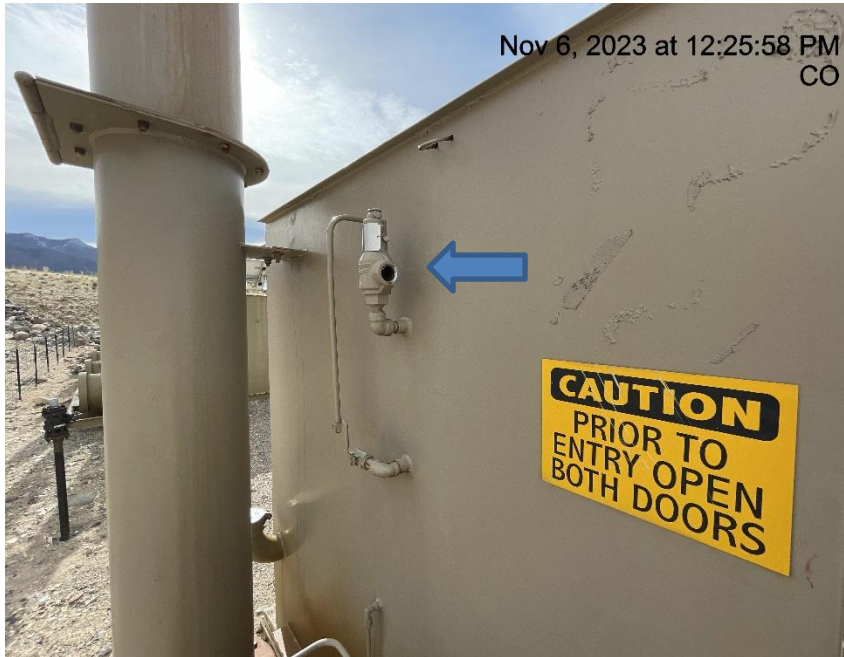
Photo # 5598 PRV lacks vent line

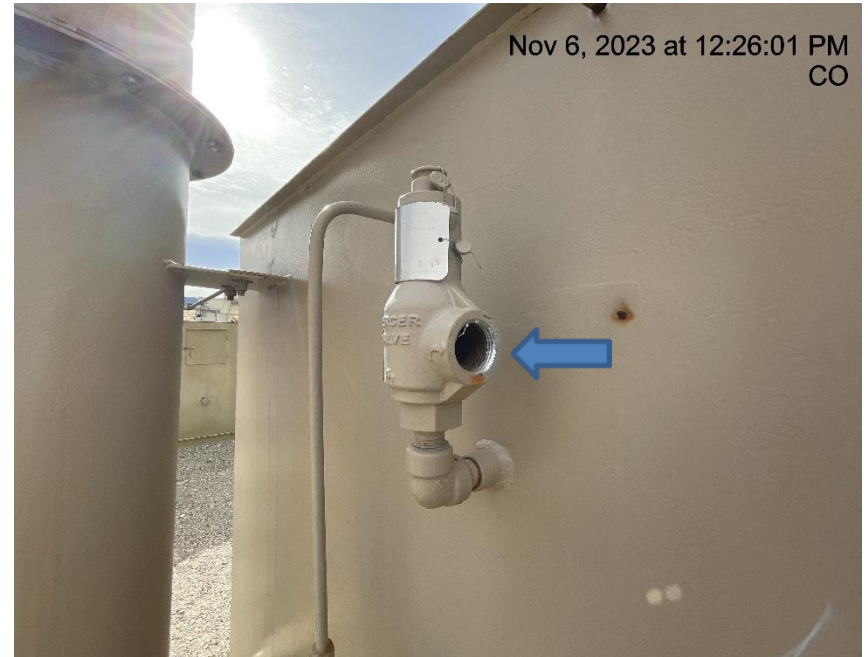
Photo # 5599 PRV lacks vent line

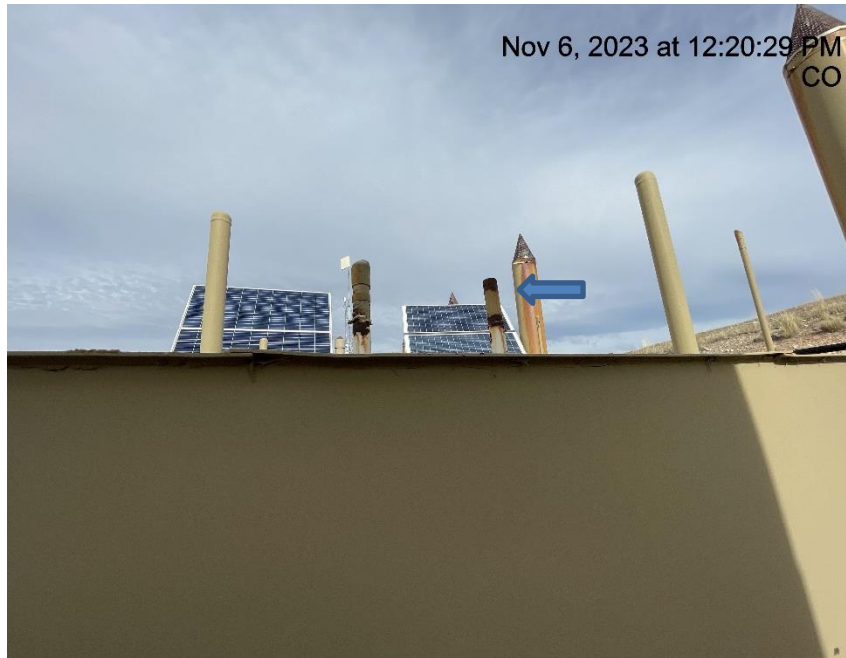
Photo # 5600 PRV vent line lacks cap

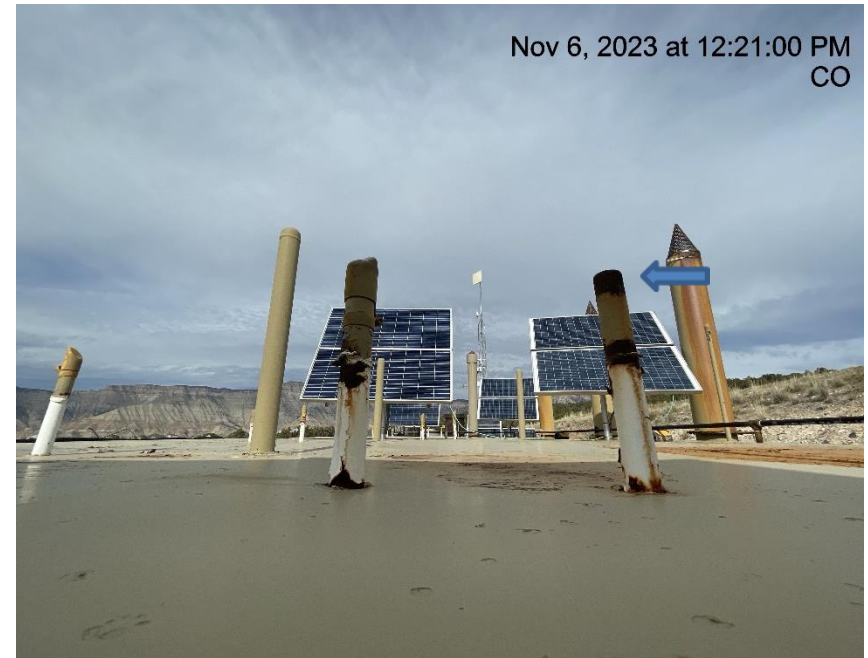
Photo # 5601 PRV vent line lacks cap

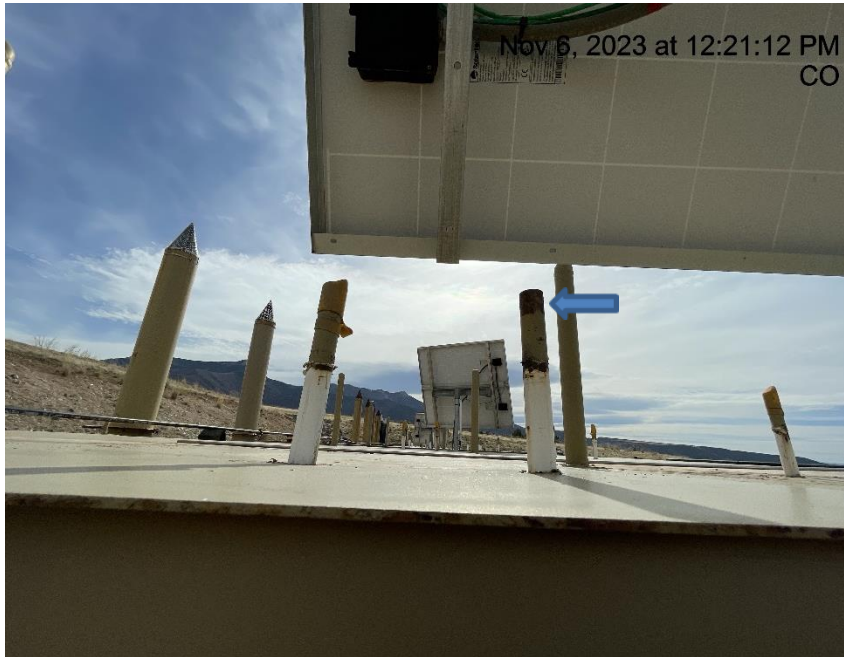
Photo # 5602 Rupture disc vent line lacks cap

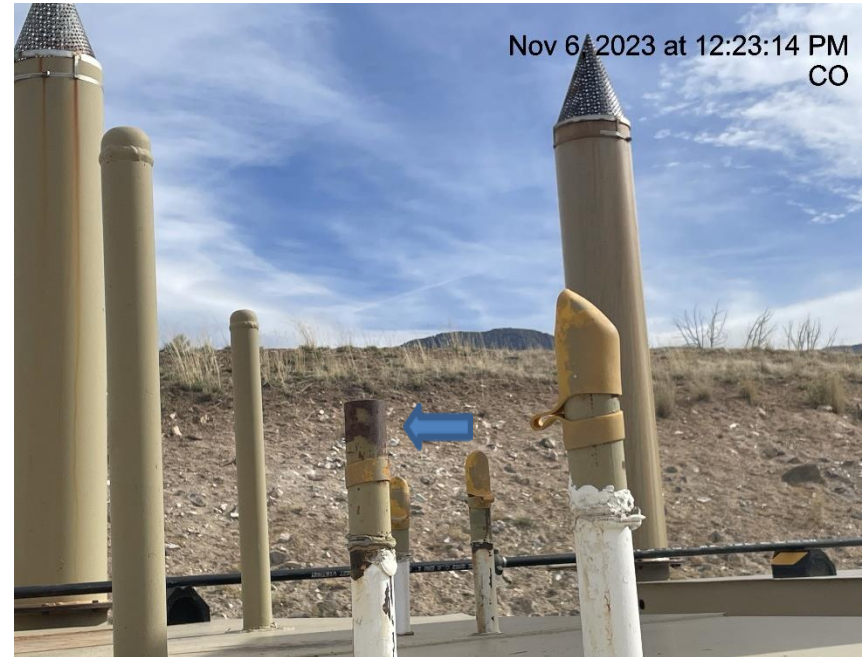
Photo # 5603 PRV vent line lacks cap

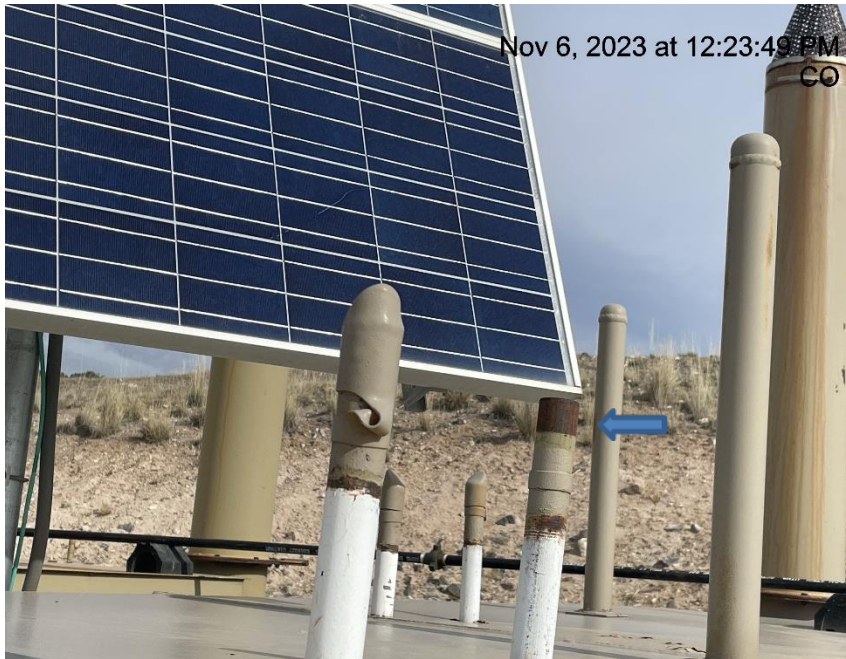
Photo # 5604 PRV vent line lacks cap
