Inspection Photos

Location Name: TEP Rocky Mountain LLC CLOUGH RWF 341-15 Pad

Location # 335572

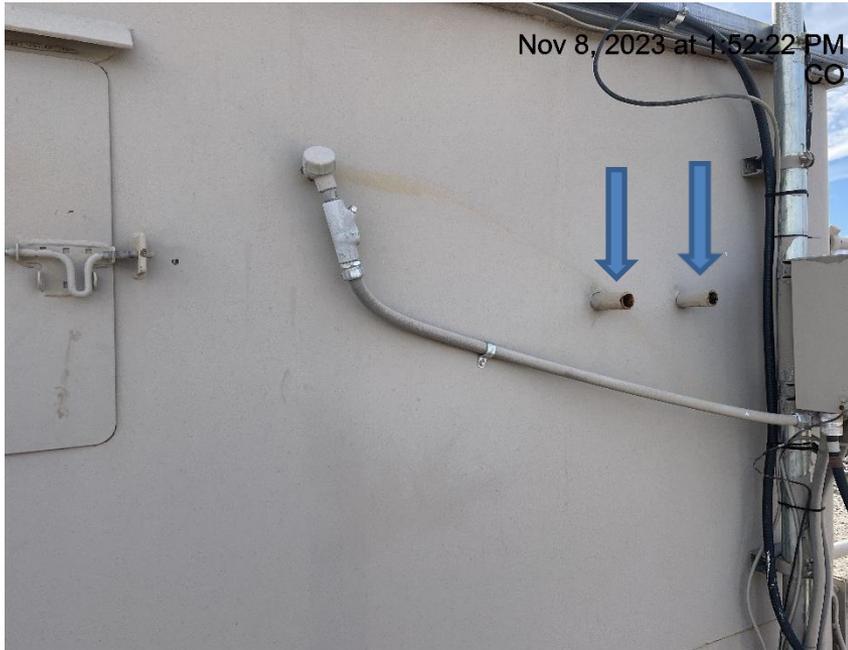
Photo # 6021 RWF 332-15 & 432-15 separators have PRV & rupture disc vent lines that terminate in an unsafe manner

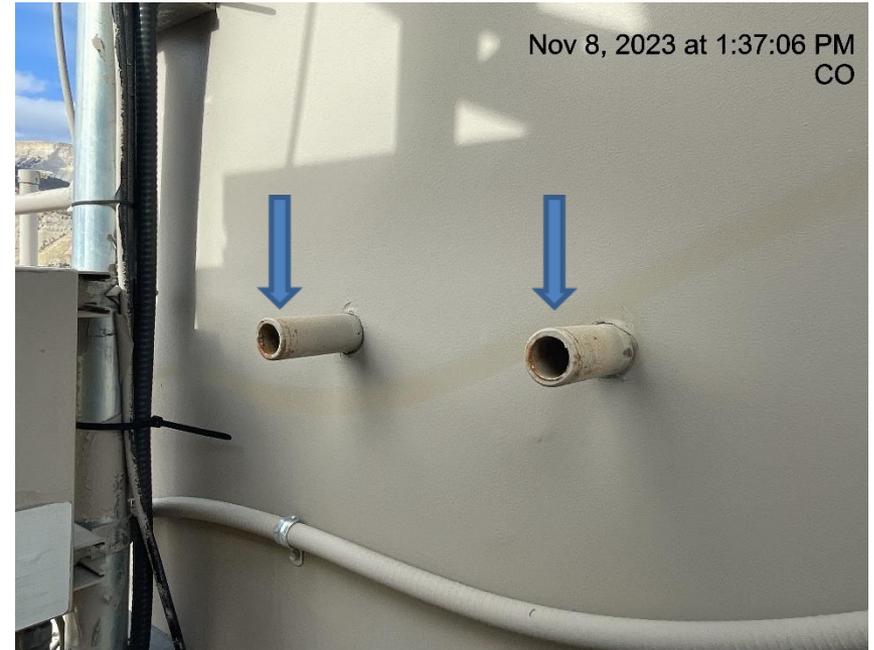
Photo # 6022 RWF 332-15 & 432-15 separators have PRV & rupture disc vent lines that terminate in an unsafe manner
