Inspection Photos

Loc: 429093

Operator: **AUSCO PETROLEUM INC**

Inspection Date: 11/08/2023

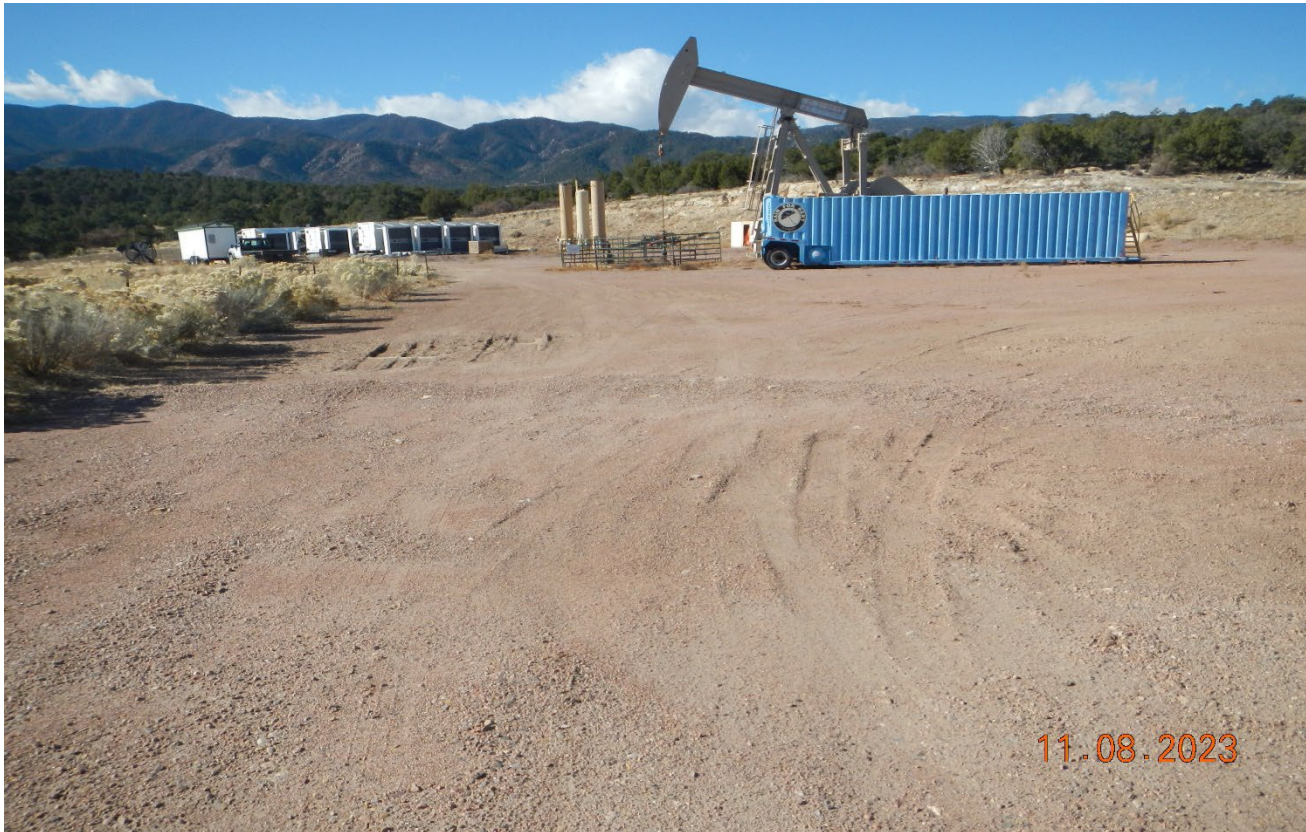
Photo 1. Facing southwest toward the location. The blue frac tank which appears to be unused, does not have secondary containment and needs to be removed. Previous corrective action was not completed.

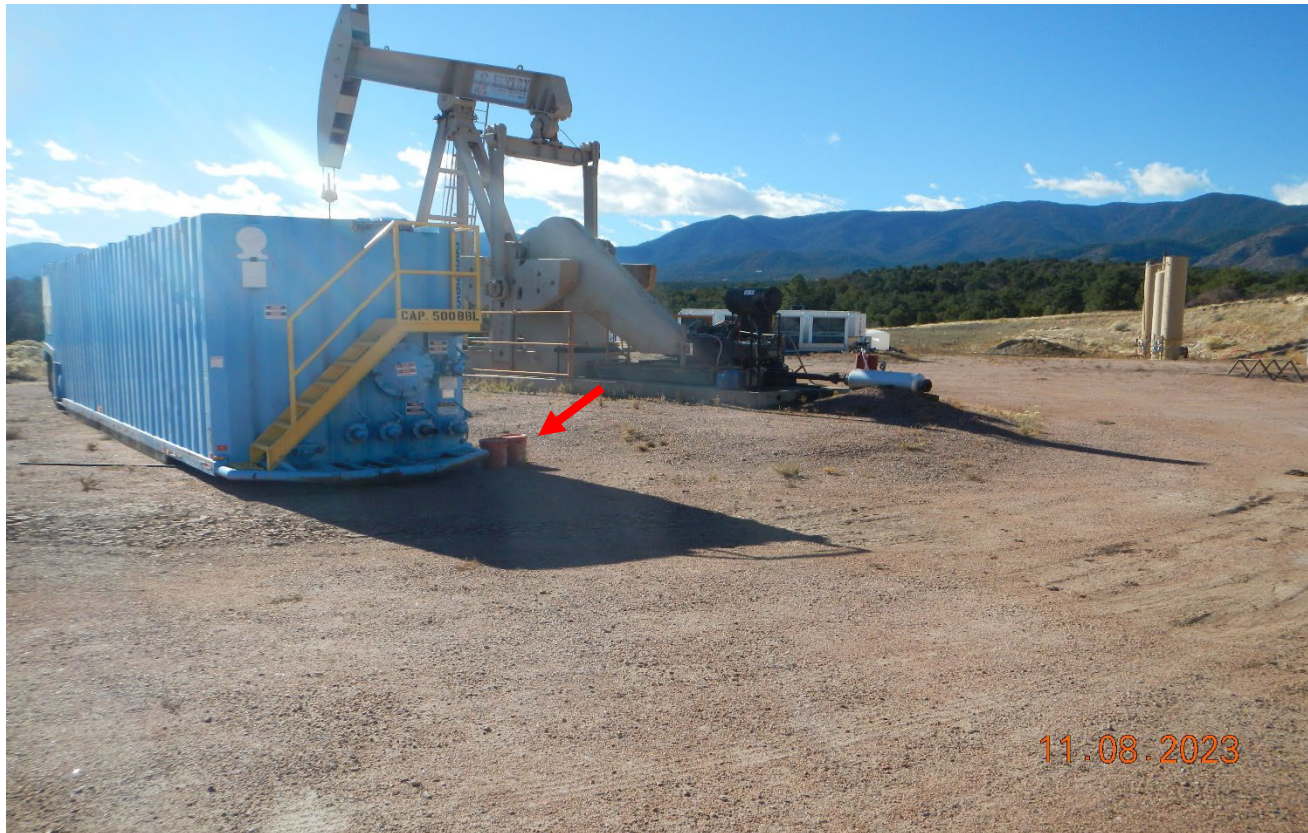
Photo 2. There are 2 orange buckets that appear to have oil with no labeling and no containment. Previous corrective action was not completed.

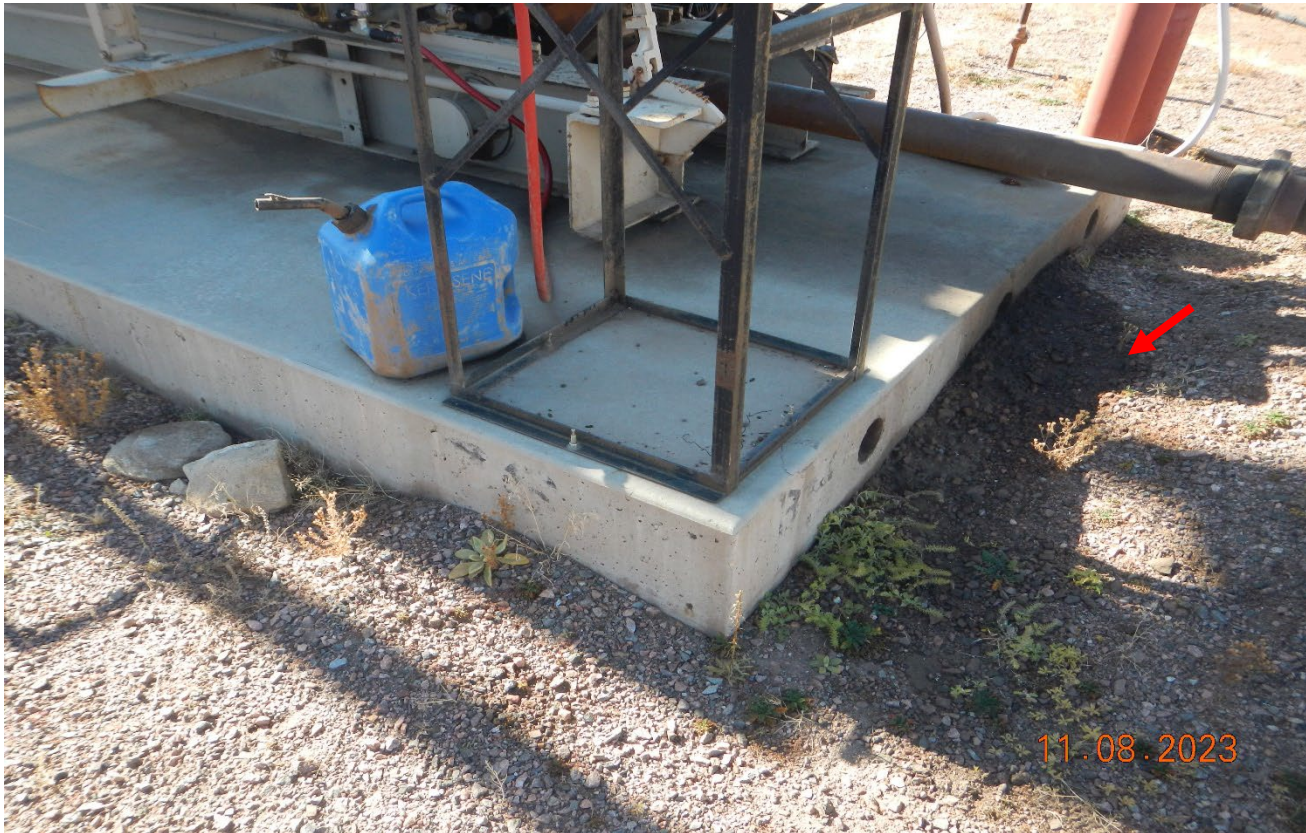
Photo 3. There is oil stained soil at base of pump jack. There is a blue chemical jug not properly stored in containment.

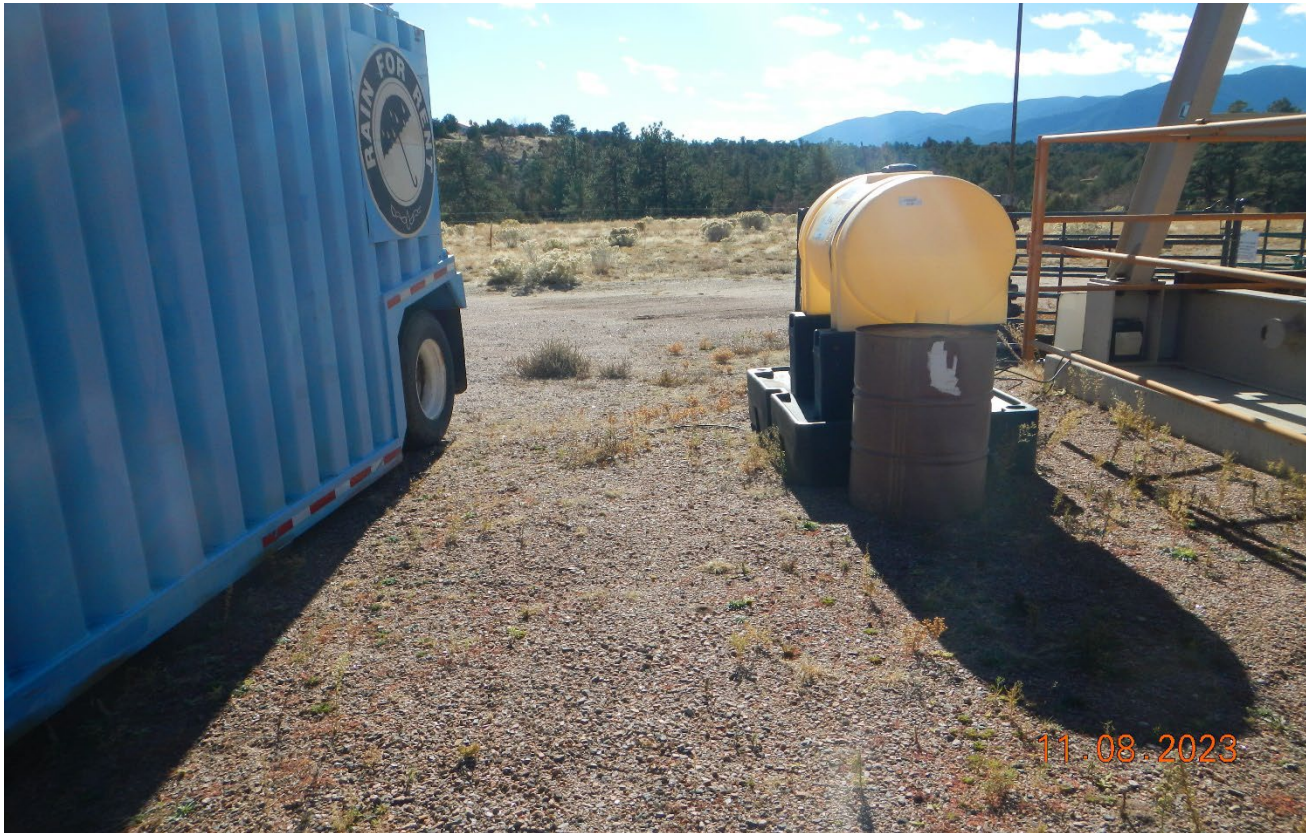
Photo 4. There is an unknown barrel with no labeling or containment. Previous corrective action was not completed.

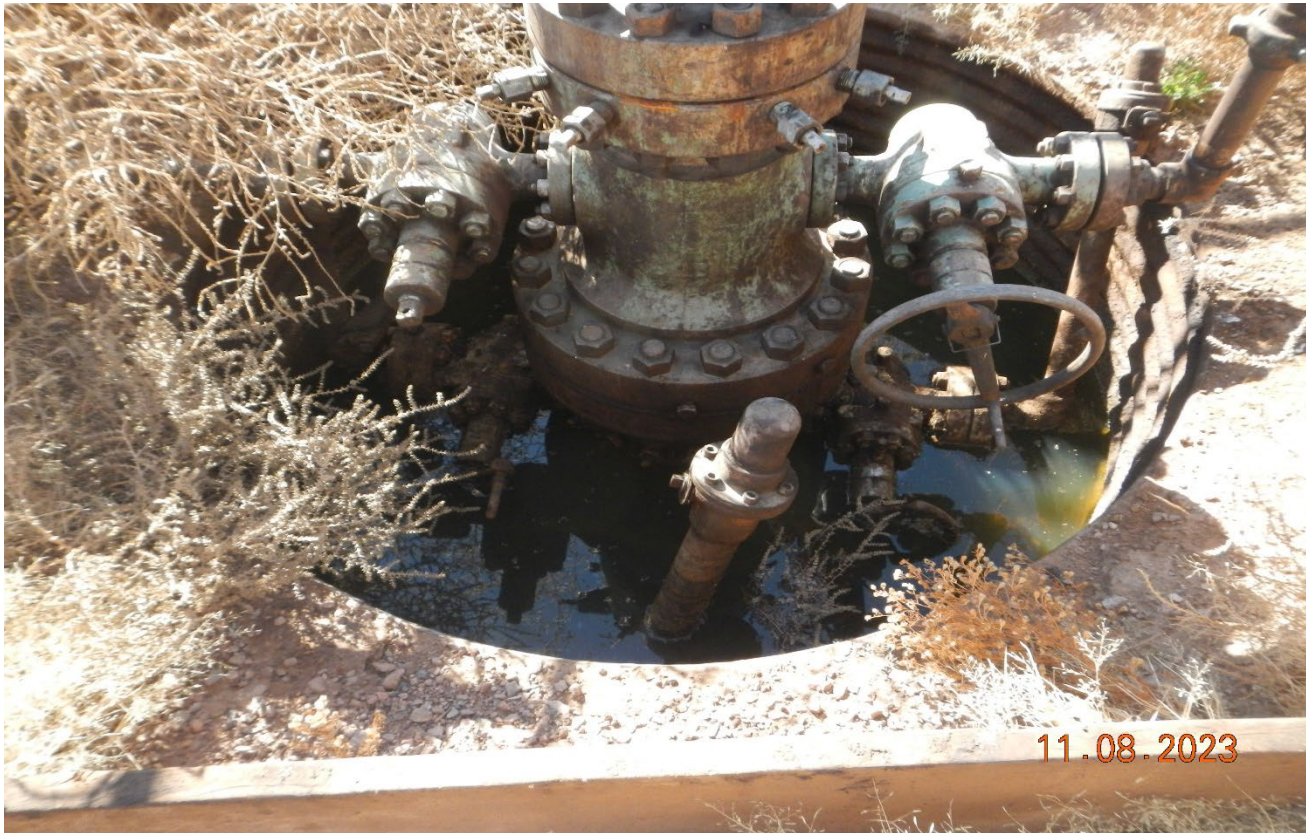
Photo 5. There is no wildlife protection at the wellhead.

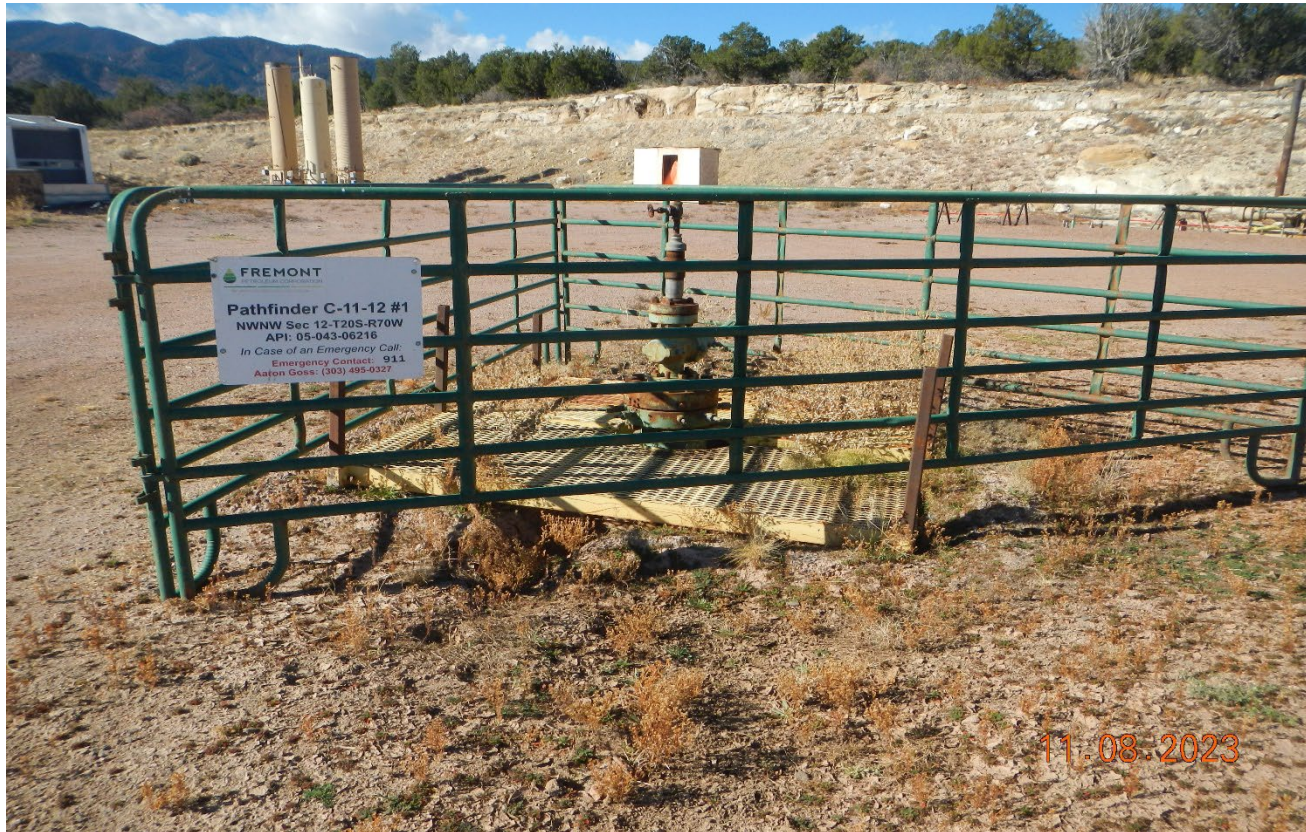
Photo 6. The other wellhead on location does have wildlife protection.

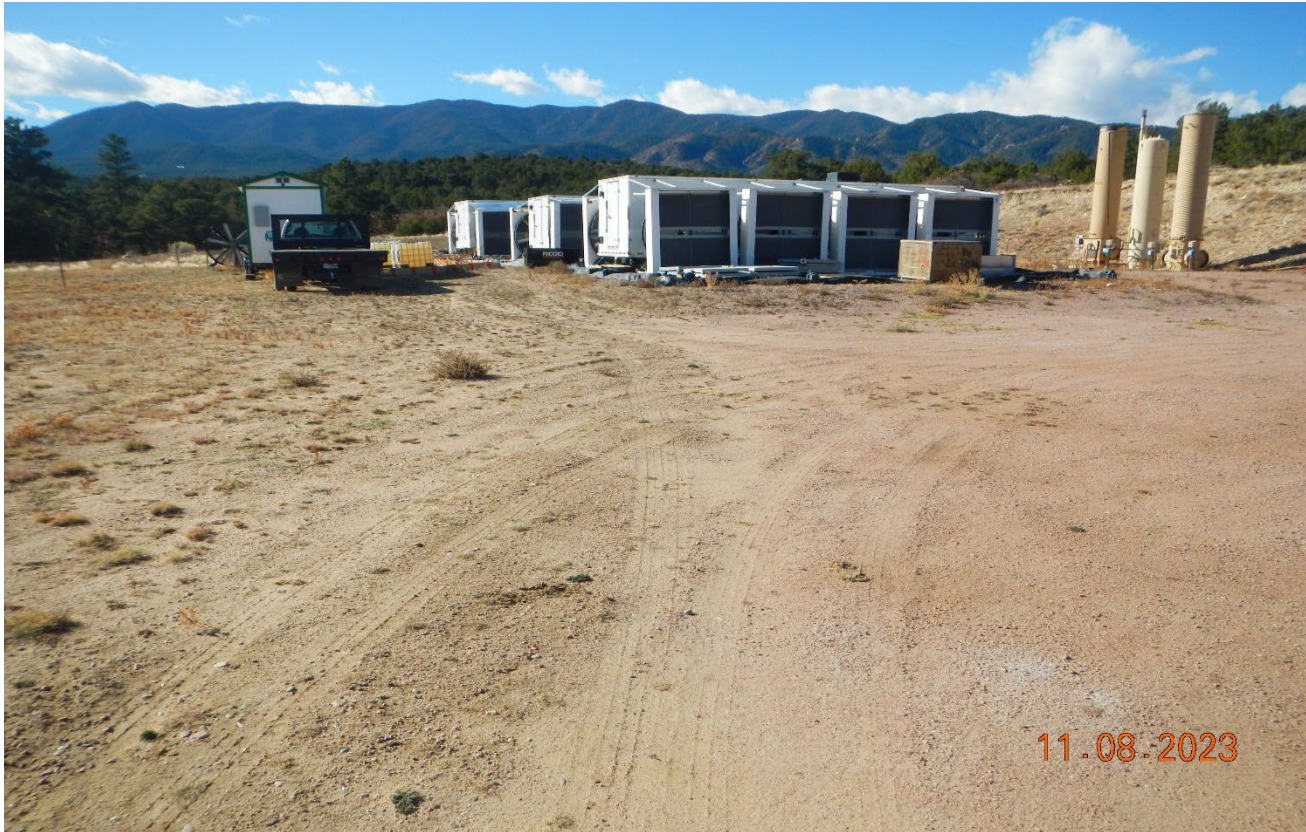
Photo 7. Facing southwest toward the bitcoin equipment which is not in operation.

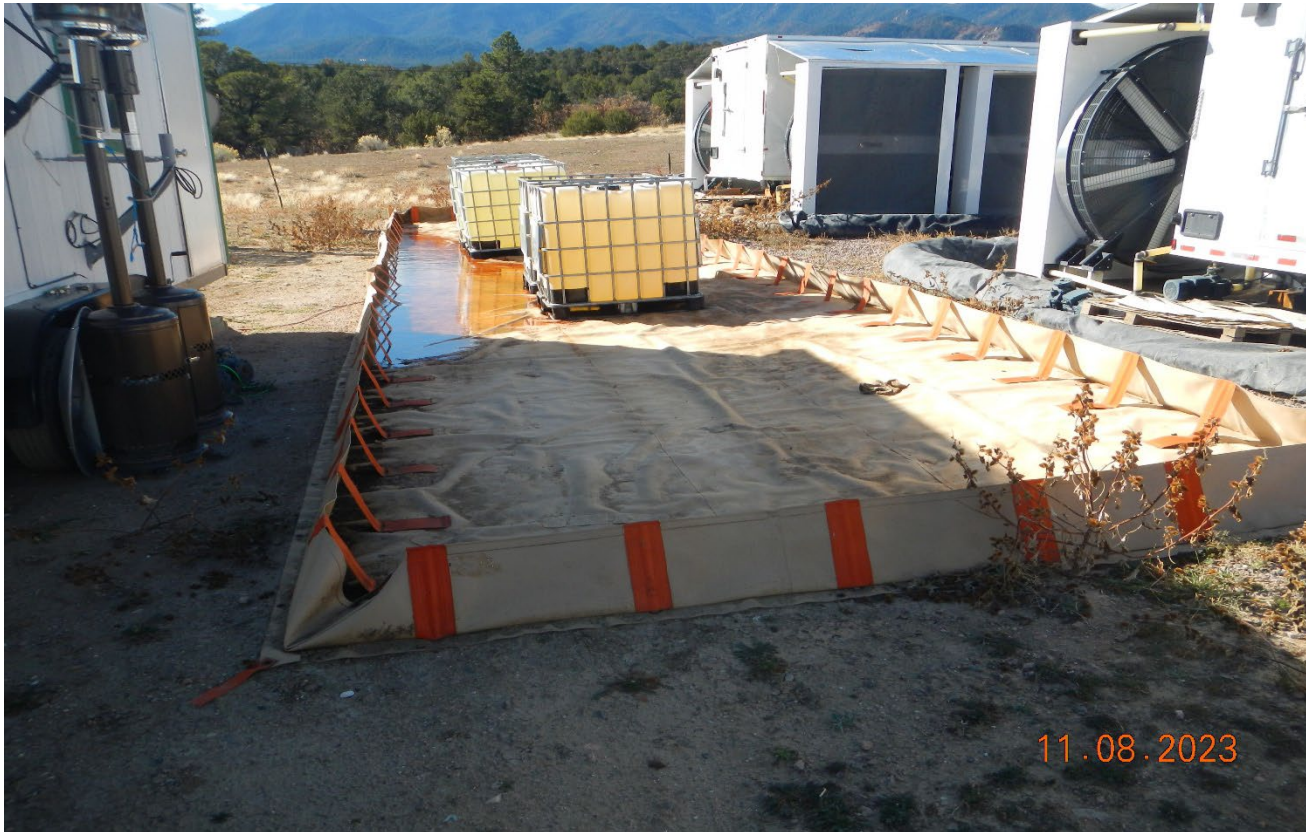
Photo 8. There is a portable secondary containment installed for the 2 chemical totes.

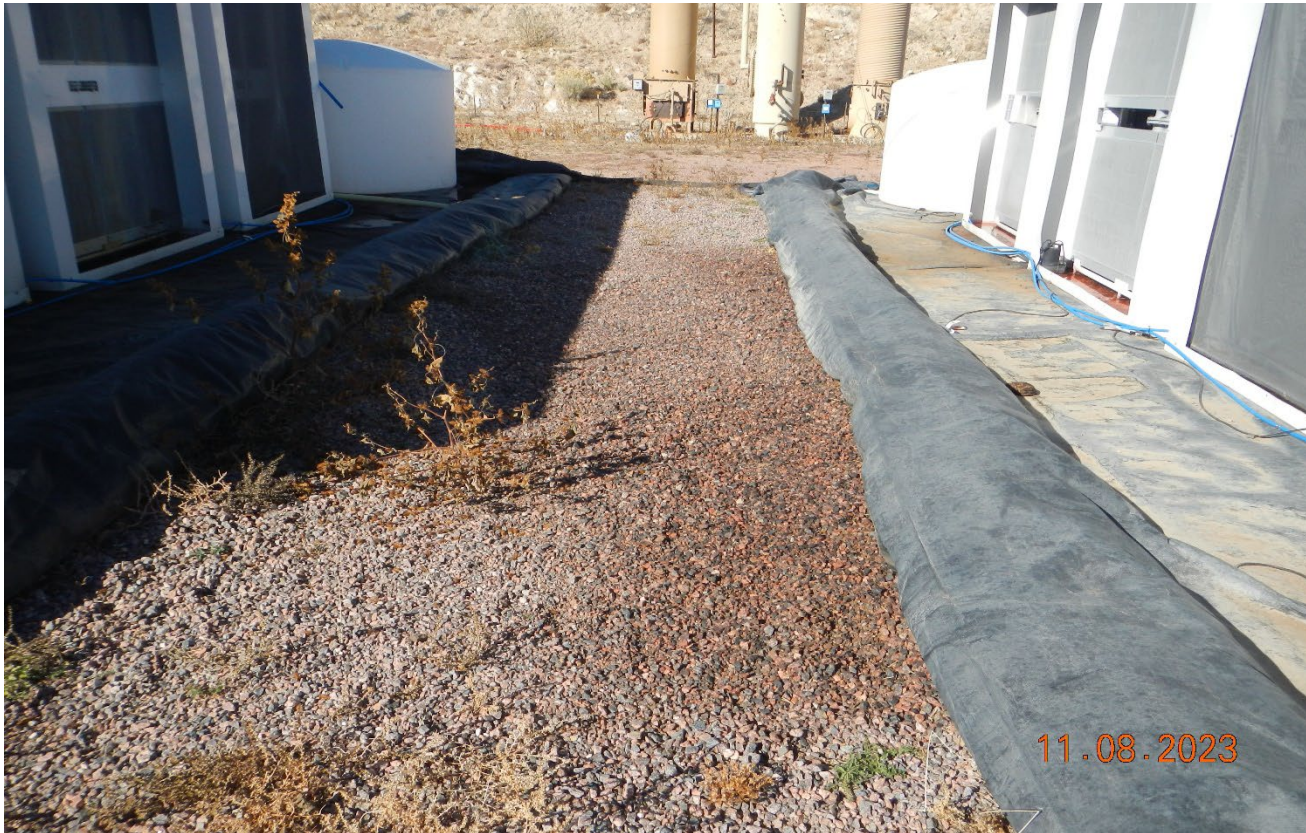
Photo 9. It appears in between the equipment there is darkened gravel from a possibly leak which has not been cleaned up. Previous corrective action was not completed.

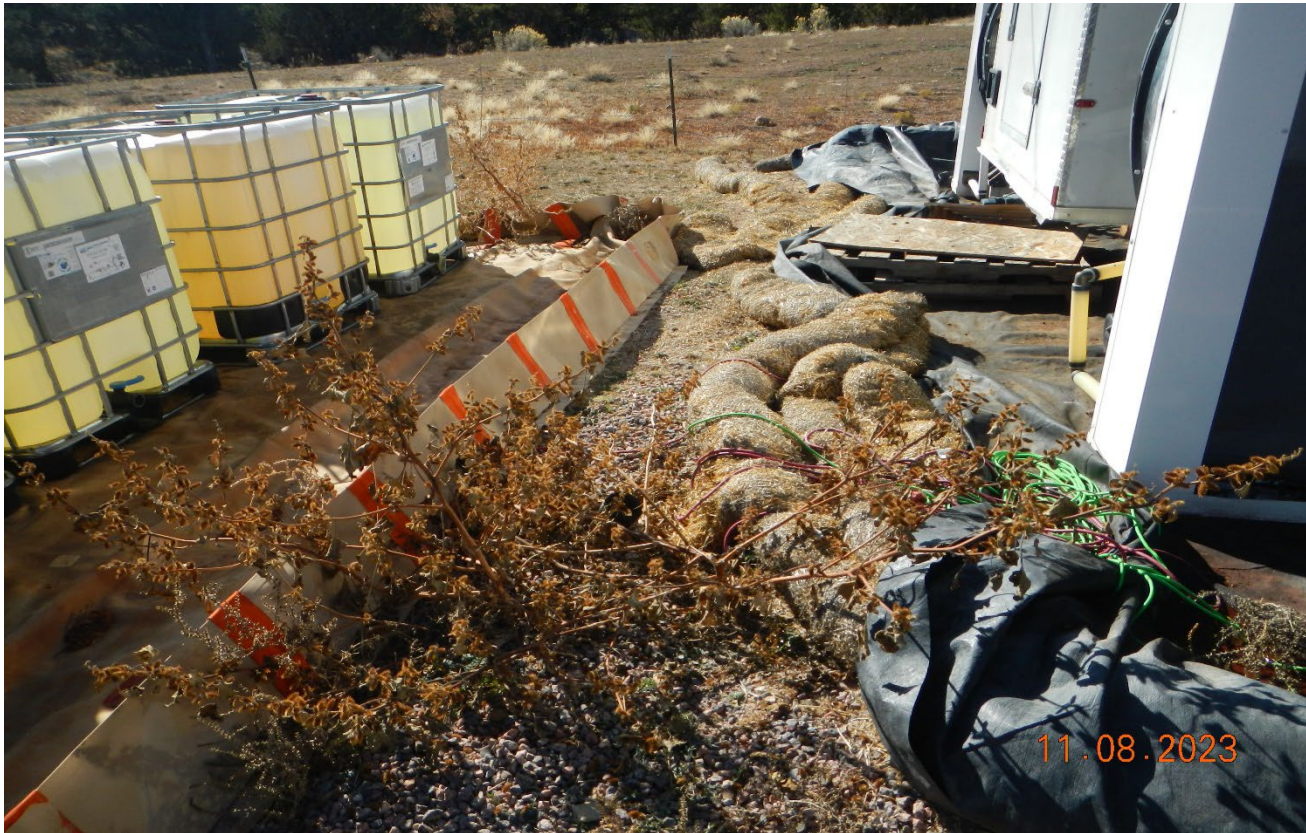
Photo 10. The plastic liner has become folded over needs to be repaired. Liner should be properly staked down.

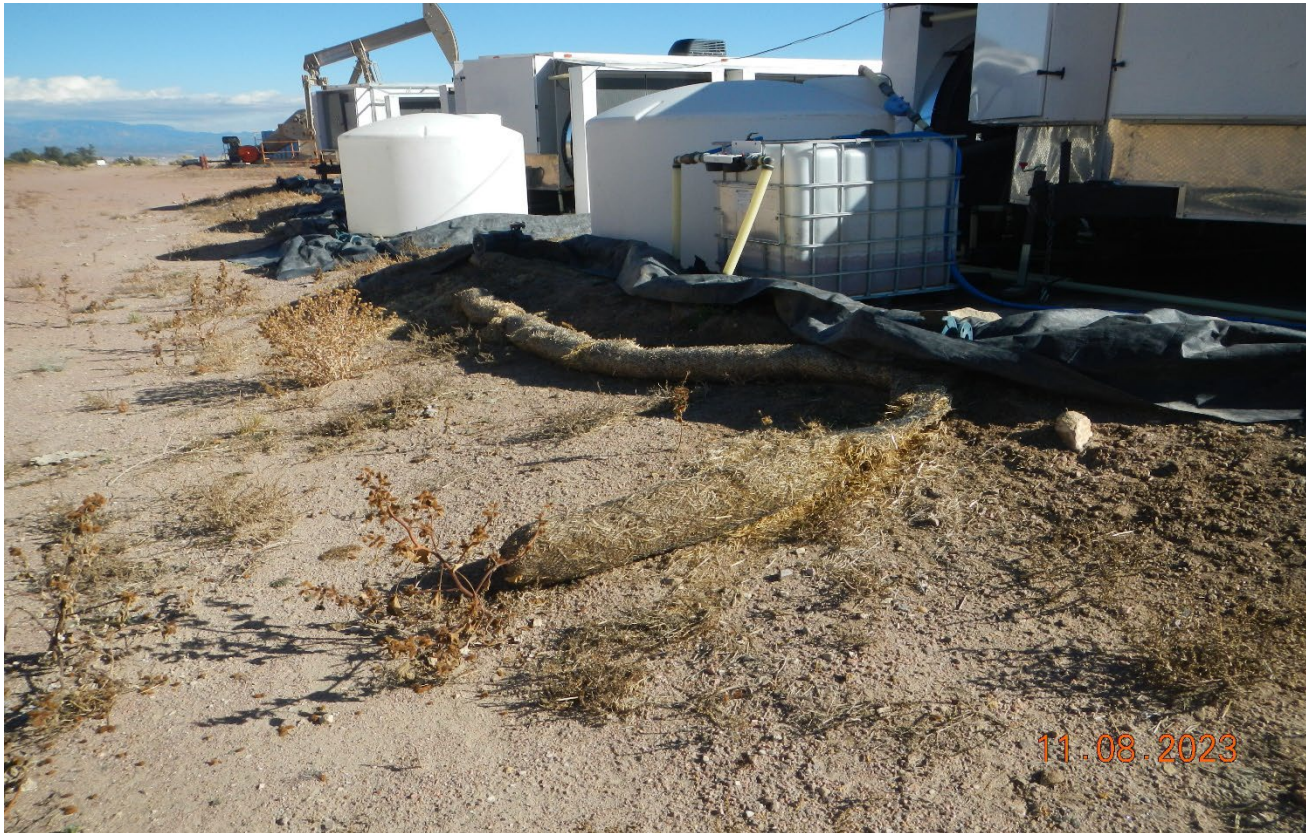
Photo 11. Facing north toward the bitcoin equipment. There are multiple tanks and secondary containment is not sufficient or maintained to contain a spill.

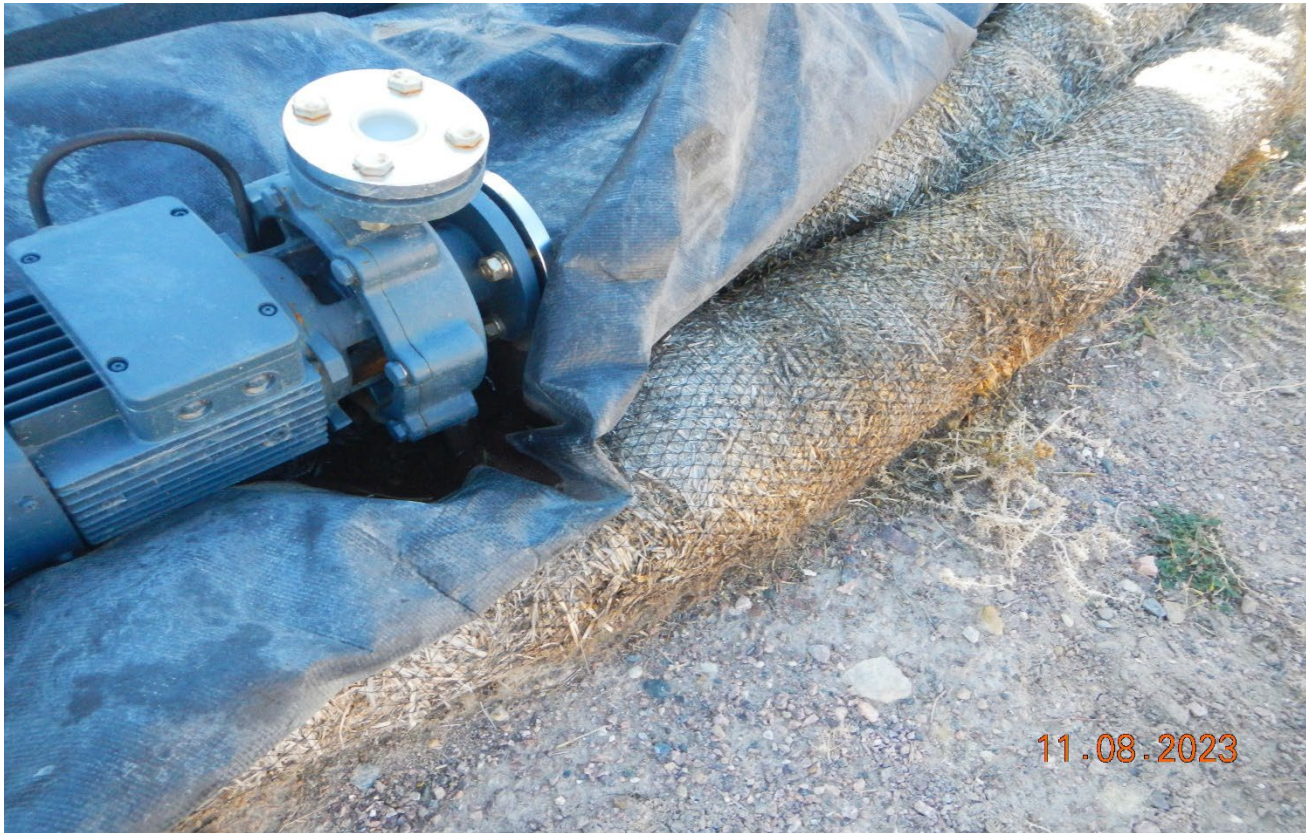
Photo 13. Facing south at the location. All gravel must be removed and the location will must be reclaimed per 1004 Rules.

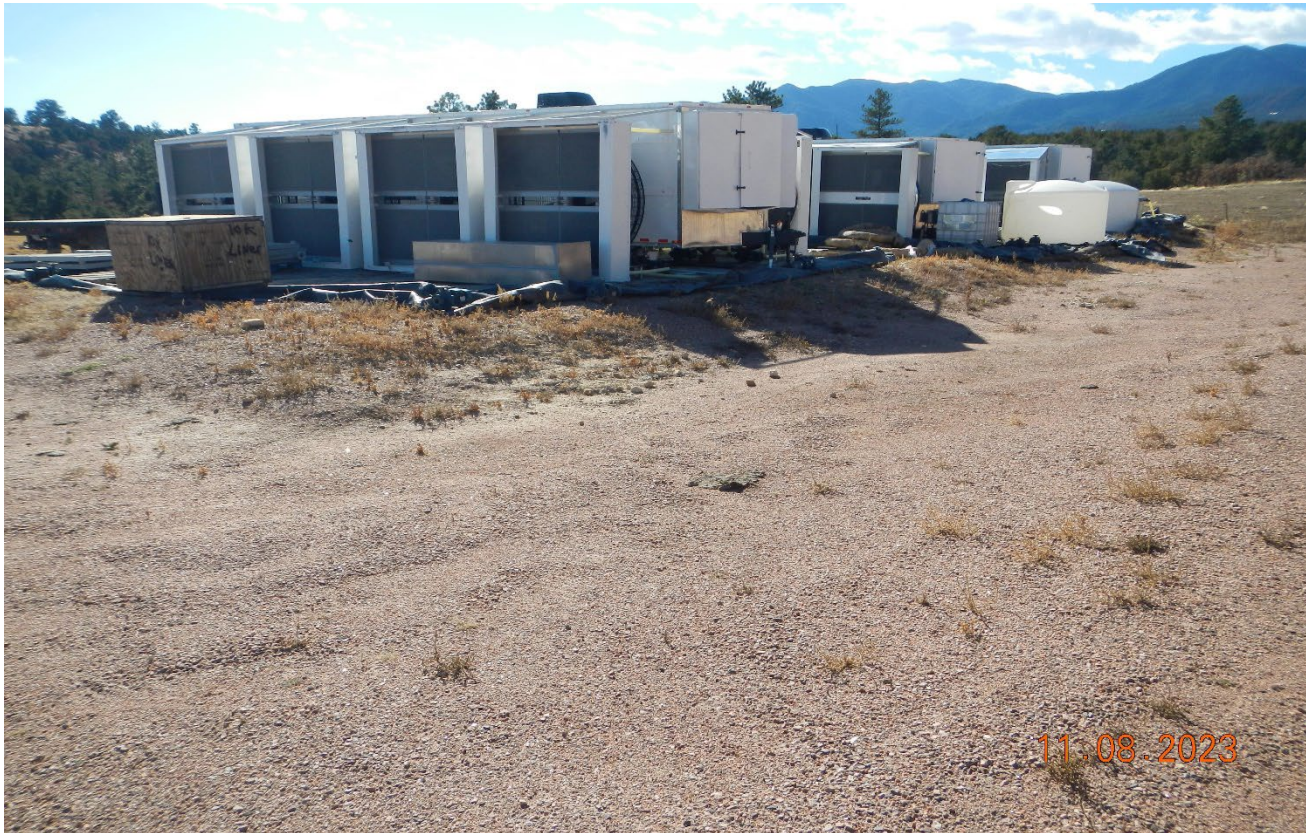
Photo 14. Facing south at the location. All gravel must be removed and the location will must be reclaimed per 1004 Rules.

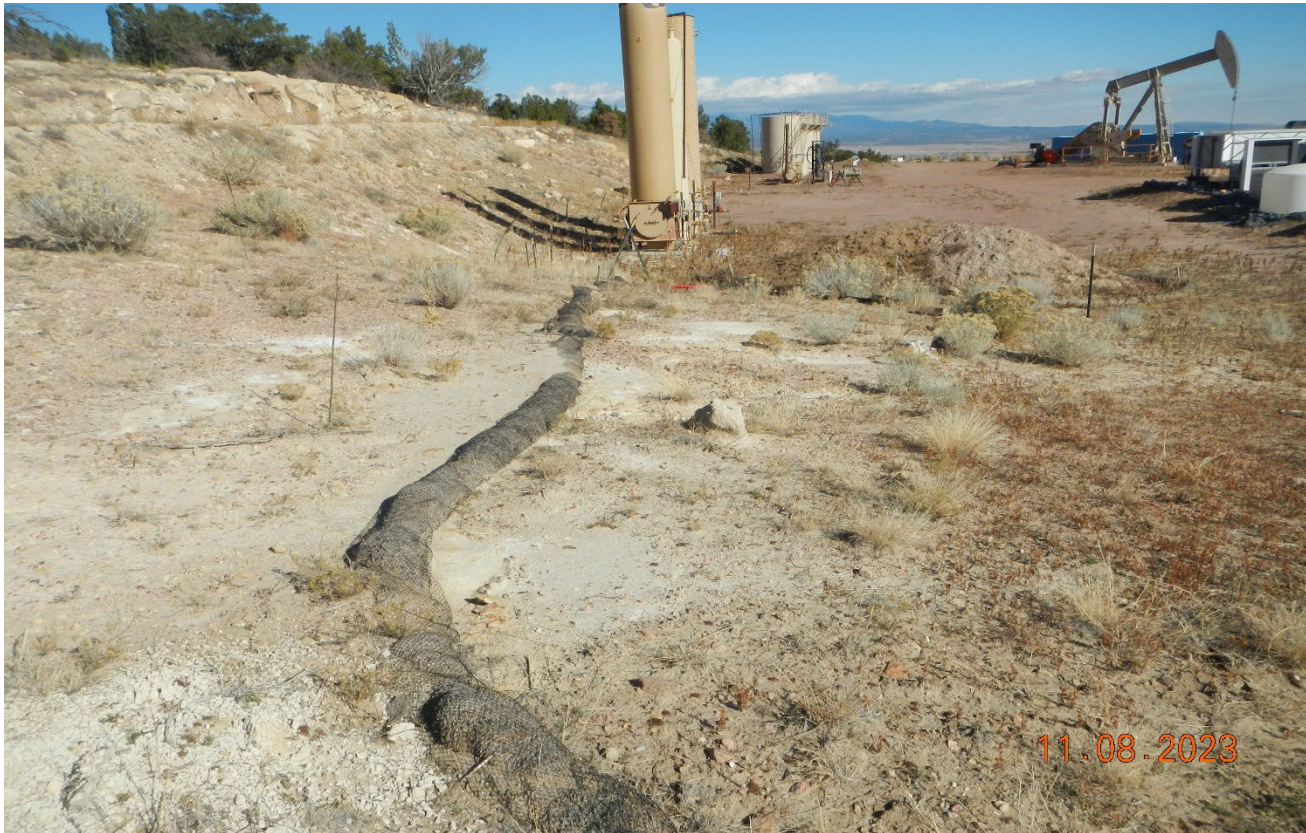
Photo 15. South side of the location facing north. The old wattles in this area needs to be replaced or removed. Previous corrective action was not completed.

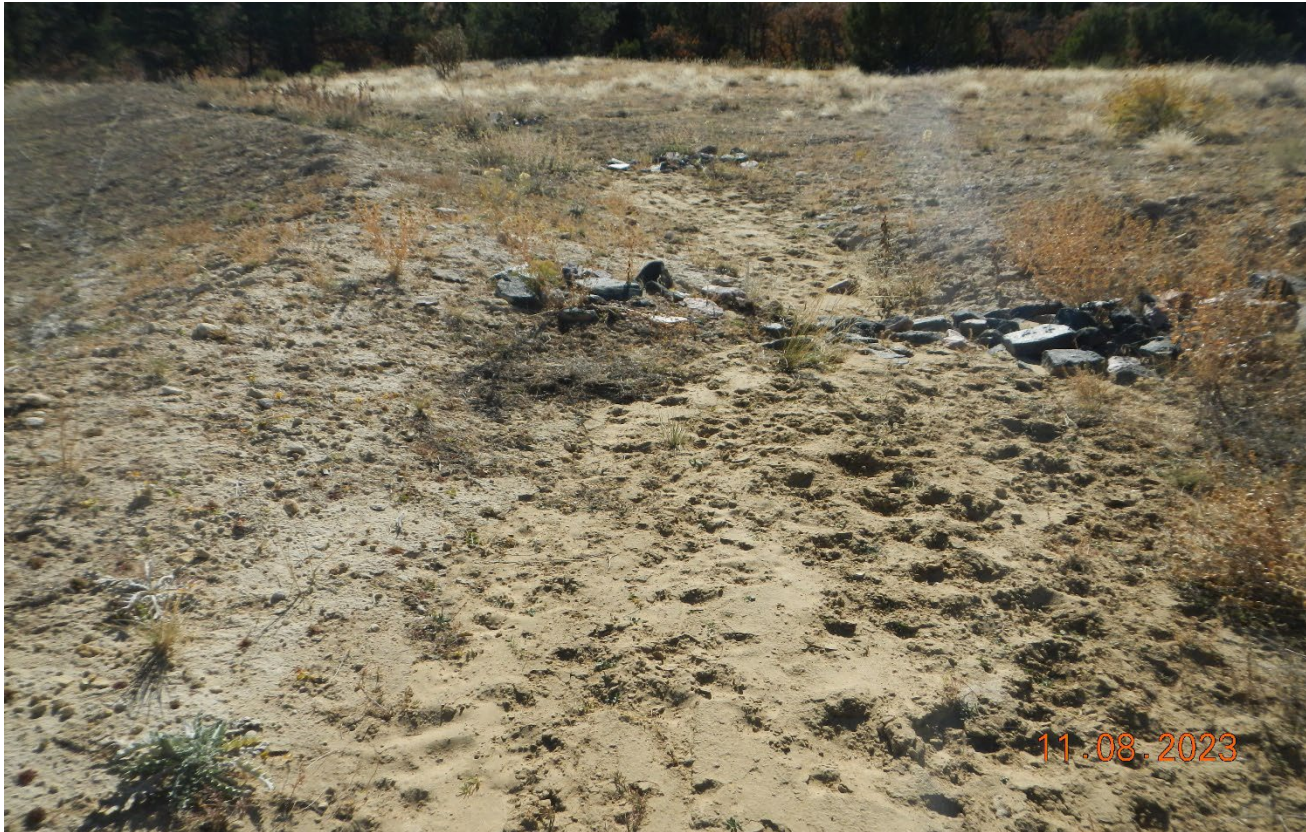
Photo 16. Facing south at the perimeter ditch. The check dams have filled in with sediment and need to be cleaned out. Previous corrective action was not completed.

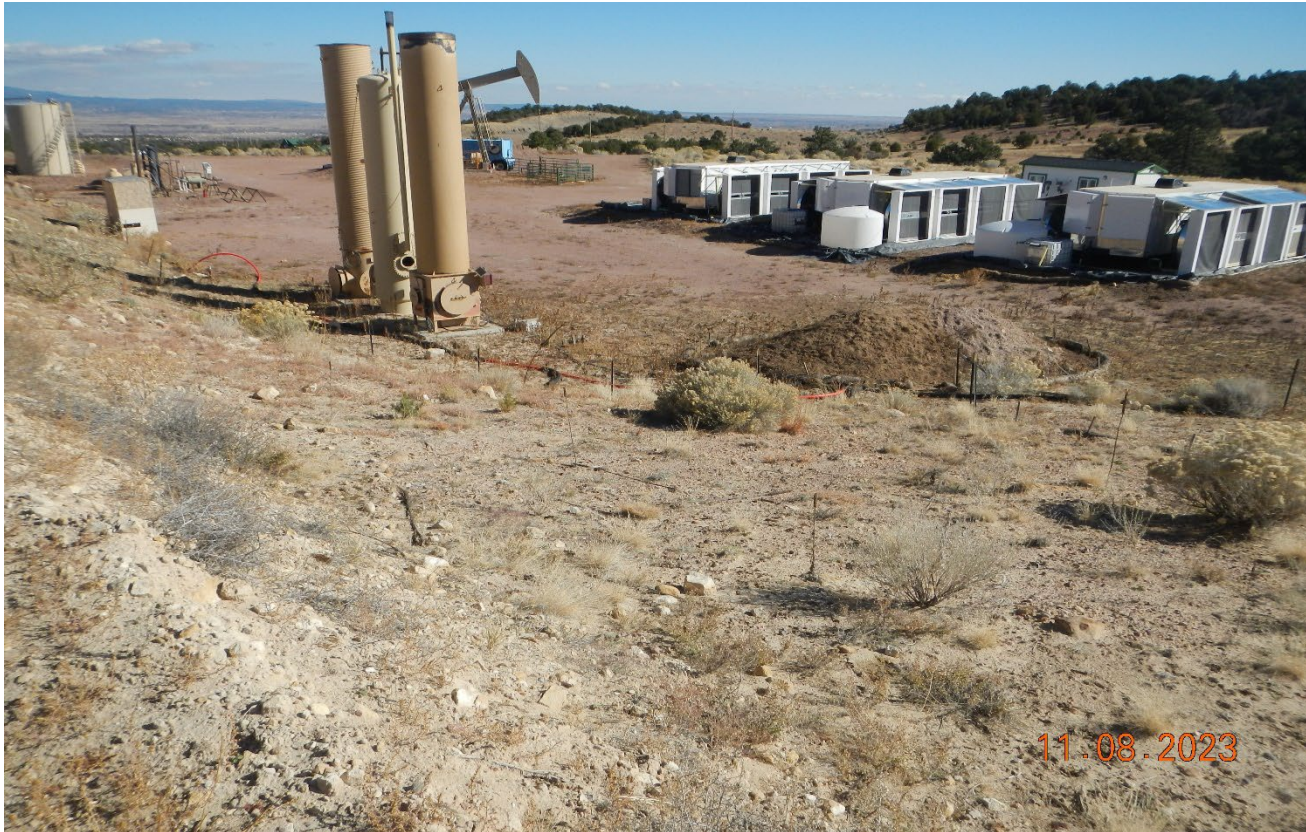
Photo 17. Facing south at the location. All gravel must be removed and the location will must be reclaimed per 1004 Rules.

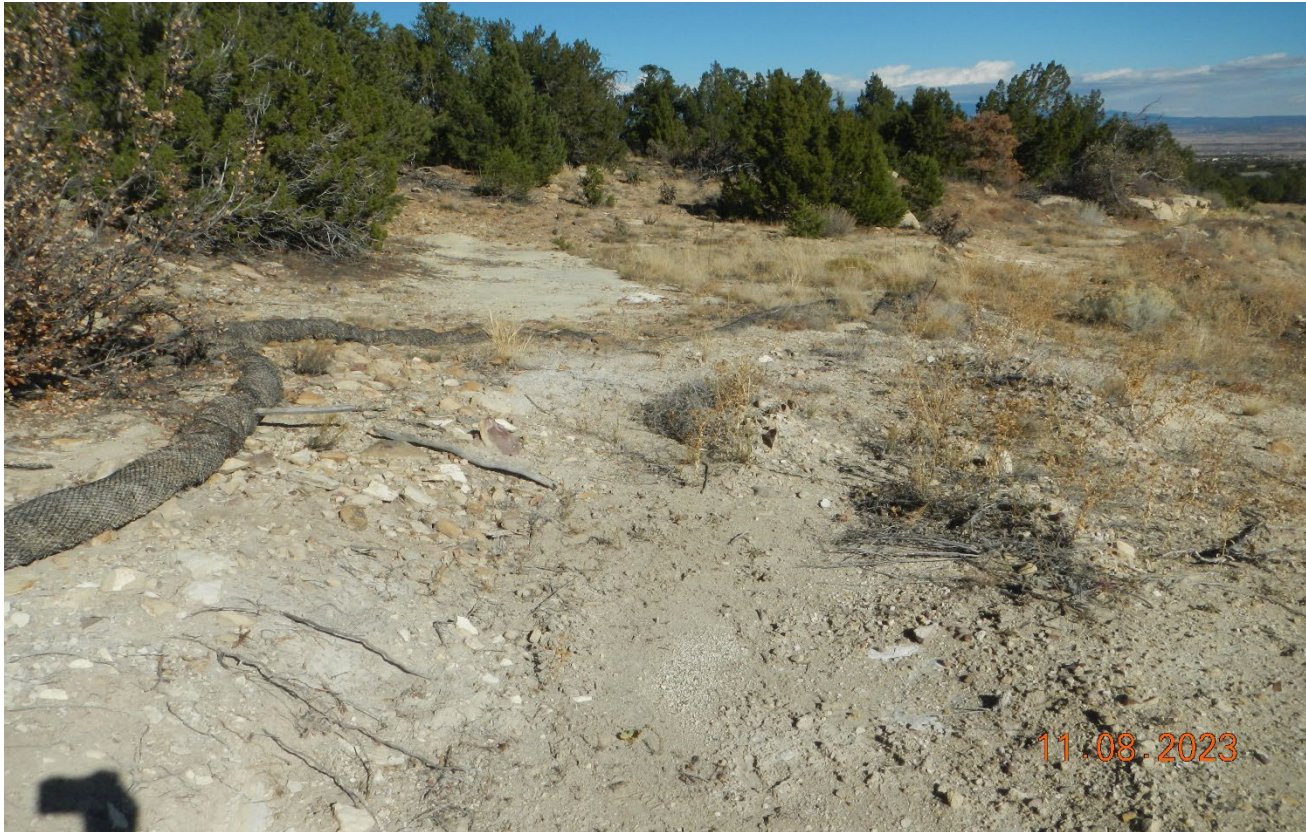
Photo 18. The wattles along the west perimeter of the location are degraded and need to be replaced or removed.

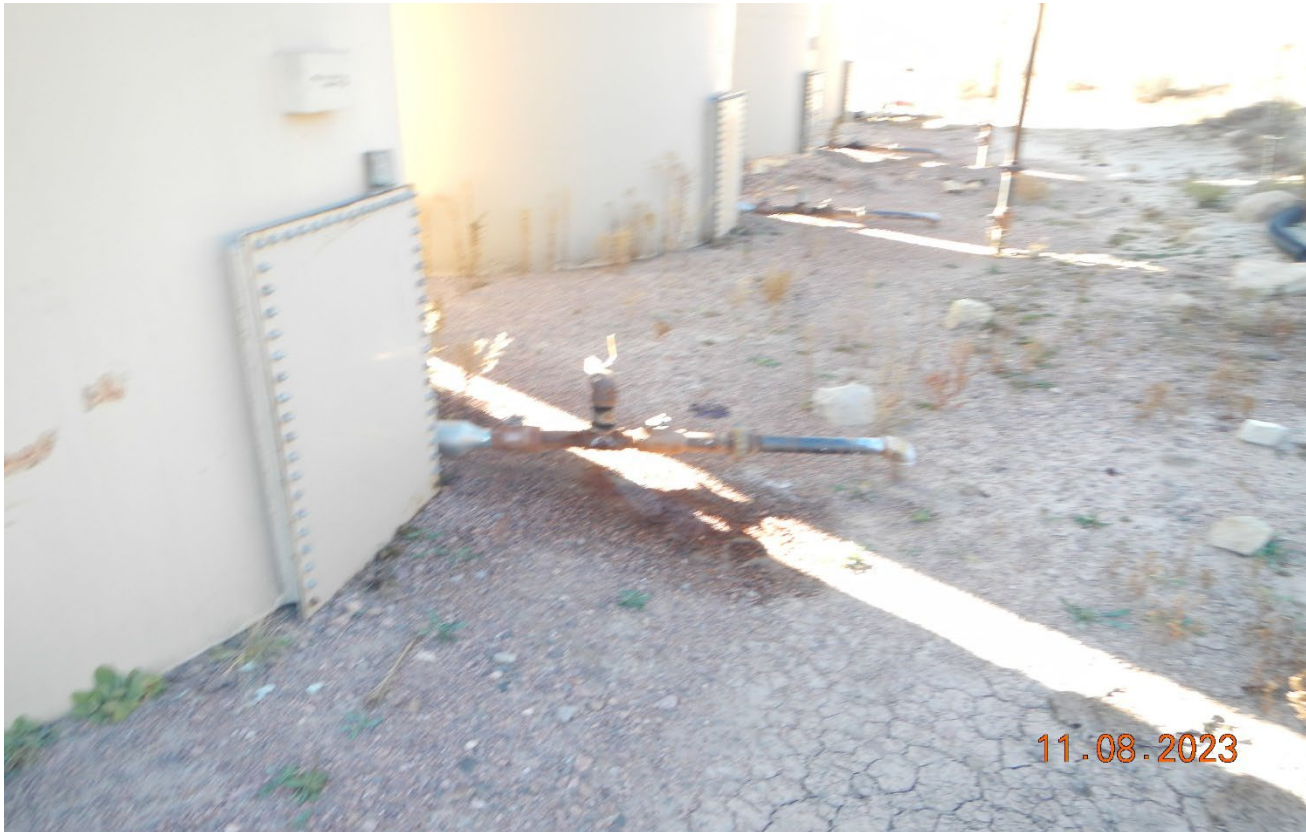
Photo 20. There is a dripping leak at the backside of the tank. Operator was immediately notified.

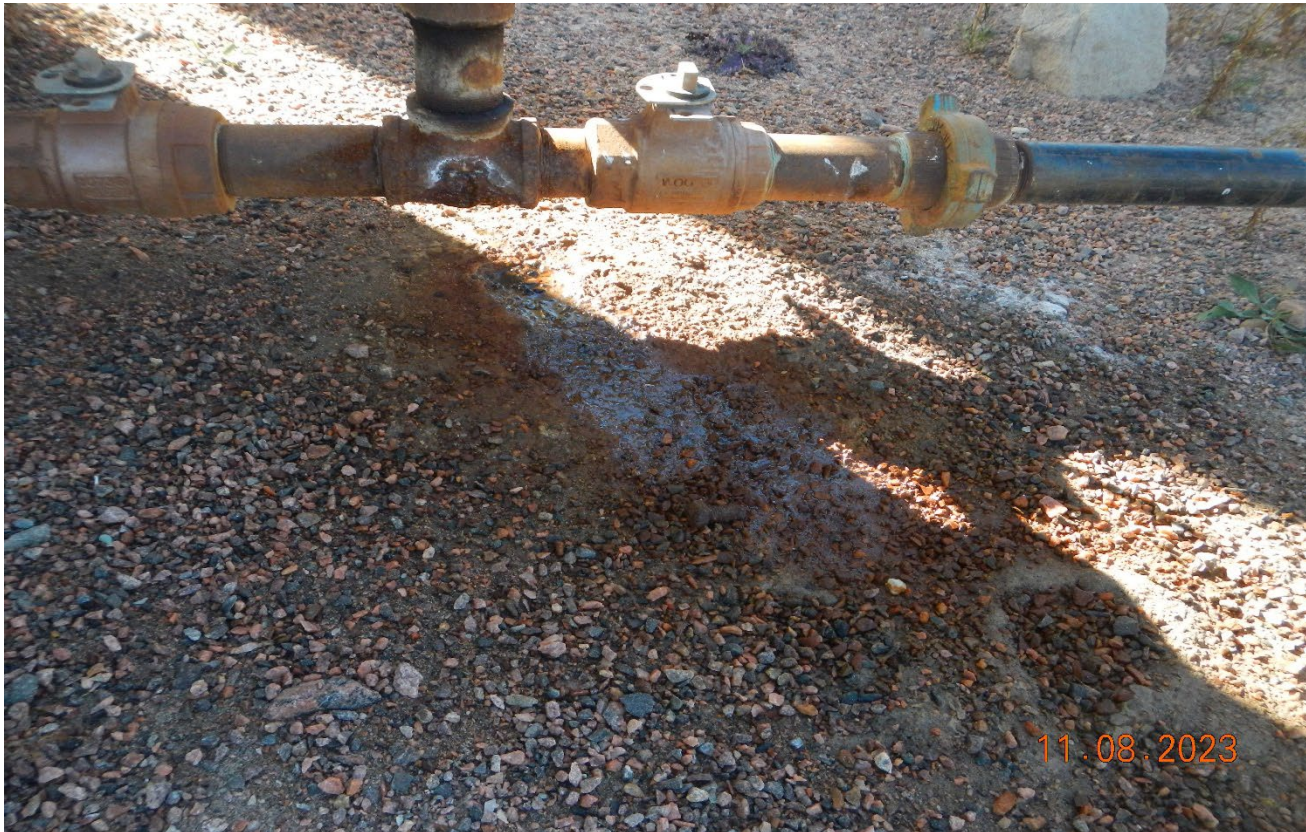
Photo 21. There is a dripping leak at the backside of the tank. Operator was immediately notified.
