Inspection Photos

Loc: 424805

Operator: **JAVERNICK OIL**

Inspection Date: 11/08/2023

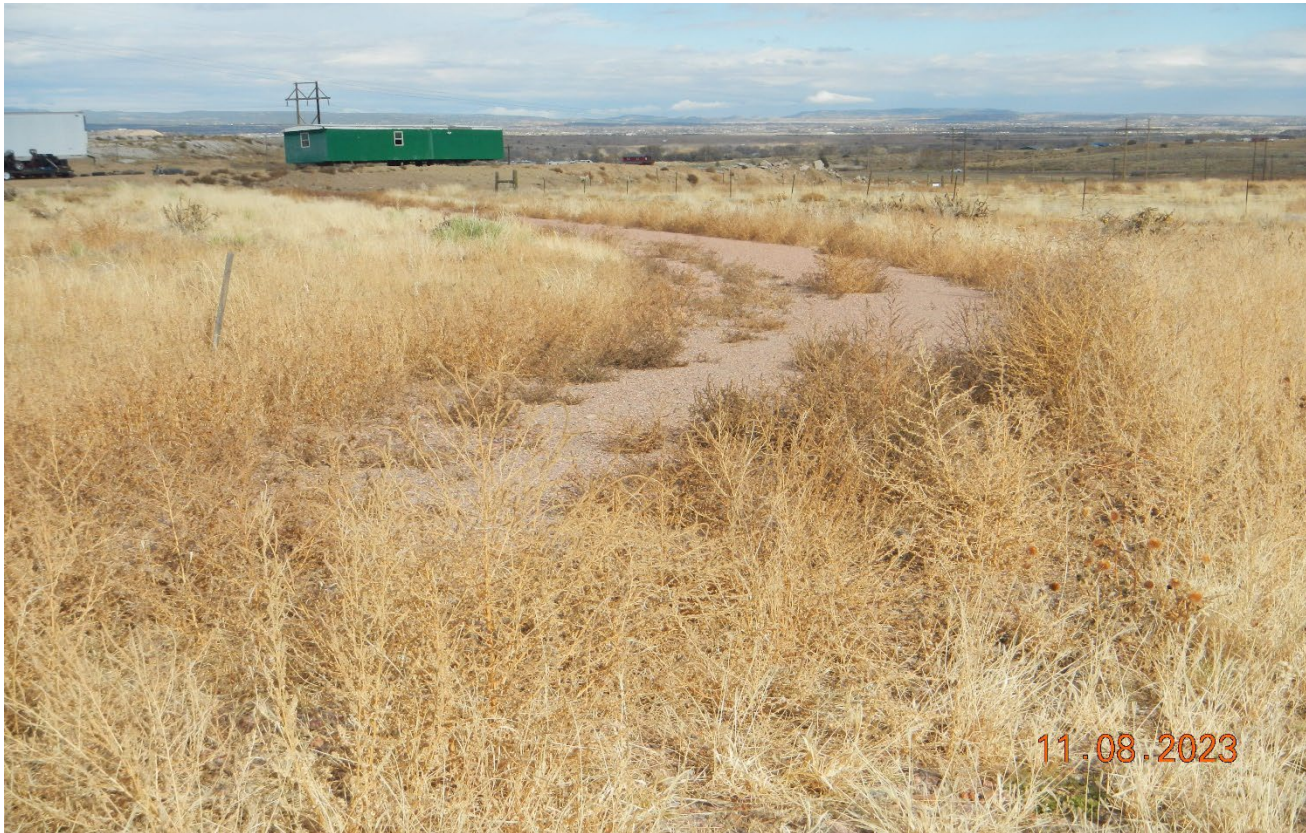
Photo 1. Facing northwest at the beginning of the access road. There is undesirable weeds along the access and the access road has not been reclaimed..

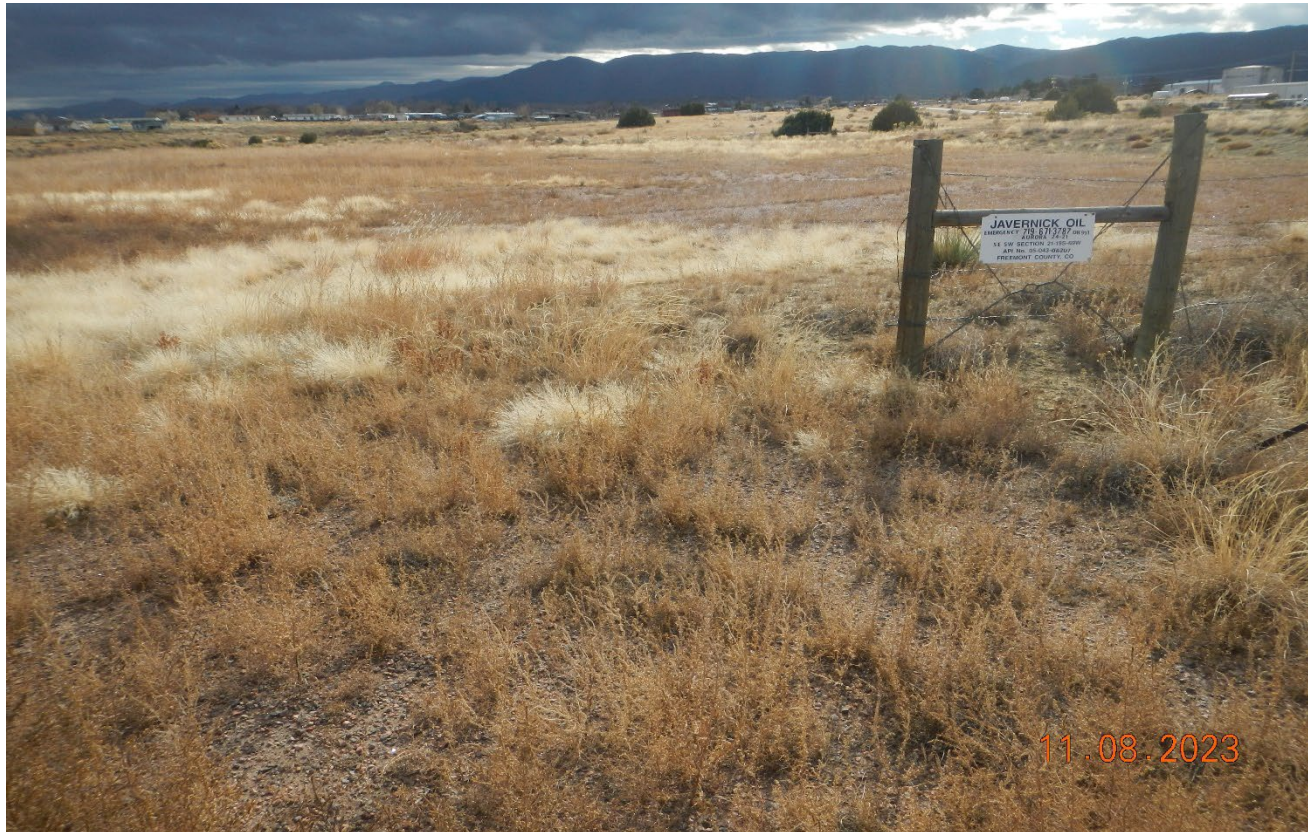
Photo 2. Facing south toward the location which has not been reclaimed per 1004 Rules. The fence remains around the location and is not maintained.

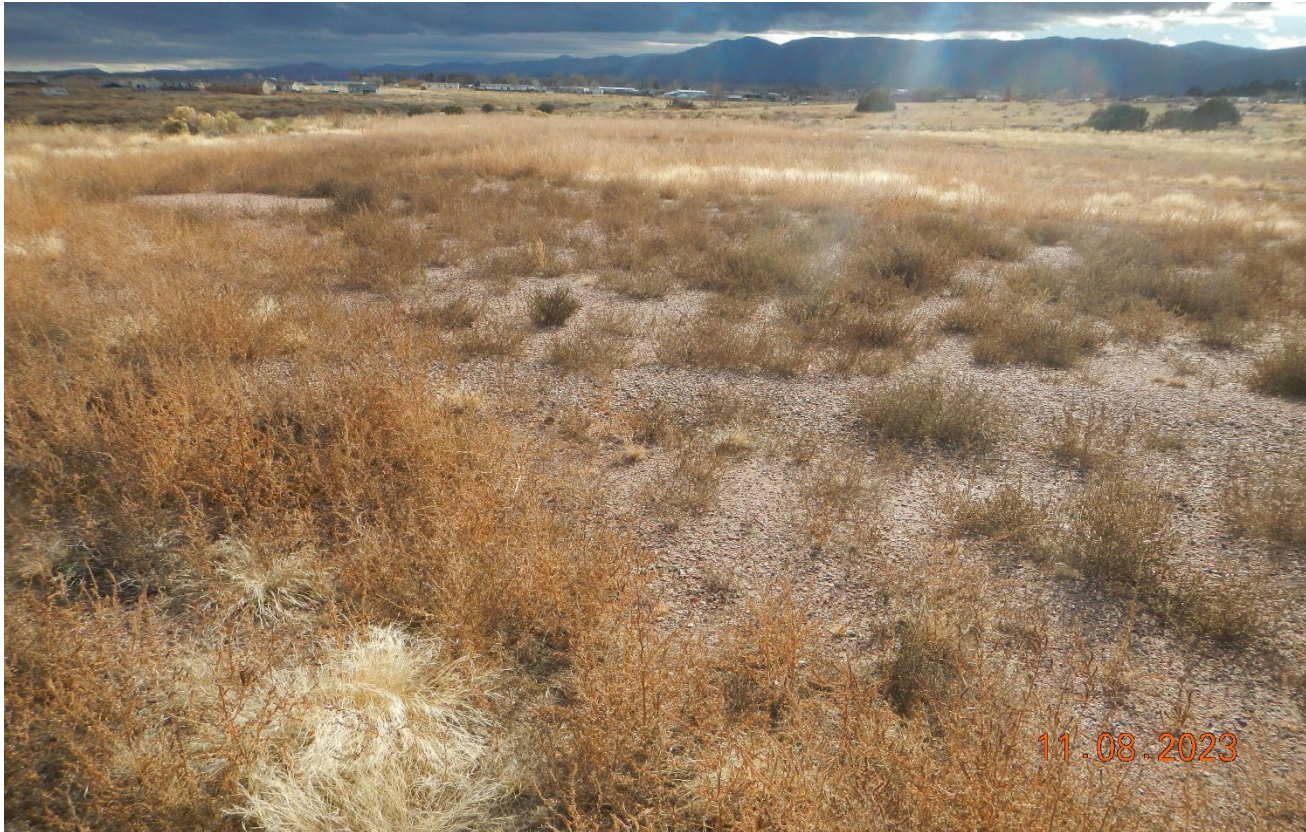
Photo 3. East side of the location facing south. Gravel remains at the location and there are undesirable weeds. Previous corrective action was not completed.

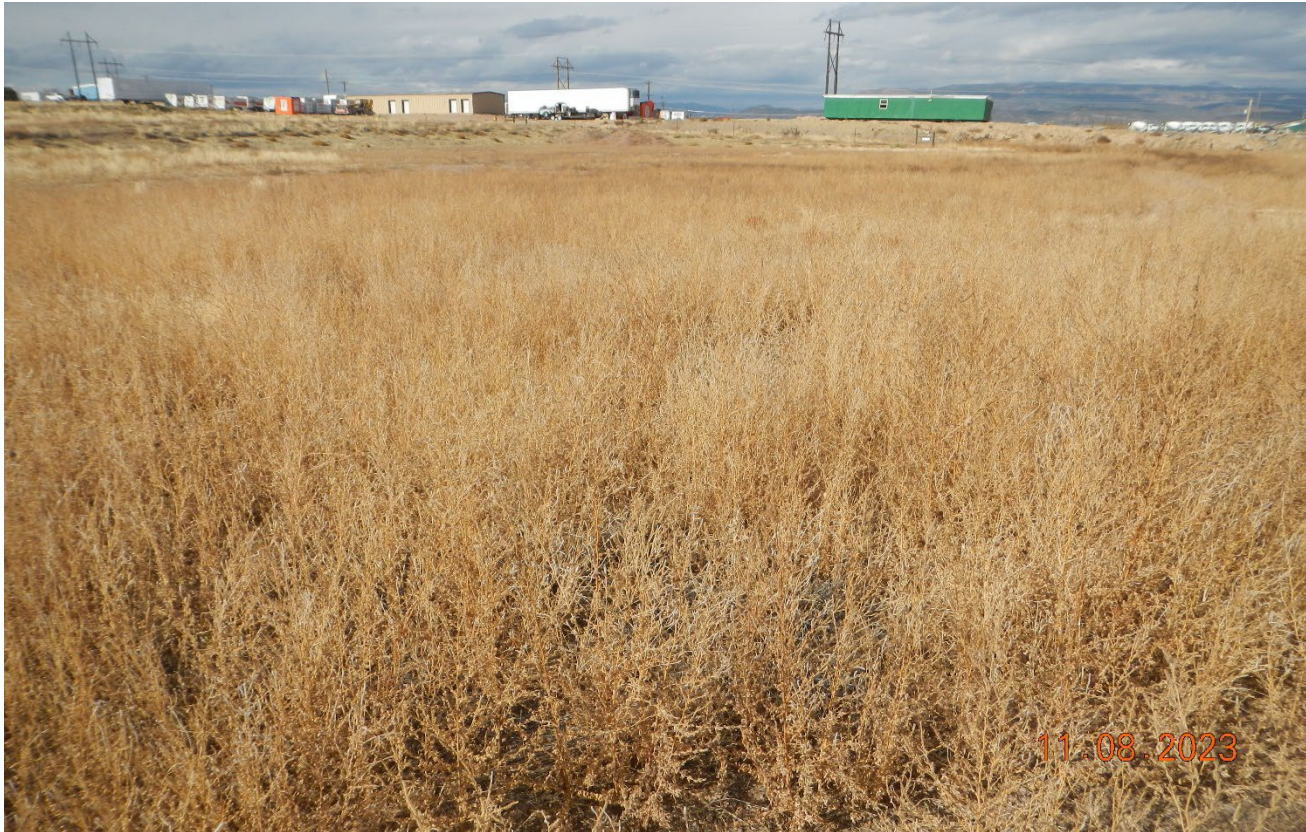
Photo 4. Facing northwest at the location. There is tall dry undesirable weeds throughout the location which is a fire hazard.

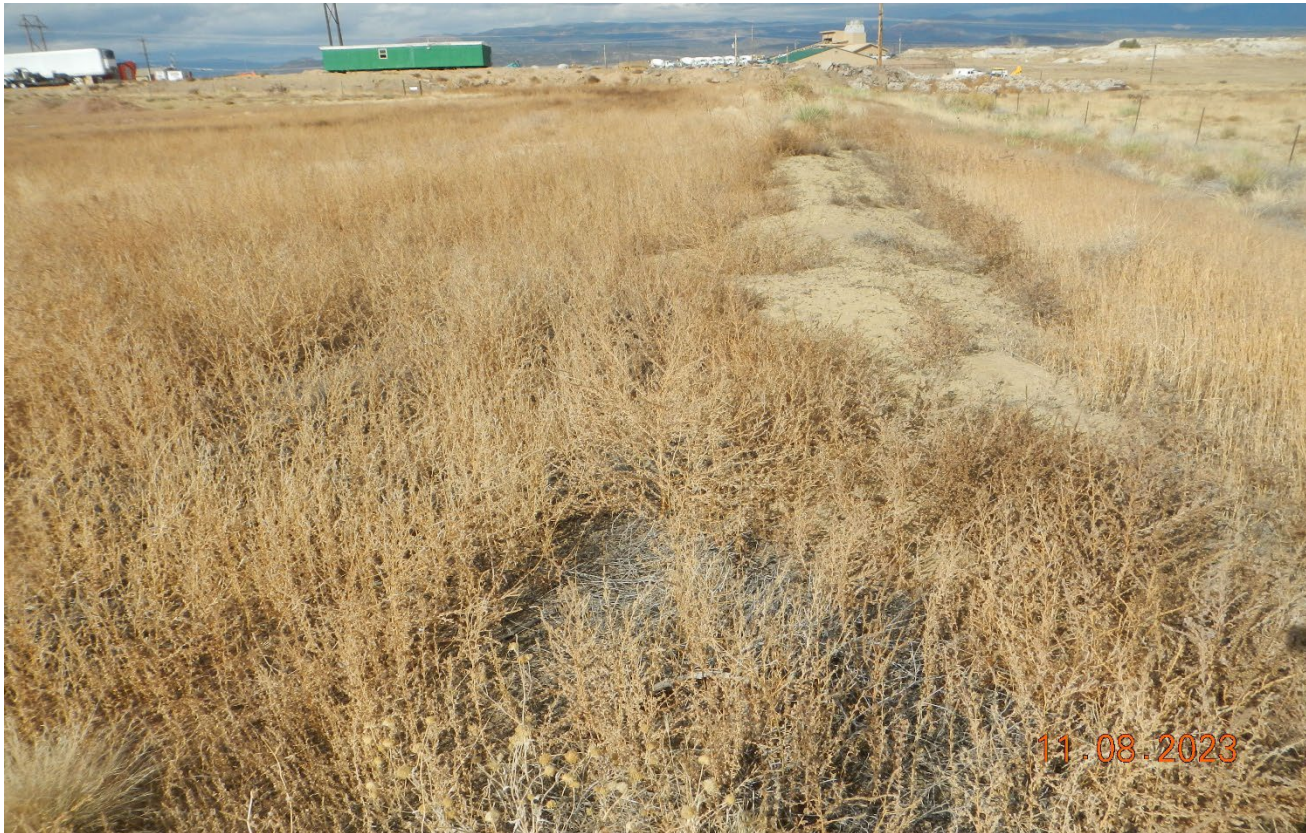
Photo 5. Southeast corner of the location facing north along the fill slope. There are undesirable growing along the fill slope that need to be controlled. The location has not been recontoured. Previous corrective action was not completed.

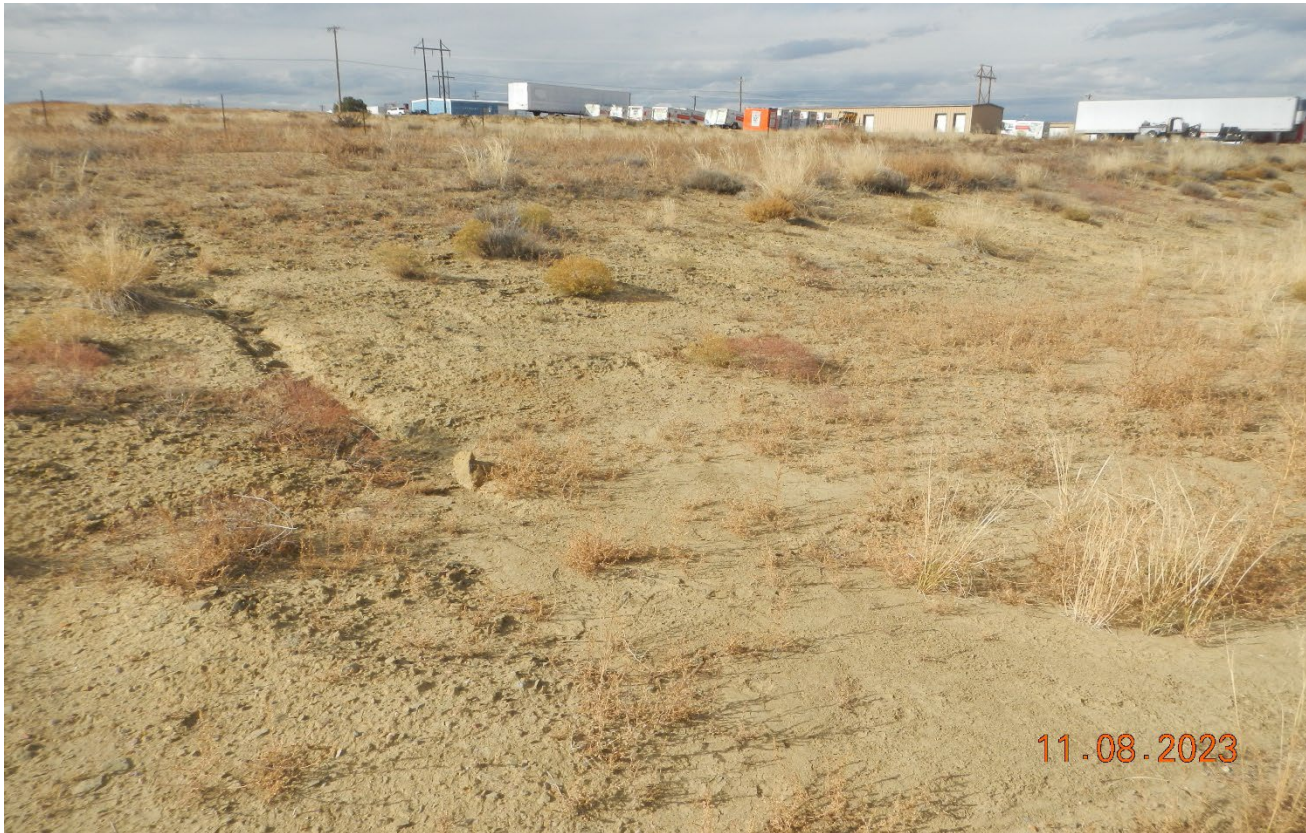
Photo 6. Facing northwest along the cut slope. There is rilling erosion along the cut slope which is not stabilized. Previous corrective action was not completed.

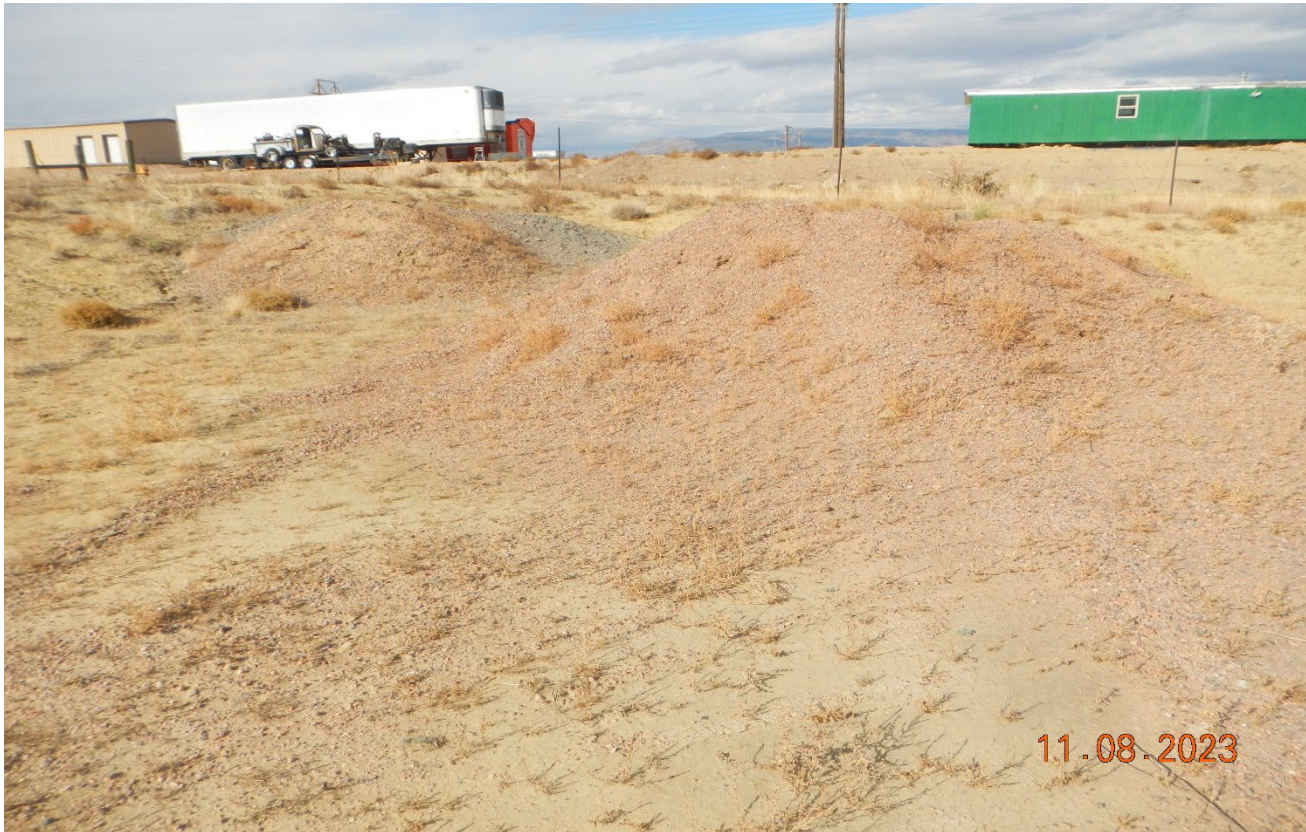
Photo 6. There are two gravel pile at the remain at the northwest corner of the Location. Previous corrective action was not completed.
