Inspection Photos

API: 043-40000

Operator: JAVERNICK OIL

Inspection Date: 11/8/2023

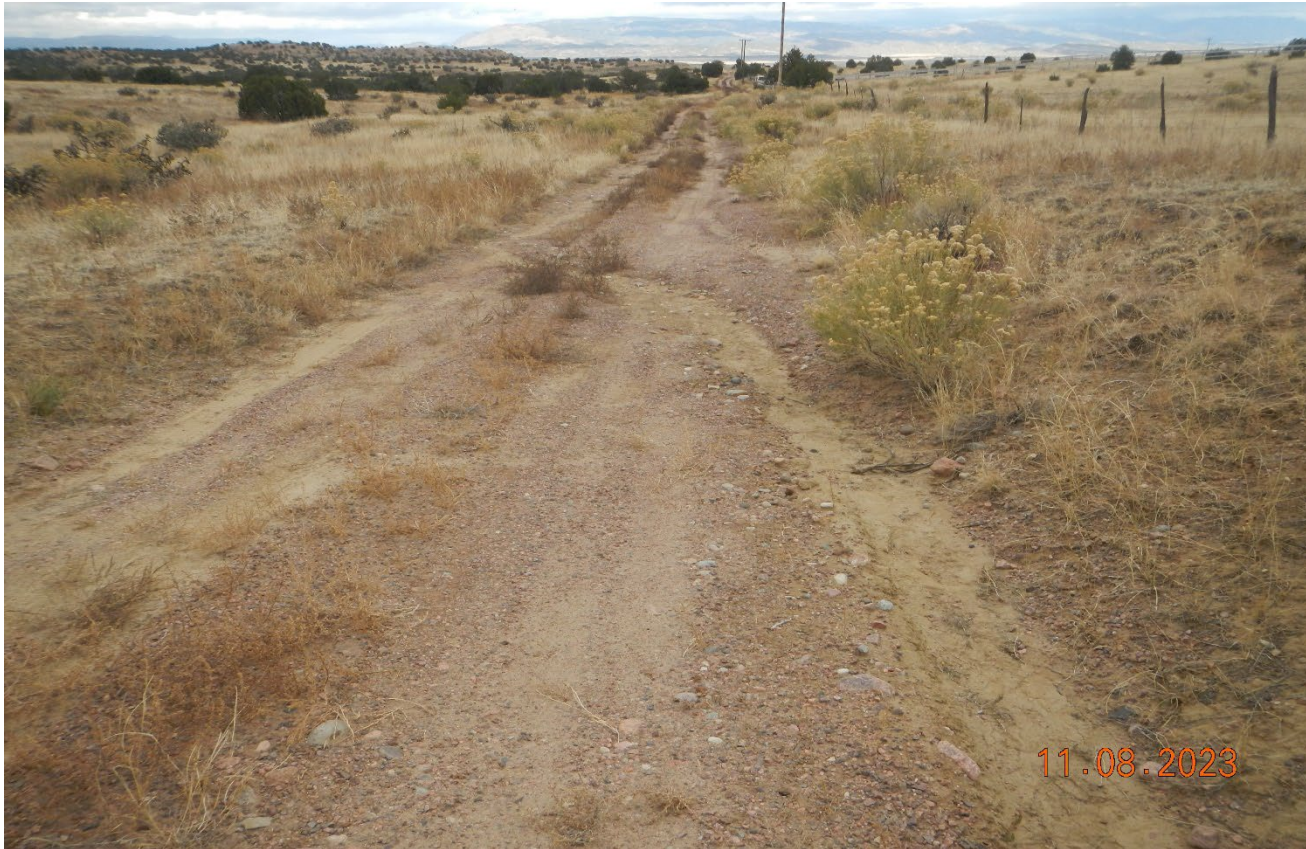
Photo 1. Facing north along the former access road. There is erosion along the road that must be repaired.

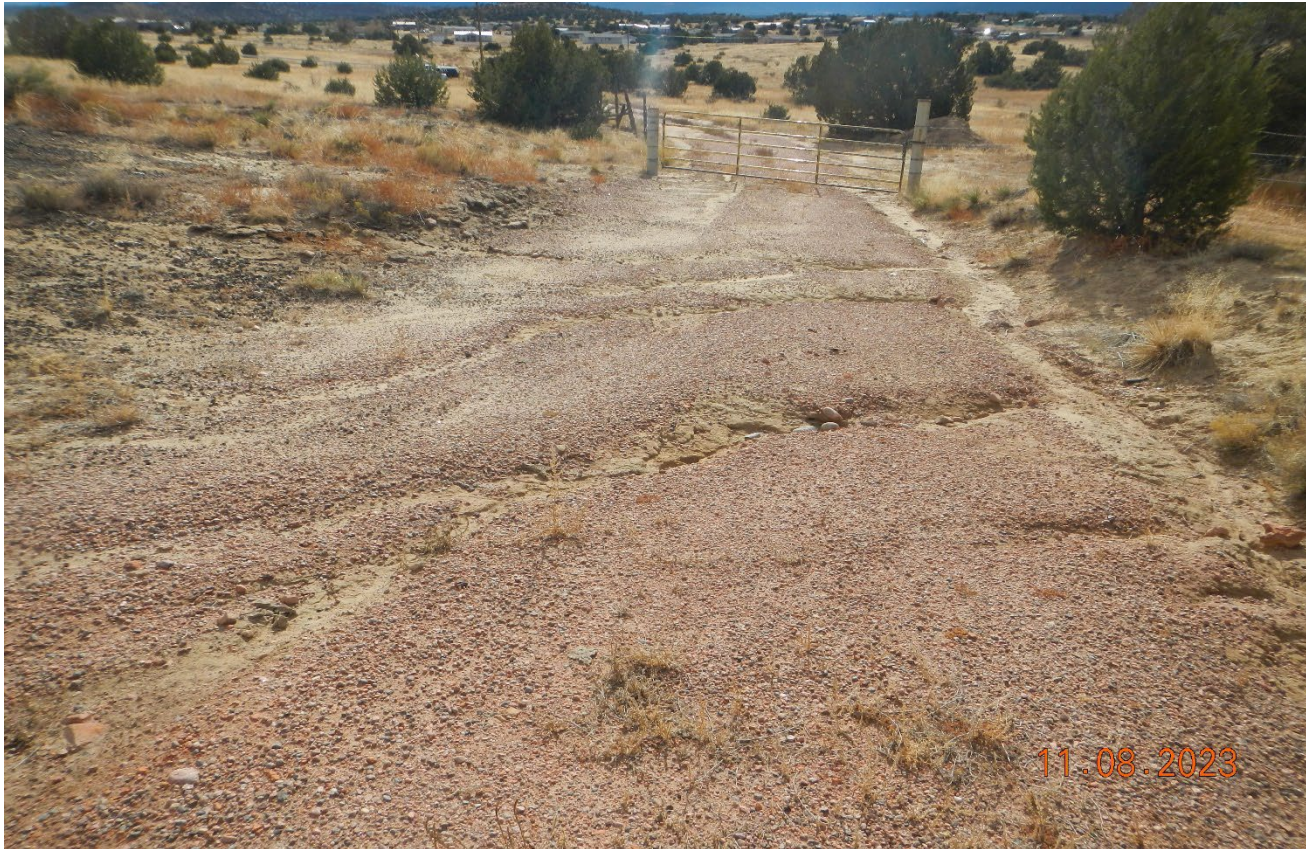
Photo 2. Facing southwest toward the access road which must be reclaimed. There is erosion occurring along this area that needs to be repaired and stabilized.

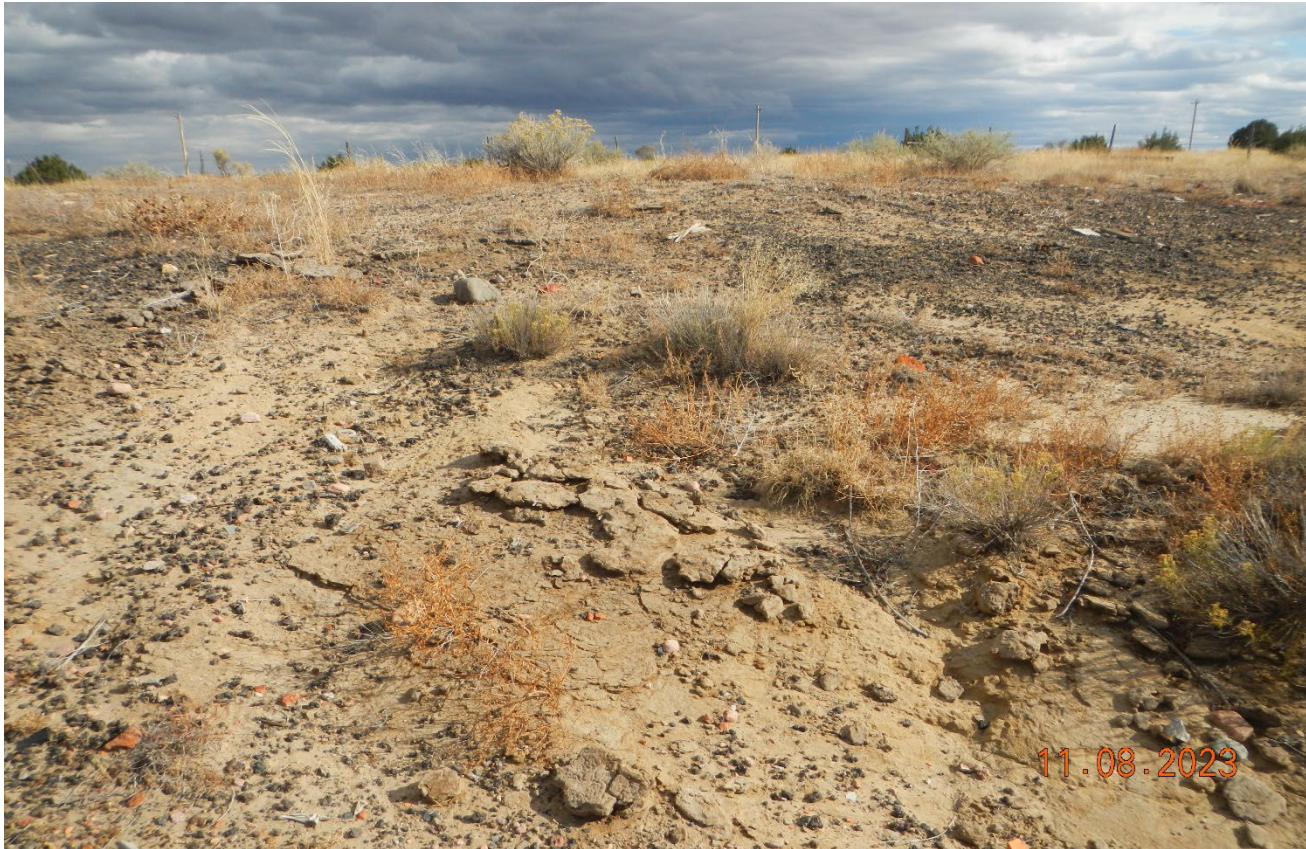
Photo 3. Facing east toward the abandoned wellsite which was never reclaimed. Soils remain bare of vegetation and there is erosion occurring. There is various debris throughout the location and stained soils.

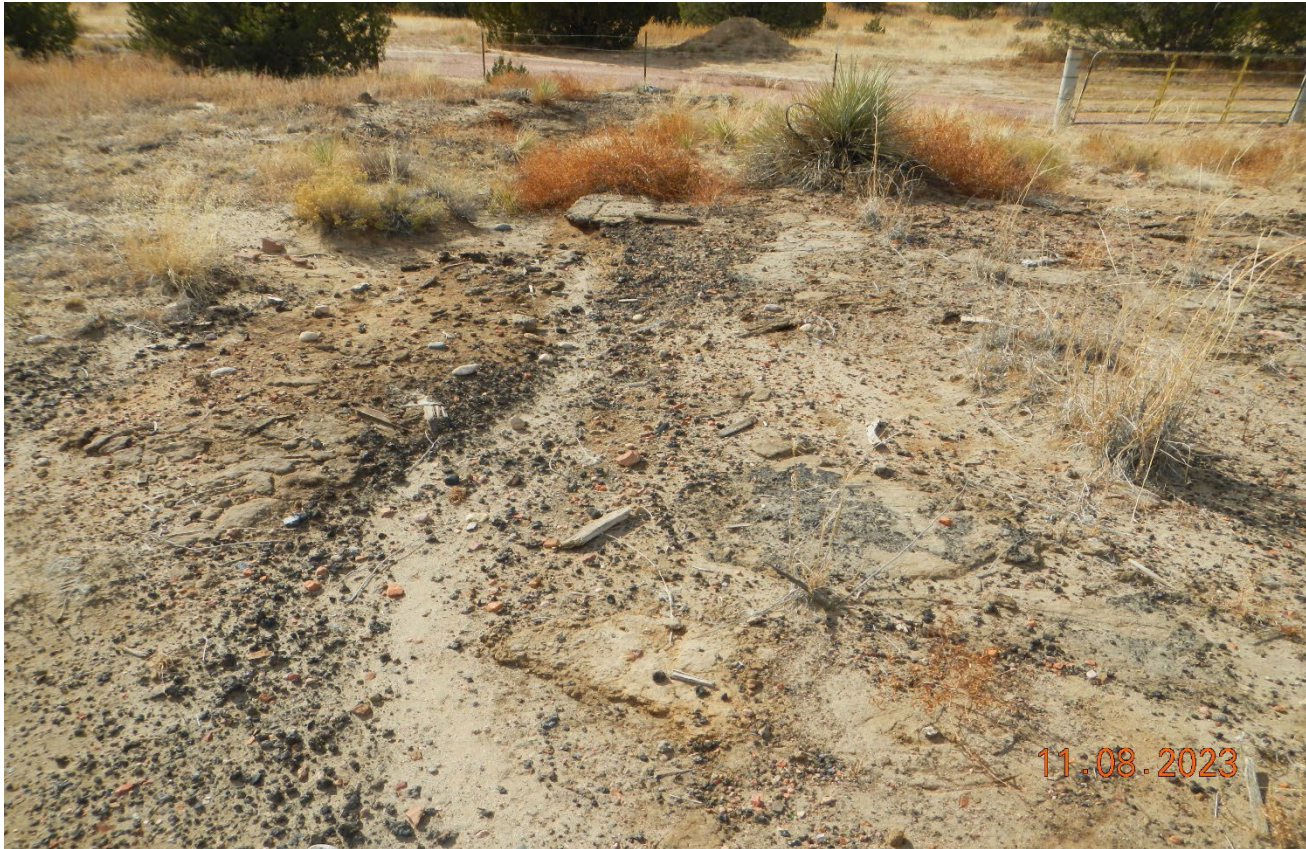
Photo 4. Facing south at the location. There is various debris and stained soils throughout the location.

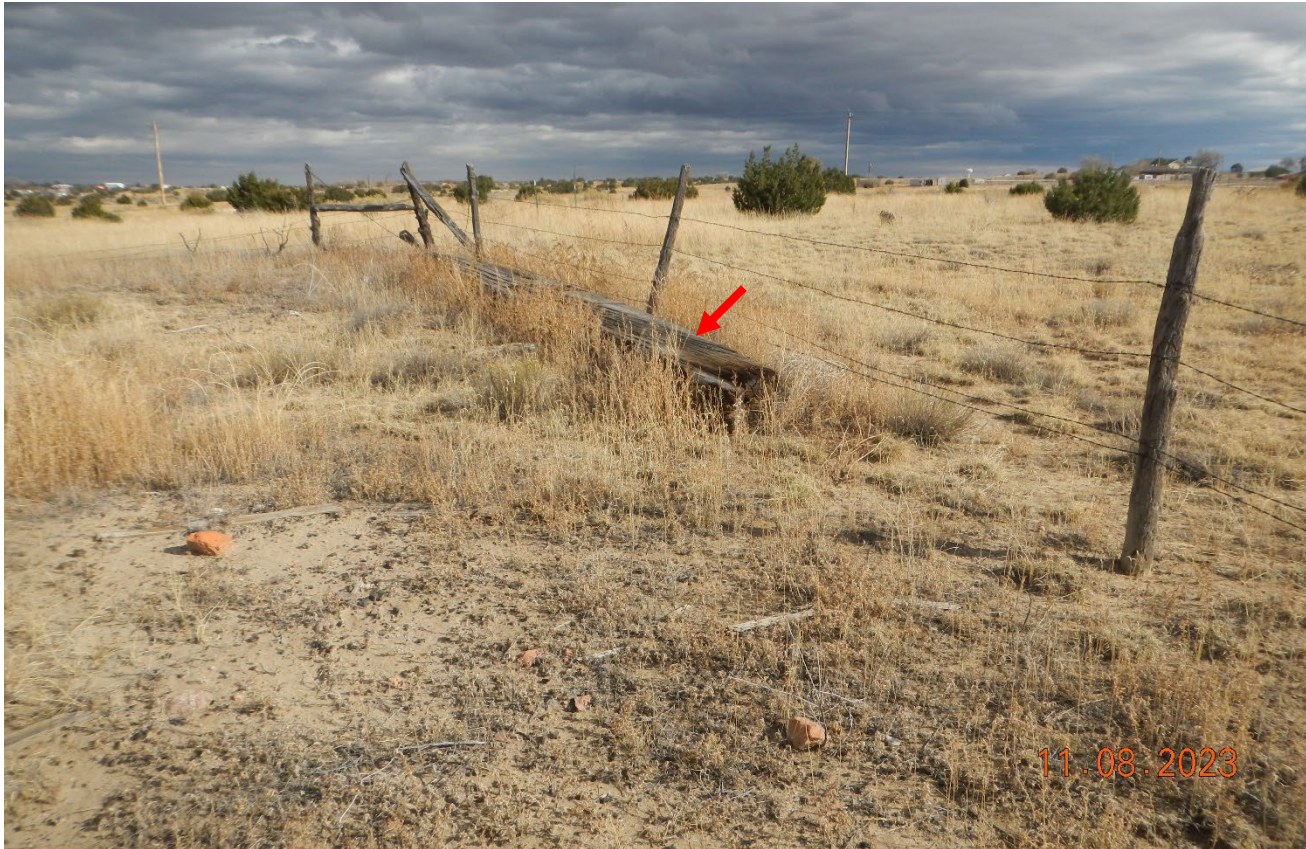
Photo 5. Facing southeast. There is a degraded perimeter fence that remains around the location. There is also an old bridge timber that remains.

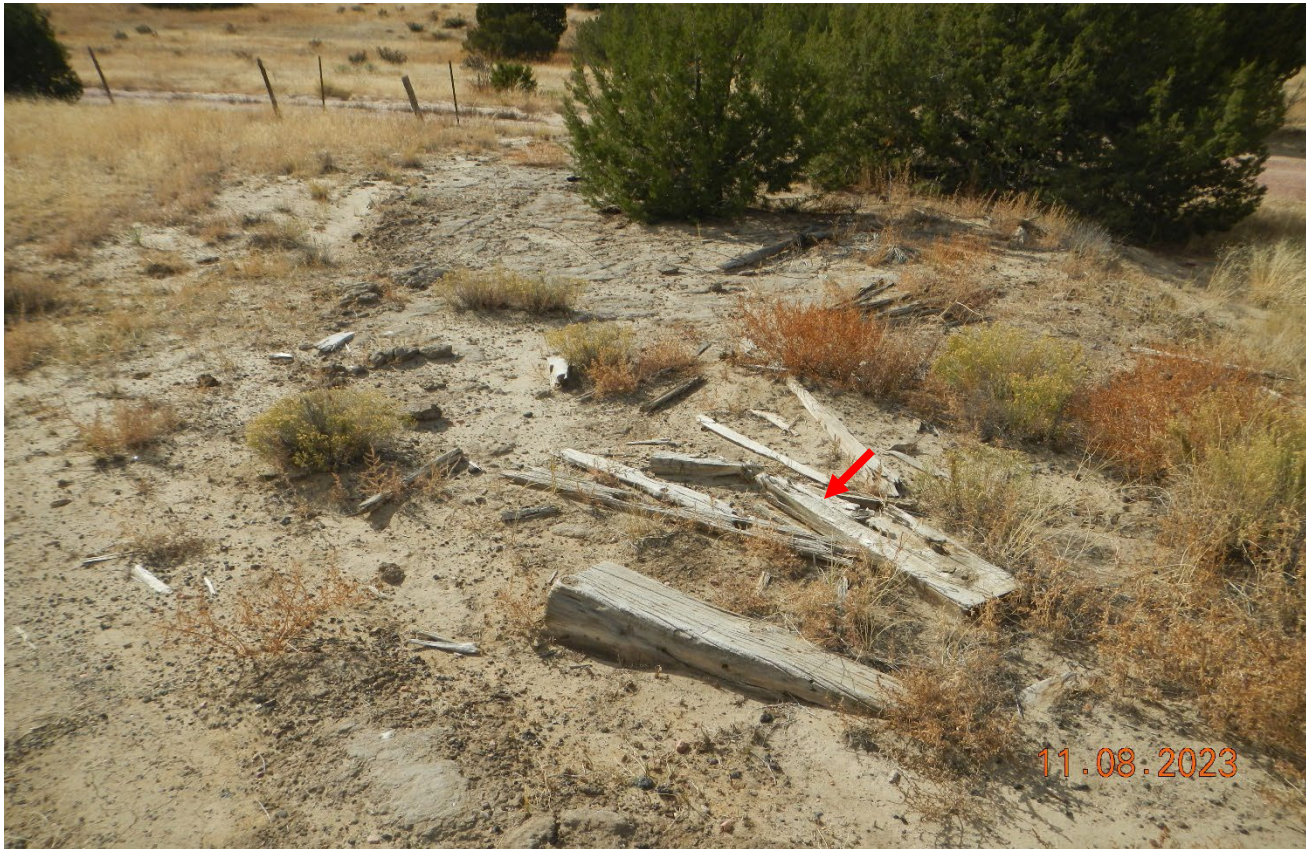
Photo 6. Facing southwest at the location. There is various debris throughout the location.

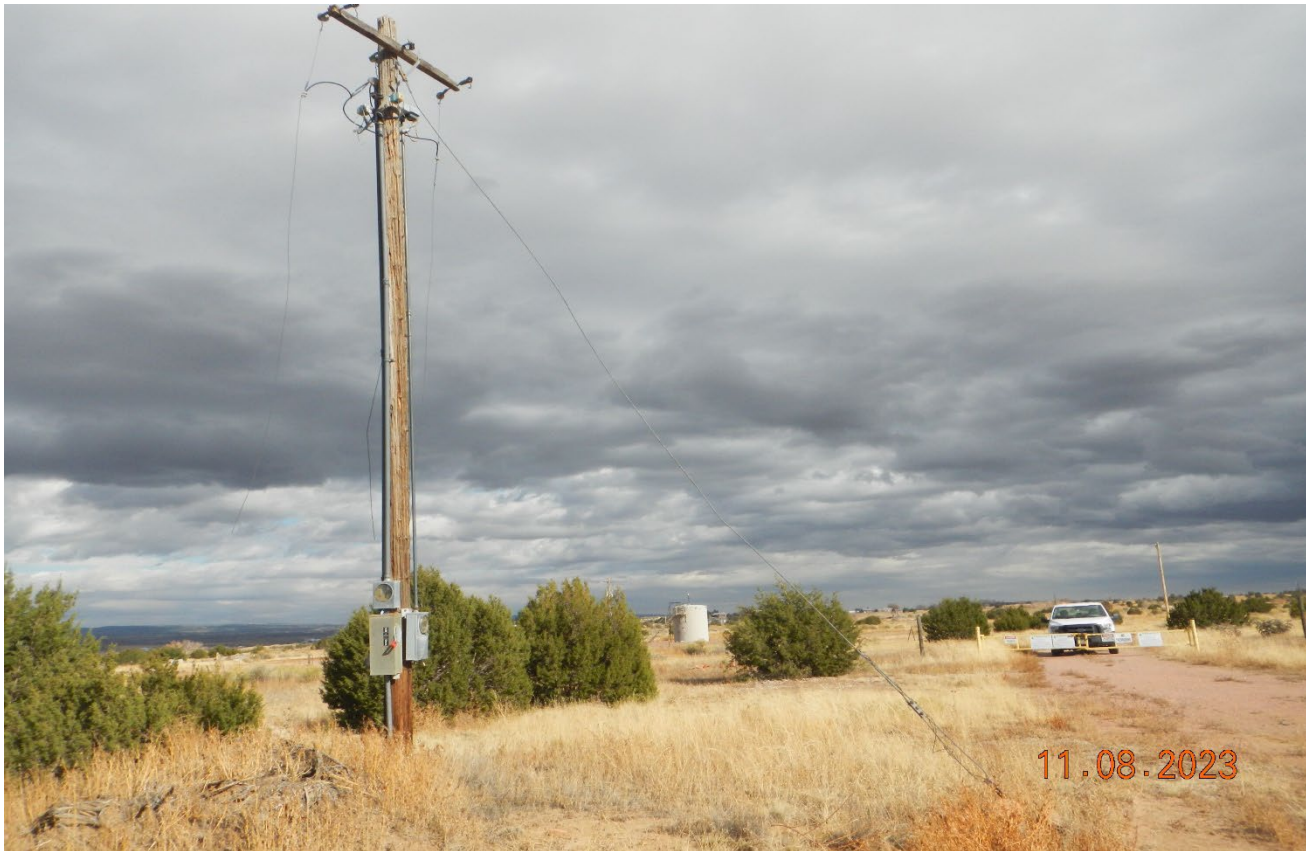
Photo 7. Facing northwest at the wellsite. There is an abandoned powerpole that has not been removed
