# Inspection Photos

API: 043-40001

Operator: JAVERNICK OIL

Inspection Date: 11/8/2023

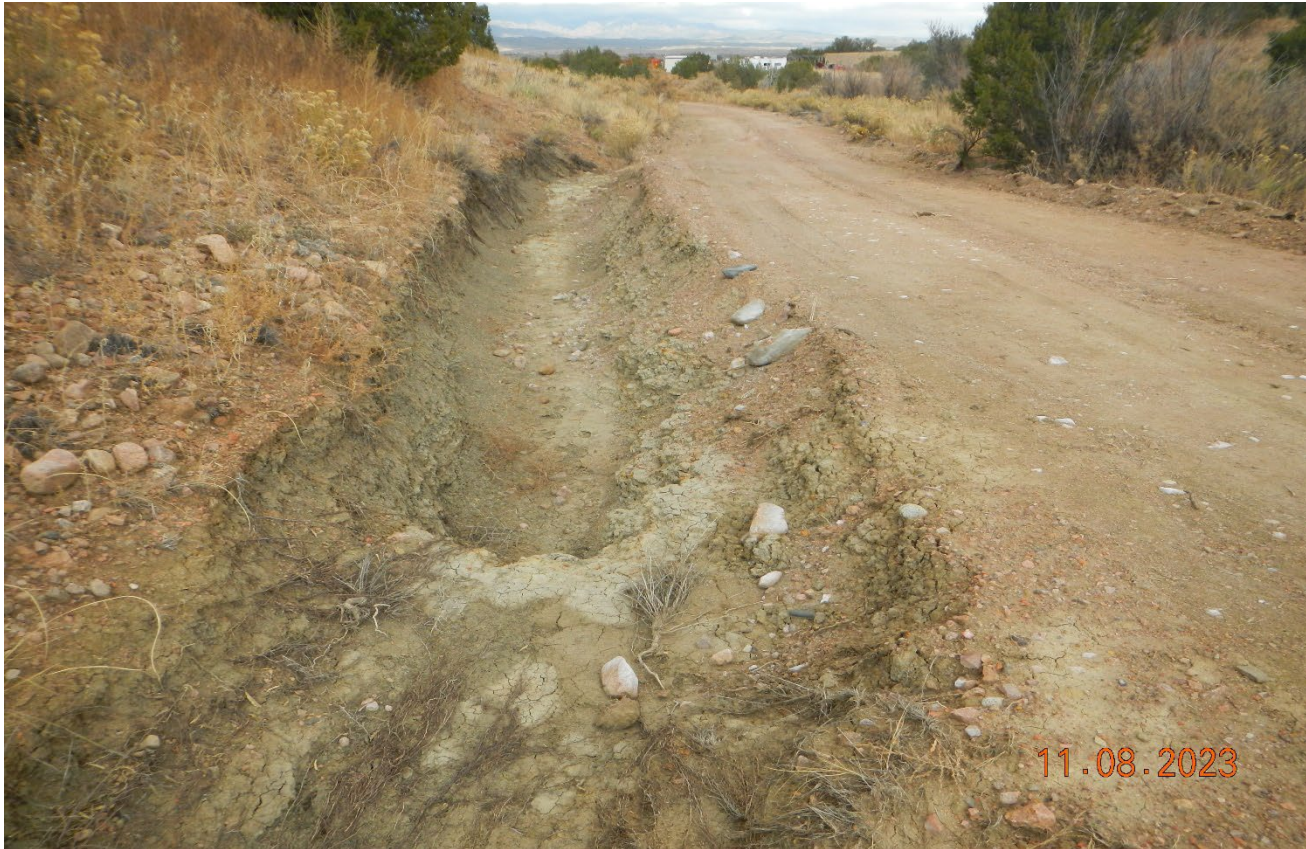
**Photo 1.** Facing north along the access road. A recent storm event has created an erosion gully along the roadside which needs to be repaired.

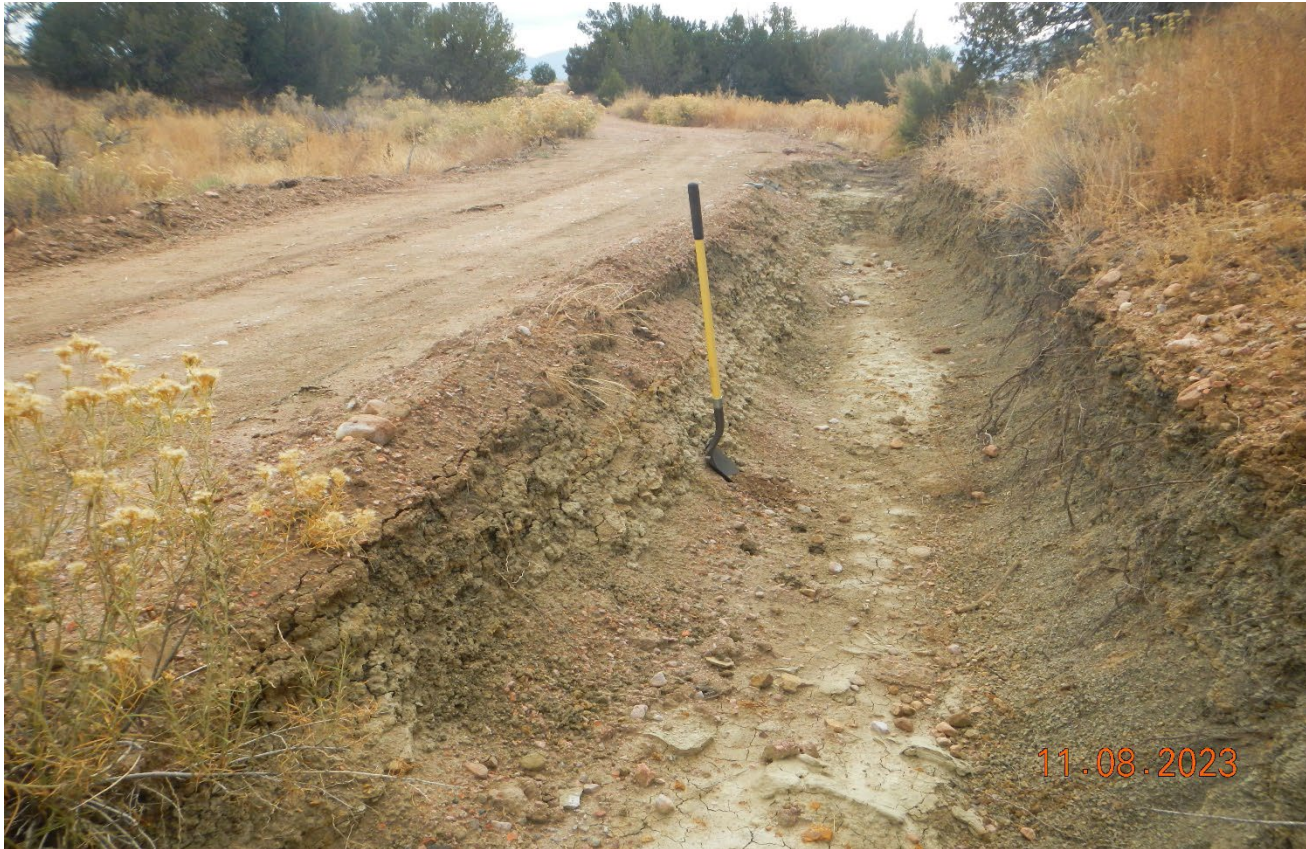
**Photo 2.** Facing back south toward the erosion gully along the roadside which needs to be repaired. A 4.5 ft. shovel shows depth of erosion.

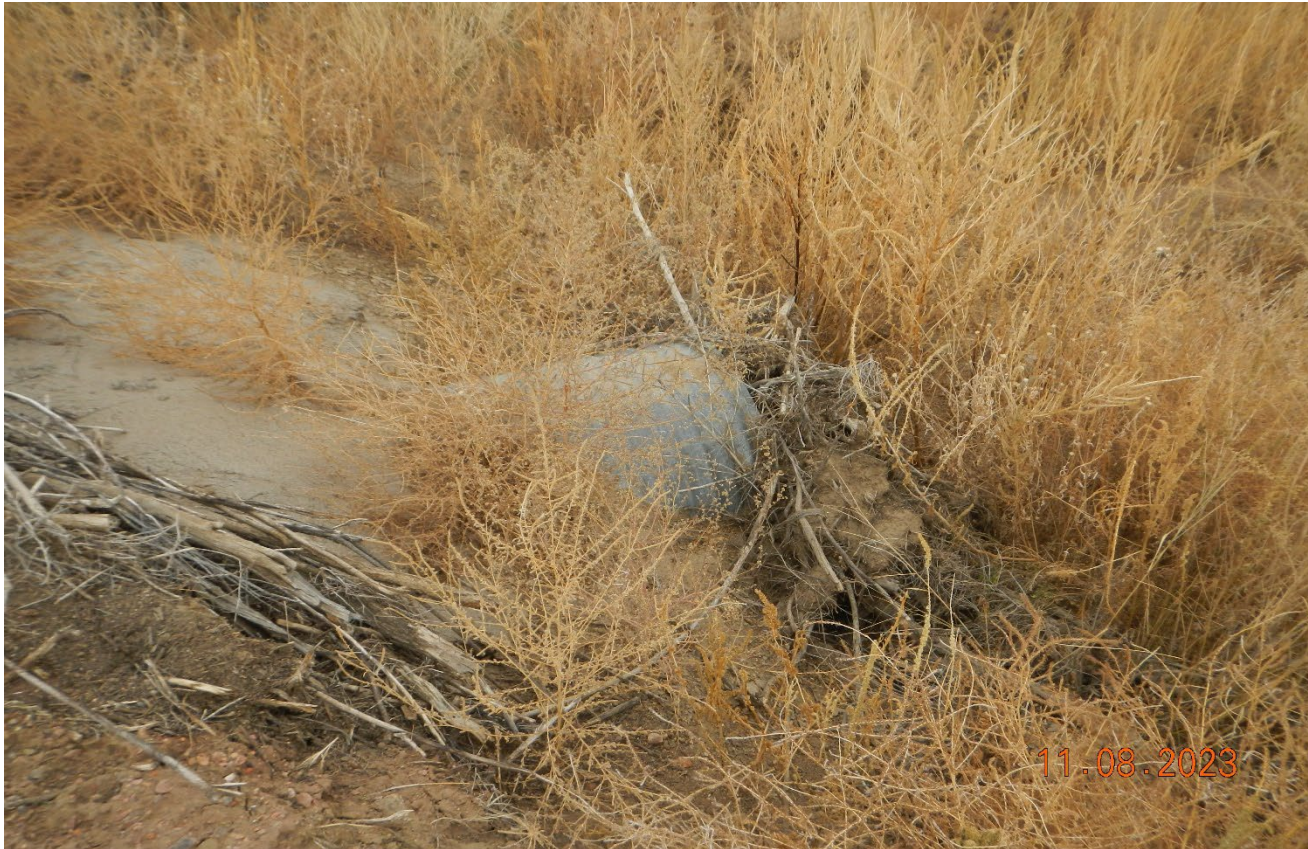
**Photo 3.** The culvert at this drainage crossing has filled in with sediment and debris and must be cleaned out.

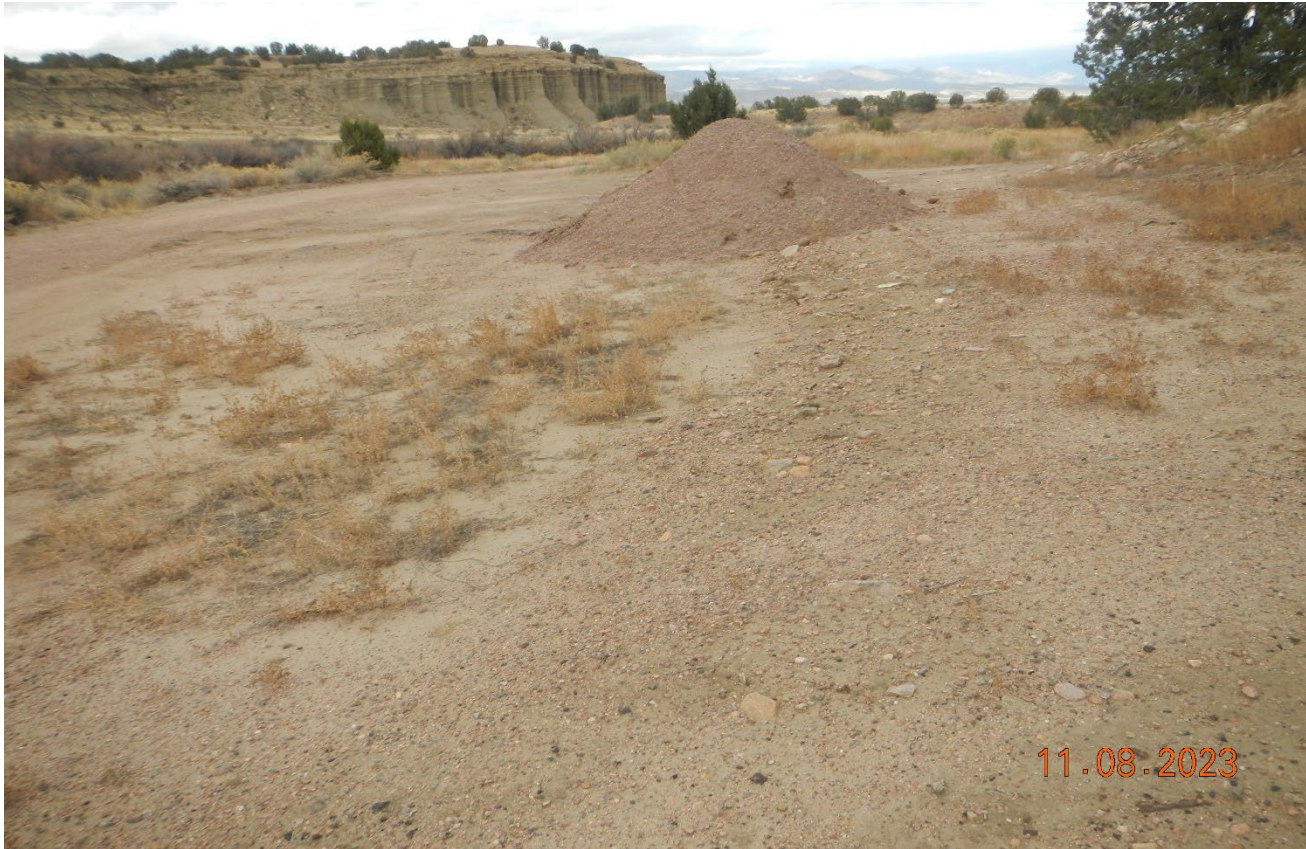
**Photo 4.** Facing northeast toward the abandoned wellsite which was never reclaimed. Soils remain bare of vegetation. Previous corrective action was not completed.

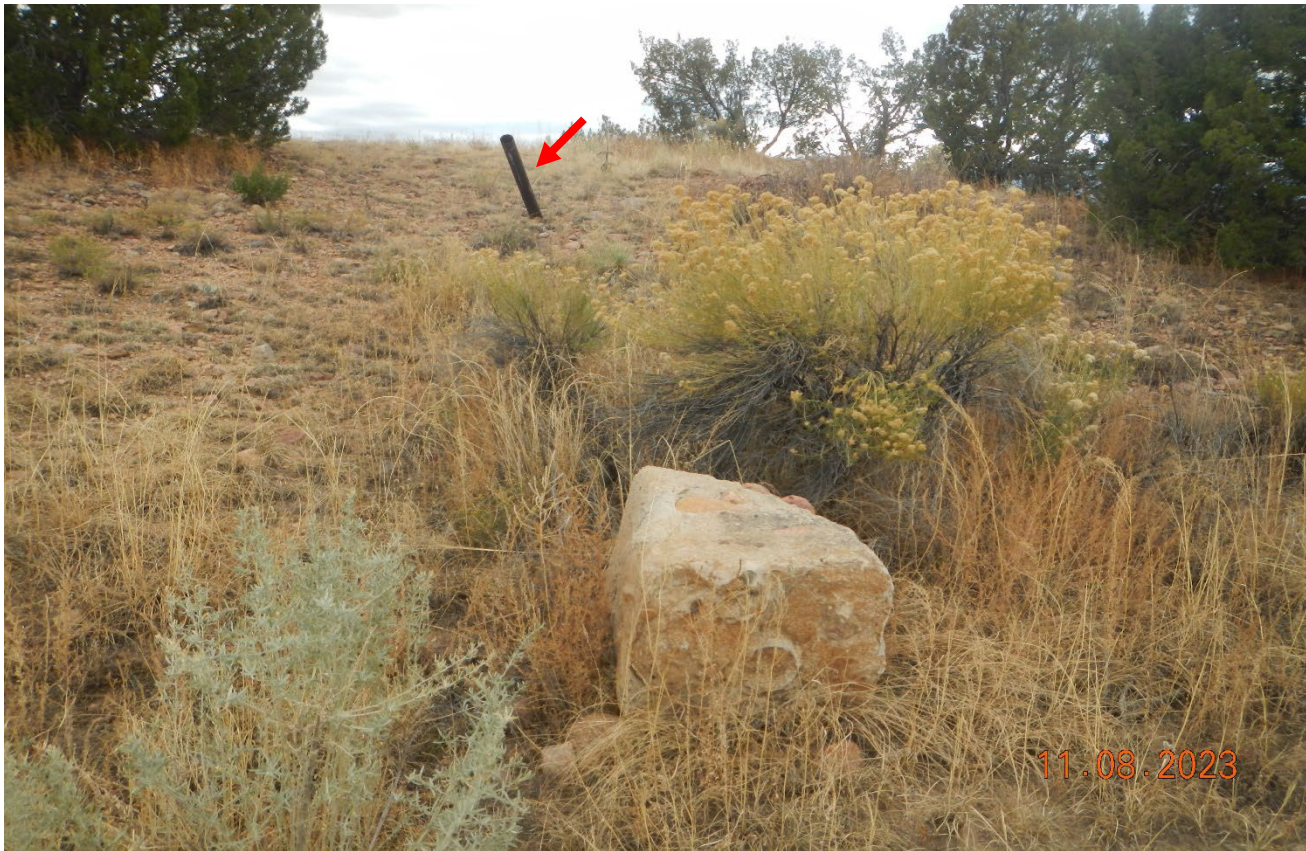
**Photo 5.** There is a cement block and guy line anchor that remains at the east side of the location that needs to be removed.

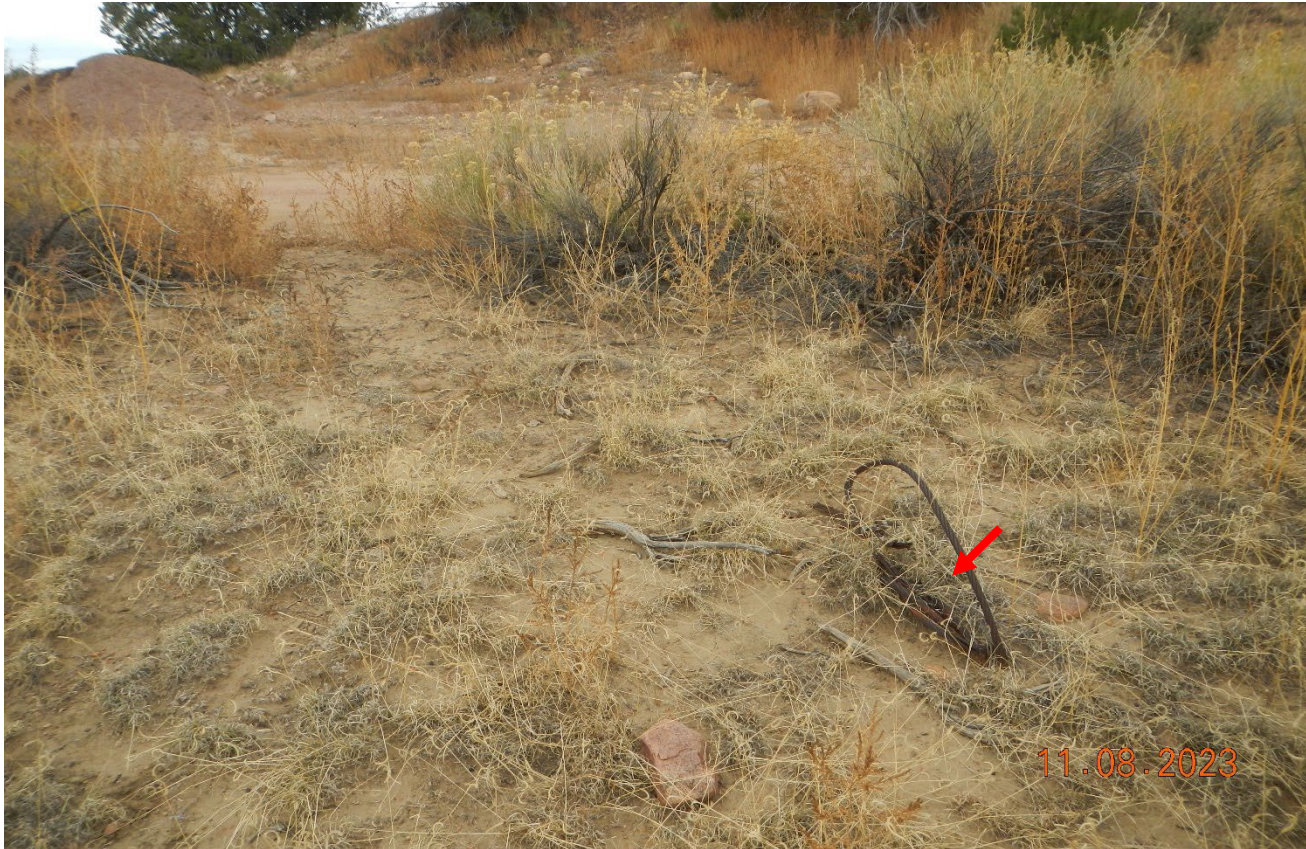
**Photo 6.** Facing northeast at the wellsite. There is a metal cable guyline anchor that remains at red arrow.
