Morningstar Gallegos 32-5 19-2: Location ID/API #:007-06219

COLORADO
Oil & Gas Conservation
Commission
Department of Natural Resources

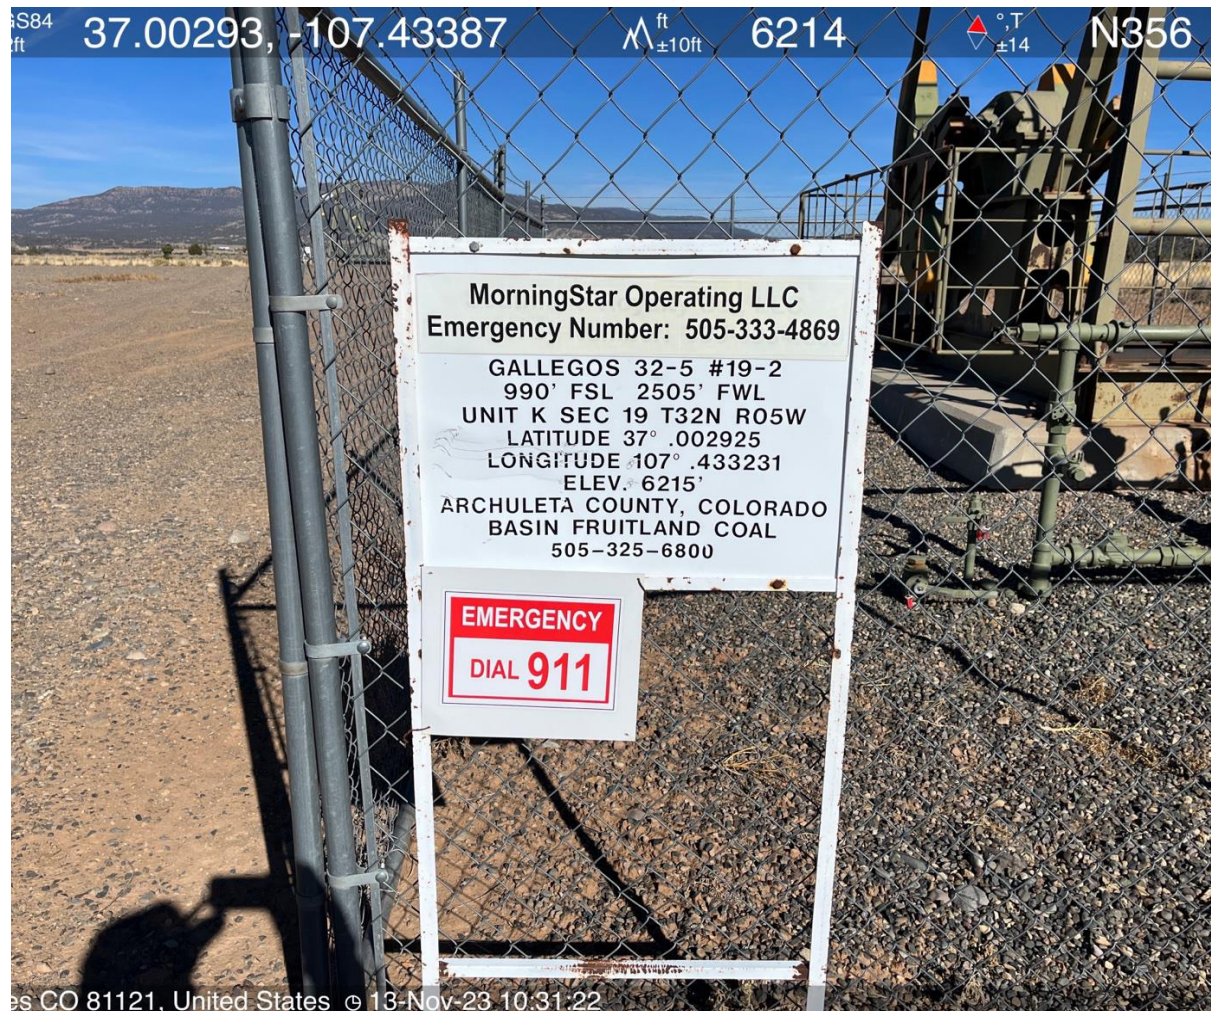
Photo #1 View of the posted well location signage.

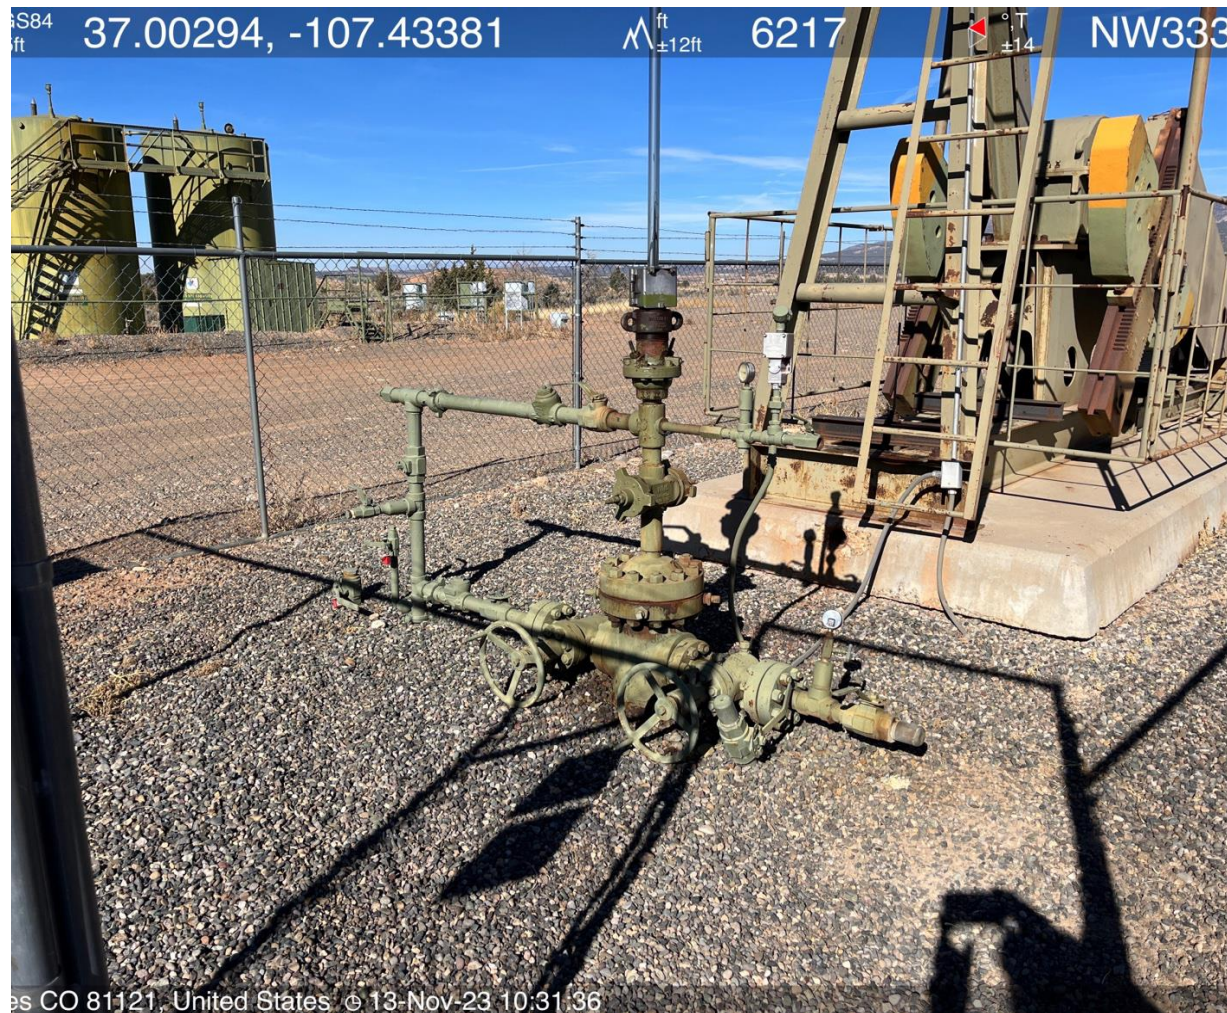
Photo #2 View of the Gallegos 9-2 wellhead assembly.

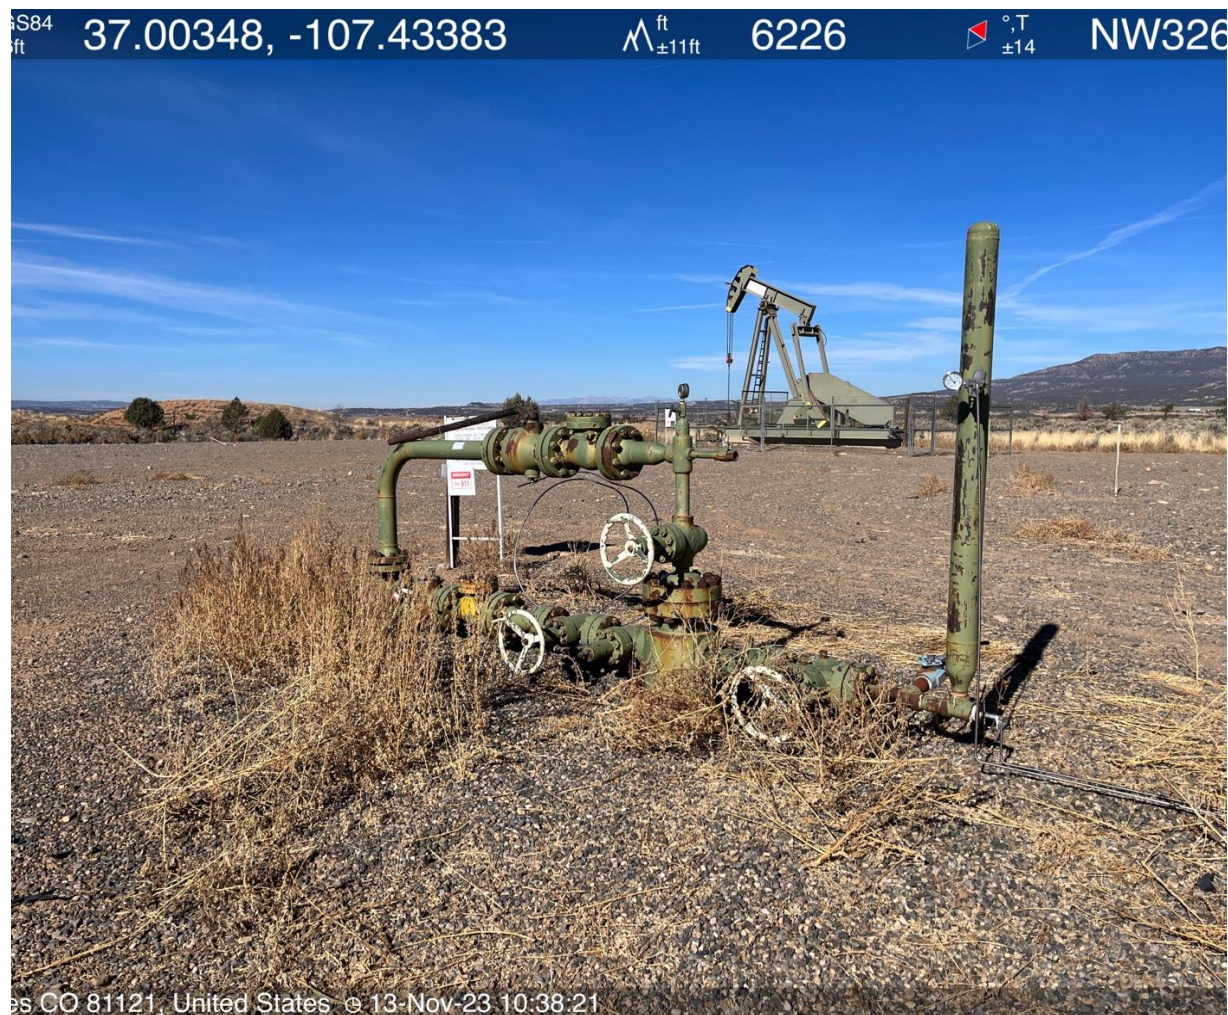
Photo #5 View of the Candelaria 20-2 wellhead assembly.

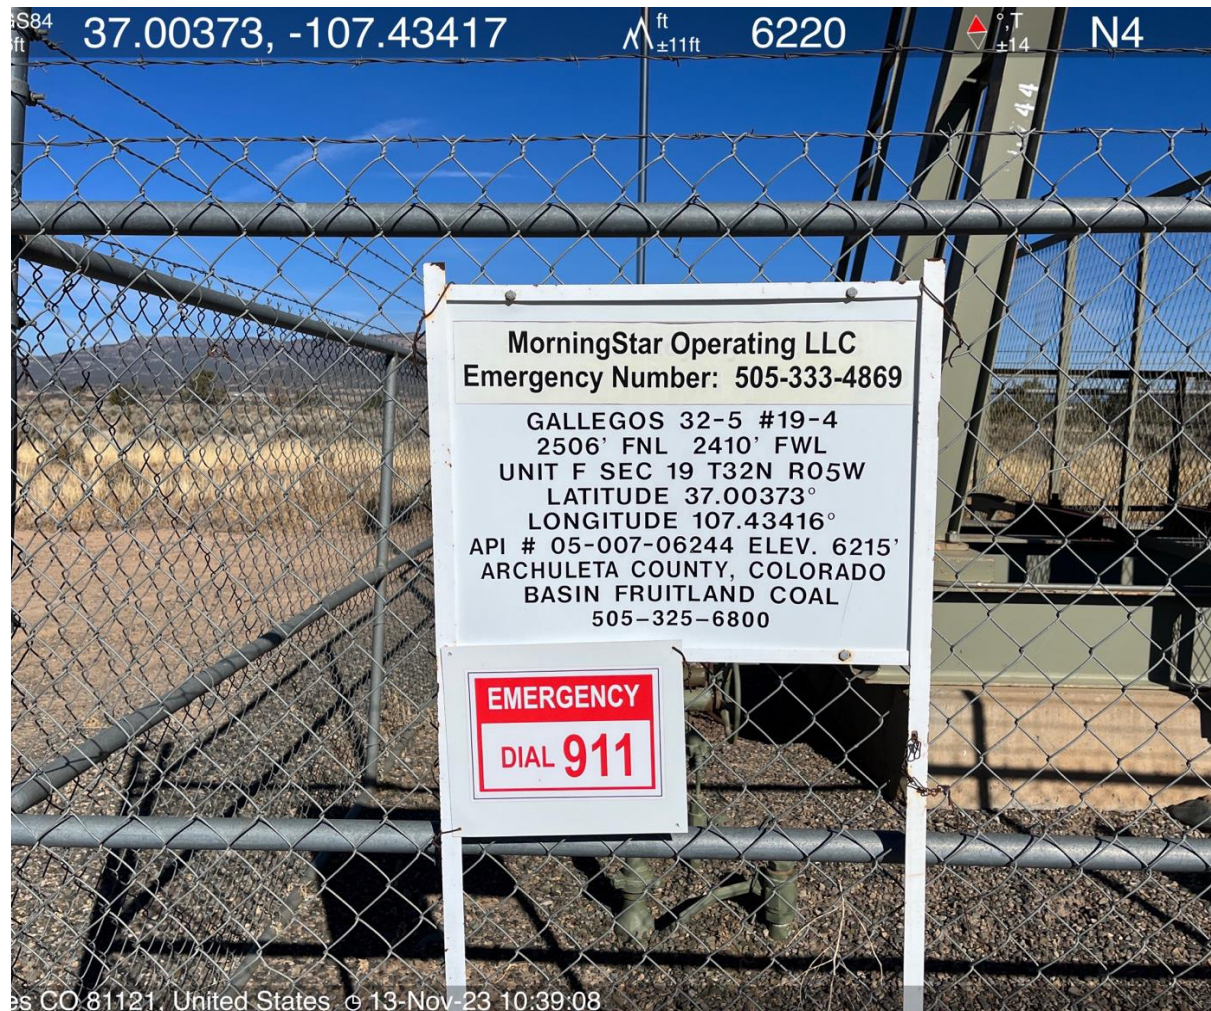
Photo #7 View of the posted well location signage.

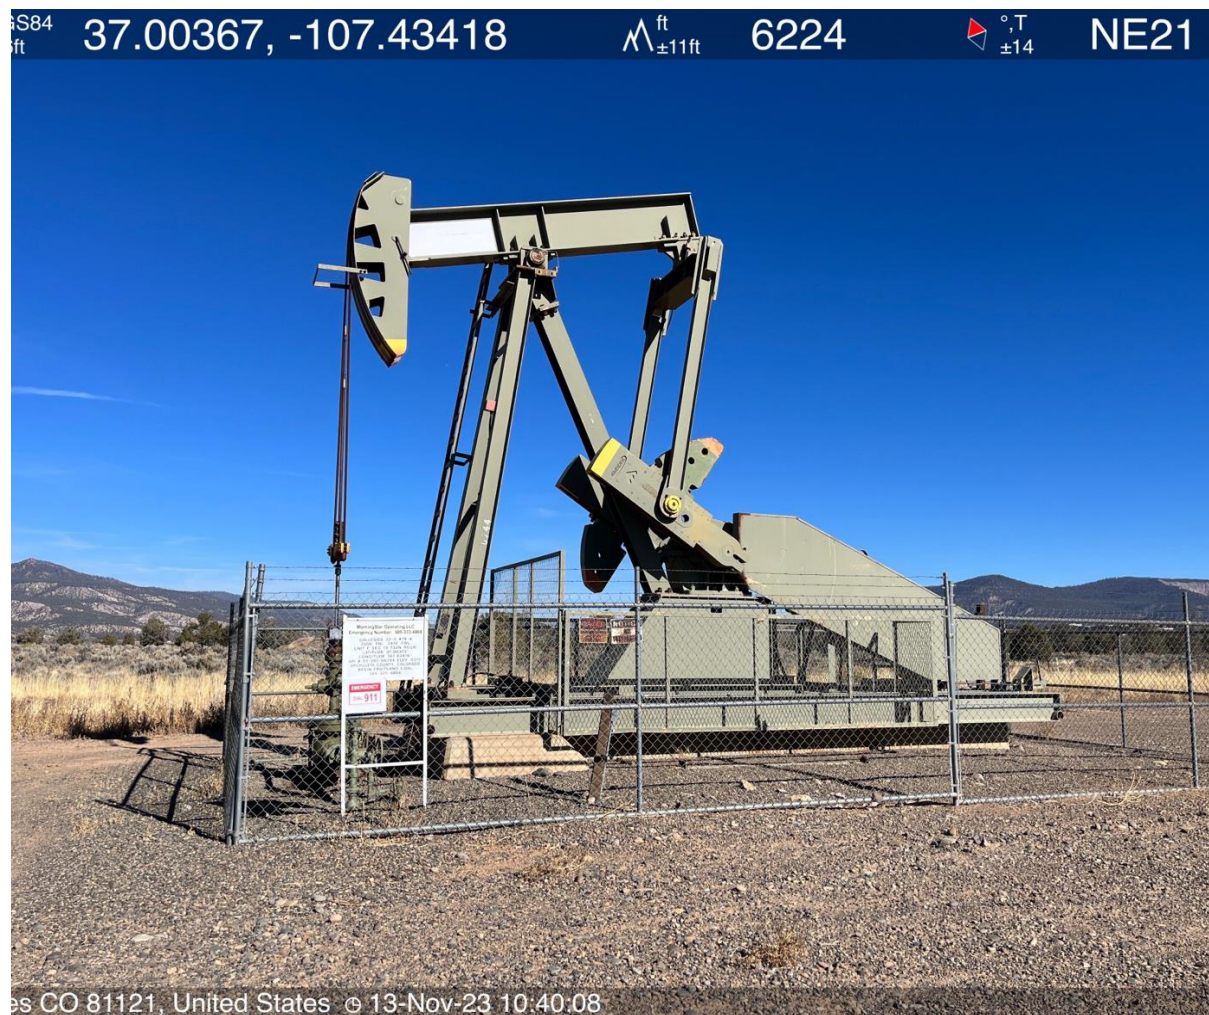
Photo #9 View of the Gallegos 19-4 pumpjack.

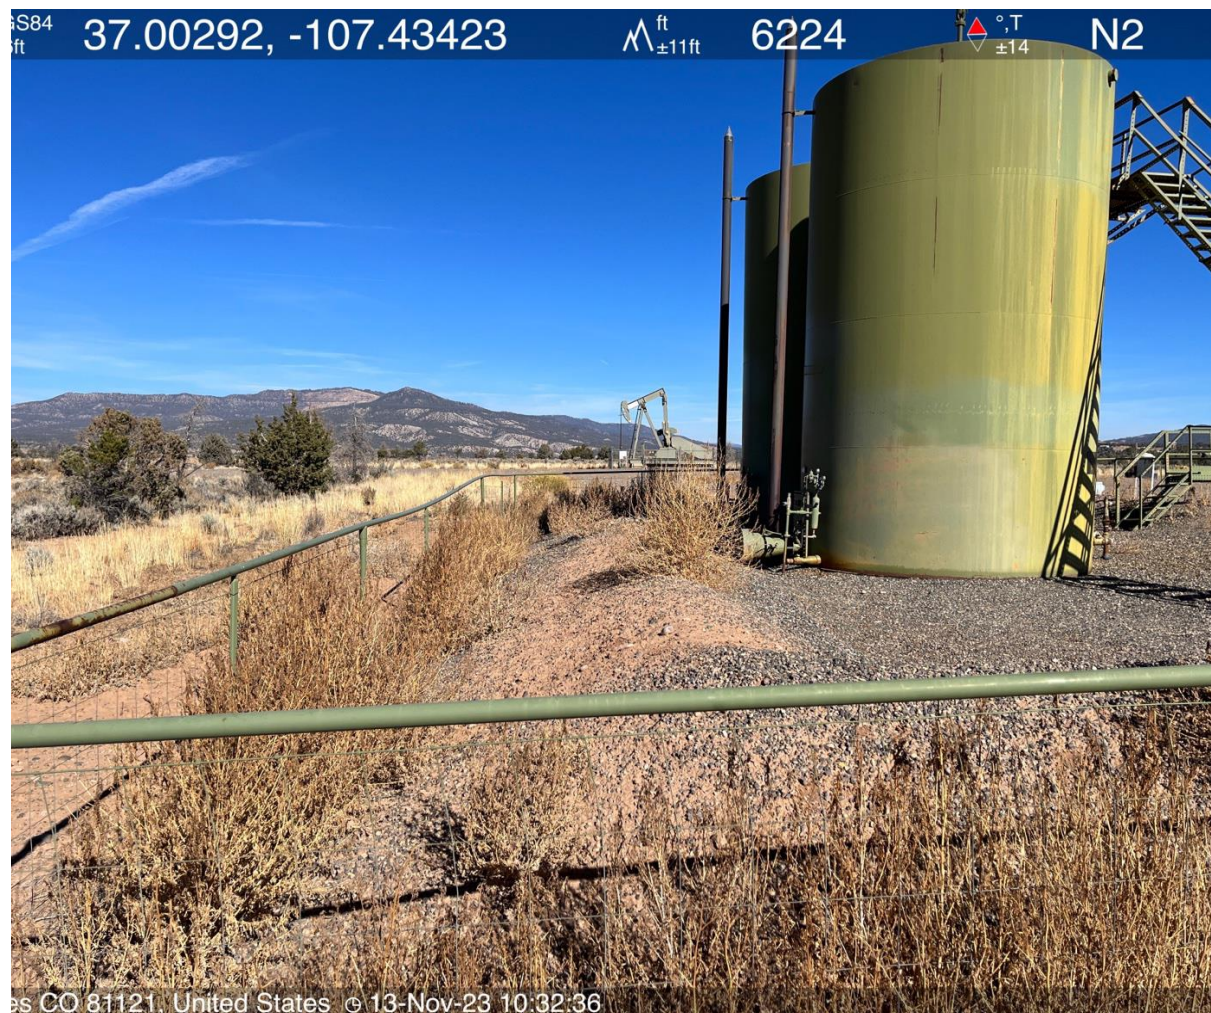
Photo #10 View of weeds growing in tank berm.

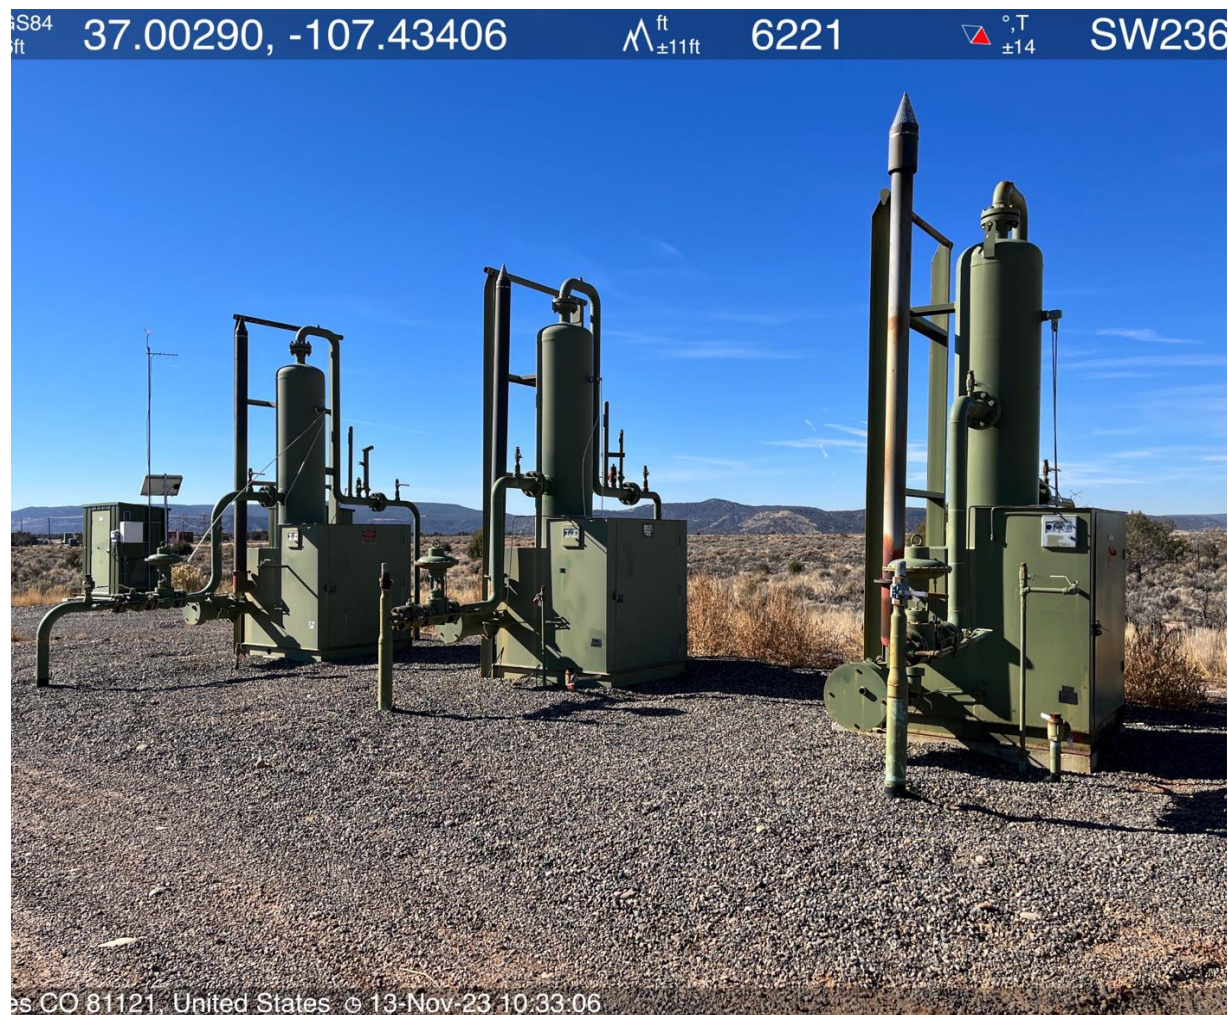
Photo #11 View of separation equipment.

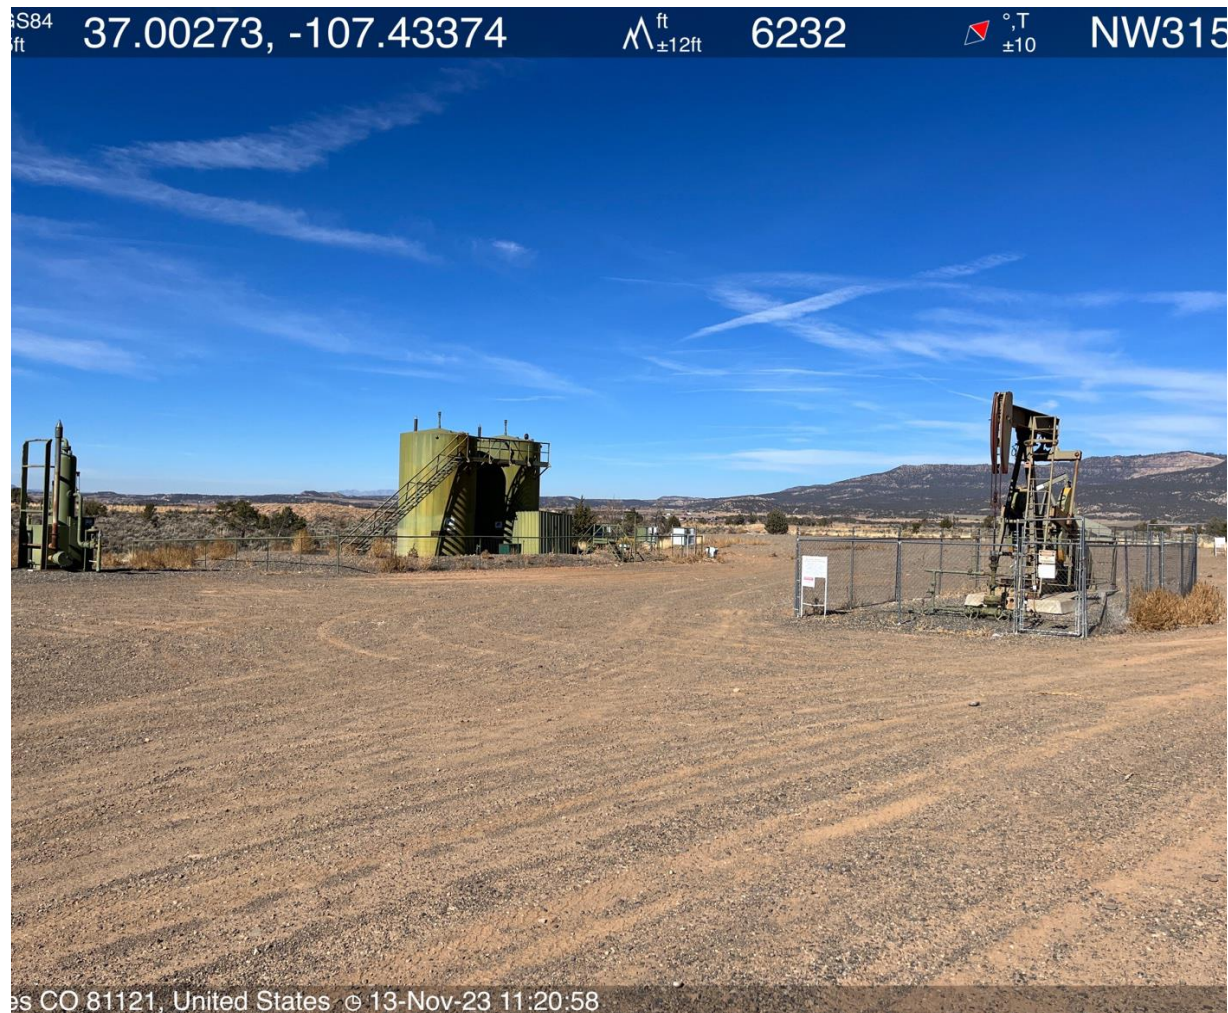
Photo #14 Overview of the well location, west view.

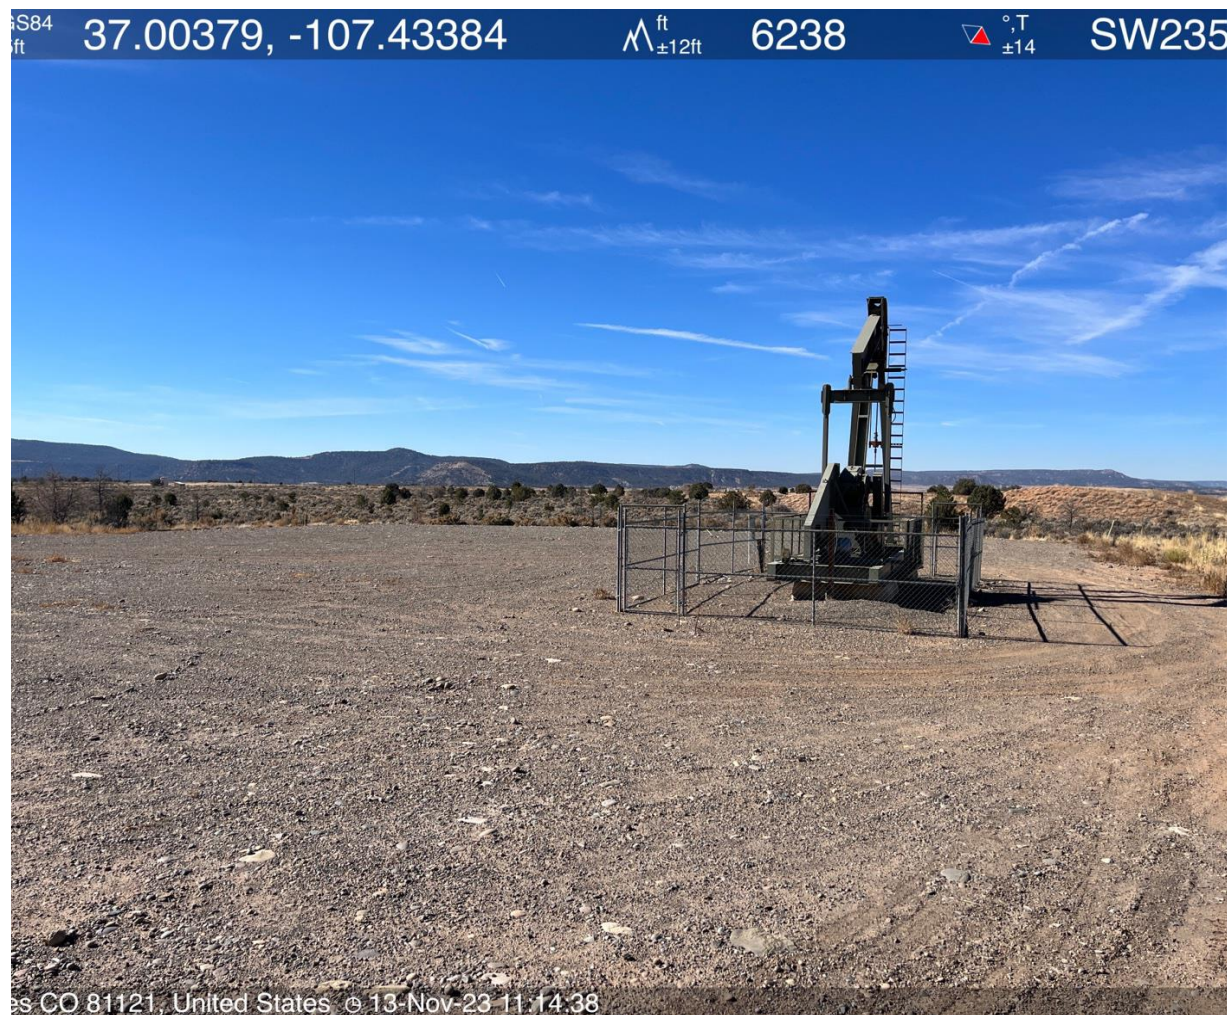
Photo #16 Overview of the well location, north side.

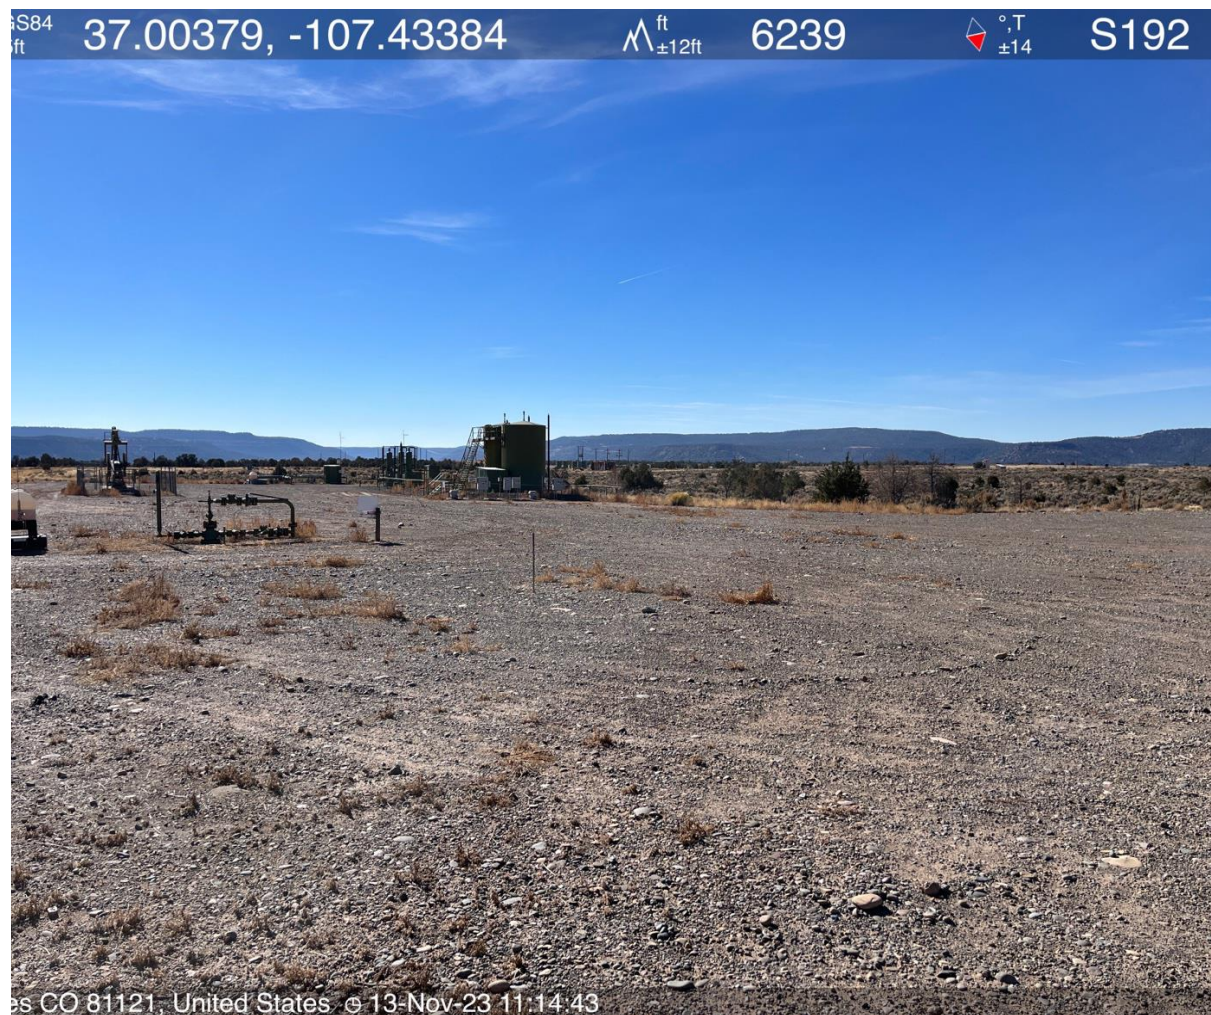
Photo #17 Overview of the well location, west view.
