**KT Resources LLC
WRD Dow 20-13
Location ID: 316300**

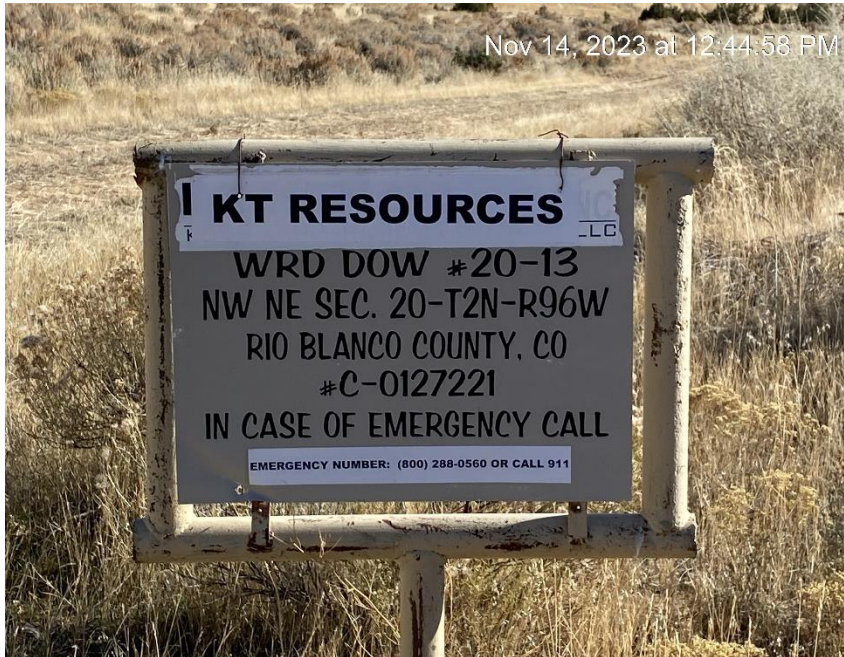
As entrance signs are replaced additional information will be required

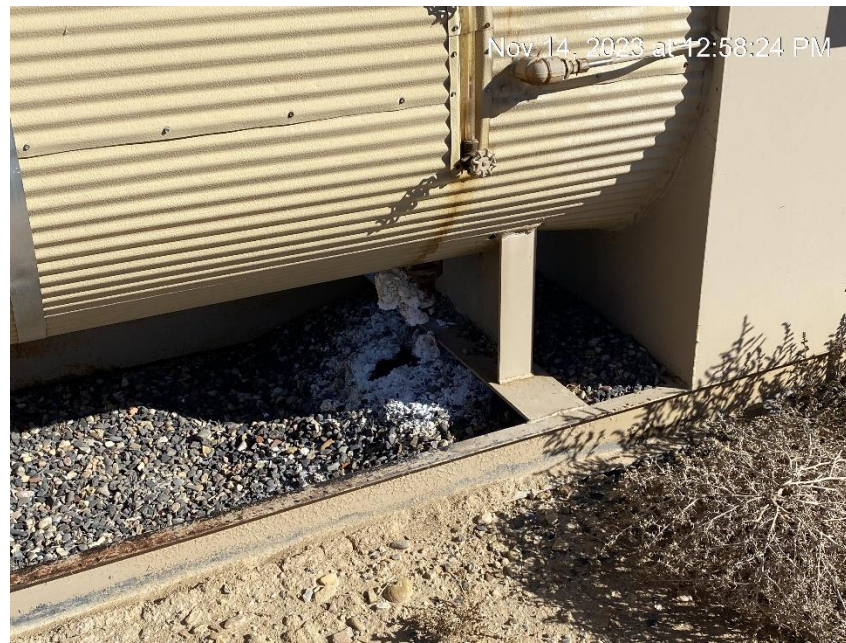
Calibration displayed but out of compliance.

Leaking equipment. Impacted soil.

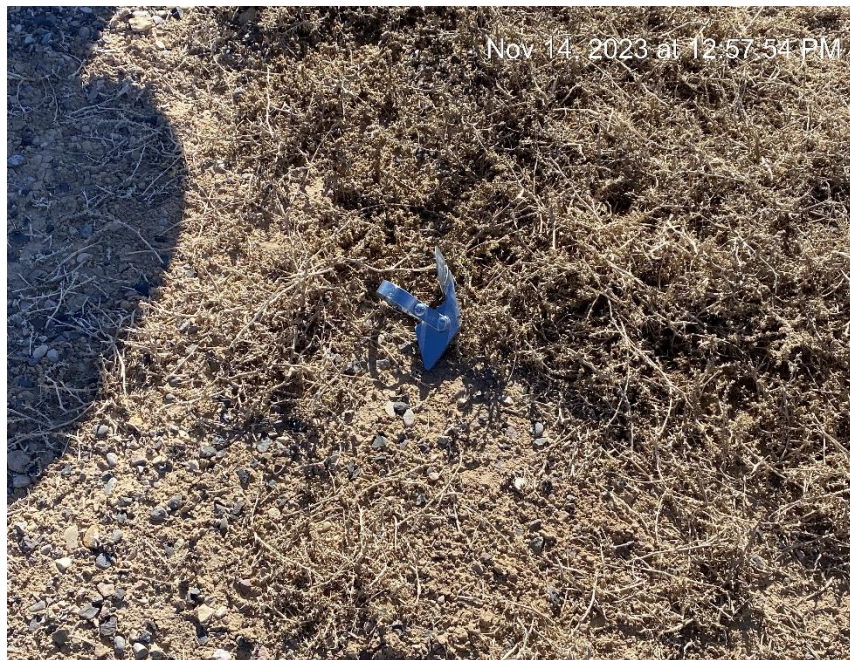
Rain cap off relief valve

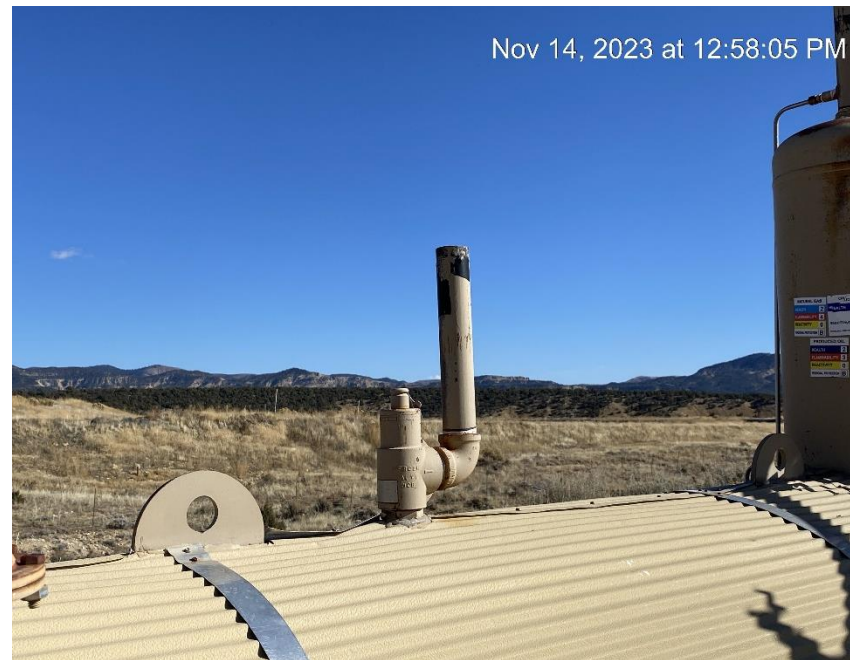
Venting from relief valve

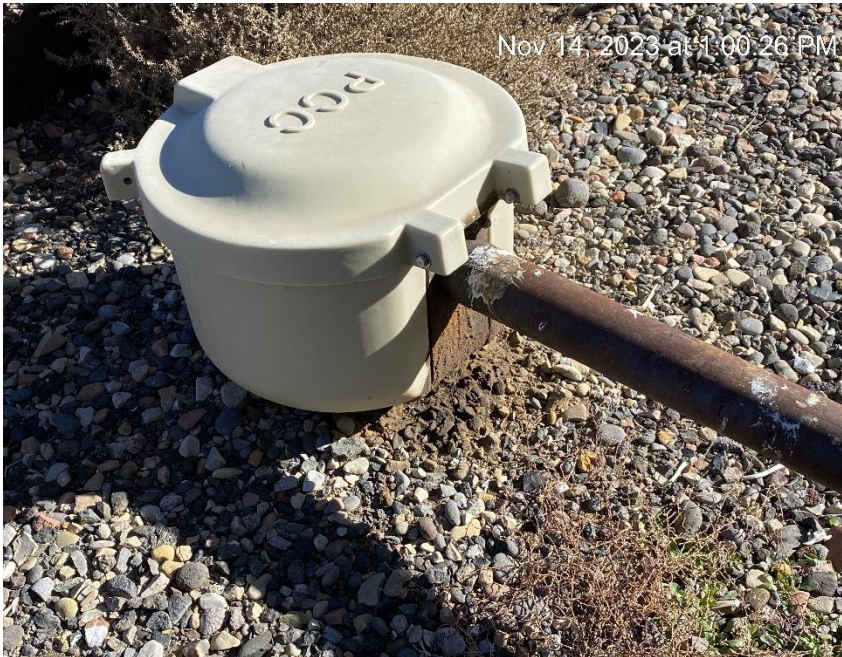
Stained soil

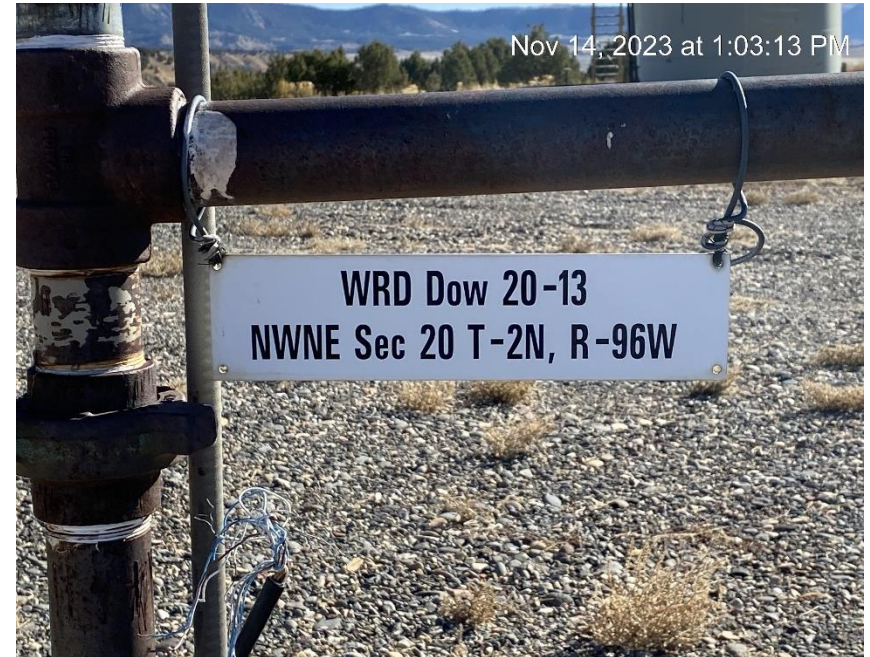
As well signs are replaced additional information will be required
