Inspection Photos
Location Name: Ocoma 31-25
API # 05-123-15677

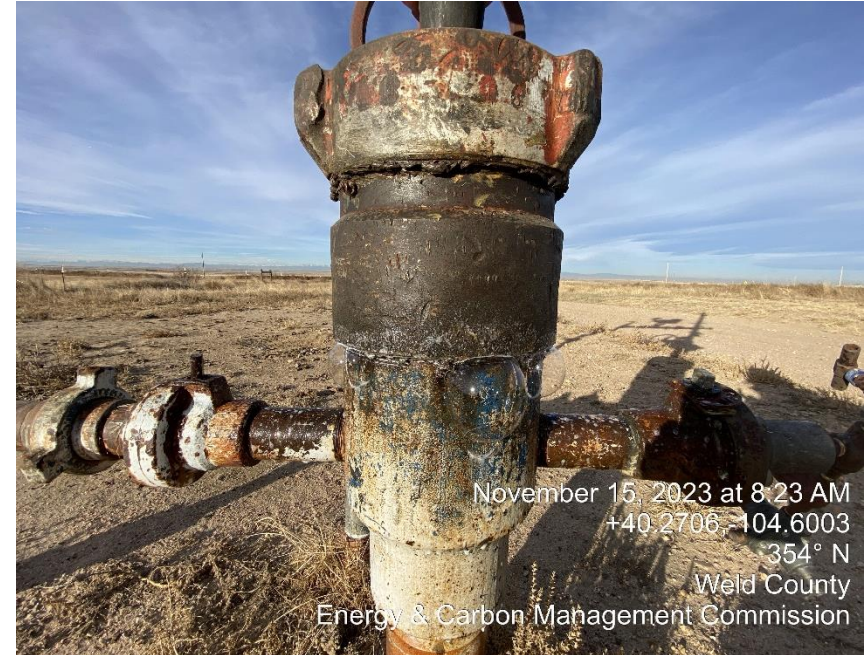
Appears to be leaking

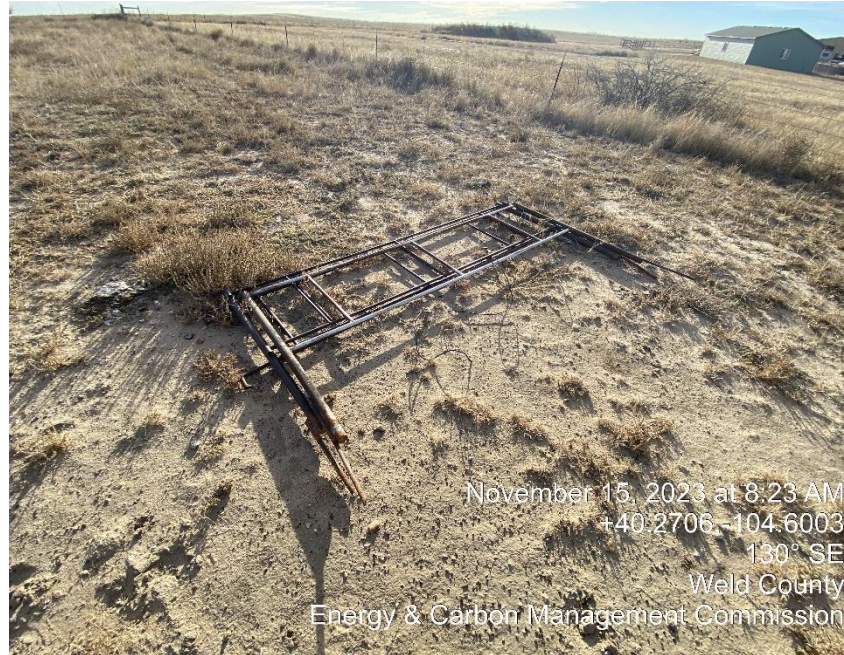
Unused Panel Fence
