Construction and Stormwater Inspection

Date: 11/14/2023

Operator: MDS ENERGY DEVELOPMENT LLC - 10814

Inspection Photos
Location Name: Castor 7-59 10
Location ID: 471039

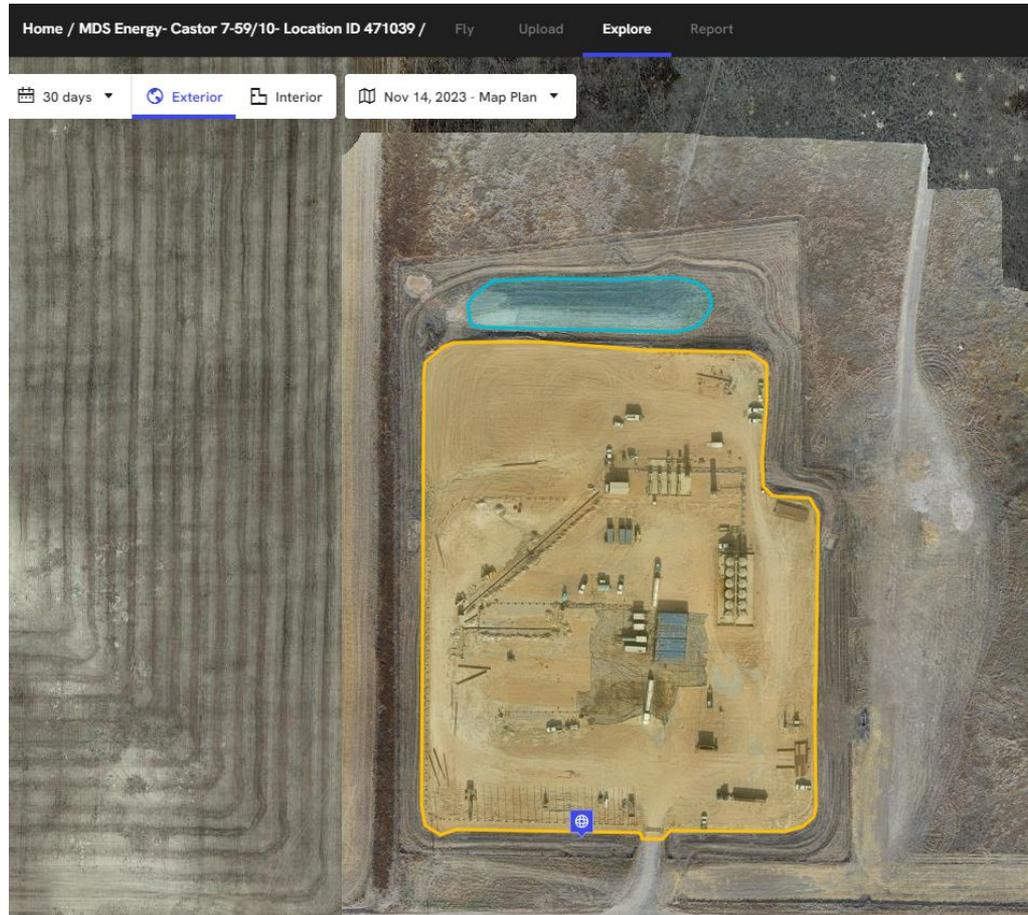
Photo 1. Drone aerial overview of the Castor 7-59 10 location. The blue shaded portion represents the topsoil stockpile and the yellow shaded portion represents the disturbance area where topsoil should have been salvaged from.

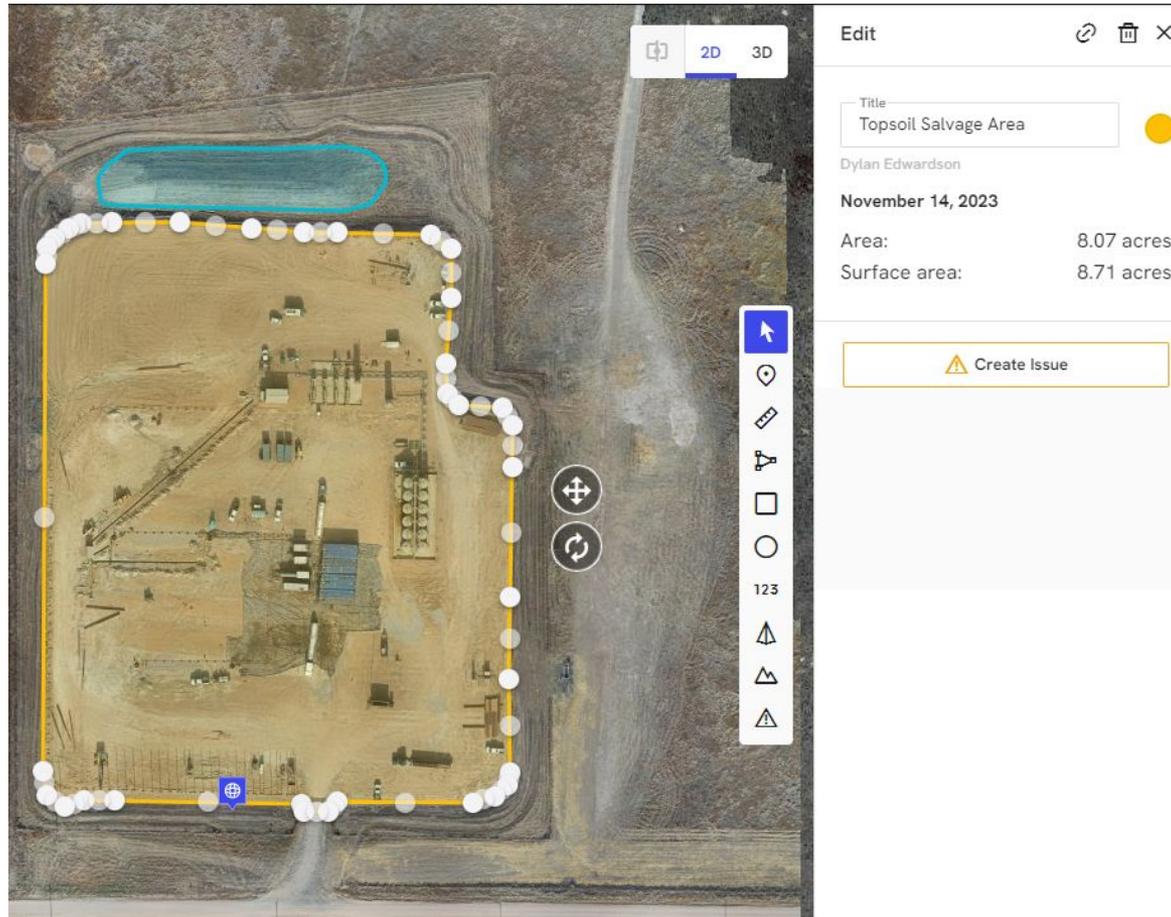
Photo 2. The yellow shaded portion of the location is approximately 8 acres in size and represents the disturbance area where topsoil should have been salvaged to a minimum required depth of 6", or greater depending on topsoil depths observed on location. ECMC Staff has determined that approximately 3.25" of topsoil was originally salvaged during the initial construction phase based on a topsoil stockpile volume of approximately 3,495 CY (see Photo 3 for additional) illustrated by the blue polygon to the north.

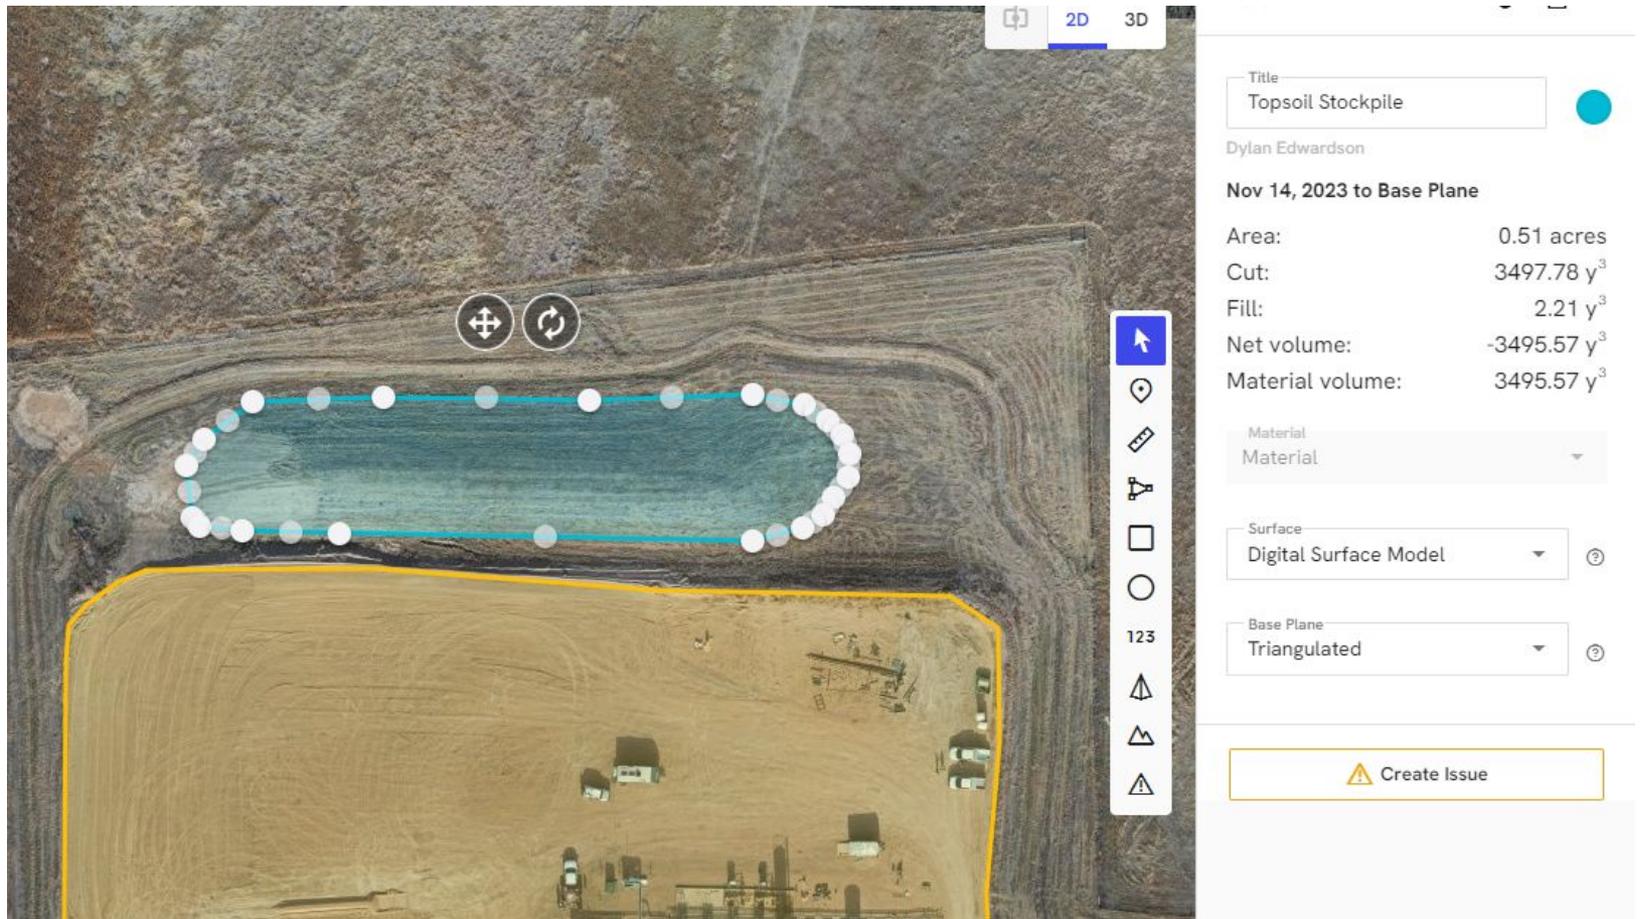
Photo 3. The blue shaded area illustrates the topsoil stockpile on the northern portion of the location. Utilizing drone technology, Staff estimates there is approximately 3,495 CY of stockpiled topsoil on location. The Operator should have salvaged approximately 6,447 CY of topsoil at the minimum required depth of at least 6" over the ~8 acre salvageable disturbance area.

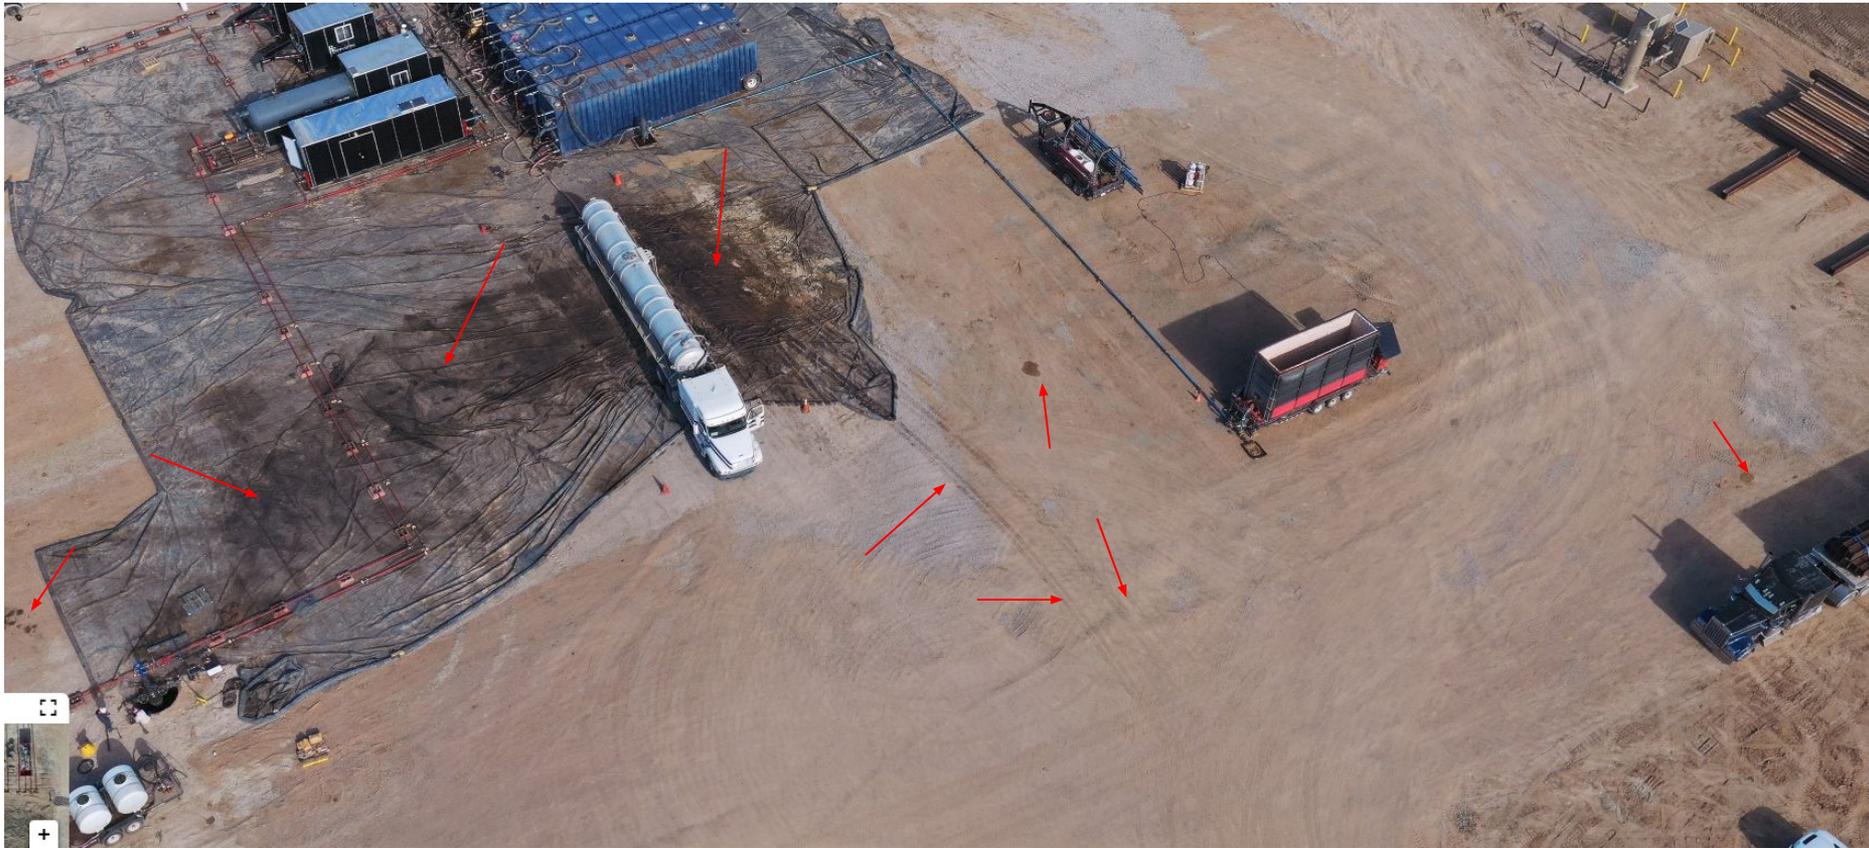
Photo 4. Drone aerial imagery shows stained soils and a spill/release of hydrocarbons that are being tracked outside of the secondary containment. It does not appear that any remaining free fluids have been properly contained and disposed of.

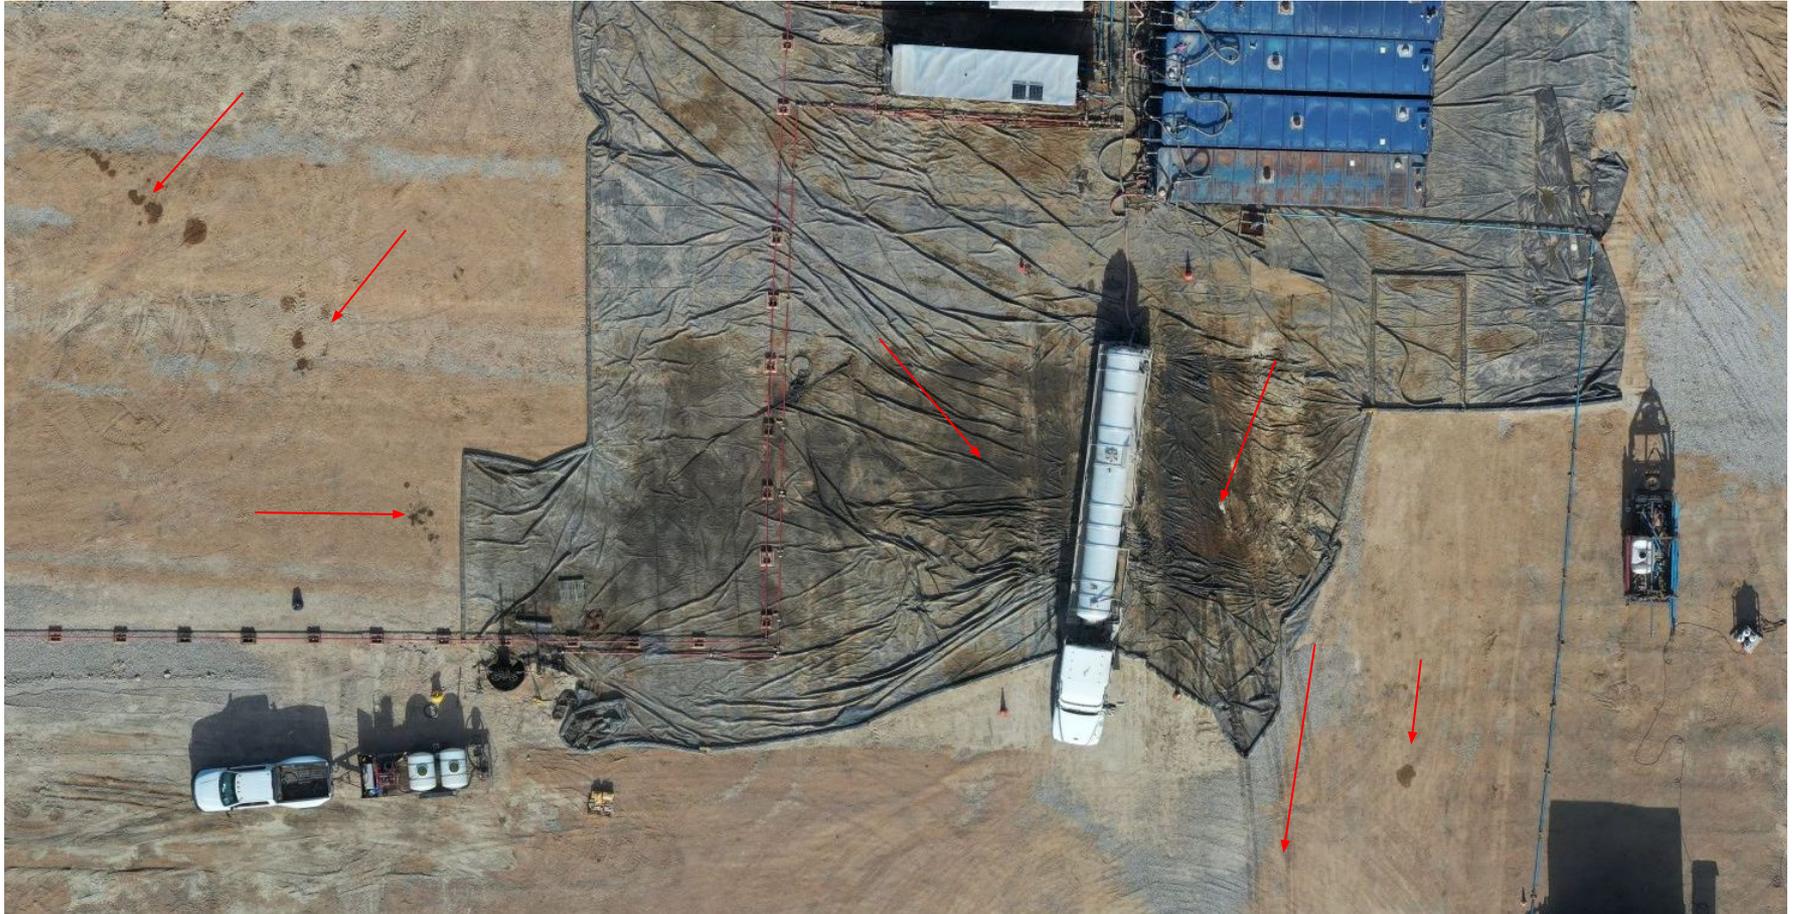
Photo 5. Continued from Photo 4.

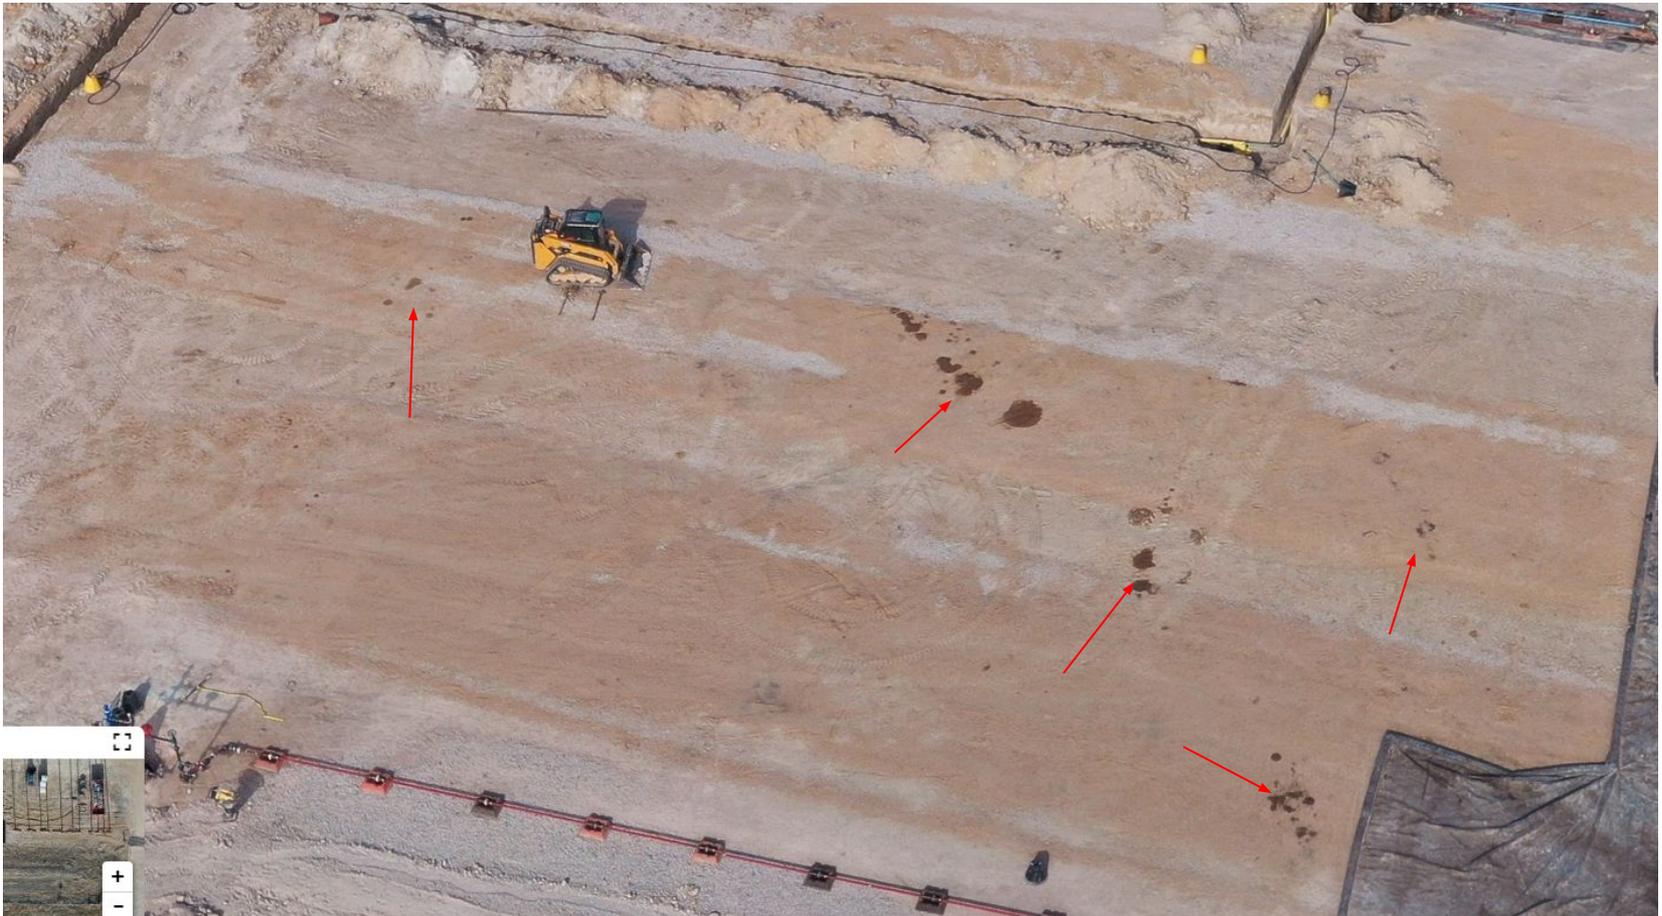
Photo 5. Drone aerial imagery illustrating stained soils throughout the production area.

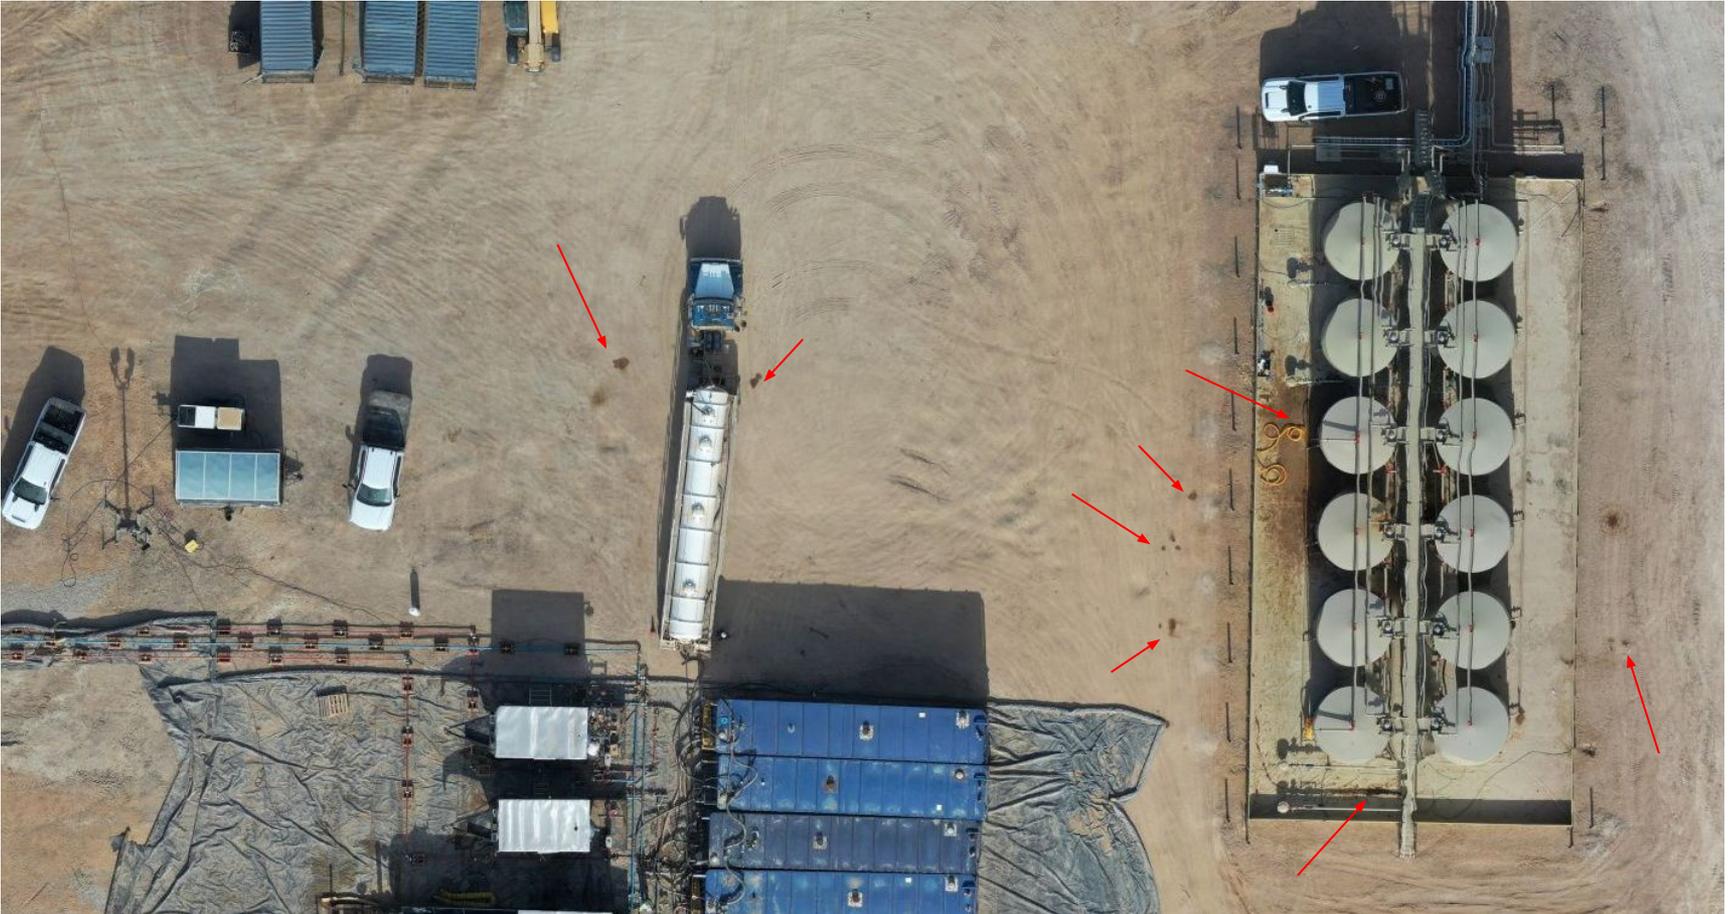
Photo 6. Drone aerial imagery illustrating stained soils throughout the production area and hydrocarbon impacts within the secondary containment of the tank battery.
