**Inspection Photos**  
**CHAMPLIN 86 AMOCO F**  
**Spill ID 482153/Remediation Project No 22276**

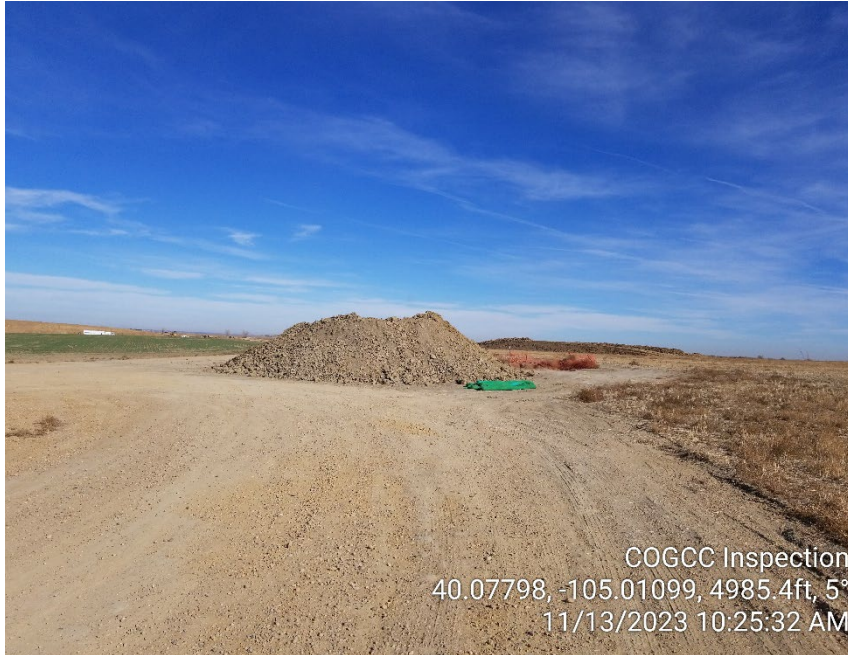
**Photo 1 – Backfill dirt stockpile – AM inspection.**

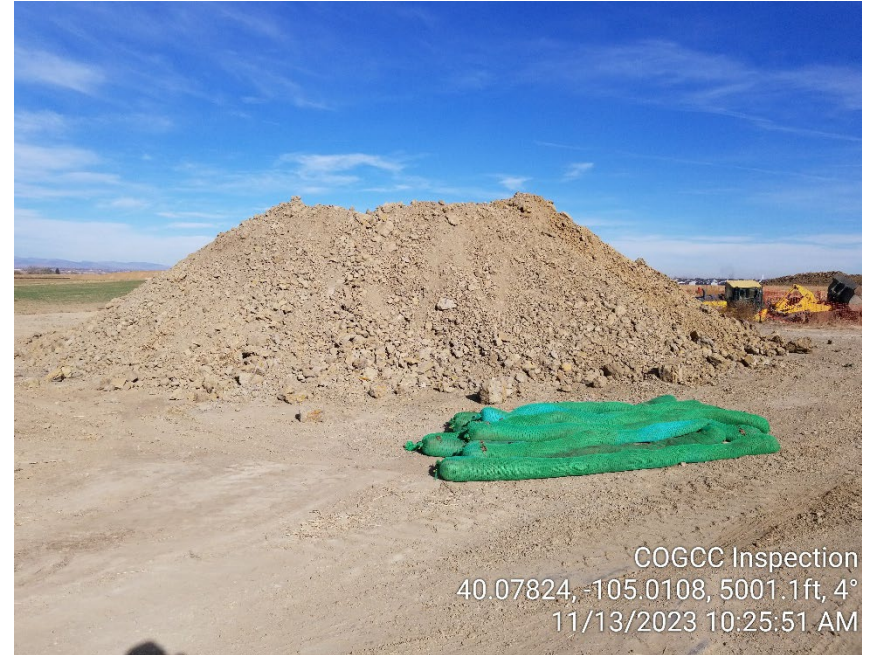
**Photo 2 - Backfill dirt stockpile. Backfill in process – AM inspection.**

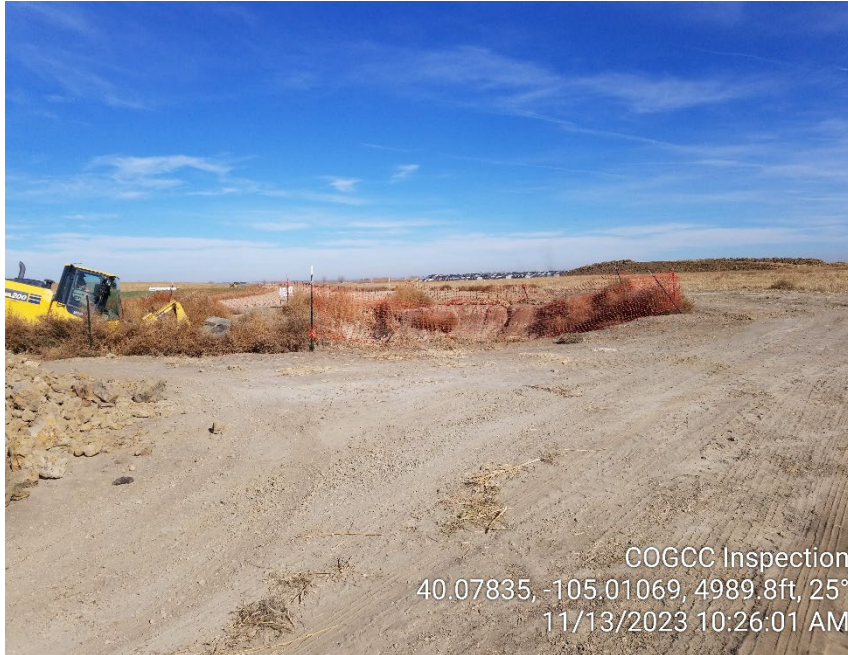
**Photo 3 – Backfill in process – AM inspection.**

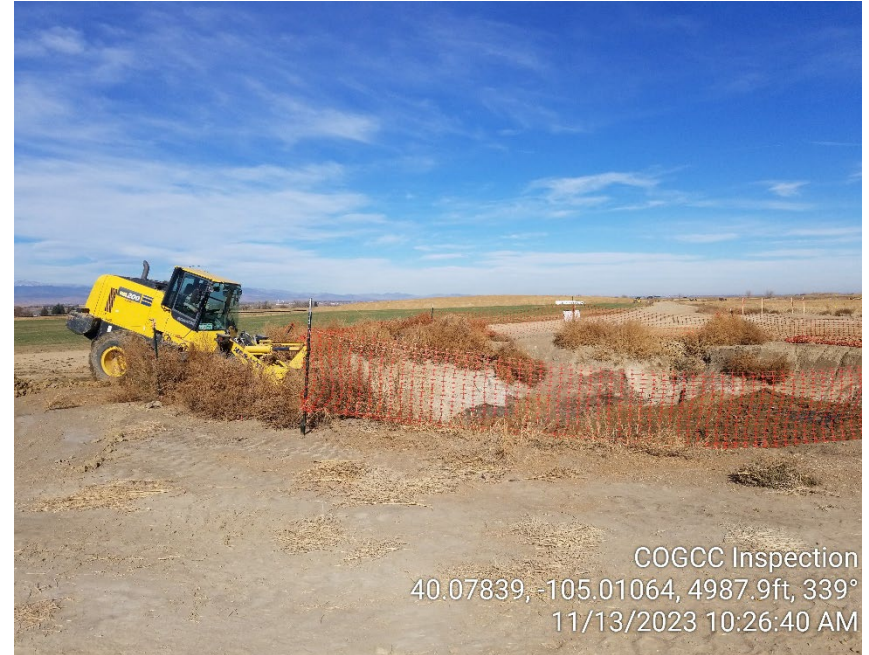
**Photo 4 - Backfill in process – AM inspection.**

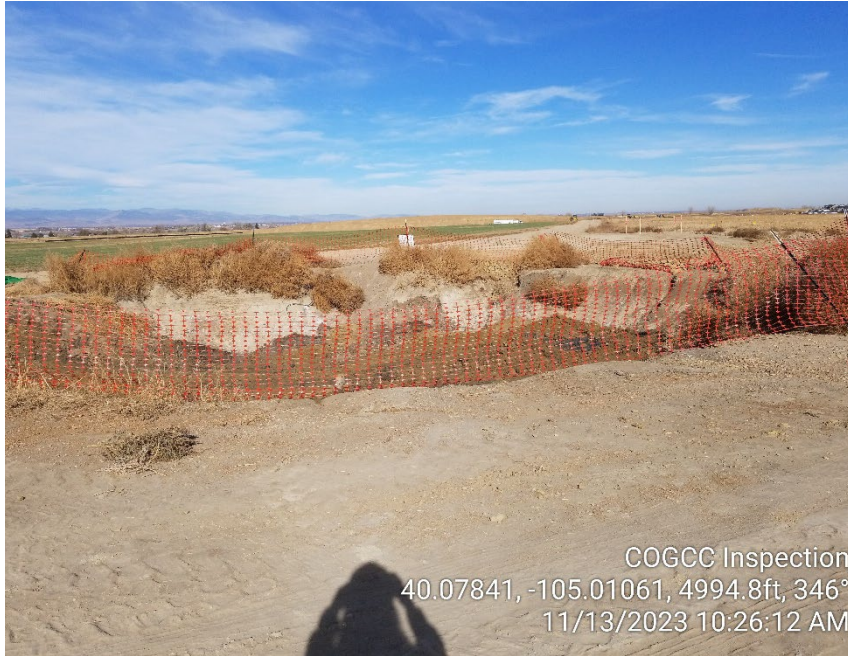
**Photo 5 – Backfill in process – AM inspection.**

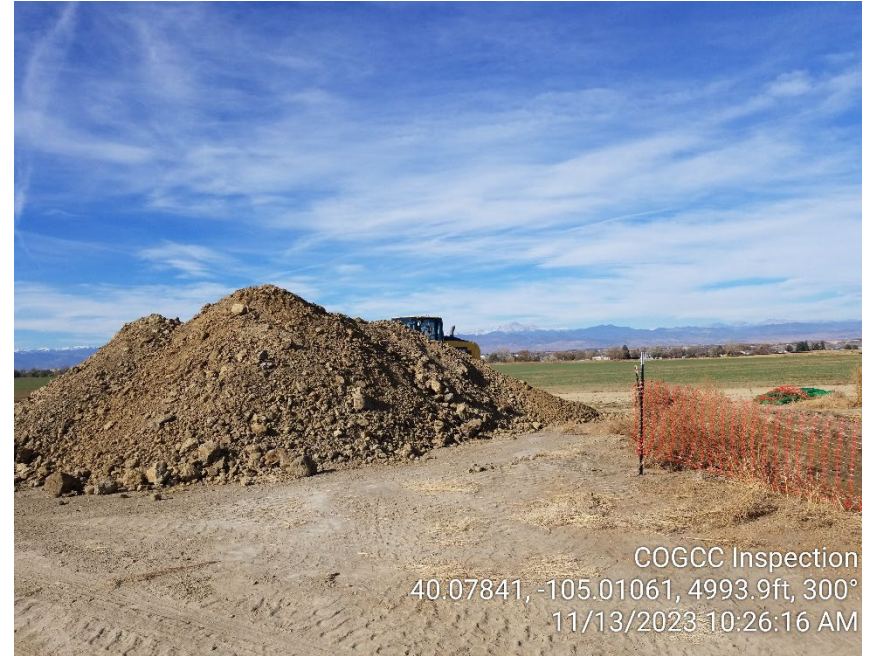
**Photo 6 - Backfill dirt stockpile – AM inspection.**

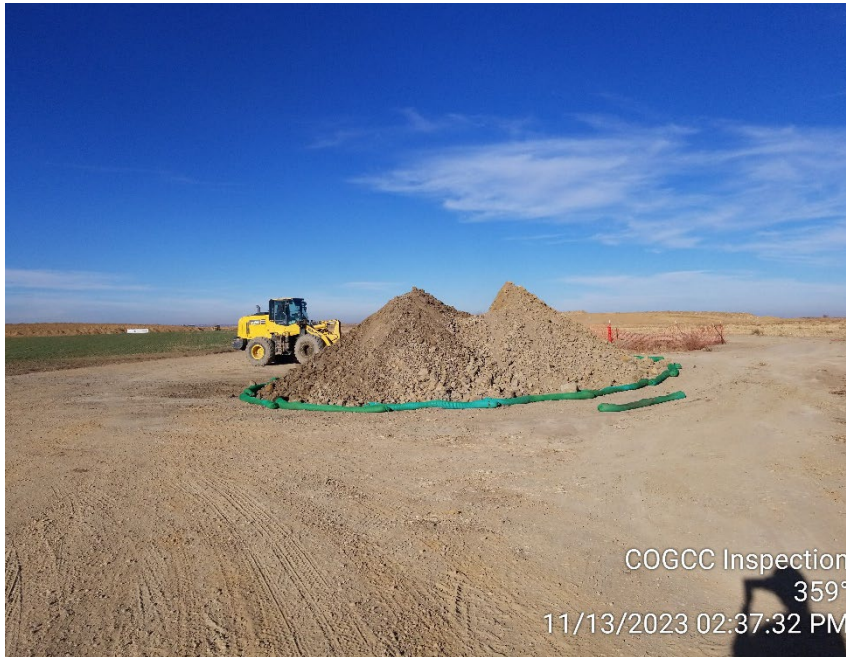
**Photo 7 – Backfill dirt stockpile – PM inspection.**

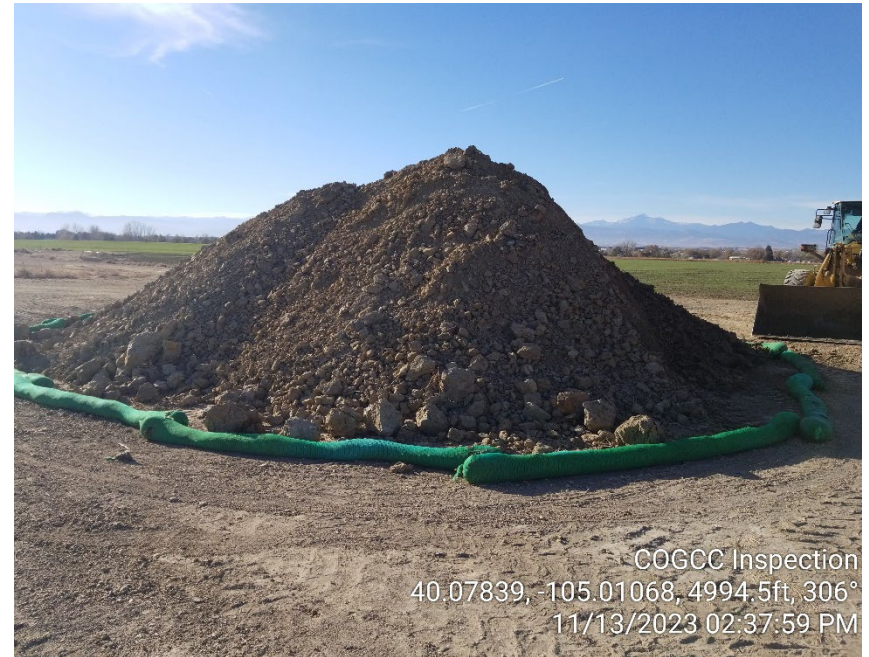
**Photo 8 - Backfill dirt stockpile – PM inspection.**

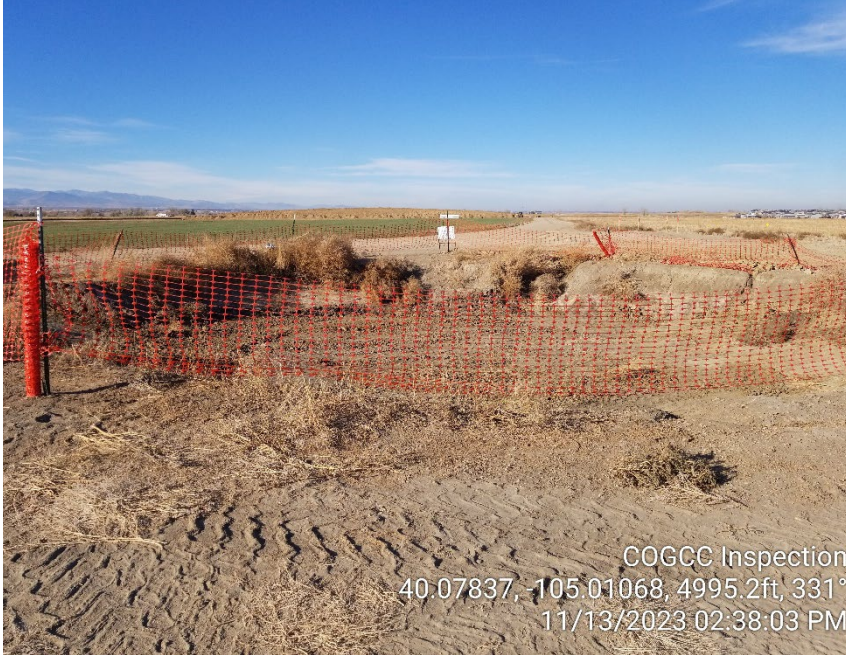
**Photo 9 – Partially backfilled excavation/weeds –  
PM inspection.**

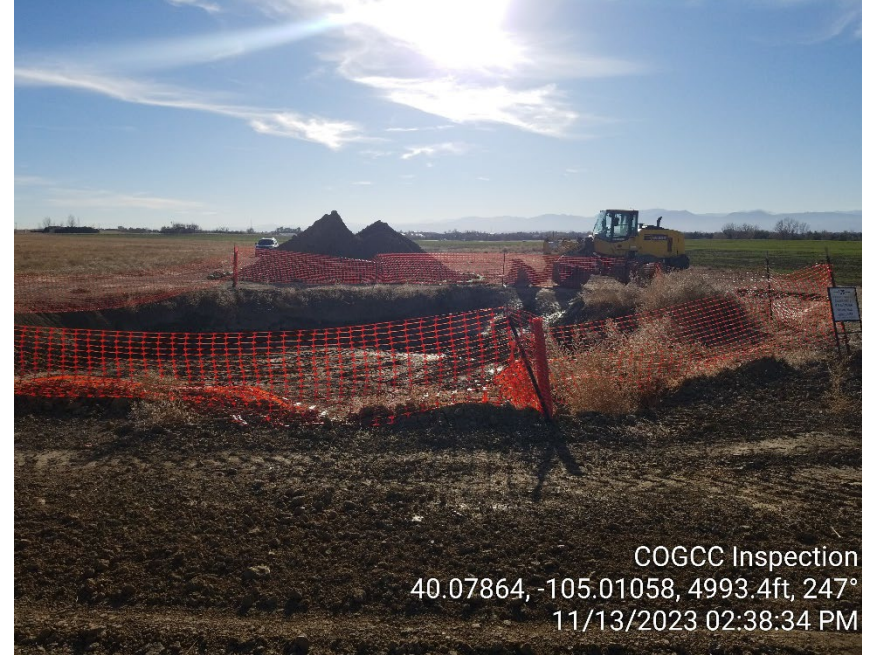
**Photo 10 - Partially backfilled excavation/weeds –  
PM inspection.**

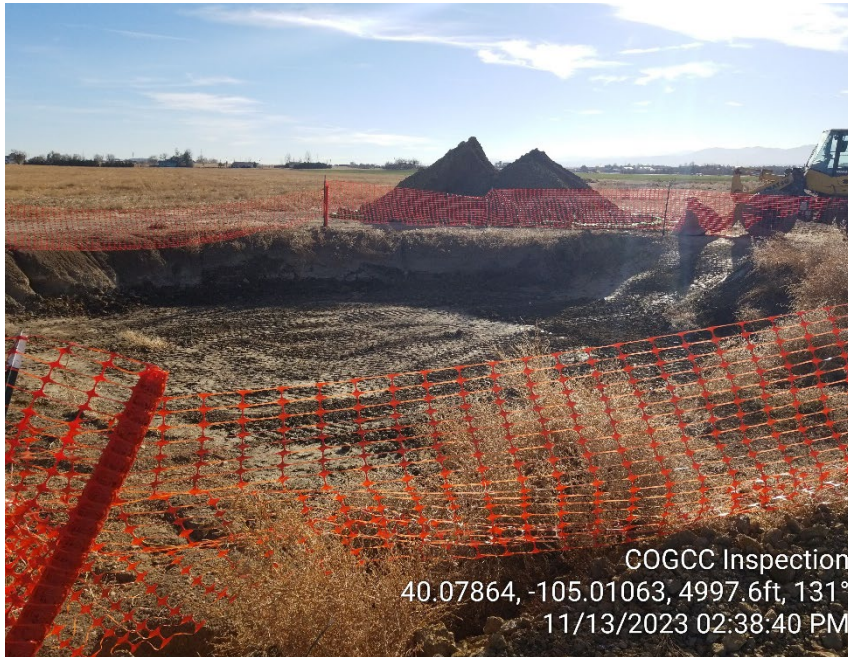
**Photo 11 – Partially backfilled excavation/weeds – PM inspection.**

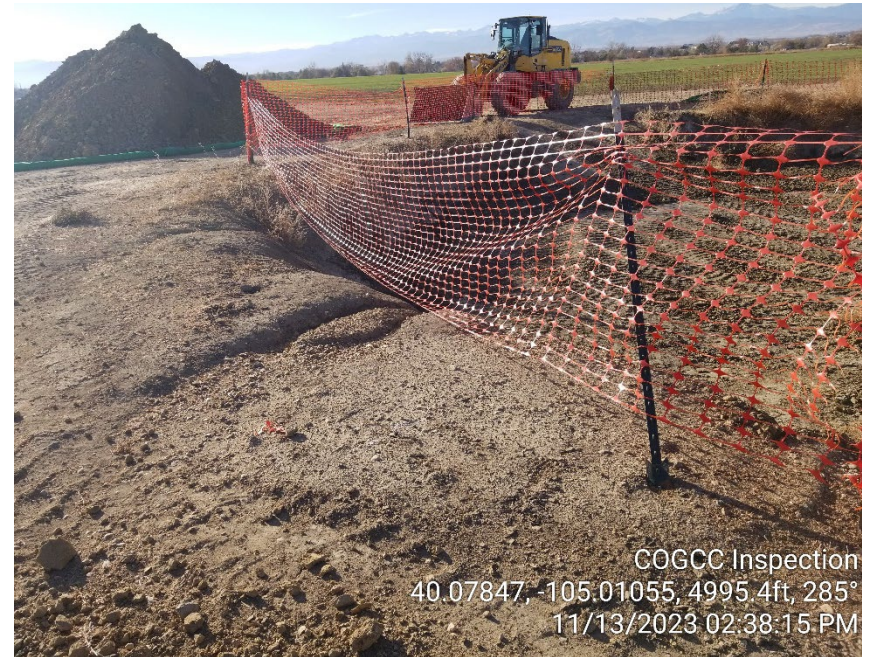
**Photo 12 - Fencing – PM inspection.**
