Inspection Photos
Lawrence Totems Consolidation Line
Spill ID 477024/Remediation Project No 15811

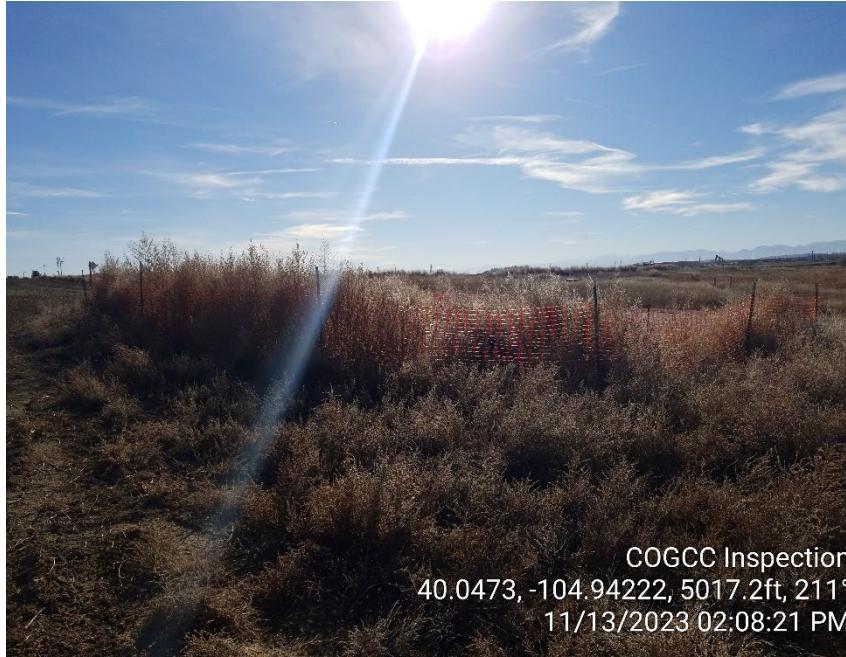
Photo 1 – Site photo/weeds.

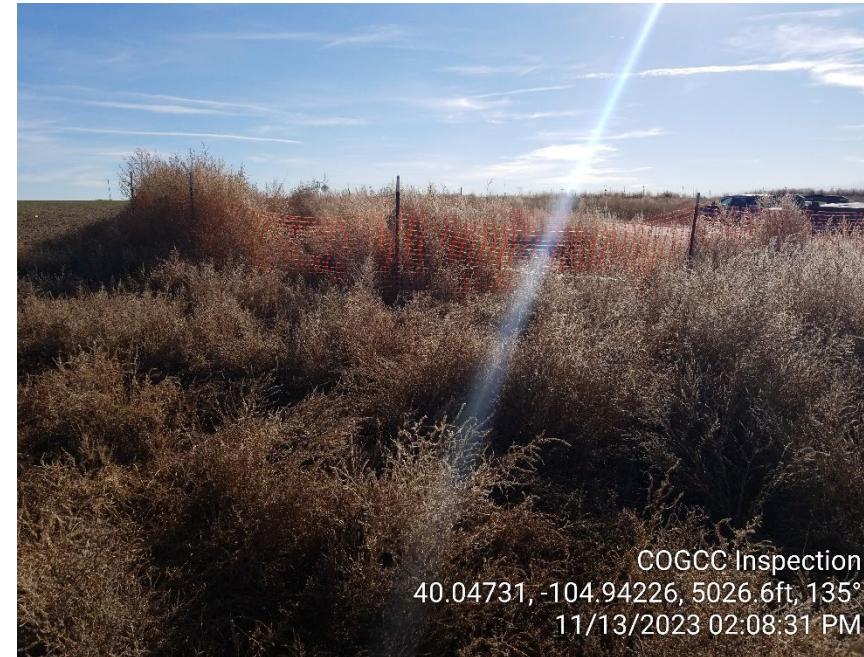
Photo 2 - Site photo/weeds.

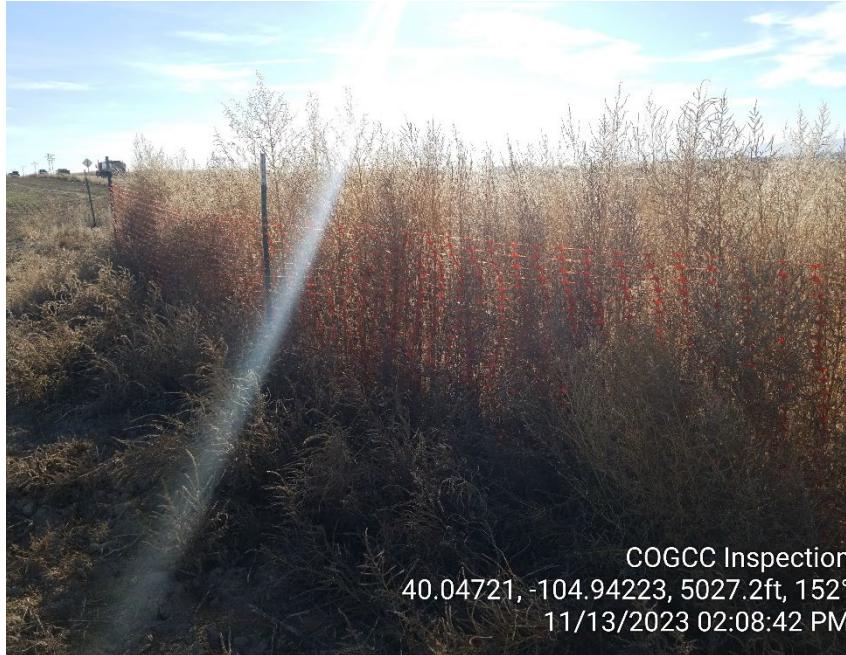
Photo 3 – Weeds.

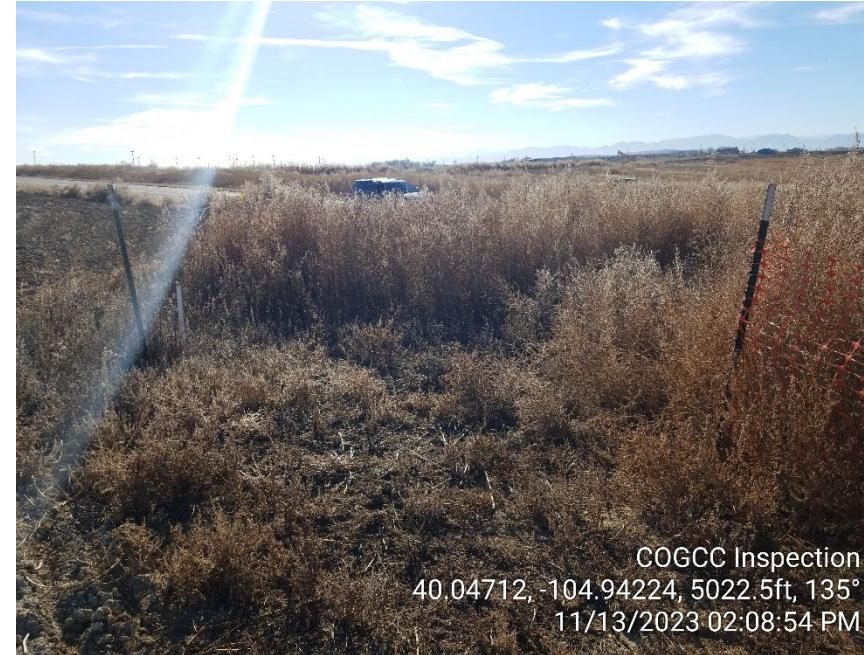
Photo 4 - Weeds/monitoring well.

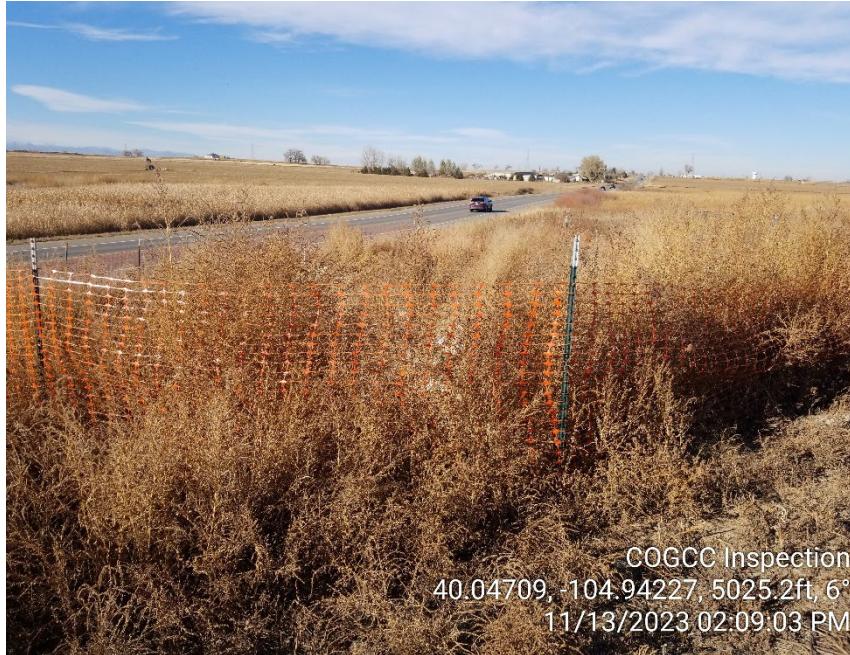
Photo 5 – Site photo/weeds/excavation area.

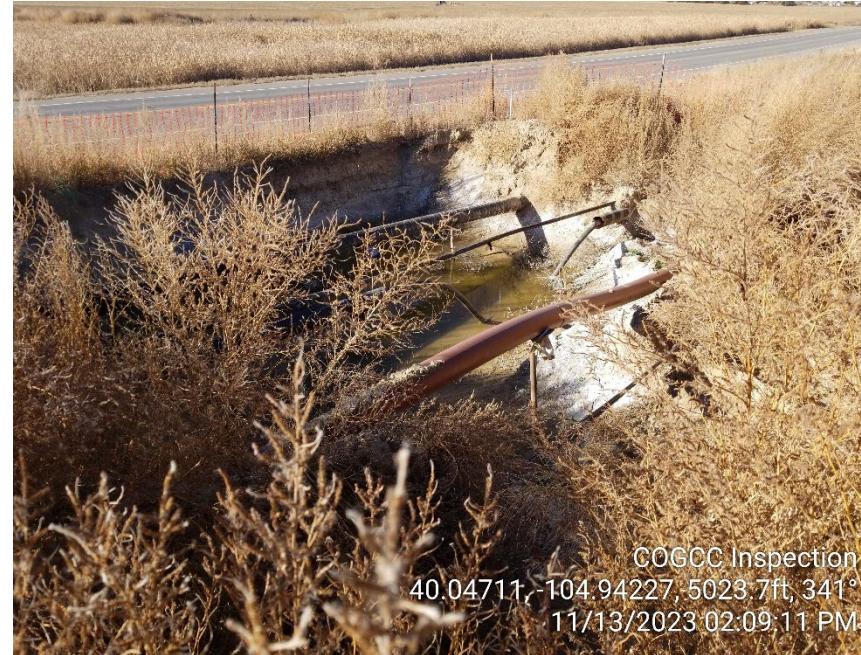
Photo 6 - Excavation area.

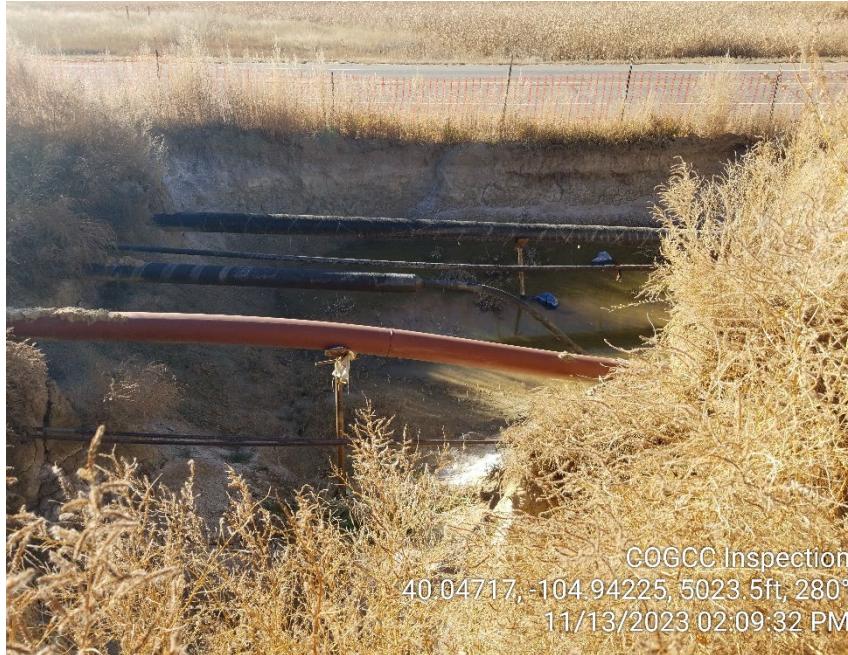
Photo 7 – Excavation area.

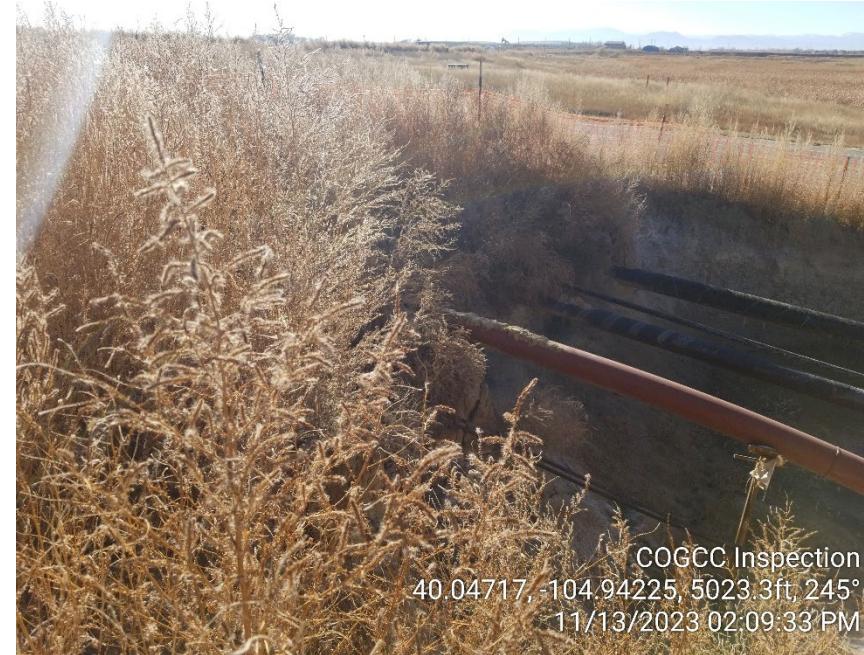
Photo 8 - Excavation area.

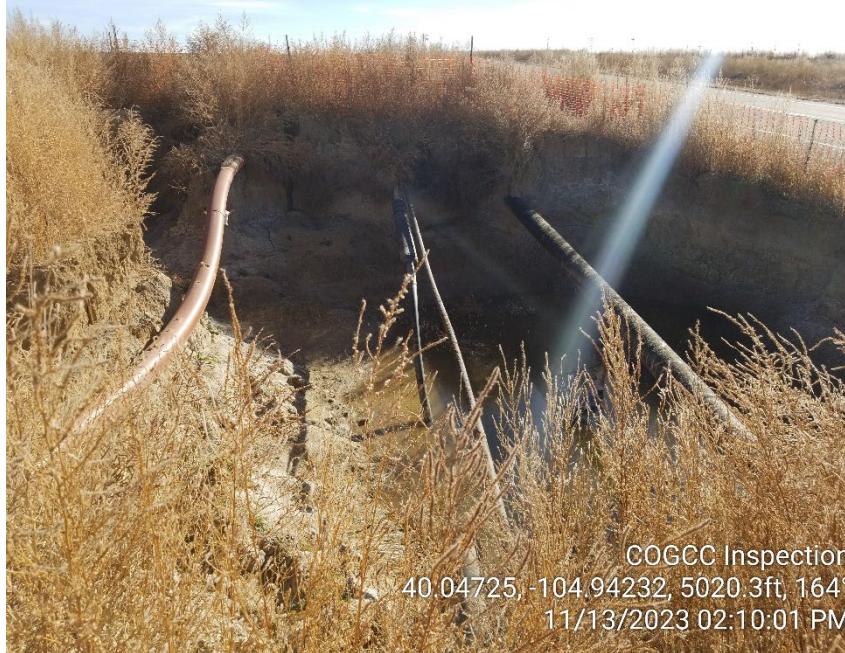
Photo 9 – Excavation area.

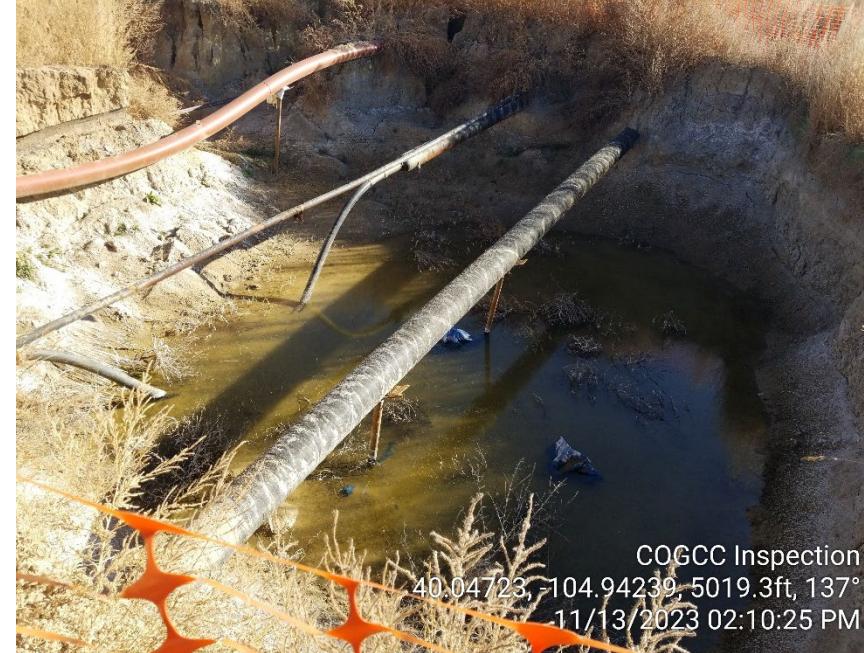
Photo 10 - Excavation area/groundwater.

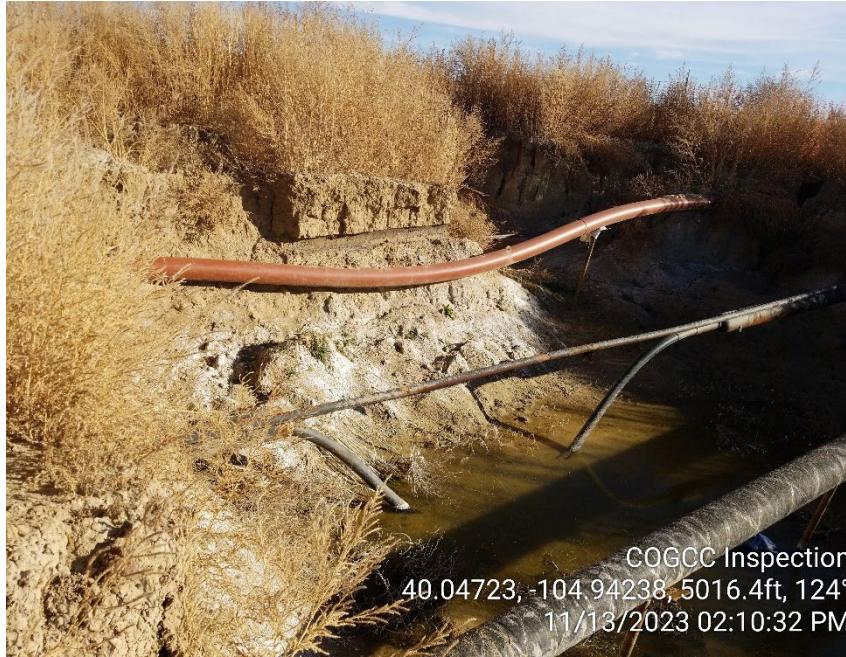
Photo 11 – Excavation area.

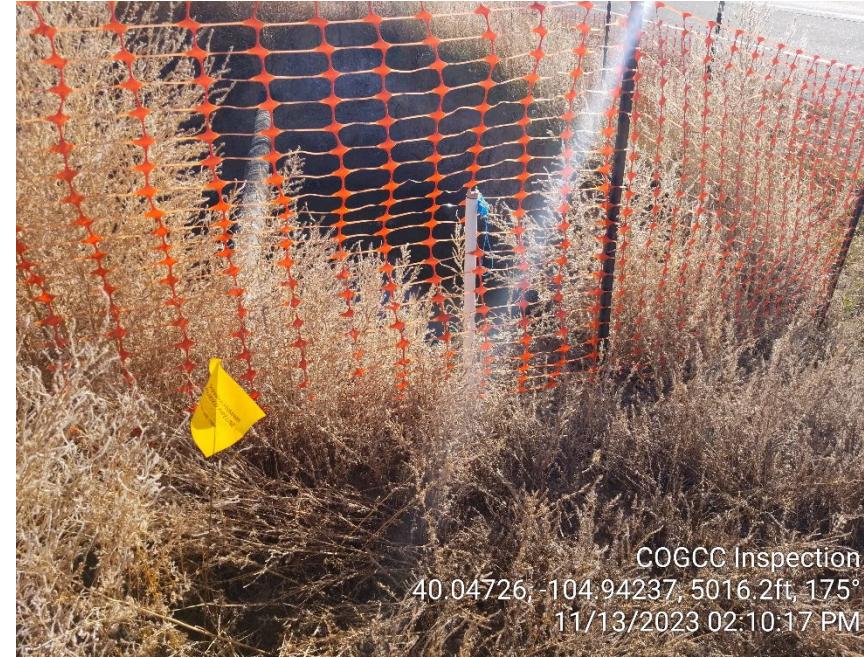
Photo 12 – Monitoring well.
