**KT Resources LLC  
Ant Hill Unit 18-41  
Location ID: 316340**

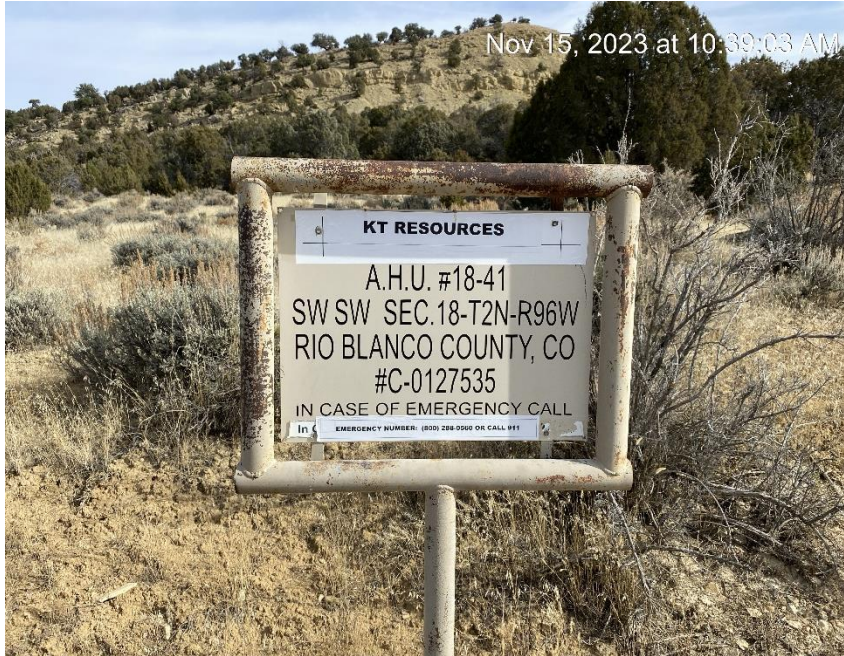
**As entrance signs are replaced additional information will be required**

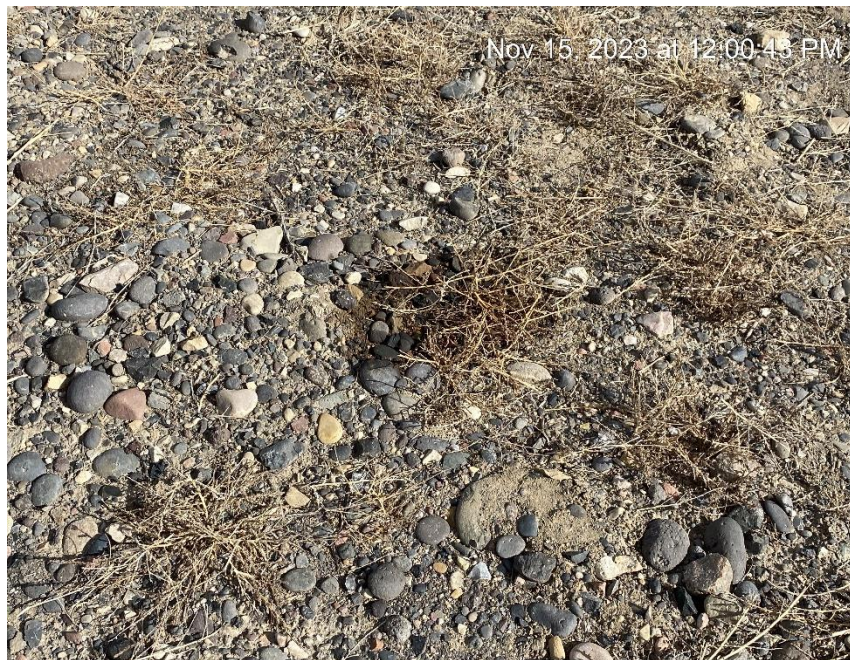
**Oily waste and staining**

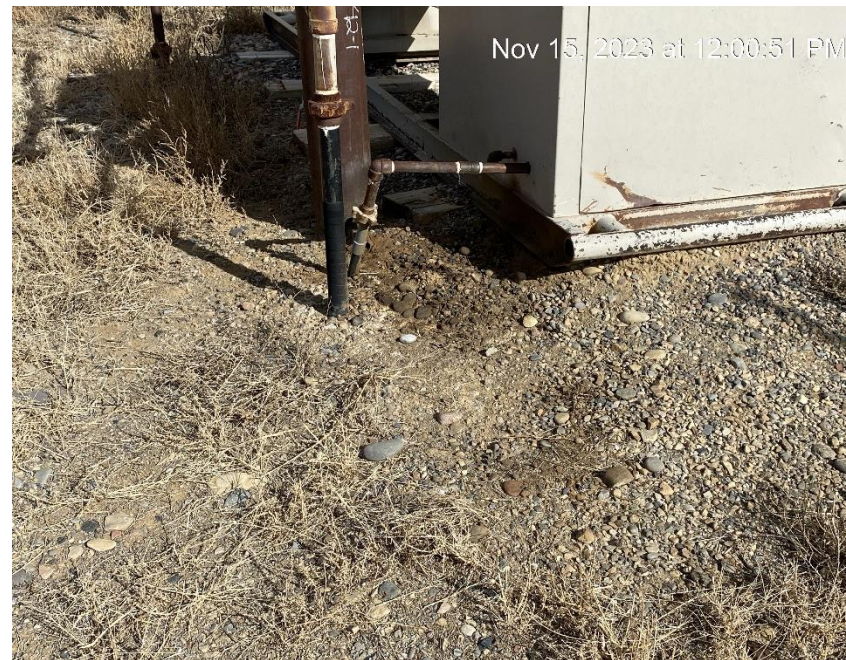
**Oily waste and staining**

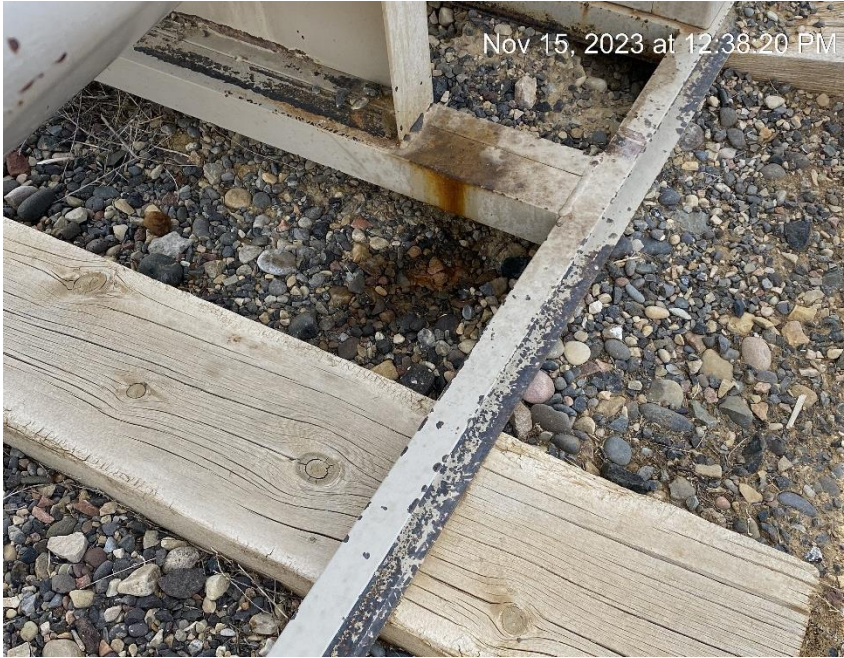
## Oily waste and staining

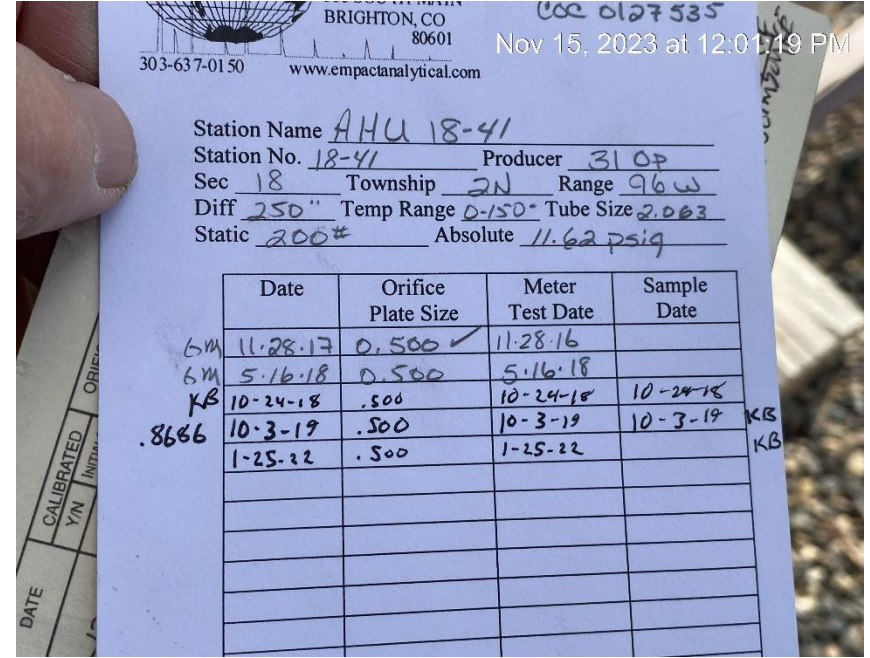
## Gas meter calibration overdue

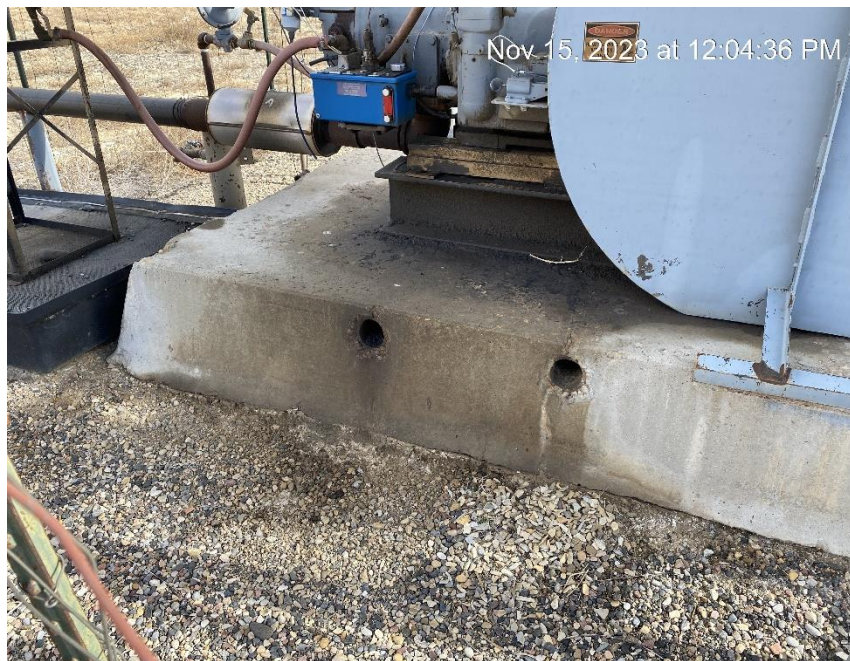
**Oily waste and stained soil**

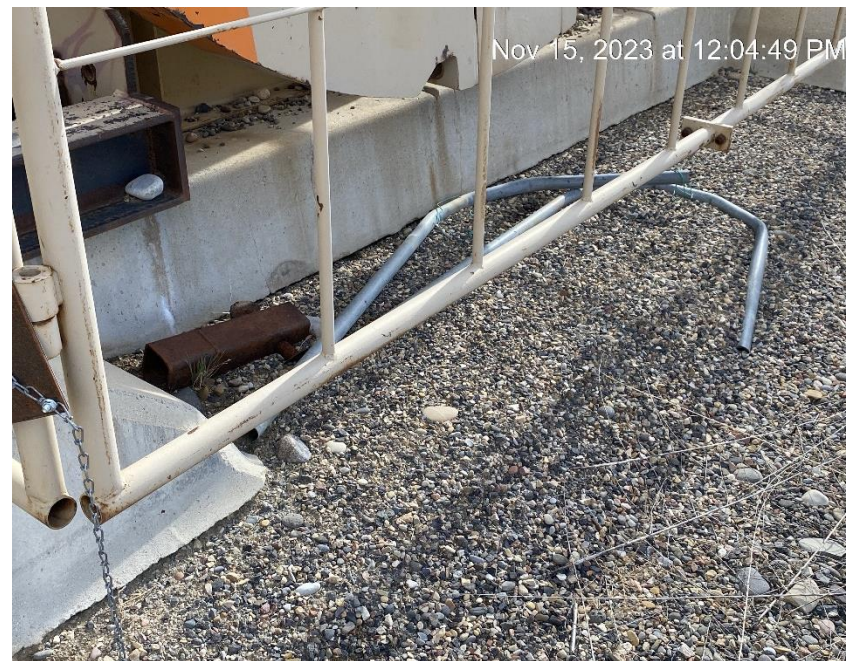
**Debris**

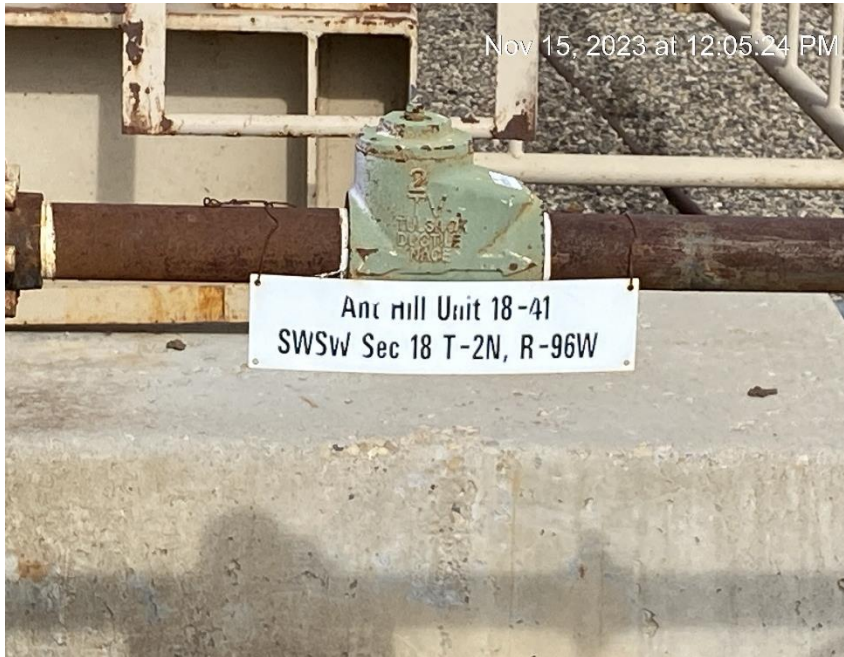
**As well signs are replaced additional information will be required**

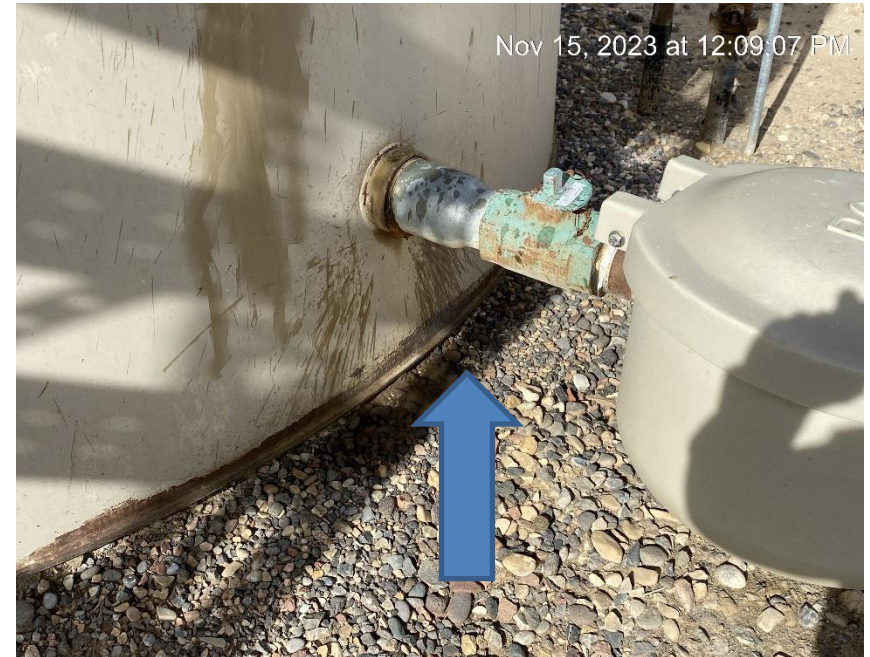
**Staining**

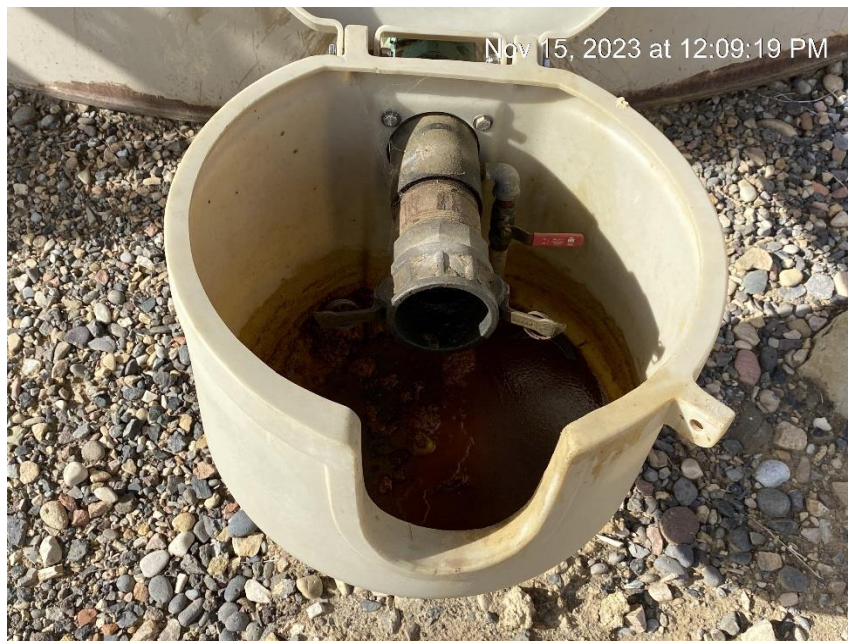
**Open end load line**

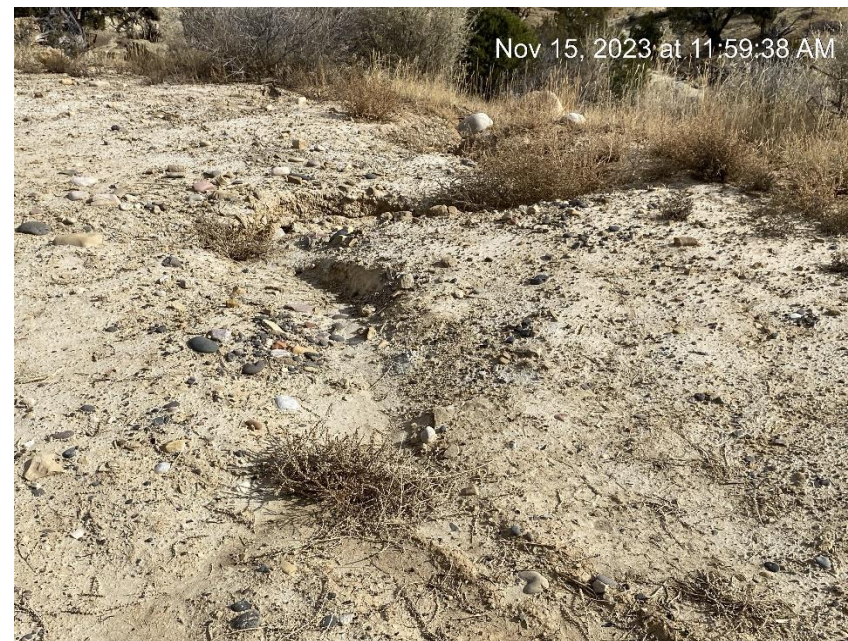
**Erosion and sediment migration exiting location**

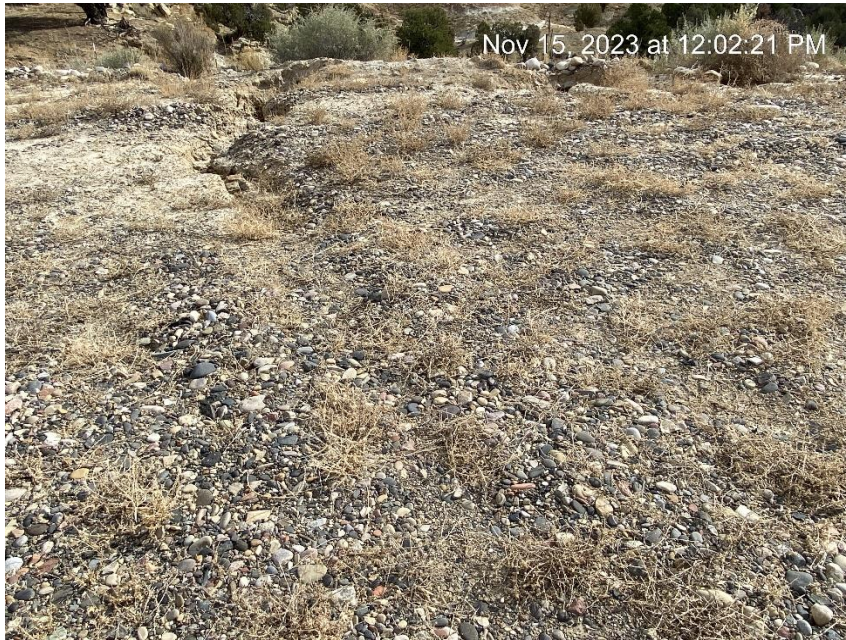
**Erosion and sediment migration exiting location**

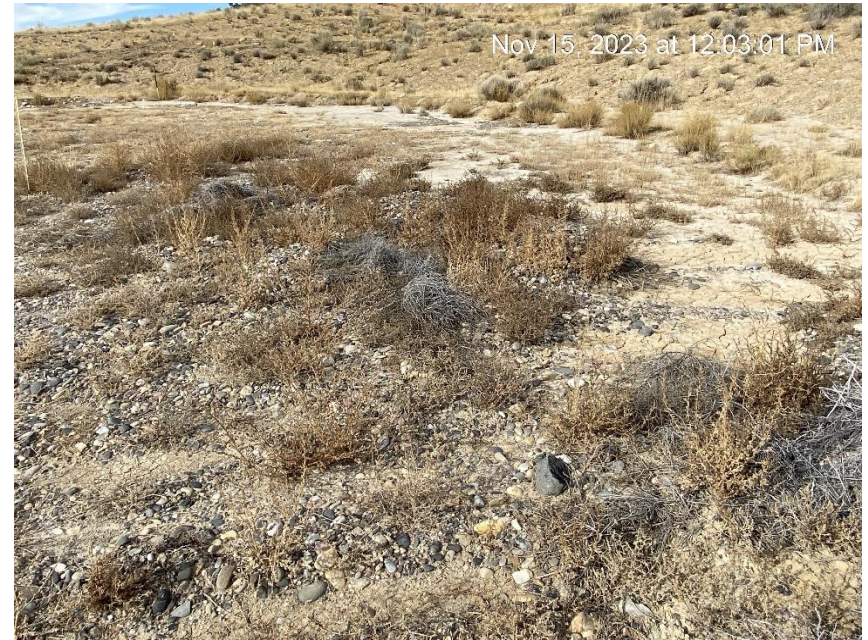
**Sediment migration entering location**

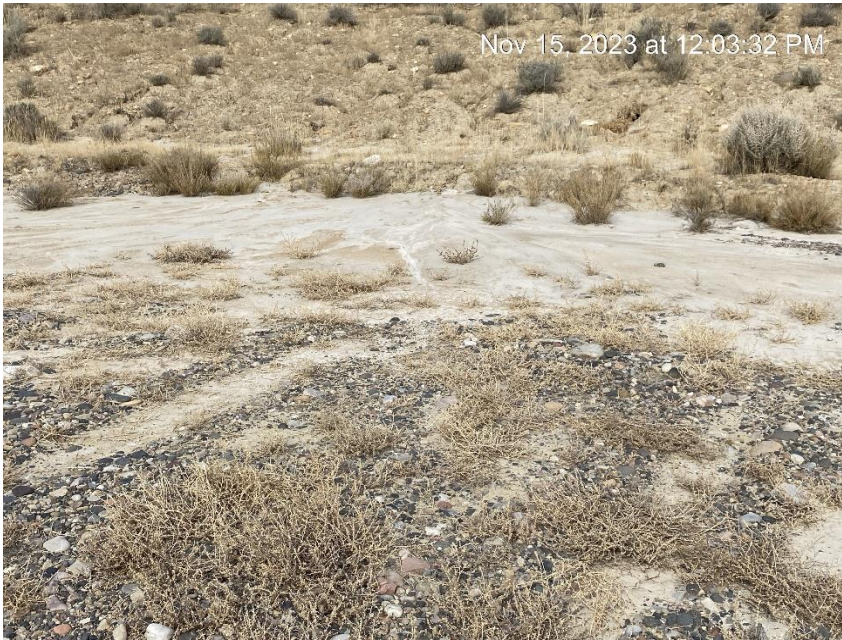
**Sediment migration entering location**

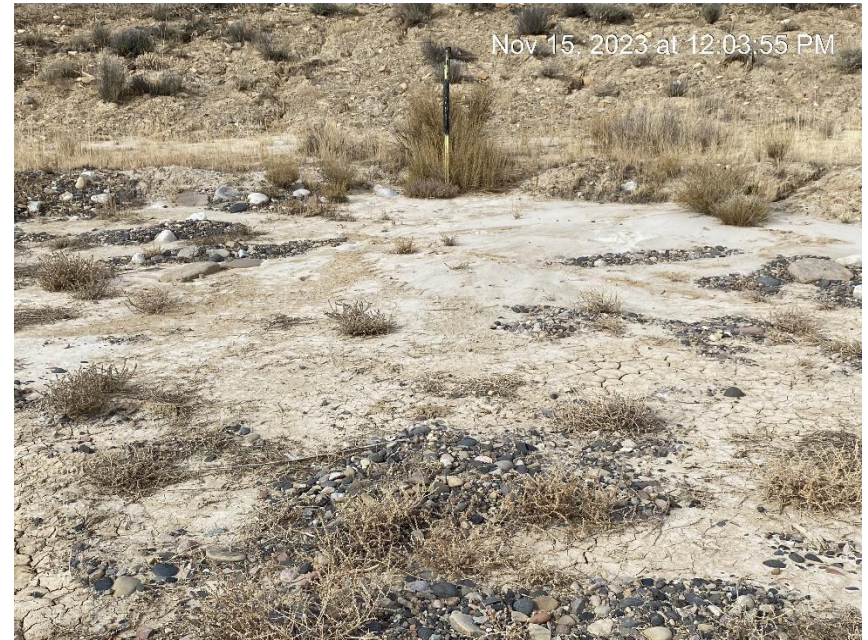
**Sediment migration entering location**
