**Inspection Photos**  
**Location Name: Razor 29H PAD**  
**Location ID: 439542**

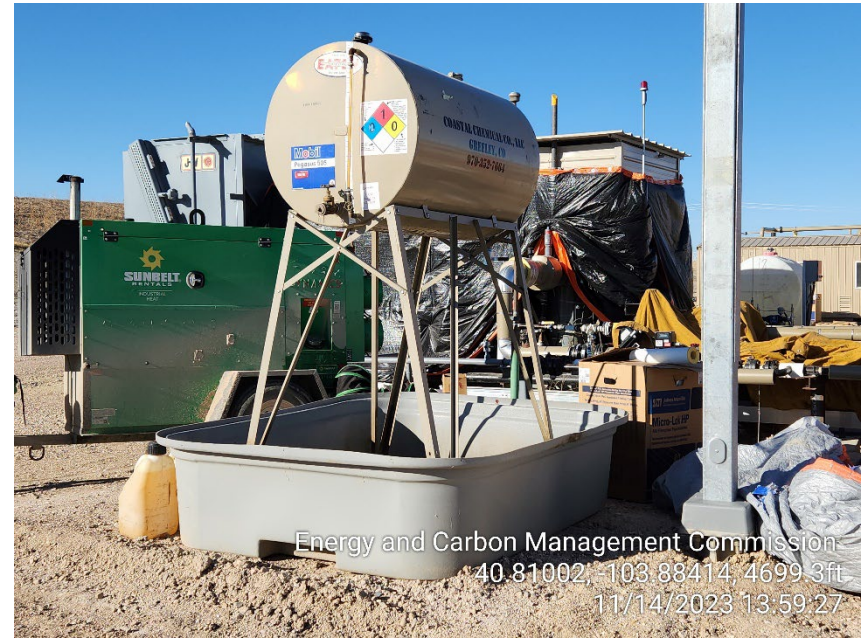
**Photo 2 – Wildlife Netting missing**

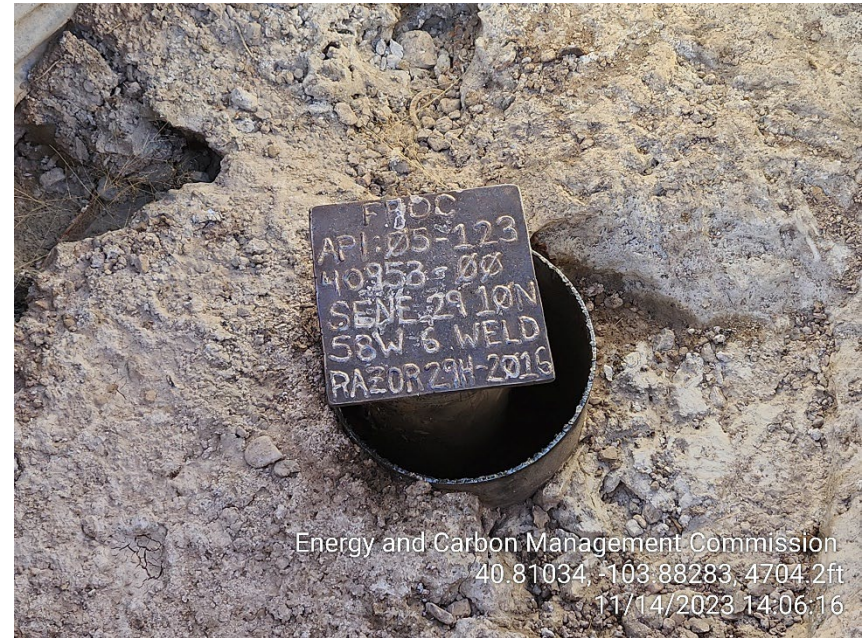
**Photo 6 – Razor 29H-2016 – PA'd – Cut and Capped**
