Inspection Photos

Operator: CAERUS PICEANCE LLC

Location ID: 485123 / 485124

Inspection Doc: 696205419

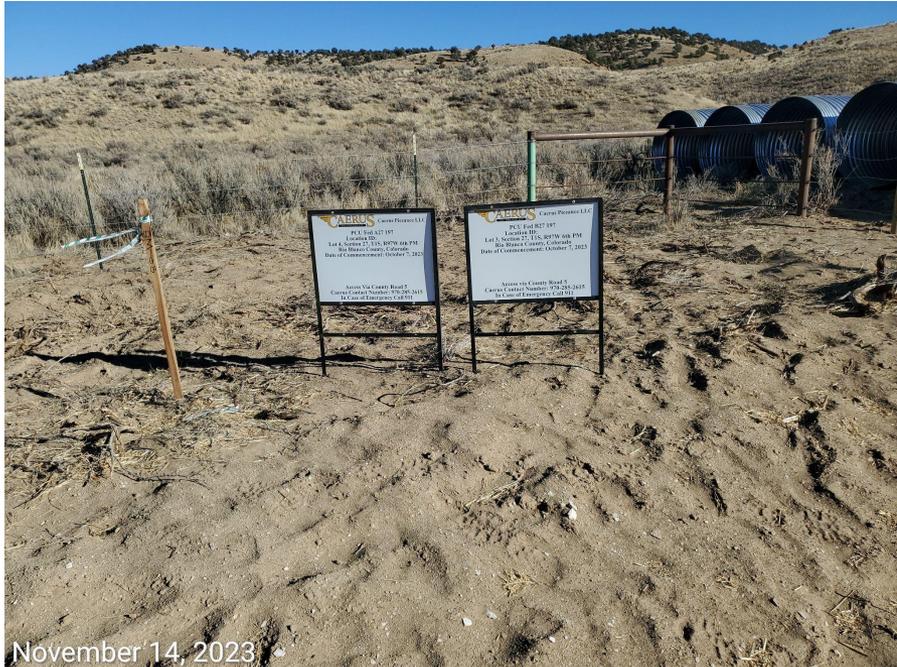
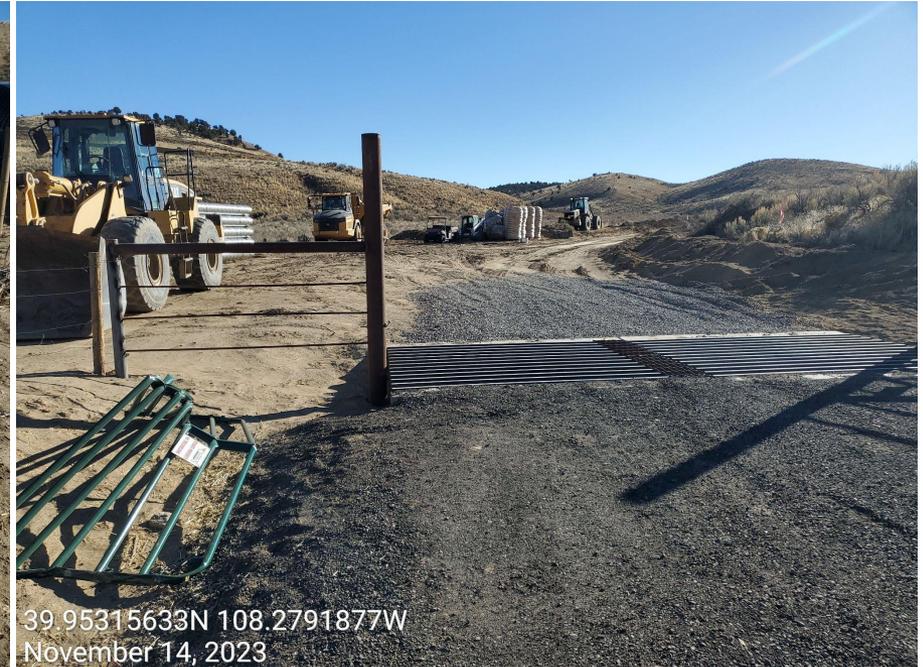
Photo 1: Signage at the Location entrance.

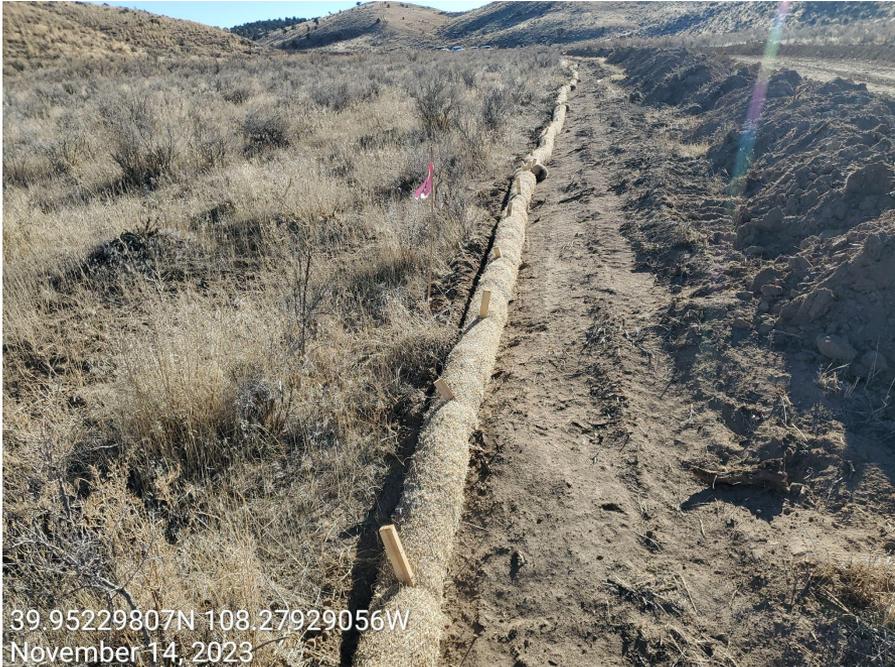
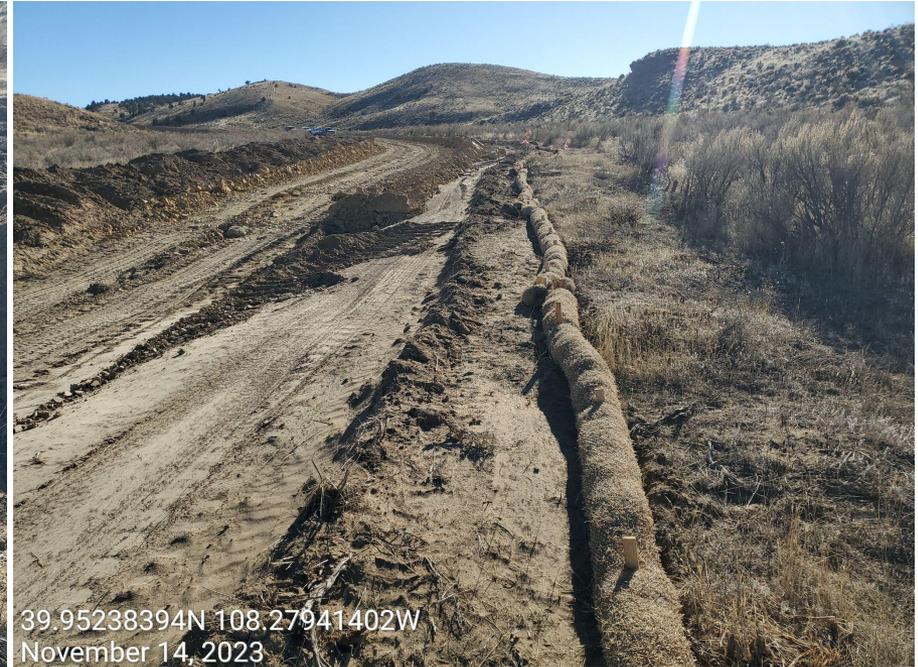
Photo 2: Photos examples showing erosion logs implemented to manage runoff/runoff, and stormwater sediment transport.

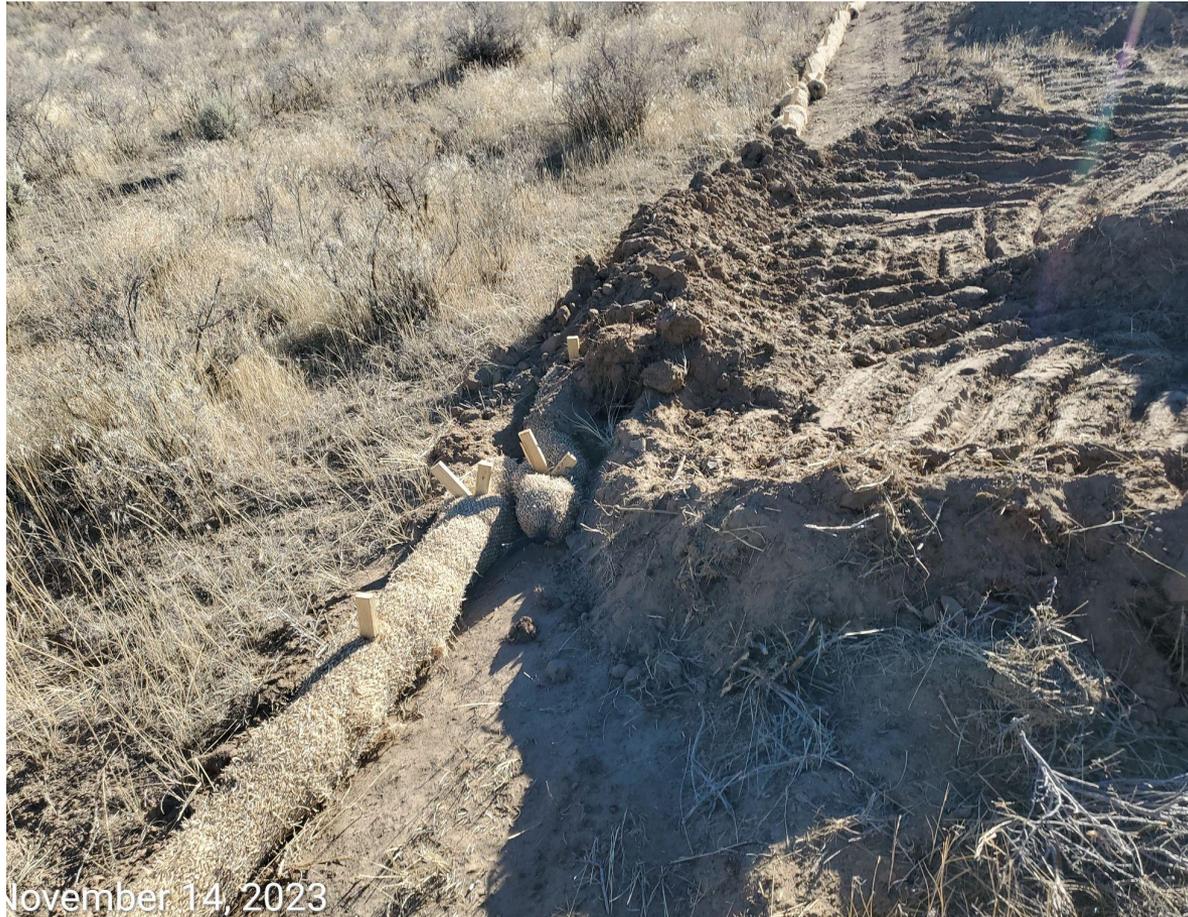
Photo 3: Photo example showing area where soils have been pushed over the erosion logs during construction.

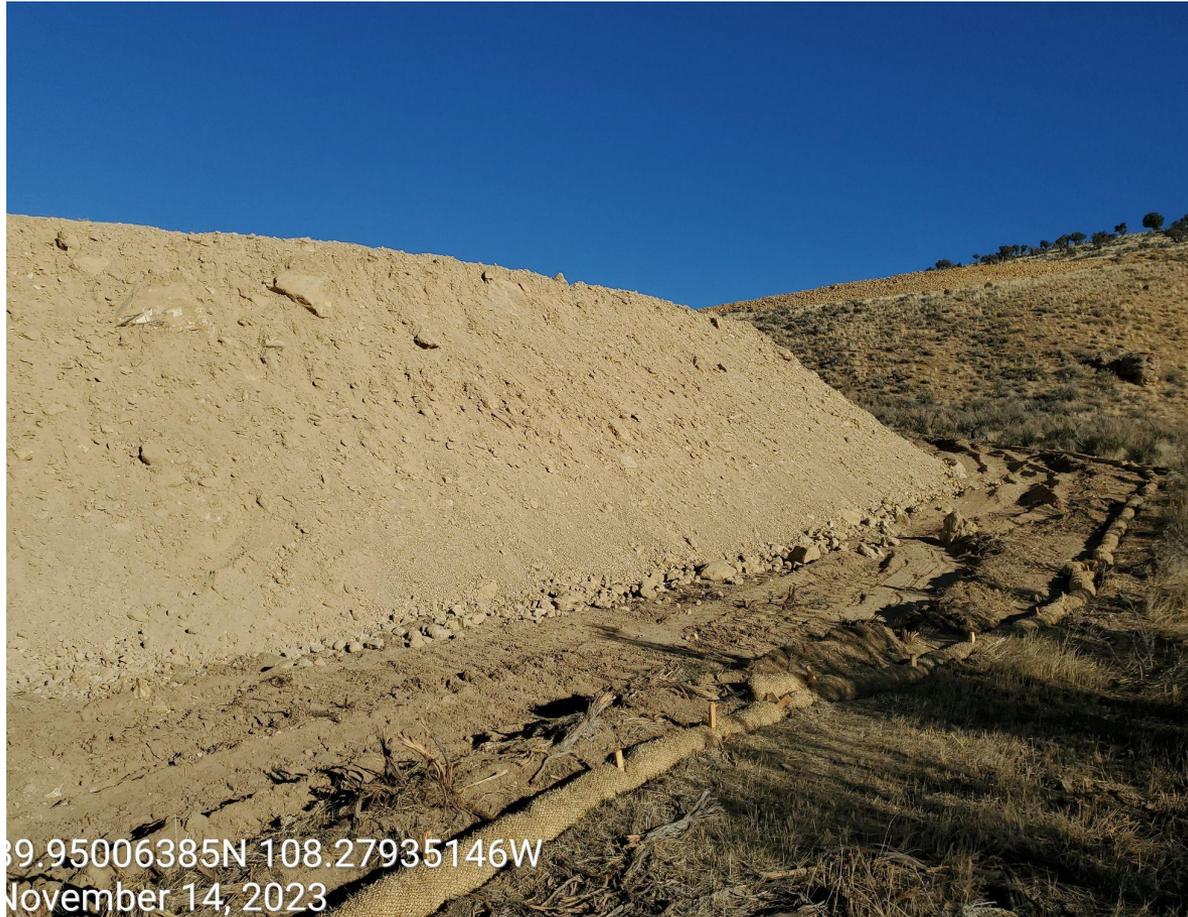
Photo 4: Photo example of slopes along the Location that will require additional stabilization control measures. Soils at risk to wind and water erosion; fugitive dust control measures required.

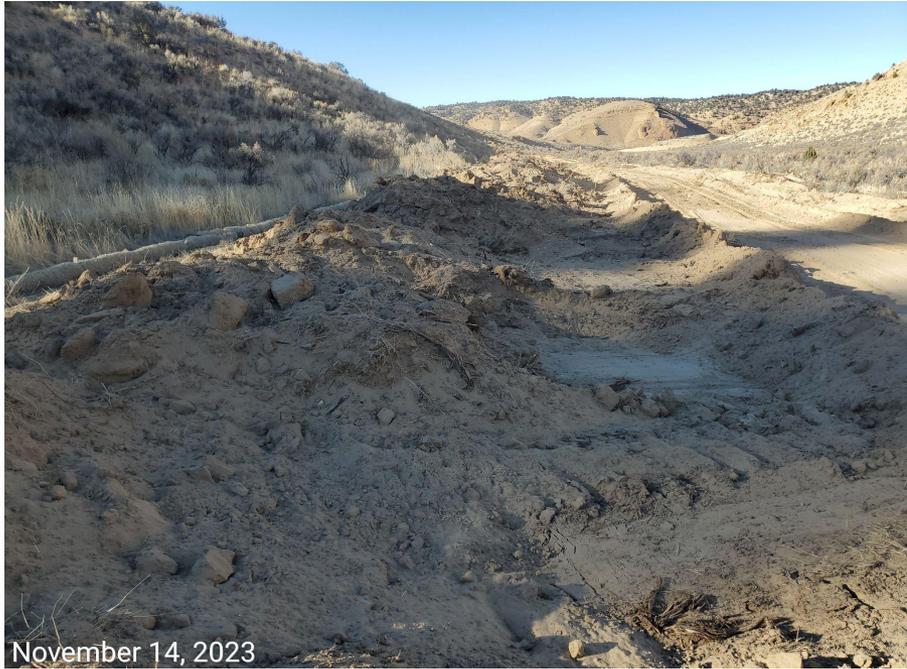
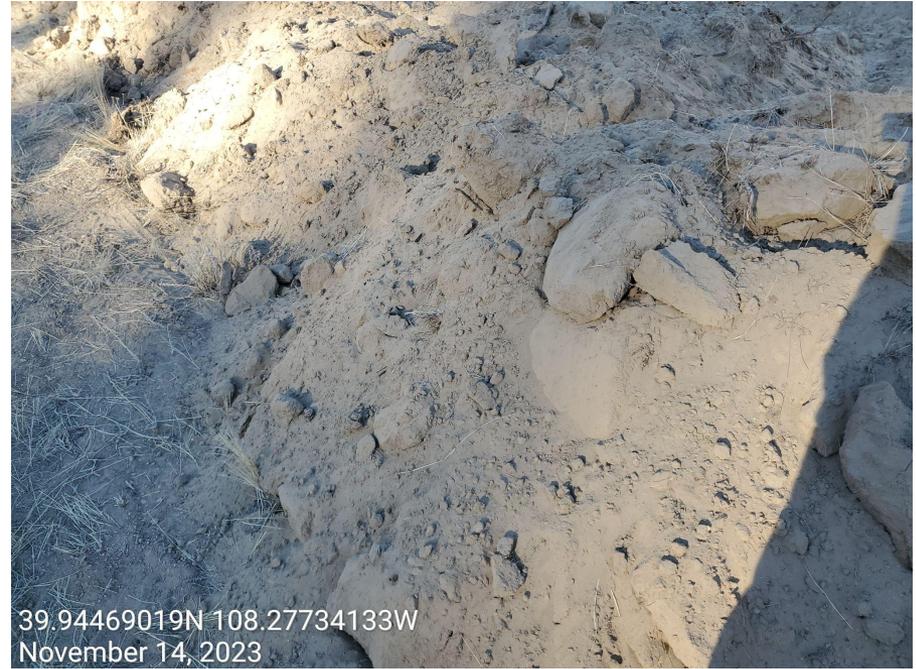
Photo 5: Photos examples showing topsoil salvaged along the access road. Soils currently loose and at risk to wind and water erosion; fugitive dust issues observed at time of inspection.

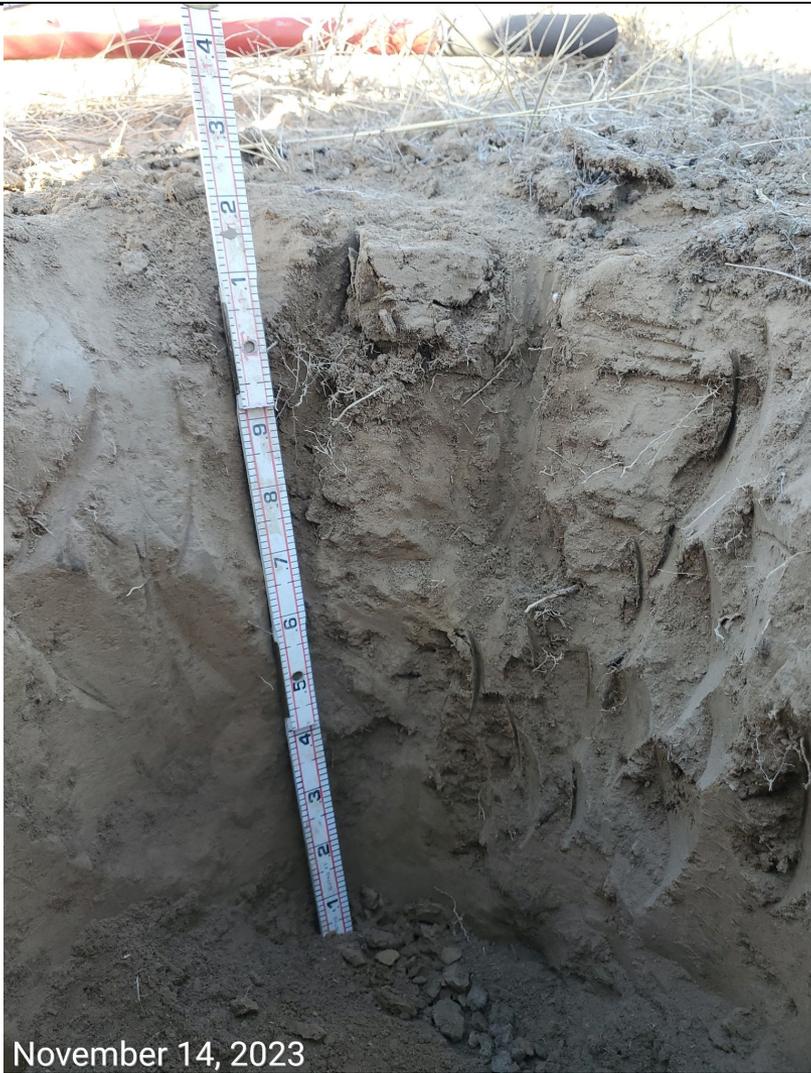
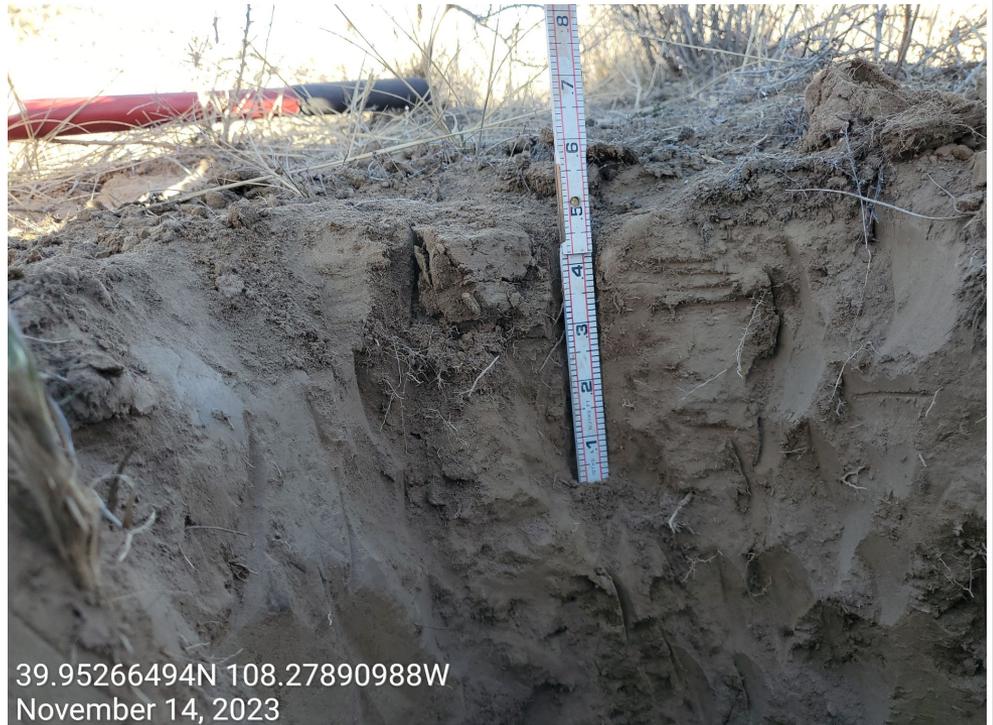
Photo 6: Soil test pit conducted within the “drainage” section of the access road. Topsoil depth at pit determined to be 6 inches.

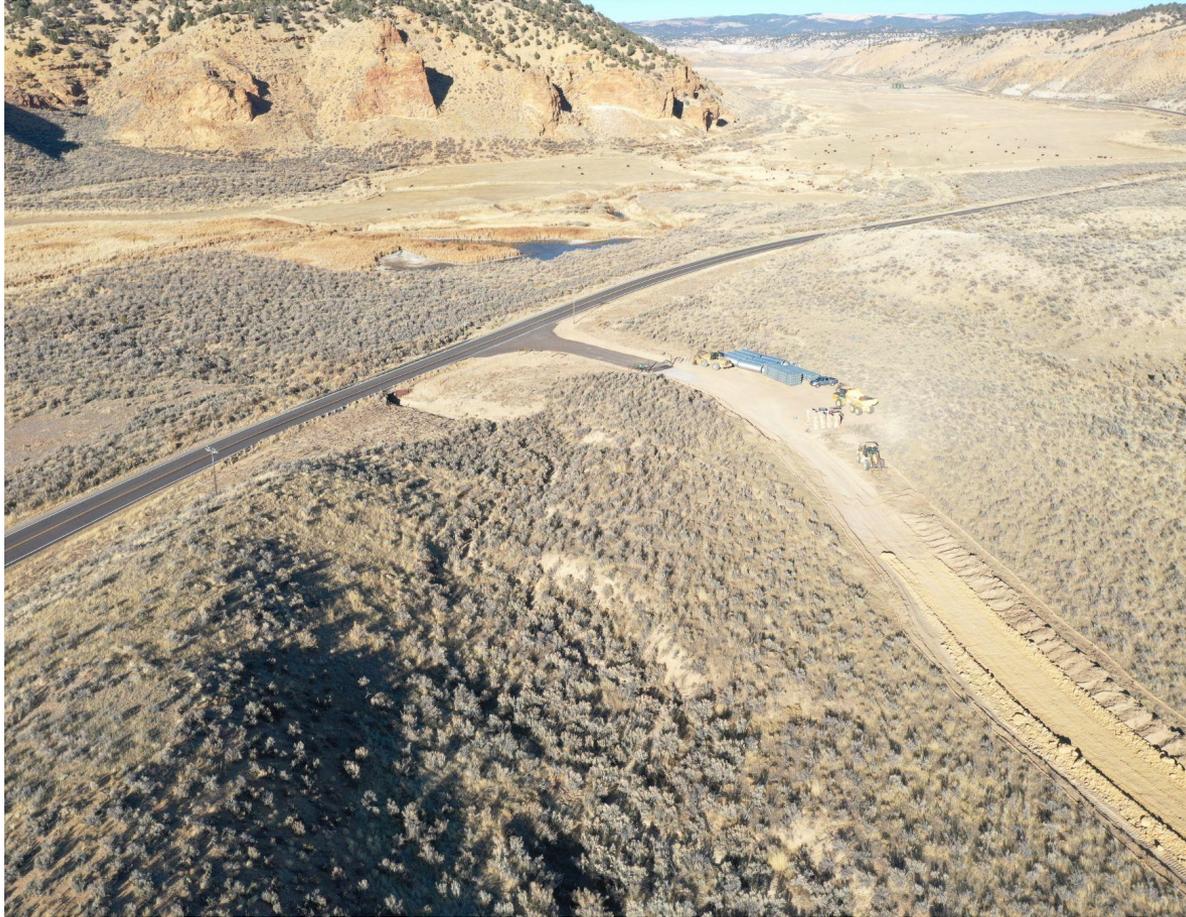
Photo 7: Photos 7-12 taken with use of a sUAS. Photos provide aerial views of the access road construction in process.

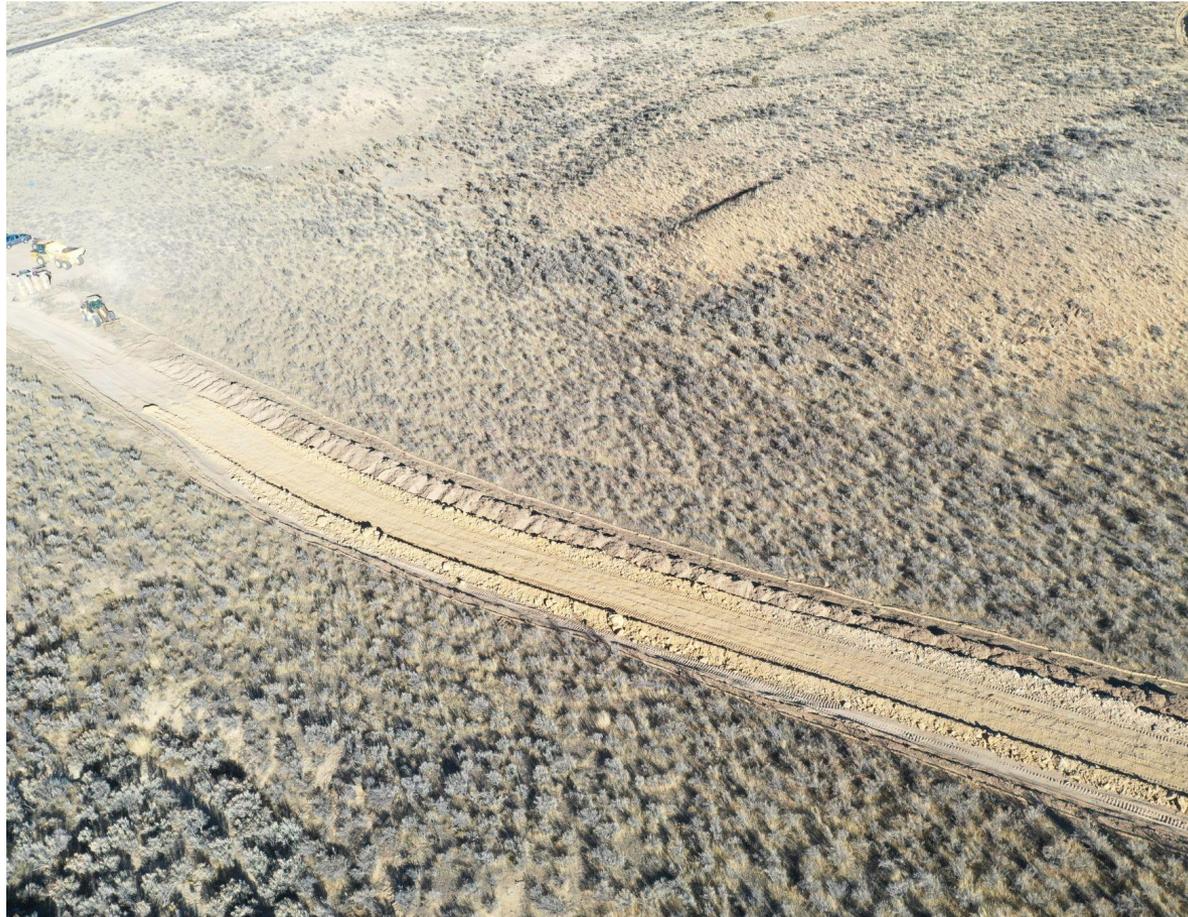
Photo 8: See comments under photo 7.

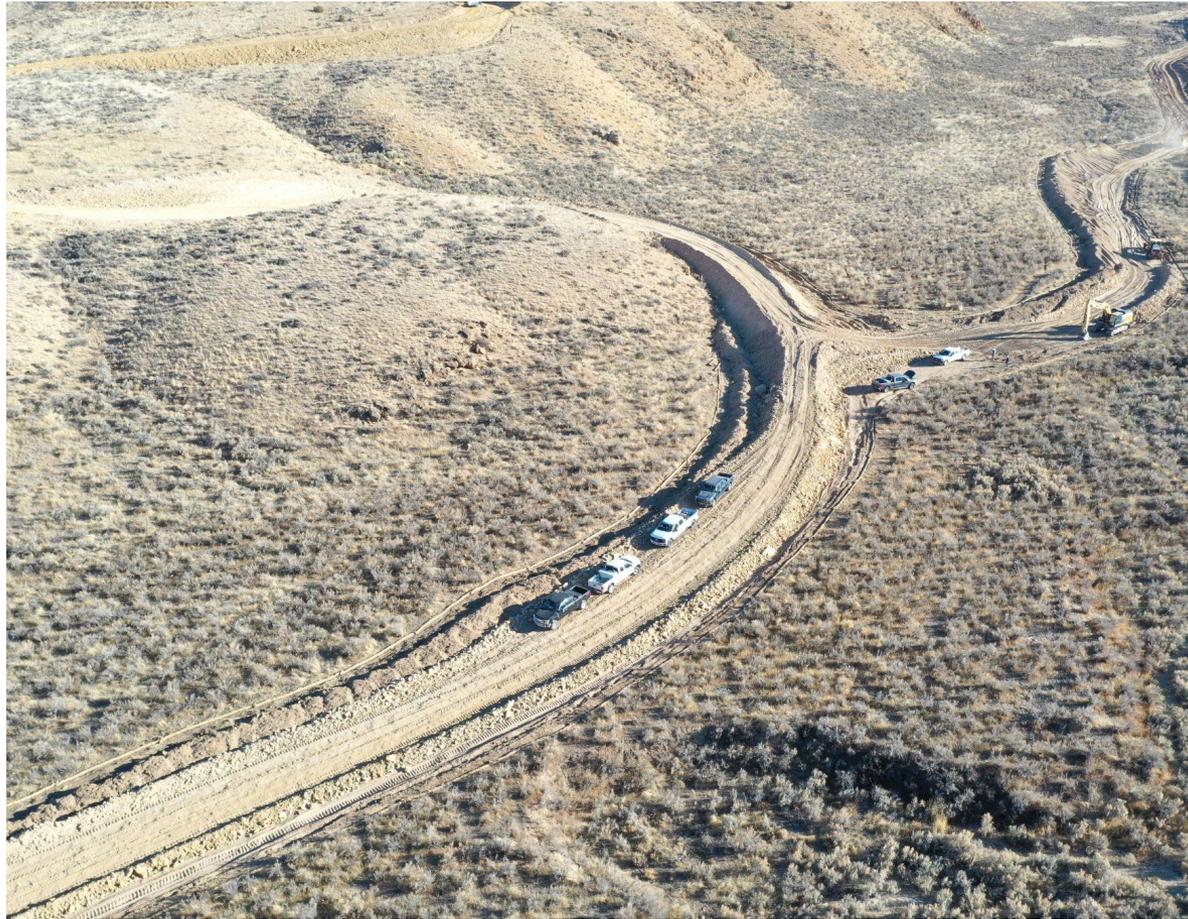
Photo 9: See comments under photo 7.

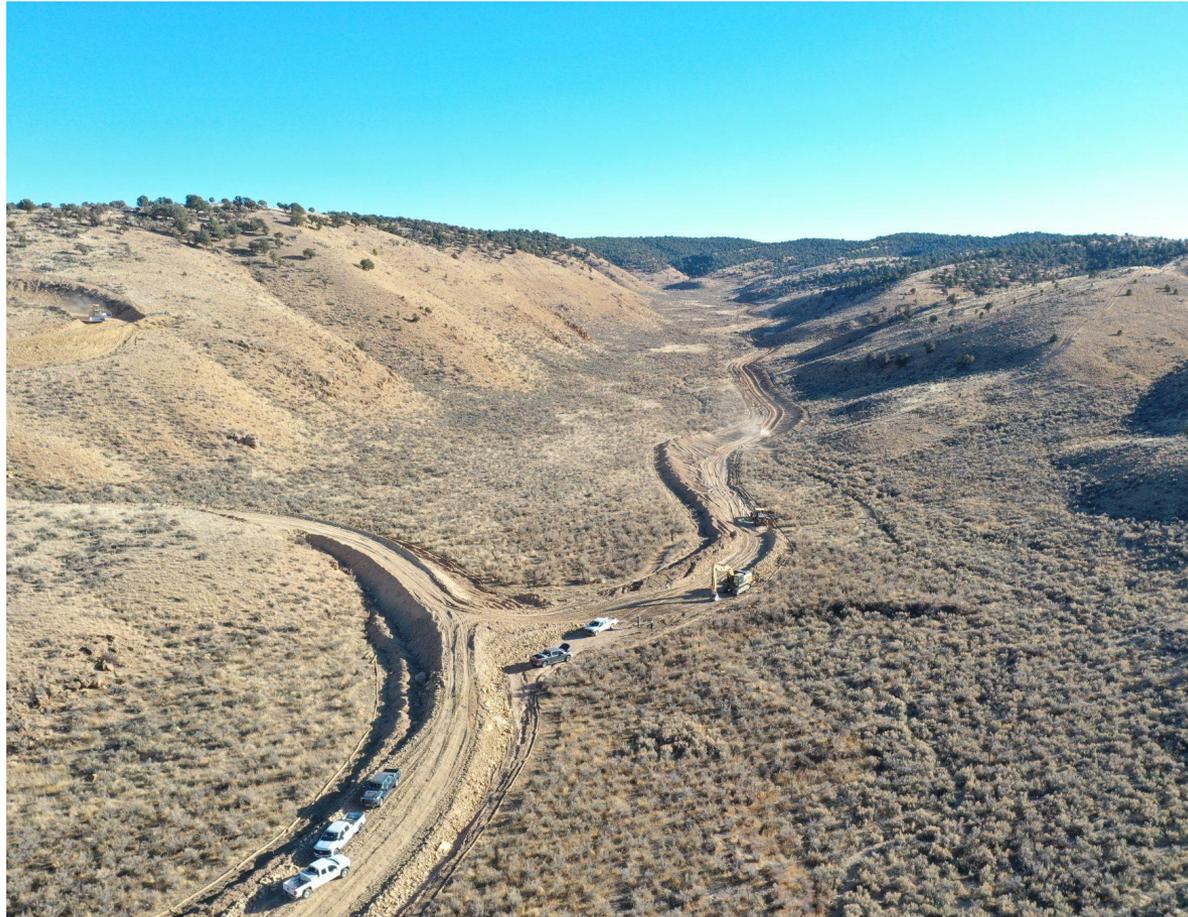
Photo 10: See comments under photo 7.

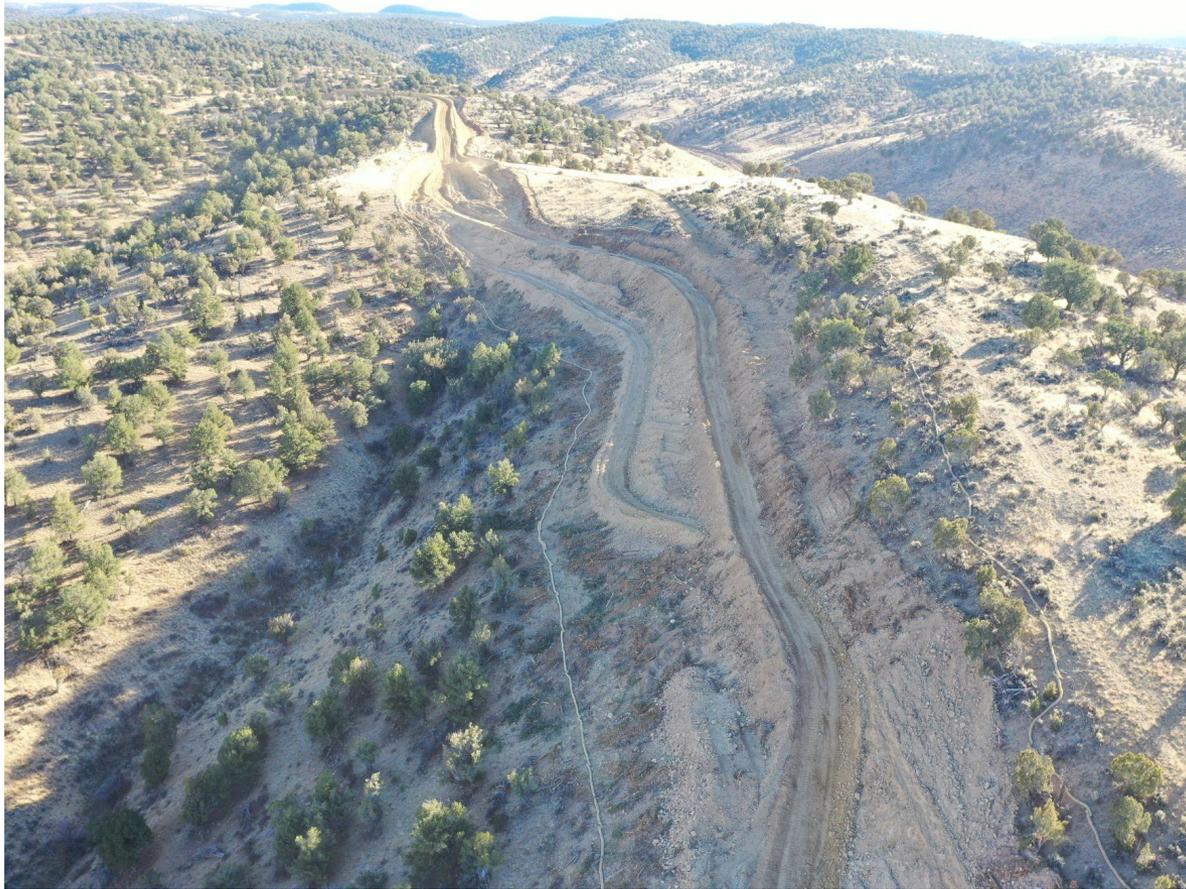
Photo 11: See comments under photo 7. Photo shows the access road leading to the proposed PCU Fed #B27-197 Location.

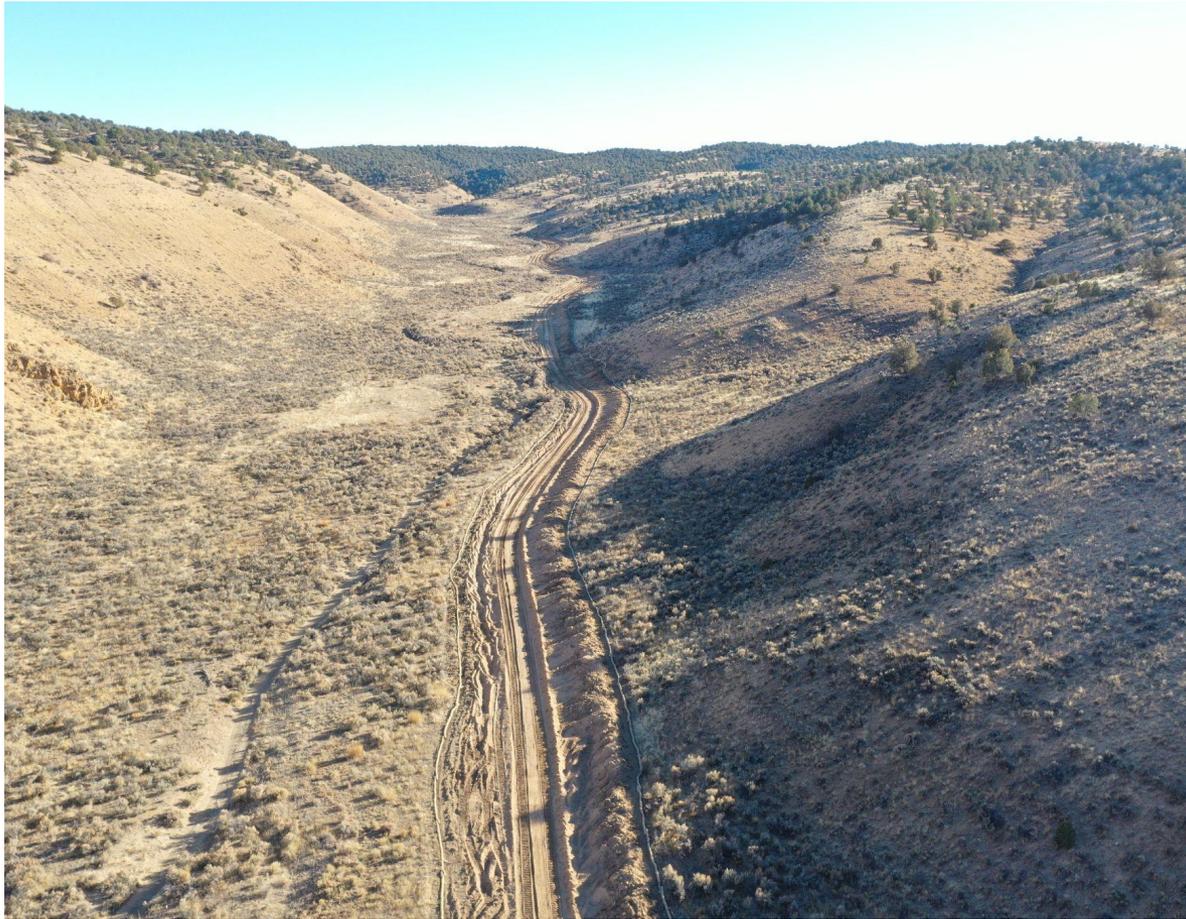
Photo 12: See comments under photo 7. Photo shows the access road leading to the proposed PCU Fed #A27-197 CDP Location.
