# Inspection Photos

Loc: 309208

Operator: EVERGREEN NATURAL  
RESOURCES LLC

Inspection Date: 11/14/2023

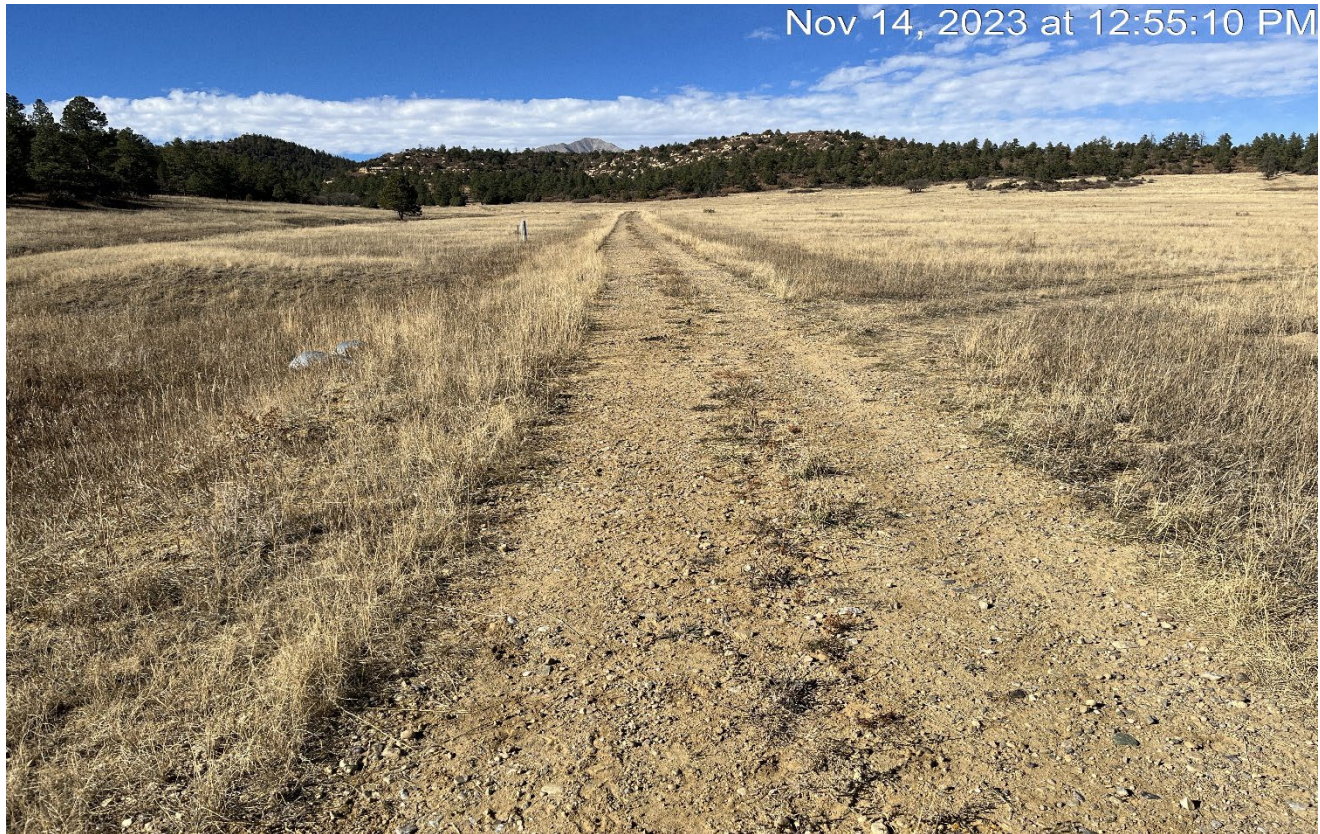
**Photo 1.** Facing northwest along the access road that remains per approved variance.

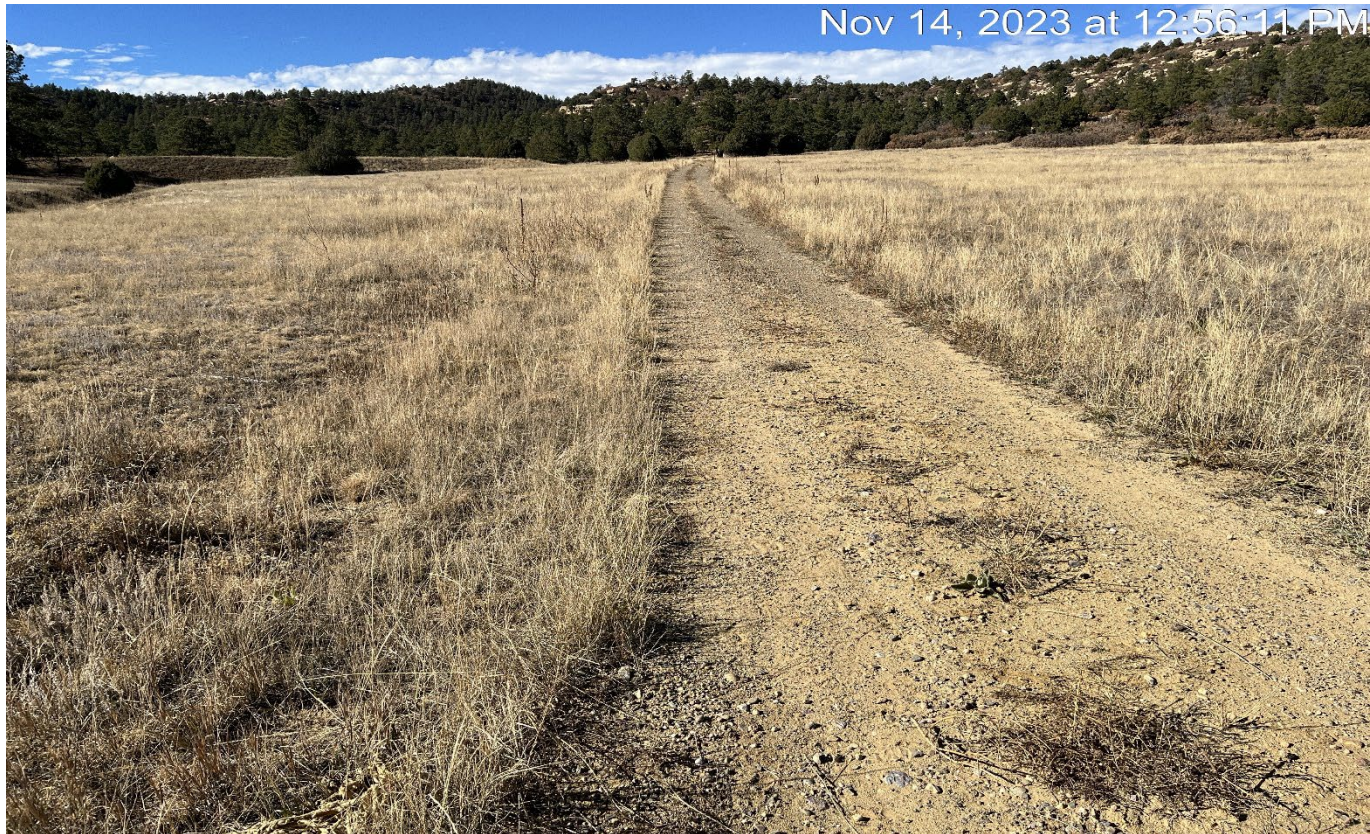
**Photo 2.** Facing northwest further along the access road which is stabilized with BMP's.

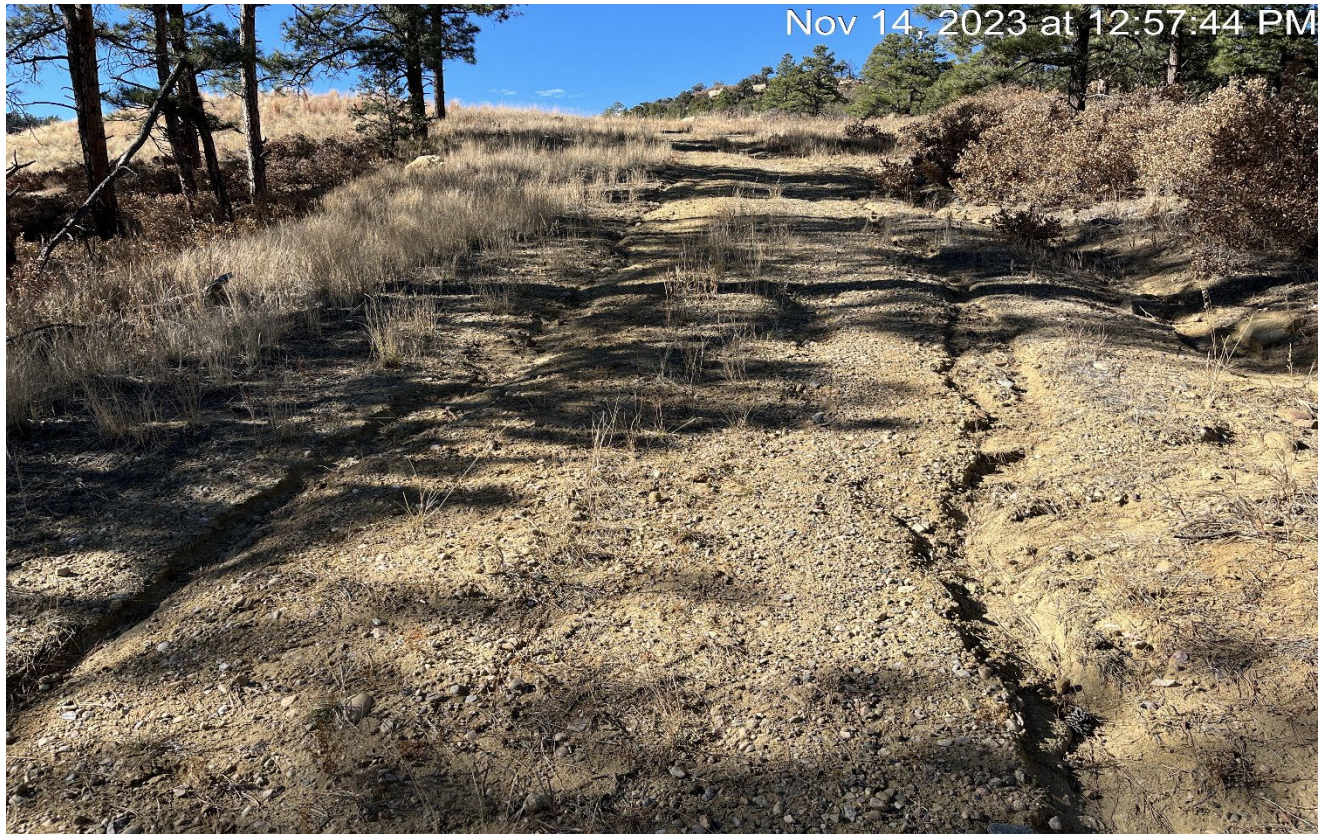
**Photo 3.** Facing northwest along the access road. There is erosion occurring along this area ascending to the location and will need to be repaired.

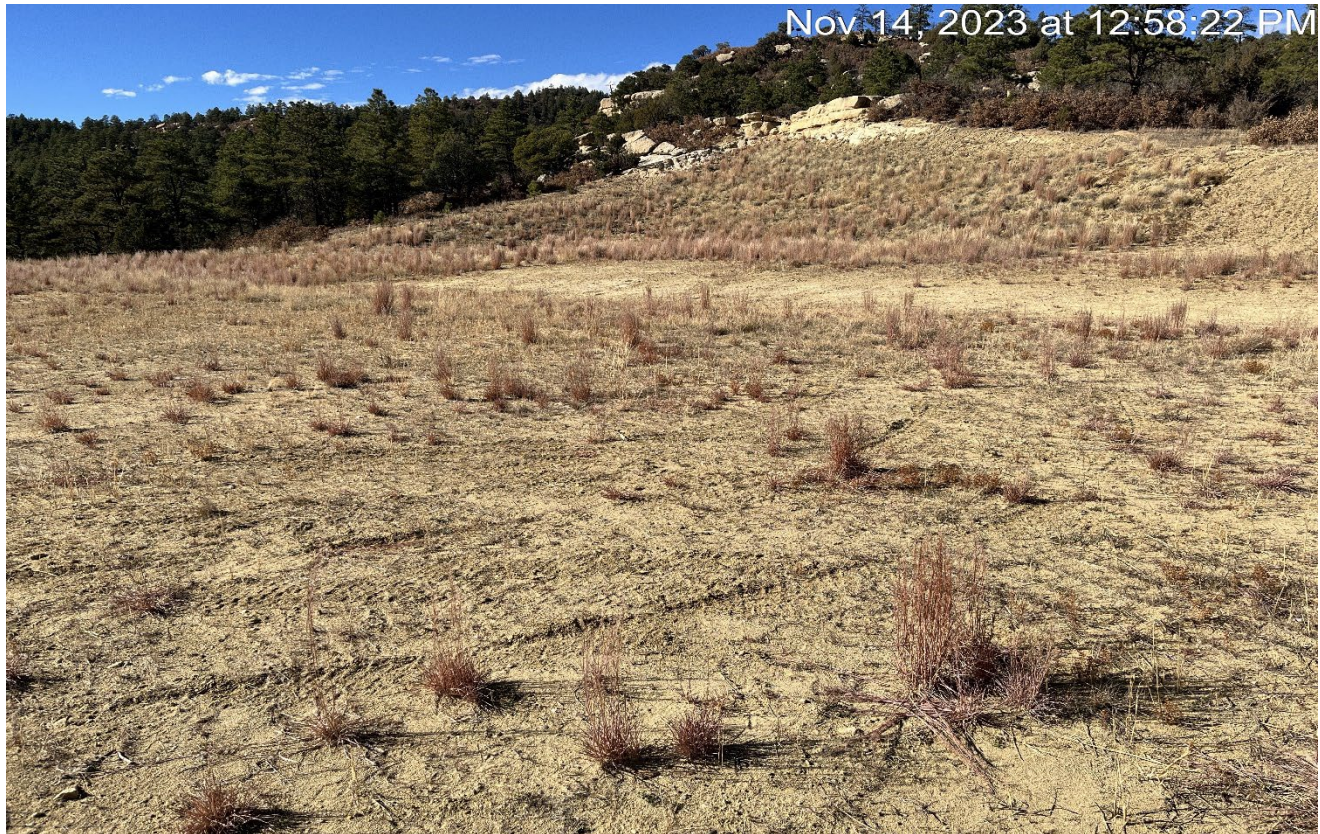
**Photo 4.** Facing northwest toward the location that remains per approved variance.

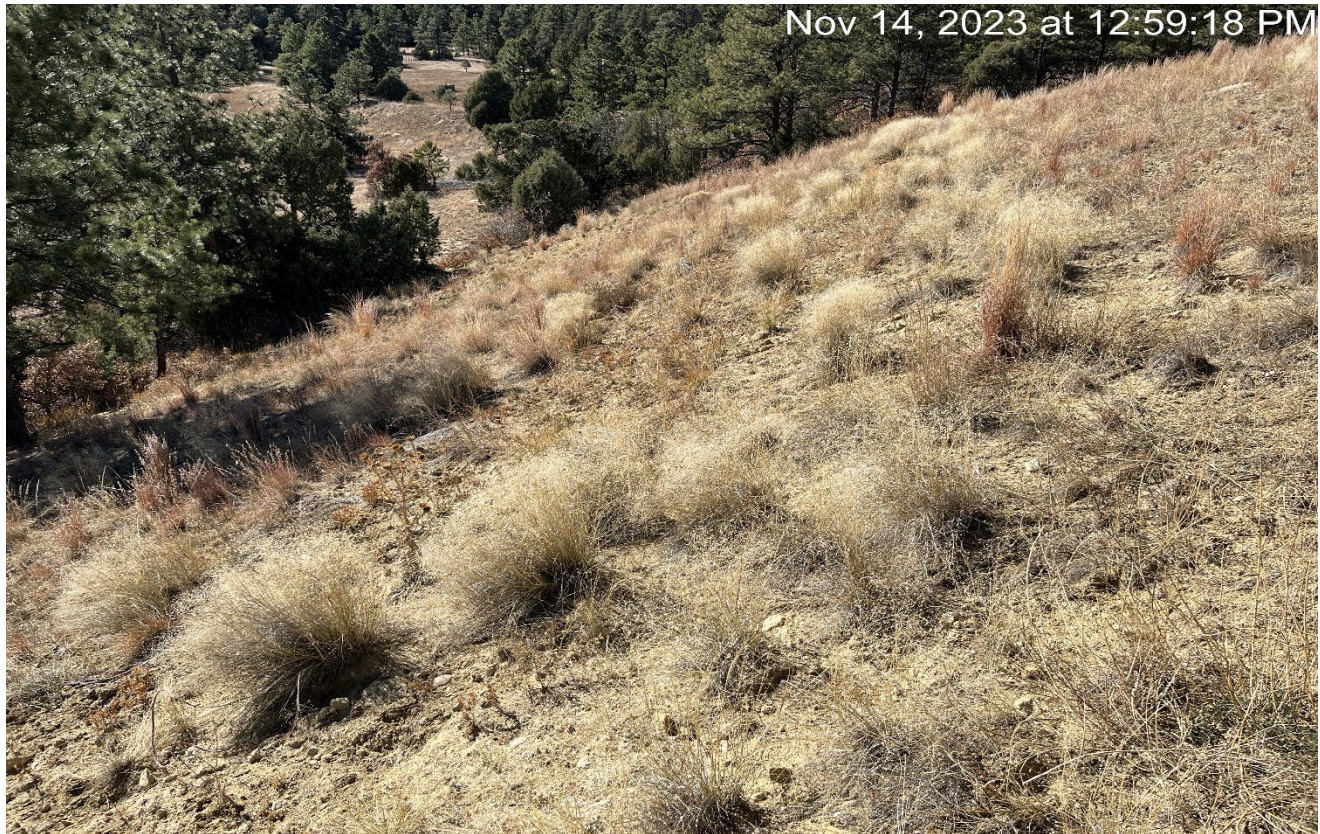
**Photo 5.** Facing along the fill slope of the location.

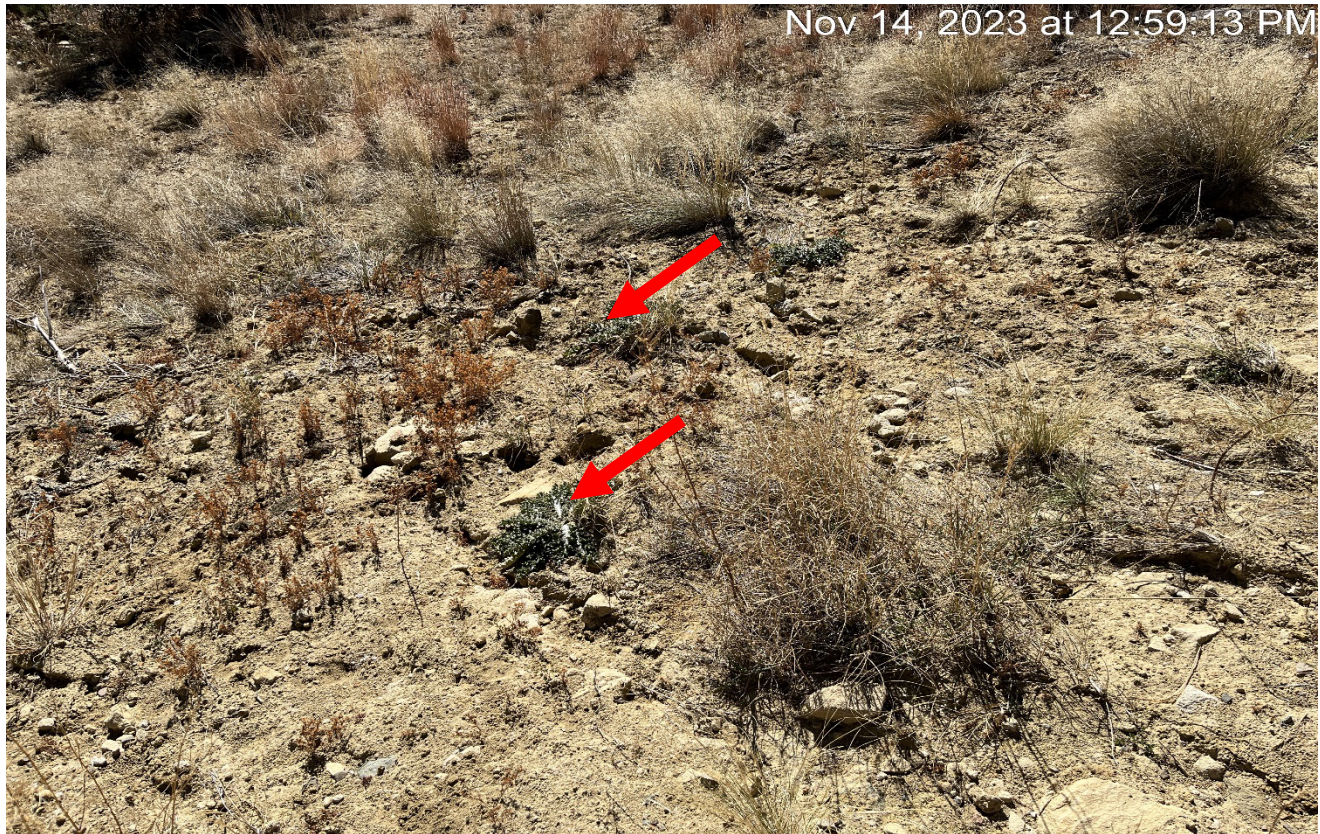
**Photo 6.** There are a few noxious weeds along the fill slope that will need to be controlled. Red arrow points to Musk thistle rosettes.

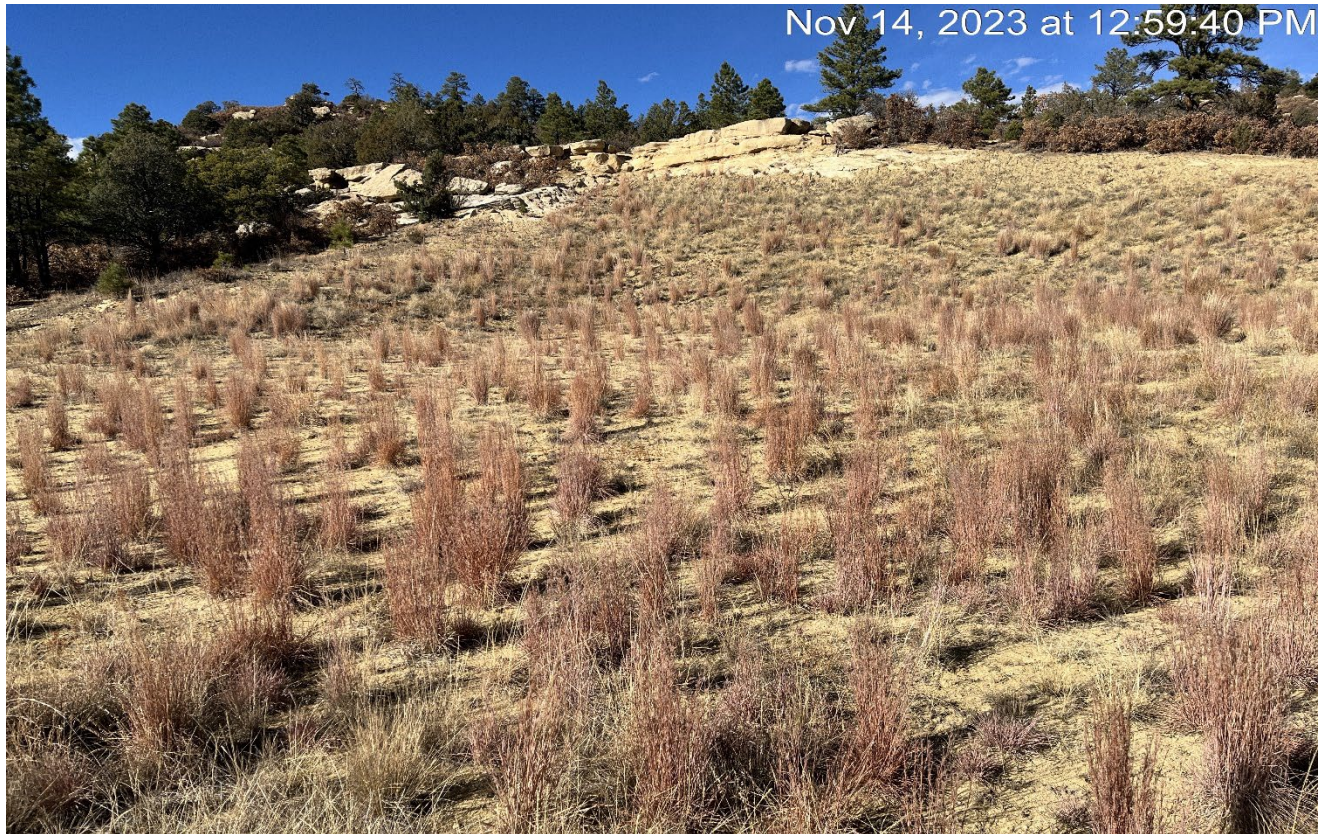
**Photo 7.** Facing northwest toward the cut slope.

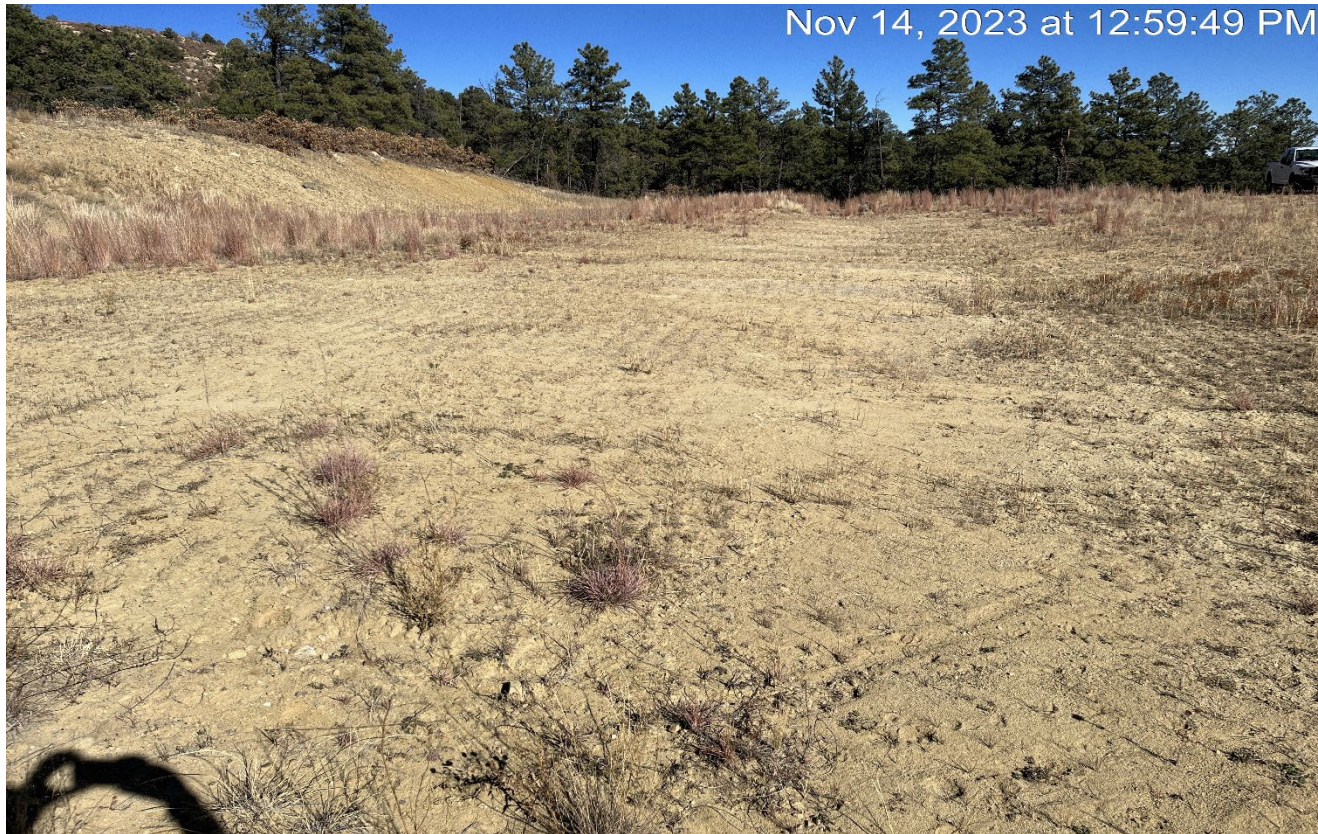
**Photo 8.** Facing northeast at the location. This area appears to have been reseeded but has not yet established vegetation.

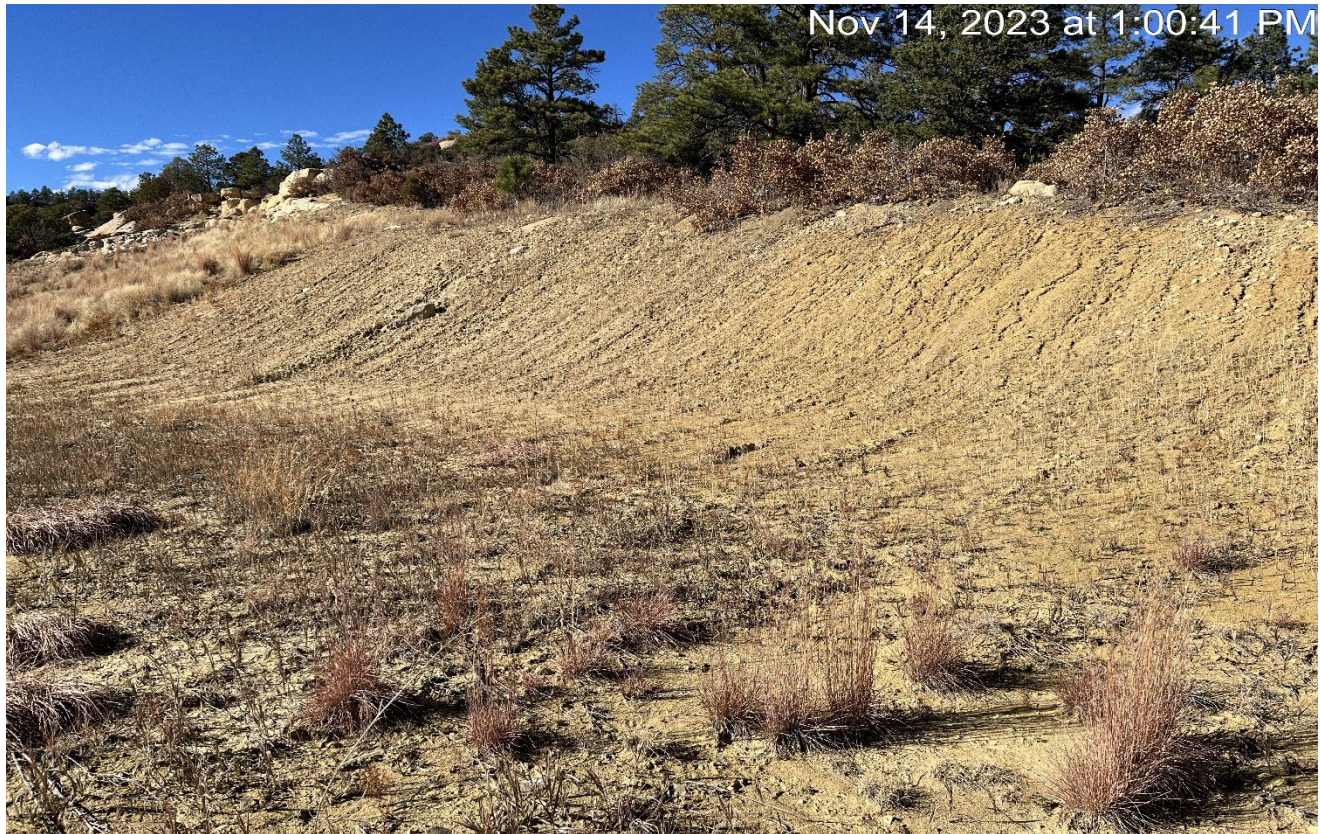
**Photo 9.** Facing northwest at the east cut slope. There is erosion along this area of the cut slope which is not yet stabilized.
