Interim Reclamation and Stormwater Inspection

Operator: VERDAD RESOURCES LLC - 10651

Location ID: 423033

Location Name: Wickstrom 5-44-5-60

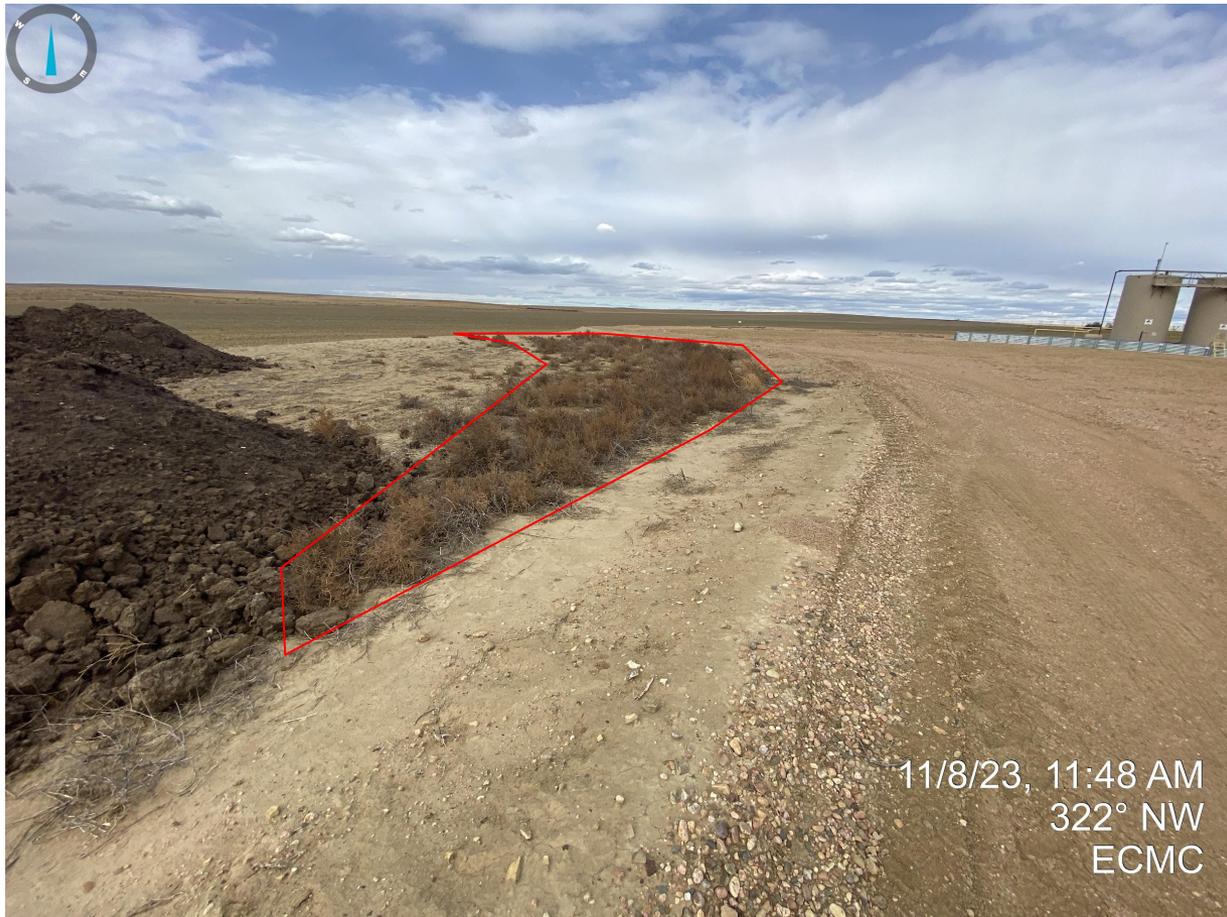
Photo 1. Undesirable vegetation (e.g. russian thistle and kochia) observed on the western portion of the location. The weedy vegetation is now considered debris.

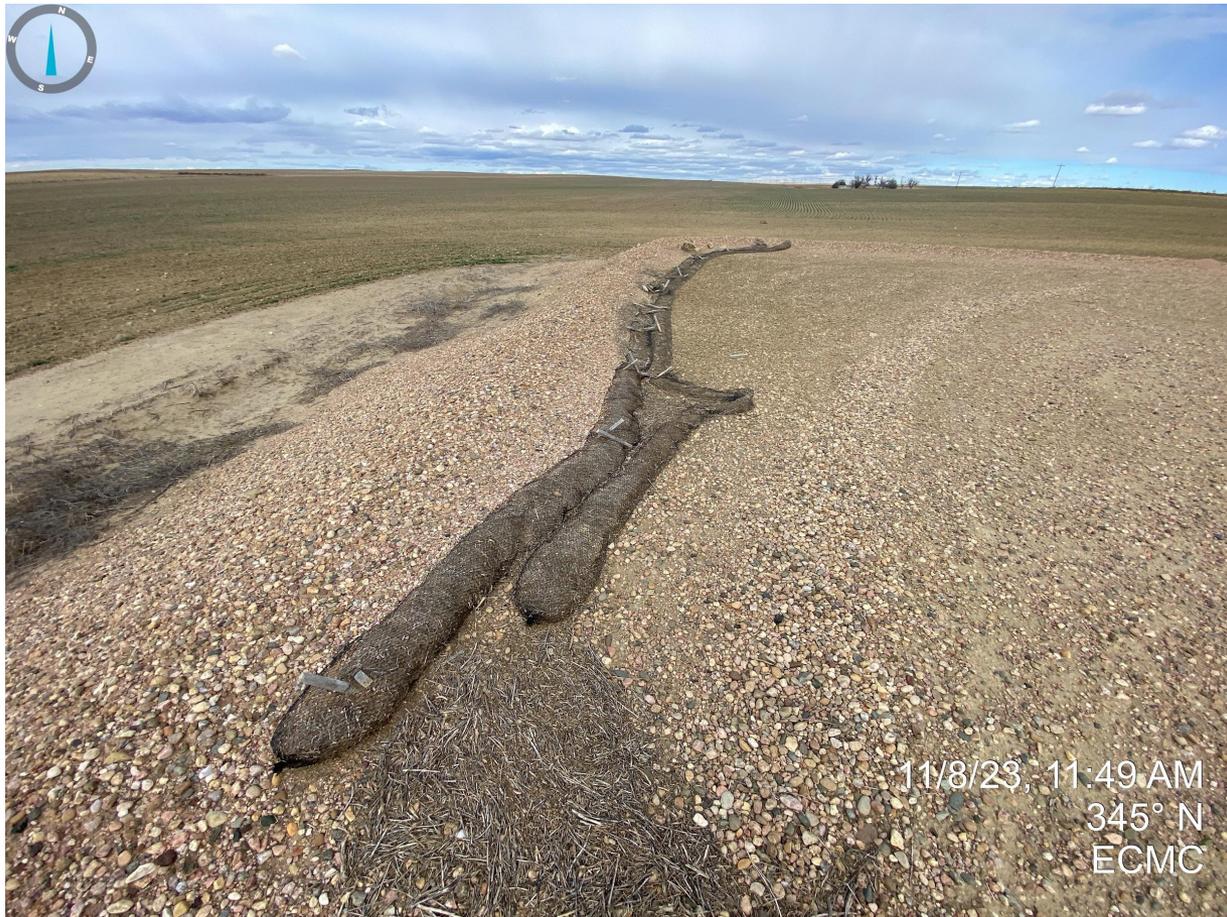
Photo 2. Degraded straw wattles observed on the northwestern portion of the location are now considered debris.

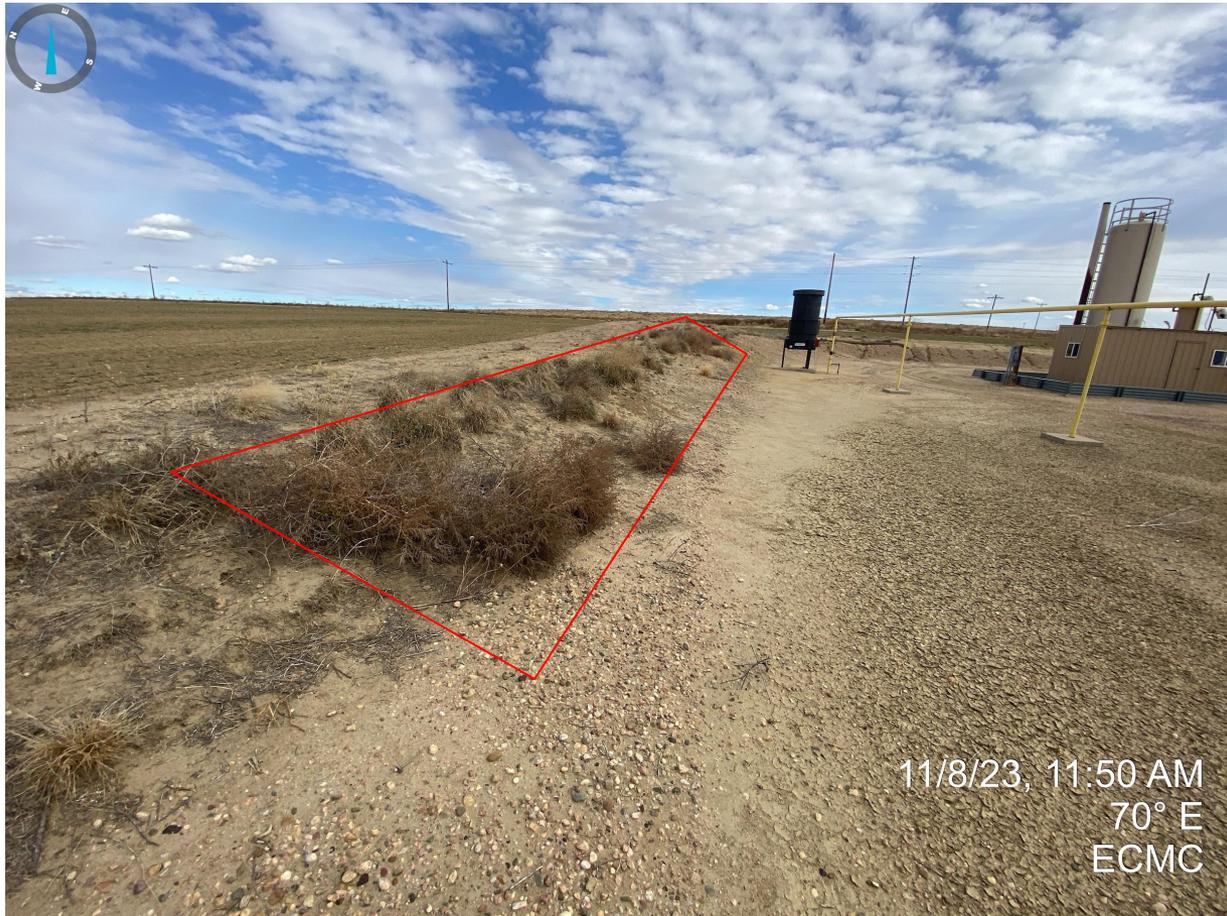
Photo 3. Undesirable vegetation (e.g. russian thistle and kochia) observed on the northern portion of the location. The weedy vegetation is now considered debris.

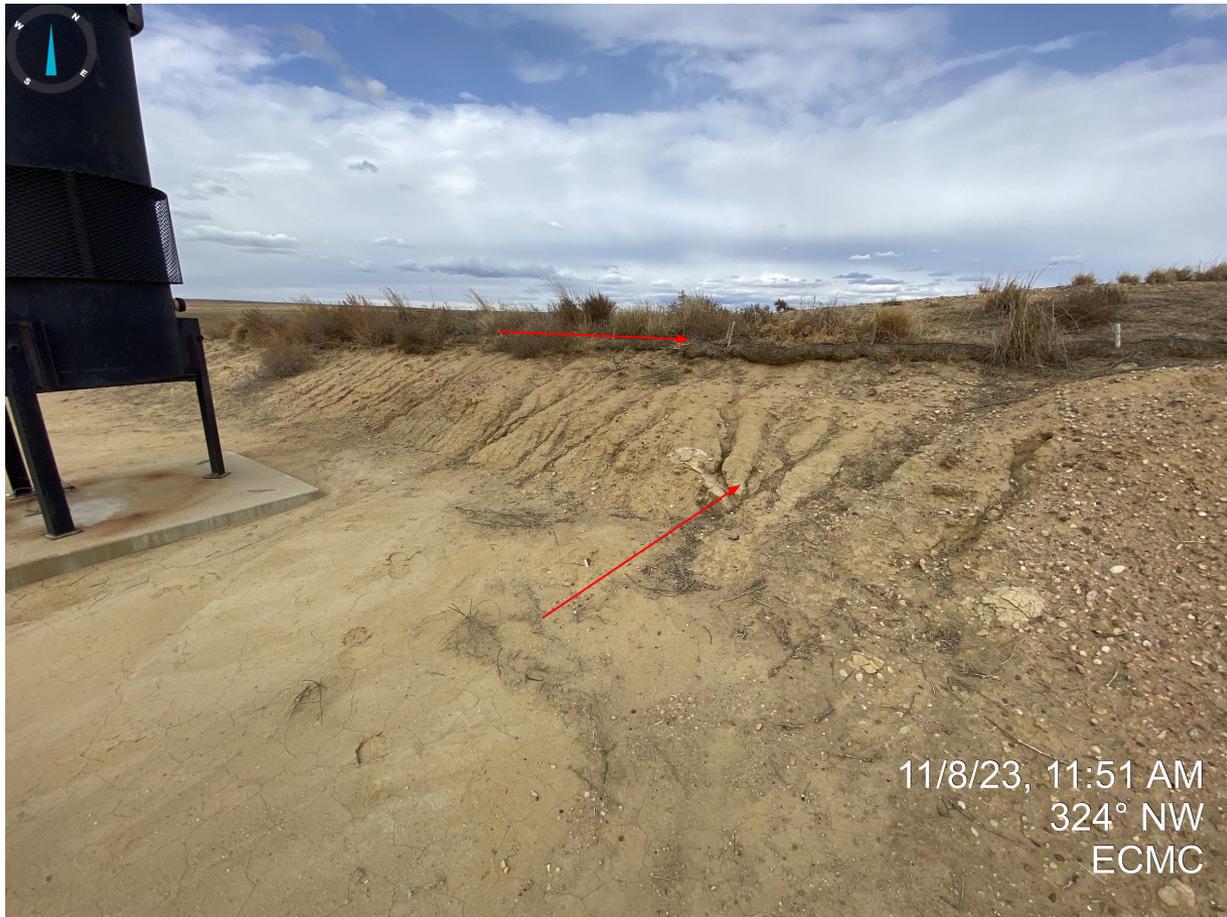
Photo 4. Production areas are not stabilized with evidence of erosion degradation (e.g. rilling) and inadequate stormwater controls measures (straw wattles) that are beginning to degrade.

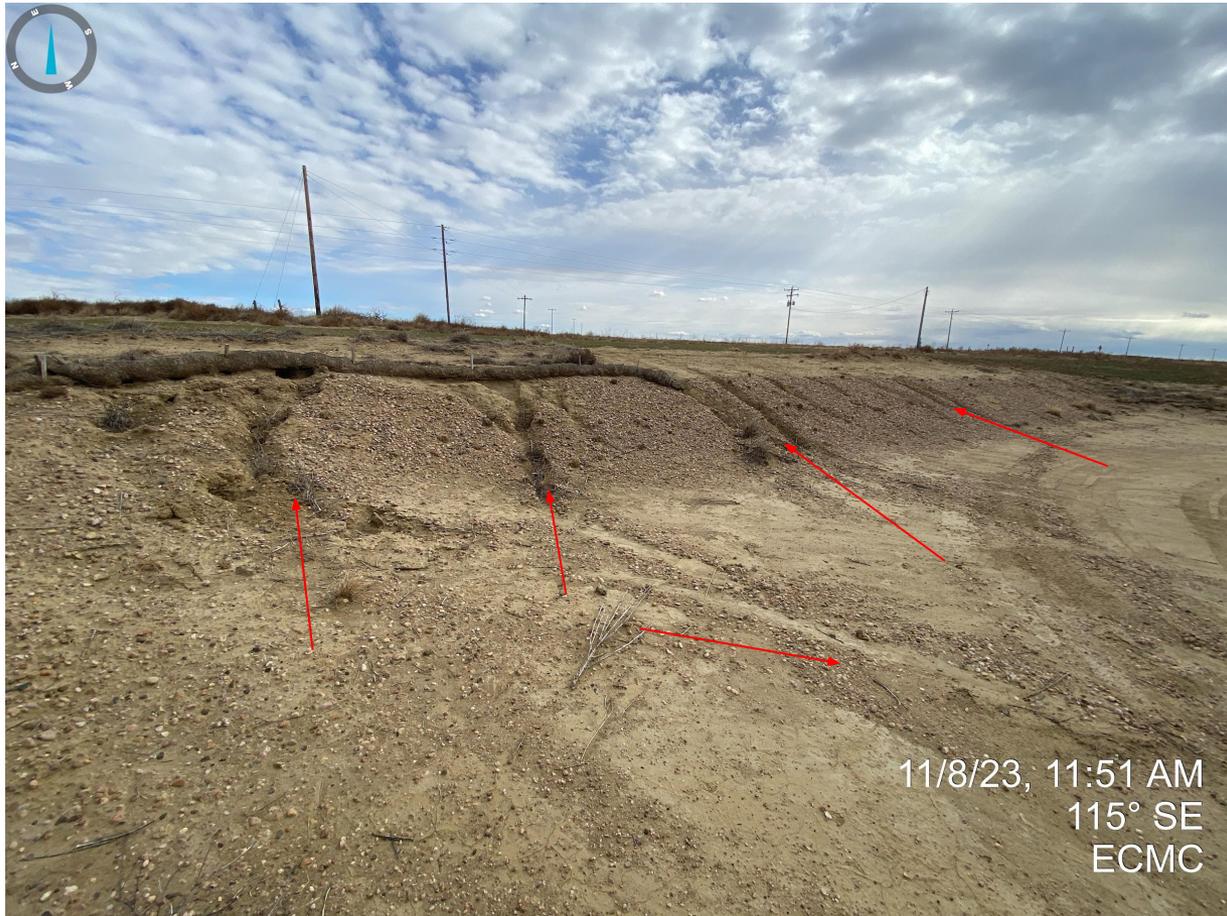
Photo 5. Northeast corner of the location; see comments in Photo 4.

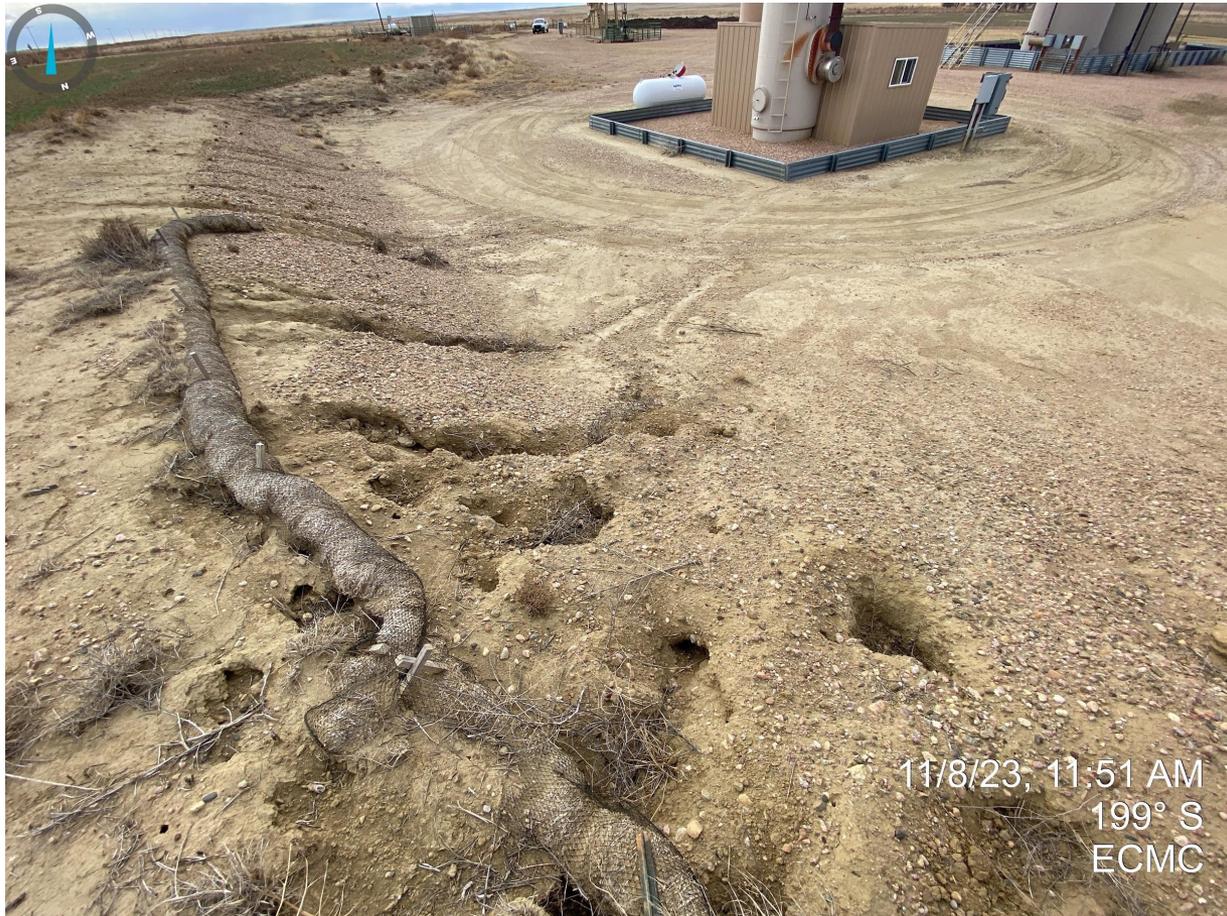
Photo 6. Continued from Photo 5.

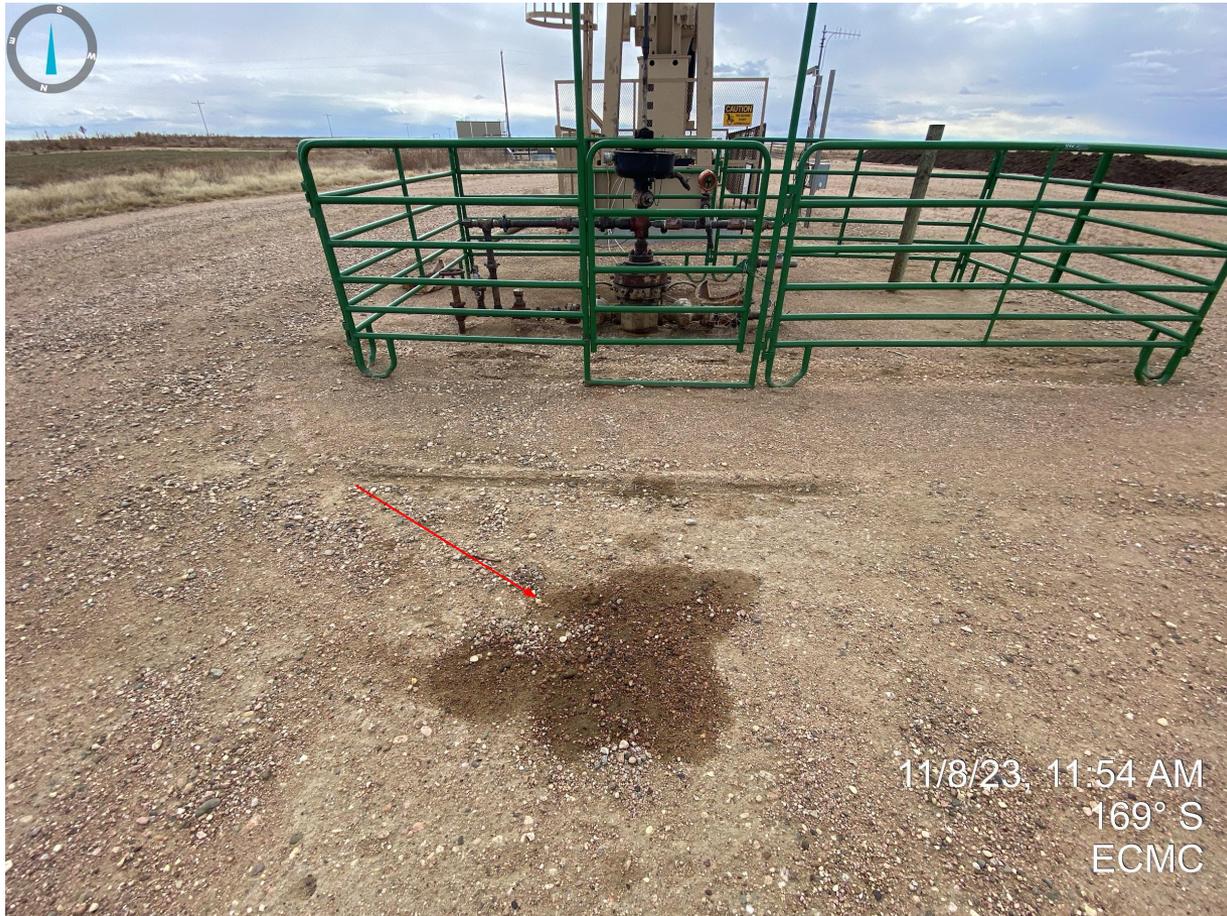
Photo 7. Stained soil near wellhead.

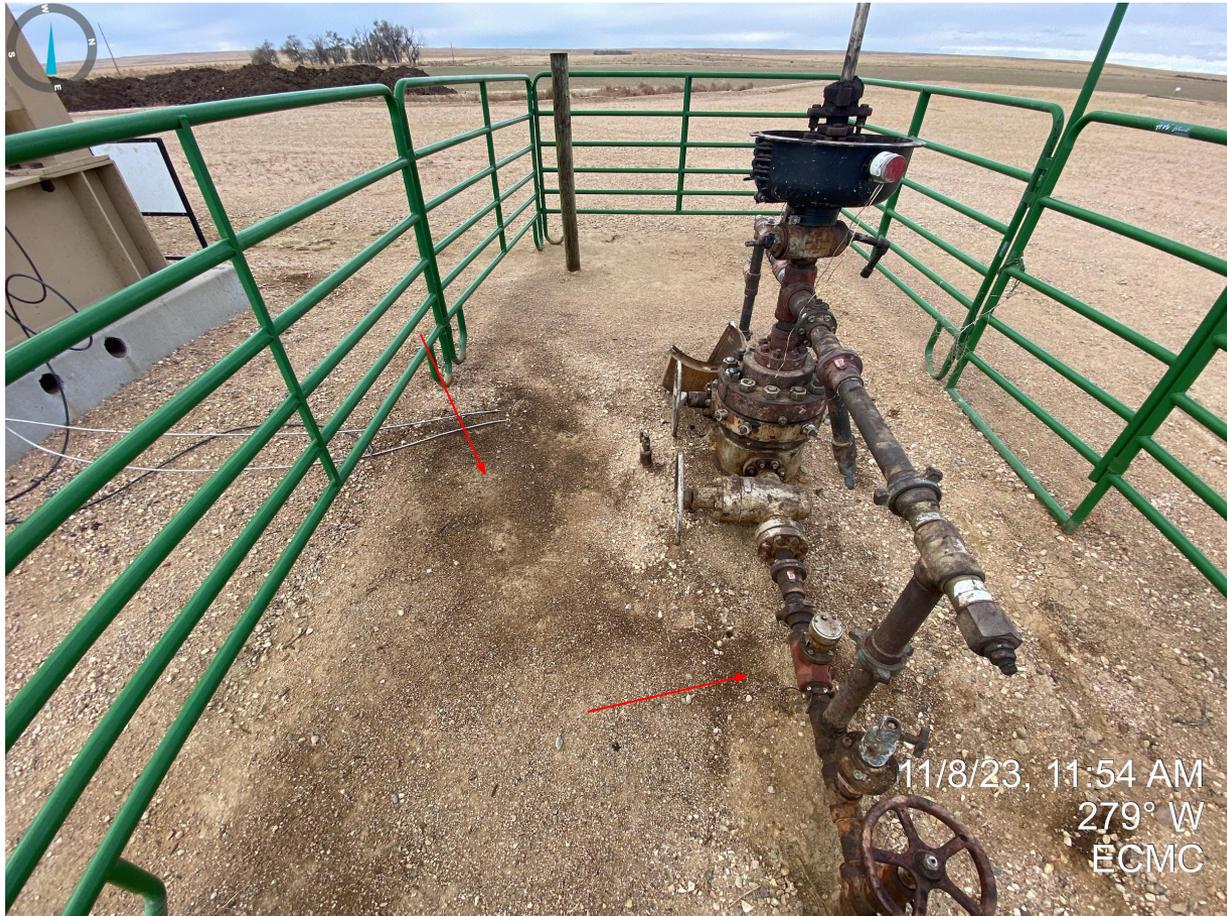
Photo 8. Stained soil at wellhead.
