Storm Water Management and Erosion control

Location Name: MUSTANG RESOURCES LLC JUHAN RULISON UNIT 34-94-6S-94W Pad

Location ID: 322325

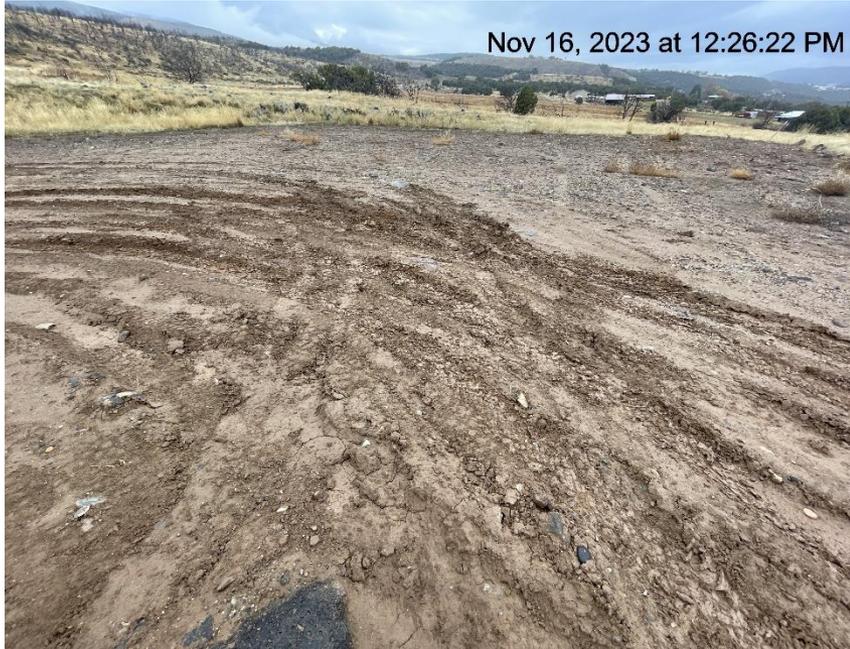
Photo # 6928 Lack of stabilization/compaction/insufficient BMP's

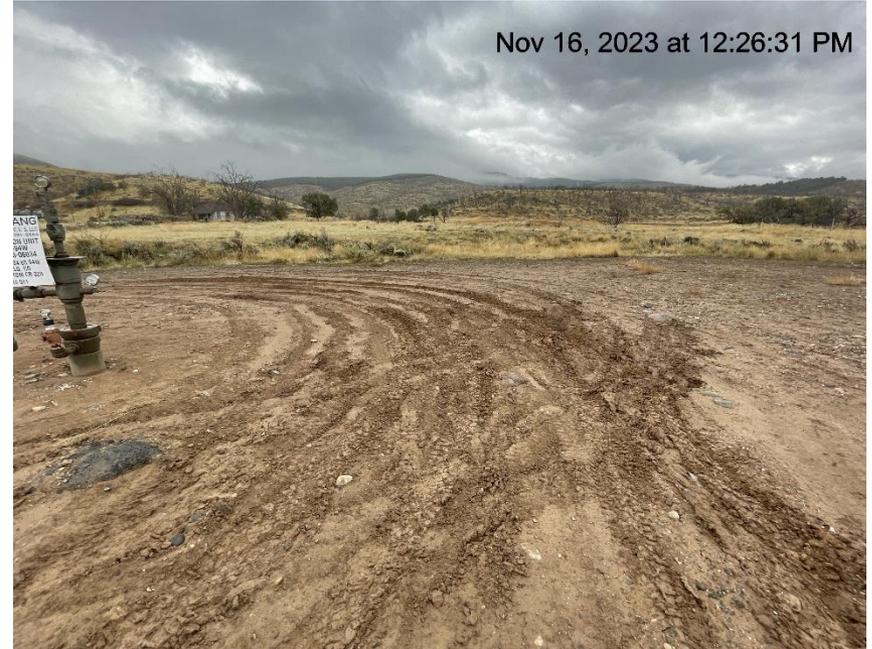
Photo # 6929 Lack of stabilization/compaction/insufficient BMP's

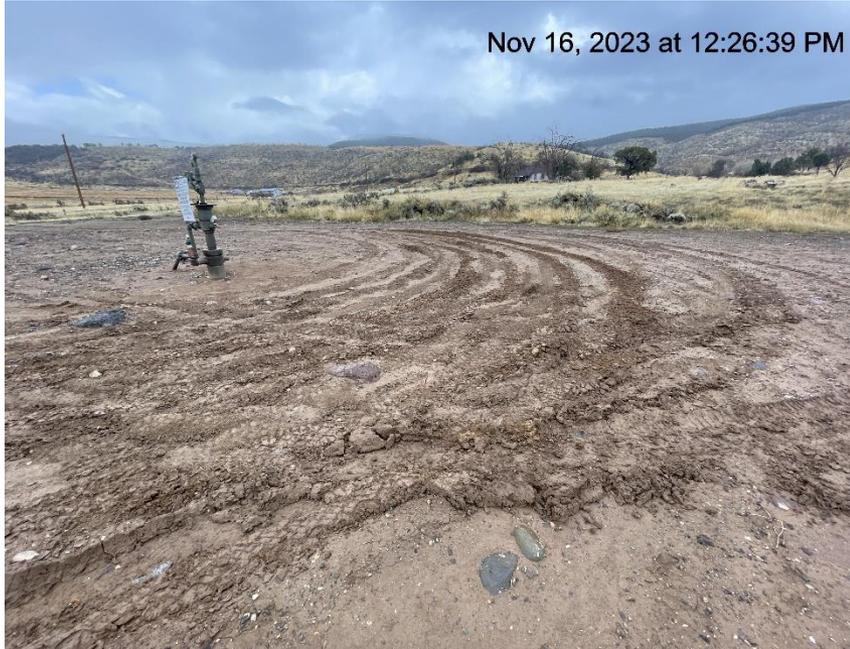
Photo # 6930 Lack of stabilization/compaction/insufficient BMP's

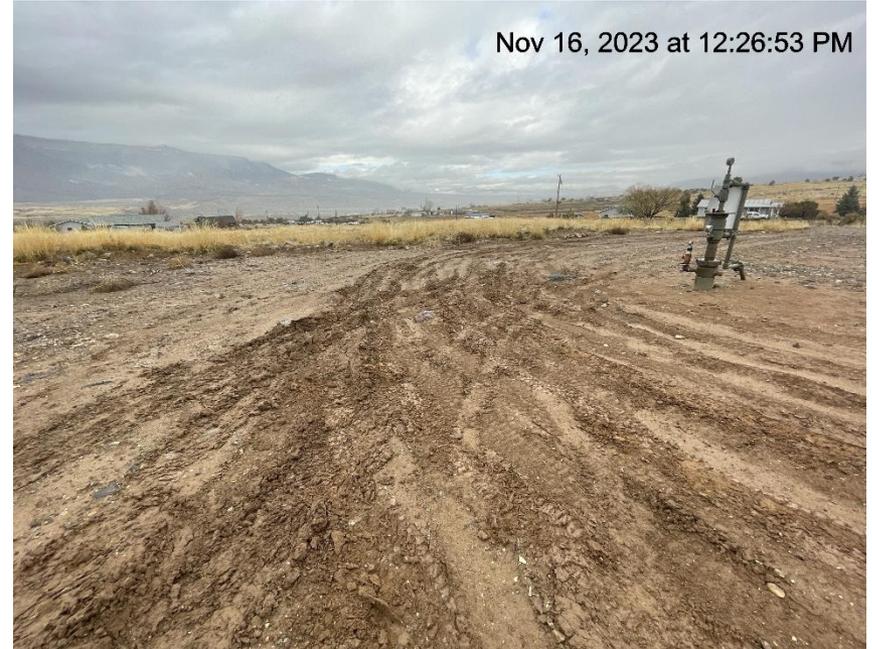
Photo # 6931 Lack of stabilization/compaction/insufficient BMP's

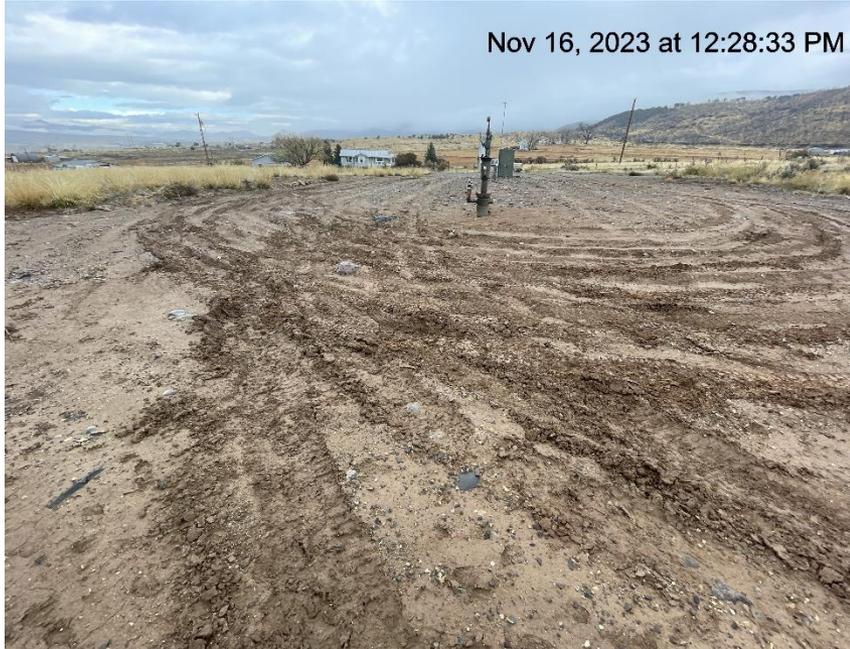
Photo # 6932 Lack of stabilization/compaction/insufficient BMP's

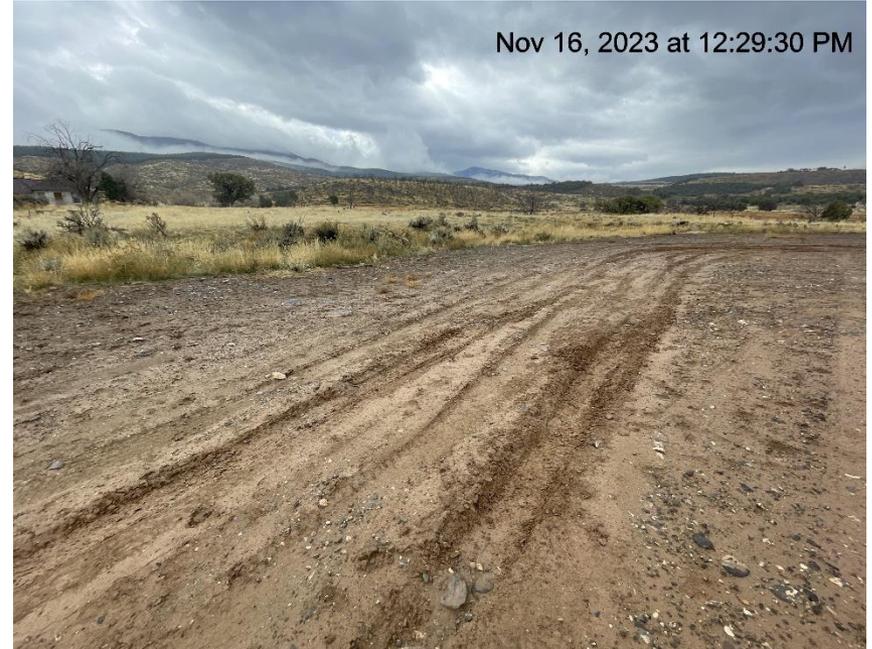
Photo # 6933 Lack of stabilization/compaction/insufficient BMP's
