Inspection Photos

Location Name: VISION ENERGY LLC, SOUTH SHALE RIDGE-68S98W/13NWNW

Location ID: 312601

Date: 11/15/2023

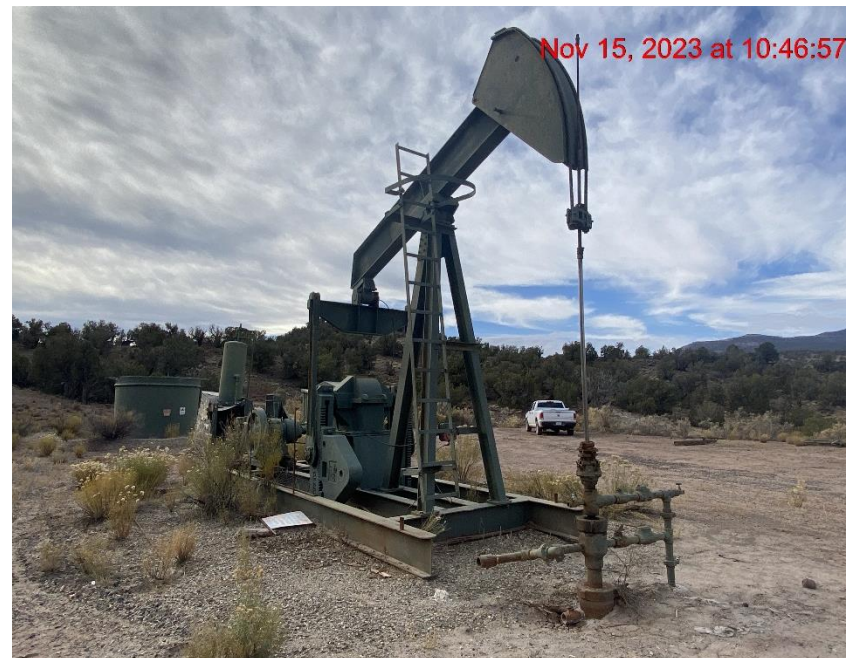
Wellhead/Weeds/Inaccurate Sign – Photo #07548

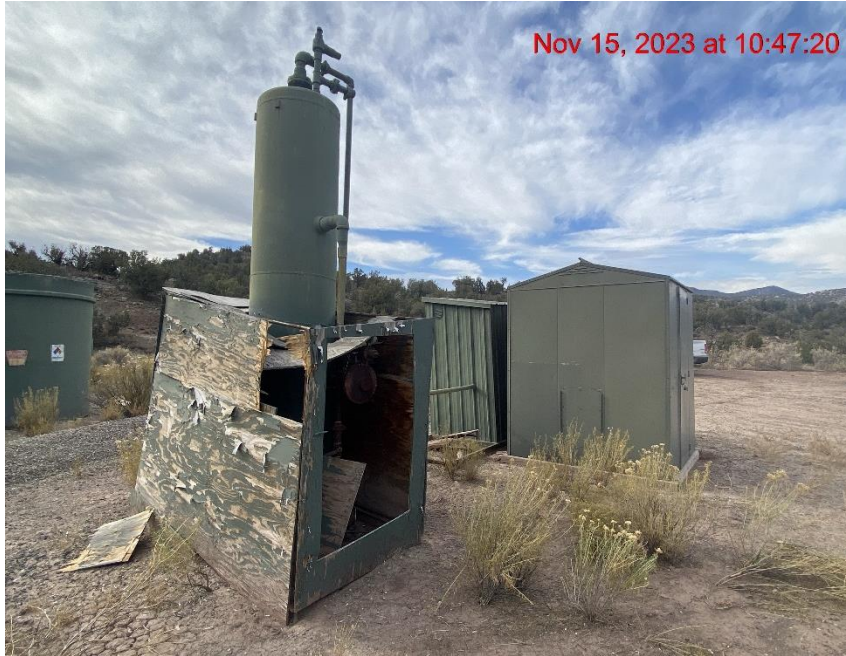
Separator/Gas Meter/Wildlife Entry Hazard/Weeds – Photo #07549

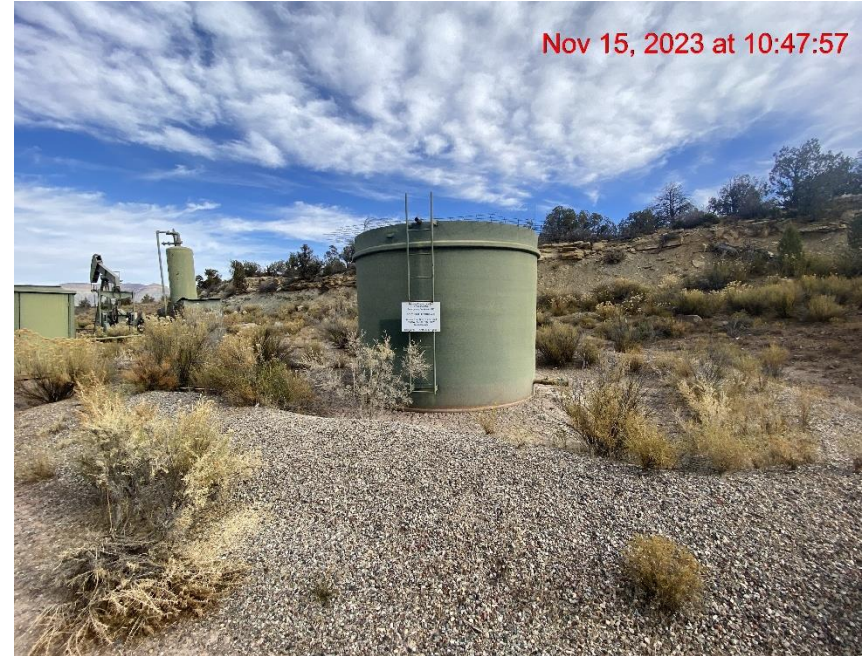
Tank Battery/Weeds – Photo #07553

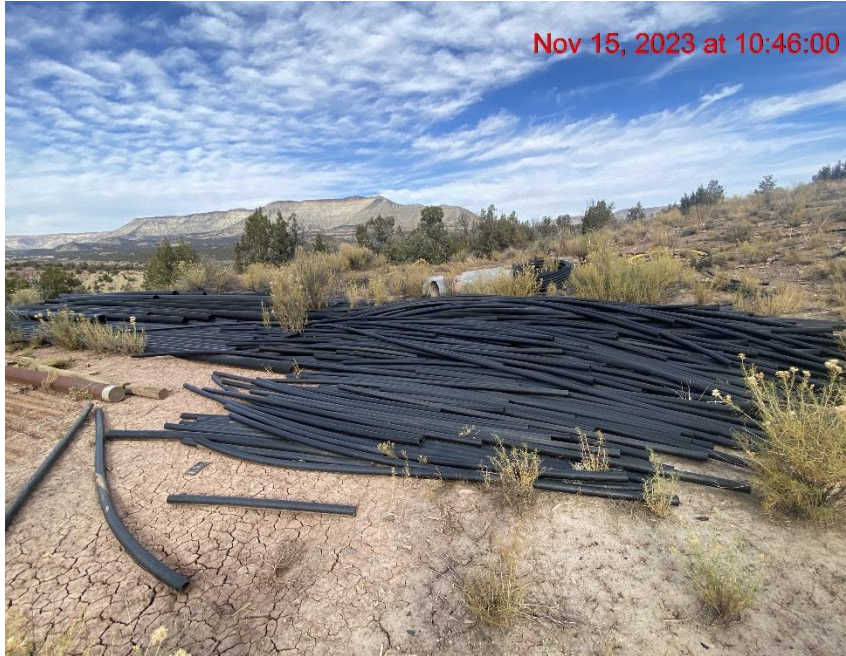
Storage of Unused Equipment – Photo #07543

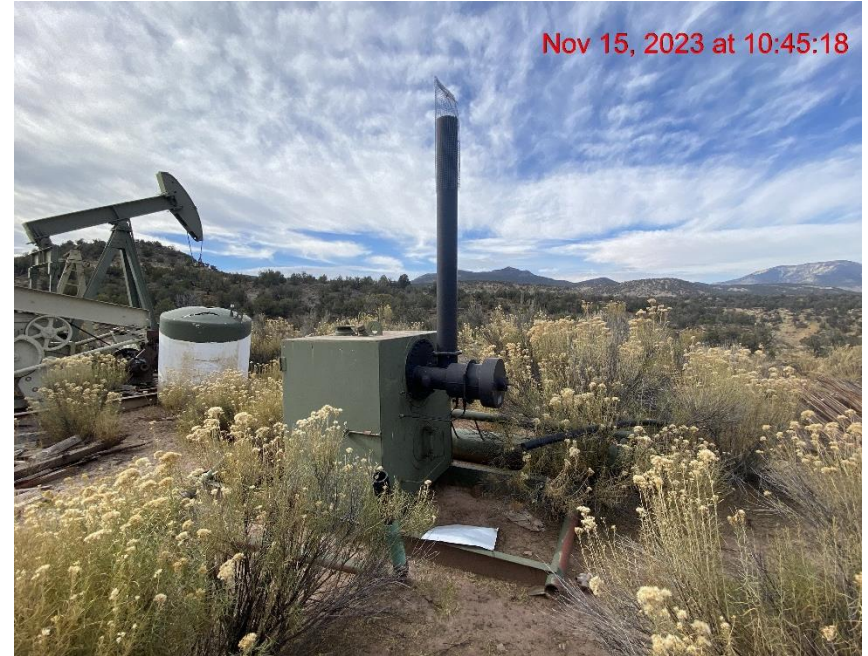
Storage of Unused Equipment/Weeds – Photo #07541

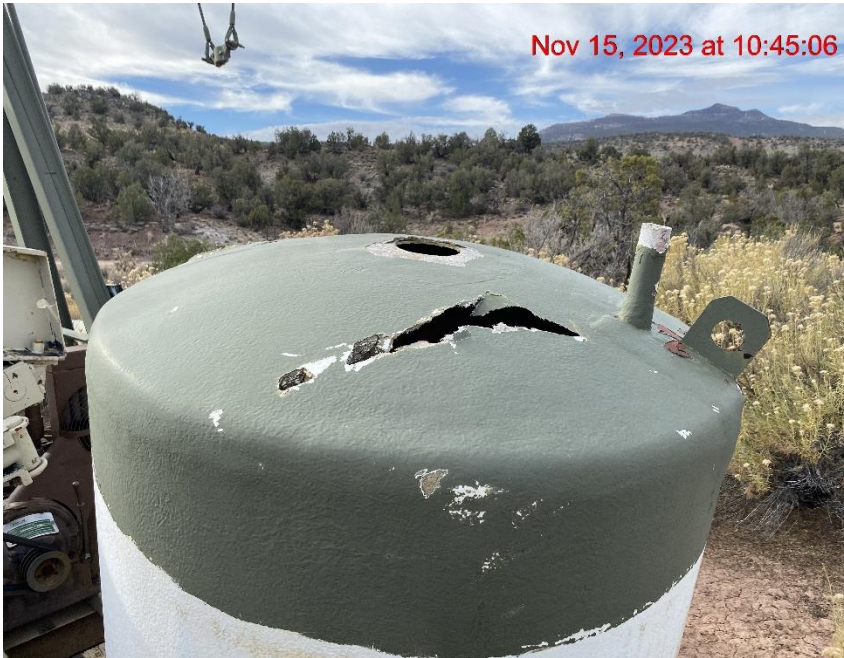
Storage of Unused Equipment/Wildlife Entry Hazard – Photo #07540

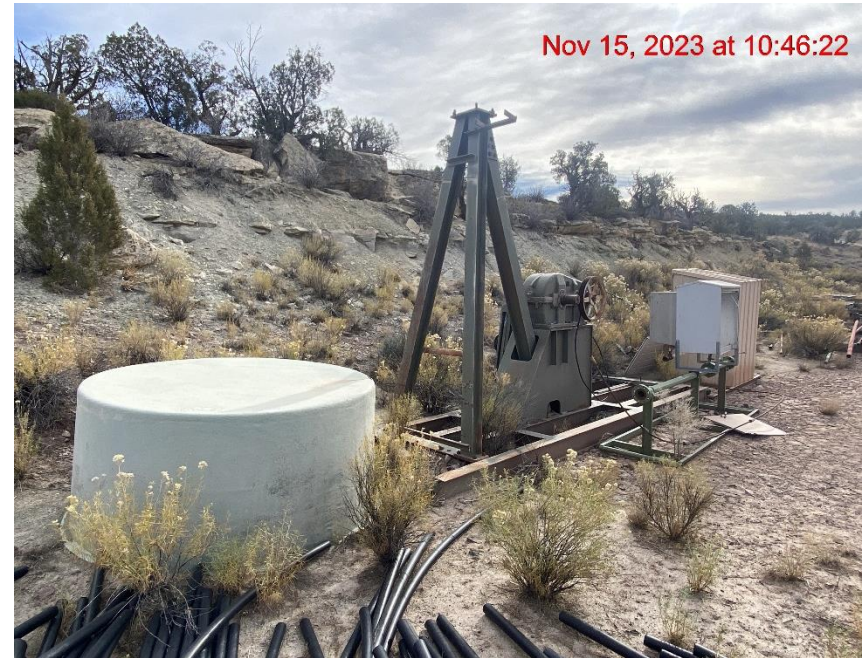
Storage of Unused Equipment/Weeds – Photo #07545

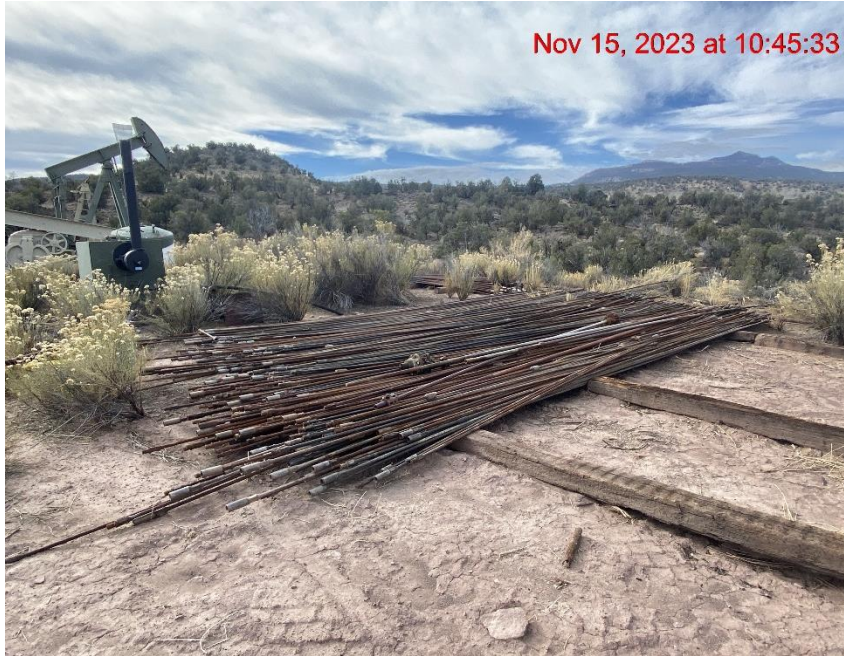
Storage of Unused Equipment/Weeds – Photo #07542

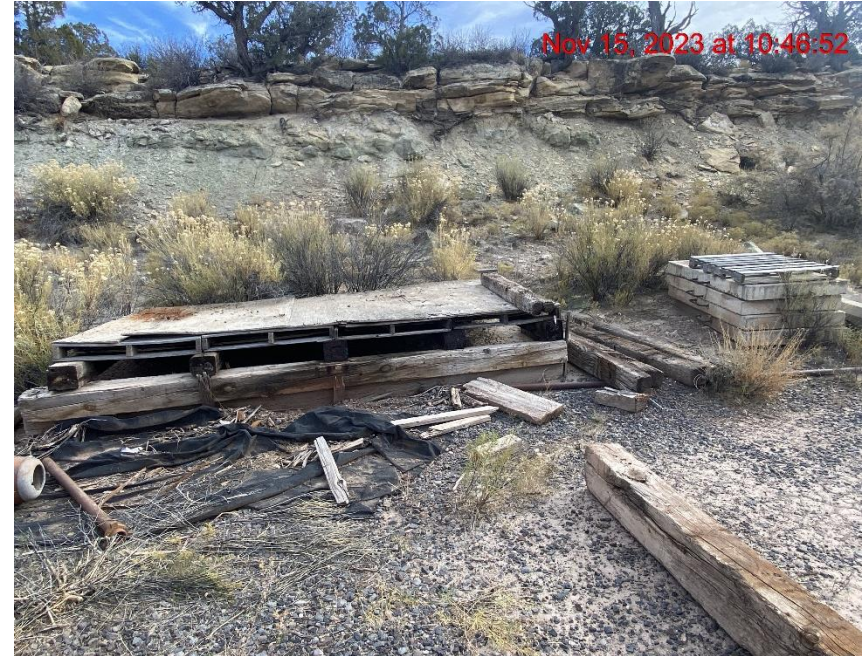
Debris/Weeds – Photo #07547

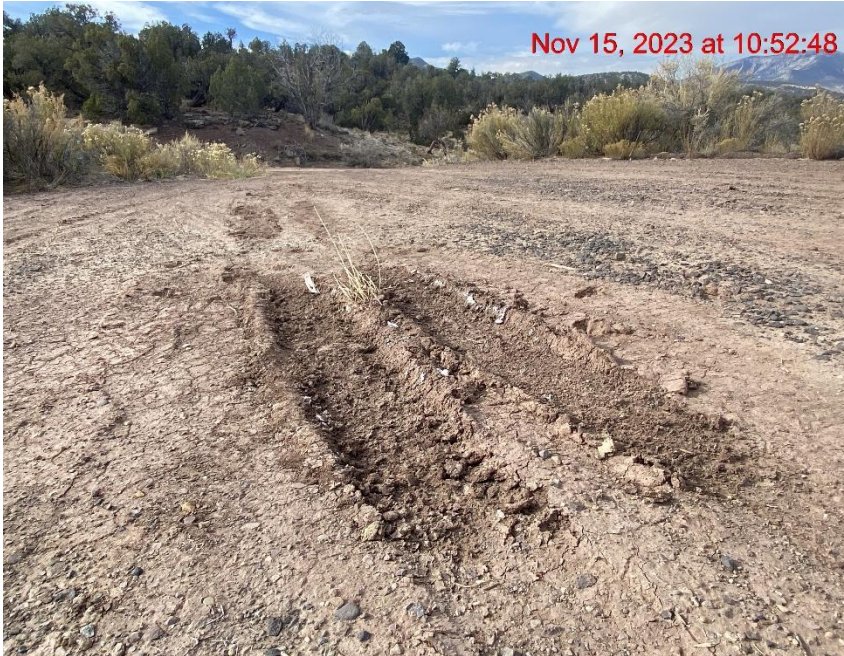
Location Lacks Stabilization – Photo #07557

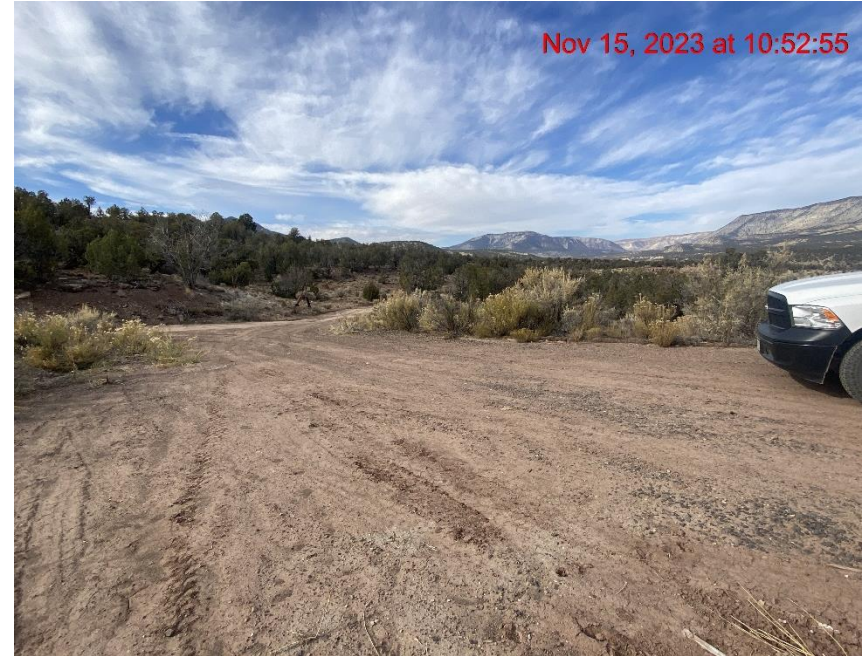
**Insufficient Vehicle Tracking BMPs at Location
Entrance/Exit – Photo #07558**

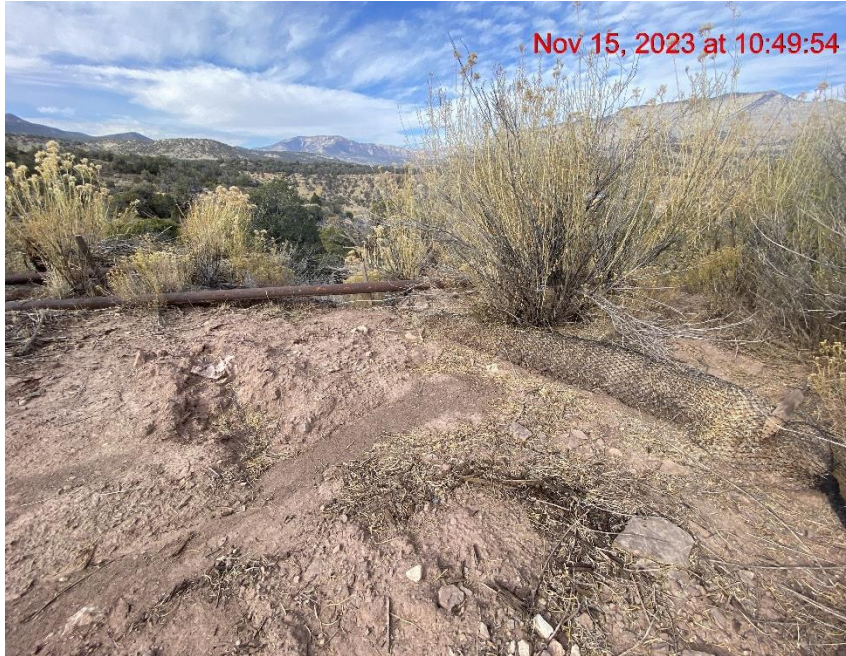
Waddle BMP Degradation— Photo #07554

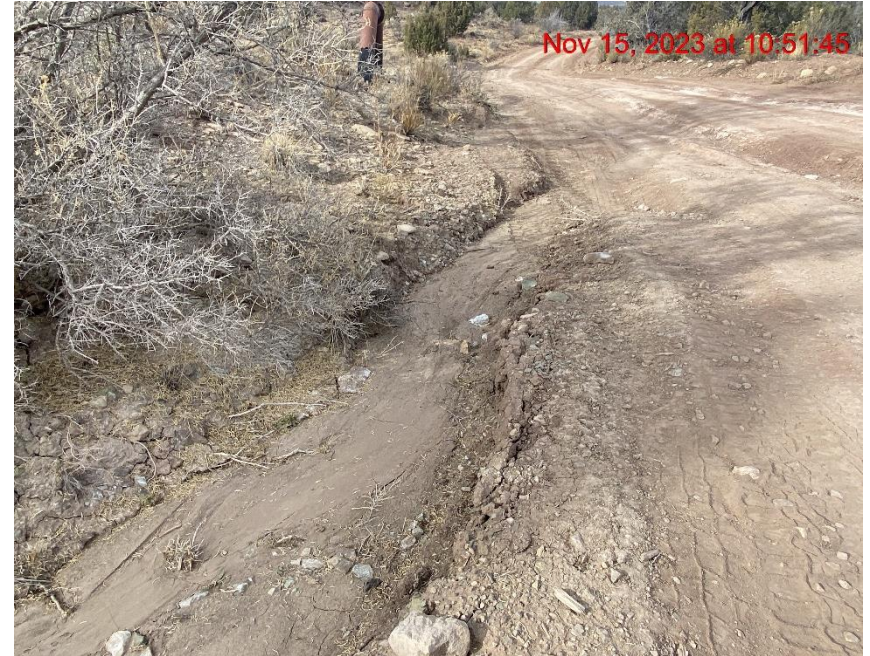
Lease Road Ditch Full of Sediment Running Onto Road – Photo #07556
