Inspection Photos

11/14/2023

Operator: CAERUS PICEANCE LLC #10456

Location ID: 483521

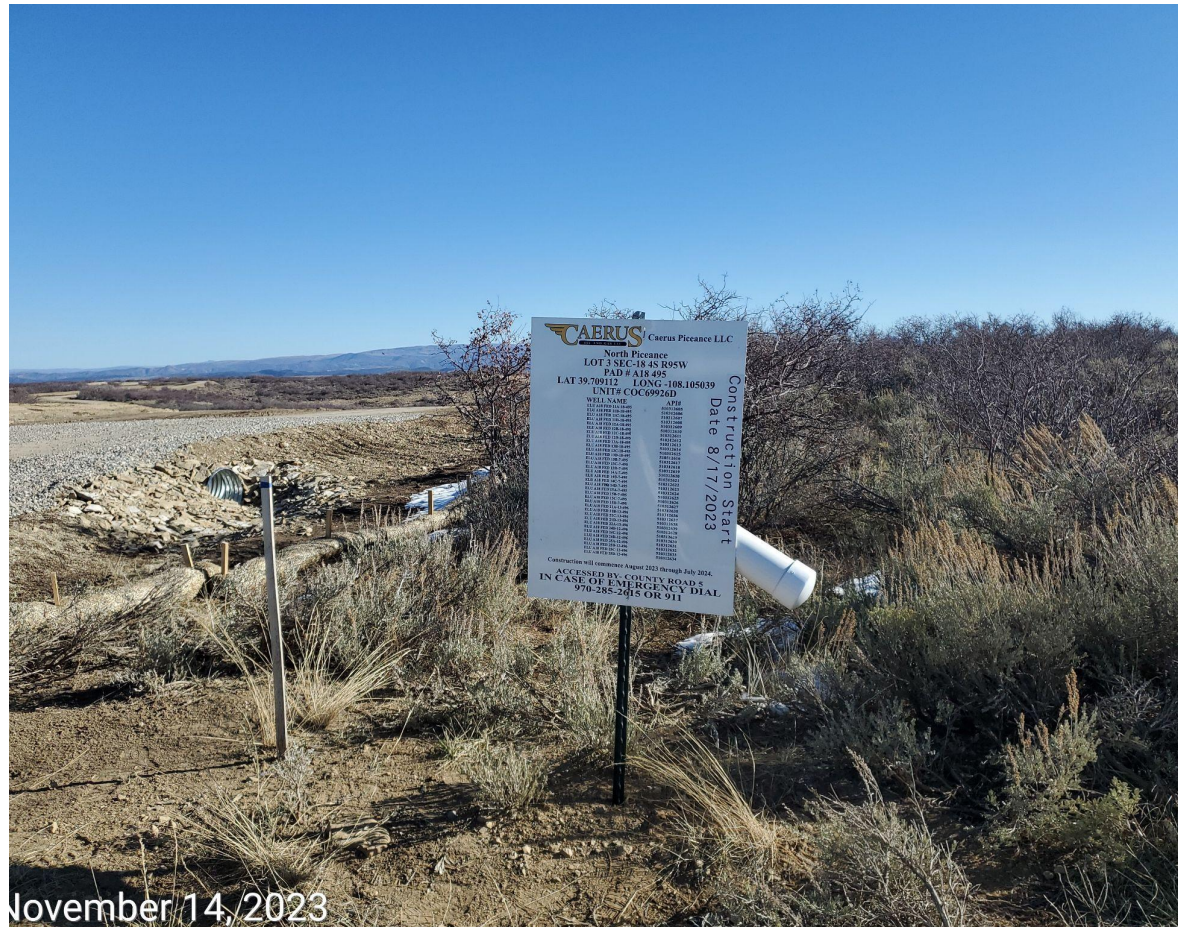
Photo 1: Photo taken from the access road entrance. Location has been constructed; signage will need to be posted at the Location entrance per 605 rules. Location ID not observed.

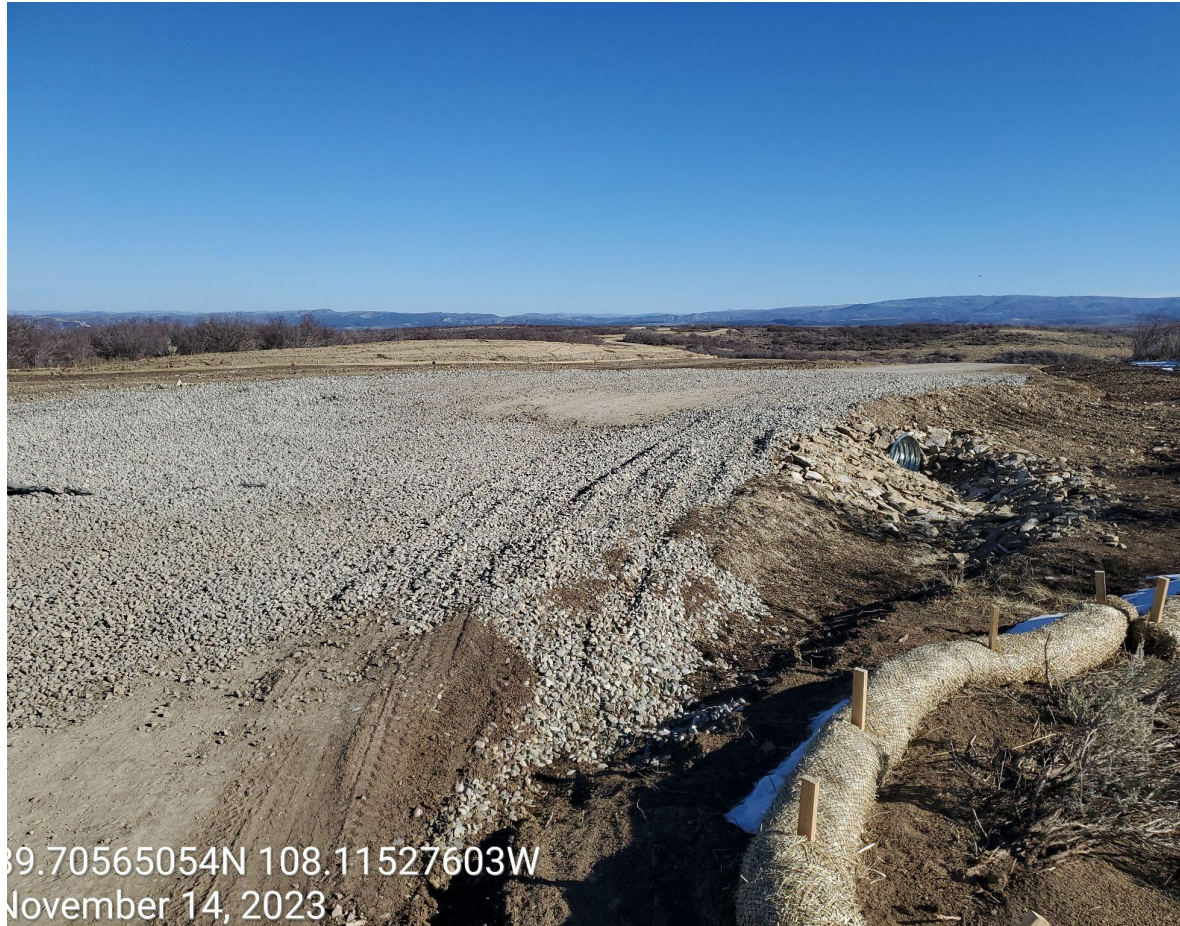
Photo 2: Photo shows the access road entrance from the lease road. Access road entrance has been graveled. Culvert implemented.

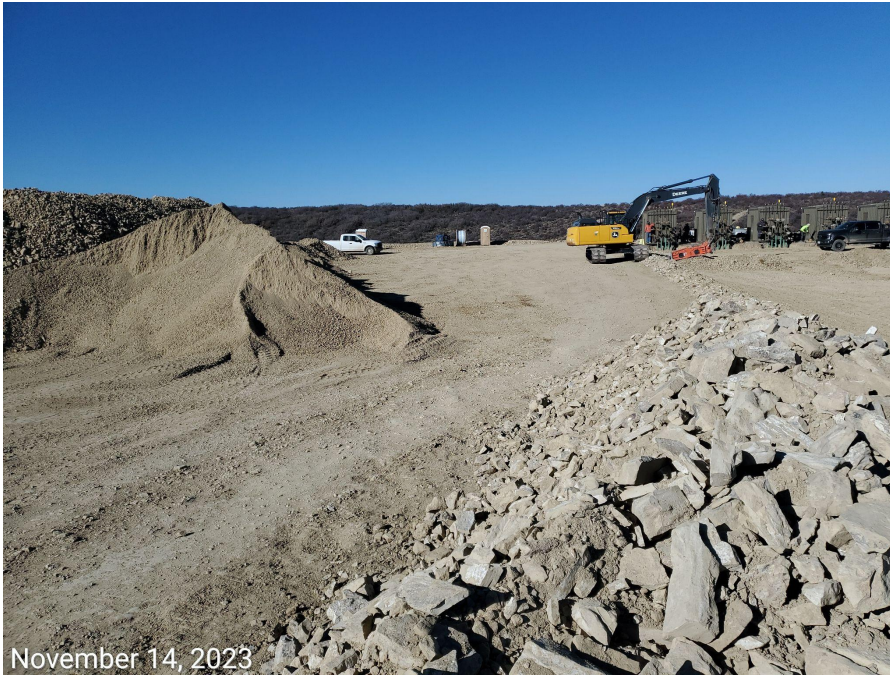
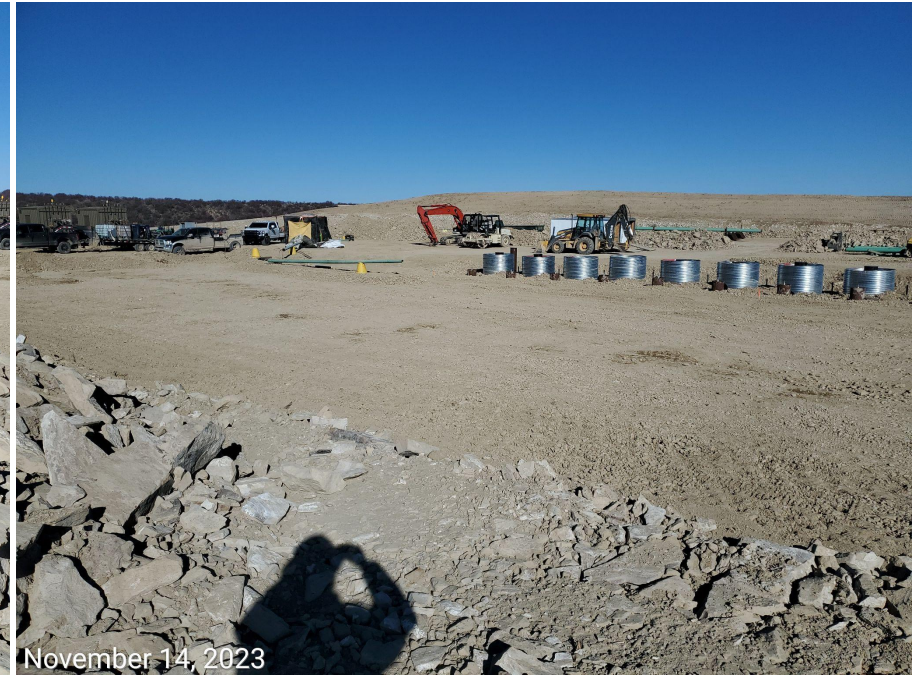
Photo 3: Photos 3-4 taken from the south end of the working pad surface. Photos provide an overview of the pad from west, northwest, northeast to east. Location construction has been completed.

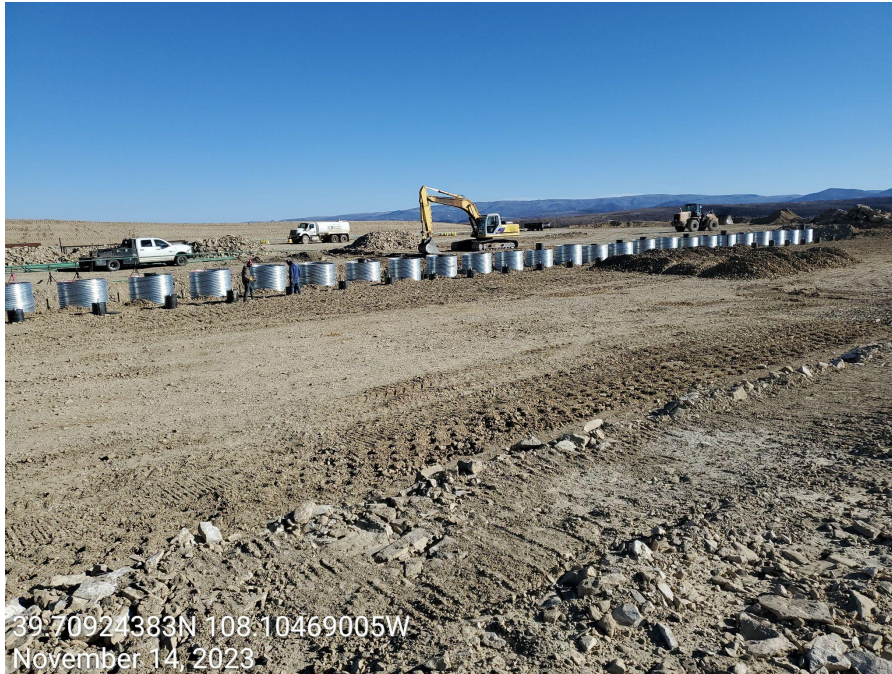
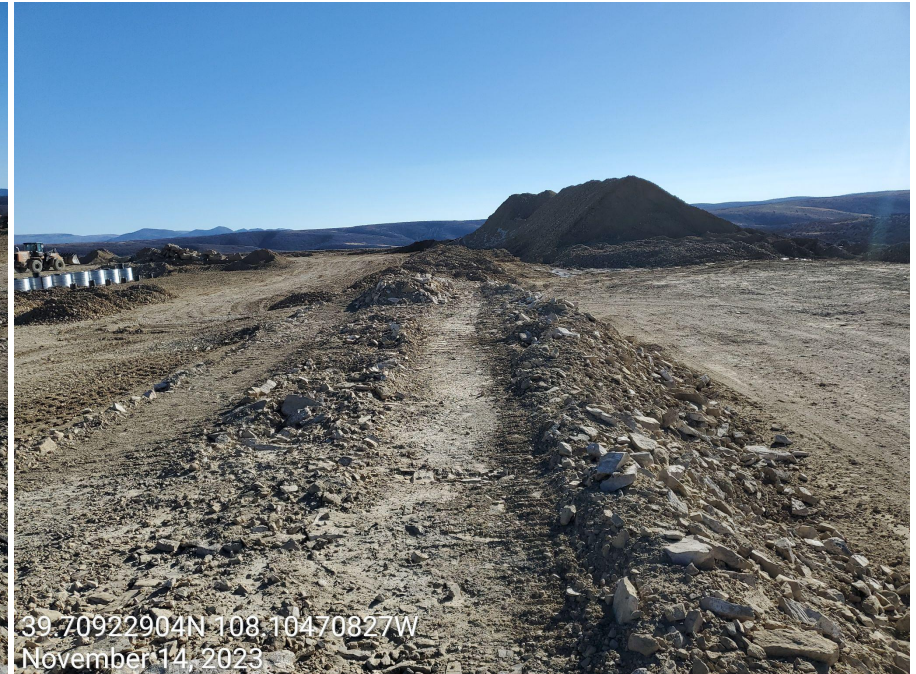
Photo 4: See comments under photo 3.

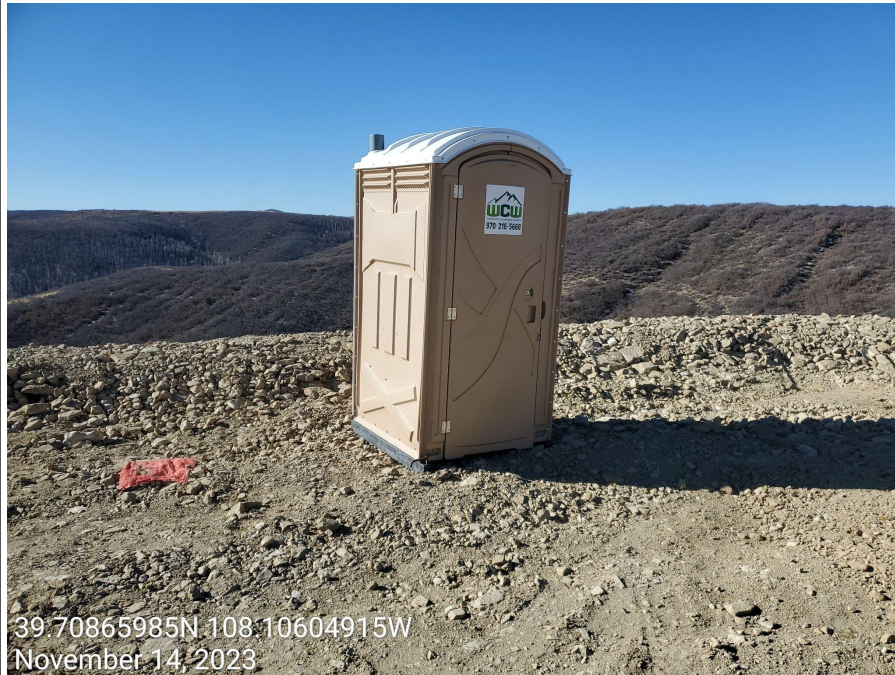
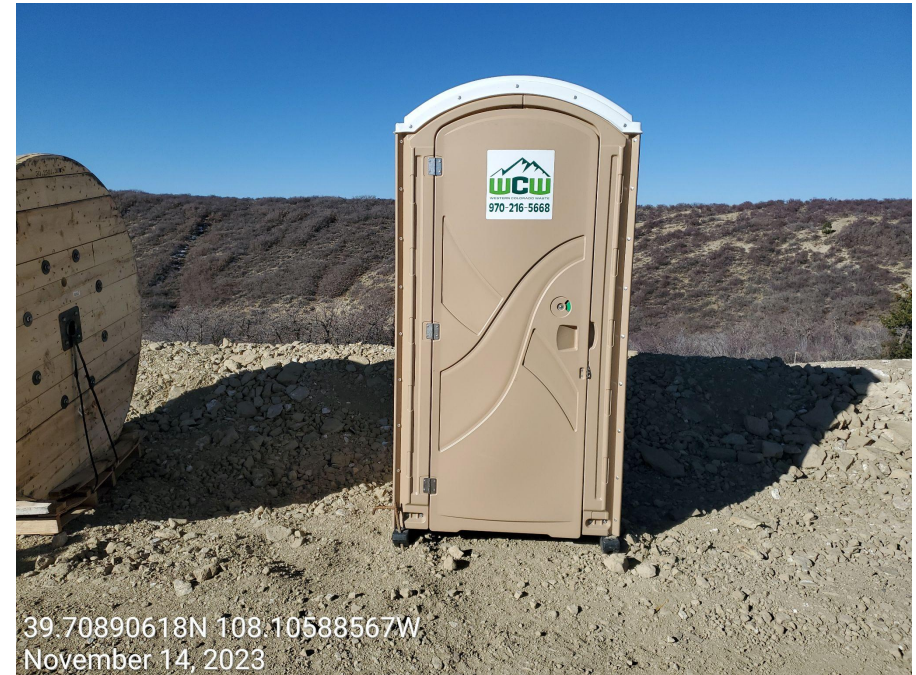
Photo 5: Photos taken from the southwest end of the Location. Photos show porta-johns on Location have been secured.

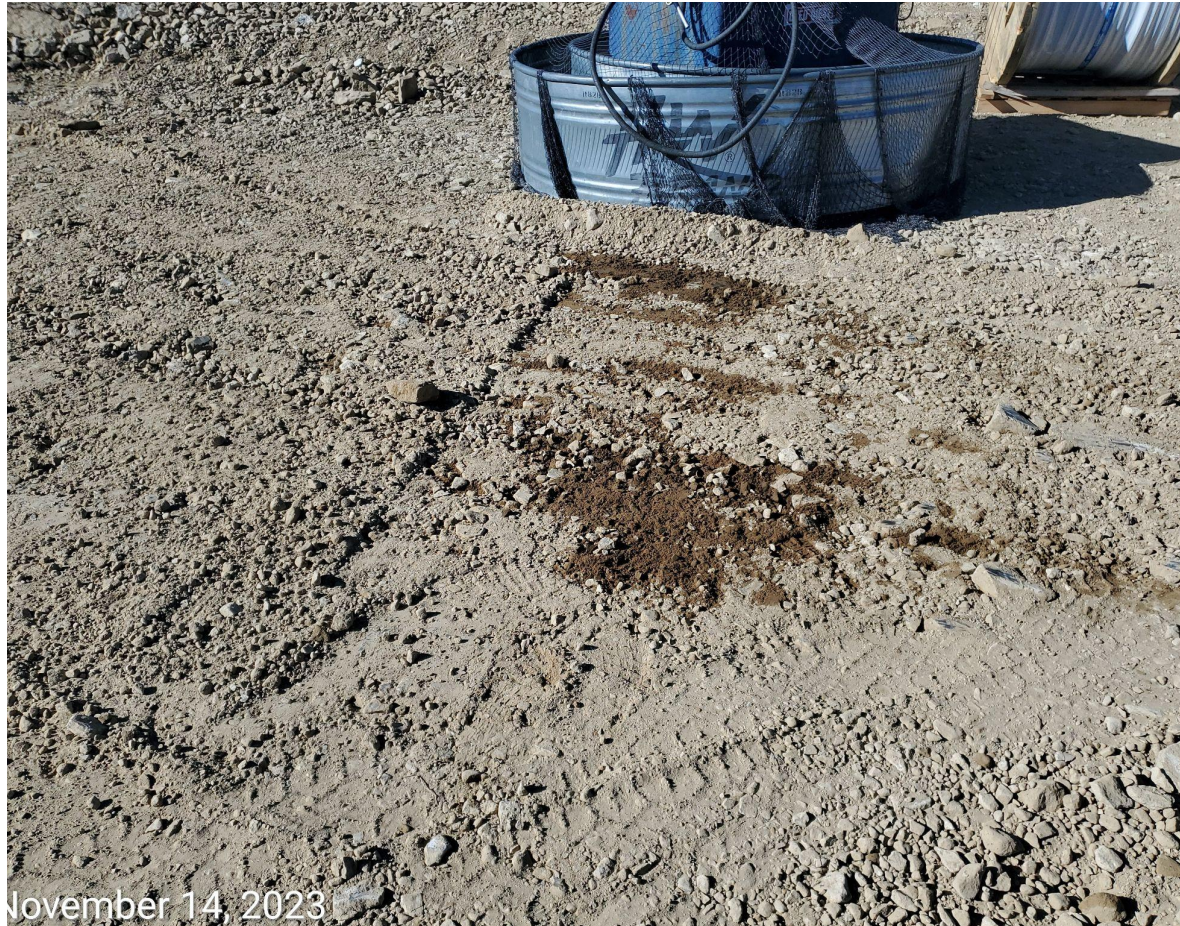
Photo 6: Photo taken from the southwest end of the Location. Photo shows stained soils next to the diesel fuel tank.

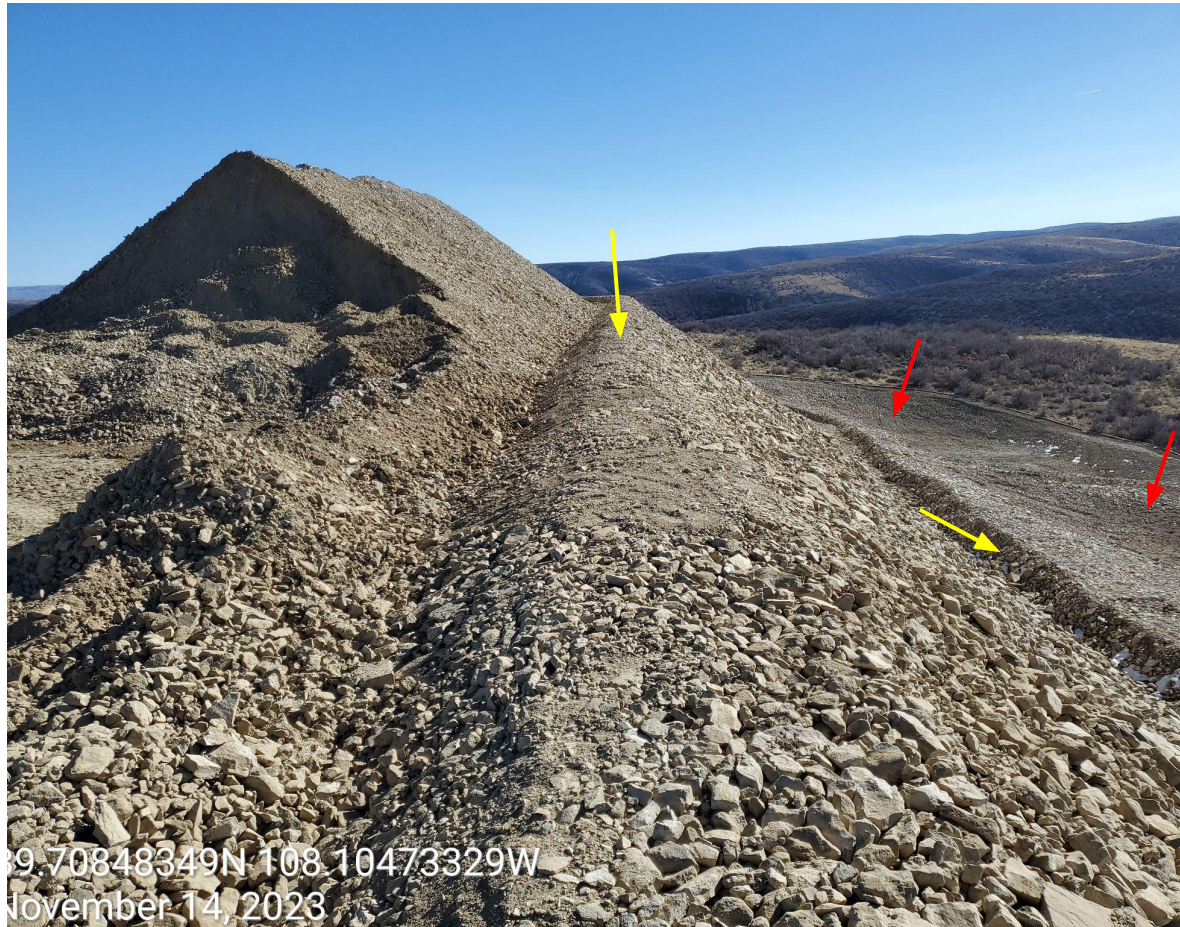
Photo 7: Photo taken from the south end of the working pad surface. Photo shows berm along the perimeter of the pad, and ditch/berm at the toe of the slopes. It is noted that there are no SW BMPs in place to divert stormwater into the retention basins on the south and southeast end of the Location (red arrows).

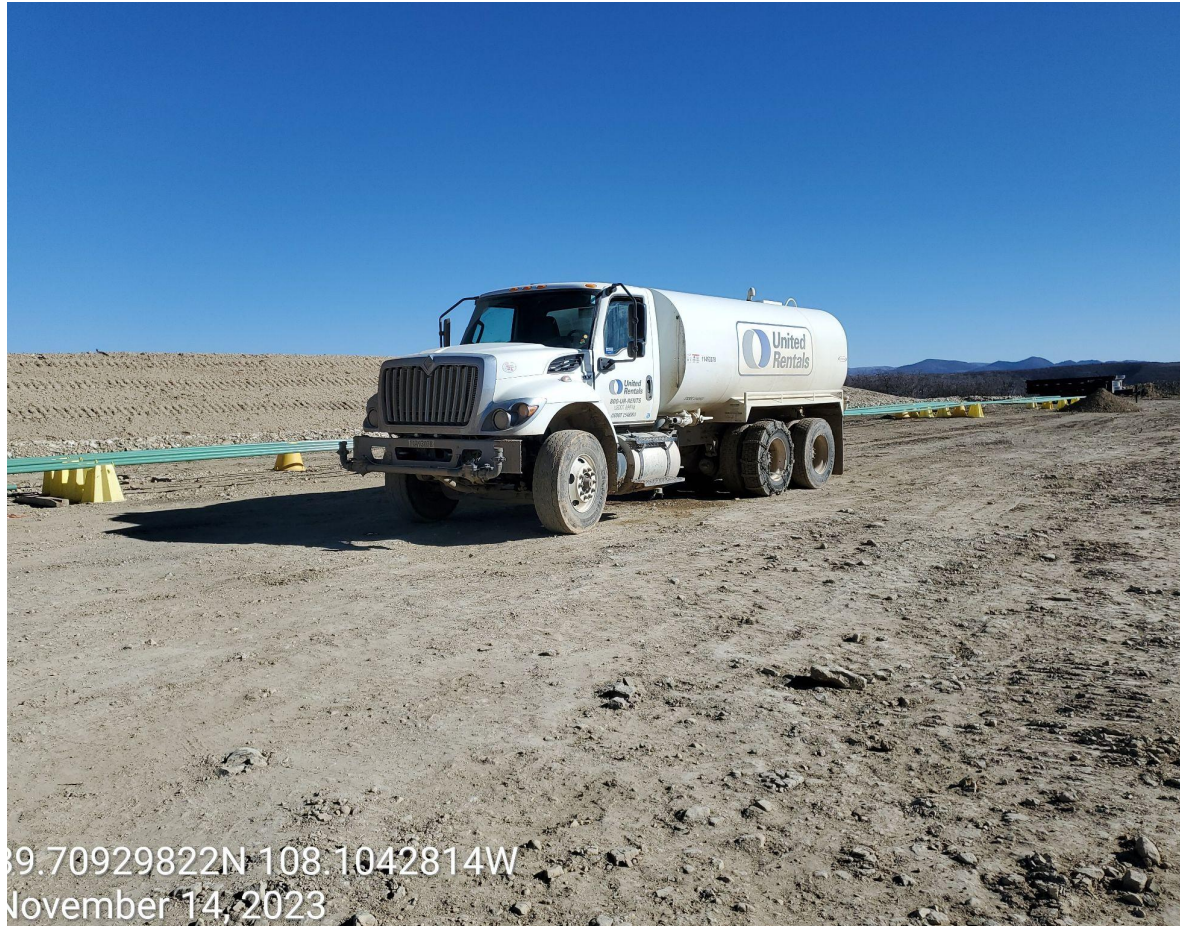
Photo 8: Water truck on Location.

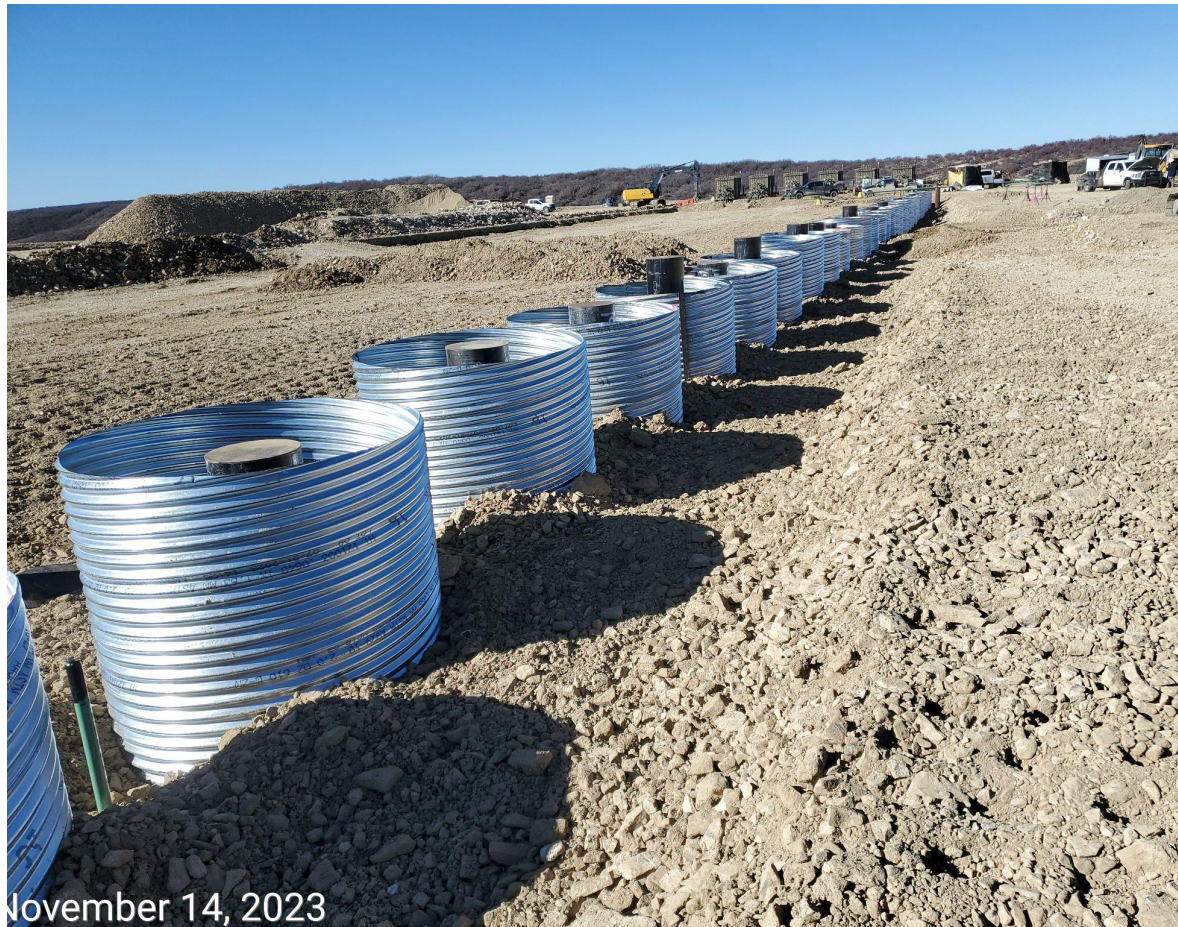
Photo 9: Conductors on Location.

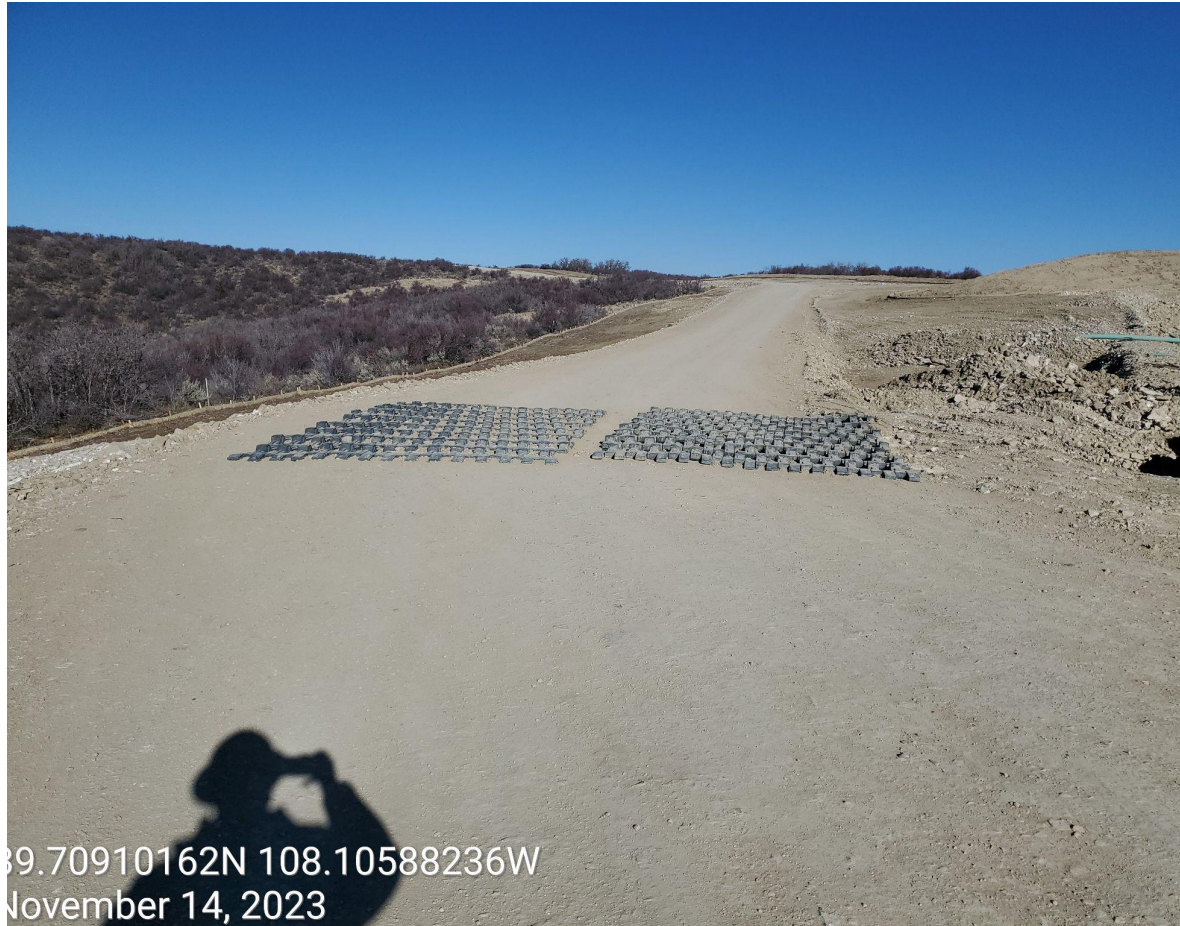
Photo 10: Vehicle tracking pad at the western Location entrance.

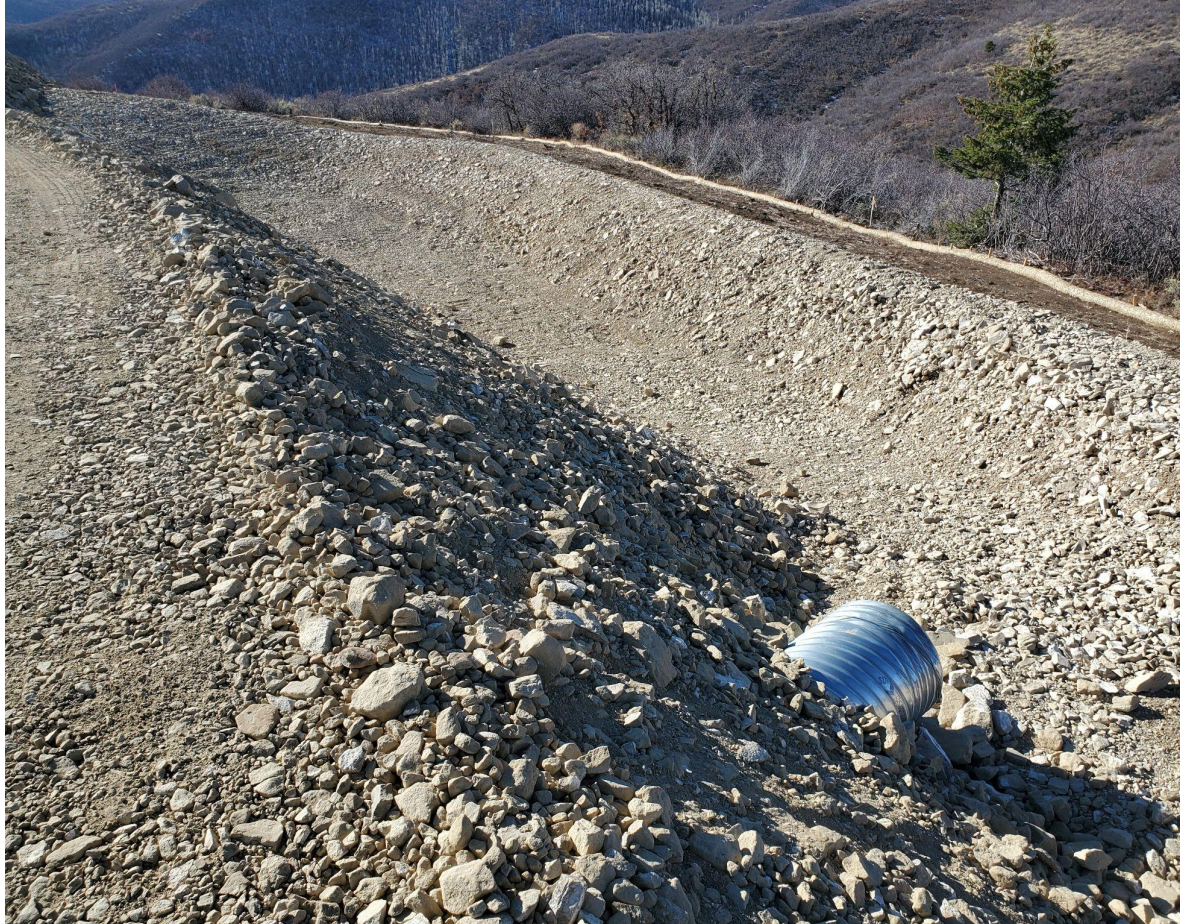
Photo 11: Photo taken from the Location entrance, on the west end of the Location. Photo shows 1 of 3 retention basins constructed on the Location. Retention basin constructed in conjunction with a culvert; basin will only collect stormwater from a small “drainage” along the eastern road (to the secondary access road) on the northwest end of the Location, and not including the working pad surface.

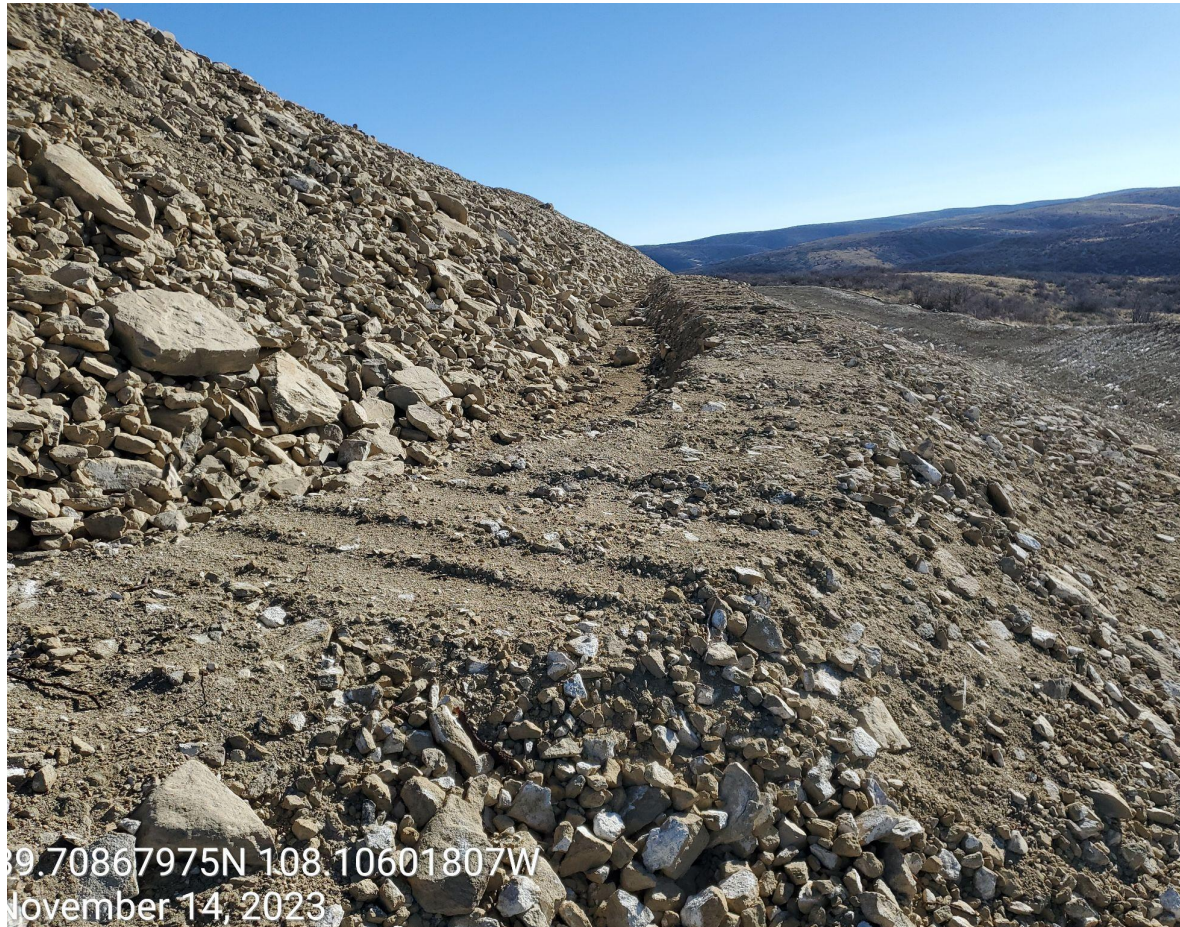
Photo 12: Photo taken from the southwest end of the Location, facing east. Photo example showing the ditch and berm along the toe of the fill slopes.

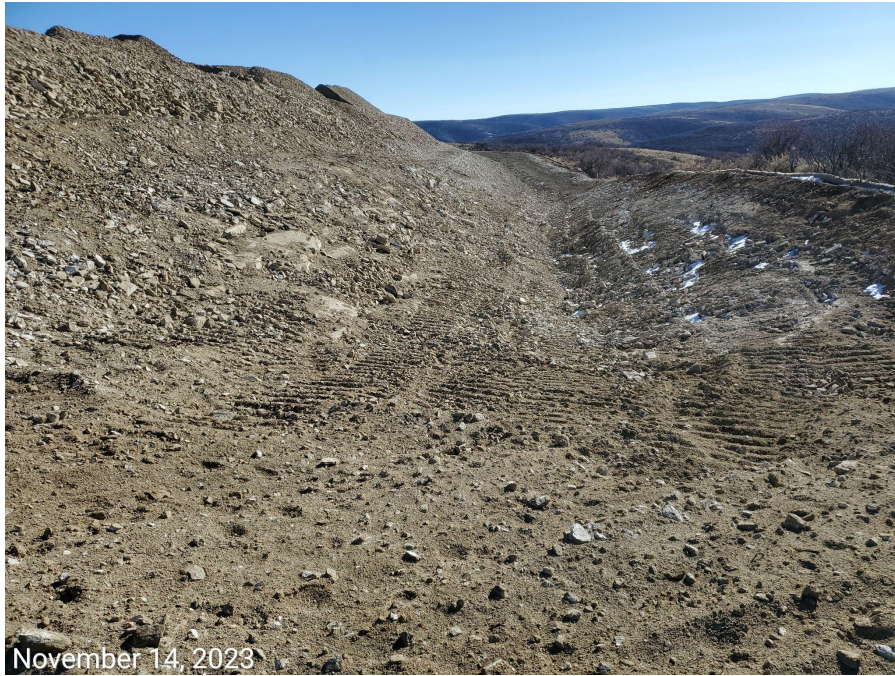
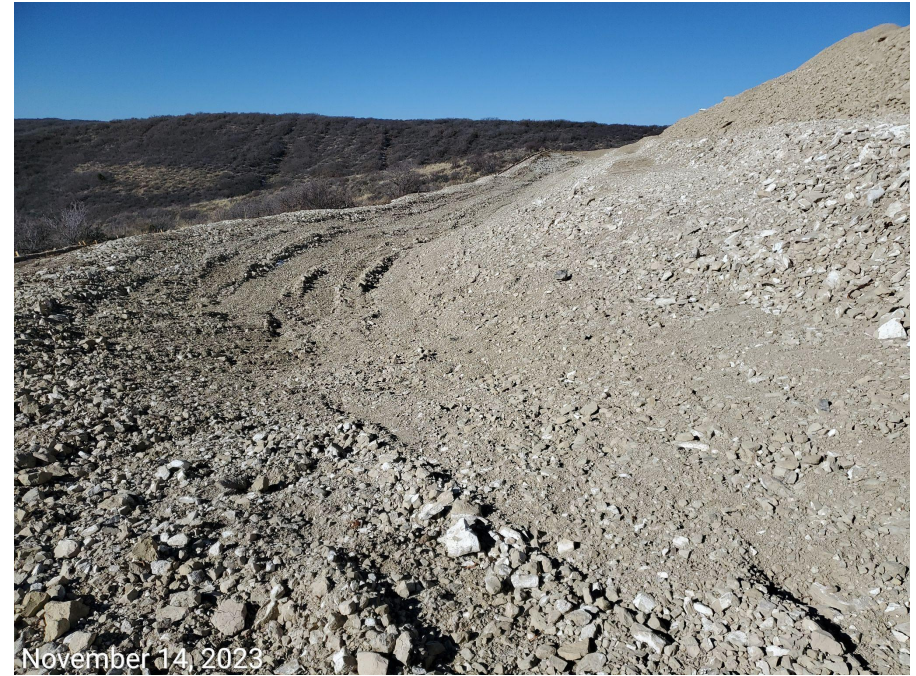
Photo 13: Photo left taken from the southwest end of the Location, facing east. Photo right taken from the southeast end of the Location, facing west. Photos show the stormwater basins on the south end of the Location. BMP has been designed and implemented in a manner that is effectively useless in managing stormwater runoff; there are currently no additional control measures (such as a diversion ditch, slope drain, engineered outlet, etc...) that will allow for proper stormwater diversion from the ~11.7 acre disturbance (including the working pad surface) into the collection basin.

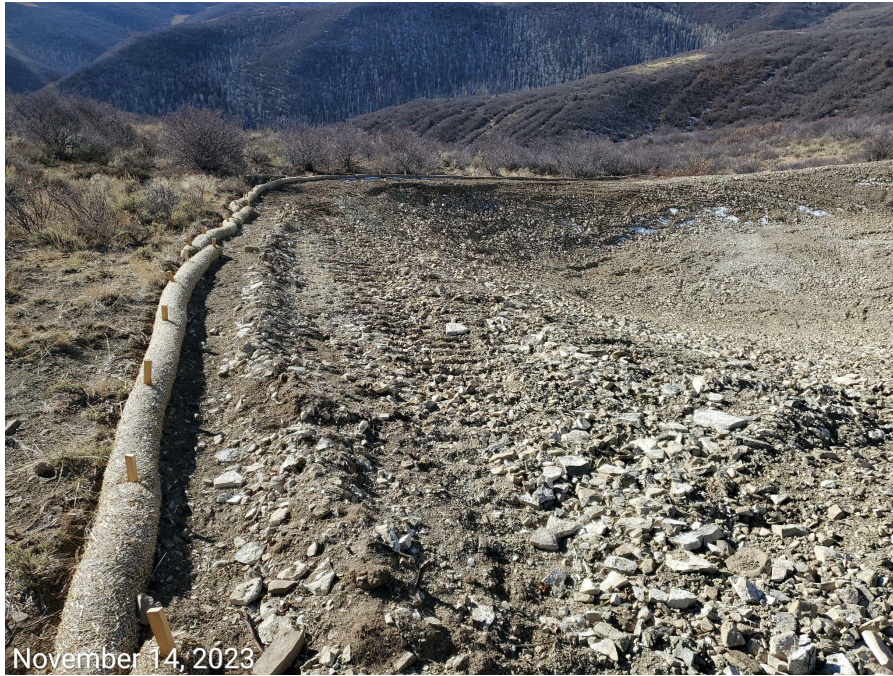
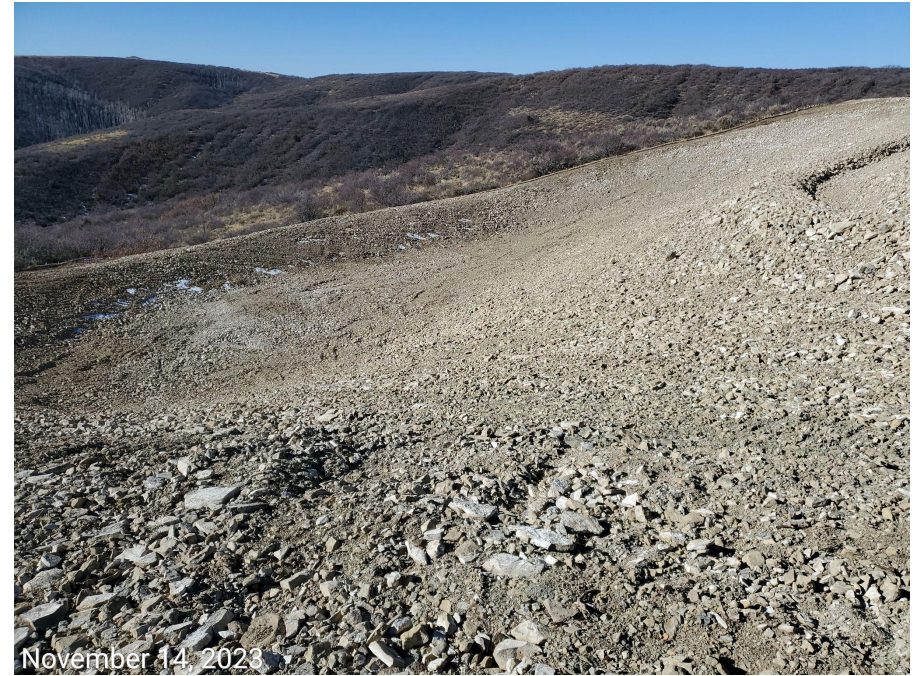
Photo 14: Photo taken from the southeast end of the Location, facing south and southwest. Photos shows the stormwater basin on the southeast end of the Location. BMP has been designed and implemented in a manner that is effectively useless in managing stormwater runoff; there are currently no additional control measures (such as a diversion ditch, slope drain, engineered outlet, etc...) that will allow for proper stormwater diversion from the ~11.7 acre disturbance (including the working pad surface) into the collection basin.

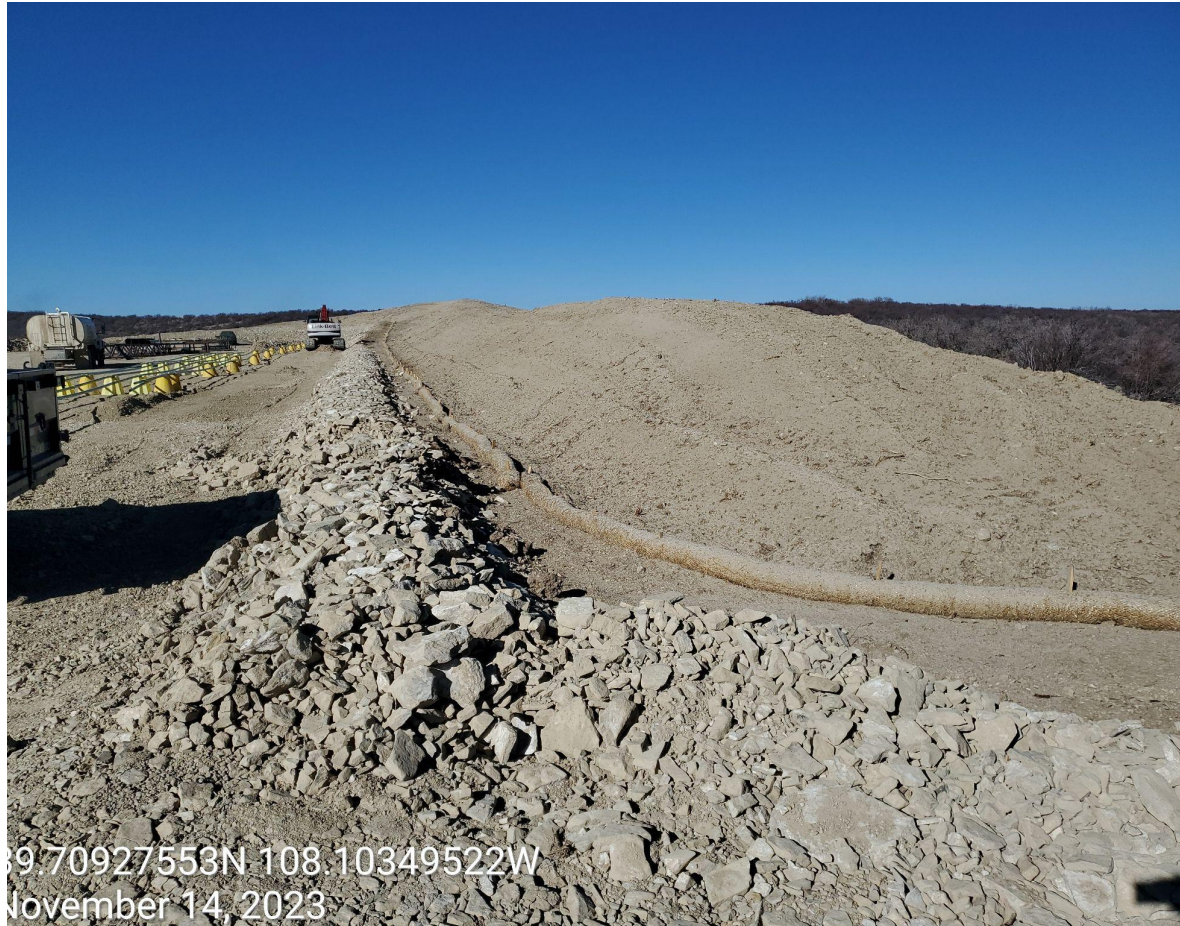
Photo 15: Photo taken from the northeast end of the Location, facing west. Photo shows the topsoil stockpile. Hydromulch has been applied to stabilize the stockpile, and to protect from wind/water erosion; erosion logs have been implemented along the perimeter to manage runoff and sediment transport.

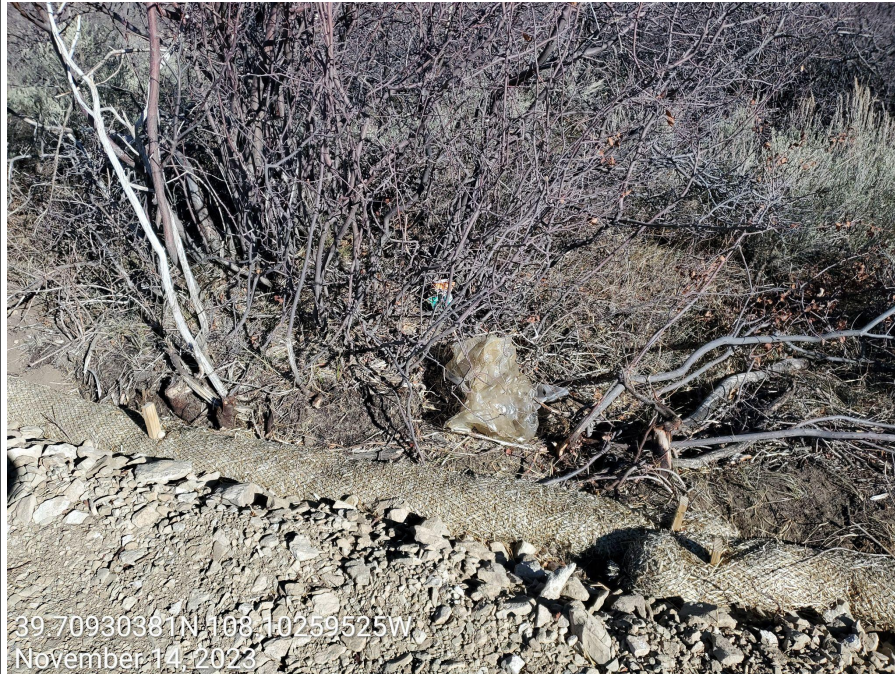
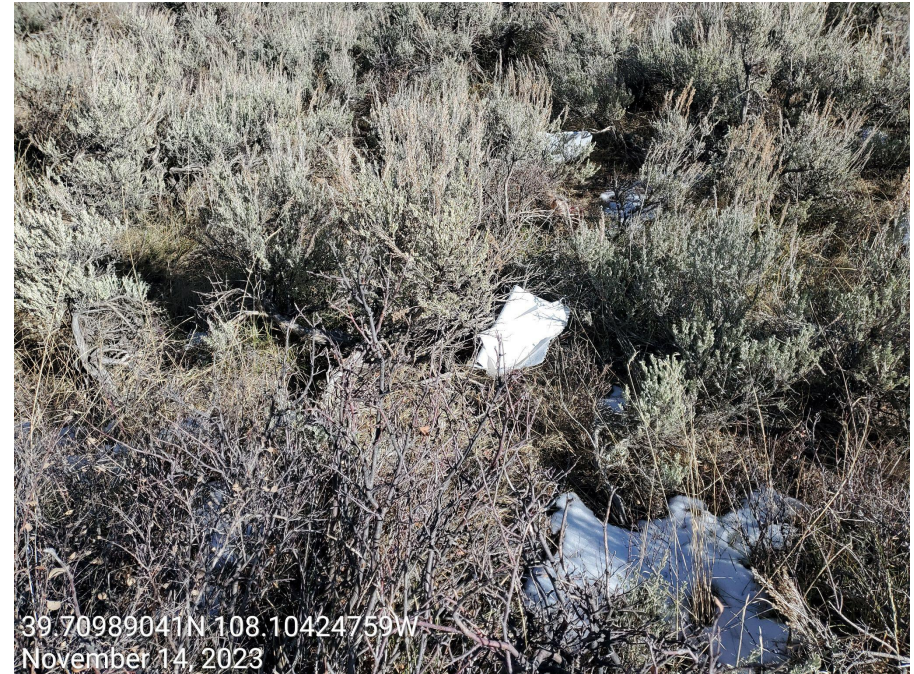
Photo 16: Photos 16-17 taken along the northern perimeter of the Location. Photos examples showing trash debris blown off the Location.

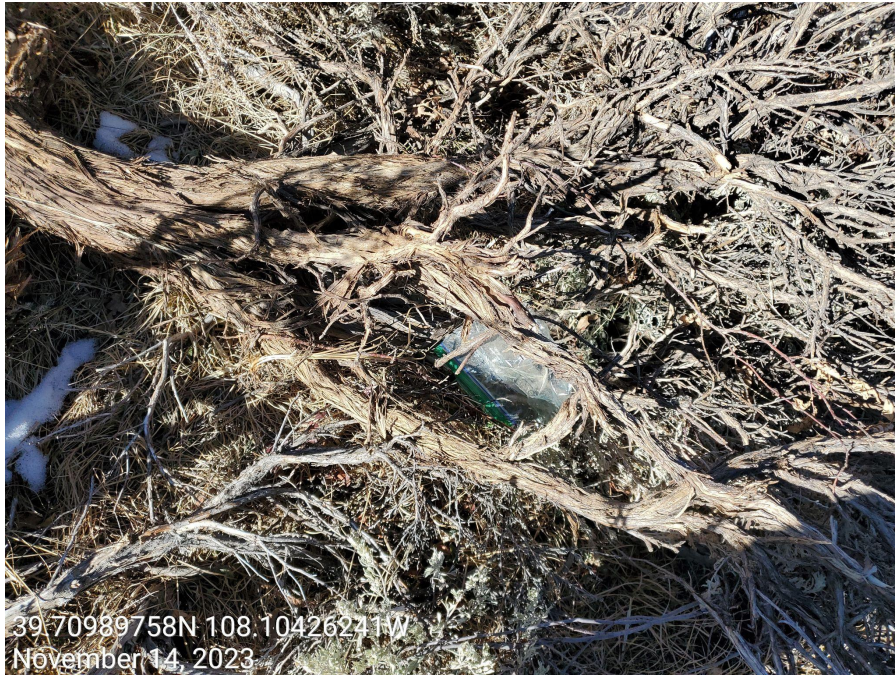
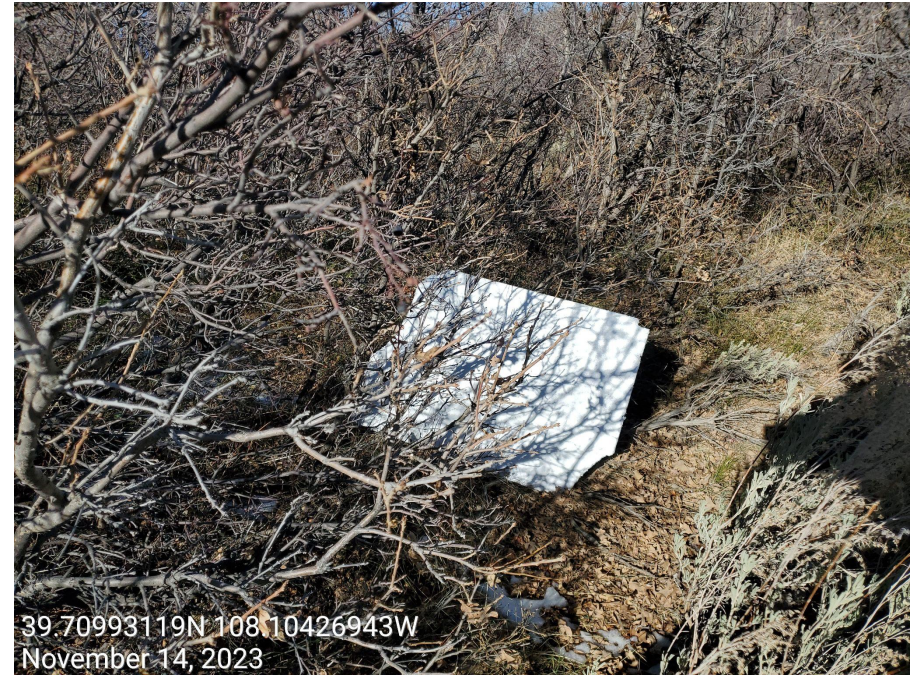
Photo 17: See comments under photo 16.

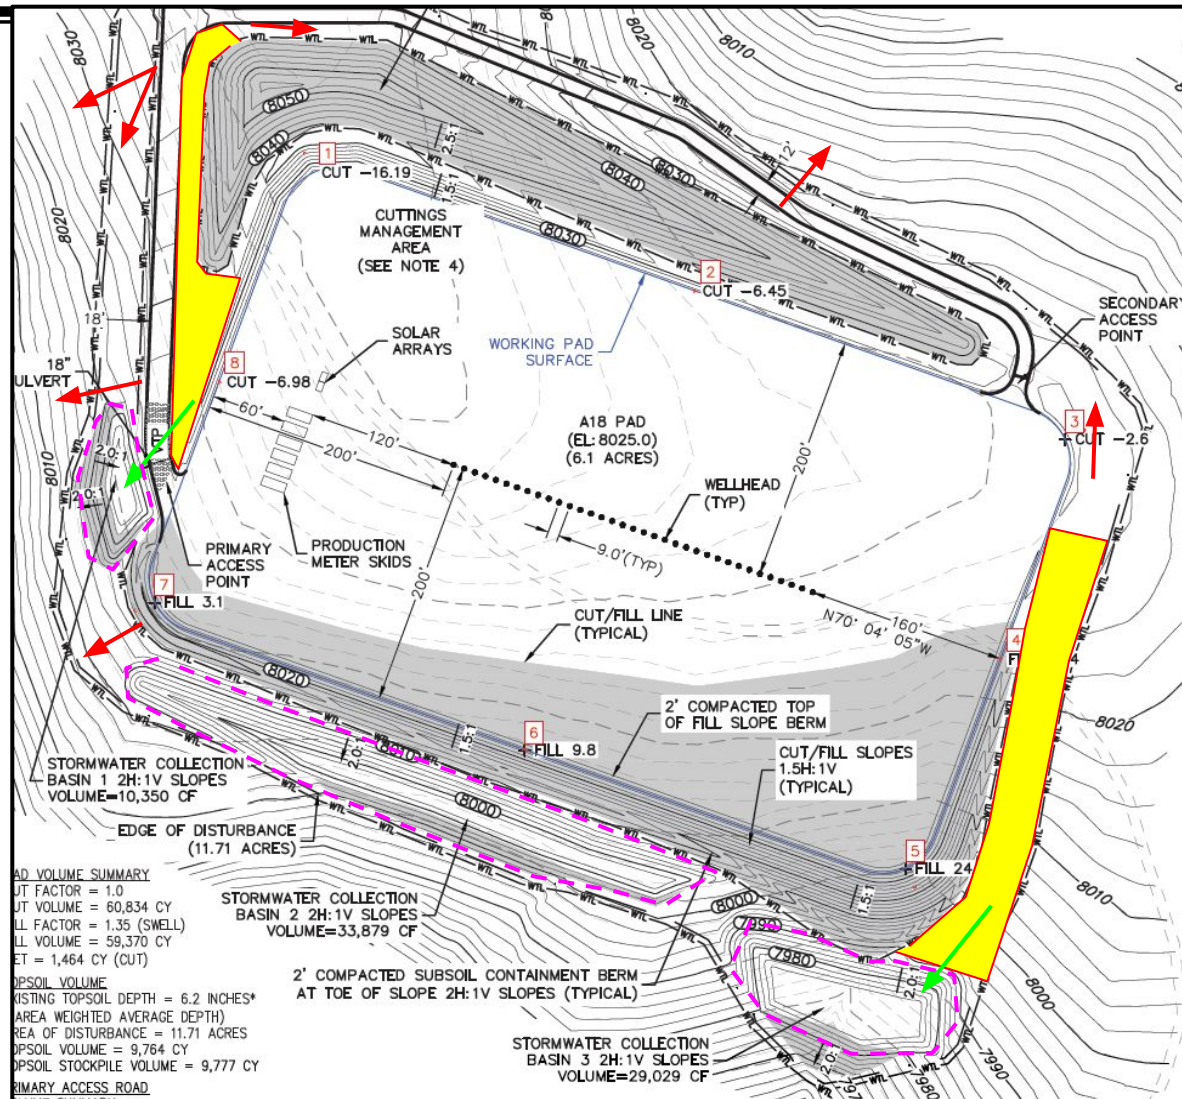
Photo 18: Operator's construction layout figure. Yellow polygons represent approximate drainage areas for stormwater runoff that would reach sediment basins (purple polygons) on the west/east ends of the Location. As built, there are no BMPs to divert stormwater into the southern/southeastern basins, or to allow water to discharge from the working pad surface. Red arrows represent stormwater flow direction based on field observations. Green arrows represent stormwater flows that would enter the basins. See comments under photos 11, 13 and 14.
