Inspection Photos

Operator: CAERUS PICEANCE LLC #10456

Location ID: 478266

Inspection Doc: 696205422

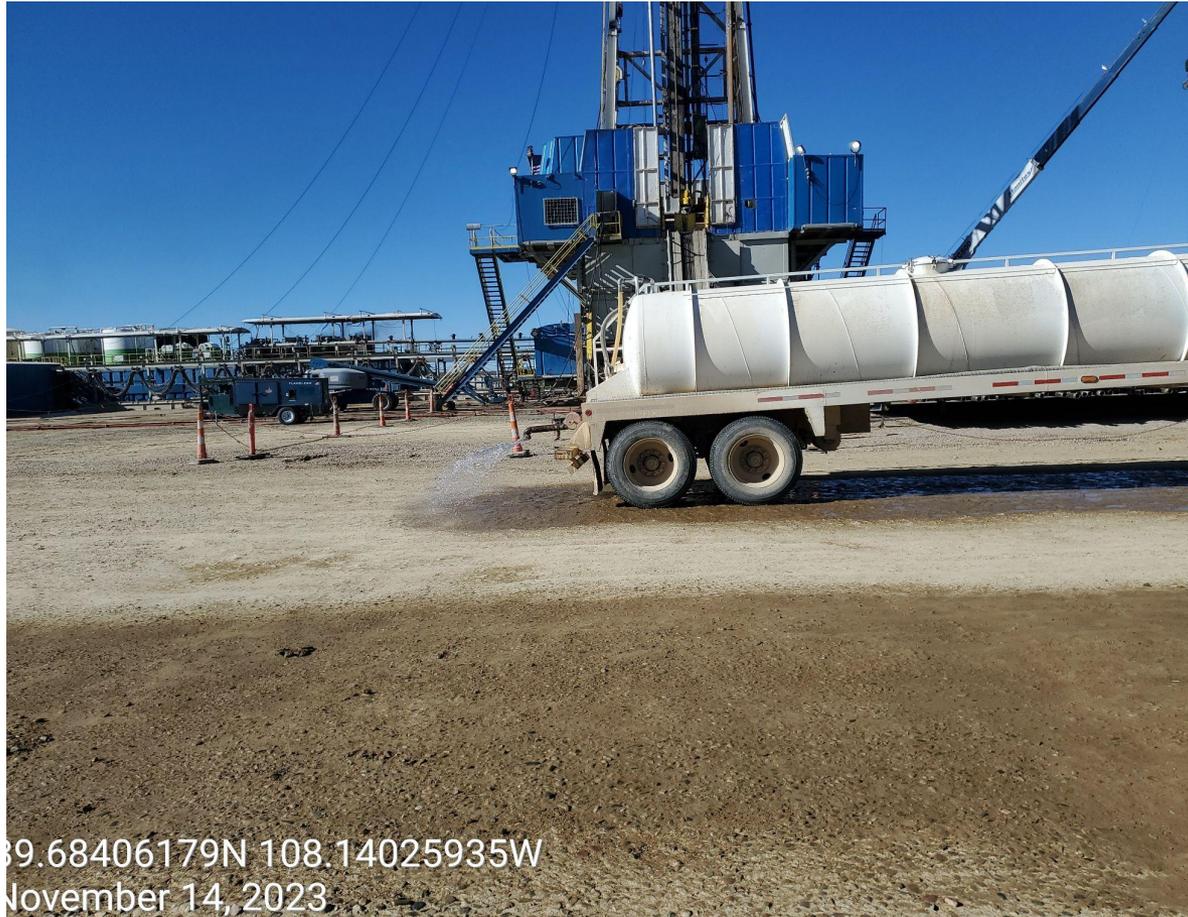
Photo 2: Water truck in use to mitigate fugitive dust.

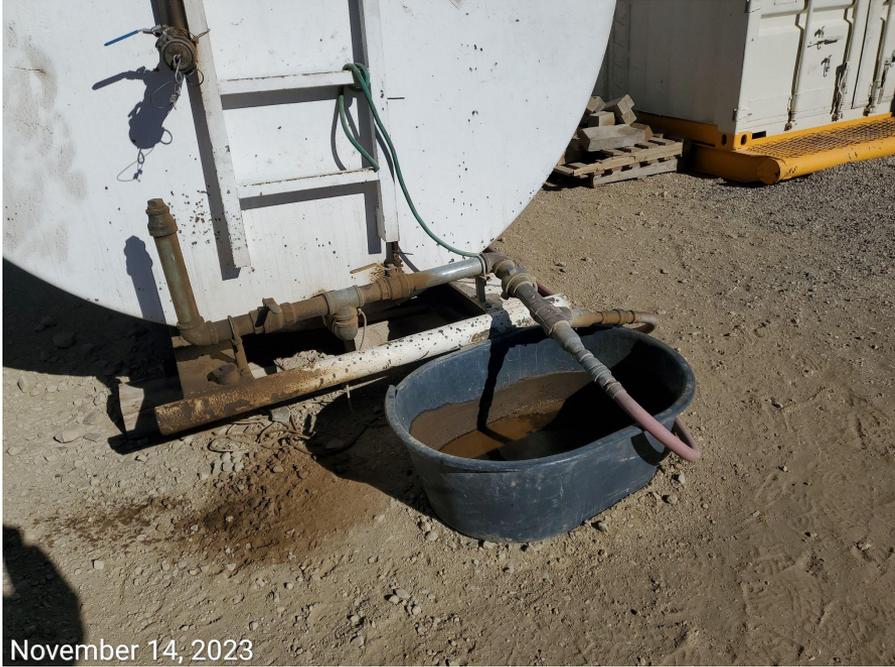
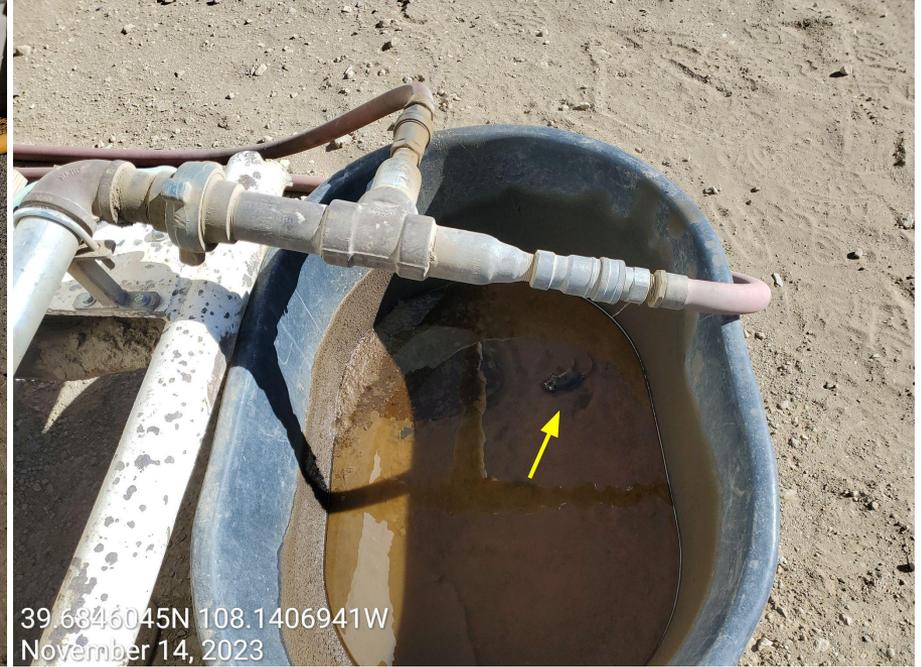
Photo 3: Wildlife protection BMPs missing at spill prevention/containment measures. Wildlife mortality (mouse, arrow) observed.

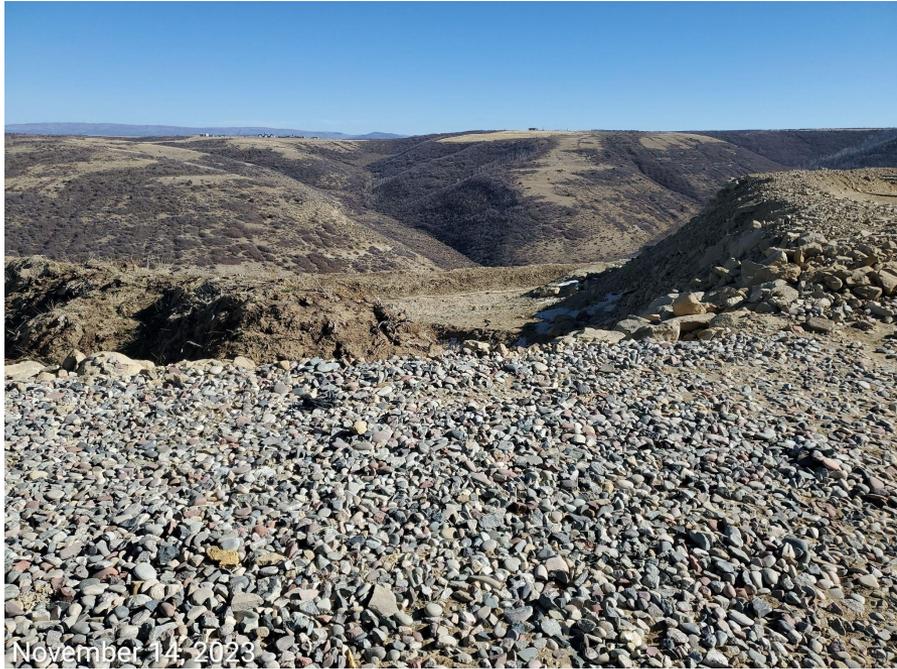
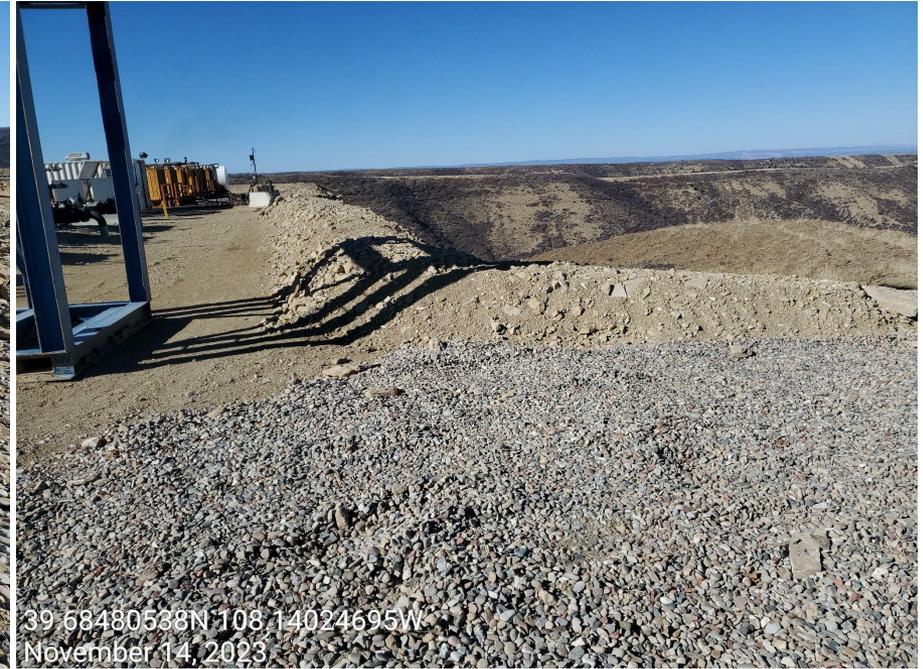
Photo 4: Photos taken from the access road entrance on the north end of the Location. Photos examples showing drain pipes per the Form 2A Location drawing/SWMP have not been installed.

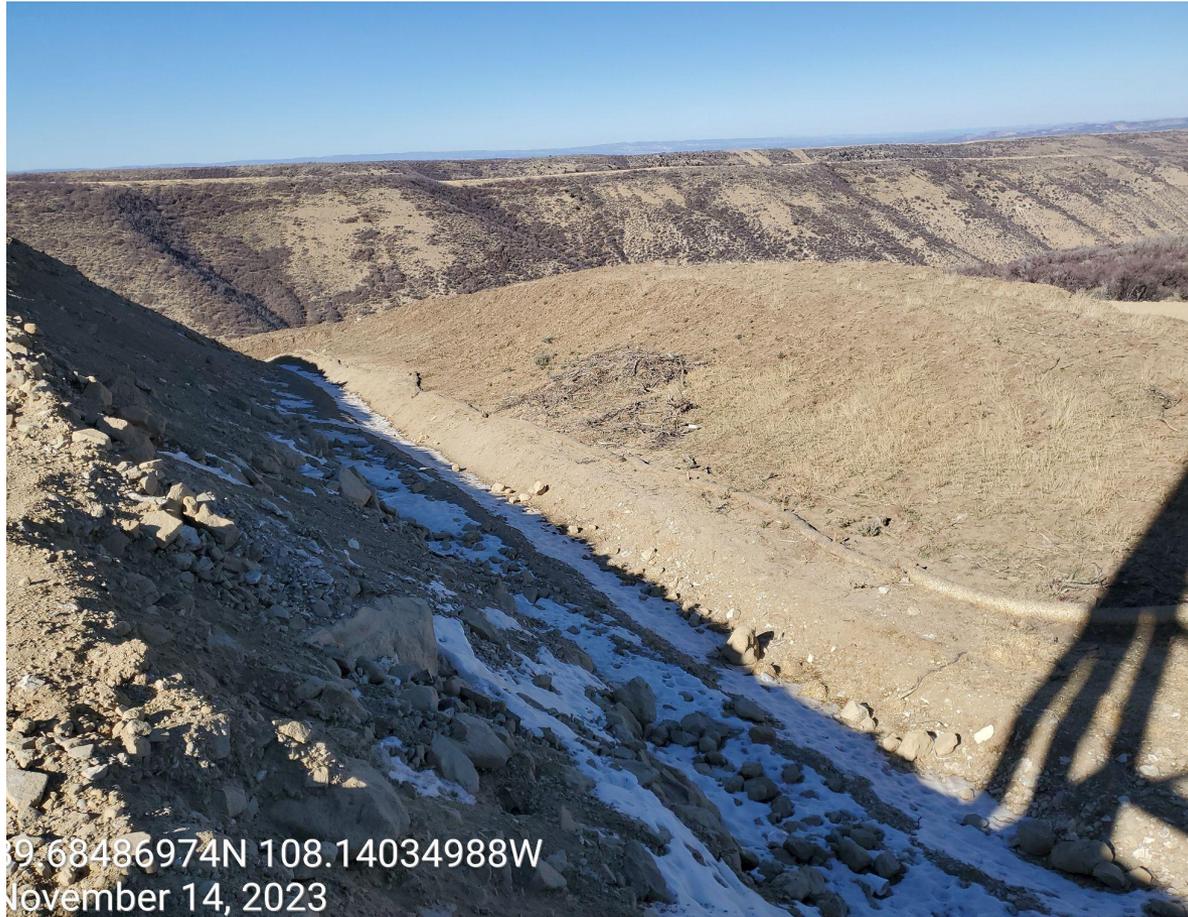
Photo 5: Photo taken from the south end of the Location; Photo example showing BMPs to minimize erosion at the fill slopes remain missing or insufficient; velocity checks not observed within ditch.

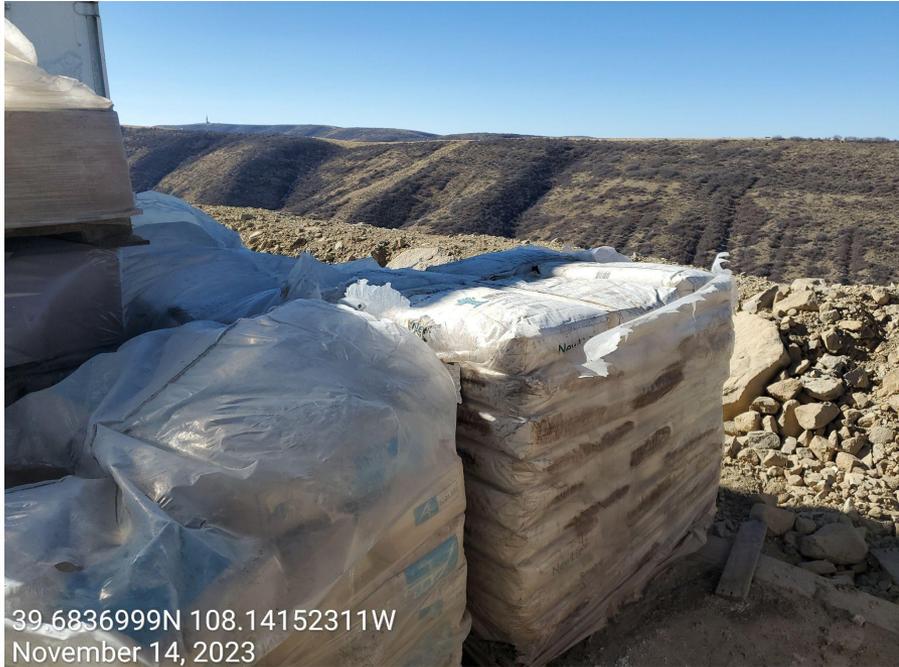
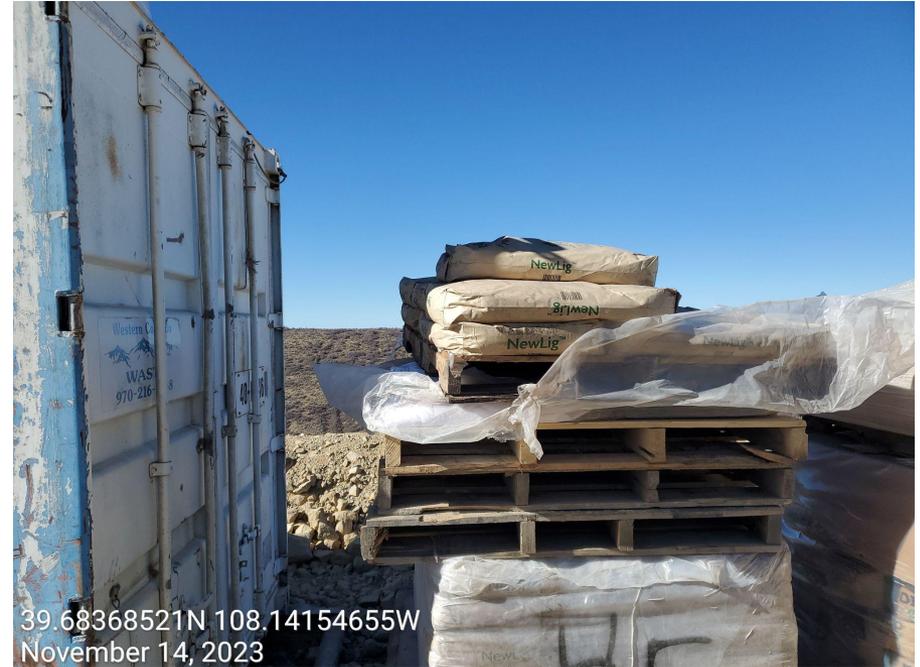
Photo 6: Photo shows improperly covered materials on Location.

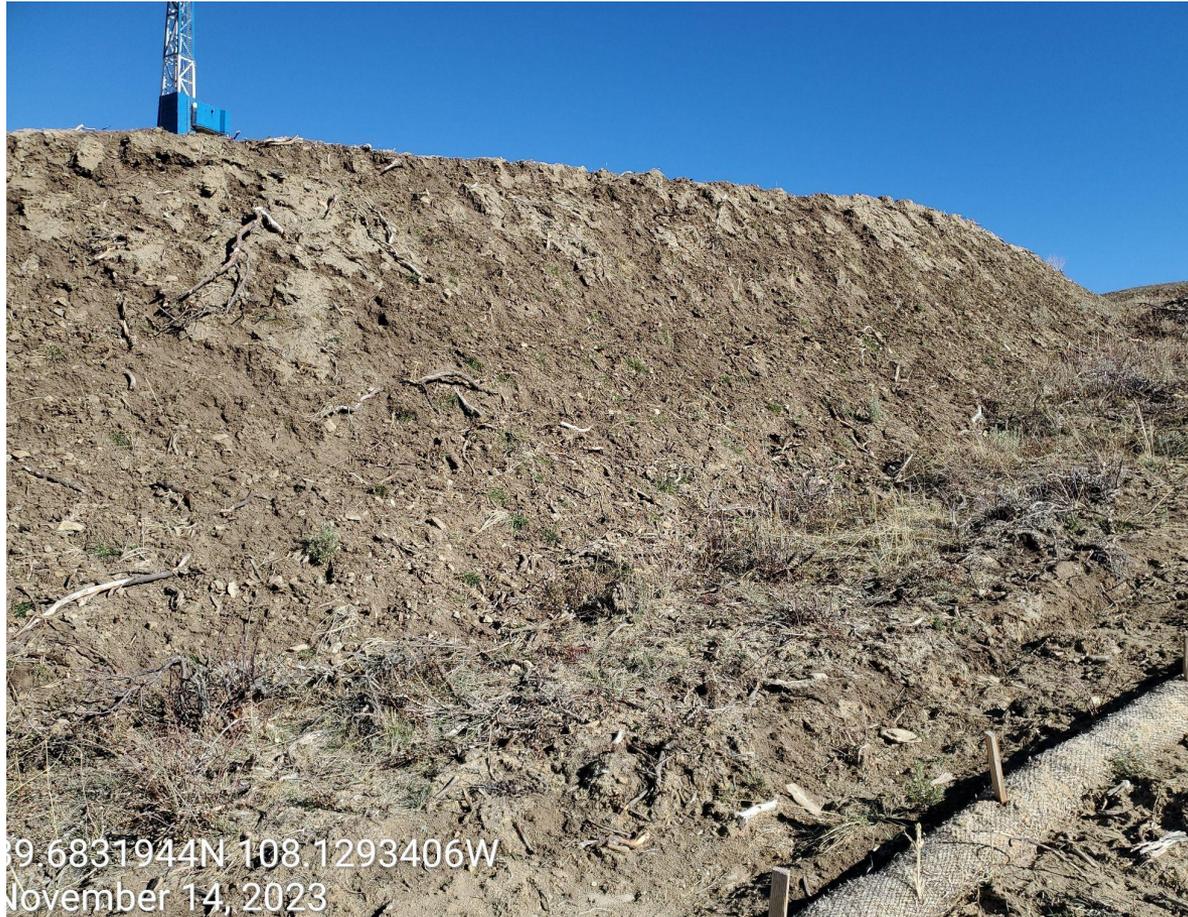
Photo 8: Photos 8-10 taken from the topsoil stockpiles along the perimeter of the Location. Photos examples showing areas of the stockpiles where hydromulch is not longer in proper functioning condition.

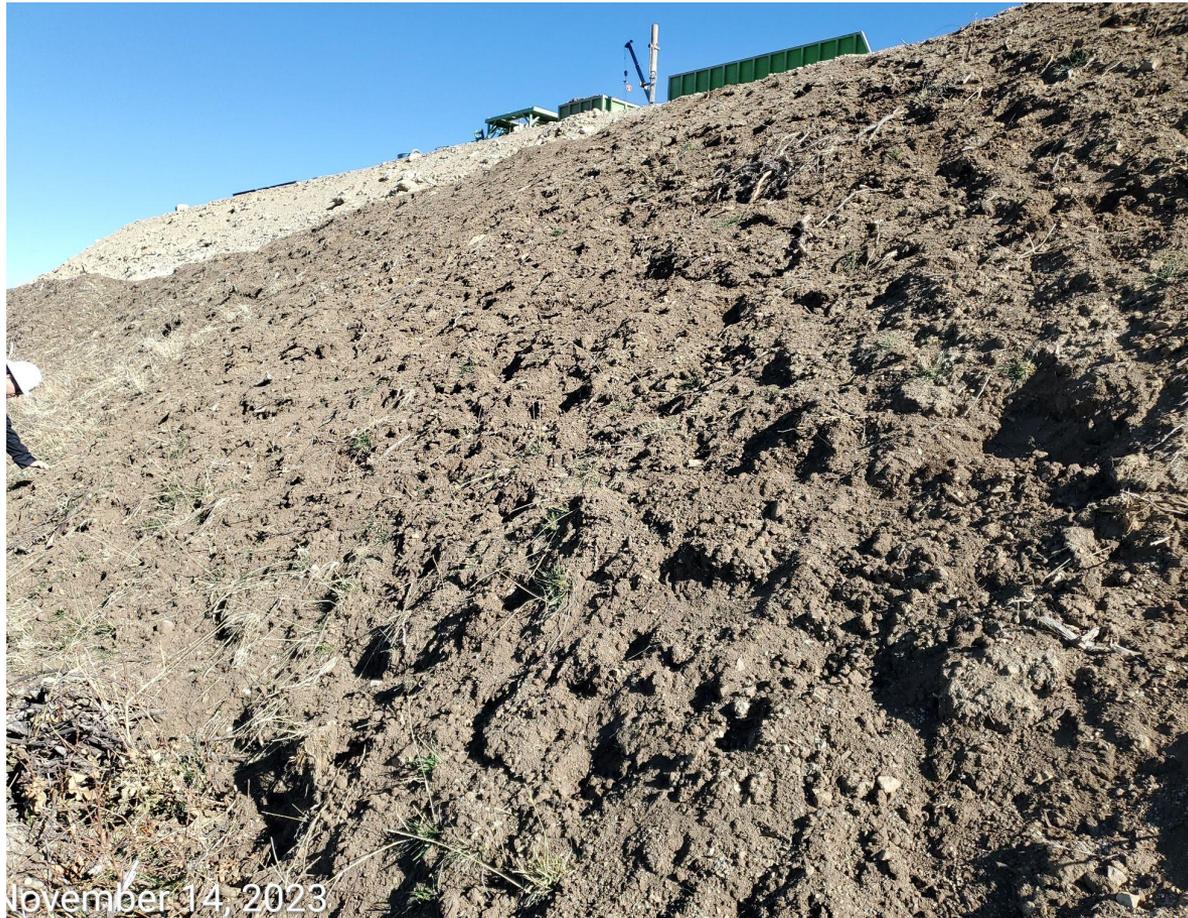
Photo 9: See comments under photo 8.

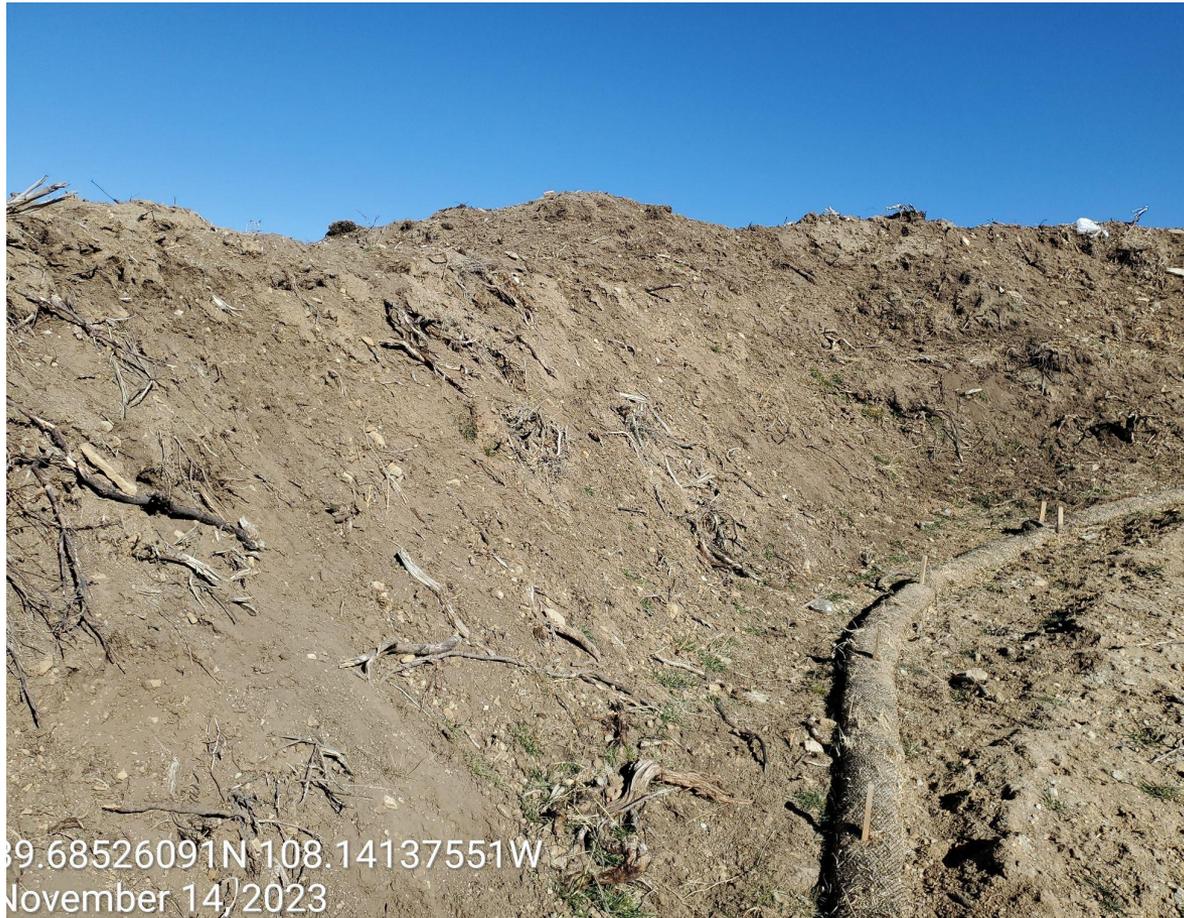
Photo 10: See comments under photo 8.

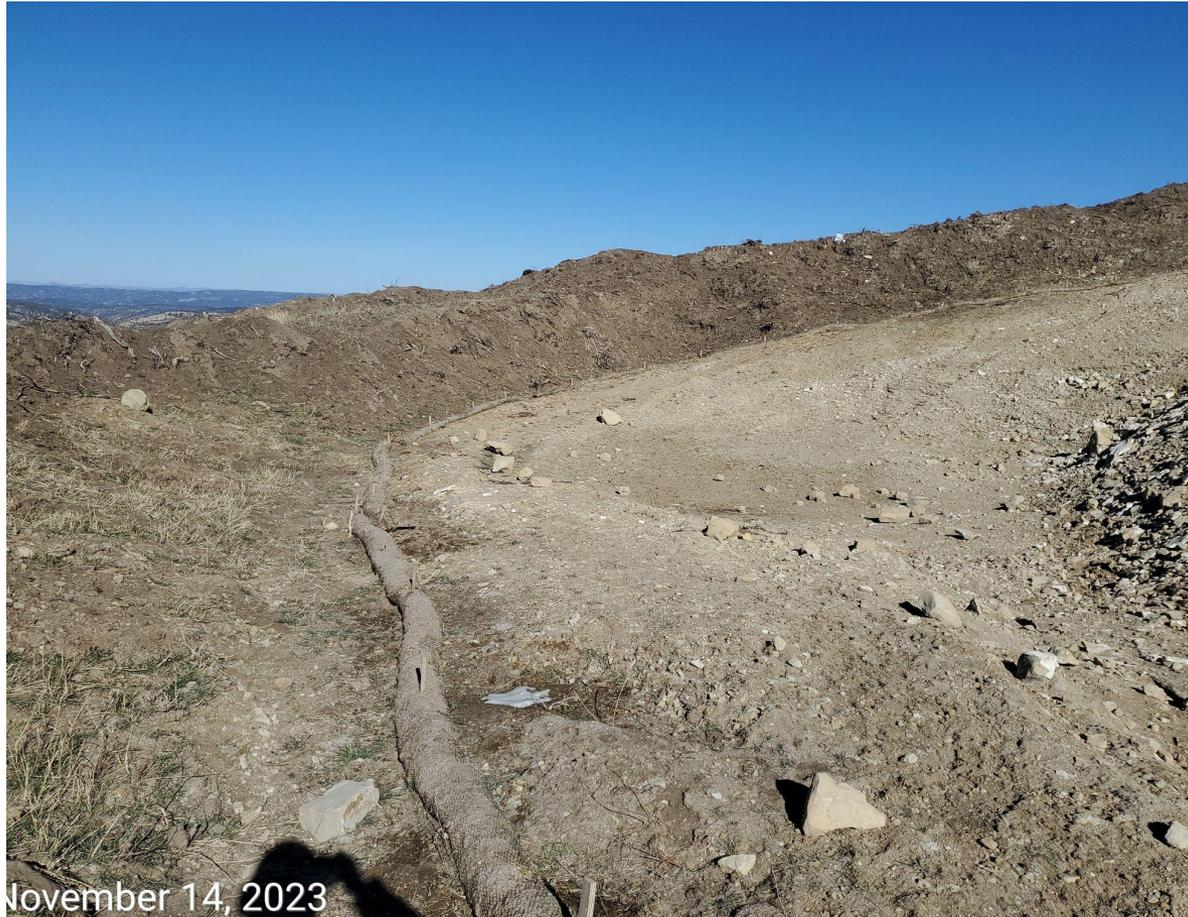
Photo 11: Photo taken from the northwest end of the Location. Photo shows sediment trap #2 appears unchanged in size. Photo also example showing areas of the topsoil stockpiles where hydromulch is no longer in proper functioning condition.
