Storm Water Management and Erosion control
Location Name: MUSTANG RESOURCES LLC MACKELY 34-12-6S-94W
Location ID: 322467

**Location Overview: Location is within High
Priority/Density/Black Bear Habitat areas/Bald Eagle Roost
Site & in close proximity to NSO Habitat area. Location is
approximately 234 yards from Spruce Creek & approximately
415 yards from the Colorado River.
Section/Township/Range: 34 6S94W**

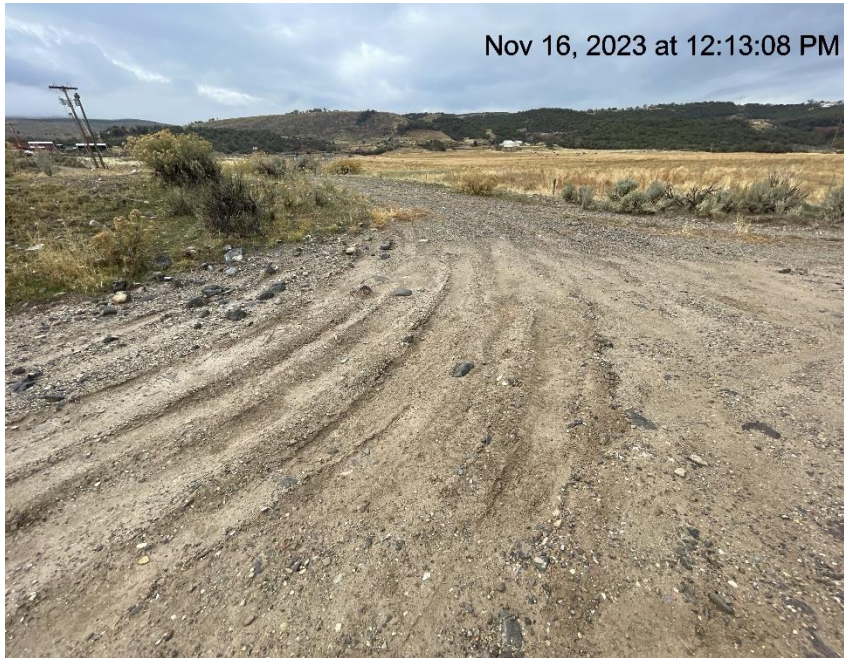
Photo # 6901 Lack of stabilization/compaction

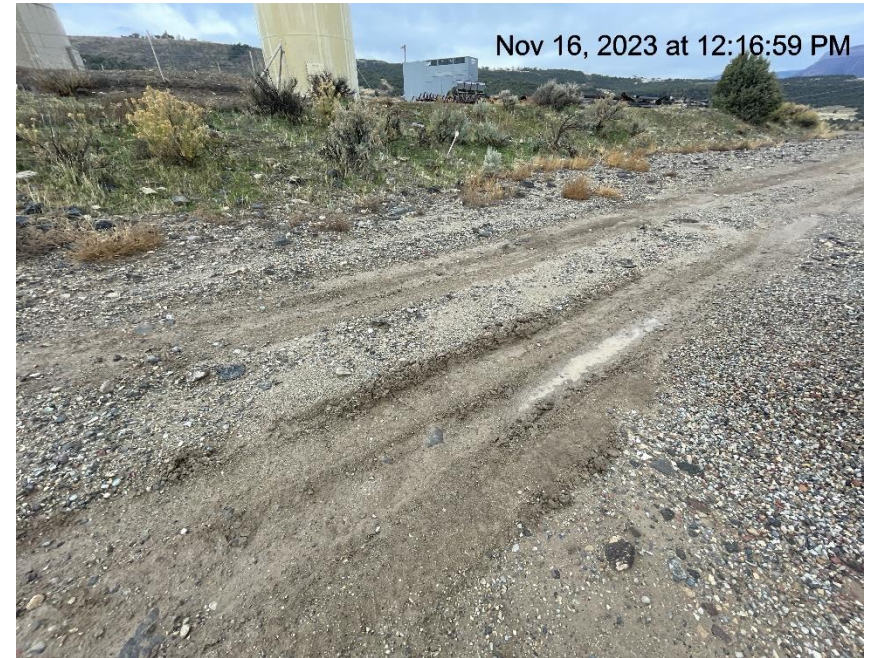
Photo # 6902 Lack of stabilization/compaction

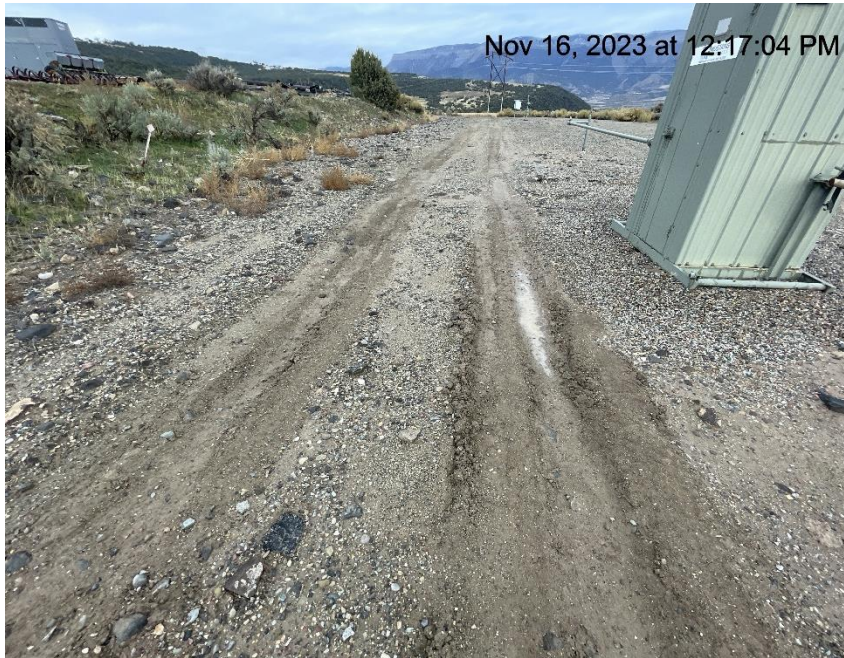
Photo # 6903 Lack of stabilization/compaction

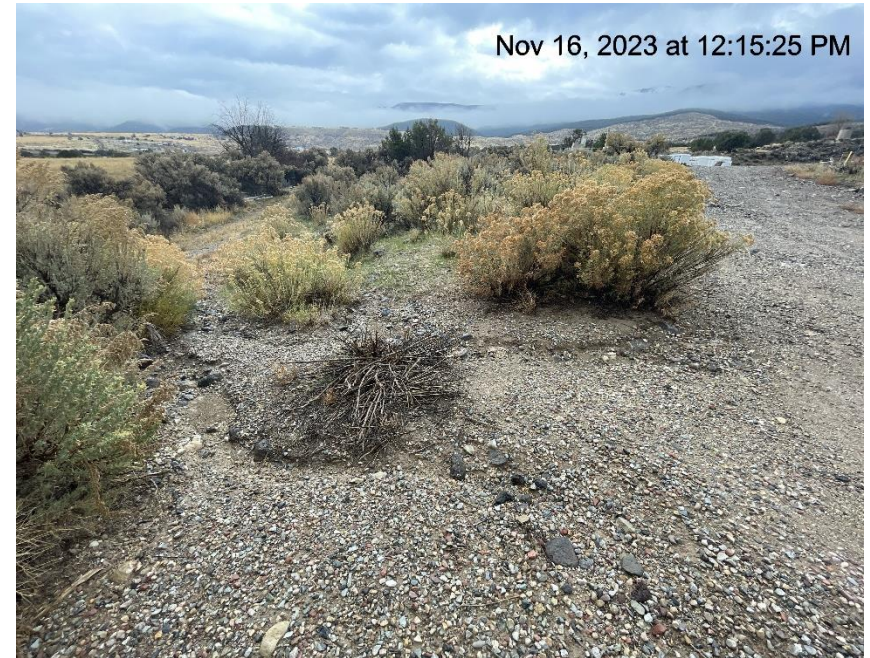
**Photo # 6904 Erosion & transport of sediment off location
(NE area of location)**

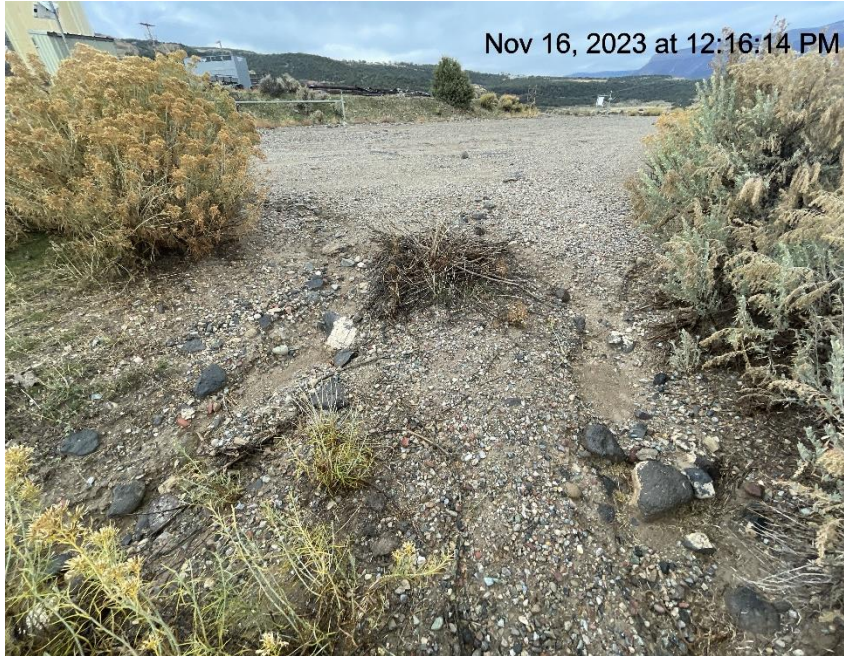
**Photo # 6905 Erosion & transport of sediment off location
(NE area of location)**

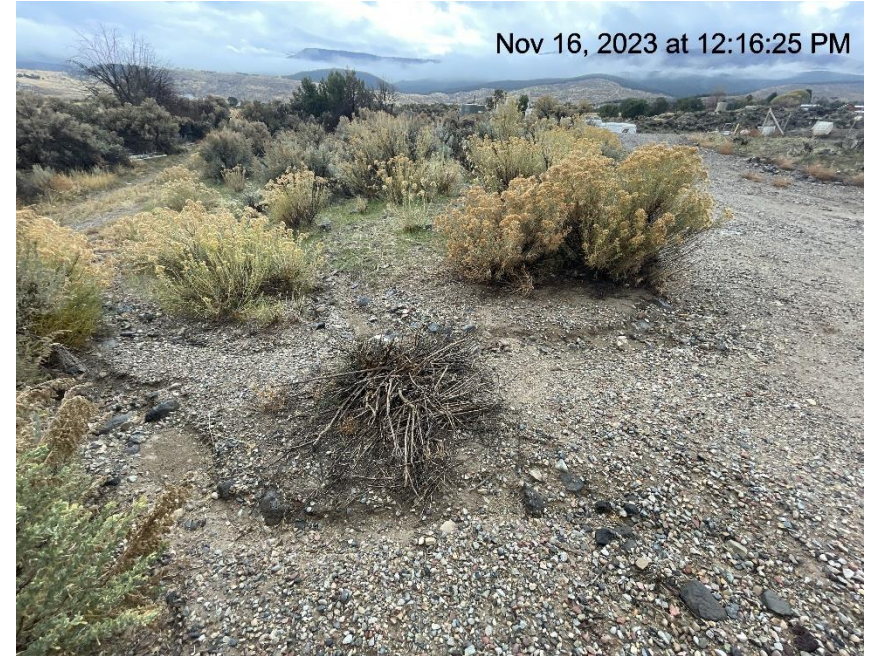
**Photo # 6906 Erosion & transport of sediment off location
(NE area of location)**
