Inspection Photos

Location Name: MUSTANG RESOURCES LLC LOUTHAN 34-32-6S-94W Pad

Location ID: 323819

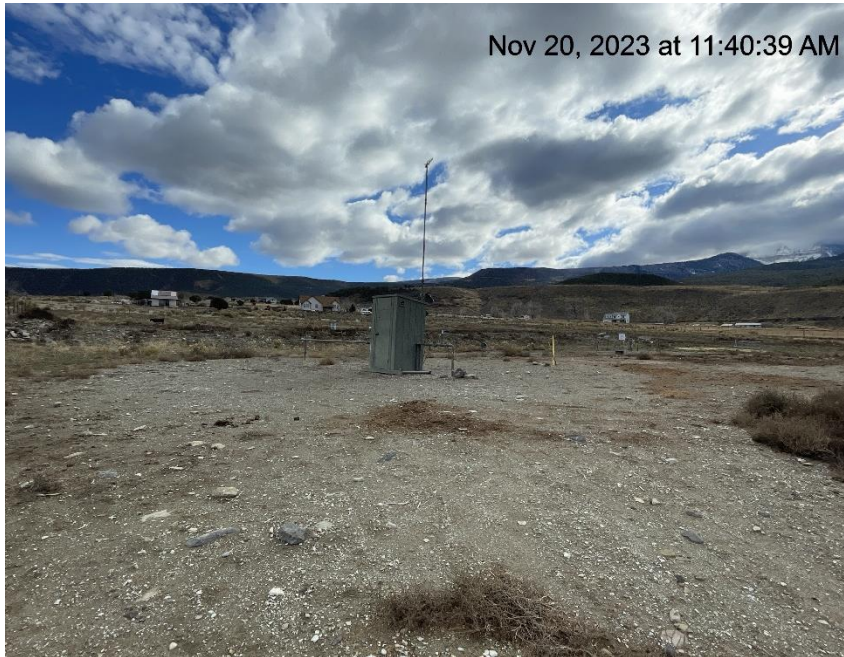
Photo # 7086 From entrance to location

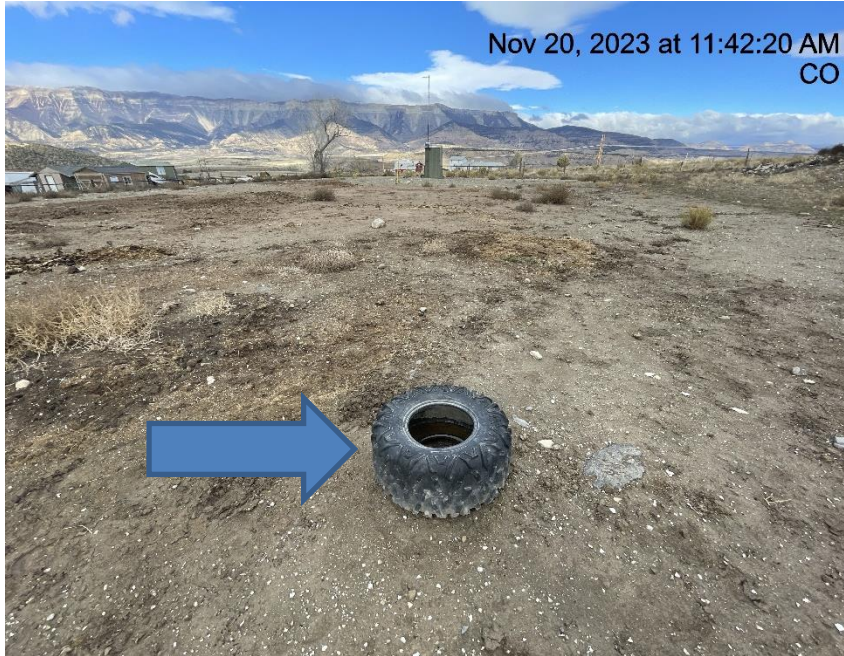
Photo # 7090 Debris

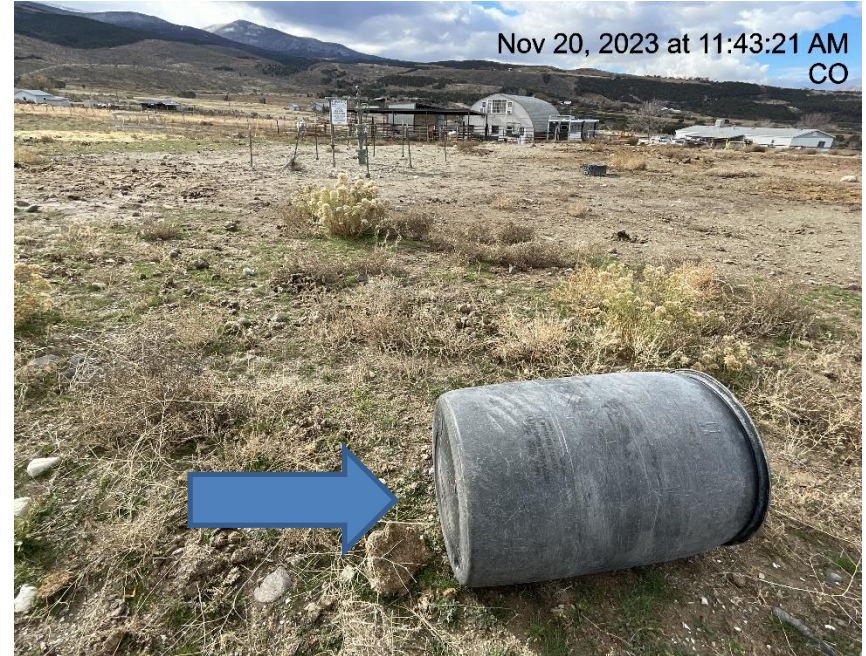
Photo # 7091 Debris

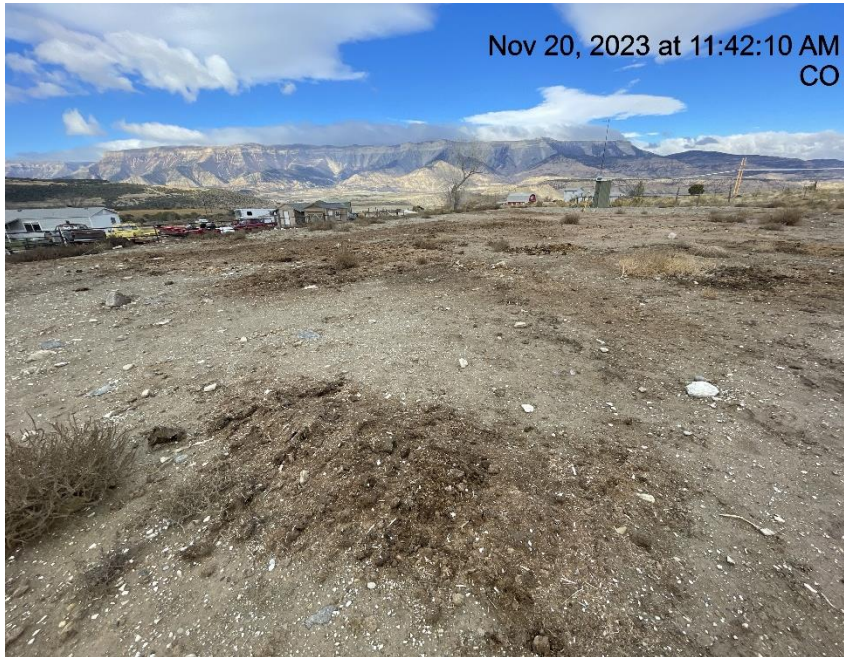
Photo # 7092 Debris/Small manure pile & manure spread over location in background

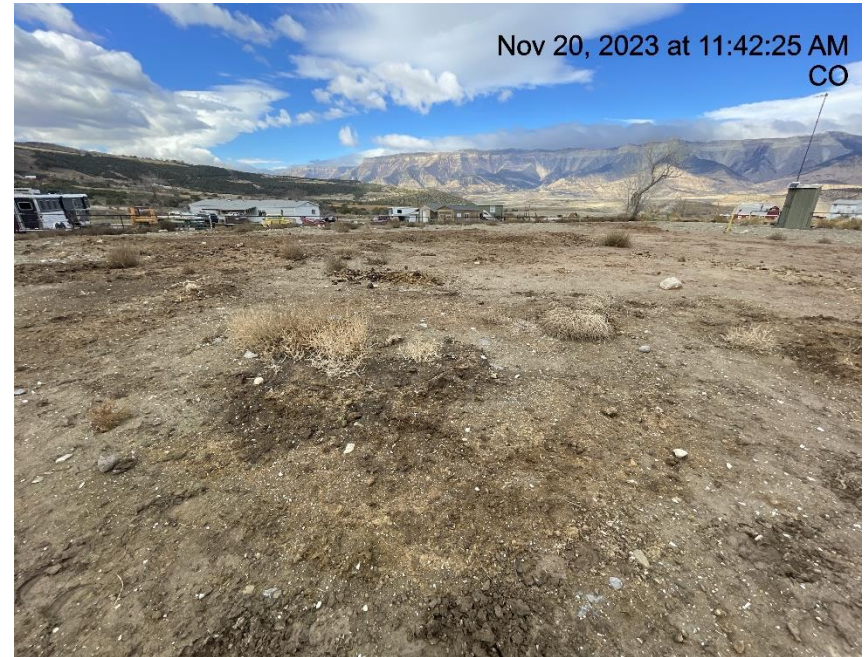
Photo # 7093 Debris/Small manure pile & manure spread over location in background

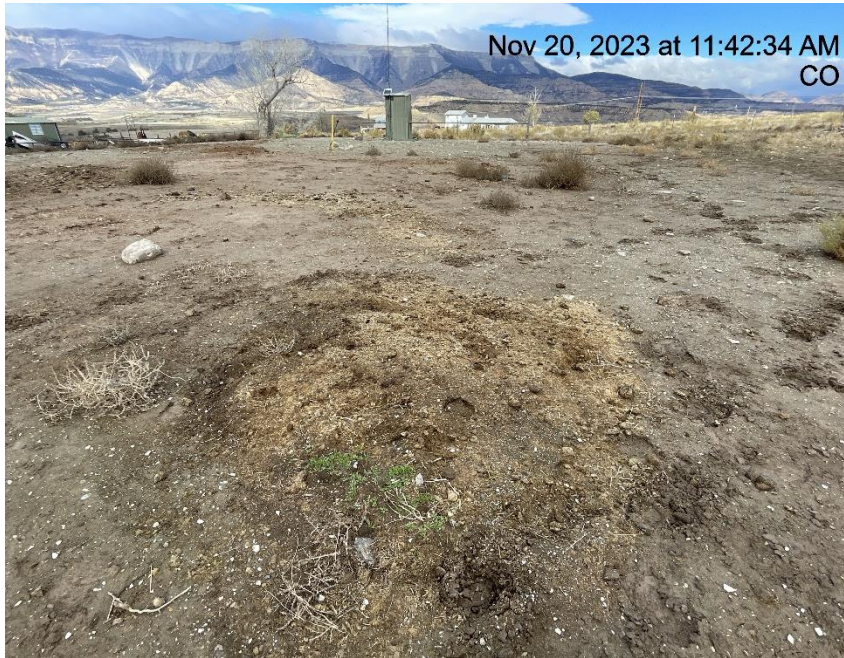
Photo # 7094 Debris/Small manure pile

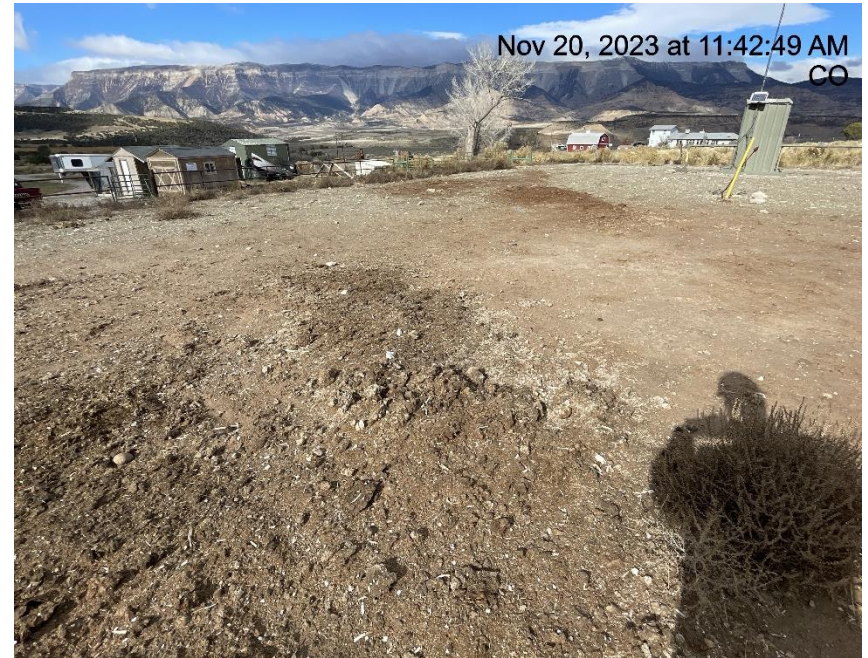
Photo # 7095 Debris/Small manure pile
