Inspection Photos
Location Name: McCarty #2
API #123-10514

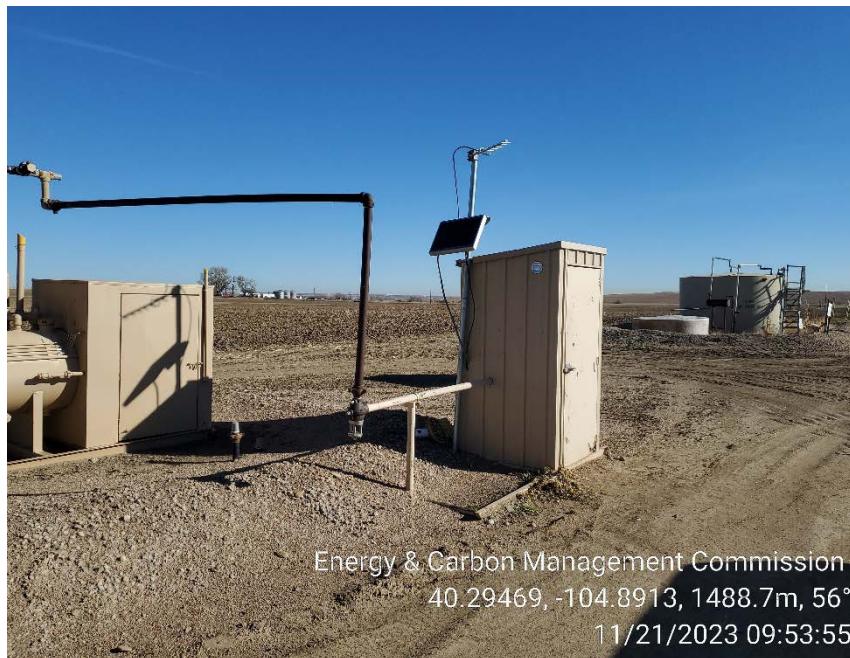
Production facility

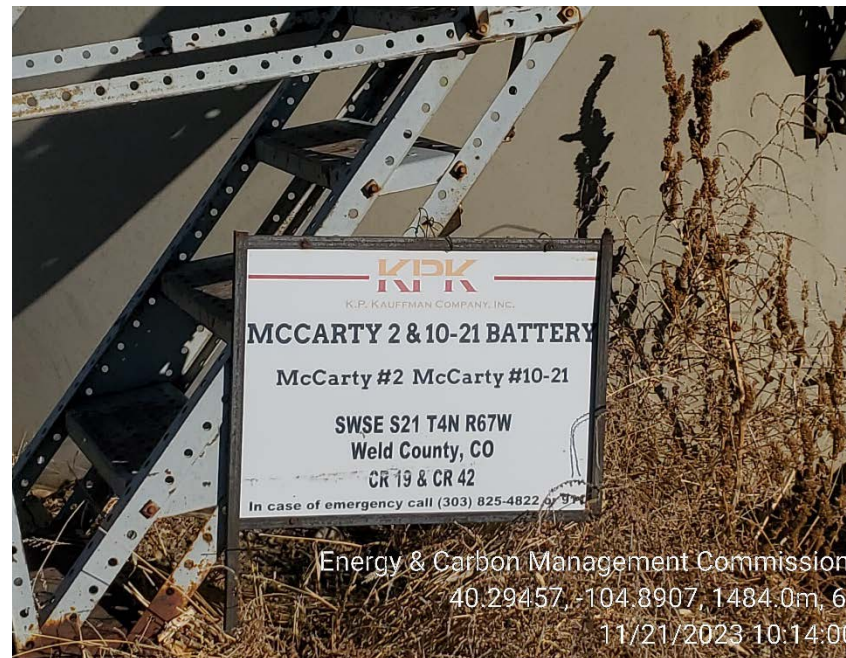
Battery sign

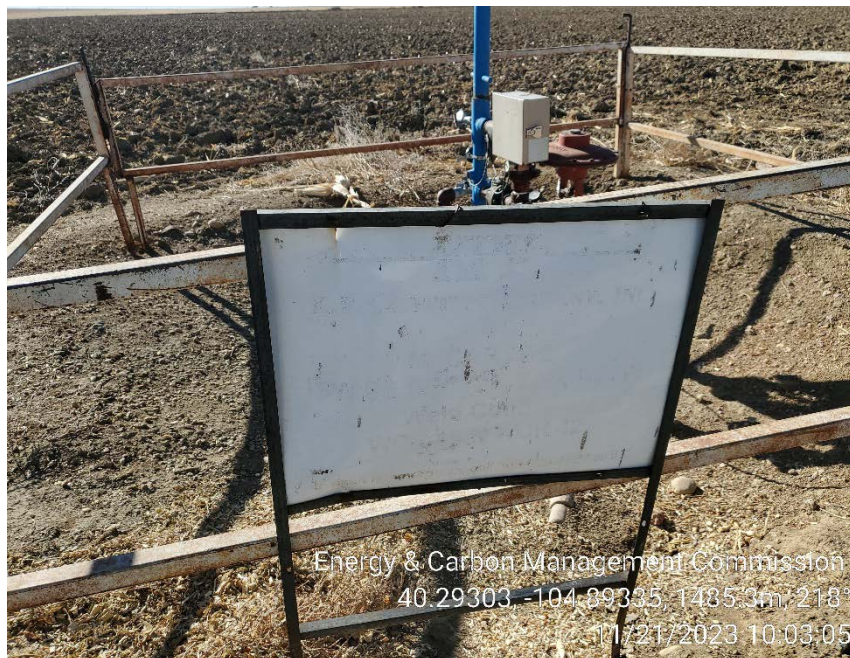
Wellhead sign

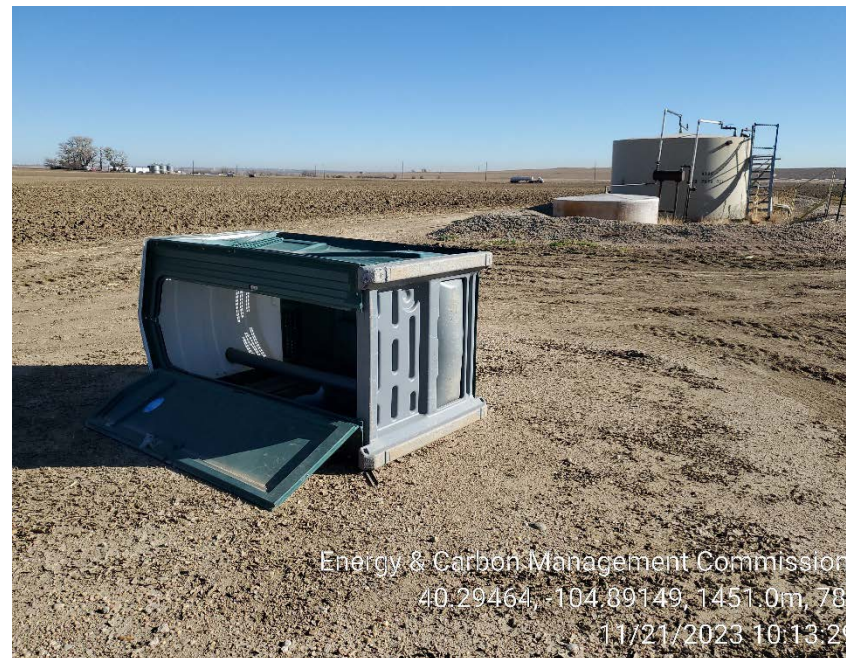
Unused equipment

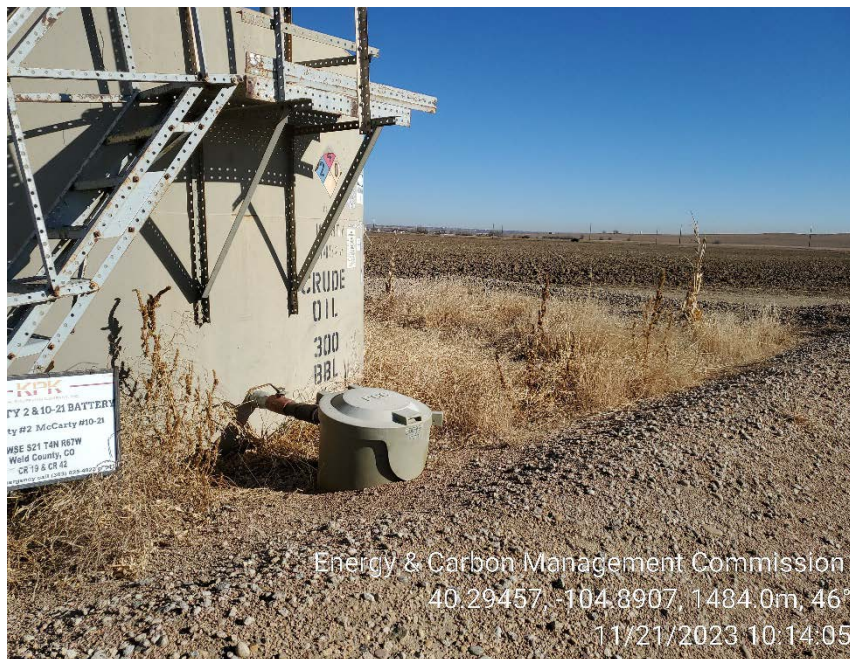
Weeds

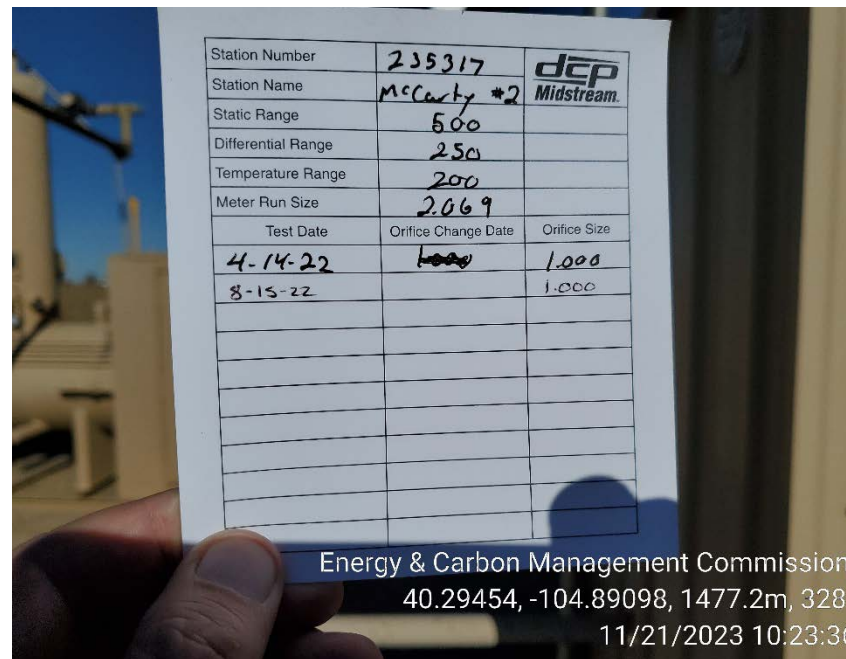
DCP meter calibration card
