Third Party Flowline Abandon in place Verification Letter

Aristocrat Angus 1-4

Client: Crestone Peak Resources Operating LLC

Facility Name: Aristocrat Angus 1-4

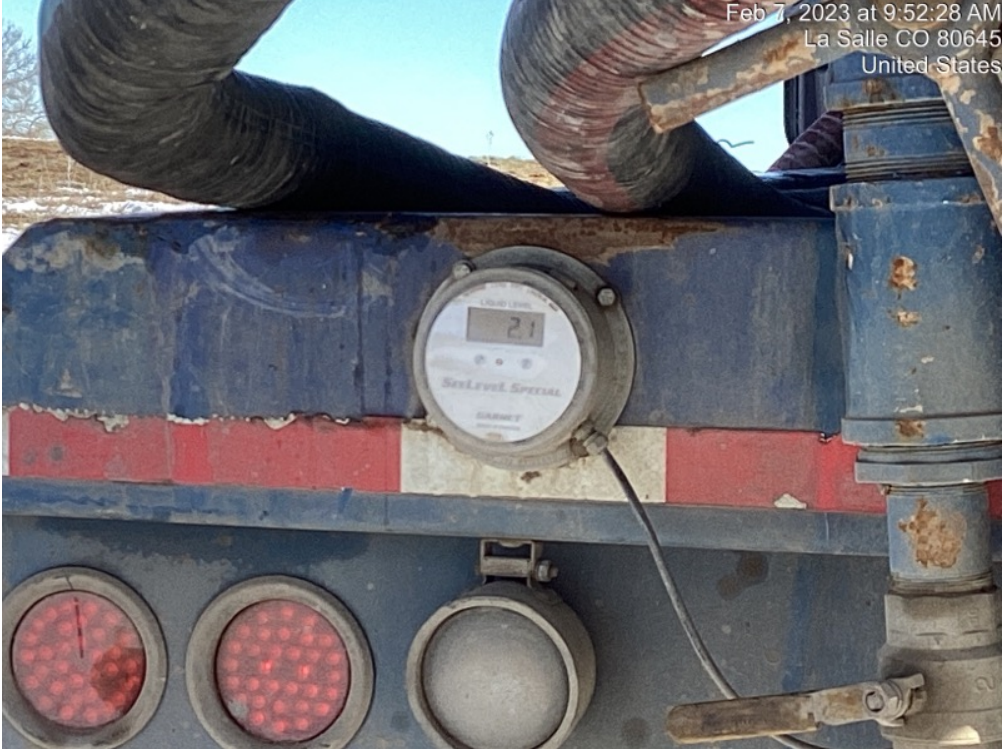
Information		Photo
<p>Photo #: Location: Description:</p>	<p>3 End B Meter on hydro vac truck located at End B prior to flushing activity</p>

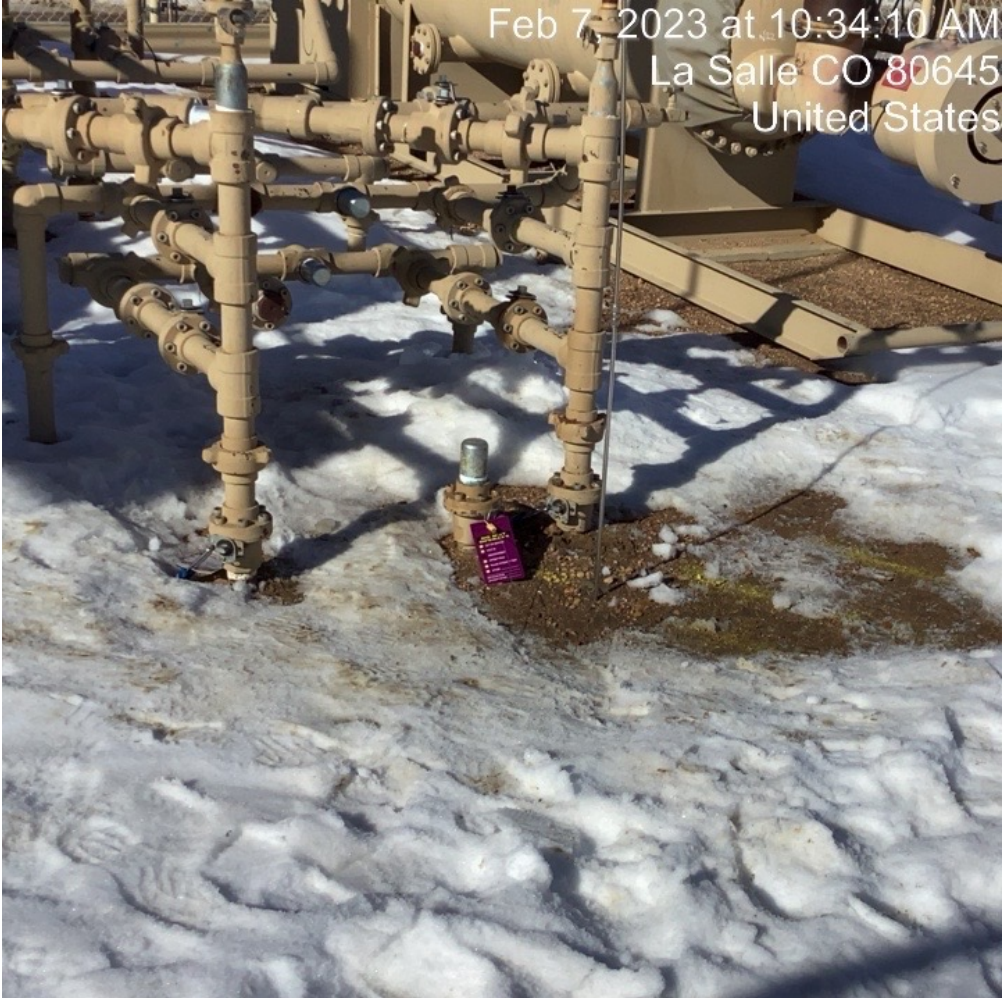
Information		Photo
<p>Photo #: Location: Description:</p>	<p>5 End B End B post flushing activity</p>	<p>Feb 7, 2023 at 10:34:10 AM La Salle CO 80645 United States</p>
