## Inspection Photos

Location Name: TEP Rocky Mountain LLC CLOUGH RMV 25-20 Pad

Location # 335236

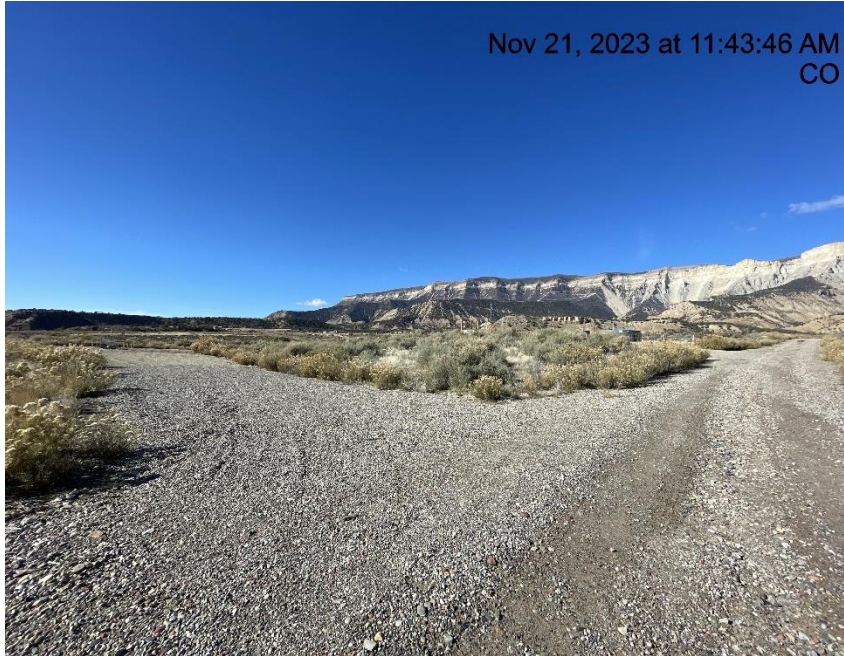
Photo # 7264 From entrance to location

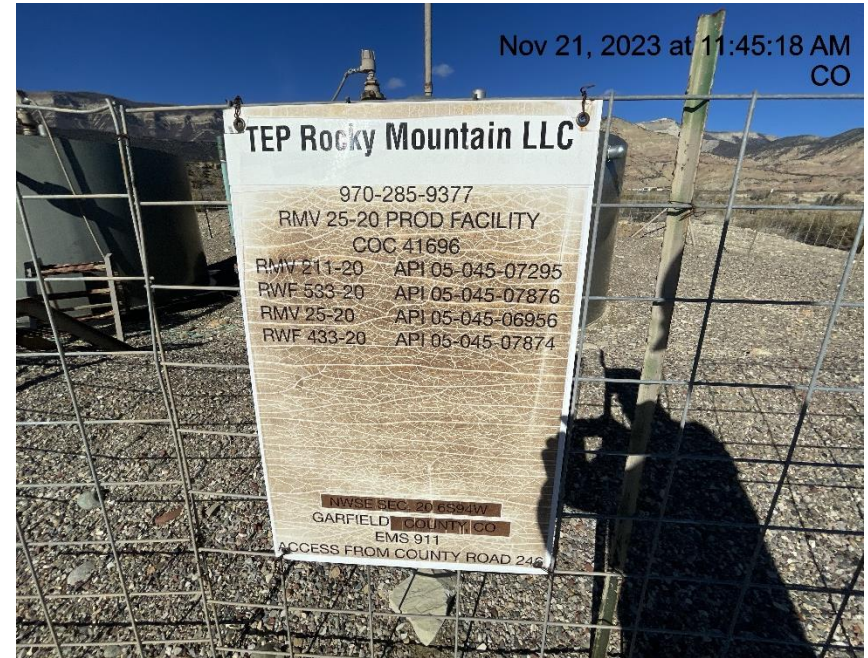
Photo # 7267 Battery sign weathered & cracking

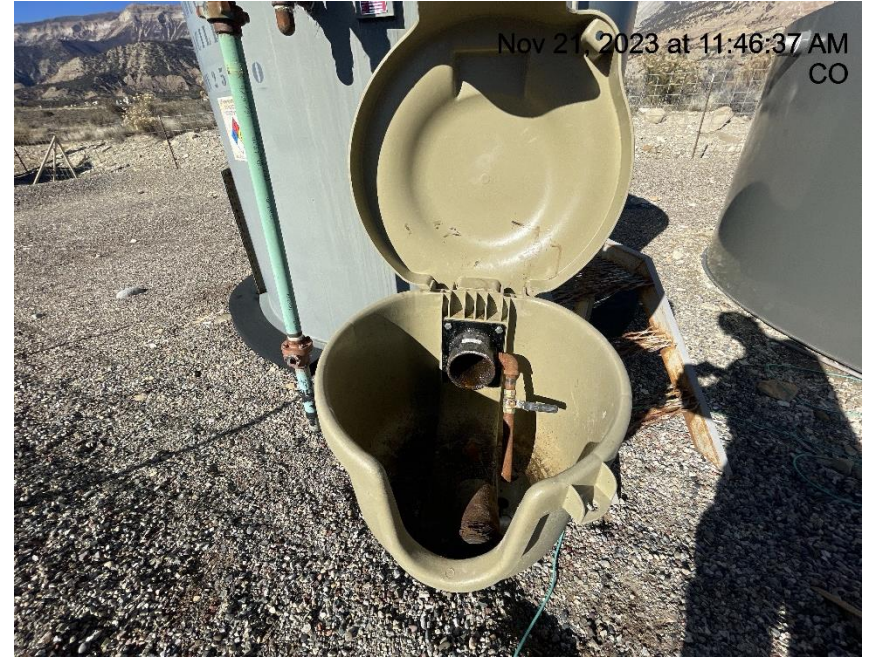
Photo # 7271 Open ended load line

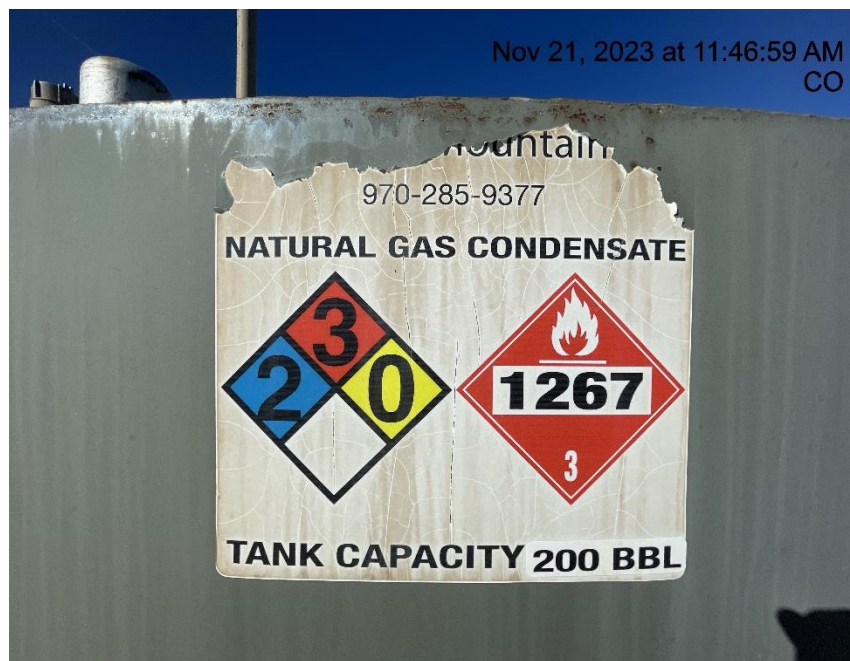
Photo # 7272 Tank label damaged & missing required information
