Inspection Photos

Loc #: 484359

Operator: DESERT EAGLE OPERATING

Inspection Date: 11/21/2023

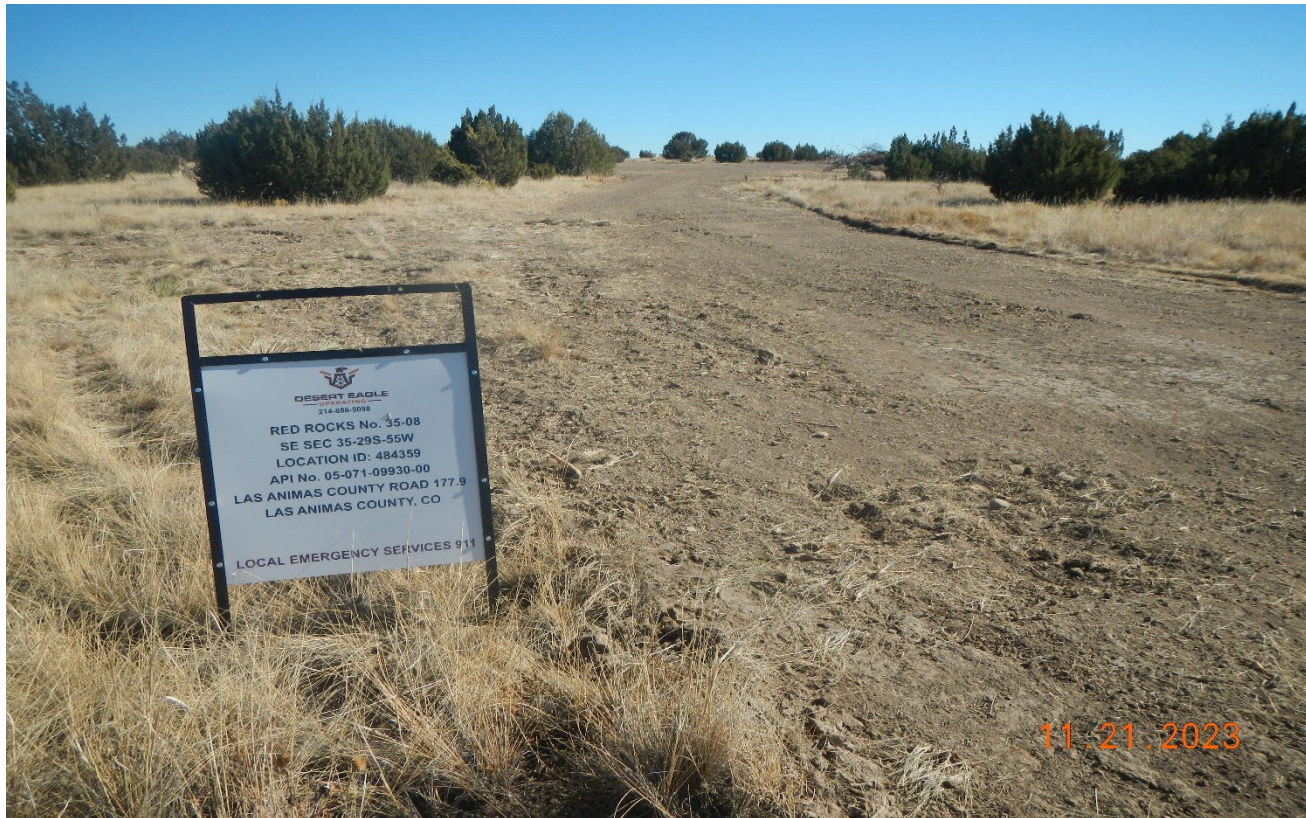
Photo 1. Facing east along the access road to the Red Rocks #35-08 drill site.

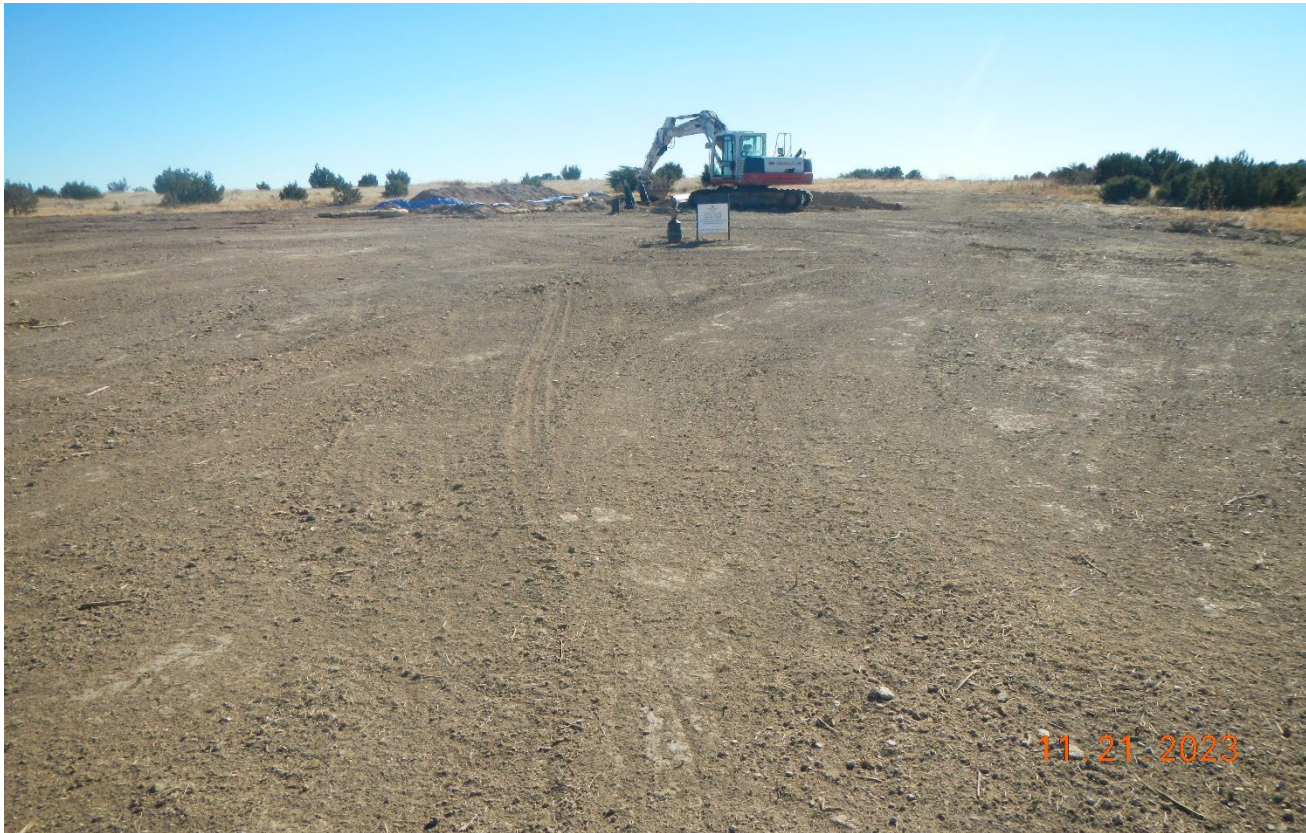
Photo 2. Facing southeast toward the Red Rocks #35-08 drill site. It appears soils have been graded however, soils are compacted from heavy equipment and will need to be properly decompacted.

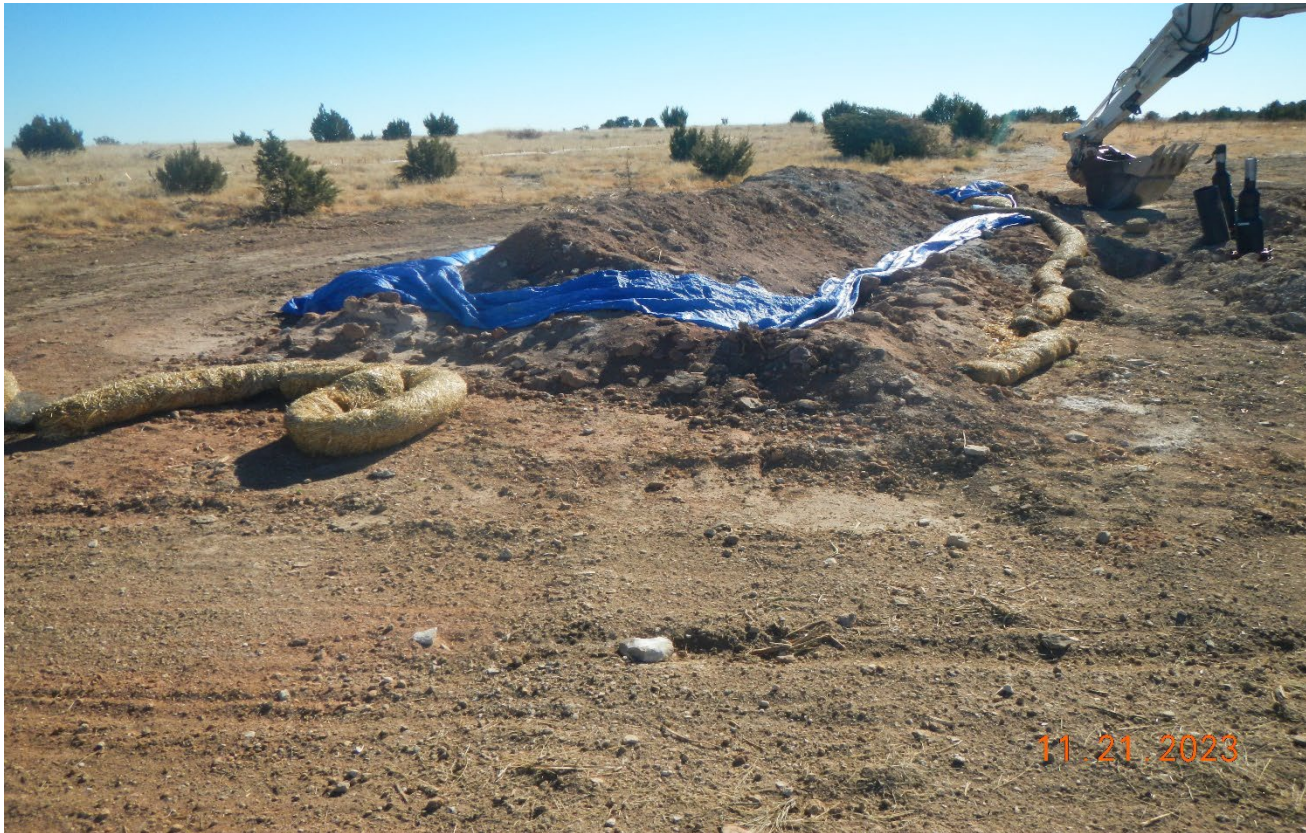
Photo 3. Facing southeast toward the drill cuttings pile. The pile is not properly stored with containment. It appears the drill cuttings were used as berms and wattles are not maintained around the pile.

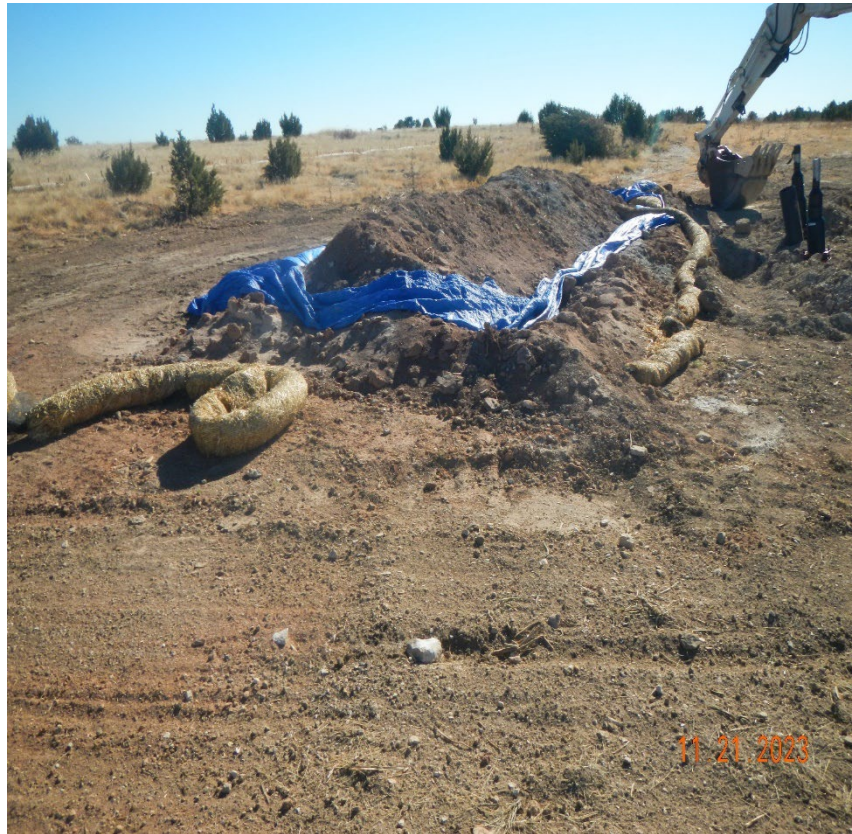
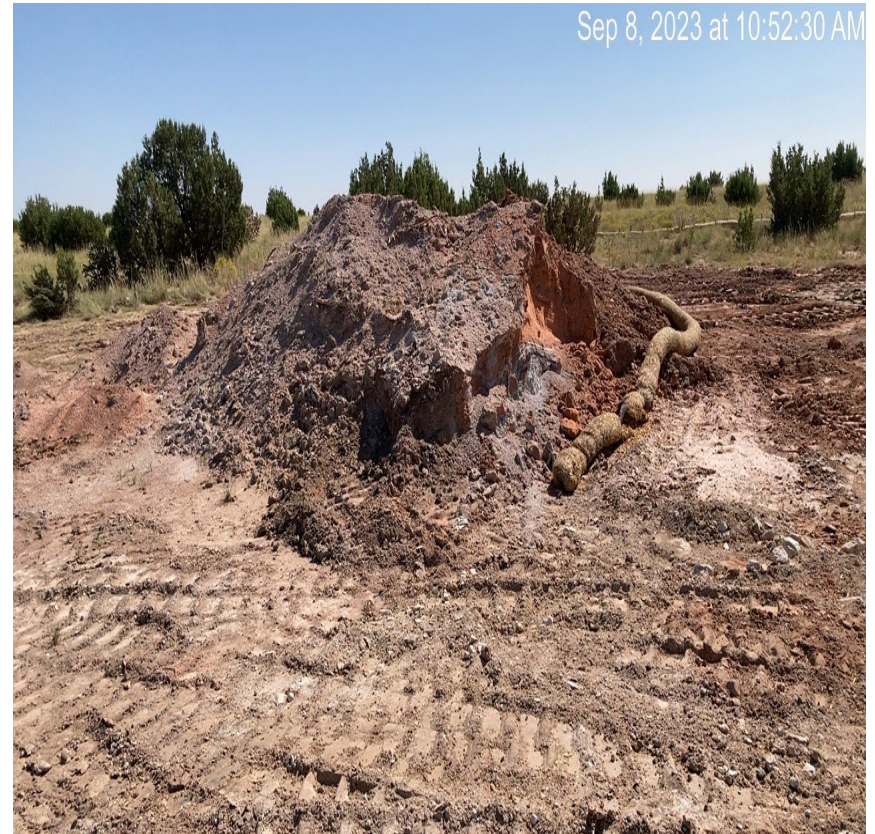
Photo 4. It appears the pile has been reduced in size since previous inspection. Photo on the left was taken 11/21 compared to the photo on the right taken 9/8/2023.

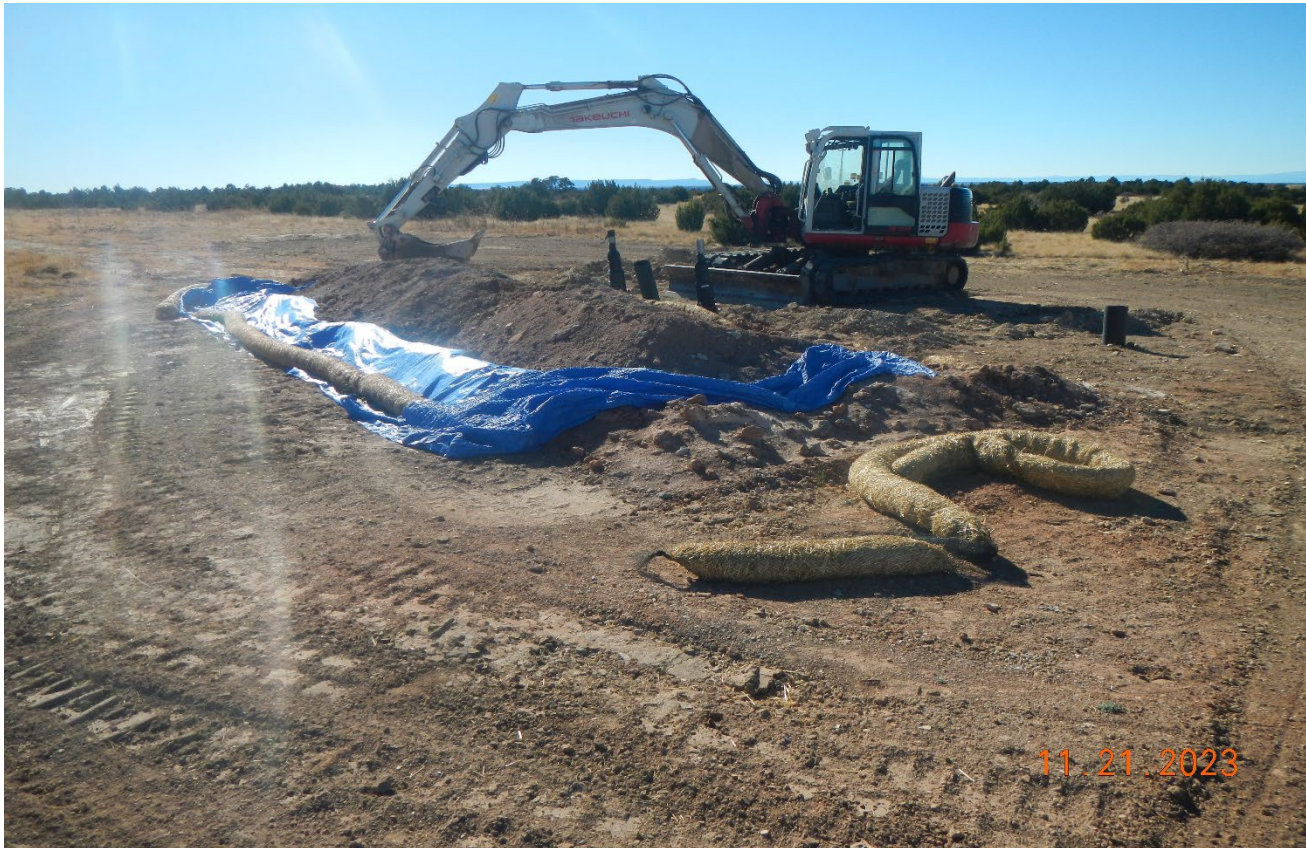
Photo 5. Facing southeast toward the drill cuttings pile. The pile is not properly stored with containment. It appears the drill cuttings were used as berms and wattles are not maintained around the pile.

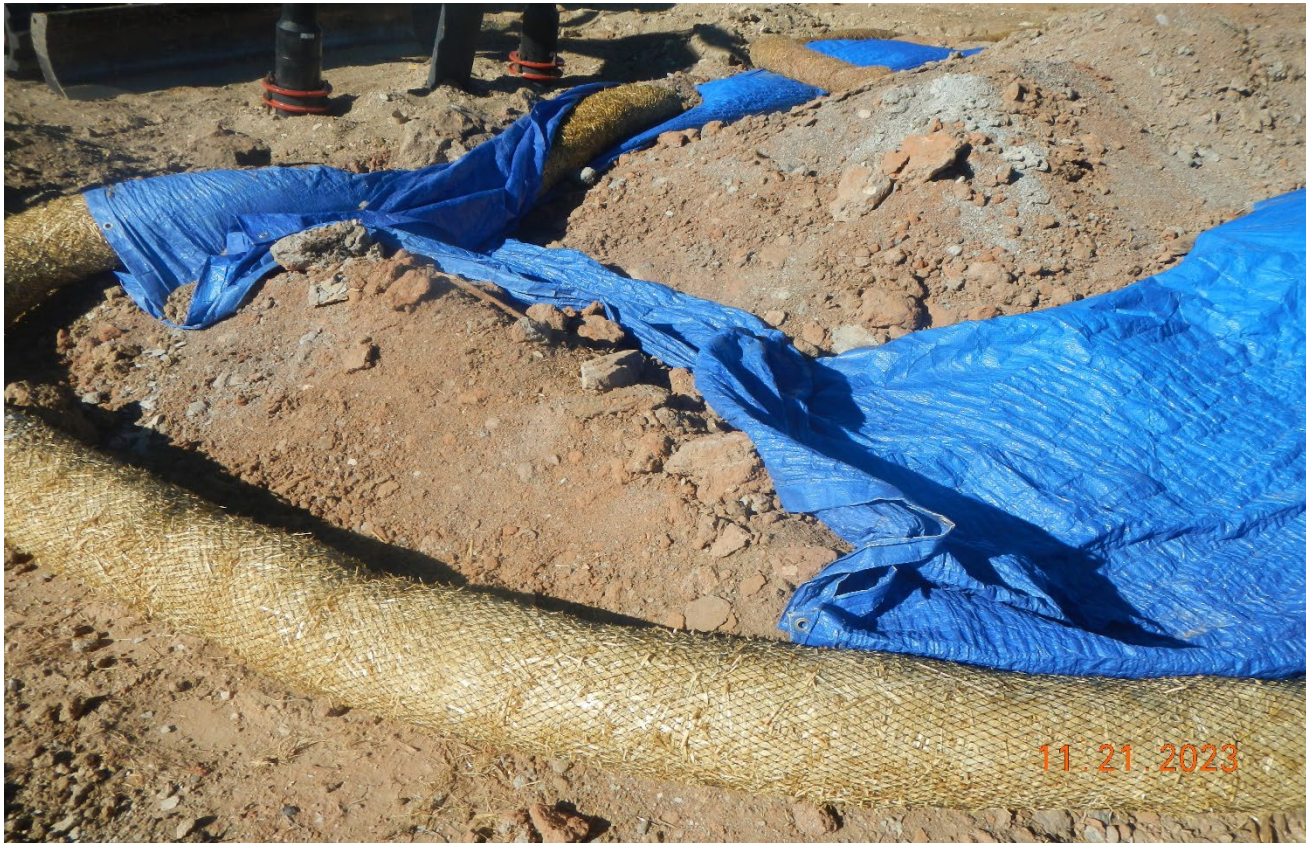
Photo 6. The material used for a berm is the same color as the drill cuttings. The cuttings pile is not properly stored with sufficient containment..

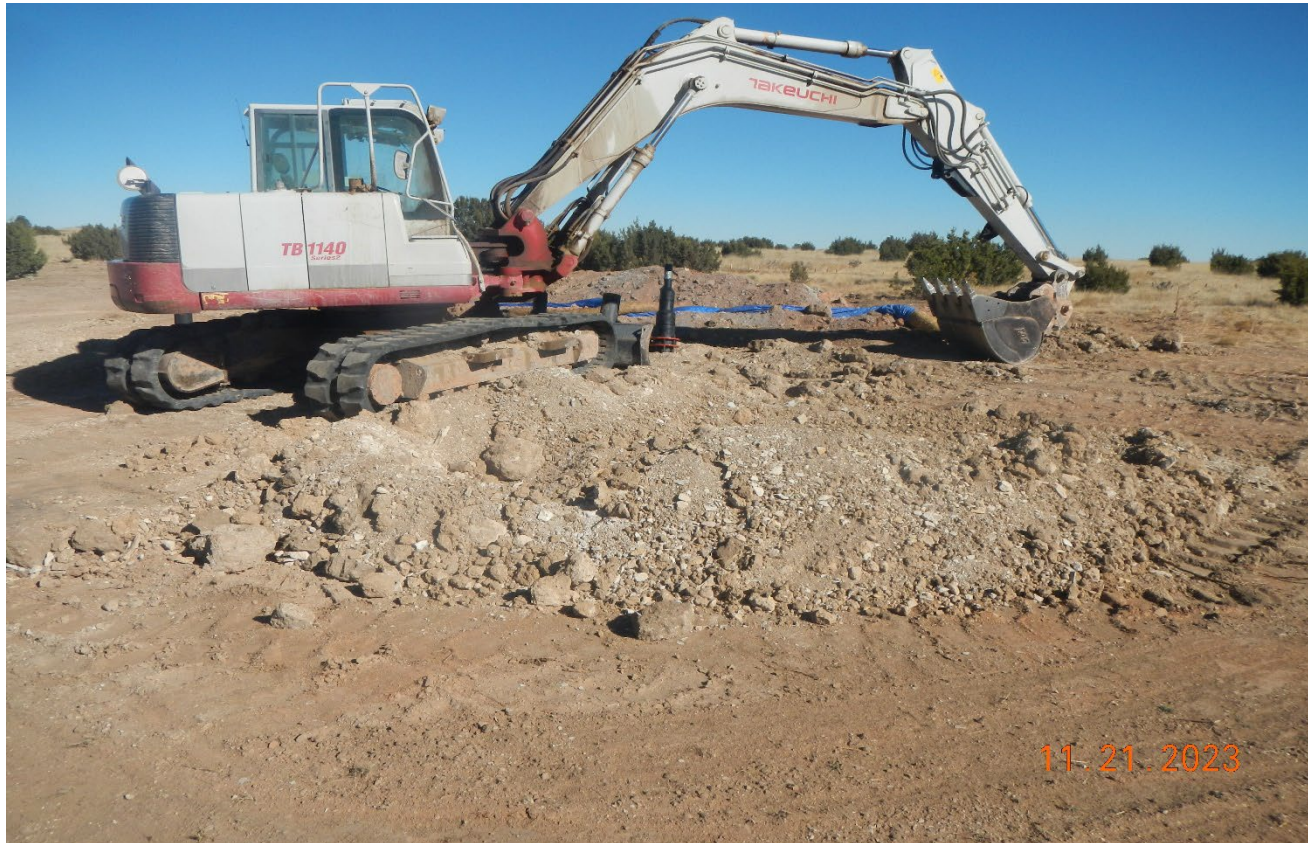
Photo 7. It appears the area of the wellhead was excavated and subsoils were brought to the surface. The subsoils have the light colored rock material shown in the pile next to the excavator.
