Inspection Photos

Location Name: VISION ENERGY LLC, SOUTH SHALE RIDGE-68S98W/14NENE

Location ID: 324270

Date: 11/22/2023

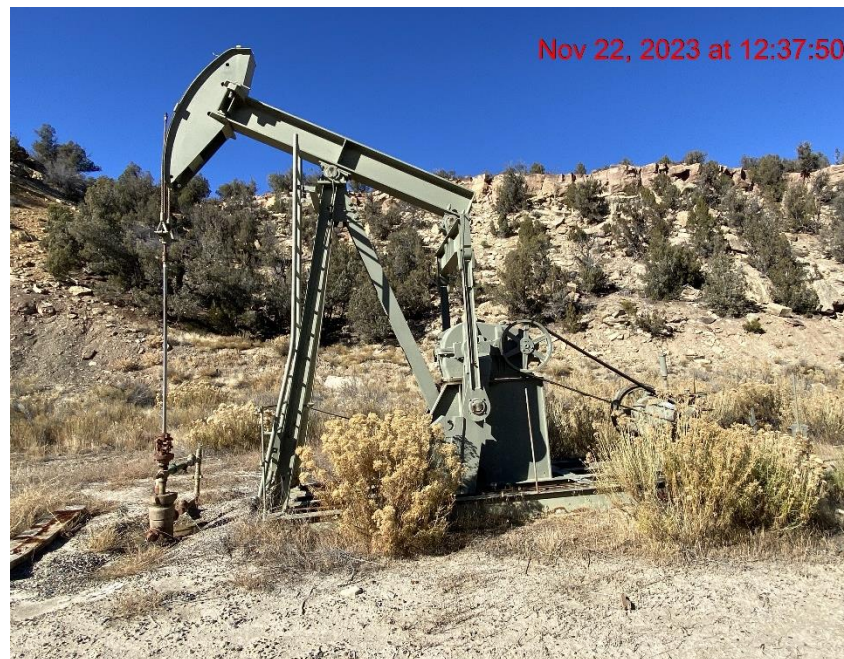
Wellhead/Weeds – Photo #07603

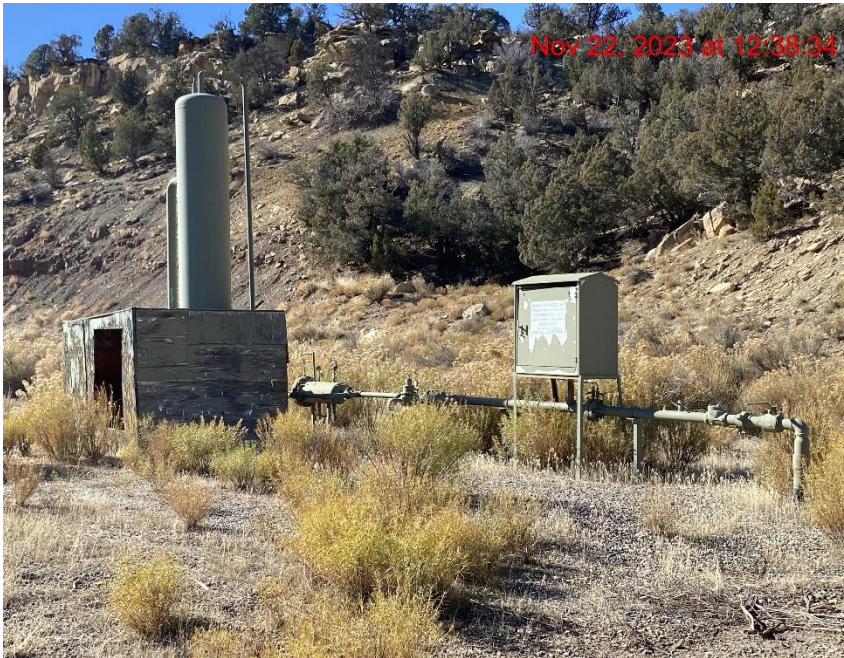
Separator/Gas Meter/Weeds – Photo #07605

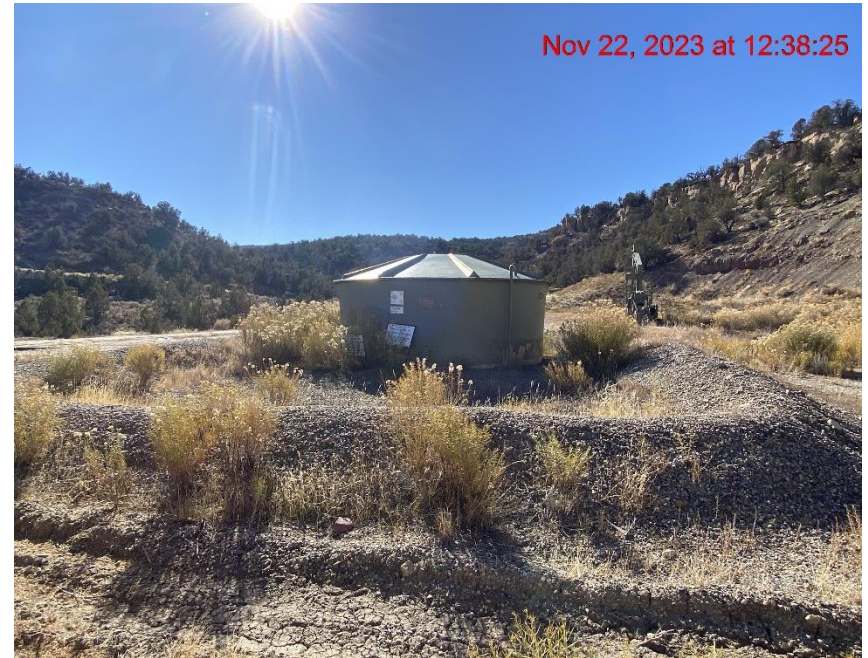
Tank Battery/Weeds – Photo #07604

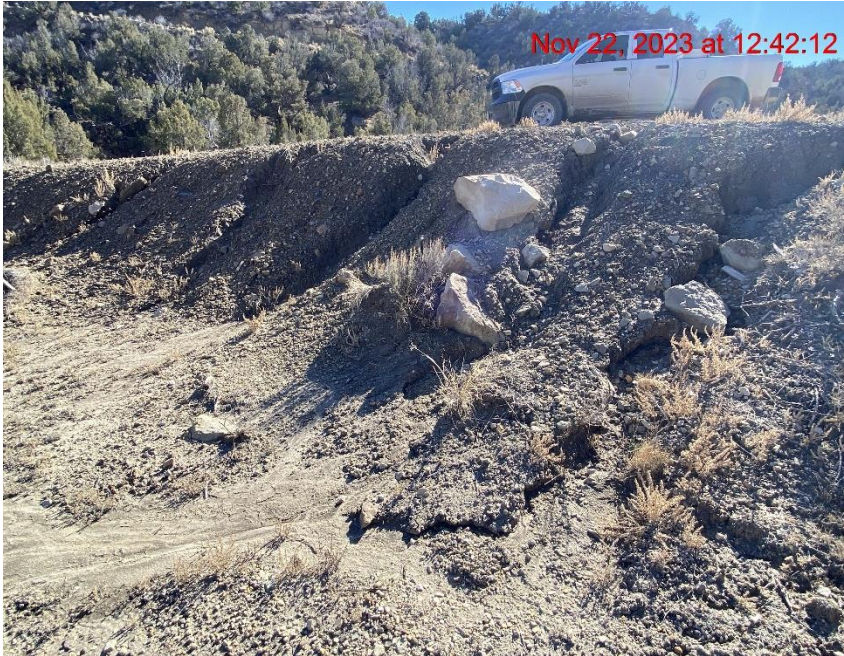
Erosion Transporting Sediment Off Location – Photo #07614

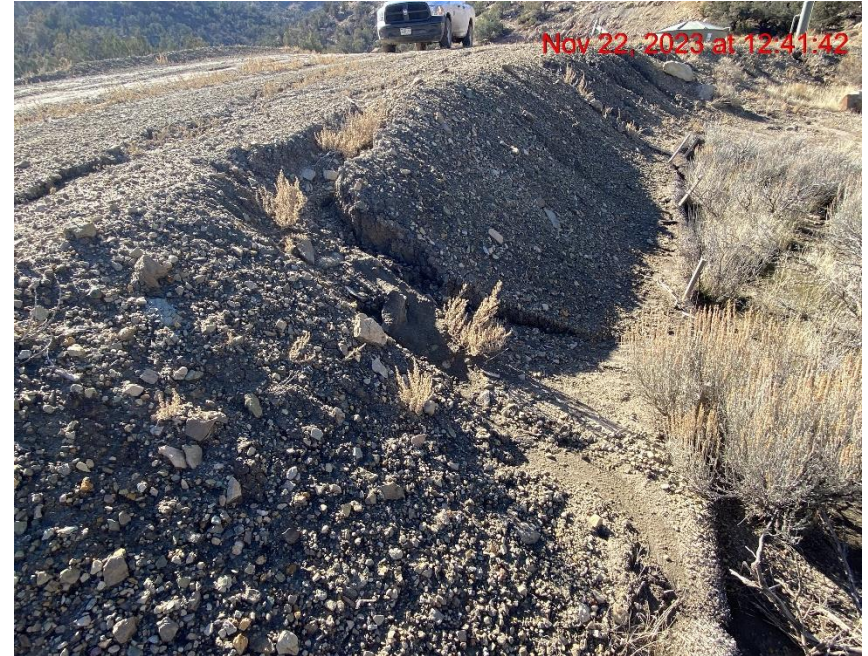
Erosion Transporting Sediment Off Location – Photo #07612

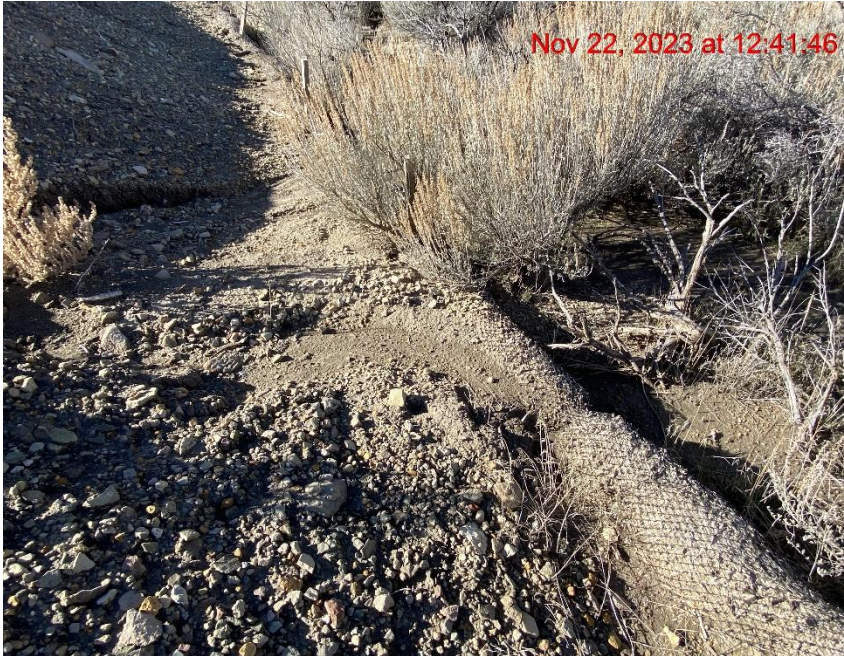
Insufficient Waddle BMP – Photo #07613

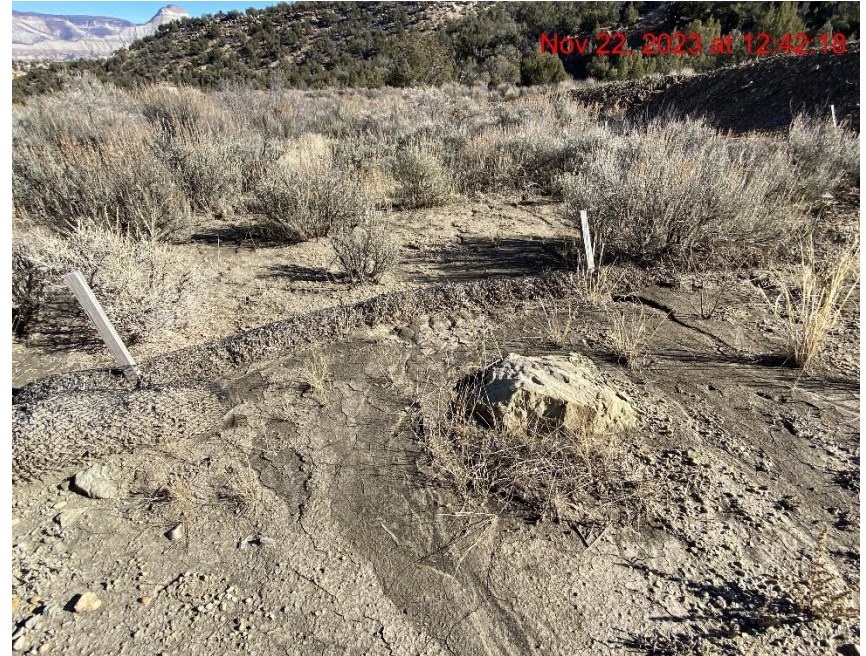
Insufficient Waddle BMP – Photo #07615

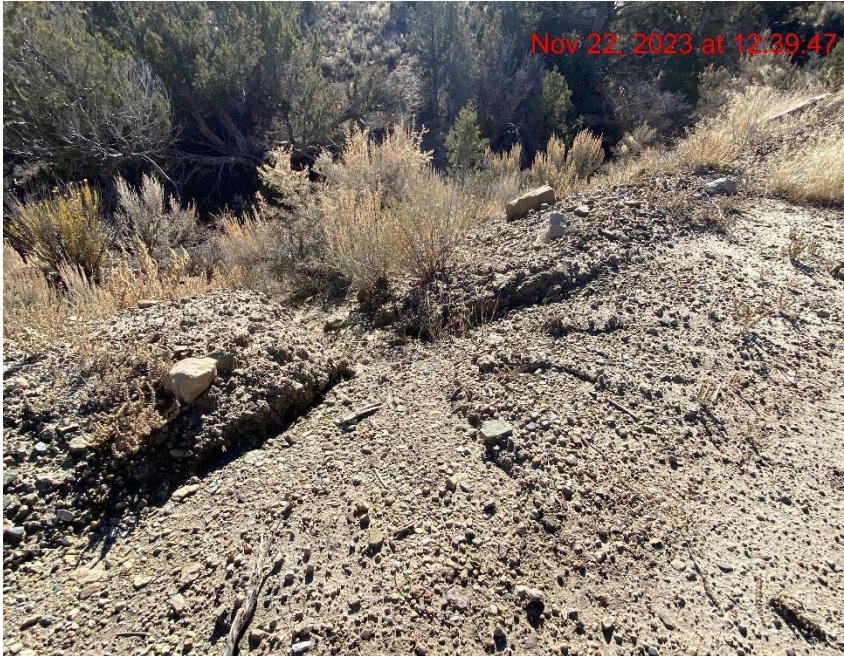
**Erosion Transporting Sediment to Watershed – Photo
#07606**

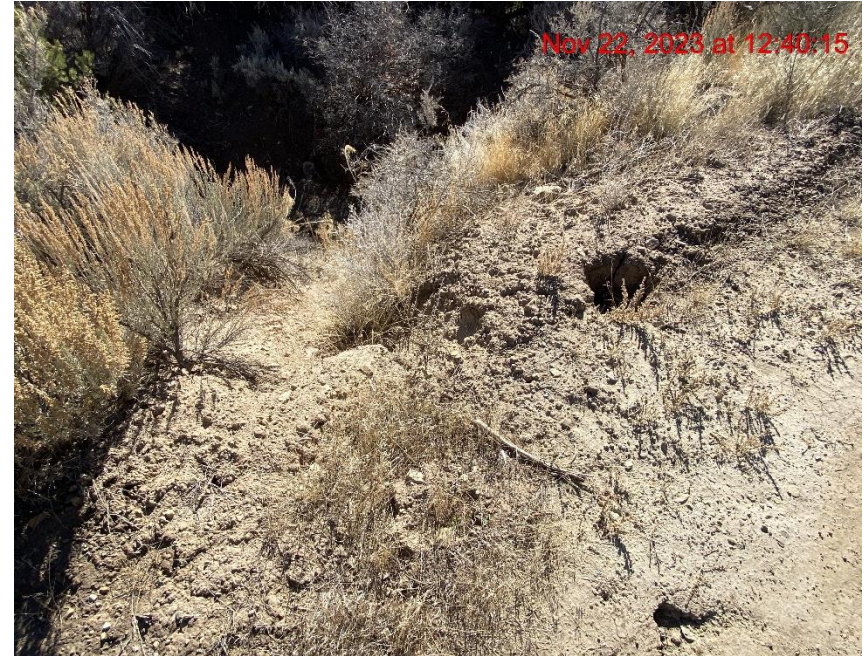
**Erosion Transporting Sediment to Watershed – Photo
#07607**

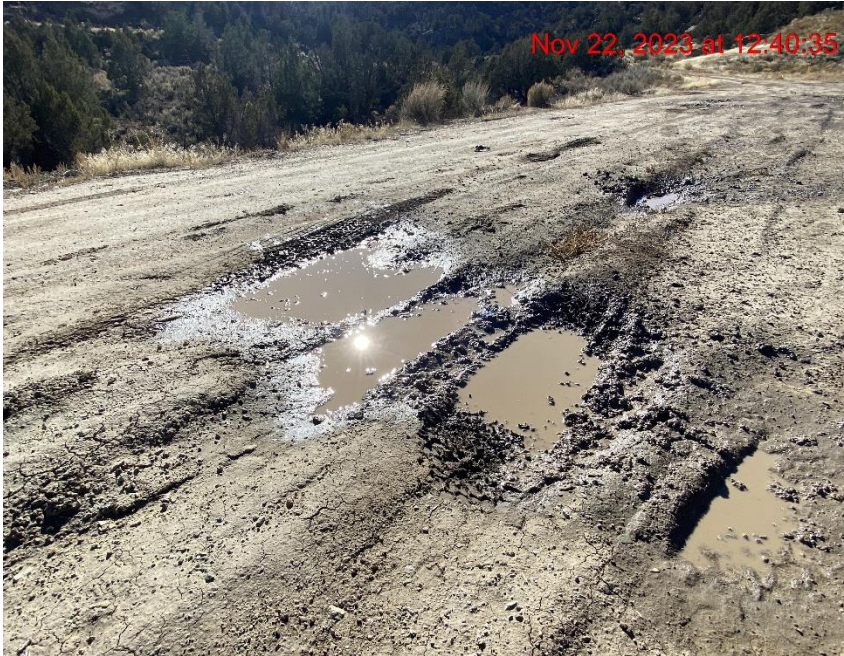
Lack of Stabilization – Photo #07608

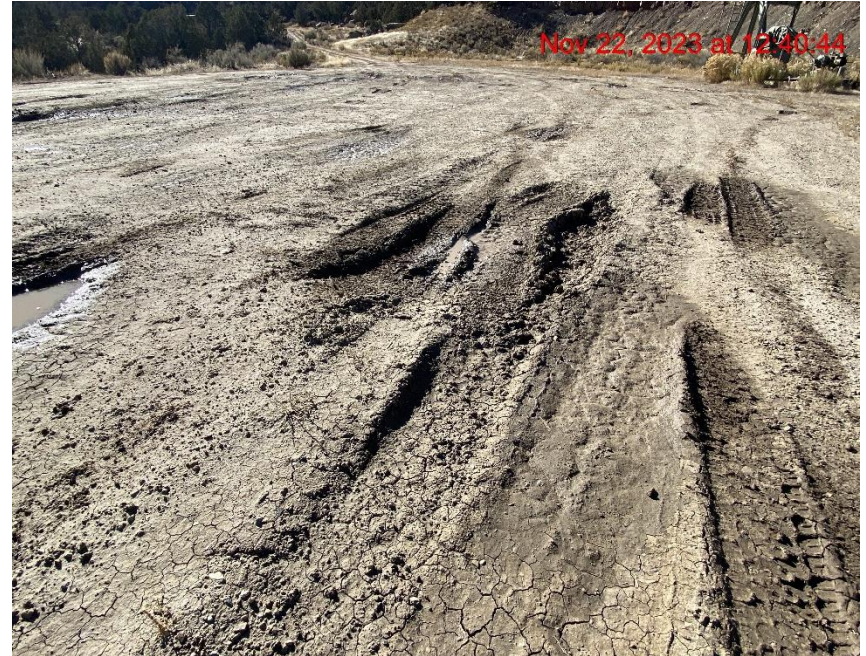
Lack of Stabilization – Photo #07609

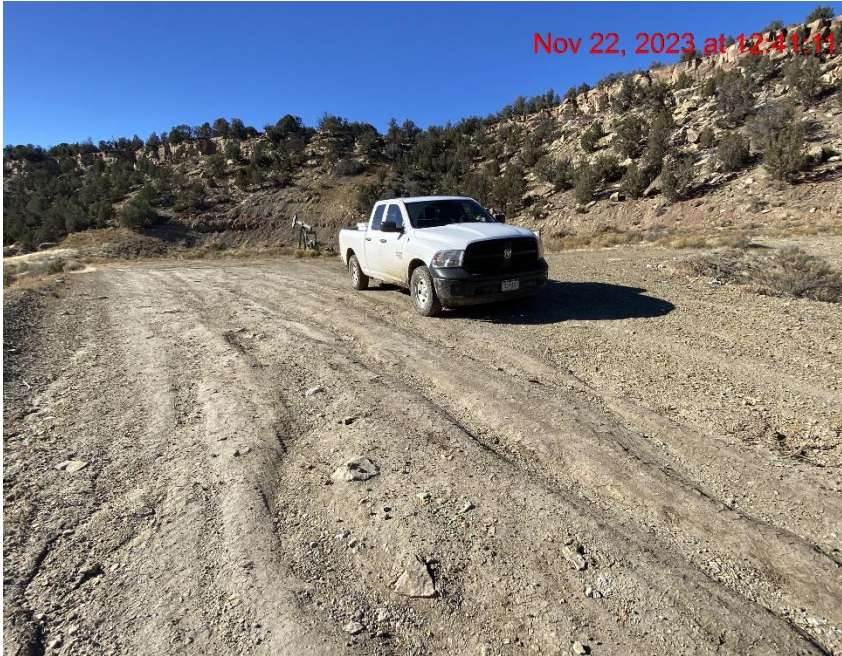
Insufficient Vehicle Tracking BMPs at Location Entrance/Exit
– Photo #07610
